ENGINEERING OPINION
INVESTIGATION OF FOUNDATION PERFORMANCE
RESIDENCE AT 16711 BENTFIELD WAY, HOUSTON, TEXAS, 77058
Date of Inspection: February 21, 2019
Date of Report: February 24, 2019

16711 Bentfield Way, Houston, Texas, 77058

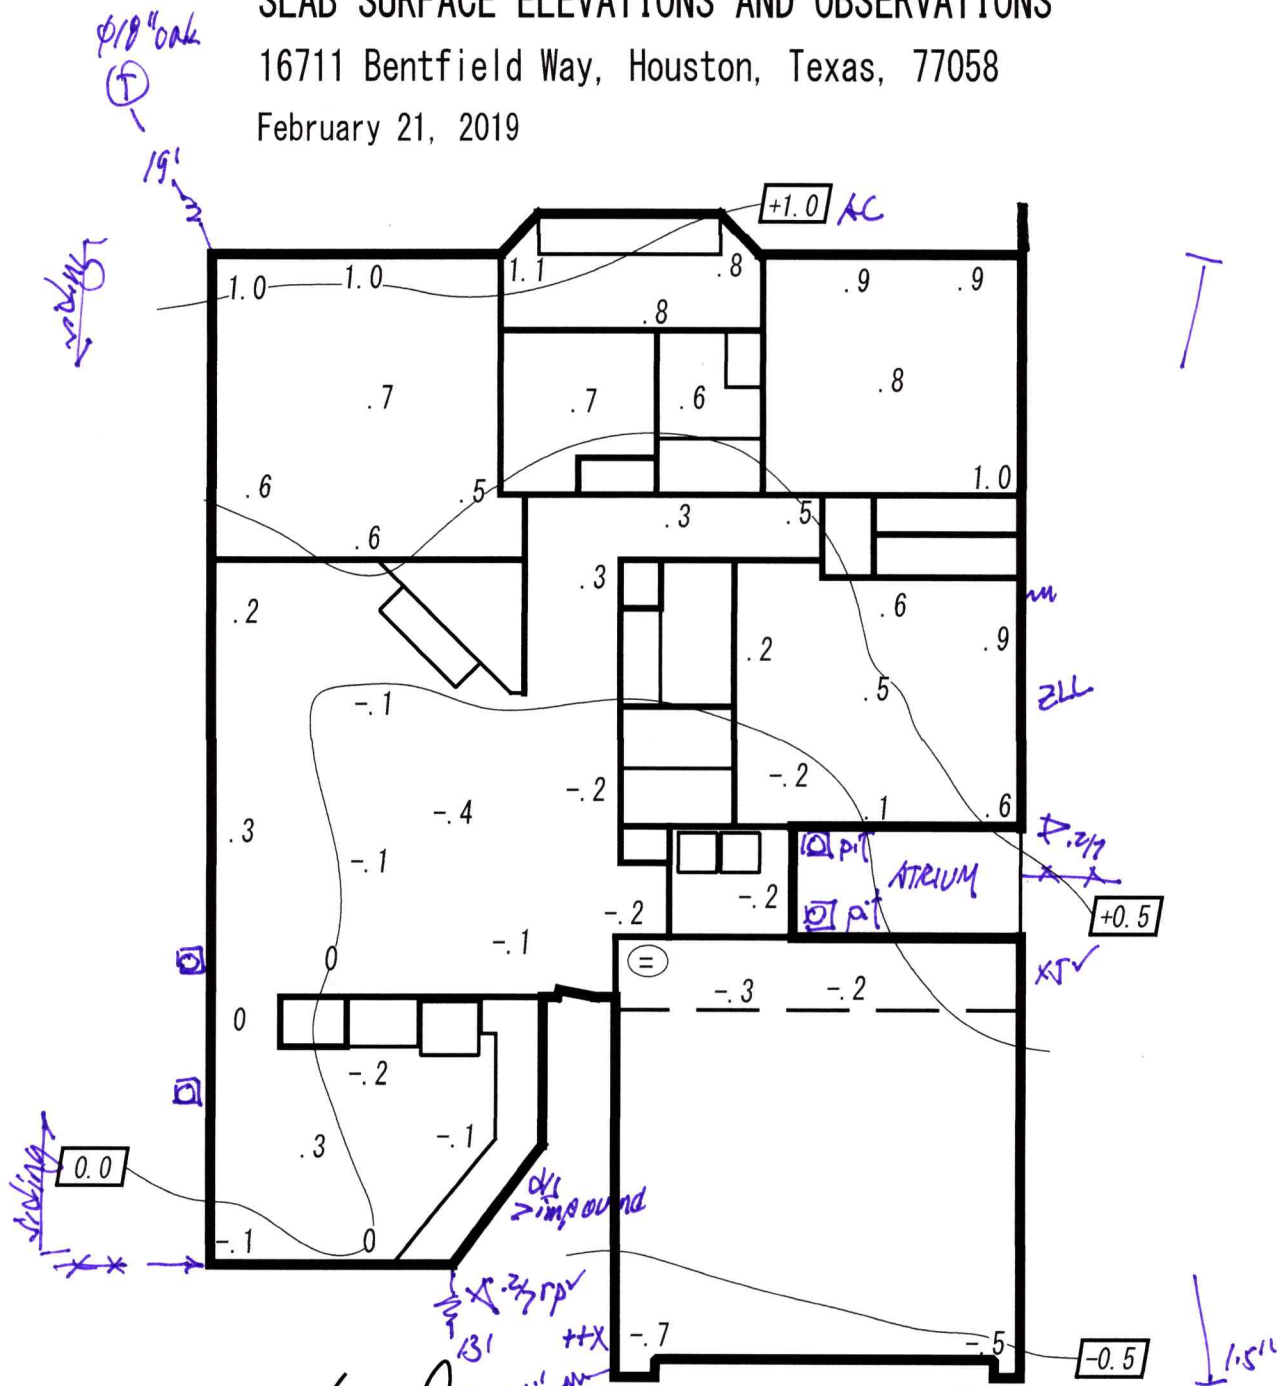
SLAB SURFACE ELEVATIONS AND OBSERVATIONS

Damages and conditions at the exterior are shown on the attached Elevation survey sheet. Observed a deviated brick mortar line at the right wall, up in the middle. Also observed a separation at the atrium wall, opened at the top. The left side is siding; siding does not show damages from foundation movement readily. Observed signs of foundation repair at the front half exterior, in the form of concrete breakouts and settlement of backfill.

Inspection of the exterior found deficient drainage and landscape conditions, as shown on the attached Elevation survey sheet. These include pits formed by backfill collapse at the atrium.

Damages and conditions at the interior are shown on the attached Elevation survey sheet. No damages indicative of foundation movement were observed.

An elevation survey throughout the house was performed using a Technidea Zipllevel. The elevations have a range of 1.8 inches, highest at the back of the master bathroom, lowest at the front left corner of the garage. The foundation is generally flat and level.

- ELEVATIONS IN INCHES
- CORRECTED FOR FLOORING
- CHARACTERISTIC DAMAGES ANNOTATED
- ISO-ELEVATION (CONTOUR) LINES AT .5 INCH INTERVALS
- GARAGE ELEVATIONS TAKEN AT CEILING

Repair the damages if desired.

Correct the detrimental drainage and landscaping conditions.
