**HOUSTON METROPOLITAN
INSPECTIONS UNLIMITED, LLC
PHONE: 713-828-0310 OR
PROPERTY INSPECTION REPORT**

Concerning: 3411 KINGS WAY CT. KINGWOOD, TEXAS 77339

DIA5-040519

APRIL 4 2019

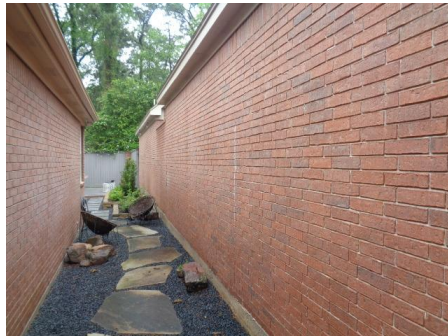
Note: We did not have access to the left side of the home. I knocked on the door and there was nobody home and there were two dogs in the back yard.

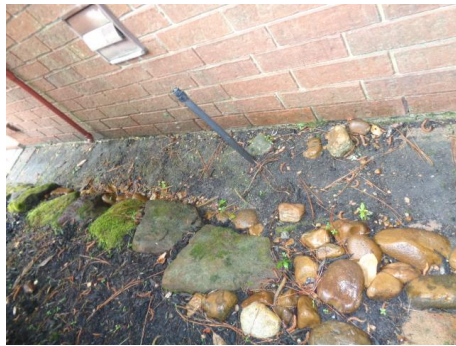
The grading should promote the flow of storm water away from the house and off the lot. The ground should slope away from the house at a rate of one inch per foot for at least the first ten feet. Ideally, at least eight (8) inches of clearance should be maintained between soil level and the top of the foundation walls. Trenching, against the foundation, is not acceptable. The target for slab exposure is 6 inches in sided areas and 4 inches in bricked veneer areas. The soil needs lowered and drains cleaned.

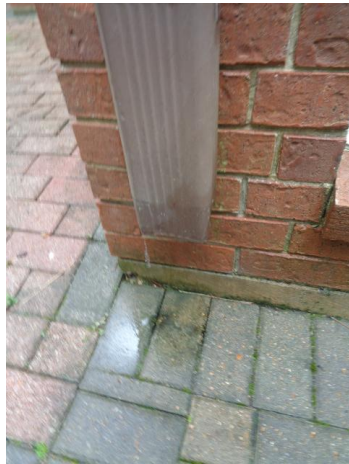
The gutter downspouts are terminating too close to the foundation; splash blocks are needed under the downspouts or downspout extensions are needed. Water runoff from the roof should be discharged at least 5 feet away from the home.

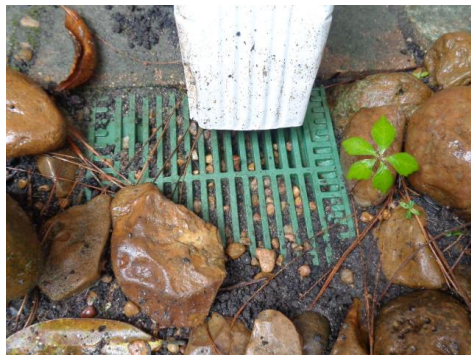
The drains in the back yard need cleaned.

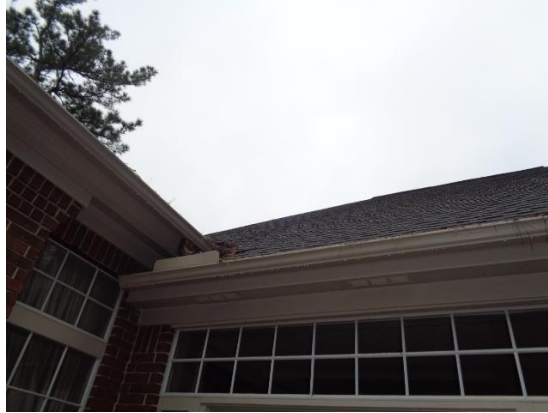
The gutters needs adjustment so they drain towards the downspout.

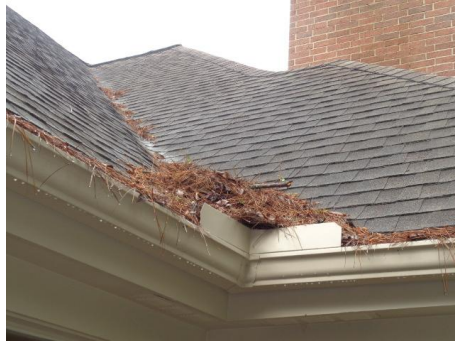
The roof & gutters need cleaned.

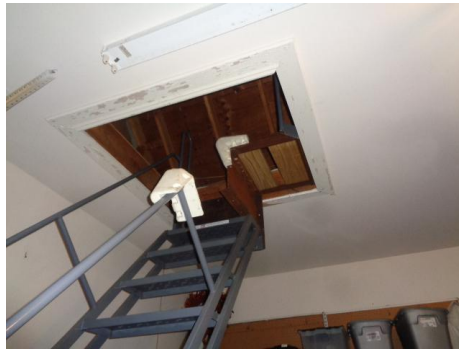
The opening in the garage ceiling does not meet today's fire safety codes for fire blocking.

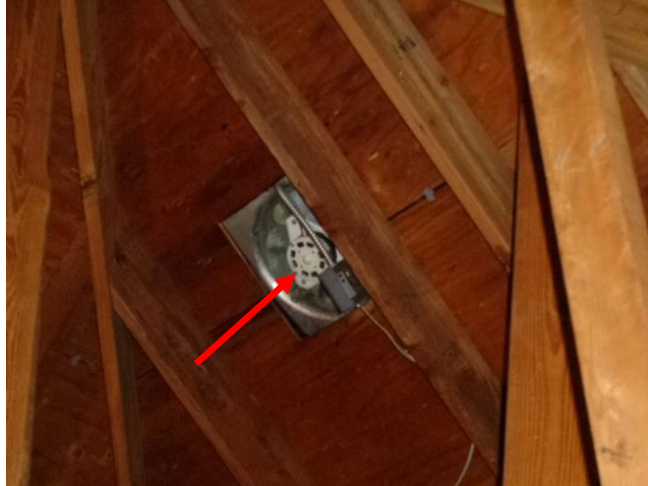
Note: There are two attic fans, which we cannot test.

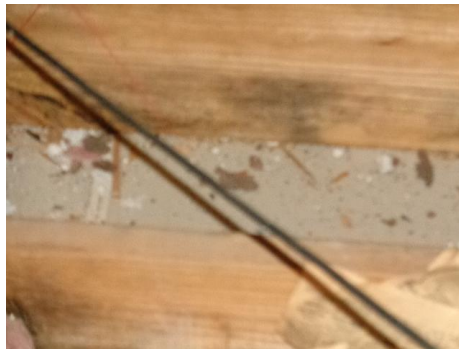
There are a couple of places in the attic where the insulation has been removed; by fireplace.

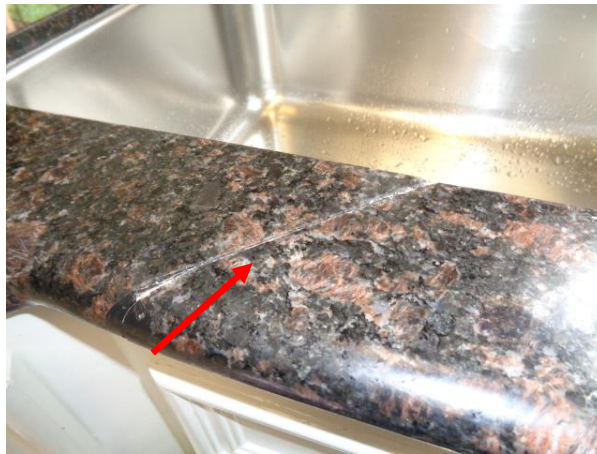
The kitchen granite counter has shifted a little.

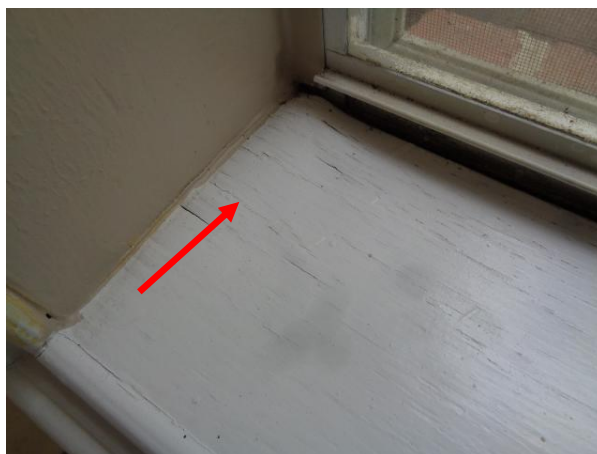
There is evidence of previous water penetration inside the window sill at the rear of the home on the left side of the back door.

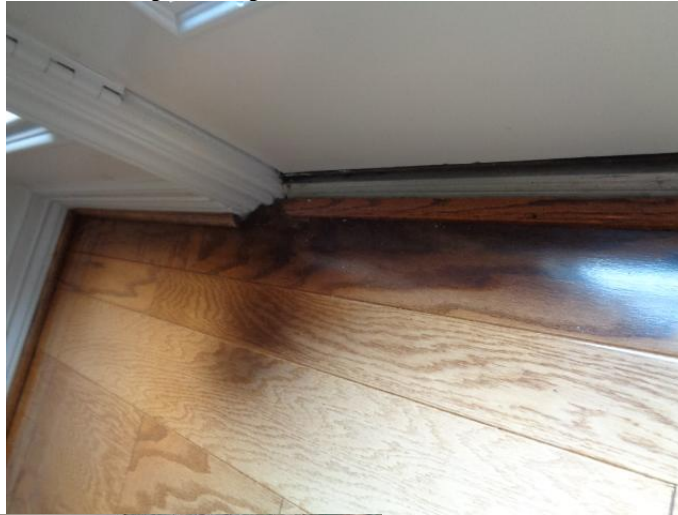
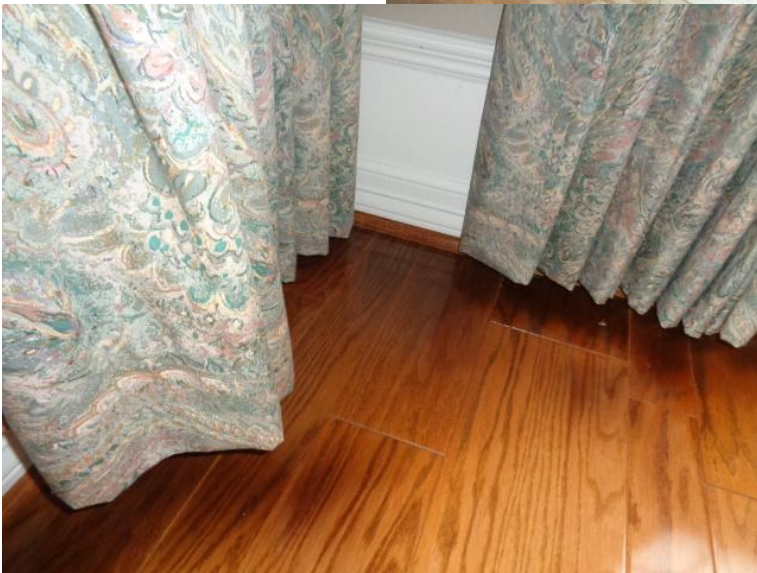
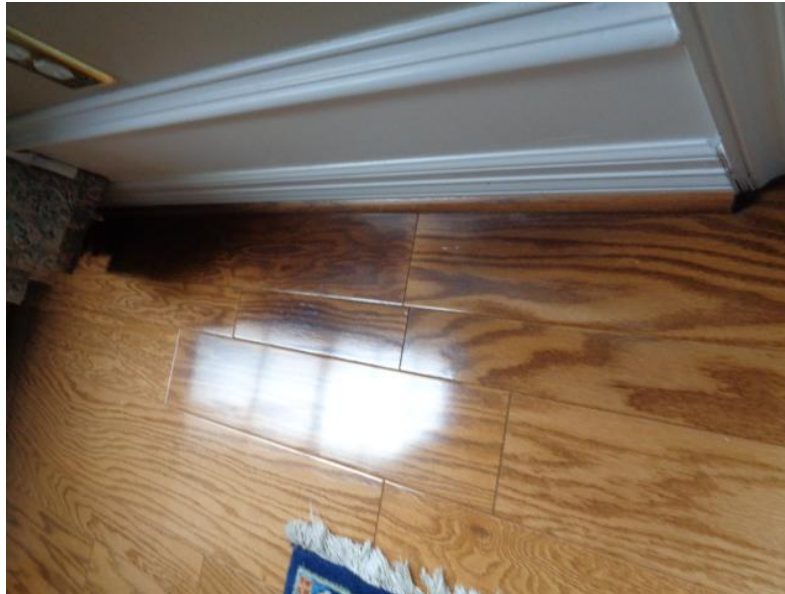
Gutters are needed at the front of the home, there is evidence of water penetration inside on the wood floors (see pictures under “F. Ceiling and Floors”). It may be advantageous to remove all the old gutters and install new 6 inches gutters which will divert a larger amount of water away from the exterior walls and doors.

The wood floors, in the front rooms, are discolored because of water penetration problems. The dark color on the edges, by the exterior walls and doors, are caused by years of moisture. We used a moisture meter and the floors were damp/wet in places.

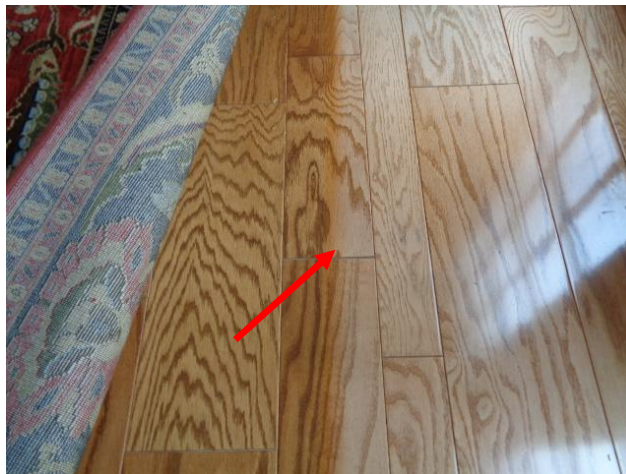
The wood floors have discolored from the sun, too (we pulled up the area rugs and it is darker under the rugs).

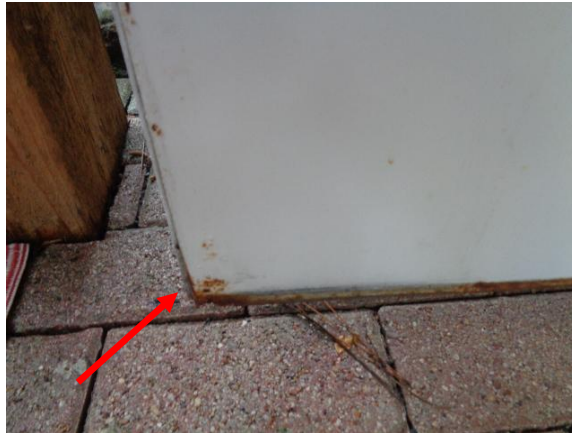
There is rust at the base of the kitchen back door.

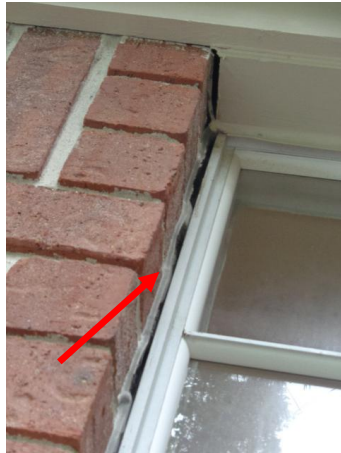
There are missing window screens.

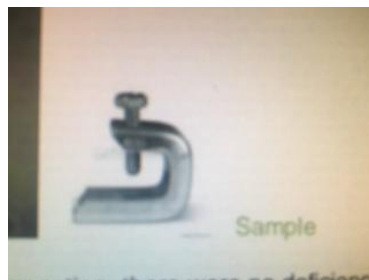
Observed absence of damper stop clip which is required when there are gas logs.

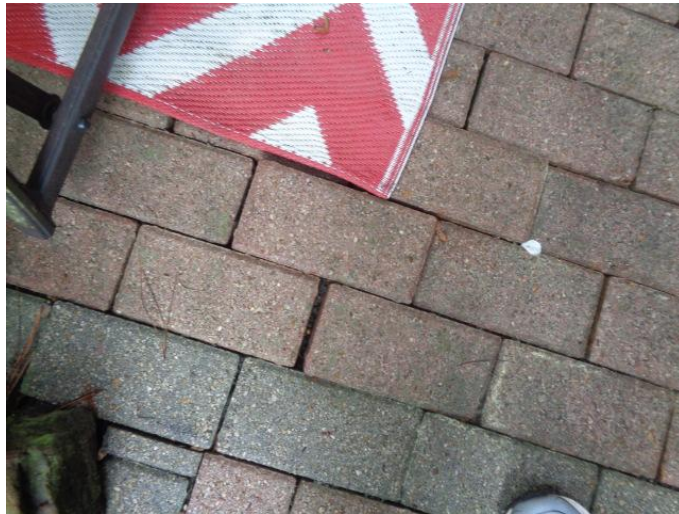
The pavers have shifted in the back yard in several areas, which cause a trip hazard.

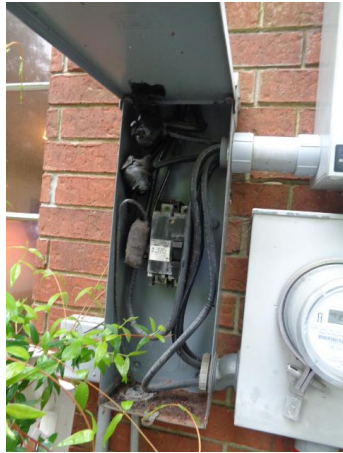
The dead front cover is missing on the electrical panel box located on the rear wall of the home.

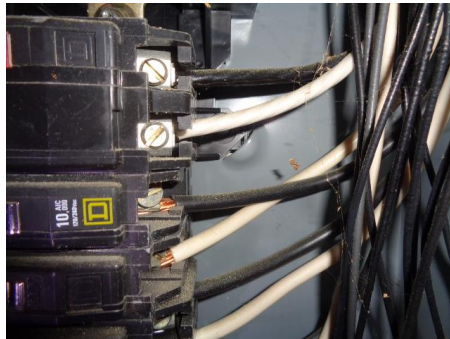
There were "white wires" attached to breakers. White wires are deemed neutral and must be identified as hot wires by tape or red or black paint at breaker end.

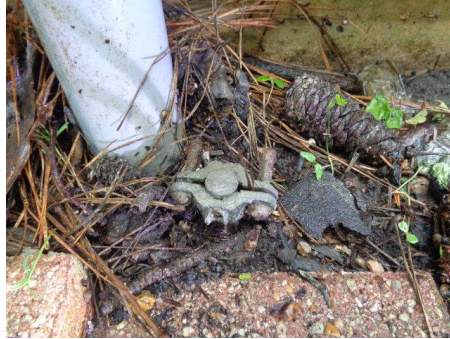
The grounding wire is NOT connected to a grounding rod.

Note: The ground wire is not connected to the grounding rod with an acorn clamp.

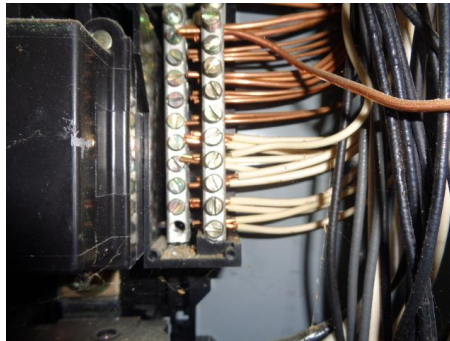
Today's breaker panels have a neutral bar on one side and a grounding wire bus bar on the other – all neutral wiring and all grounding wires should be attached only to the appropriate bar – on the neutral side, each wire should be connected to a separate lug.

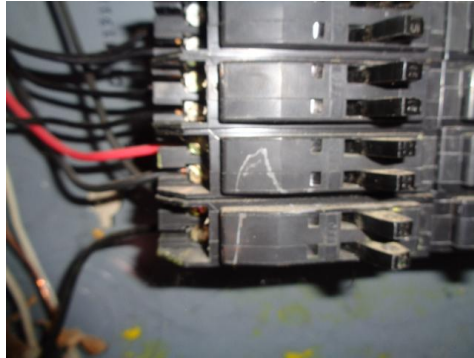
Also, there were breakers which appeared to serve a single conductor, indicating conductors may be connected to 240-volt circuits (red and black); trip ties are needed.

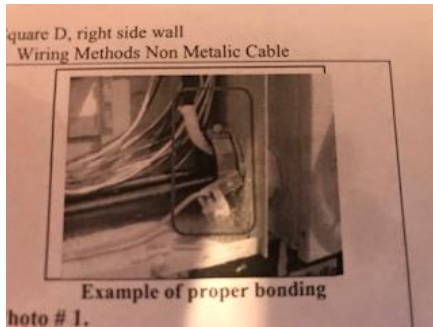
Current building standards require the box to be bonded.

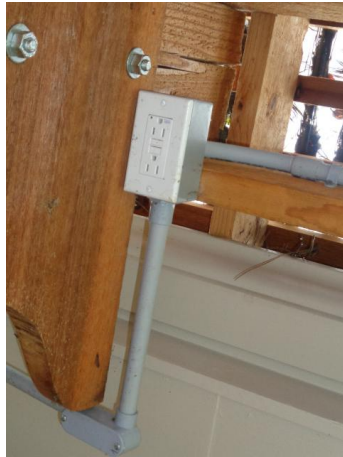
Ground Fault Circuit Interrupters(s) GFCI protection were missing on the garage ceiling receptacles and one wall receptacle and laundry room receptacles. While this may not have been a code requirement when the home was built it is now a requirement for all TREC Licensed inspectors to call this item to the buyers attention and mark as deficient.

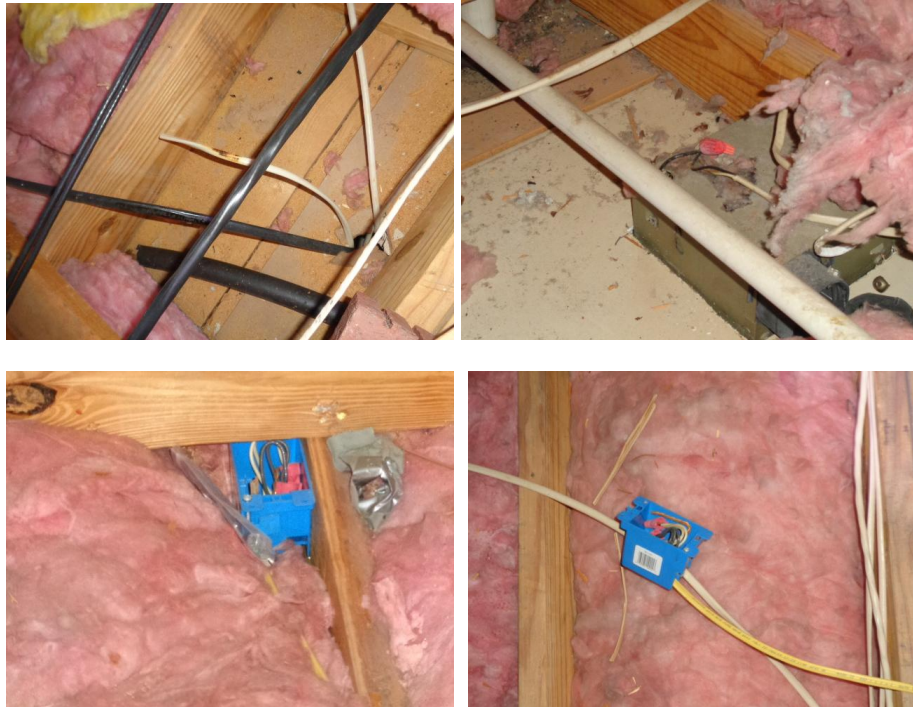
There are spliced wires that need installed in a junction box and covers needed on junction box.

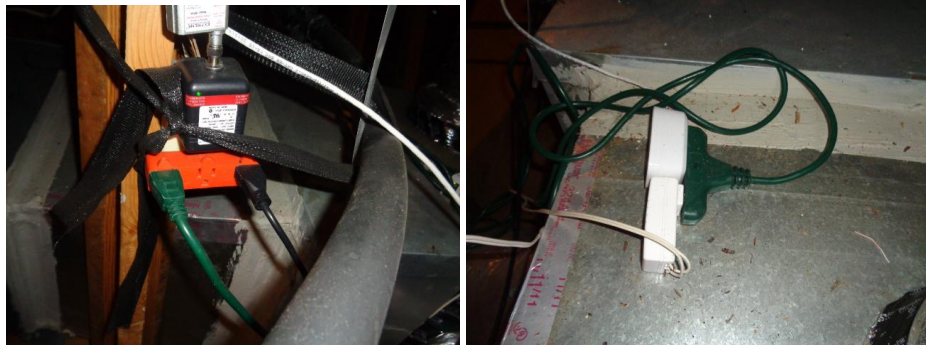
Extension cords cannot be used as permanent wiring.

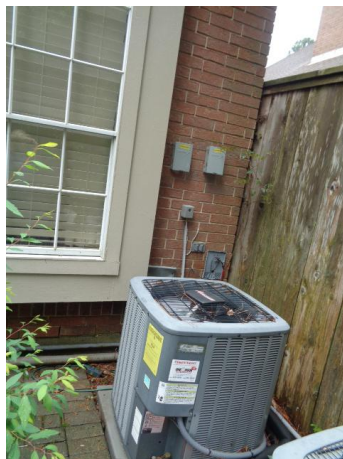
The AC service disconnect is located behind the condenser and does not have full clearance required for safe access.

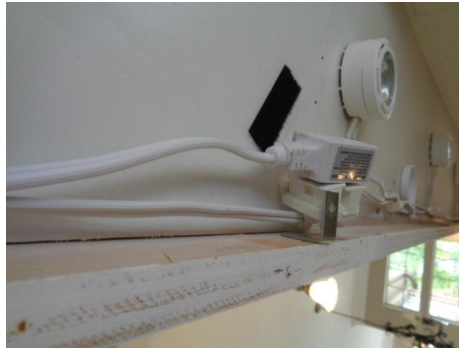
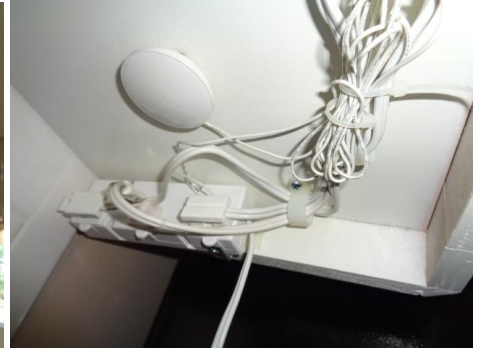
There are spliced wires and extension cords under the kitchen cabinet.

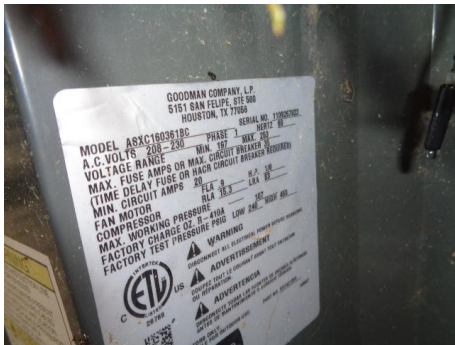
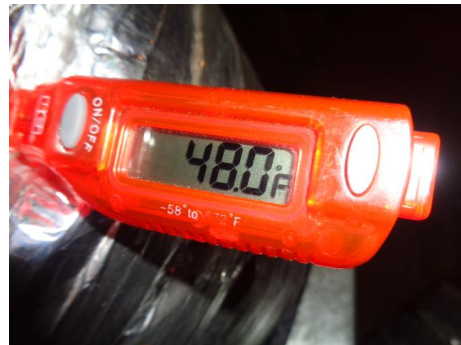
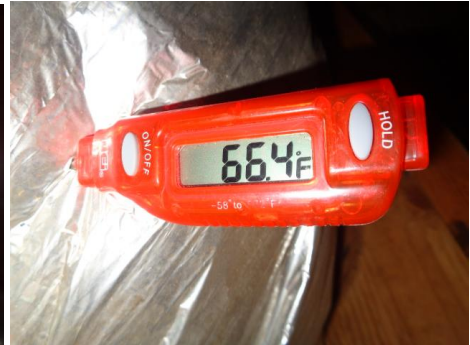
The AC unit is a 3 ton, dated 2011. This unit was cooling sufficiently. There was a 18.4 degree differential between the supply and return air.

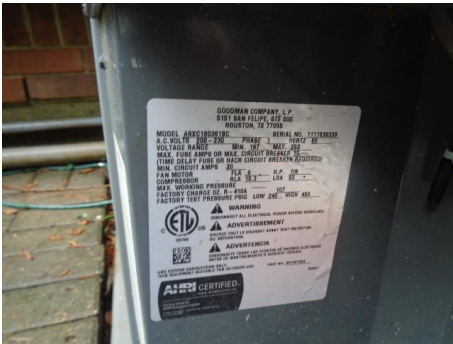
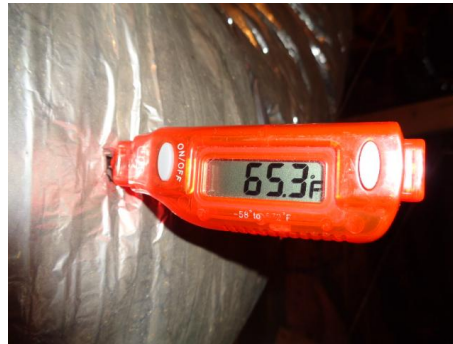
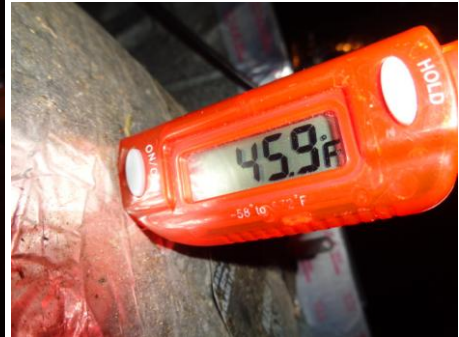
The AC unit is a 3 ton, dated 2011. This unit was cooling sufficiently. There was a 19 degree differential between the supply and return air.

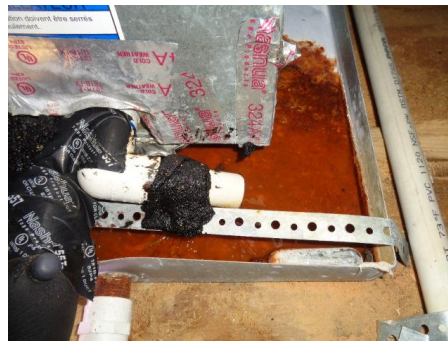
There is rust and water in the auxiliary drain pan under evaporator housing in the attic. This is to the bedroom unit.

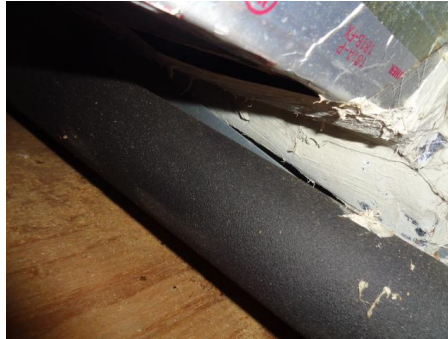
Also, there is air leakage under this coil.

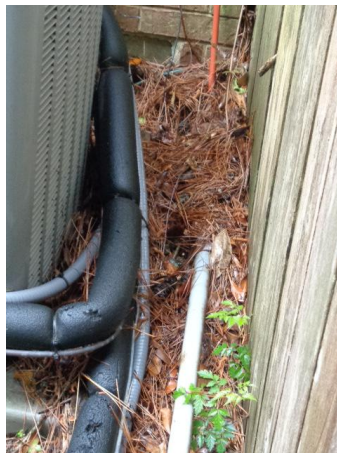
The debris needs cleaned away from the outside units.

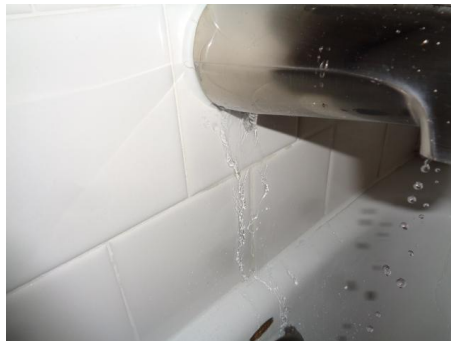
Hall Bathroom: Water leaks behind the tub faucet and water is leaking behind the wall and coming out of the right corner on the tub ledge.

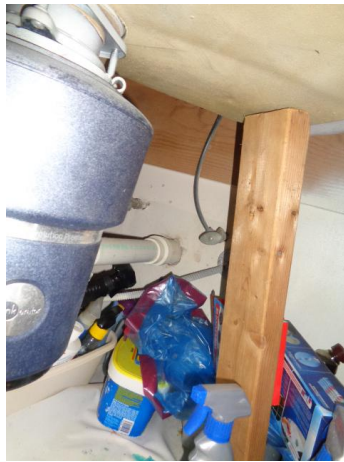
Kitchen Sink: There were no visible leaks. The sink is being held up with 1 X 6 boards under the sink. Note: We had limited visibility under the sink because of all the "stuff".

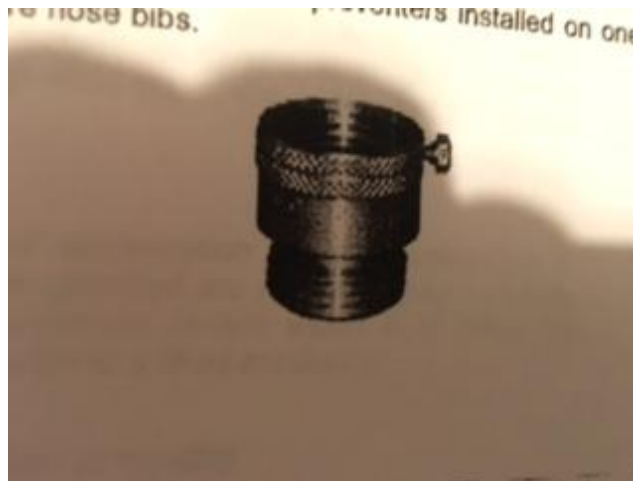
Outside spigots:
 There are no backflow preventers installed on one or more hose bibs.

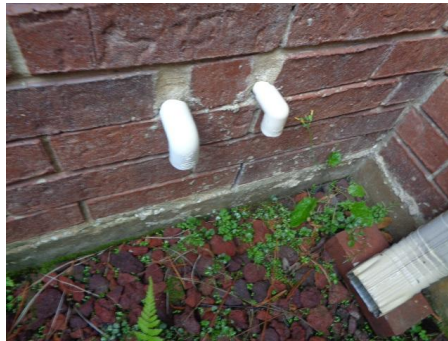
The drain lines are not supposed to be located higher than 6 inches from the ground.

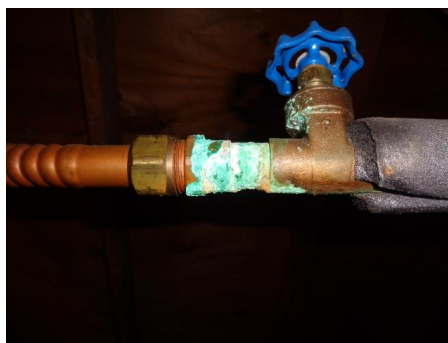
There is corrosion on the fitting by the water shut-off valve

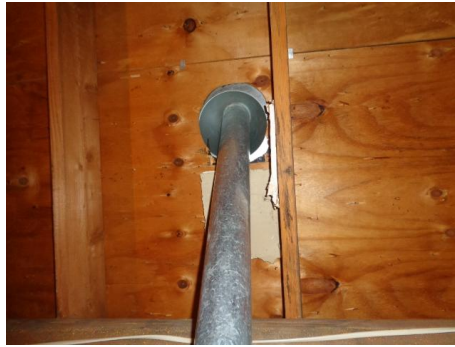
The tie strap is missing around the flue pipe.

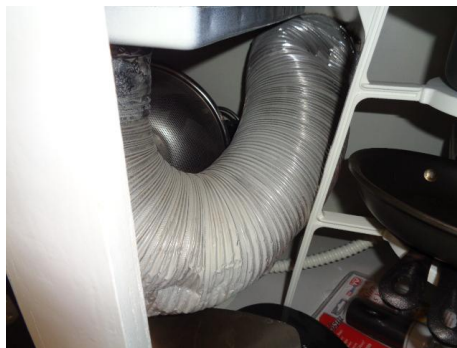
The vent pipe is supposed to be hard pipe and the grease filter is missing.

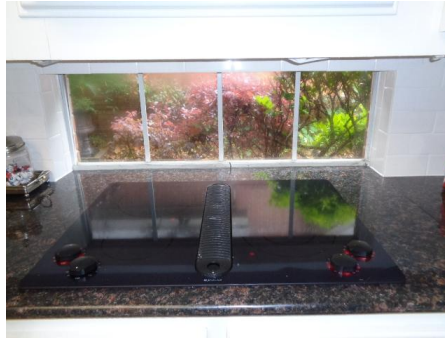
The wood over the cook top is too close. There is only 16 ½ inches and 30 inches is required.

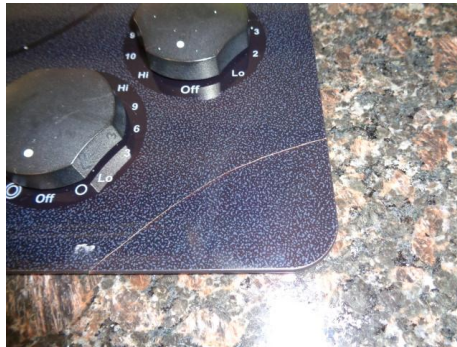
The left front burner knob will not turn. There is a crack on the right front corner of the cook-top.

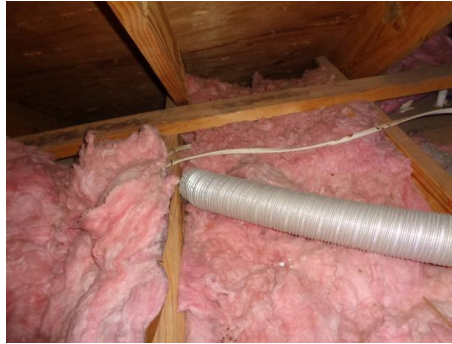
All bathroom exhaust fans vents should terminate to the exterior of the dwelling.

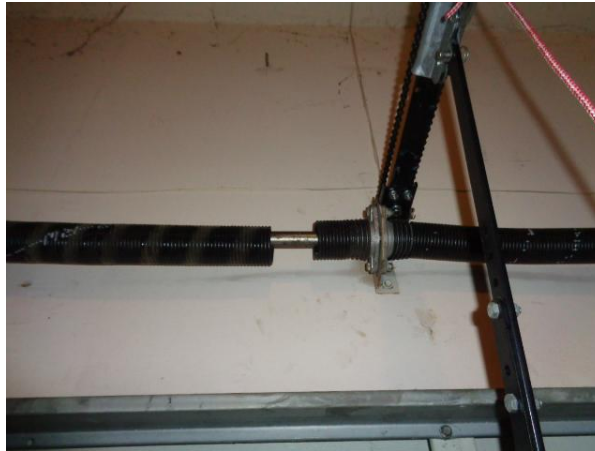
We did not operate the garage door opener because the spring is broken.
