## Inspection Report

**Property Address:**  
16208 Pinewood Dr  
Porter TX 77365

# PROPERTY INSPECTION REPORT

**By:** Derrick McMullen 7117 / AK Inspection Services/AK Termite and Pest Control 4/2/  
2019  
(Name and License Number of Inspector) (Date)

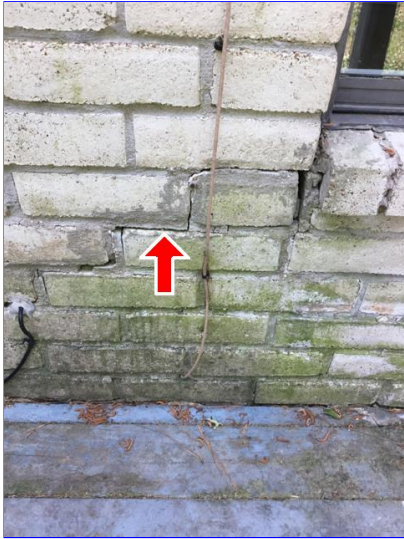
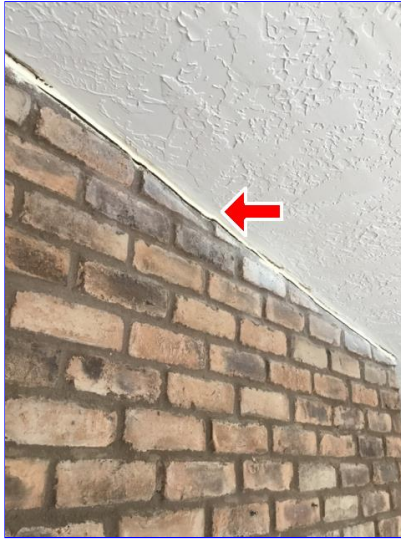
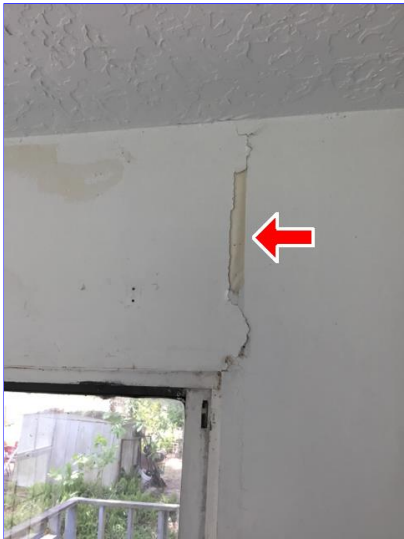
(1) Movement was observed in the masonry veneer, evident at several of the window openings. It is possible that water intrusion has caused hidden damage in walls. The extent of possible damage cannot be determined. [Item 1\(Picture\)](#) [Item 2\(Picture\)](#) [Item 3\(Picture\)](#)

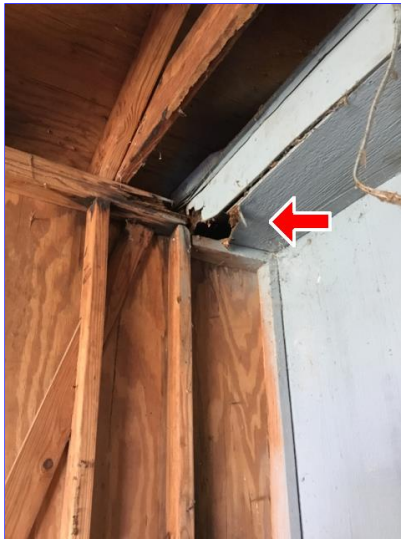
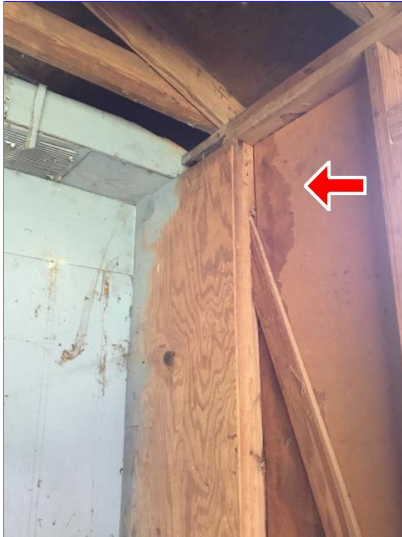
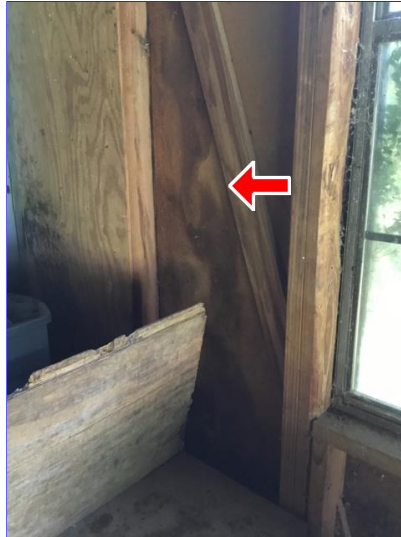
The wall structure, fascia, soffit, and possibly the roof structure were found to be damaged in the back corners of the garage. [Item 4\(Picture\)](#) [Item 5\(Picture\)](#) [Item 6\(Picture\)](#)

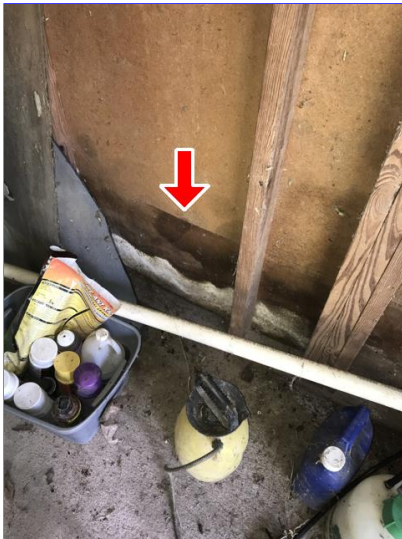
E. Item 7(Picture)

Water damage was observed along the lower edges of the garage walls. [Item 7\(Picture\)](#)

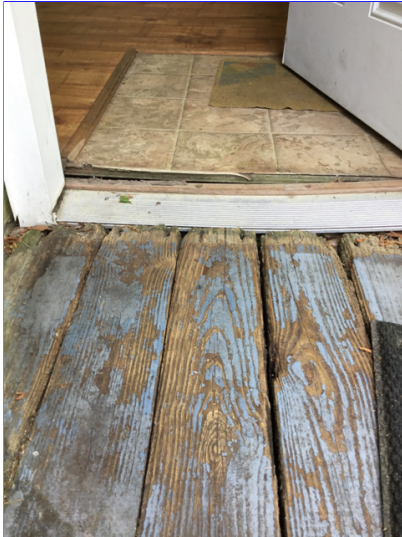
F. Item 1(Picture)

Damage was observed in the floor structure at the front entrance. The extent of damage could not be determined. The floor would give/sag when crossed and the threshold was not level. Item 1(Picture)

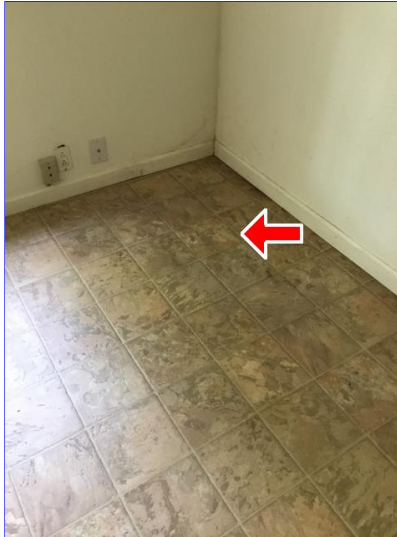
F. Item 2(Picture)

The floors in the hall bathroom were found to dip/sag. It appeared that the sub-flooring and possibly the joists were damaged. The extent of damage could not be determined. Item 2(Picture)

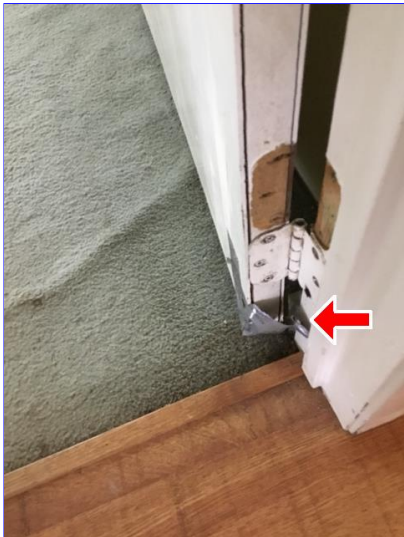
G. Item 1(Picture)

The door at the back right bedroom was found to be damaged and taped. Item 1(Picture)

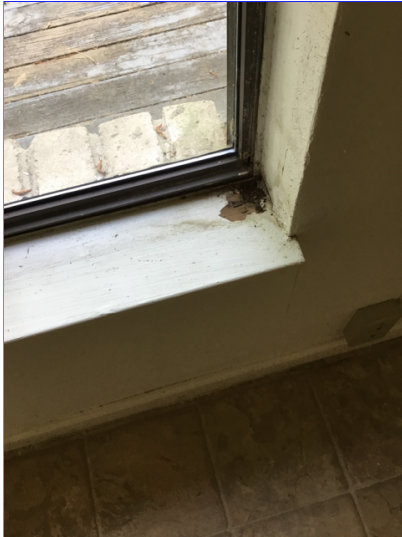
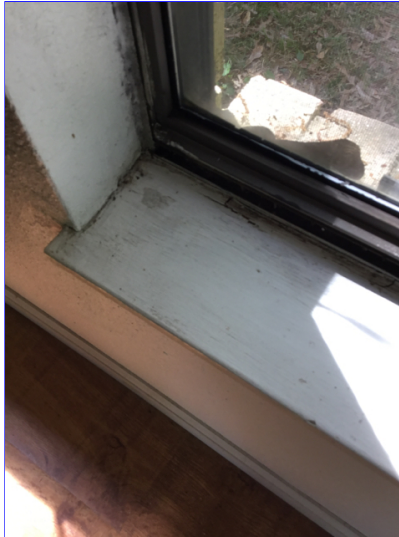
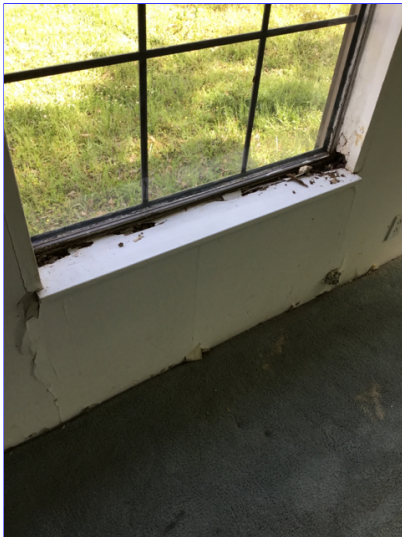
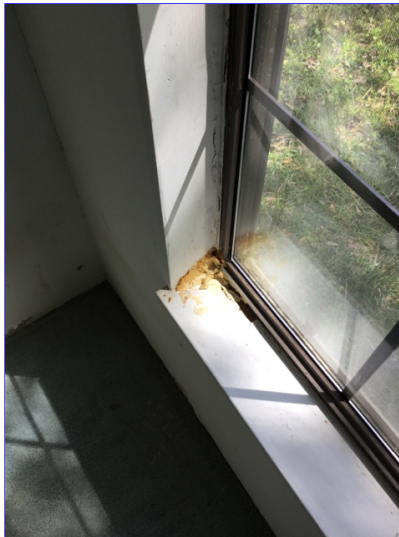
Various window openings were found to be damaged, ie, in the dining room, in the living room, in the master bedroom, etc. The extent of damage could not be determined. [Item 1\(Picture\)](#) [Item 2\(Picture\)](#) [Item 3\(Picture\)](#) [Item 4\(Picture\)](#)

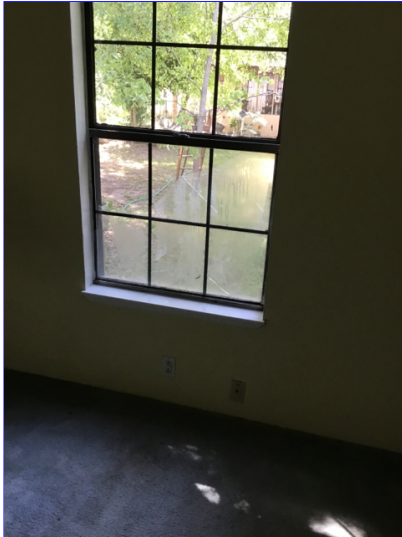
H. Item 5(Picture)

The glass was found to be damaged in the window in the back right bedroom. [Item 5\(Picture\)](#)

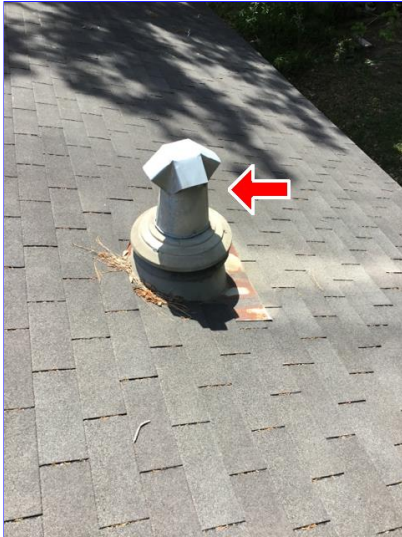
J. Item 1(Picture)

The damper was found to be damaged and did not close fully. In addition, the top of the firebox, the damper, and visible areas of the flue were found to be corroded.

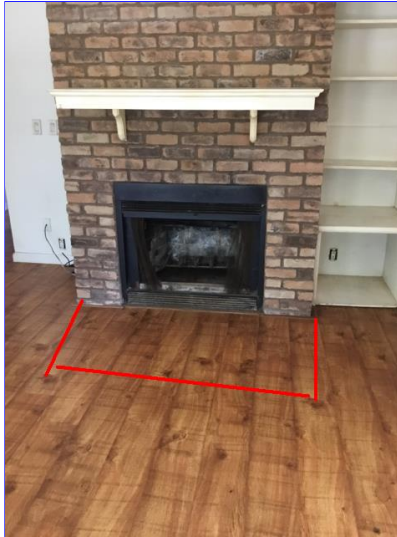
J. Item 2(Picture)

(2) Inspection of the flue was greatly limited. Visibility in the flue was limited due to design and installation practices. Item 2(Picture)

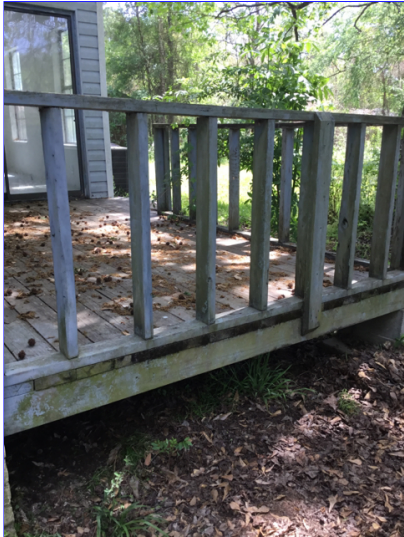
K. Item 1(Picture)

The decking on the front porch was found to be damaged and was not sufficiently supported in various areas. The extent of damage could not be determined.

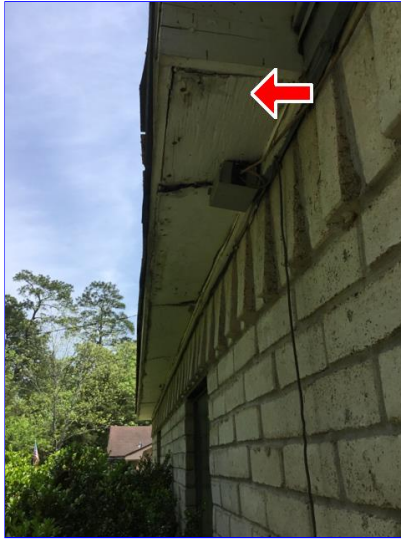
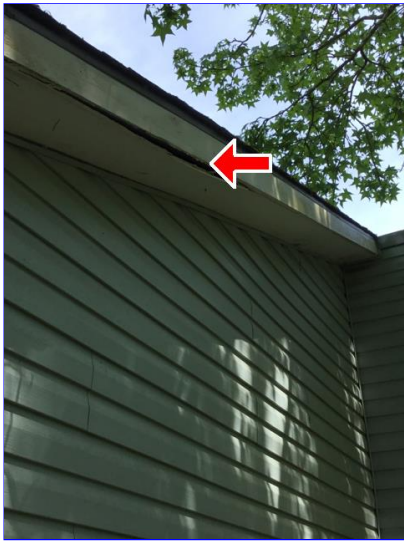
The soffit was found to be damaged in various self evident areas, ie, to the left of the front porch, over the back porch etc. Item 2(Picture) Item 3(Picture)

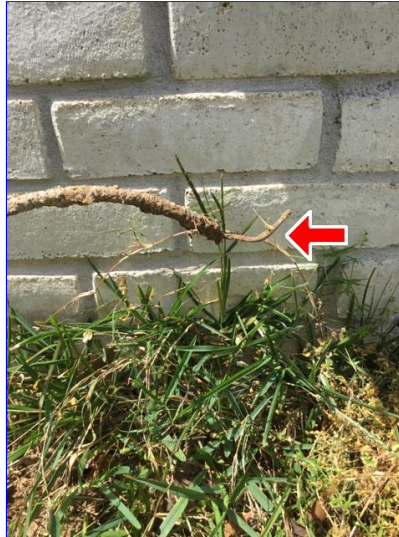
A. Item 2(Picture)

The electrical system should be equipped with 2 ground rods/devices installed in an approved manner, connected to the ground busbar through a single wire or parallel wires. In the event 2 ground rods are installed, the ground rods should be spaced a minimum of 6ft apart. (if 25 ohms of resistance or less can be verified, the second ground rod is not required) No ground rods were observed. A ground wire was located, however, the wire was not attached to an alleged ground rod. Item 2(Picture)

It is recommended that a qualified licensed electrician be contacted for further evaluation and repair of the panels and circuits.

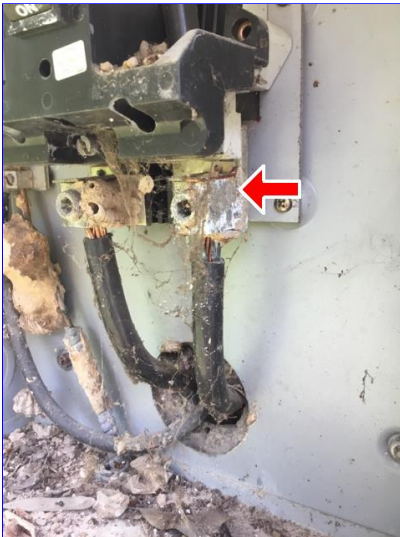
A. Item 3(Picture)

The lugs in the panel were found to be corroded. Item 3(Picture)

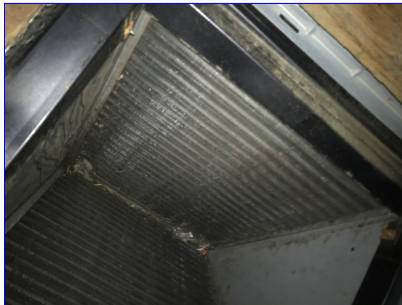
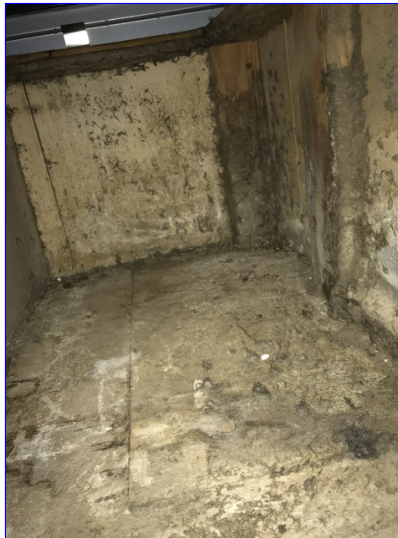
(1) The return chase and evaporator coils were found one excessively dirty. The return chase and coils should be properly cleaned. Item 1(Picture) Item 2(Picture)

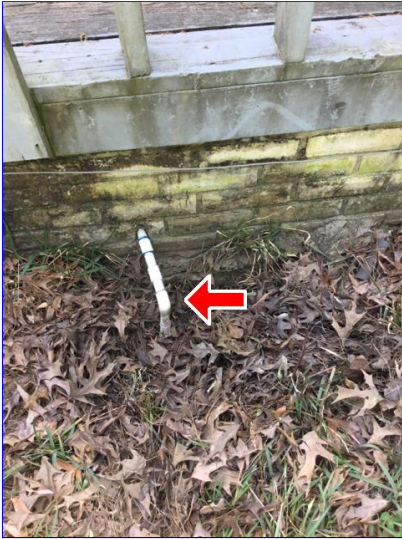
A. Item 1(Picture)

Exposed water supply lines were observed at the front porch and in the crawl space. Water supply lines subject to freezing temperatures should be properly insulated. Item 1(Picture)

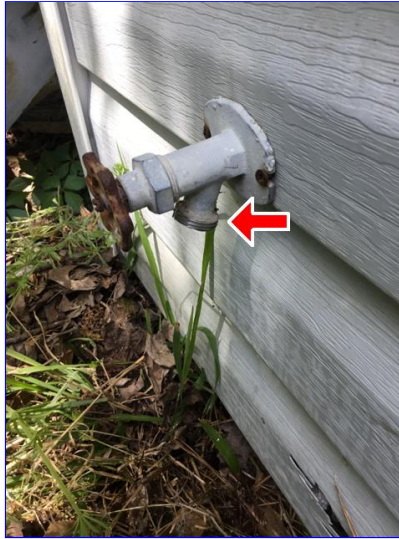
A. Item 2(Picture)

The absence of a back flow prevention device was observed on at least one hose bib. The exterior hose bibs should be properly equipped with back flow prevention devices. Item 2(Picture)

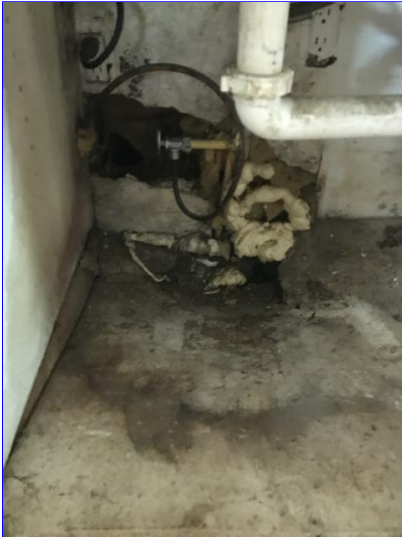
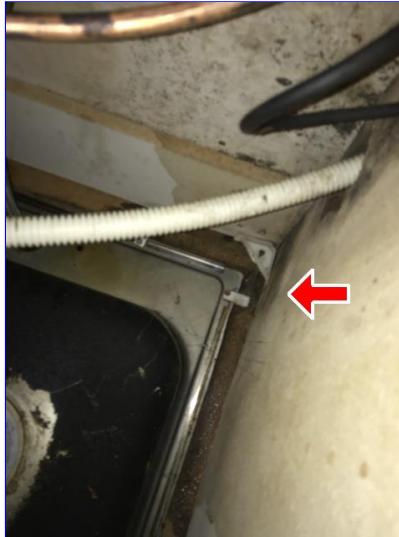
Water damage was observed in the cabinets and countertop at the kitchen sink. The integrity if the cabinets and countertops had been compromised. Item 3(Picture) Item 4(Picture)

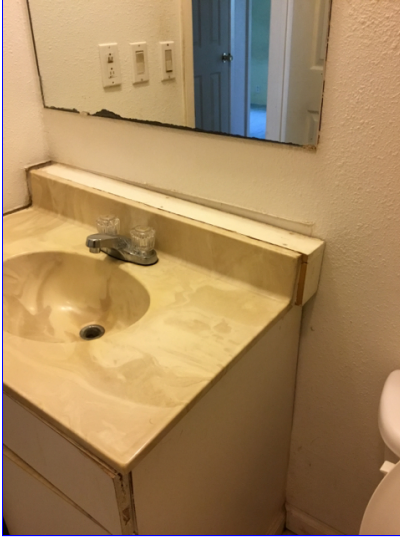
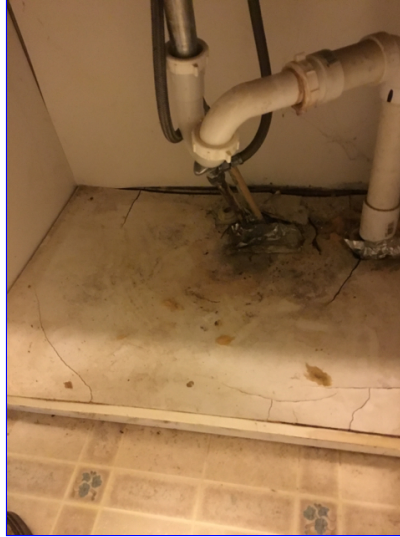
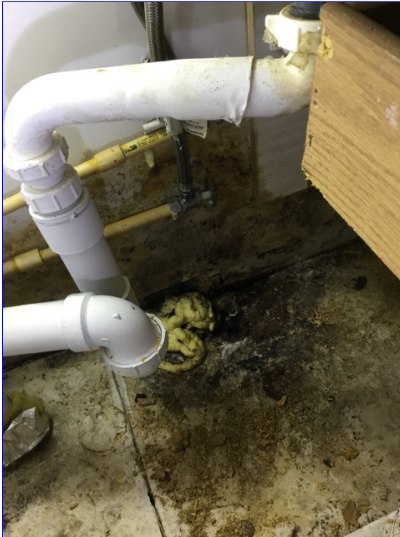
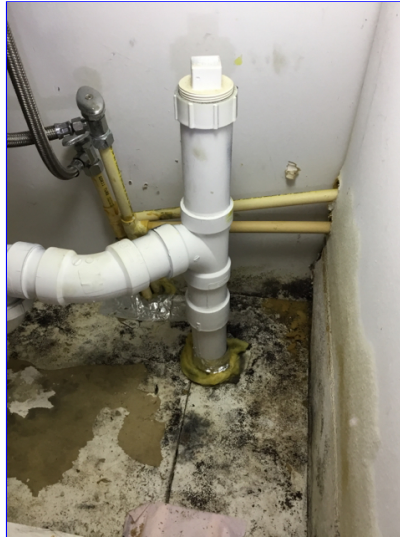
The cabinets in each bathroom were found to be water damaged. The cabinet in the hall bathroom had shifted substantially due to the sloping floors. Item 5(Picture) Item 6(Picture) Item 7(Picture) Item 8(Picture)

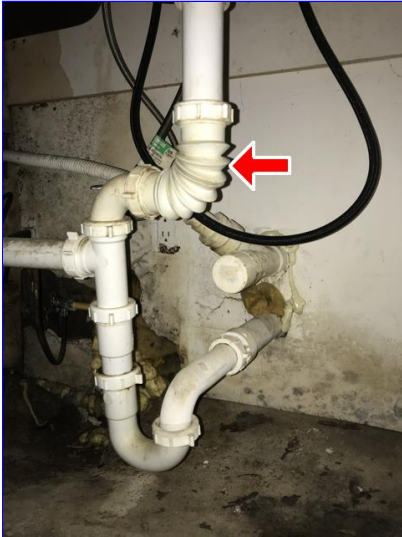
B. Item 1(Picture)

(1) A flexible section of drain line was observed below the kitchen sink. Drain lines should be smooth bore and are not permitted to be flexible. The flexible drain line should be replaced with an approved drain line. Item 1(Picture)

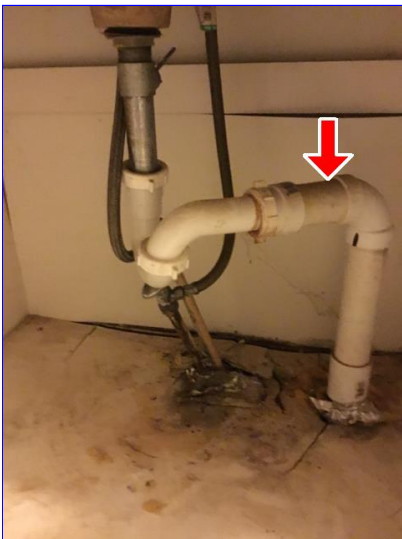
B. Item 3(Picture)

S traps were provided at each bathroom sink. S traps are not permitted and the traps may siphon dry as a result. In addition, venting was not observed at the bathroom sinks. Approved venting should be provided. Item 3(Picture)

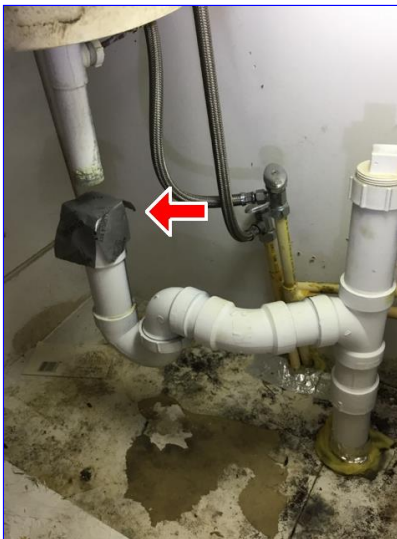
B. Item 4(Picture)

The left sink was not connected to the sewer drain line. Item 4(Picture)

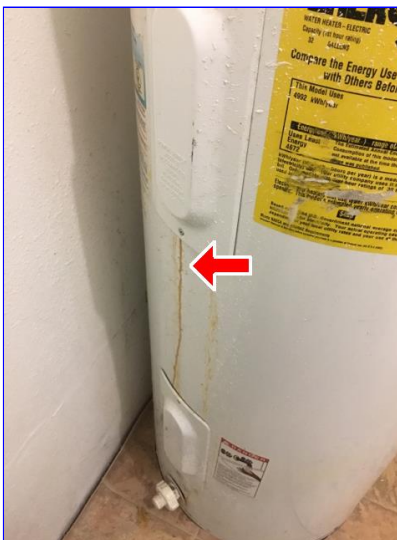
C. Item 2(Picture)

Corrosion was observed on the water heater, below the heating element. It appeared that water had leaked prior to the inspection. Item 2(Picture)

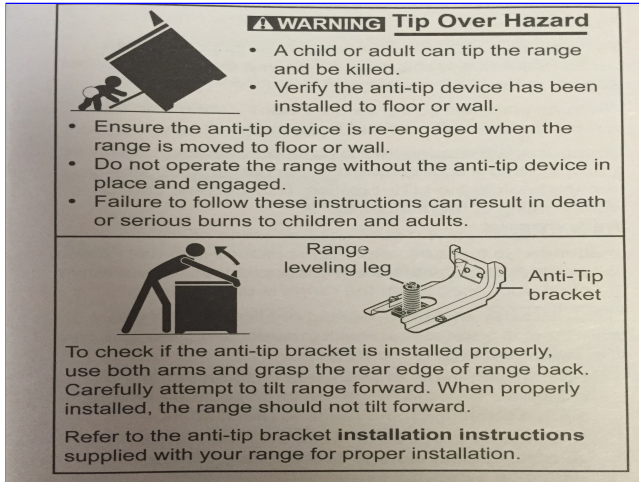
D. Item 1(Picture)

The oven light did not appear to be operational.

The breaker for the oven tripped, therefore the oven was not ran to the target temperature of 350° F.
