# **Inspection Report**

Property Address: 13403 Columbia Key Dr Tomball TX 77377

## **PROPERTY INSPECTION REPORT**

Prepared For:	Mark Goykhman		
-	(Name of Client)		
Concerning:	13403 Columbia Key Dr, Tomball, TX 77	377	
	(Address or Other Identification of Inspected Pr	operty)	
By:	Vi Tran 20411 / Bill Harvey Inspection Services	3/24/2017	
-	(Name and License Number of Inspector)	(Date)	
-	(Name, License Number of Sponsoring Inspector)

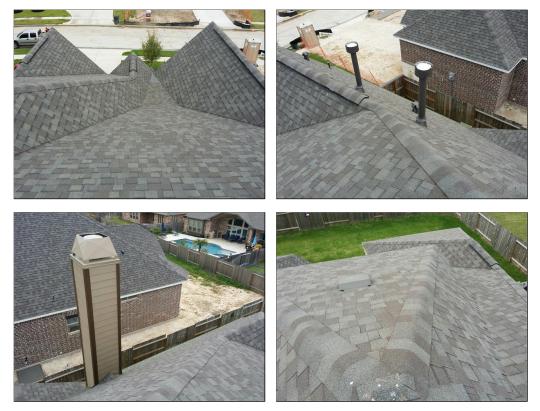
• Storm collars at the water heater vent should be sealed / caulked where needed to prevent water intrusion.

Storm collar to be caulked

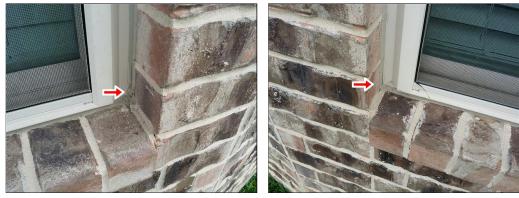
• Caulking at the windows in various locations is cracked. Caulking improvements should be undertaken as needed.

Areas of poor caulking

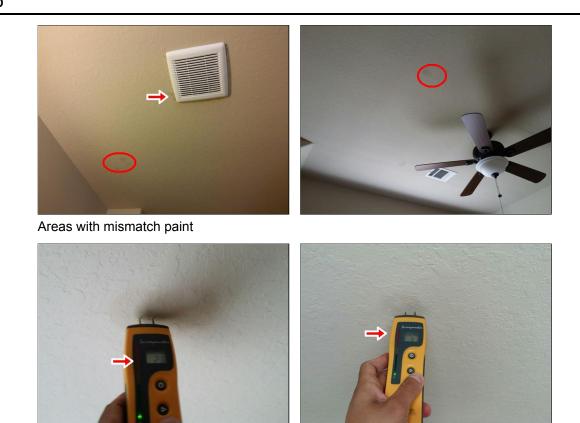
• There are several mismatched paint areas on the ceiling in the master bathroom and front corner bedroom. These area was test with a moisture meter and appears to dry. Mismatching paint should be improved.

The area is dry

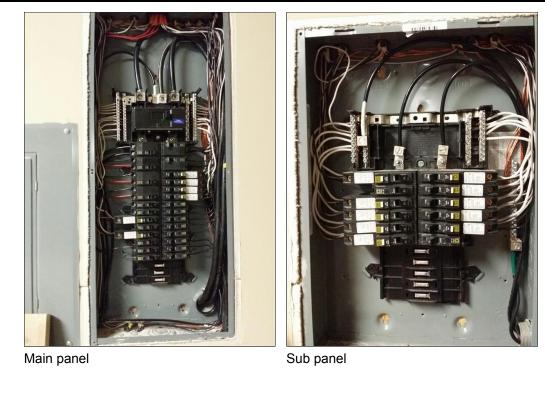
Comments:
	<ul> <li>The main panel enclosure and the sub panel enclosure was inspected with the deadfront removed. No defects were observed.</li> </ul>

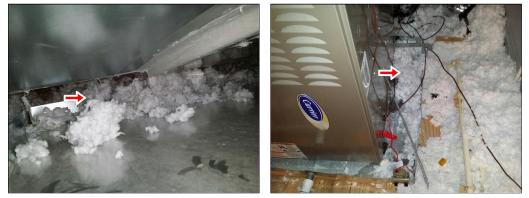
Insulation to be removed from pans

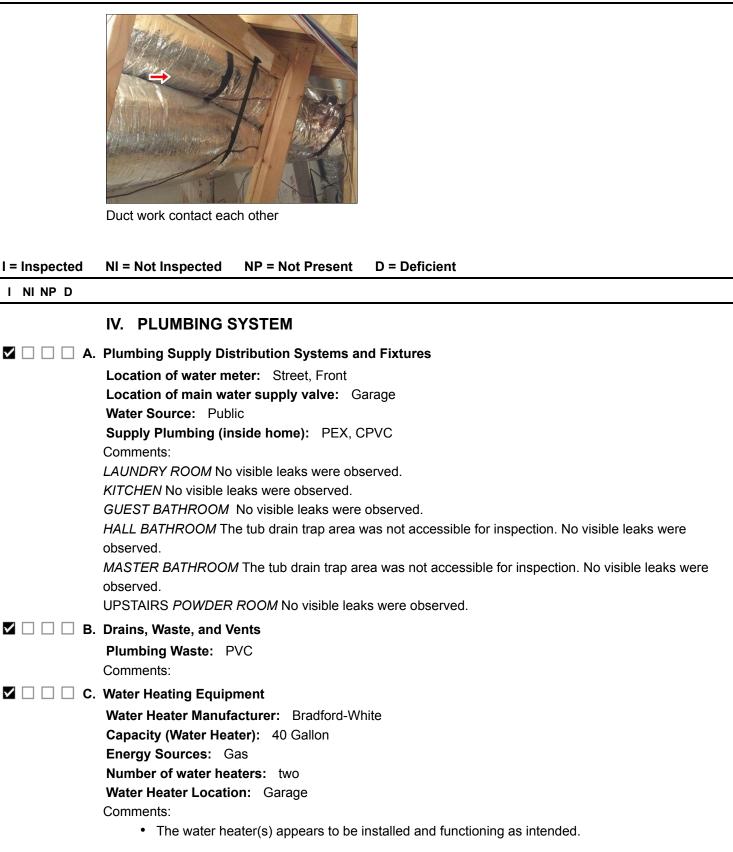
• Ductwork is in contact with other ductwork. Typically ductwork should be separated to prevent condensation between ducts.
