Structure Home Inspection

Property Inspection Report

5239 Dumore Drive, Houston, TX 77048
Inspection prepared for: Juquan Tellis
Date of Inspection: 3/12/2019 Time: 3:00 PM
Age of Home: 57 Years Size: 1,184 SF
Weather: Sunny 75 degrees

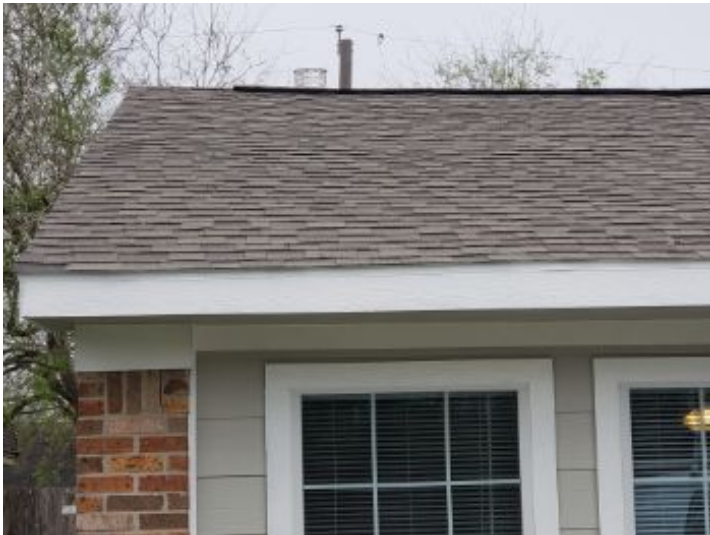
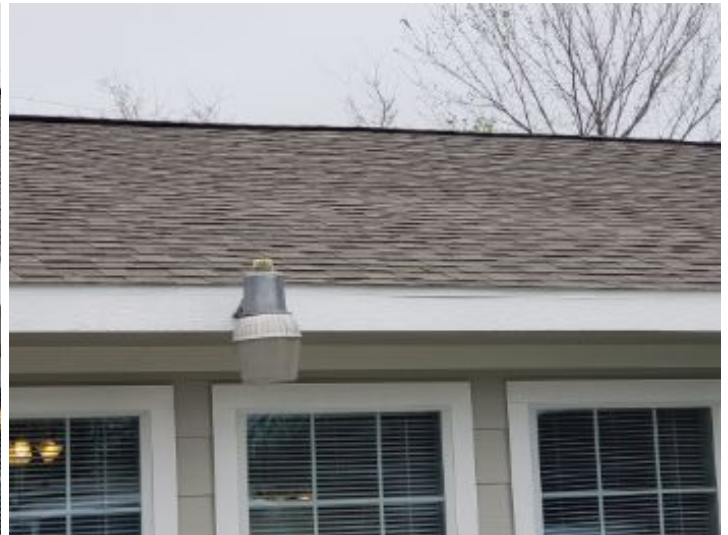
Roof shingles are 30 year warranted fiberglas laminated shingles, and in excellent condition.

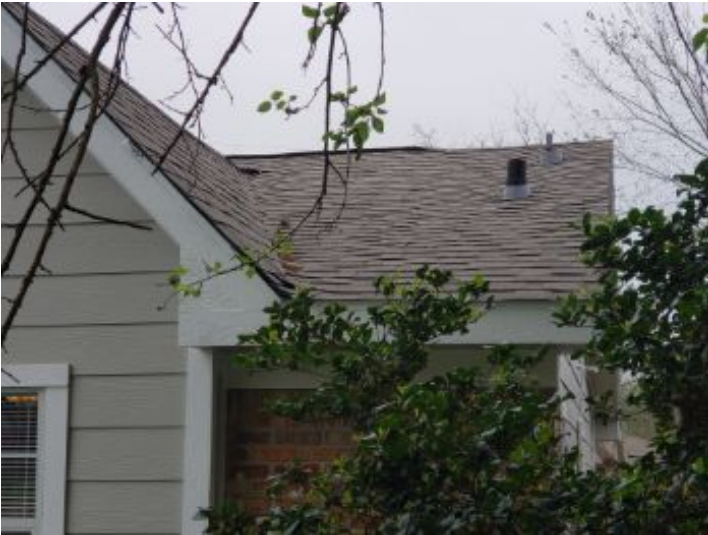
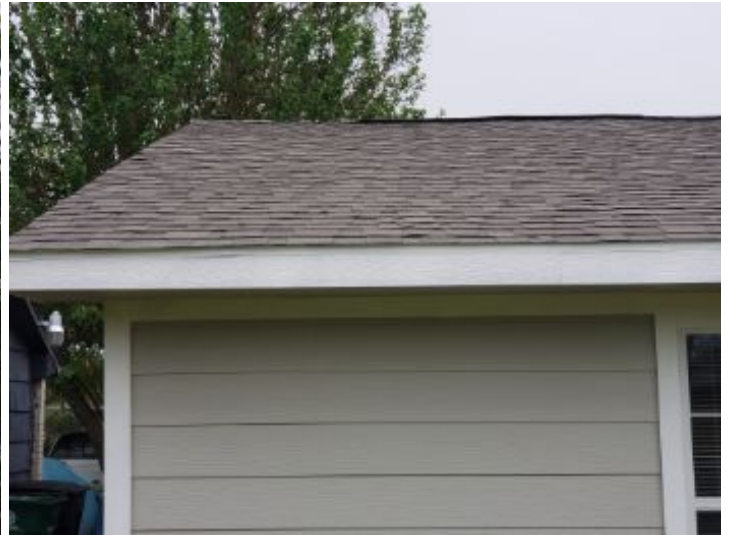
Front left corner of roof (over previous garage) missing shingles and needs repair.

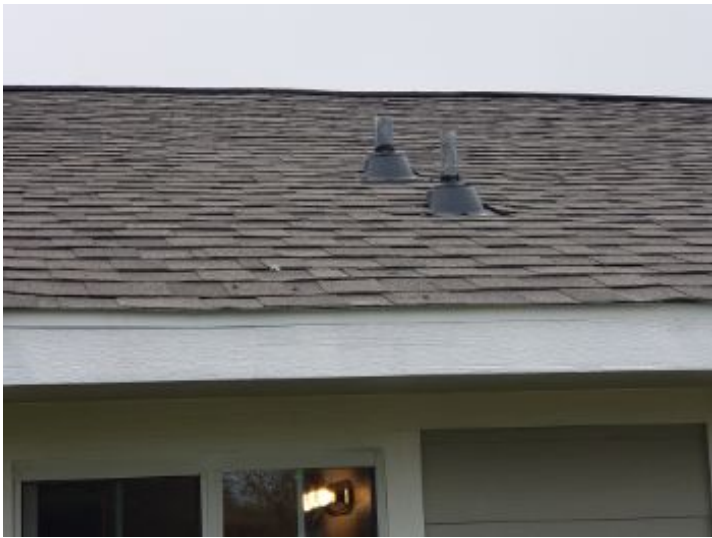
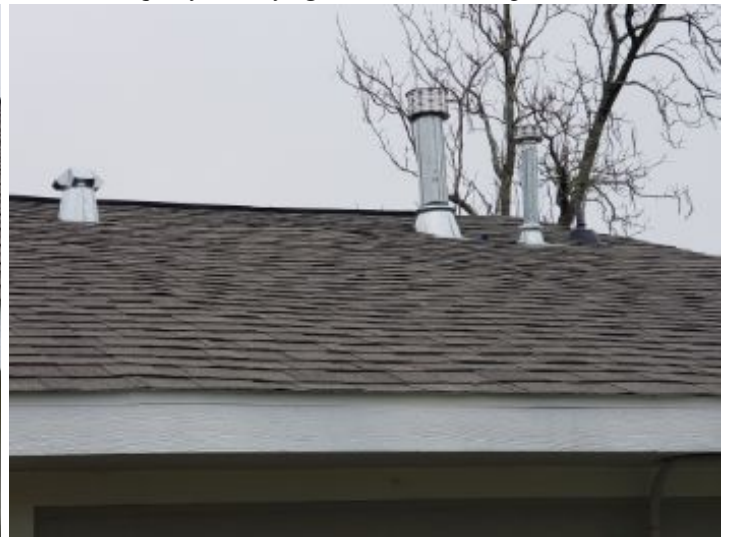
Area at the rear section of the roof appears to have a dip or deflection in the shingles. This should be investigated further by a qualified roofing contractor and repaired.

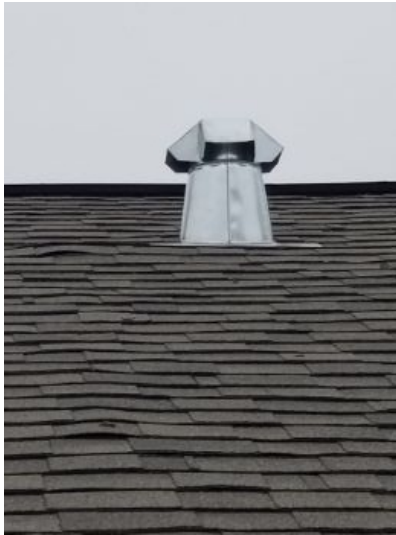
Galvanized metal roof flashings will rust over time unless sealed with a rust proof paint. Most new home builders paint the exposed flashing material with a color matched (to the roof shingles) rust proof paint.

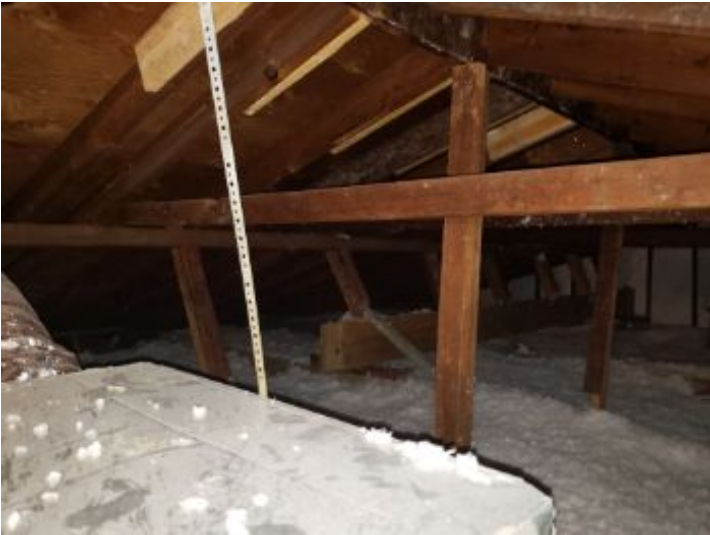
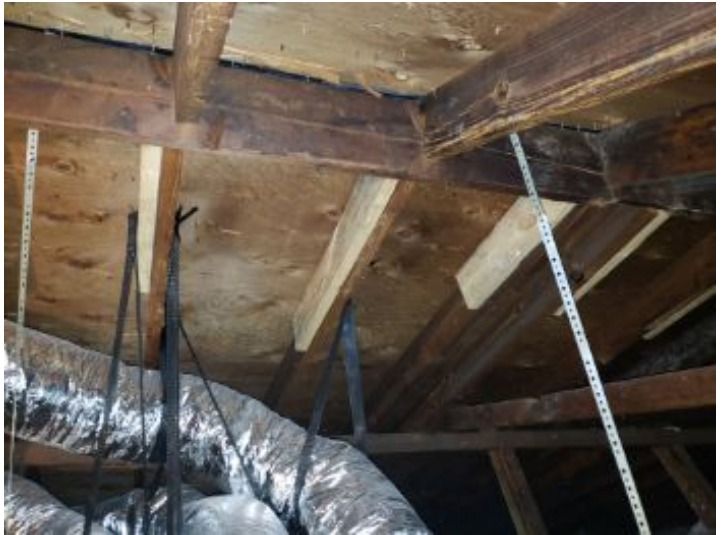
The roof structure purlins are not properly supported in one or more locations. Under current building standards; the purlins should be supported by {2x4} braces to load bearing walls at a slope of not less than 45 degrees. The bracing should be spaced within the middle third of the rafter and support every other rafter at minimum.

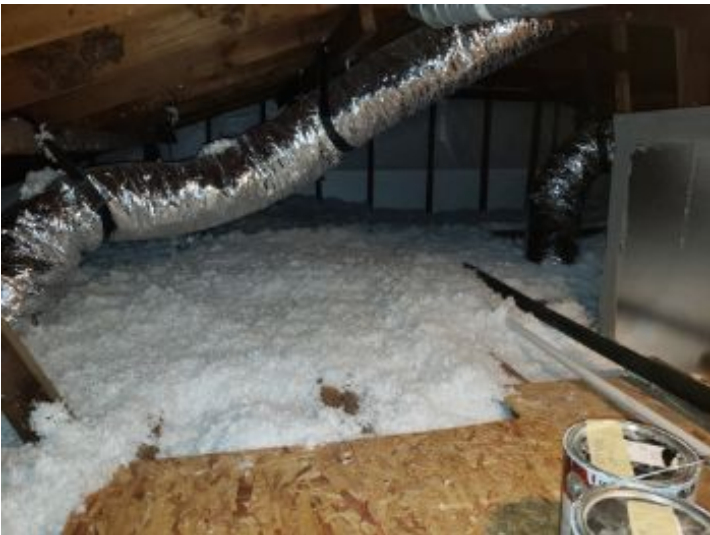
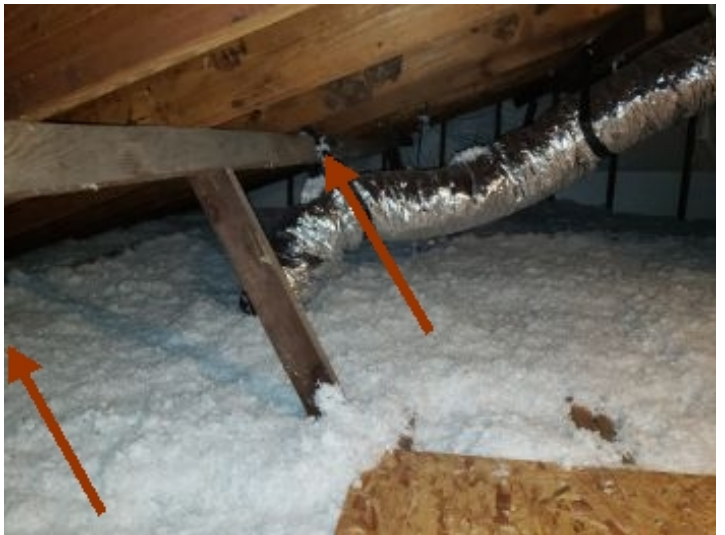
The roof structure purlins are not properly supported in one or more locations. Under current building standards; the purlins should be supported by {2x4} braces to load bearing walls at a slope of not less than 45 degrees. The bracing should be spaced within the middle third of the rafter and support every other rafter at minimum.

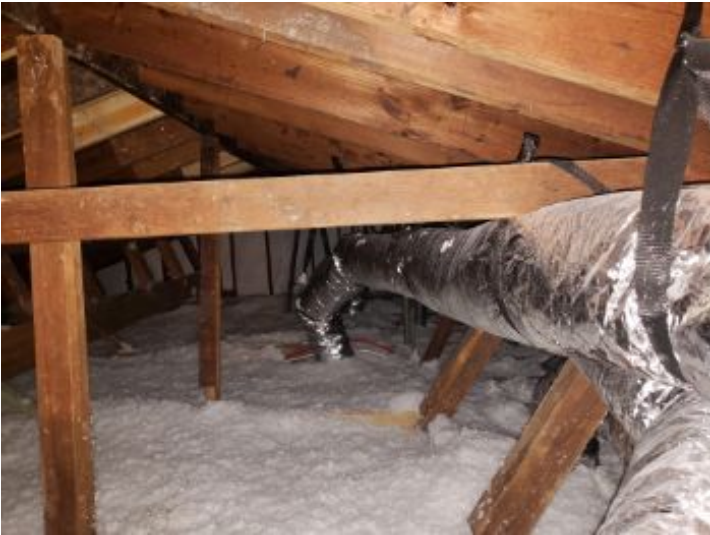
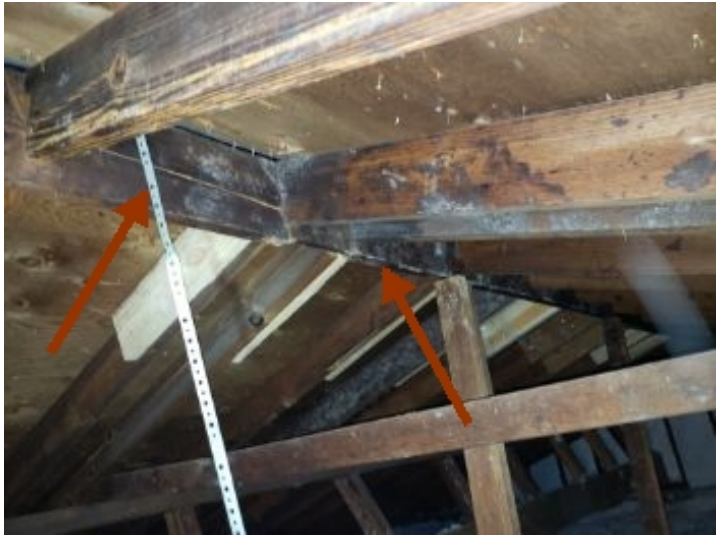
Split ridge beam observed in the attic area and needs repair.

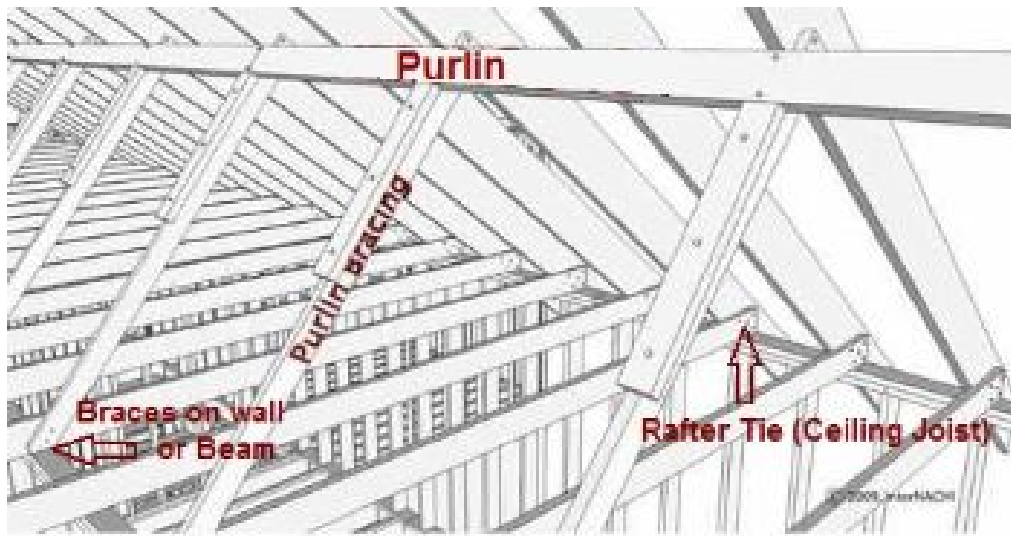
Drawing showing proper roof bracing installation.

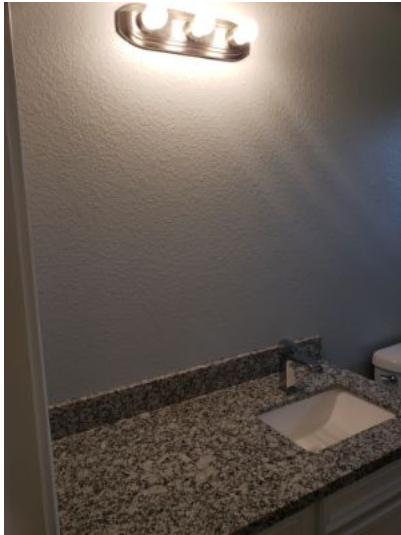
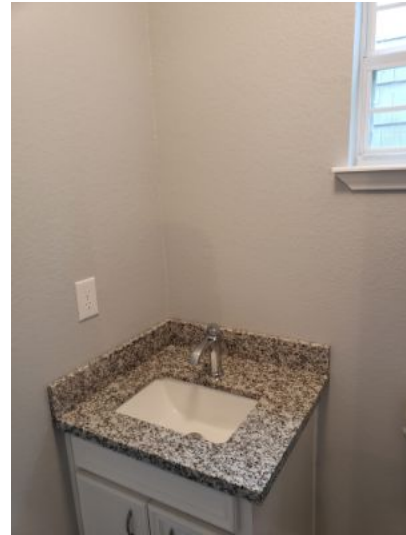
Both bathroom walls are missing mirrors.

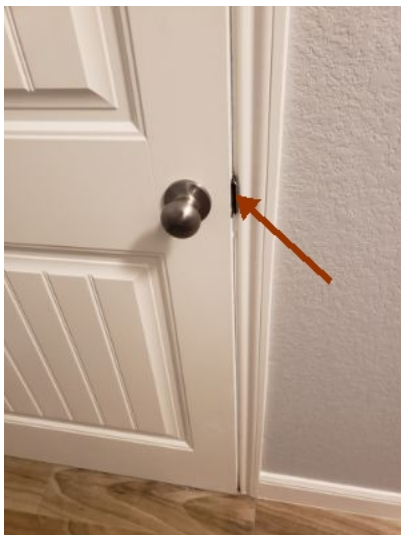
Laundry room door tight and needs adjusting to easily close.

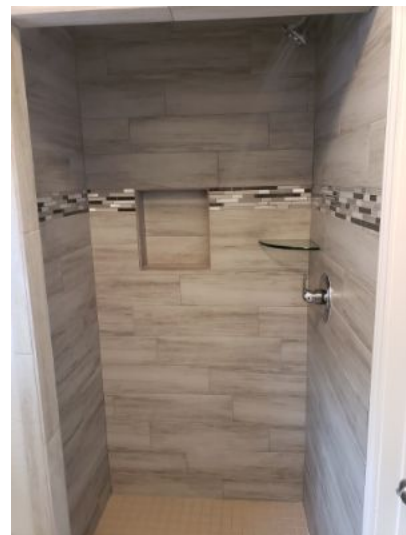
The master bathroom shower is missing a door or enclosure.

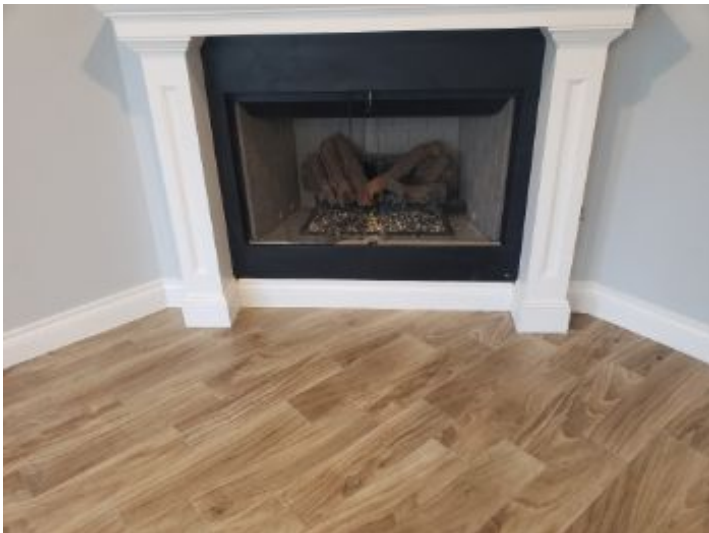
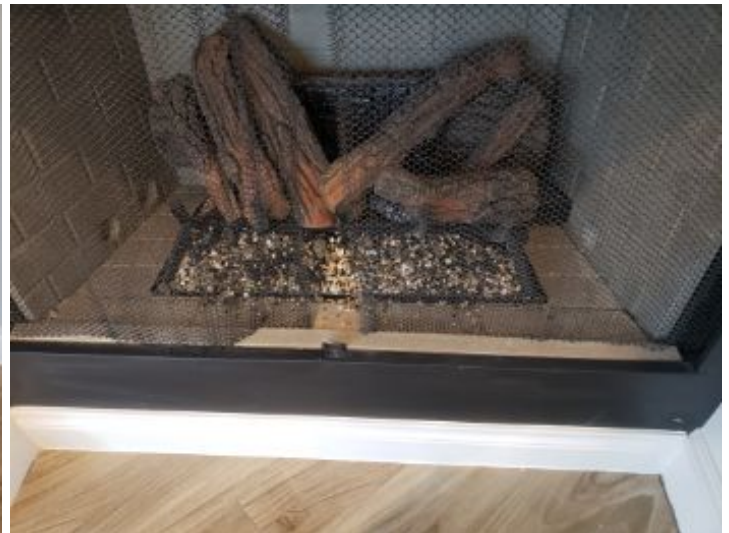
I could not get the fireplace to light and didn't detect gas coming out of the lighter when the valve was on. A remote control was not available and the switch to the right of the fireplace didn't do anything.

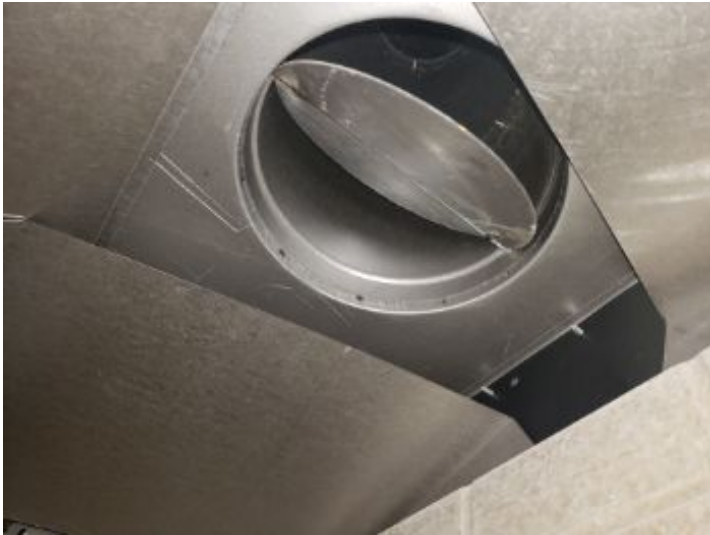
When gas logs are installed, the damper should have a C clamp installed to prevent the damper from closing.

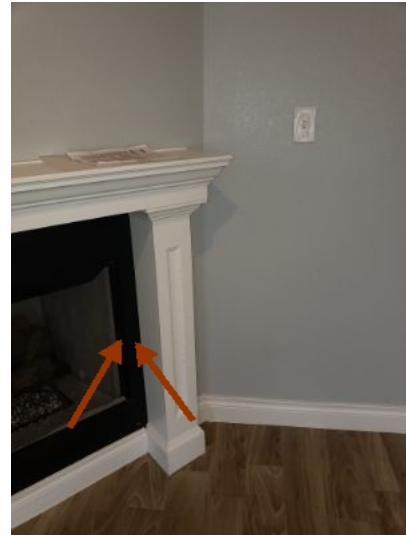
Combustible material required to be a minimum of 8" from the sides of the opening. Wood trim is currently on a few inches from the opening.

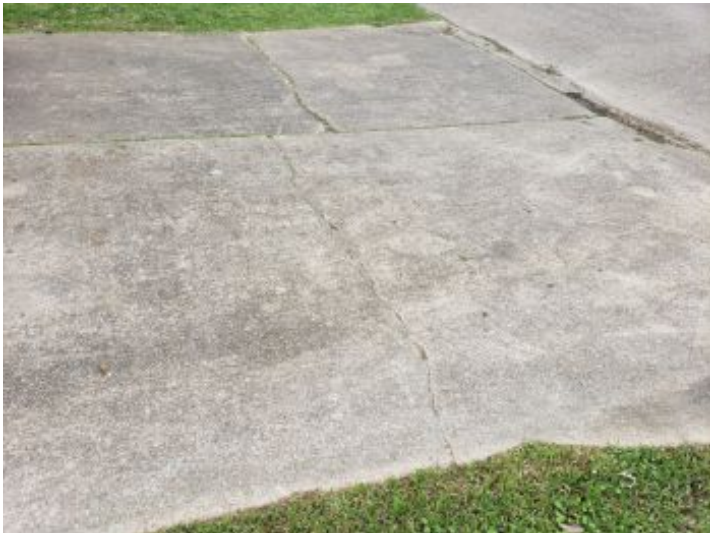
Cracks and fractures noted on the driveway/walkway, which is typical for the age of the concrete material and due to shifting soil conditions, also typical for our area.

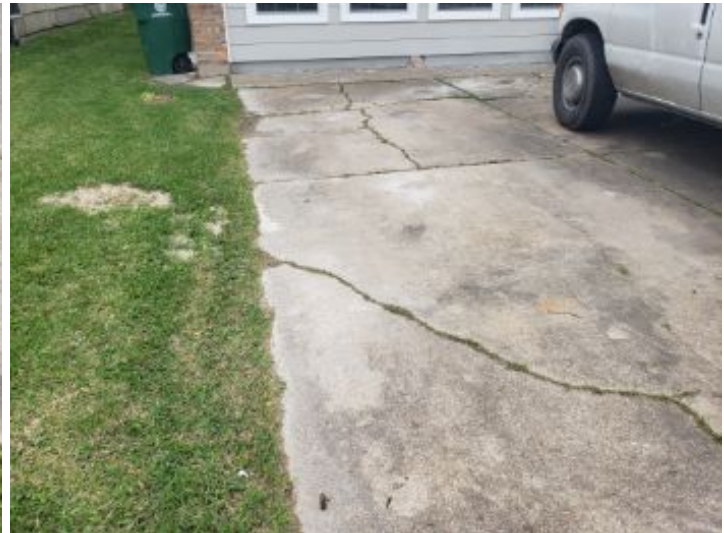
Cracks and fractures noted on the driveway/walkway, which is typical for the age of the concrete material and due to shifting soil conditions, also typical for our area.

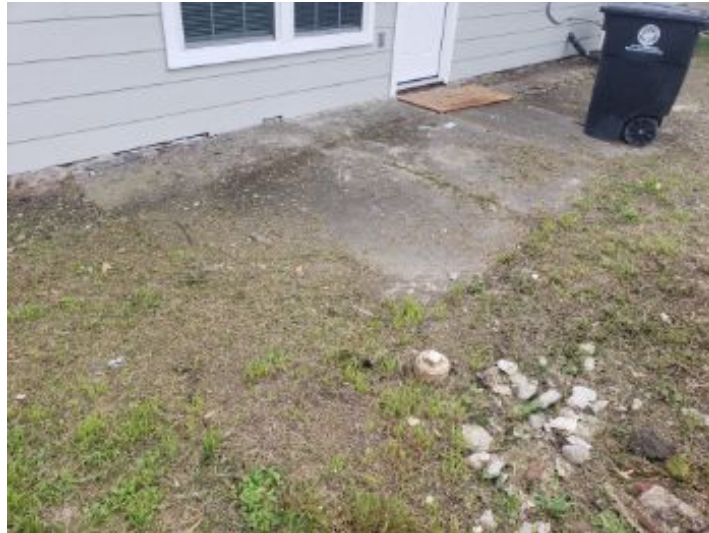
The rear concrete patio is cracked and settled beyond repair and should be replaced.

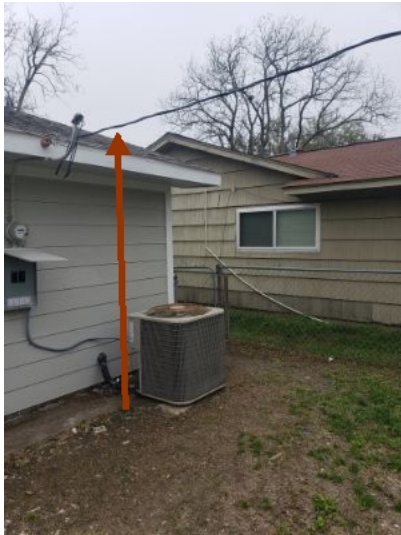
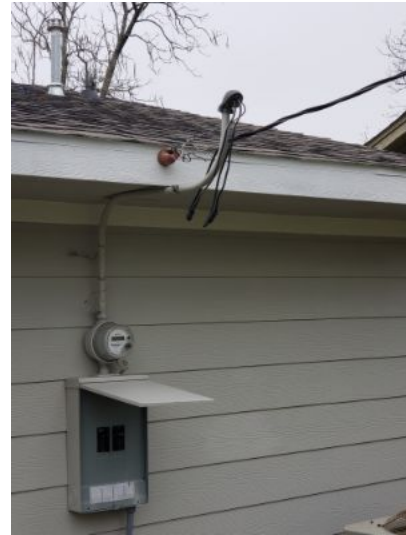
Electrical service wires and weather head installed too low for current requirements. They are at 8' from the ground and should be a minimum of 10' from the ground.

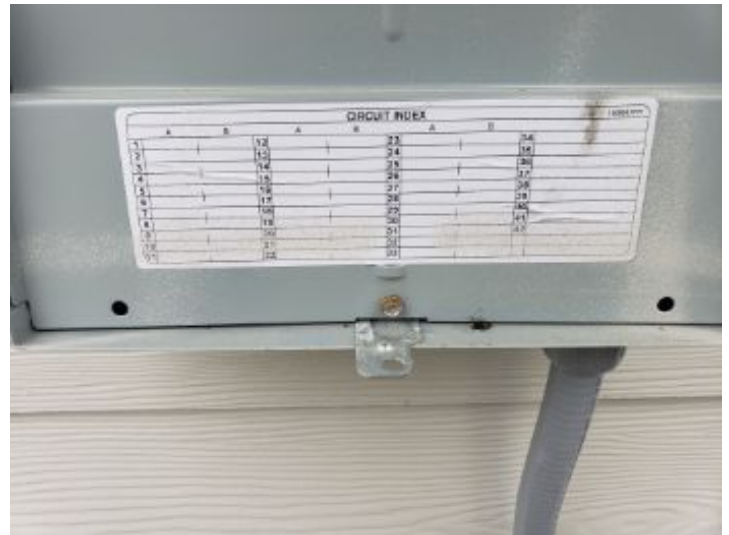
The service panel is NOT completely and/or properly labeled. All breakers must be specifically identified as to appliances, lighting and receptacles

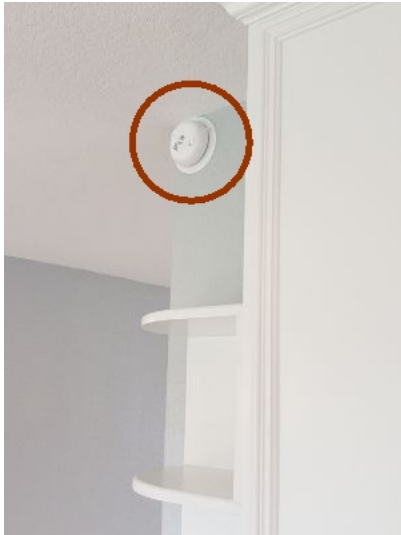
Smoke detectors should not be located in kitchens. When testing the oven, it set the smoke detection system off.

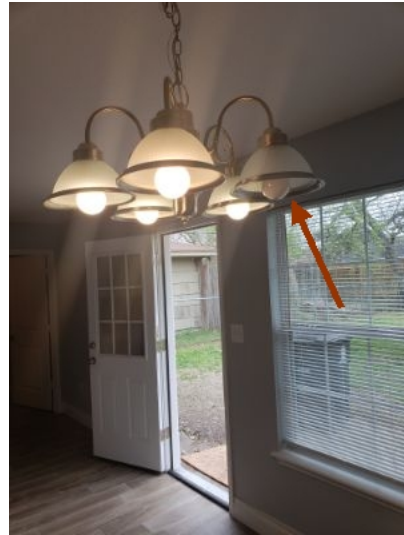
Breakfast room light fixture has a burned out bulb.

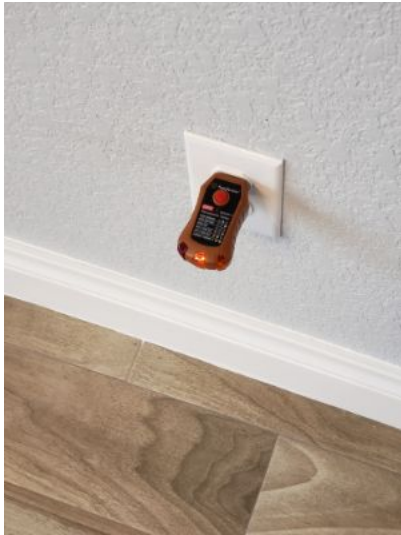
Most of the electrical wiring is original and has not been replaced or upgraded, although the home appears to be marketed as new. The original wiring is a two wire system with no ground. New three wires have been installed in the kitchen and laundry room, but most of the other wiring is a two wire system. There is nothing wrong with a two wire system, it just is not as safe as a three wire system.

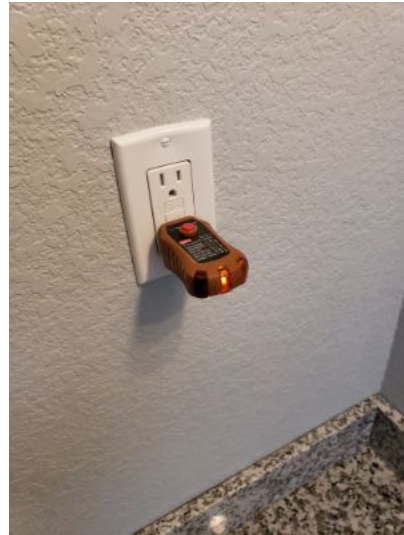
The bathroom GFCI device has an open ground (two wire system) and does not trip when shorted. The GFCI protection may not be present. Consult with a licensed electrician.

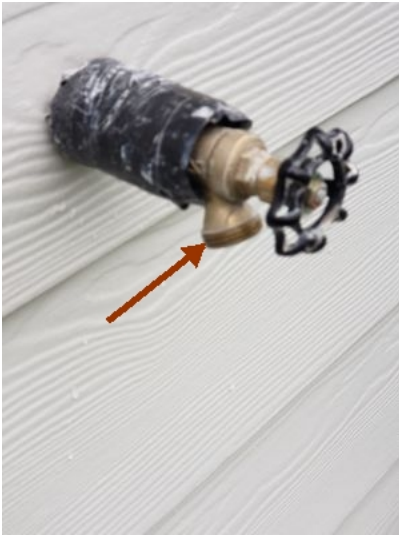
One or more of the exterior water hose bibs {faucets} was not equipped with a back flow and/or anti-siphon {vacuum breaker} device. An anti-siphon device prevents unsanitary water from being pulled back through a garden hose and/or lawn sprinklers and contaminating the household water system

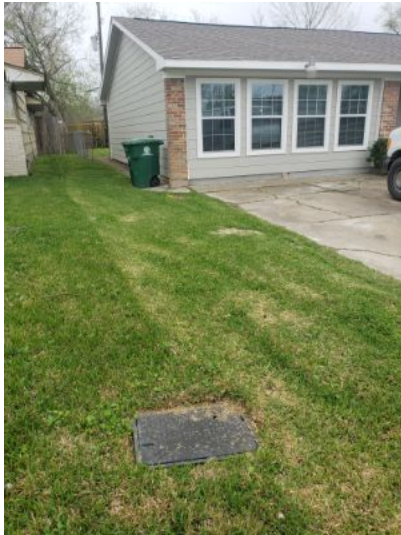
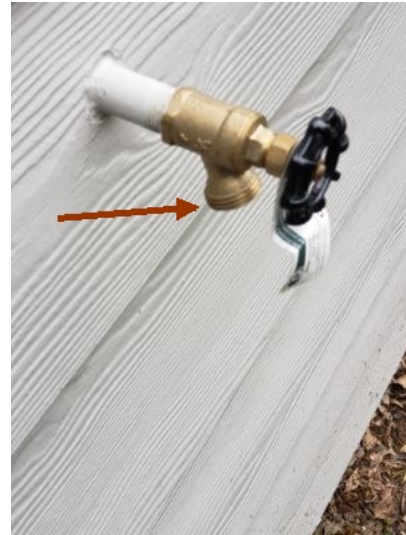
One or more of the exterior water hose bibs {faucets} was not equipped with a back flow and/or anti-siphon {vacuum breaker} device. An anti-siphon device prevents unsanitary water from being pulled back through a garden hose and/or lawn sprinklers and contaminating the household water system

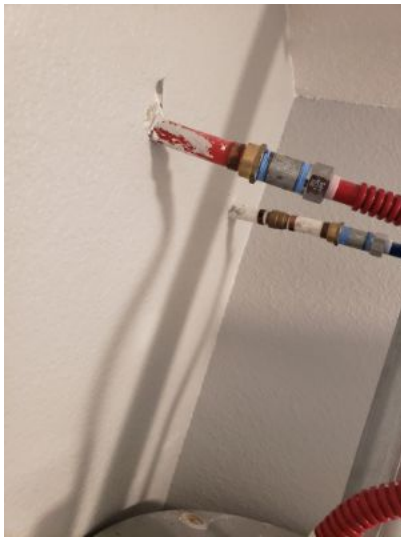
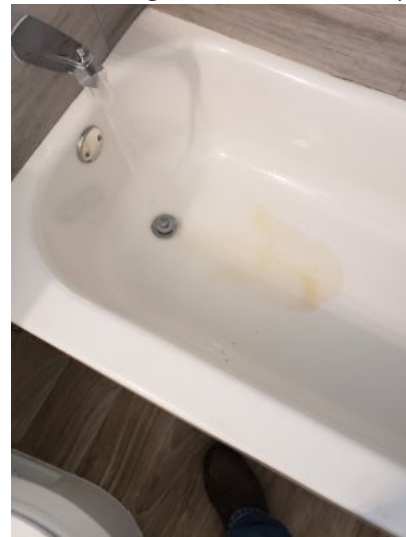
Rusty water coming out of both tub fixtures for approximately 10 seconds before it cleared up.

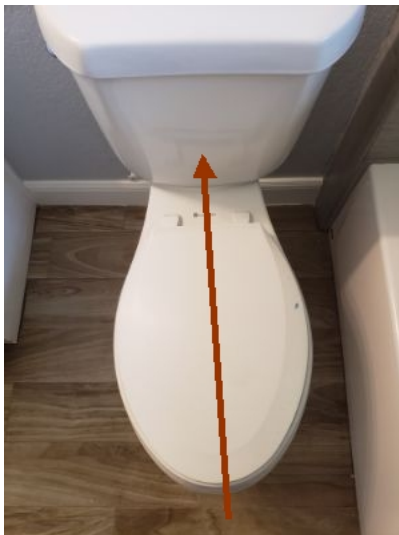
Hall bath toilet installed crooked.

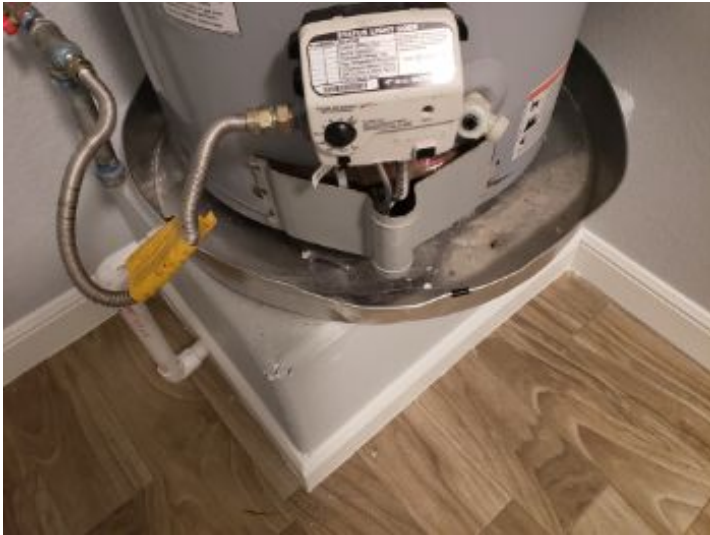
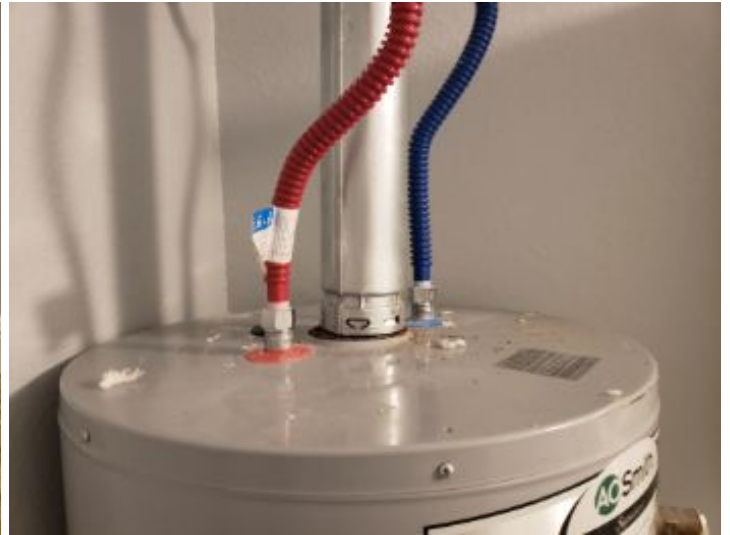
The hot and cold supply fittings were noted to be made of a flexible metal, and the water pipe is made of a plastic material (CPVC or PEX). When this type pipe is used, the metal fittings at the top need to be grounded. This can be done by installing #8 bare copper wires from the metal fittings to the gas pipe below with approved clamps.

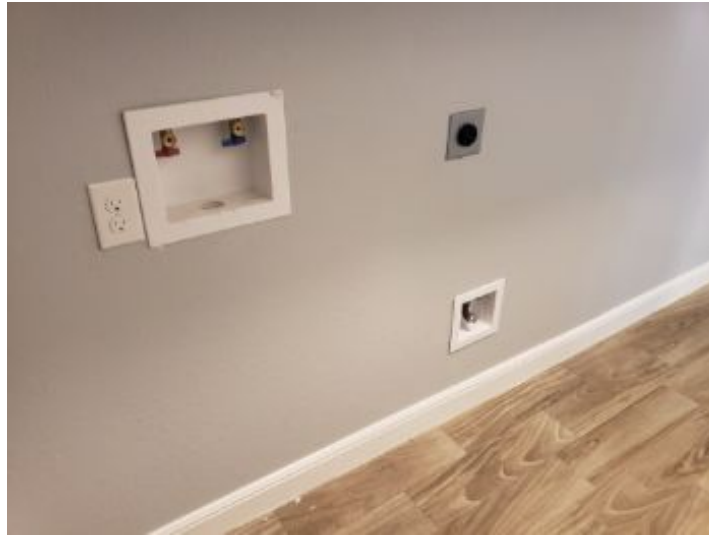
Laundry room wall missing a clothes dryer vent.
