## Property Inspection Report

1327 Falling Leaf Ln, Seabrook, TX 77586  
Inspection prepared for: Regan Bullers  
Real Estate Agent: Allison Houser - Keller Williams Realty Metropolitan

Date of Inspection: 3/17/2016 Time: 12:00 PM; 2:30 PM  
Age of Home: 26 years old Size: 2870 sqf  
Weather: Overcast

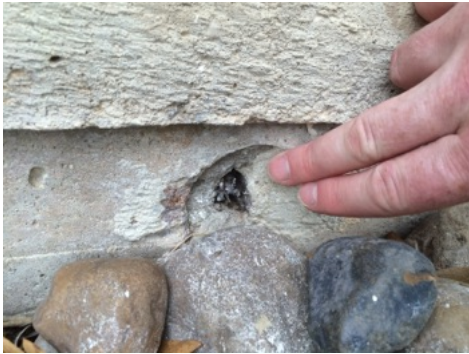
Post tension cable ends were observed on the exterior of the foundation. These should be repaired by a professional, competent and qualified foundation specialist to prevent corrosion/deterioration of the foundation's reinforcement. All exposed tendons should be patched with an approved material and method by the Post Tensioning Institute (PTI).

Rear: Exposed tendon head

1. The pocket former recesses should be filled with concrete patch material immediately after the tendon tails have been cut.
2. The patch material used should be non-shrink grout that will attain the same minimum compressive strength as the concrete foundation.

3. Prior to installing the concrete patch material, the pocket former recesses should be cleaned of any dirt, grit, oil or other substances so that a good bond is attained between the concrete and the patch material. A bonding agent can be used to enhance bond of the patch material to the concrete; however, it is important that the recommended application instructions from the bonding agent manufacturer are followed.

4. If an encapsulated system is used, the posttensioning material supplier's recommendations for cutting, capping and patching should be followed.
5. Under no circumstances should the concrete patch material used for filling the pocket former recesses contain chlorides or other chemicals known to be deleterious to the prestressing steel.

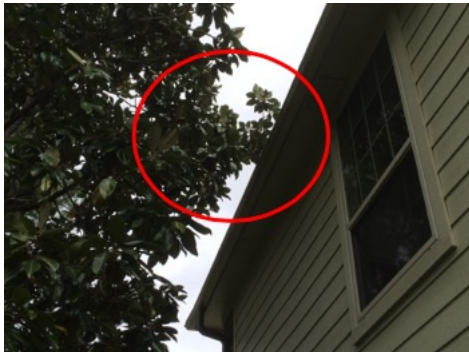
Foliage was noted close to the structure, we recommend trimming all bushes away from structure. Bushes and trees too close to the structure can prevent the wall from drying properly, their roots can affect the foundation and their branches can damage the structure. This was located on the right.

Right: Foliage close to structure

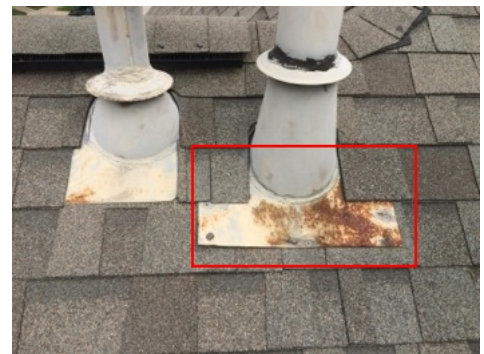
Corrosion was noted on the flashing in multiple areas of the roof. We recommend having these areas cleaned, treated and painted to prevent them from further deteriorating.

Corroded flashing

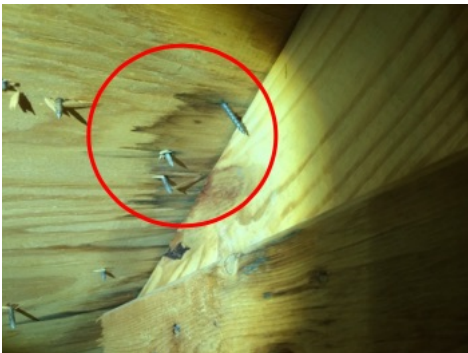
Moisture staining was noted on the roof deck or other structural elements of the roof. The area was confirmed with a moisture meter to be dry at the time of inspection. We recommend monitoring. This was observed to the left of the water heater.

Moisture stain confirmed dry

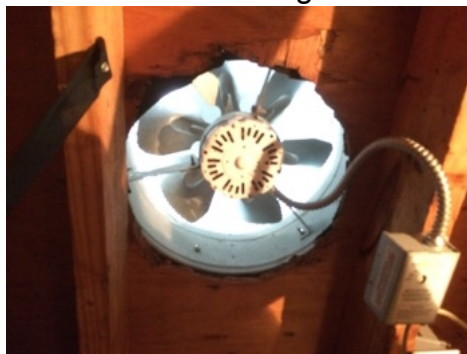
The attic was vented with a power ventilator. These were not working at the time of the inspection. They are typically on a thermostat and will operate at a preset temperature. We recommend annual inspection to insure they are working during the hot seasons and have them repaired if they deficient.

Attic power vent

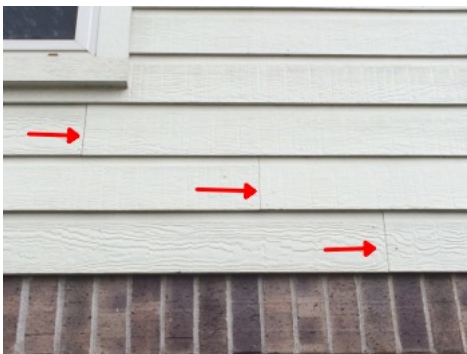
The cement board siding joints we opened. Because these appeared to have been previously caulked, we recommend having them recaulked to prevent excessive moisture to get behind the siding. This was observed on the left, rear, and right.

Left: Open siding joints

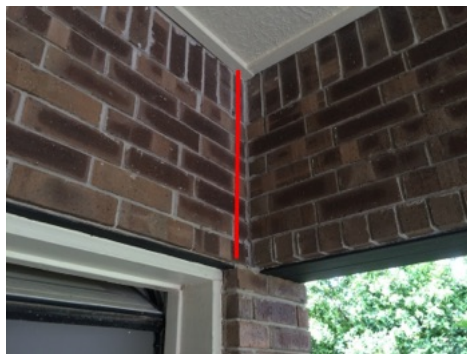
A hairline crack was noted in the brick veneer. This appeared to have been thermal expansion. We recommend repointing to prevent further deterioration. This was observed in the carport.

Carport: hairline crack

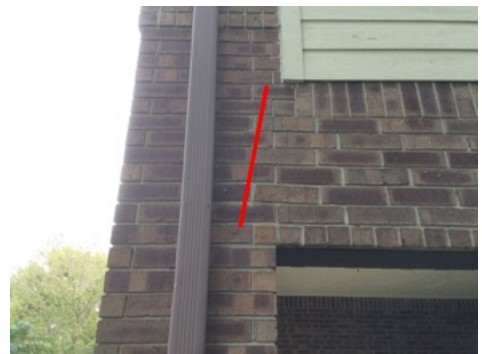
A step crack was observed on the exterior brick veneer. This typically is an indication of structural movement. We recommend patching and monitoring. This was noted on the front right post.

Front right: step crack

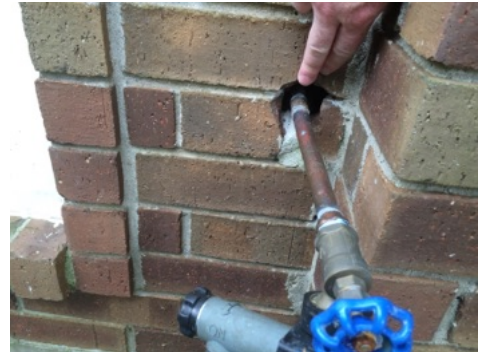
A hole was noted where a hose bibb penetrated the structure. We recommend patching to prevent pest intrusion. This was located on the front.

Front: hole in wall

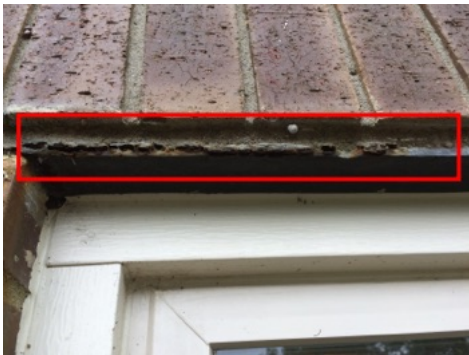
The lintels over the opening (windows/doors) were found to be rusted. These elements support the brick veneer above the openings. We recommend having them (re)ainted to prevent deterioration. This was observed on the front.

Front: rusted lintel

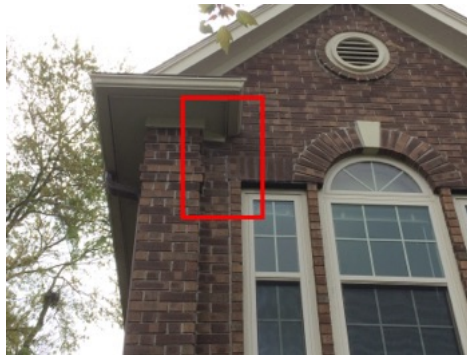
Amateur like patchwork was observed in the brick veneer grout. Silicone caulk had been used between the roof and above the front left corner of the window. We recommend monitoring for water intrusion. The areas of wall on the interior was confirmed with a moisture meter to be dry at the time of inspection.

Front left: silicone caulk used for grout patchwork

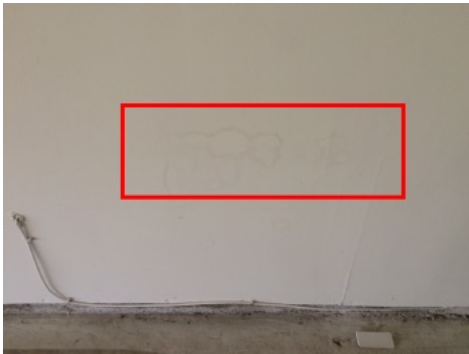
Moisture staining was noted and the area was confirmed with a moisture meter and infrared thermal Imager to be dry at the time of inspection. We recommend monitoring. This was observed in the garage.

Garage: Moisture stain dry at time of inspection

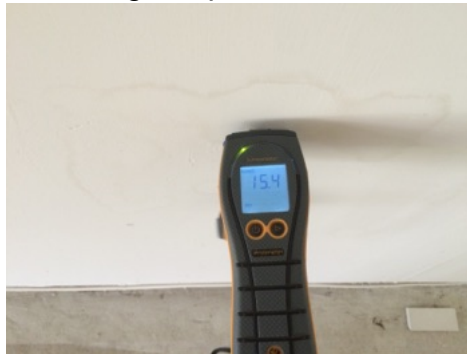
Garage: Moisture stain dry at time of inspection

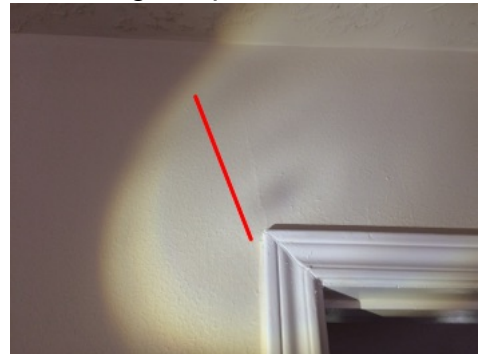
A diagonal crack was observed on an interior wall. This typically indicates foundation movement. We recommend repairing and monitoring. This was observed in the bedroom 1 above the entry door and to the left of the window.

Bedroom 1: diagonal crack

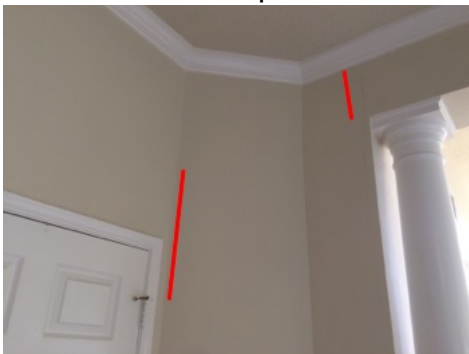
Hairline/shrinkage cracks were noted in the interior walls. This condition was mainly cosmetic in nature and should be patched. This was noted in the breakfast nook, bedroom 2, 3 and 4.

Bedroom 2: hairline cracks

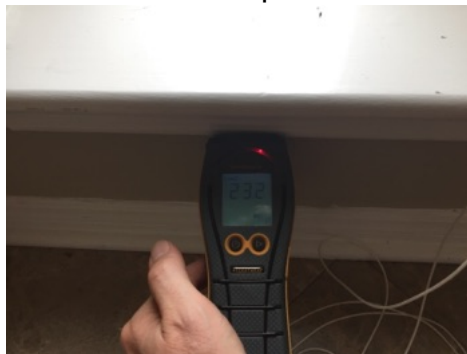
Foyer: elevated moisture under both windows

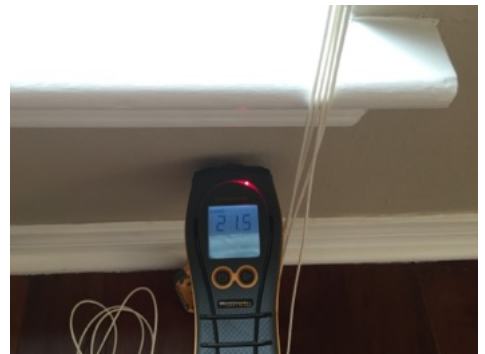
Elevated moisture was found under a window at the time of inspection. We were unable to determine the cause. We recommend having this further investigated and have any necessary repairs made. This was found in the foyer under both windows and the game room under the right corner of the right window.

Game room: elevated moisture under right corner of right window

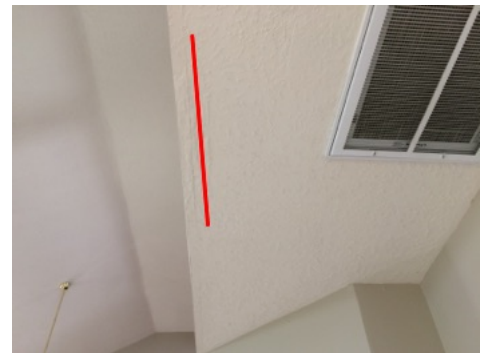
Hairline cracks which were by nature mainly cosmetic were noted on the ceiling. We recommend having these caulked and painted. This was observed in the kitchen.

Kitchen: hairline crack

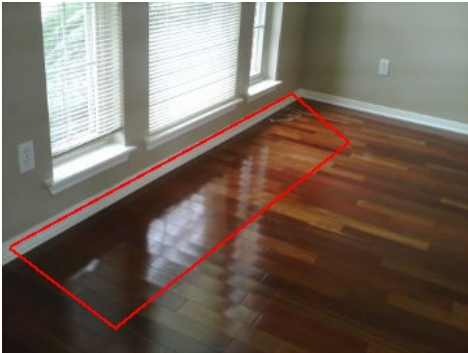
Front room: elevated moisture confirmed

We observed patchwork with elevated moisture at a window at the time of inspection. We recommend having this further investigated to determine the cause and have any necessary repairs made. This was found in the front room at the right window.

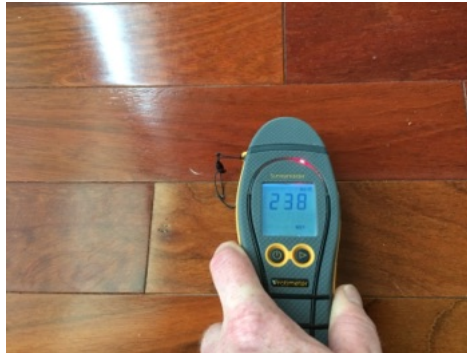
Front room: elevated moisture confirmed

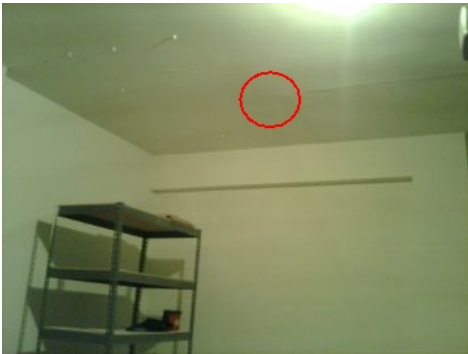
Garage: thermal anomaly confirmed with elevated moisture

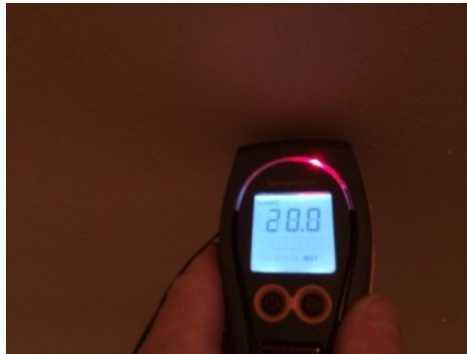
Garage: thermal anomaly confirmed with elevated moisture

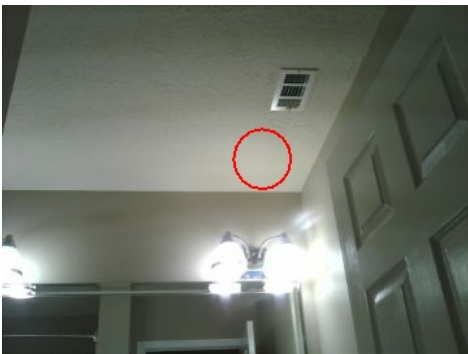
Bathroom 2: thermal anomaly confirmed with elevated moisture

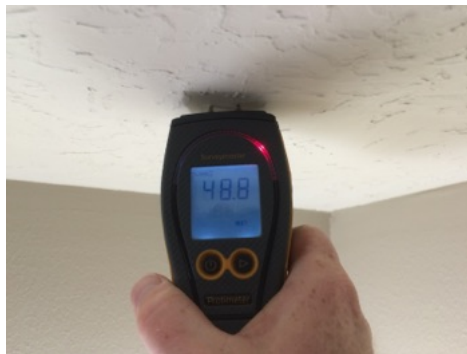
Bathroom 2: thermal anomaly confirmed with elevated moisture

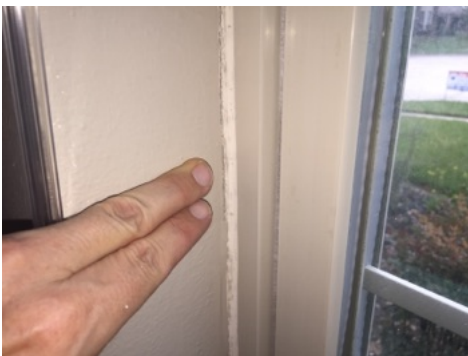
Around house: deteriorated caulk

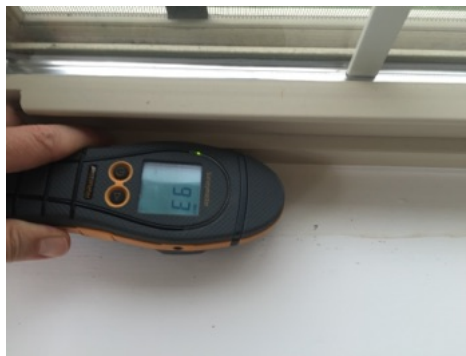
Bathroom 1: moisture staining - dry at the time of inspection

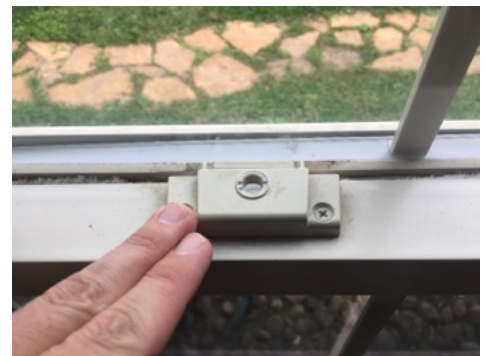
Living room: damaged latch at left window

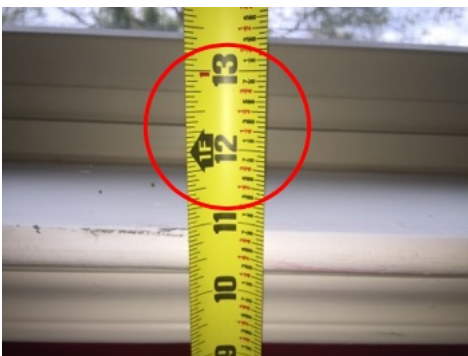
2nd floor: Windows installed too low

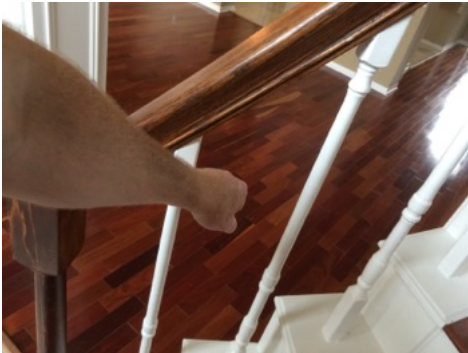
Handrail: Spindles more than 4 and 3/8" apart

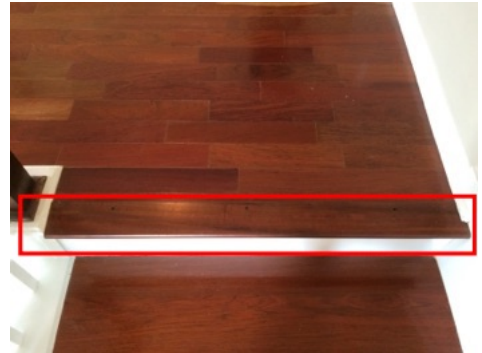
Top step: loose board

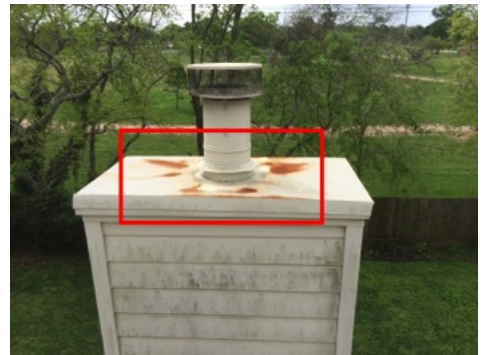
Rusted metal crown

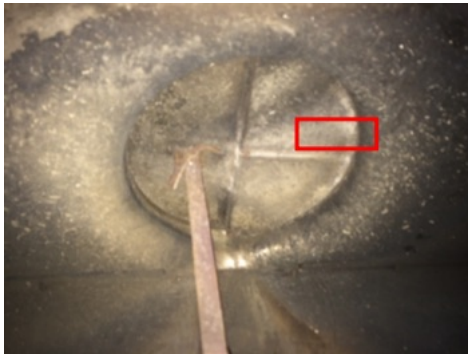
Clip missing on damper

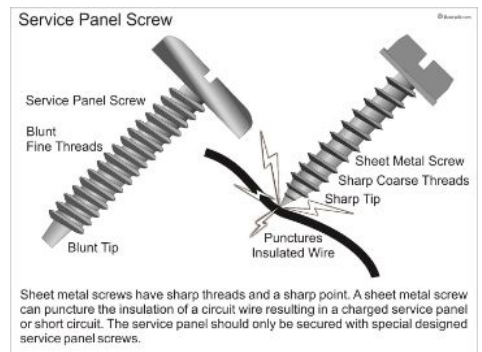
Sheet metal screws have sharp threads and a sharp point. A sheet metal screw can puncture the insulation of a circuit wire resulting in a charged service panel or short circuit. The service panel should only be secured with special designed service panel screws.

Proper screw to be used

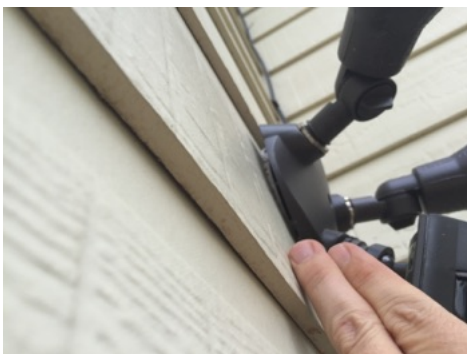
Around House: Caulk missing at fixture to wall connection

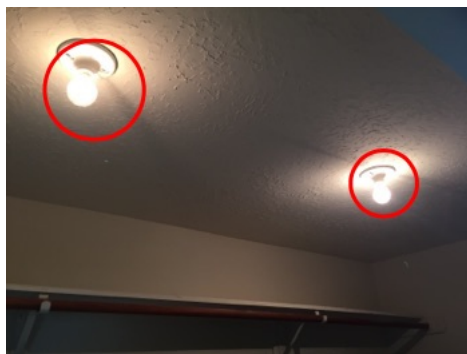
Closets: Globe missing

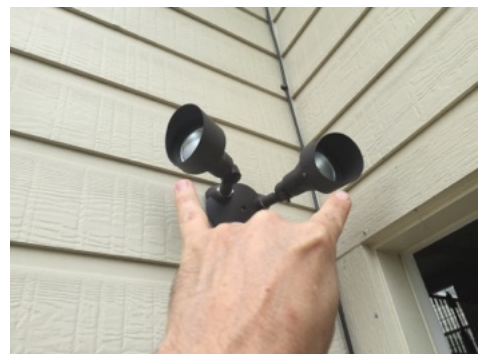
Rear: inoperable light fixture

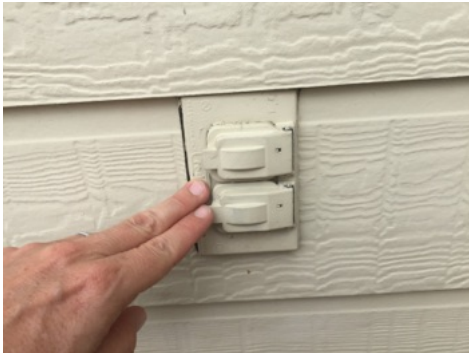
Exterior outlets: Bubbler cover recommended

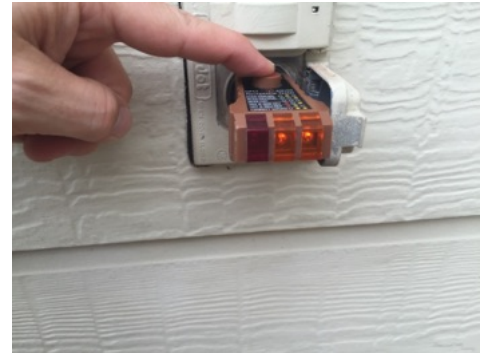
Rear: outlet not GFCI protected

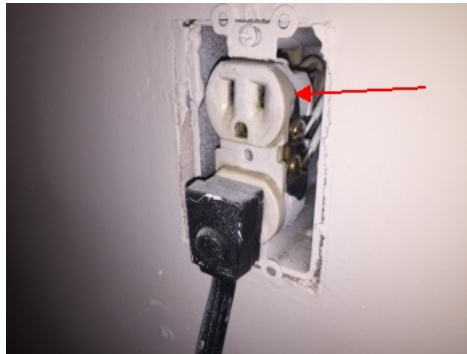
At the time of the inspection, an electrical outlet/switch cover plate was not installed. This condition left energized electrical components exposed to touch, a shock/electrocution hazard. We recommend a cover plate be installed. This was observed in the garage.

Garage: missing cover plate at back wall

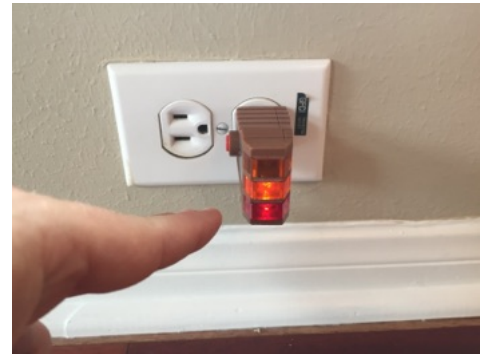
An outlet was noted with reverse polarity. This is when the neutral wire (white) and the hot wire (black) are reversed. We recommend having this corrected. This was observed in the dining room at the outlet under the window.

Dining room: reverse polarity at outlet under window

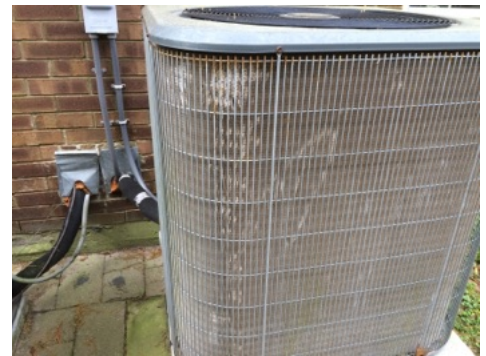
Unit 2: dirty with damaged fins

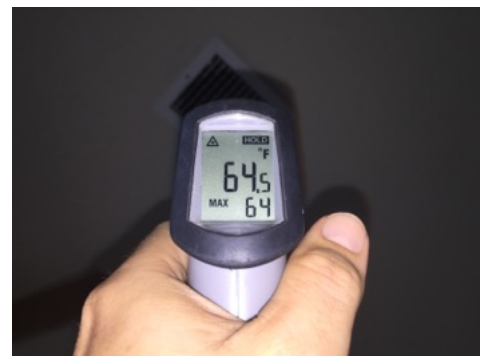
The temperature drop measured at the supply and return registers for the 2nd floor was lower than considered normal. This usually indicates that servicing is needed. A licensed, professional, competent and qualified HVAC technician should be consulted to further evaluate this condition and the remedies available for correction.

2nd floor: vent temperature

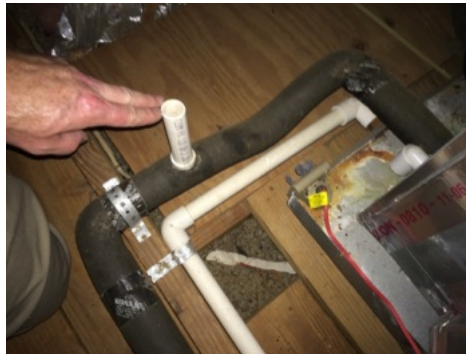
Cap missing on primary condensate drain line cleanout

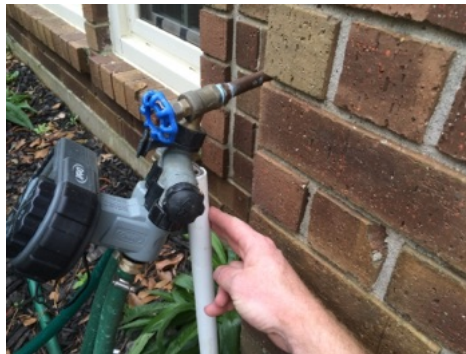
Front: improper support

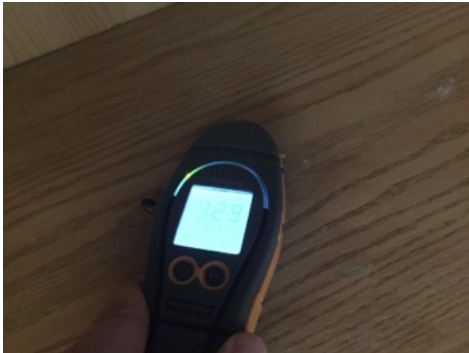
Bathroom 1: water damage - dry at the time of inspection

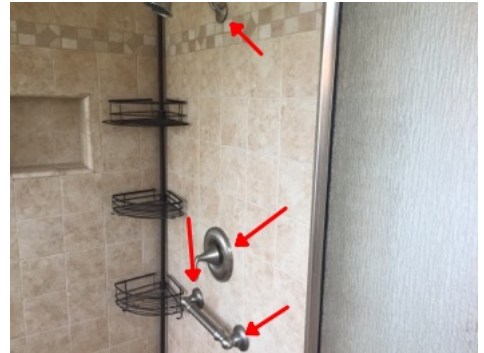
Bathroom 1: missing caulk at wall protrusions

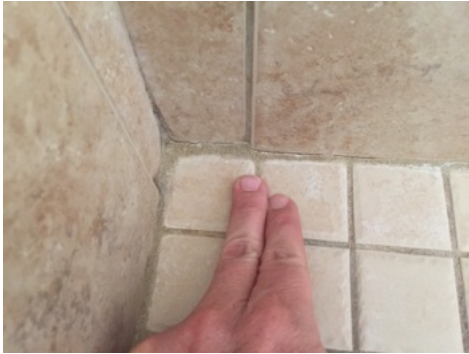
Bathroom 1: deteriorated grout/caulk at tub and shower

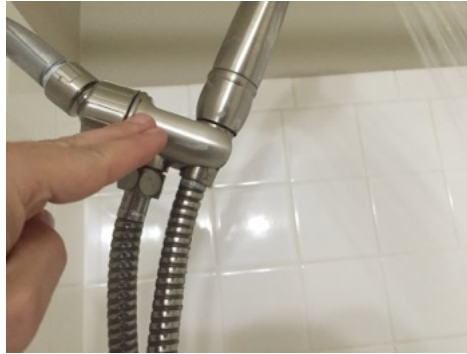
Bathroom 2: leak at shower head

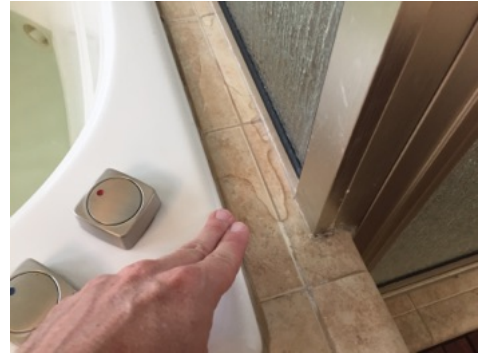
Bathroom 1: leak at shower glass connection to tub

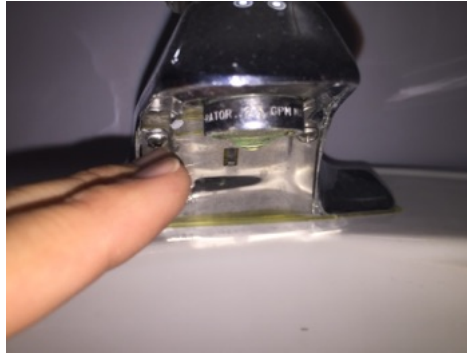
Bathroom 2: water dripped at right faucet

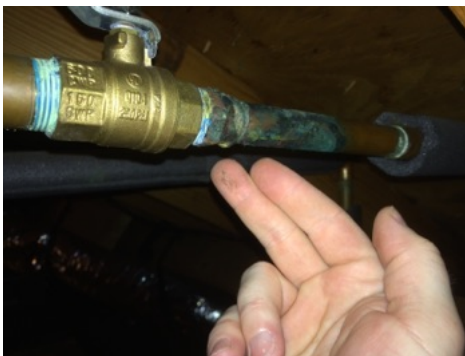
Leak at cold water supply

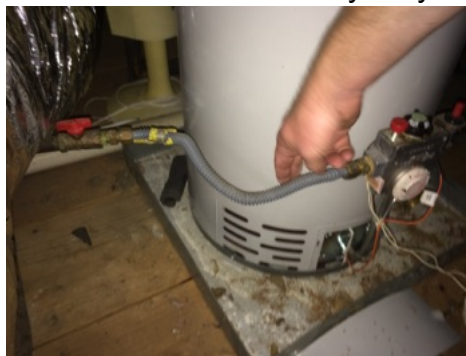
Missing drip leg

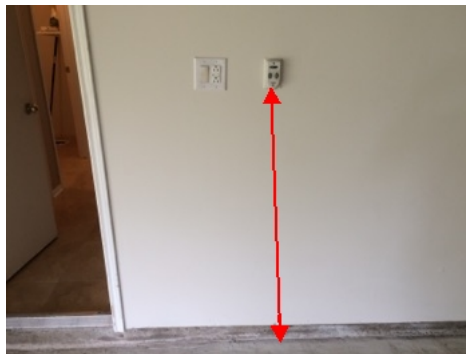
The garage door push-button switch was lower than the recommended 5-foot minimum height above the standing surface. This condition is potentially dangerous to children. We recommend that the switch be raised for safety reasons.

Switch too low

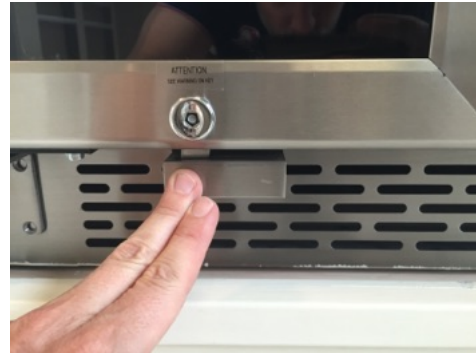
Wine refrigerator: doors locked - no key provided
