HOUSTON INSPECTIONS

PROPERTY INSPECTION REPORT

Concerning: 11219 Bottlebrush Ct, Houston, TX 77095
(Address or Other Identification of Inspected Property)

By: Dennis Inman, Lic #20664 05/07/2015
(Name and License Number of Inspector) (Date)

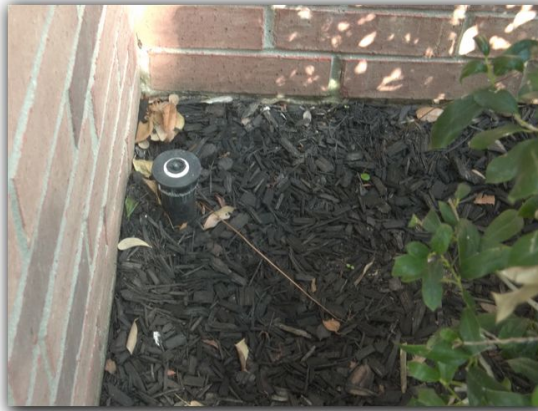
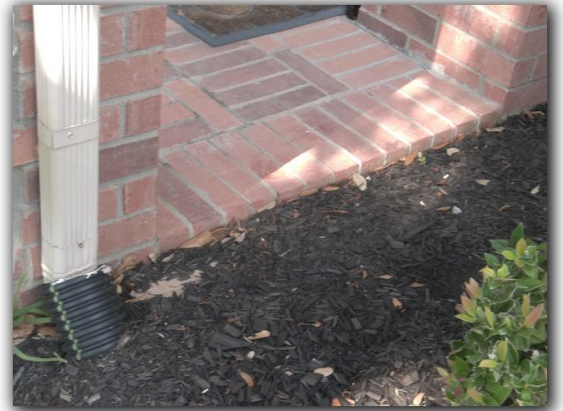
The top soil and / or mulch around the structure is too high in some areas. The soil should be lowered to provide 4-6" exposure of the foundation. Lowering the top soil will reduce the likelihood of wood rot at exterior veneers, allow proper ventilation of the wall cavities, and assist in monitoring the foundation for movement.

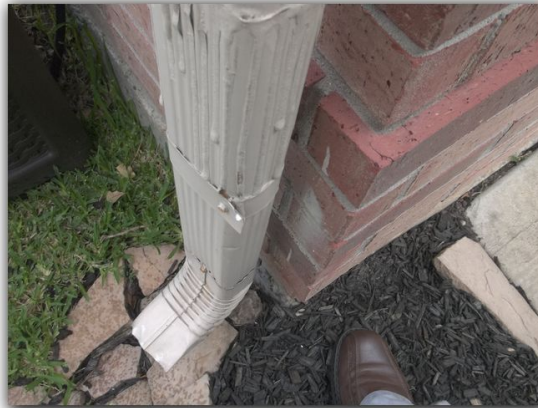
Loose gutter downspouts should be secured to insure proper function and prevent damage.

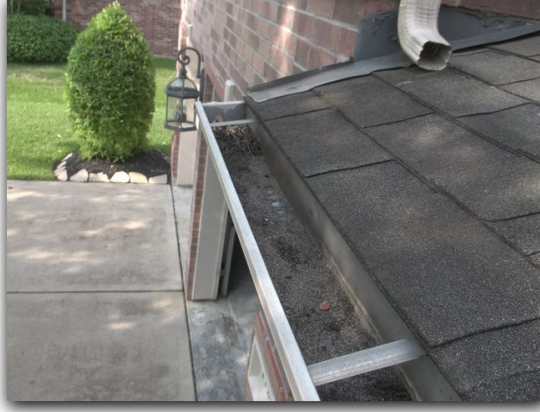
The debris should be cleaned from the gutters to allow proper drainage of rainwater from the roof covering.

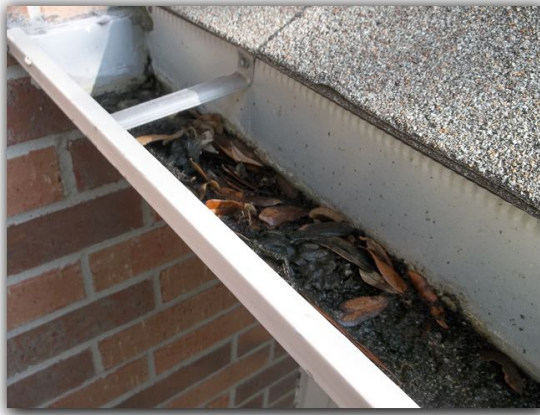
Evidence of improper sloping of the gutter was found as evident by a standing water in sections of the gutters. This problem can lead to future leaks.

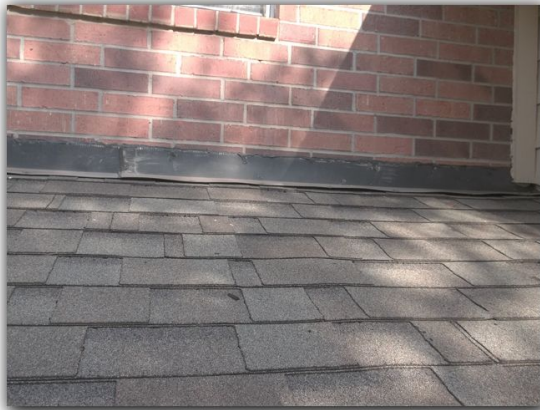
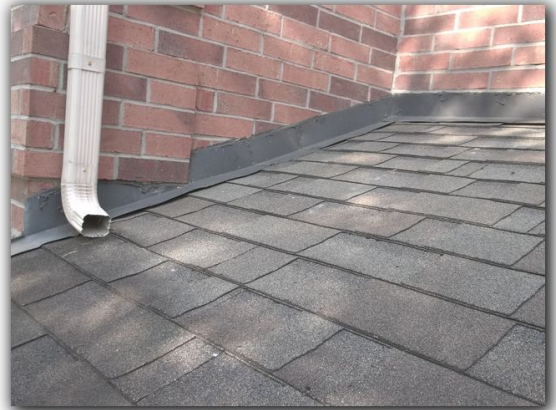
Sections of the roof flashing are raised which could lead to water penetrations. Recommend repairs.

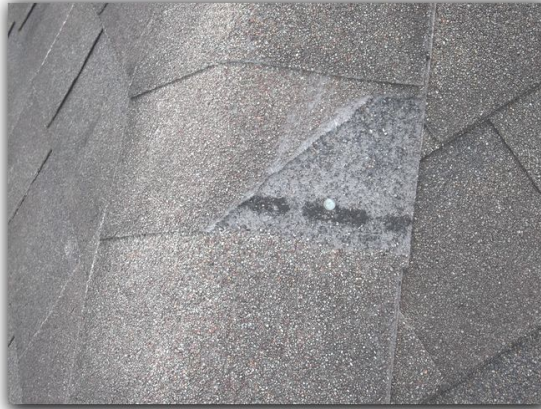
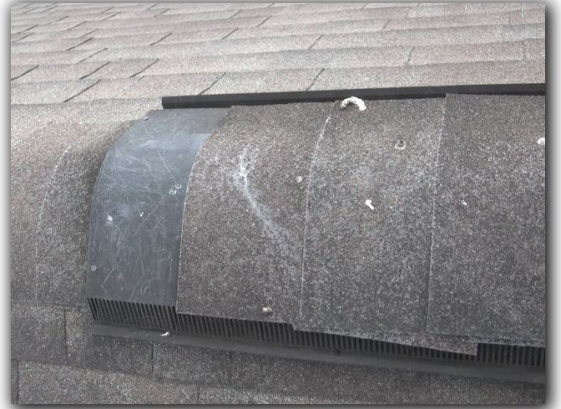
Damaged and / or missing shingles were found during the inspection of the roof covering. Recommend repairs by a qualified tradesman.

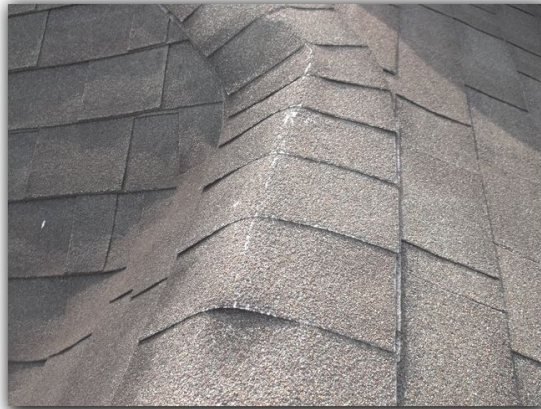
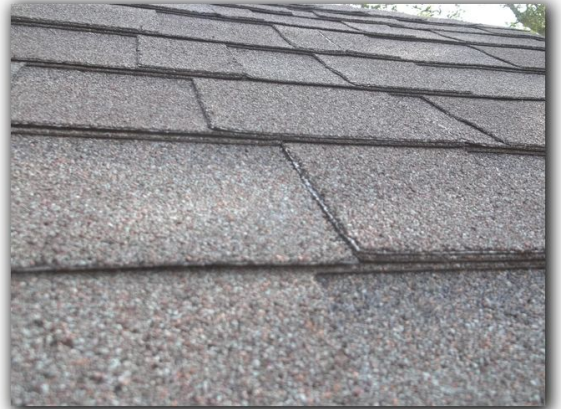
Evidence of loss of aggregate and exposed fibers were noted during the inspection of the roof covering as evident of aging.

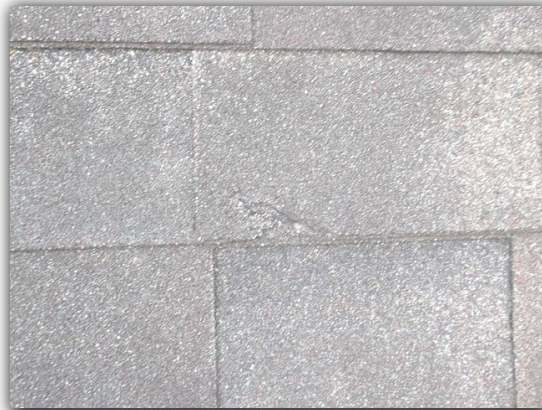
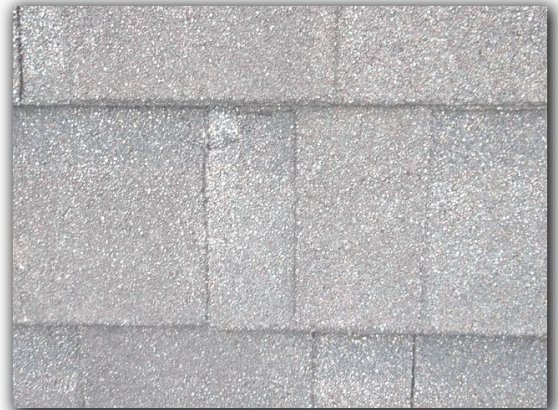
The shingles have become brittle as evident by cracked and damaged shingles. This is something that occurs to composition shingles as they age. This is an indicator that the shingles are more than half way through their serviceable lives. As the roof continues to age, unexpected repairs can and will most likely occur. The client should budget and anticipate repairs and replacement in the near future. Immediate repairs should include replacement of the damaged and / or non functional items by a qualified tradesman.

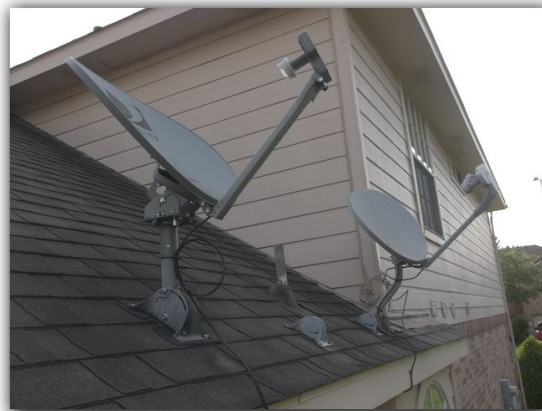
The fasteners used to secure the satellite dish to the roof should be sealed to prevent future roof leaks.

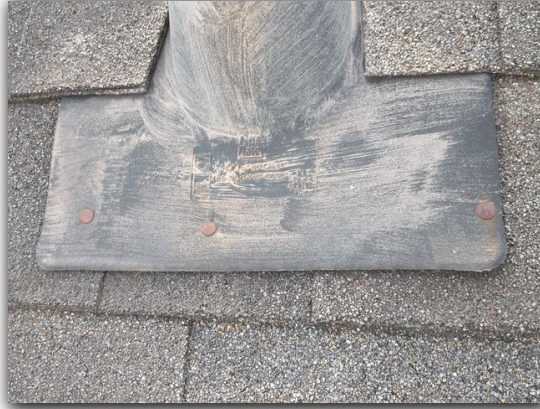
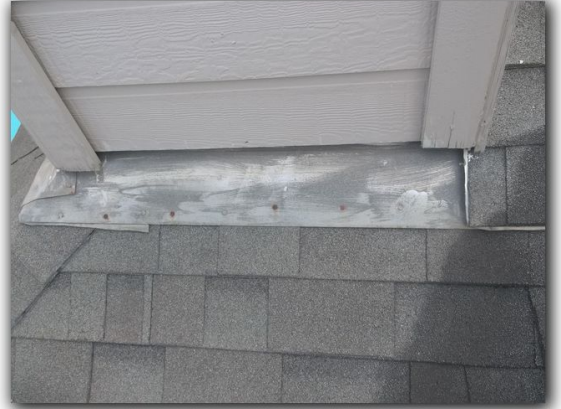
Exposed nail heads were found at roof jacks and / or sections of the flashing. All exposed nail heads should be sealed to prevent water penetrations.

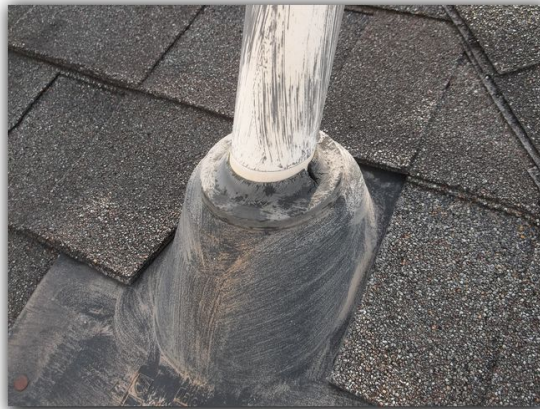
Cracked and damaged rubber / neoprene roof jacks were found at some roof jacks. Recommend replacement / repairs of the roof jacks by a qualified tradesman.

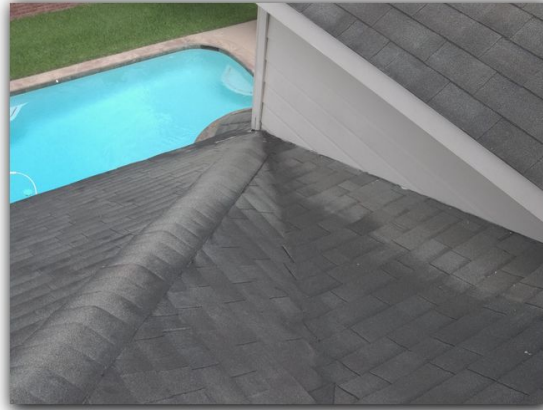
The design of the roofing system is such that several vulnerable areas exist. There is a higher potential for unanticipated repairs. Annual inspections and ongoing maintenance will be critical to the performance of the roofing system.

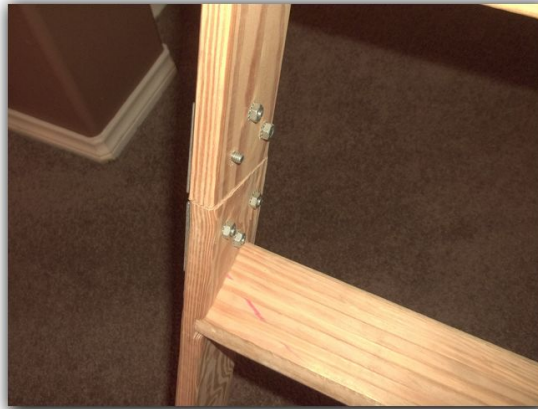
The attic ladder is unstable due to loose or missing hardware, improperly cut items, or other problems. It is recommended that the ladder be repaired or replaced prior to use for safety reasons.

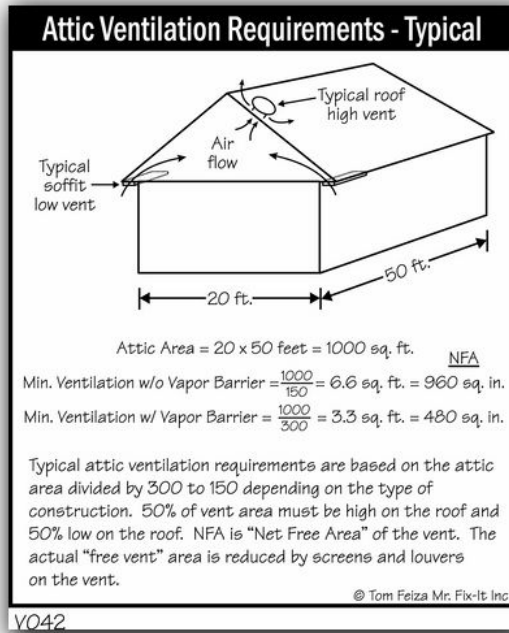
The level of ventilation should be improved. It is generally recommended that one (1) square foot of free vent area be provided for every one hundred and fifty (150) square feet of ceiling area. Proper ventilation will help extend the life of roofing materials and could (if over living space) assist with the energy efficiency of the building.

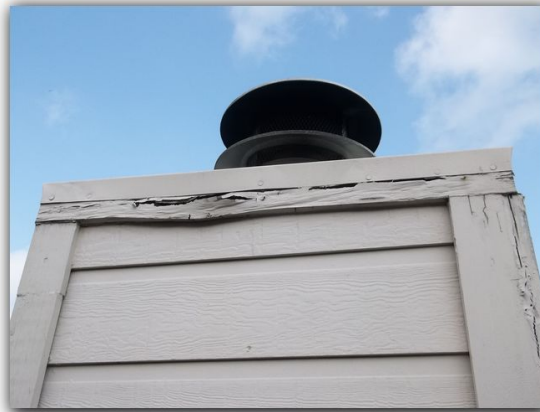
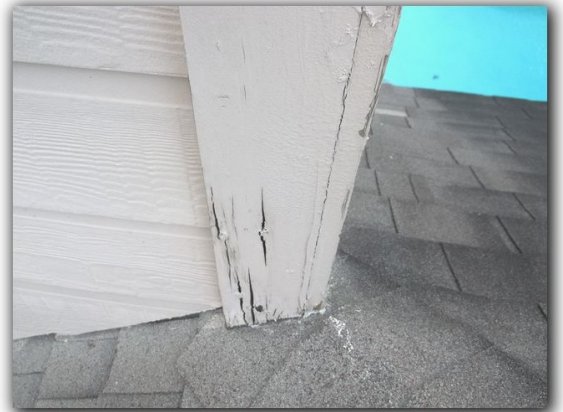
Recommend repairs / replacement of the affected areas. In addition, areas where decay is present should be removed, exposing underlying materials for inspection prior to repair by a qualified tradesman.

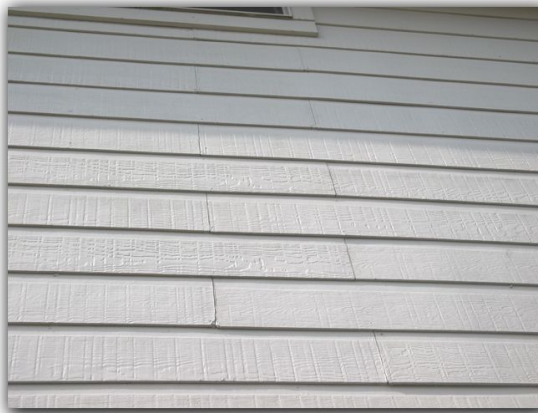
Damaged and missing sealant / caulking was found at joints, transitions, and voids on the exterior veneers. This material acts as a moisture barrier to prevent water from moving to the underlying wall cavity. The re-sealing of the exterior veneers should be considered.

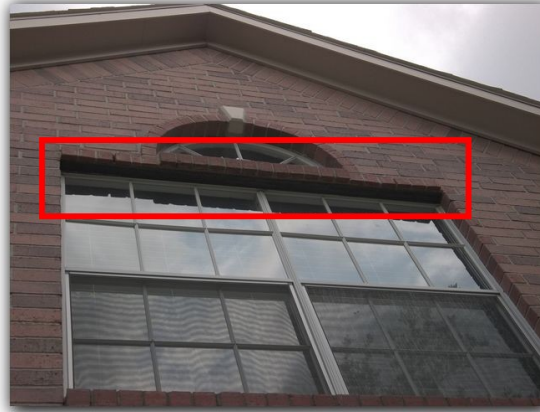
The metal lintels on the exterior of the structure are rusted. Lintels are metal that is installed over openings in the brick veneers (doors, windows, etc). Further evaluations and repairs by a qualified tradesman.

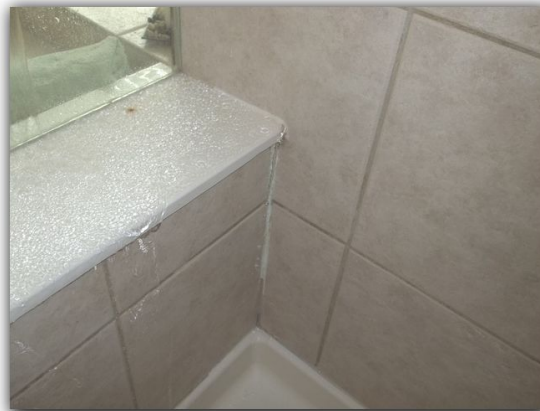
Damaged and missing grout/caulking was noted in the master bathroom shower enclosure. It is recommended that the damaged or missing items be repaired/replaced.

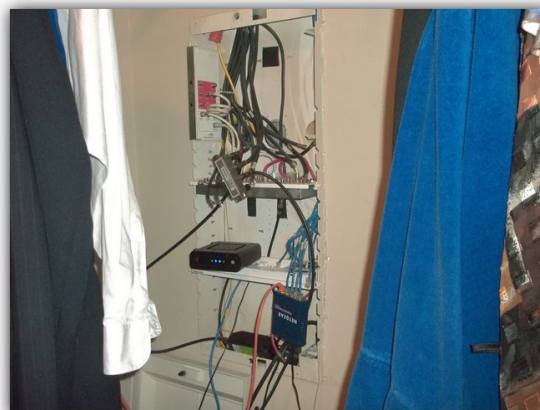
A cover panel is not installed in the media center/wall. Replacement is recommended.

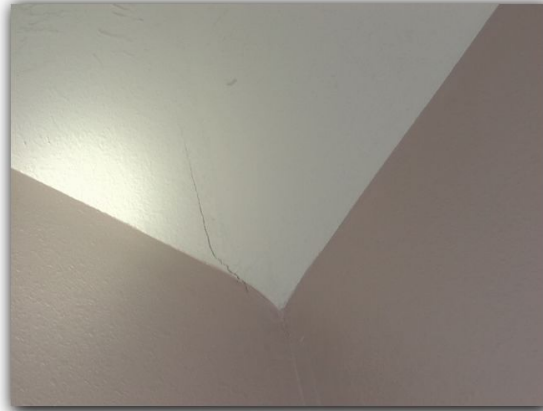
Cracking was noted on the interior ceiling of the property as evidence of settlement.

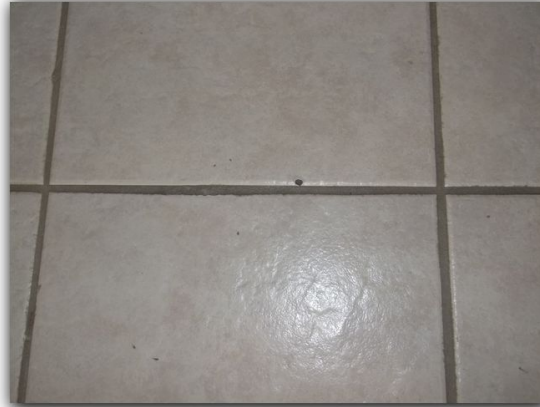
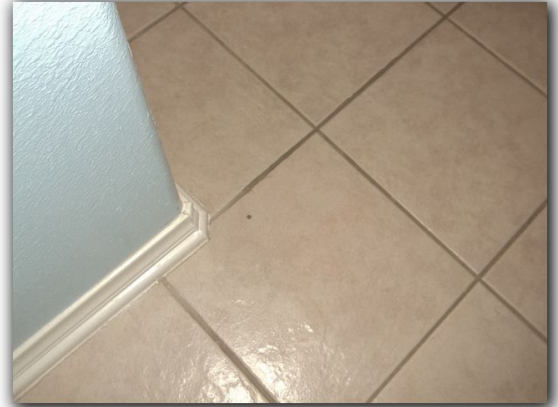
Chipped floor tiles were found in the den.

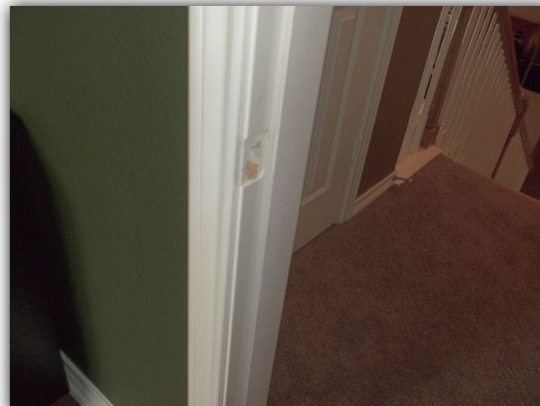
Missing hardware was noted in the rear left guest bedroom. Replacement is recommended.

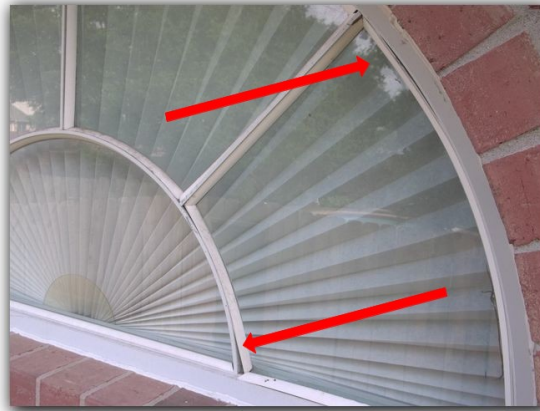
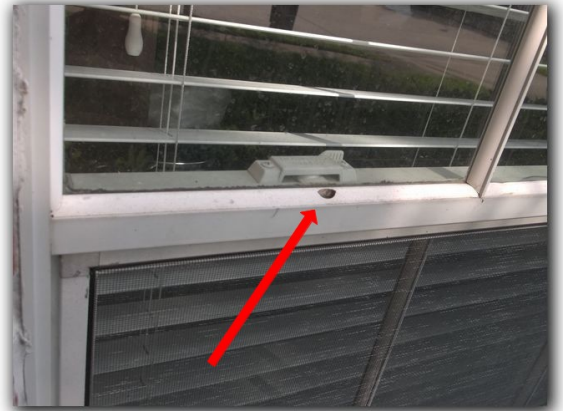
Damaged and / or missing weather striping was noted at portions of the exterior windows. All weather striping should be in good condition and installed at all windows.

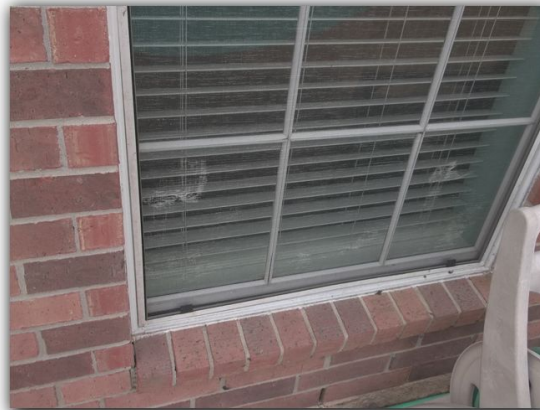
Damaged window screens were found at various windows.

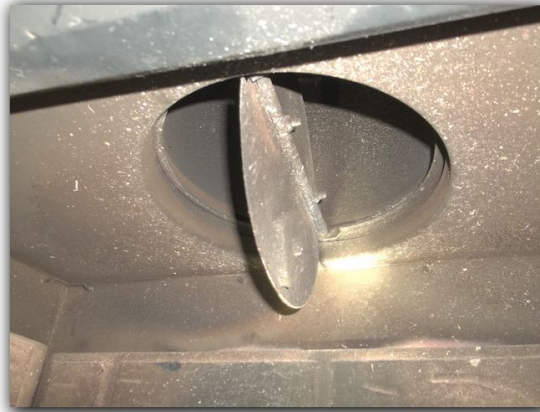
The build up of soot and possibly creosote was noted on the visible portions of the chimney, smoke ledge, and fireplace. A certified chimney sweep should be hired to clean the fireplace and chimney prior to use.

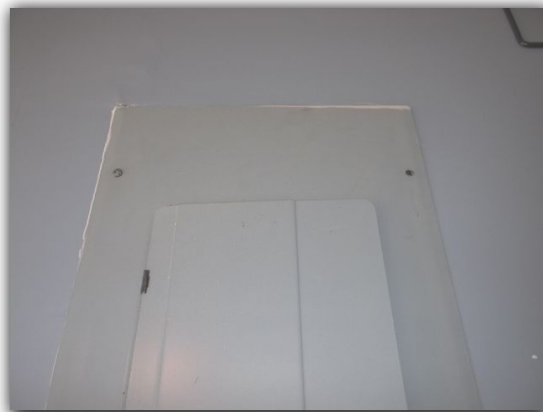
Missing screws were found at the dead front cover located at the main service panel. Approved screws should be installed at the dead front to properly secure the cover.

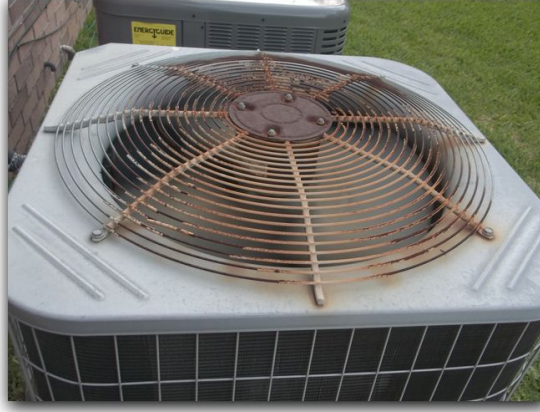
Items Damaged, Non-Functional, or Operating Improperly
Rust and corrosion was noted at the exterior of unit #1.

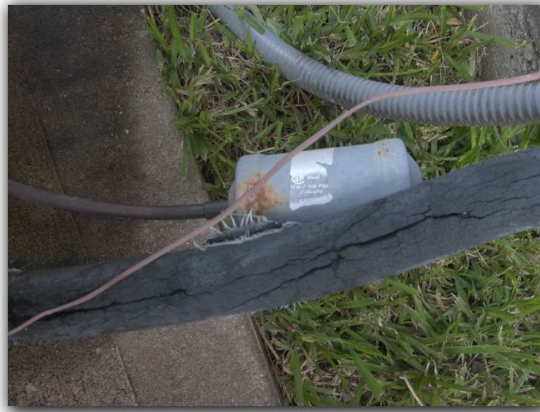
The refrigerant line dryer(s) at the exterior portion of the air conditioning system(s) is rusted at unit #1. These components should be inspected annually, cleaned and repainted to prevent leaks and other problems from developing.

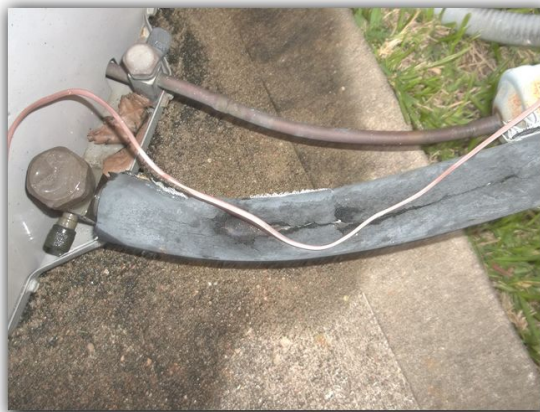
Damaged and missing insulation on the visible portions of the refrigerant lines should be repaired/replaced at unit #1.

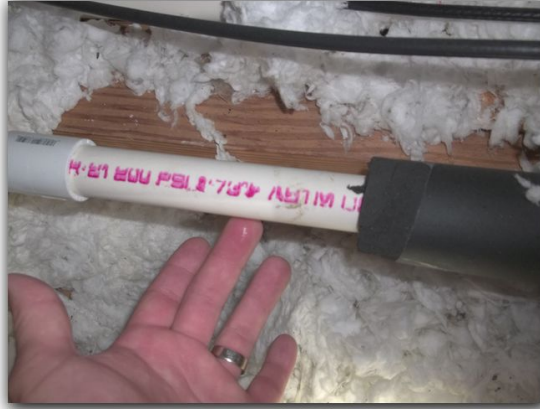
The primary drain lines have not been insulated properly. Condensation was found at the exterior of the primary drain line of unit #1 in the attic. Improvement is recommended.

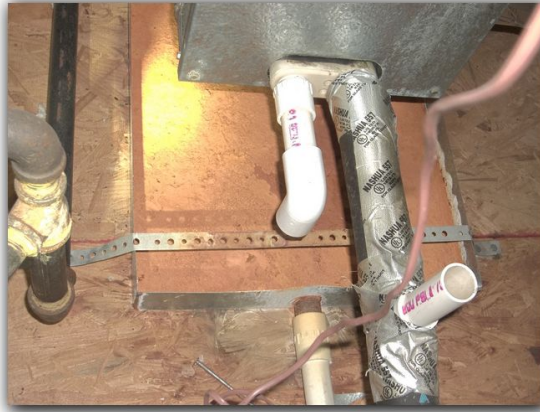
The overflow pan is rusted under the evaporator coil, apparently from water overflowing from the condenser drain line in the past.

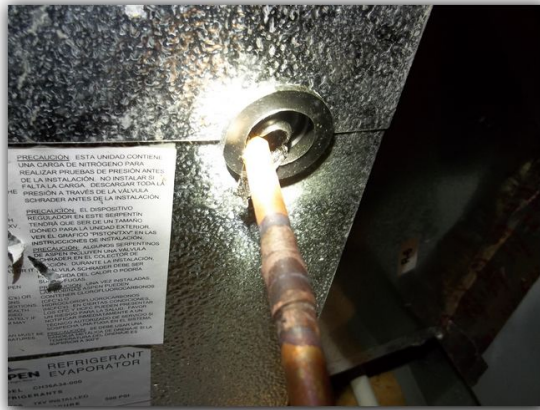
Air leakage was found at the evaporator coil housing of unit #2. Repair by a licensed HVAC contractor is recommended.

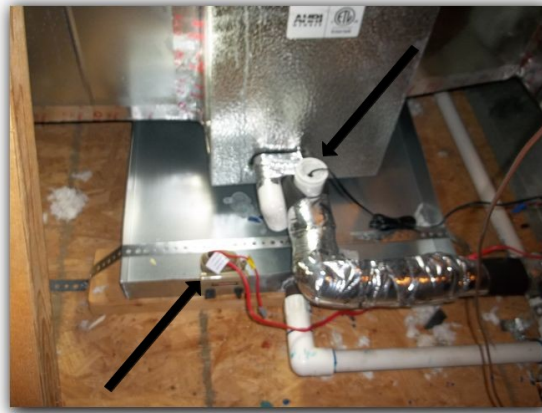
Float switches have been installed at the primary drain line and emergency drain pan of unit #2 in the attic. This is a feature that turns off the outside unit in the event water flow becomes obstructed at this line.

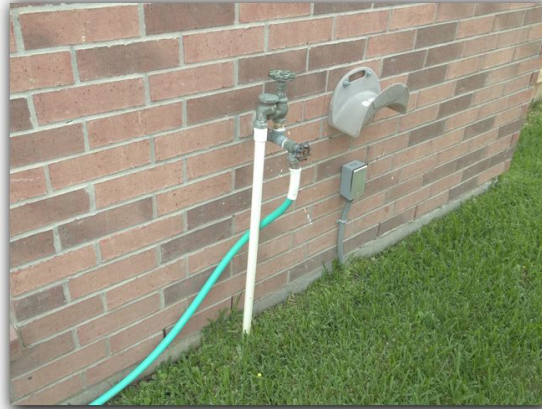
The supply piping on the exterior of the building / structure should be insulated to protect from freezing.

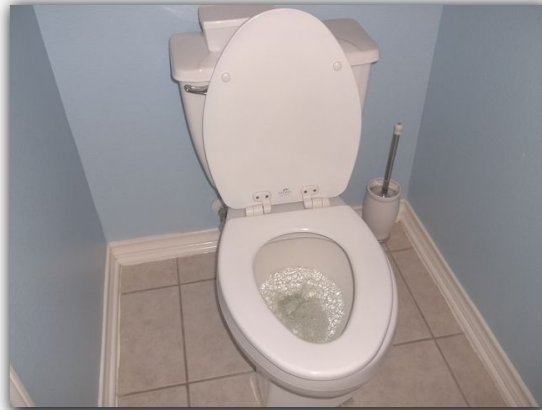
The toilet is loose at the floor. The toilet should be re-secured properly to the floor and the voids between the floor and the toilet should be sealed.

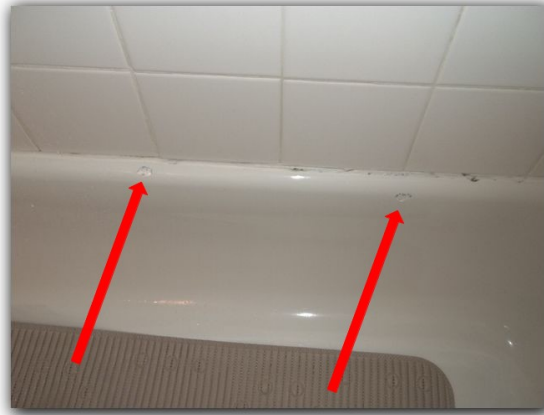
Surface damage was found at the tub. The damage should be repaired to prevent the damage from extending to through the fixture.

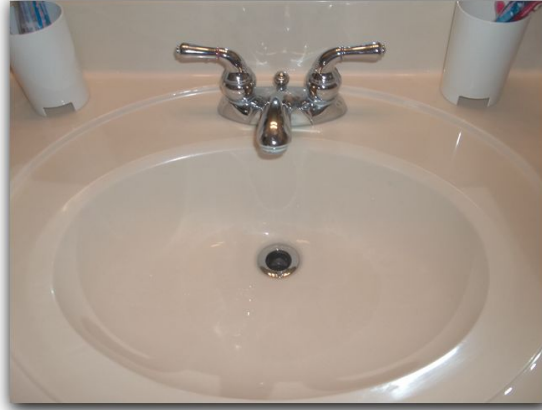
Items Damaged, Non-Functional, or Operating Improperly
Left Guest Bathroom
The sink and tub stoppers are missing.

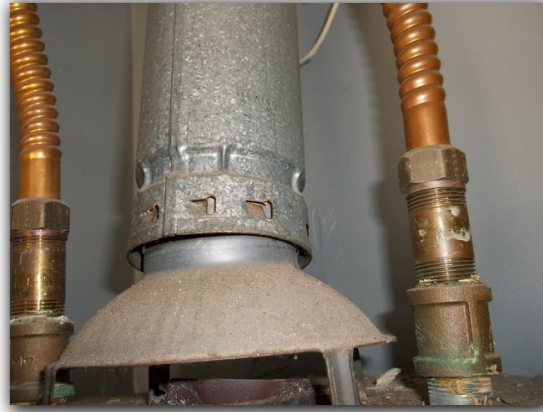
The water heater flue pipe have not been installed properly on top of the water heater. This is safety issue and is allowing carbon monoxide to escape into the attic. Recommend repairs as soon as possible.

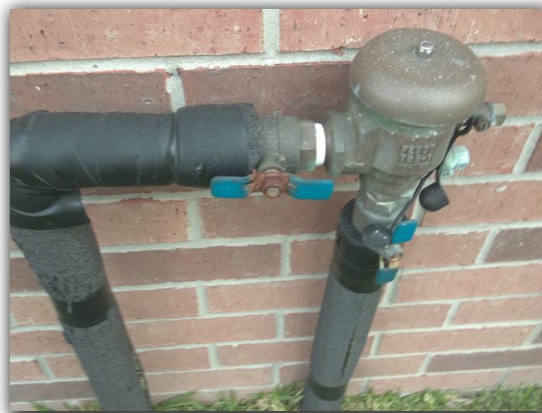
Rust and corrosion were found at the valve handles installed at the backflow prevention device. The valve handles should be repaired as the rust will eventually cause the handles to become inoperative.

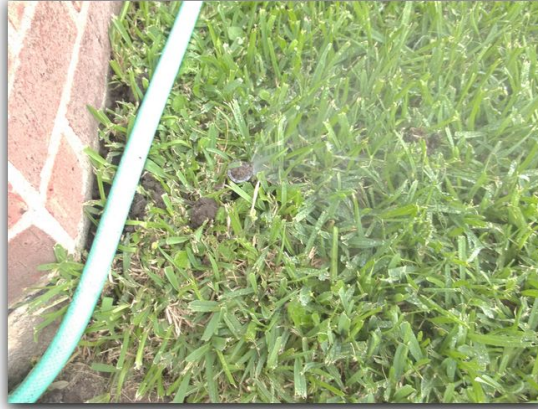
Heads were found in zone #_5 that need to be raised due to the height of the grass and other vegetation. This problem is preventing the heads from properly watering the designated area.

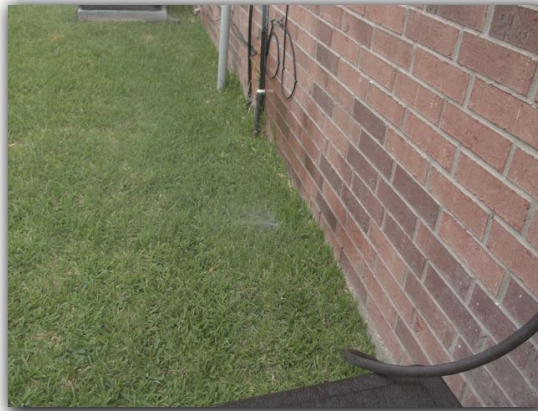
Several sprinkler heads are spraying against the exterior veneers. This can lead to future damage and other problems. Recommend adjusting the heads.

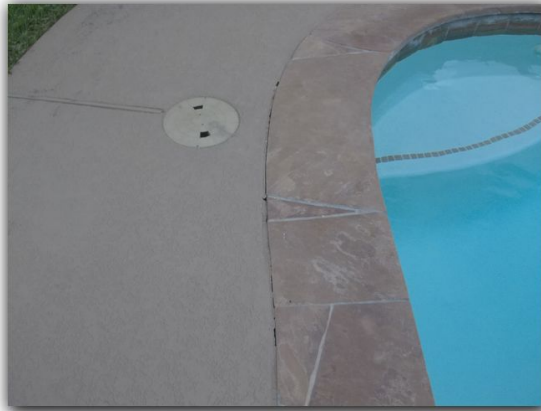
Damaged and missing sealant was found at several areas between the pool coping and decking. All damaged and missing sealant should be repaired/replaced to prevent the leakage of water into these voids.

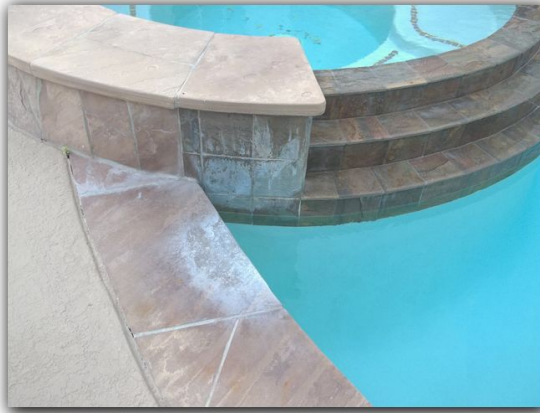
Efflorescence was observed at the natural stone that has been installed at the pool. Efflorescence appears as an unsightly white plaque on porous surfaces, and is the most common salt issue. Water, full of dissolved salts (minerals) is absorbed into pavers from all six sides, travels through the pores to the top surface, where it evaporates, leaving the salts behind. Fresh efflorescence is easily removed with a dry brush, but over weeks the salts react with the air and hardens, until only acid washing or grinding will remove it. Sealing stone with a suitable water-repellent impregnating sealer can provide enough protection to give softer stones a reasonable lifespan around a salt water pool. It is recommended that a qualified tradesman be consulted to perform the needed repairs.

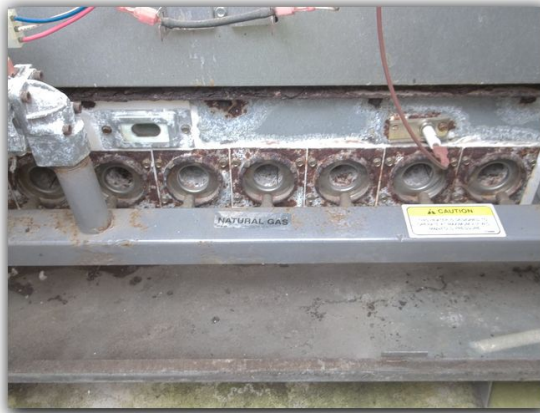
During the inspection of the pool/spa's heater, rust buildup was observed at the burner compartment. A qualified tradesman should be consulted to clean and repair the heater.

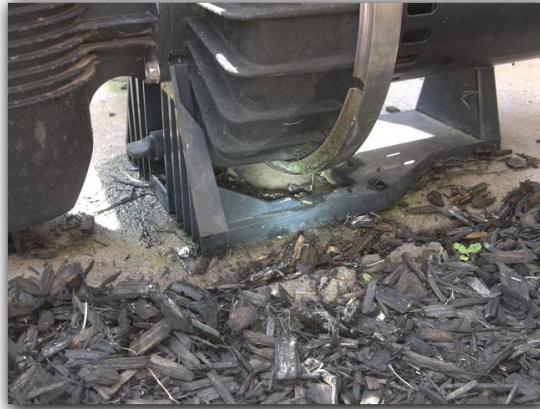
A leak was found at the rear pool pump. Repair by a qualified tradesman is r

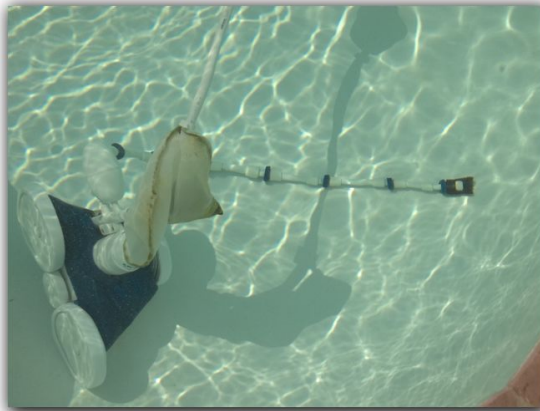
The sweeper agitator is worn/damaged. Replacement is recommended.
