# PROPERTY INSPECTION REPORT

**Concerning:** 2913 Port Rose Ln, League City TX 77573  
(Address or Other Identification of Inspected Property)

**By:** Nick Jones - TREC #9019 05/02/2019 10:00  
(Name and License Number of Inspector) am (Date)

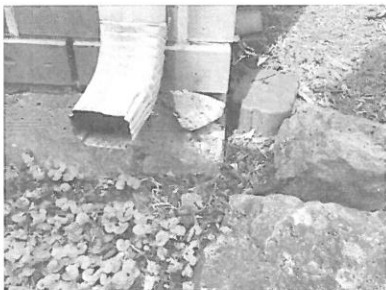
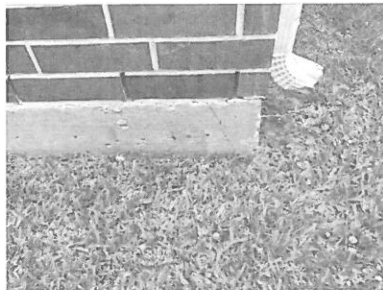
### 1: Slab: Corner Pops

Cracks noted at the corners of the foundation walls. Referred to as a "corner pop", these are very common and not a structural issue at this time. They should however be properly sealed to prevent further deterioration.

Recommendation: Contact a qualified professional.

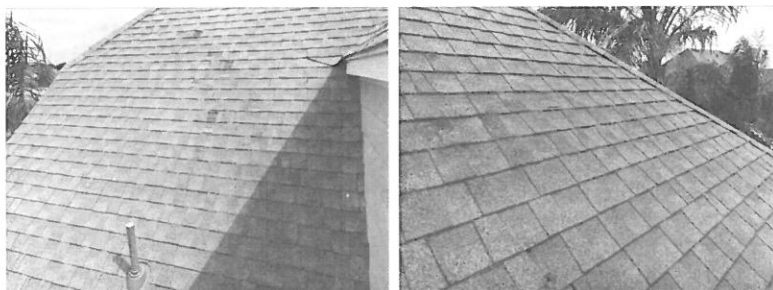
**3: Wear and damage**

Excessive wear observed to the roof covering at the back right in back left roof slope's. Disappears related to tree limbs that were previously hanging on the roof covering. The covering is worn, the shingles are damaged, and the roof is a need of repair at these areas. Recommend further evaluation and correction as needed.

Recommendation: Contact a qualified roofing professional.

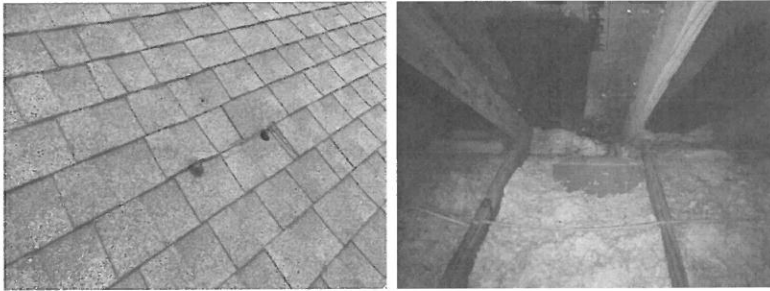
**4: "Soft" spot and water damage**

Hole observed in the roof covering at the back left roof slope above the master bedroom area. Extensive water damage observed to the roof sheathing at this location, and signs of water penetration observed in the attic space and at master bedroom ceiling. Recommend further evaluation of this condition to determine the extent of necessary repairs.

Recommendation: Contact a qualified roofing professional.

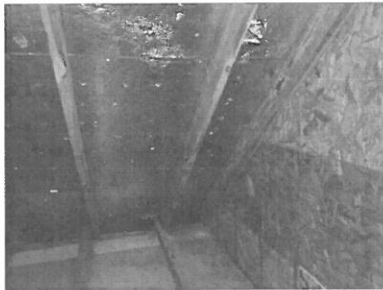
**5: Sheathing damage in garage attic**

Signs of water penetration to the roof sheathing observed at the attic space above the garage. This area can be accessed from the front right lower attic space hatch. This condition is indicative of moisture penetration, and requires further evaluation by qualified roofer.

Recommendation: Contact a qualified professional.

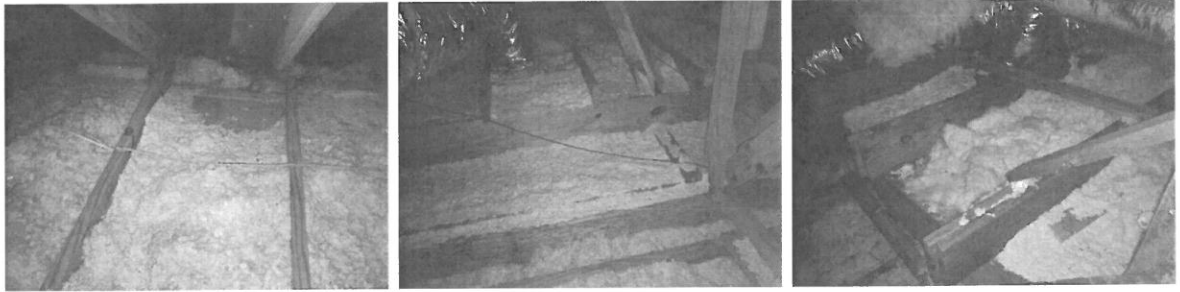
### 3: Degraded/moisture damaged insulation

Several locations throughout the attic space where the insulation has been damaged from moisture issues, or the insulation is degraded or displaced. These locations include above the master bedroom area, where moisture issues from roof leaking as well as ductwork have degraded the insulation, as well as multiple locations throughout the attic space where the insulation has been displaced. Thermal imaging revealed multiple locations with poor insulation that should be supplemented. Recommend further evaluation and correction as needed for energy efficiency reasons.

Recommendation: Contact a qualified insulation contractor.

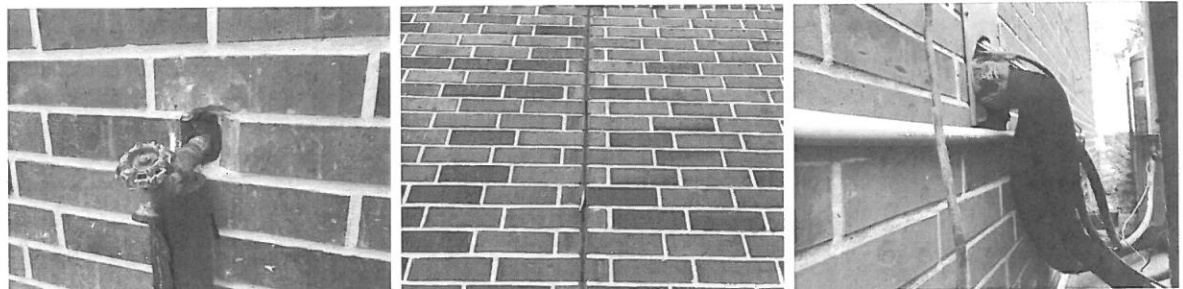
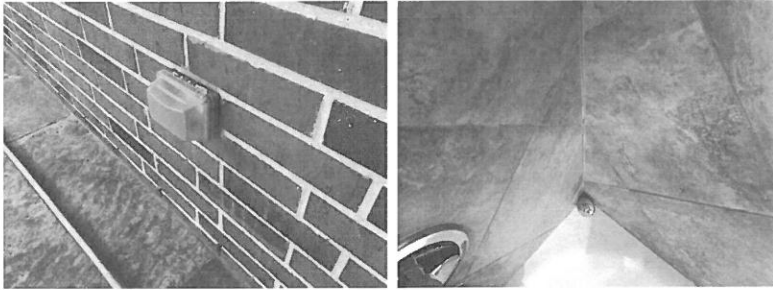
#### 1: Caulking & Sealing

Caulking and sealing is needed various locations to prevent any possible moisture penetration into the building or other issues. These locations include around wall vent covers, electrical outlets/fixtures, transitions between siding, plumbing penetration, brick control joints, A/C lines, and gaps in shower enclosures and backsplash.

Recommendation: Contact a qualified professional.

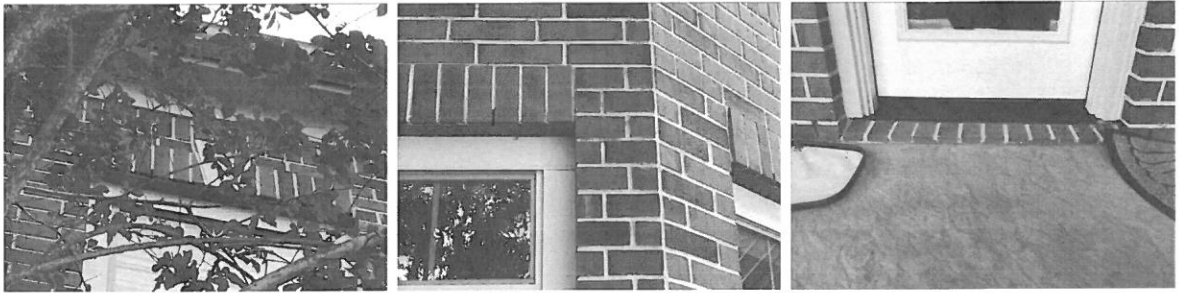
## 2: Exterior Walls: Minor Mortar Cracks in Brick/Stone

Minor cracks were observed in the mortar for the masonry at various locations around exterior of home. Recommend repair to prevent further deterioration.

Recommendation: Contact a qualified professional.

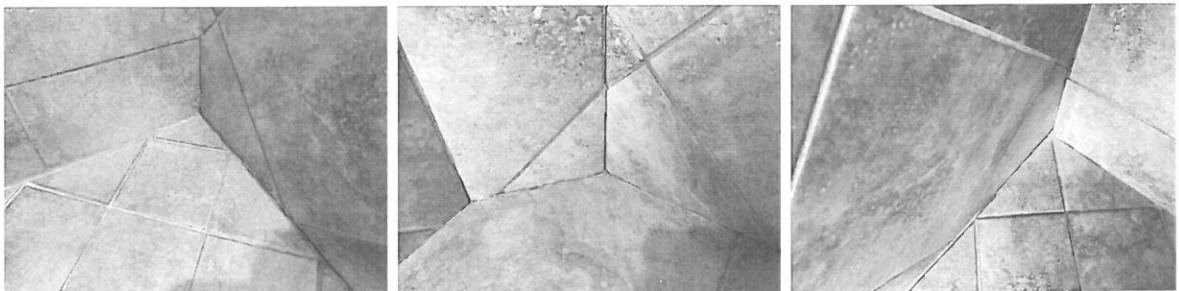
## 3: Master shower enclosure

Excessive cracking and separation observed at the grout and tile near the corners of the master shower enclosure. Sections of the walls give when pressure was applied, indicative of potential moisture penetration. Recommend further evaluation of these conditions to determine the extent of necessary repairs.

Recommendation: Contact a qualified professional.

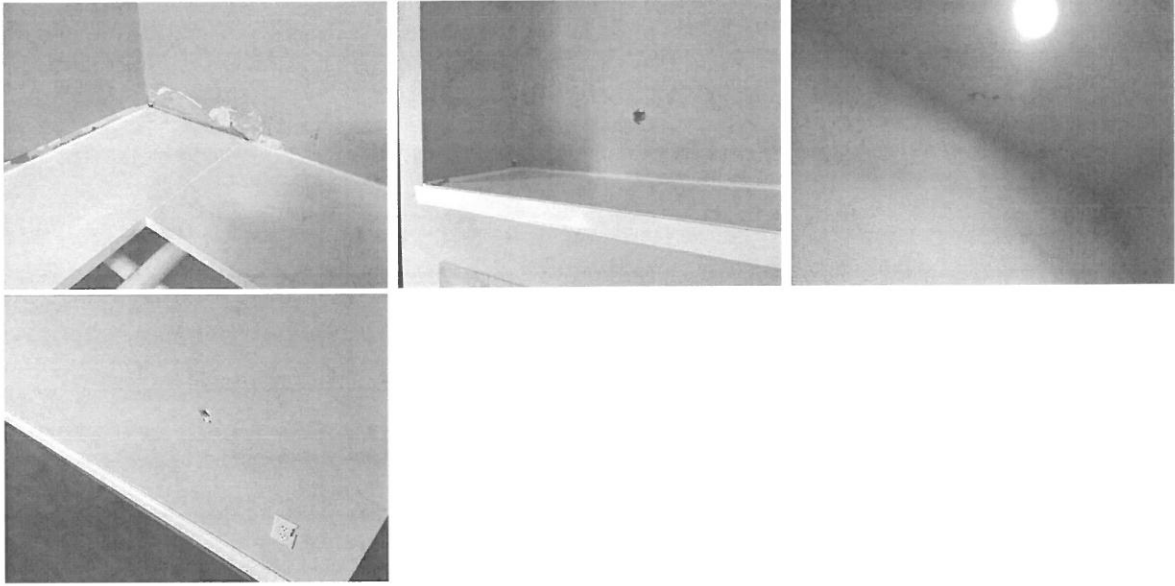
## 4: Damaged drywall

Damage observed the drywall at various locations around the home, including the back corner of the master closet, near master fireplace, upstairs hallway, and upstairs back right bedroom. Recommend correction as needed.

Recommendation: Contact a qualified professional.

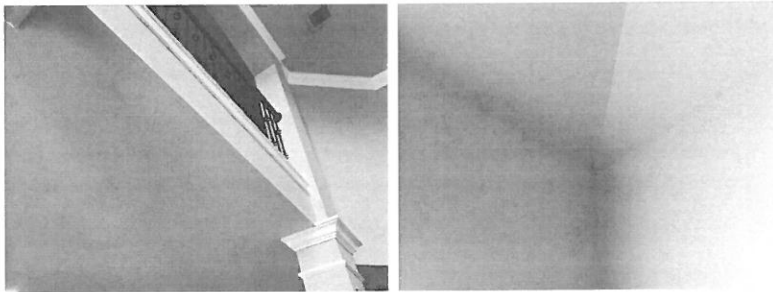
**1: Ceiling: Cracked Tape Joints**

Cracked taped joints were observed on the ceiling finish at multiple locations. Repair as needed to prevent further deterioration.

Recommendation: Contact a qualified professional.

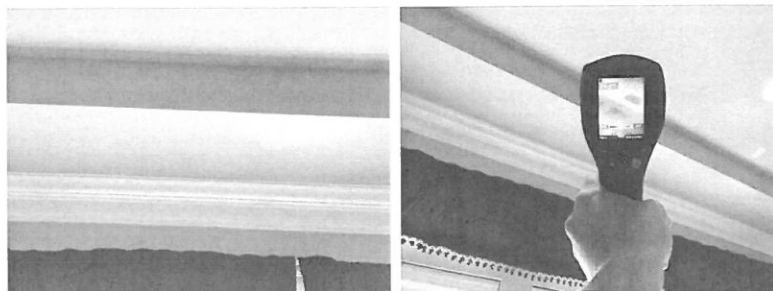
**2: Ceiling: Water Mark**

Water staining observed at the interior of the home at the ceiling in master bedroom. Thermal imaging revealed signs of active moisture and displaced/degraded insulation at these locations. Recommend further evaluation to determine the extent of the damage and necessary repairs.

Recommendation: Contact a qualified professional.

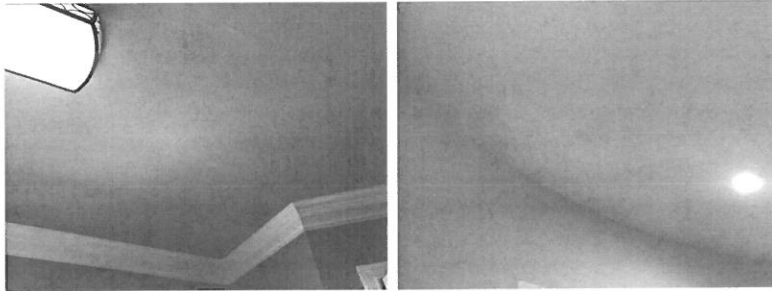
### 3: Note: Patched Ceilings

Patched ceiling areas were observed at the time of the inspection. These patches appear related to previous issues. Some of the repairs are of poor cosmetic quality, recommend correction as desired. Consult with the sellers to attempt to determine the nature of any previous repairs.

Recommendation: Contact a qualified professional.

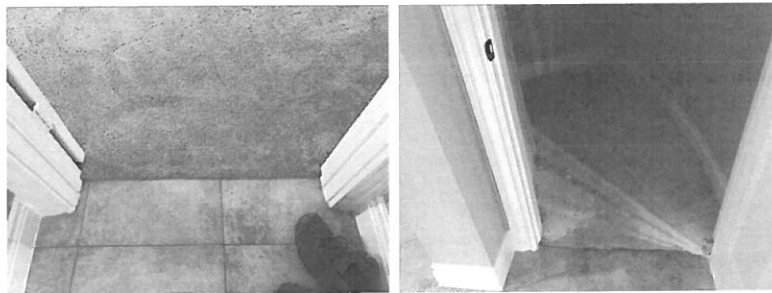
### 4: Carpet

Staining observed on the carpet at various locations, including near the door to the master bedroom area. Recommend correction as desired.

Recommendation: Contact a qualified professional.

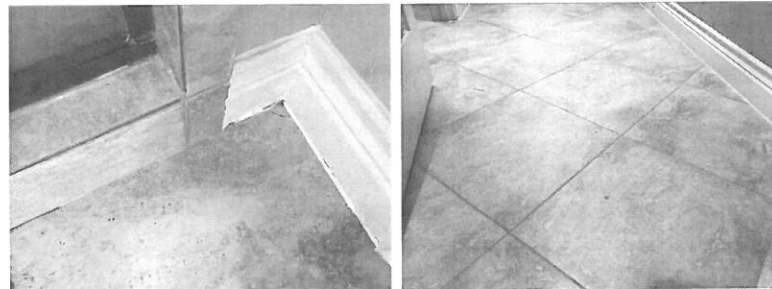
### 5: Cracked tiles

Cracked floor tiles observed in the master bathroom near the shower entry. Recommend correction as desired.

Recommendation: Contact a qualified professional.

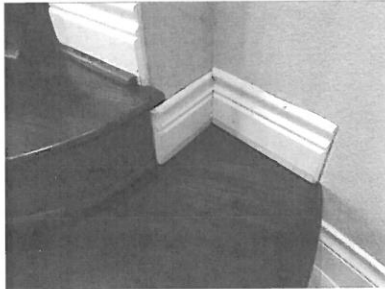
**6: Moldings absent**

Sections of the shoe molding are absent near the stairs in front of the study area. Recommend correction as desired.

Recommendation: Contact a qualified professional.

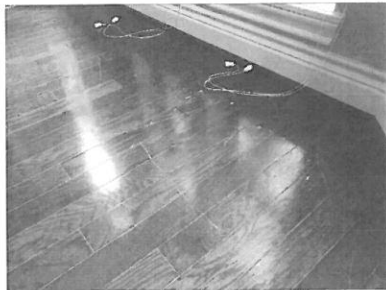
**7: Scratches to wood floor**

Scratches observed to the wood floor coverings at various locations throughout the home, including the front left living/den area. Recommend further evaluation corrections as needed.

Recommendation: Contact a qualified professional.

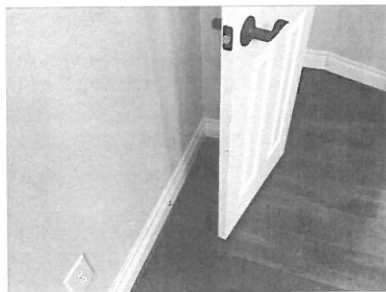
**1: Interior Door Hardware: Missing Door Stops**

One or more door stops were observed to be missing. Recommend adding door stops to prevent damage to drywall finish.

Recommendation: Contact a qualified professional.

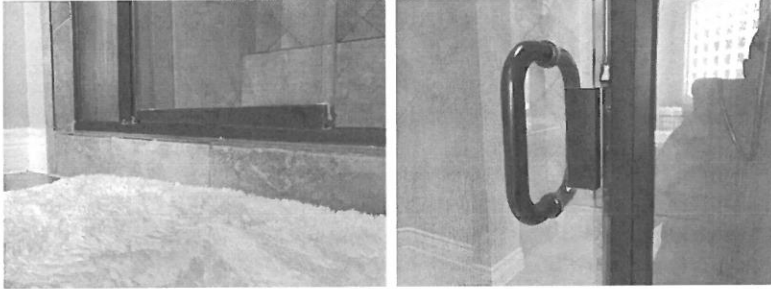
**2: Master shower door**

The seal is absent from the base of the master shower enclosure door. Excessive rusting observed on the latch components, and the door seals poorly when closed. Recommend correction.

Recommendation: Contact a qualified professional.

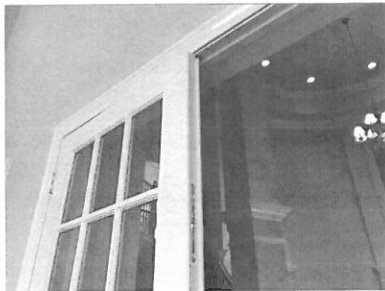
**3: Study door bolt**

The top bolt at the study door does not properly engage the jamb. Recommend adjustment.

Recommendation: Contact a qualified professional.

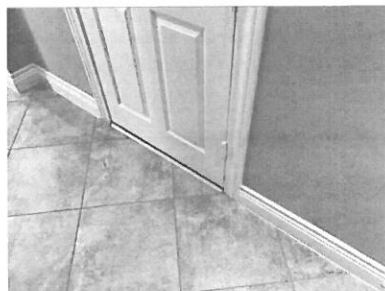
**4: Self closing hinges not adjusted**

The self-closing hinges at the interior garage door are not adjusted at the time of inspection. Recommend correction as desired

Recommendation: Contact a qualified professional.

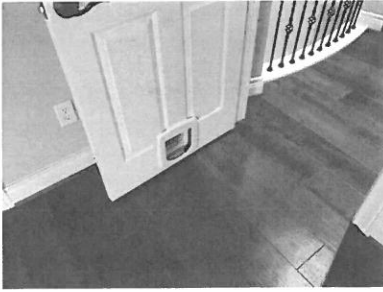
**5: Note: Pet door installed**

A pet access door has been installed at the upstairs front left bedroom door. Recommend you budget for repair or replacement of the door as desired

Recommendation: Contact a qualified professional.

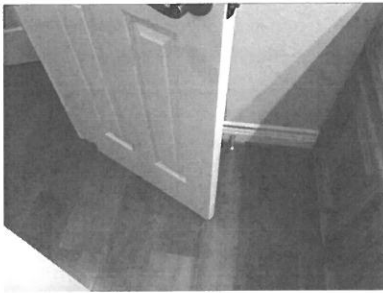
**6: Upstairs right bathroom door**

The door to the upstairs right bathroom is rubbing the floor excessively. Recommend adjustment and repair to the floor.

Recommendation: Contact a qualified professional.

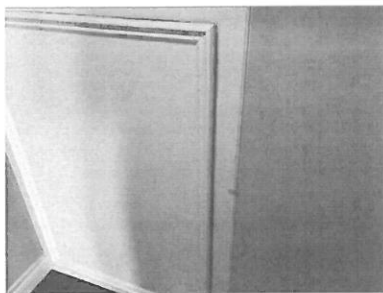
**7: No latch at attic door**

No latch in place for the attic access door at the upstairs back right bedroom closet. Recommend correction.

Recommendation: Contact a qualified professional.

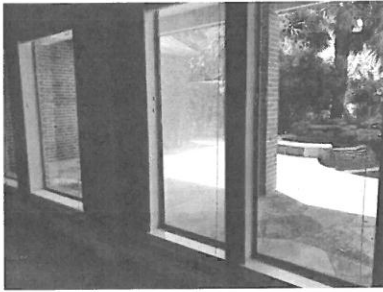
**1: Failed Seal**

Seal appears compromised on double pane window near the back exterior door. This condition is indicated by build-up observed between the panes of glass and will potentially require replacement of the glass. Recommend further evaluation and correction as needed.

Recommendation: Contact a qualified window repair/installation contractor.

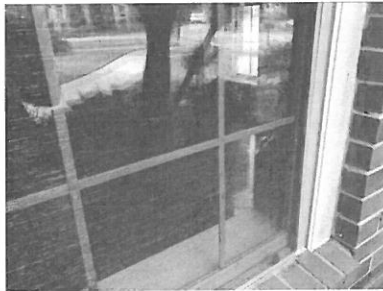
**2: Missing/Damaged Screen(s)**

One or more windows were observed to have missing/damaged screens. Recommend replacement.

Recommendation: Contact a qualified window repair/installation contractor.

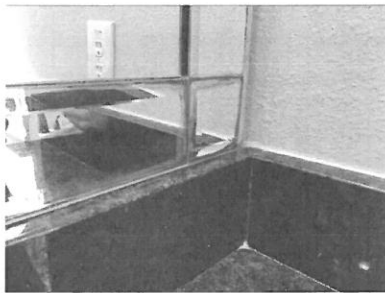
Damage observed to the backing on the mirror at the left most master vanity sink area. This is caused by moisture from normal use getting behind the glass. Recommend further evaluation and correction as desired.

Recommendation: Contact a qualified professional.

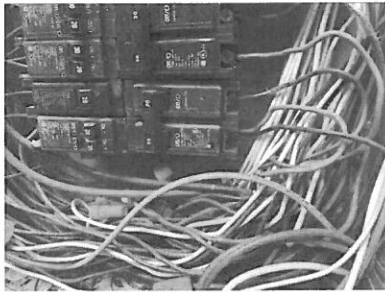
**1: Double Lugged Breaker**

The bottom right 20 amp tandem breaker has a screw terminal that has been double tapped. This terminal is not designed for multiple conductors. Recommend further evaluation and correction as needed.

Recommendation: Contact a qualified electrical contractor.

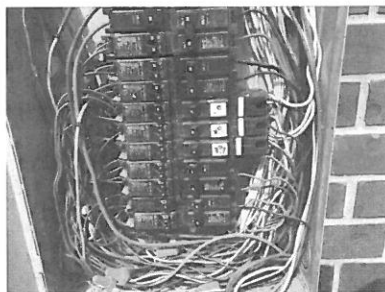
**2: Arc-Fault Test Faulty**

The top most arc-fault breaker was tested but did not perform as intended. Evaluation and/or remediation by a licensed electrician is recommended.

note: recommend replacement of the other arc fault breaker's to avoid future issue.

Recommendation: Contact a qualified electrical contractor.

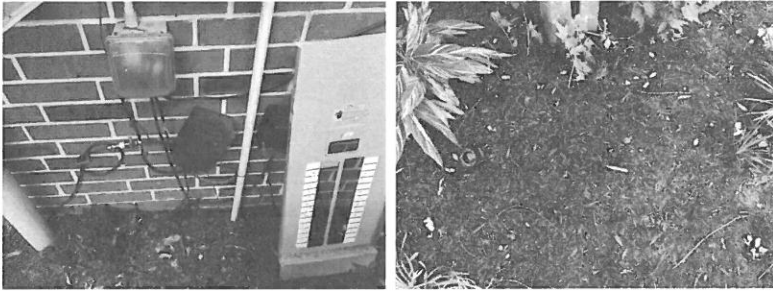
Note: damage was observed to multiple light fixtures around the exterior of the home. Recommend further evaluation of the system.

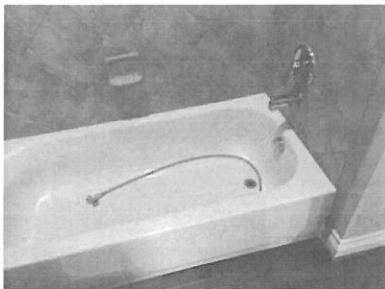
The showerhead at the upstairs right bathroom was disassembled at the time of inspection. Recommend repair or replacement as needed.
