Moisture Assessment Report

2715 Newman Street,
Houston, Tx 77098
05/05/2015

Judy and Jim Paukert

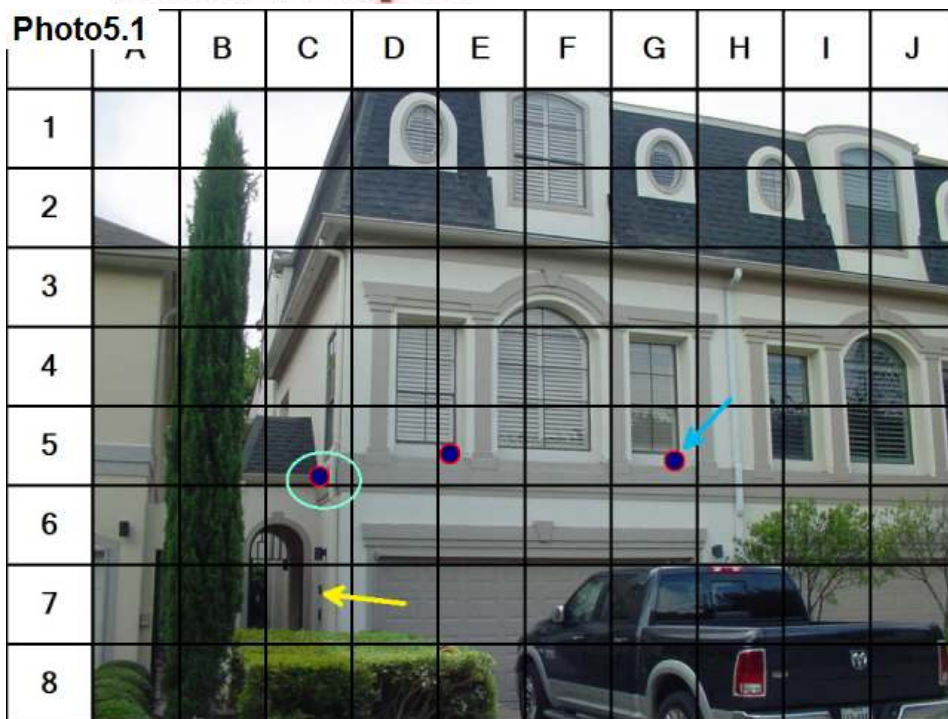
Grid Location	Item Description	Moisture Readings	Substrate Condition	Observations-Photo #5.1	Chapter Reference
				Always maintain sealants at all windows, doors and penetrations. Reseal all as needed.	Ch 3.1,3.2
G5	Moisture probe reading at window lower right	14%	Firm	Area where high moisture probe reading was taken at window lower right.	
E5 / C5	Moisture probe reading below window lower right and below kickout flashing.	10% / 17%	Firm / Firm	Area where moisture probe was made below window lower right and below kickout flashing.	
Blue Circle	Kickout Flashing			Kickout flashing is present and sealed. See Detail #5.4 and #5.5-	Ch.3.4
Yellow Arrow	Penetrations			Seal all penetrations as needed. Some are not sealed. See Detail #5.6	Ch 3.1
Blue Arrow	Sealant Separation at Windows			Some sealant separation noted at window areas. See Detail #5.2 and #5.3 - Assess all windows for sealant separation and seal as needed.	Ch 3.2

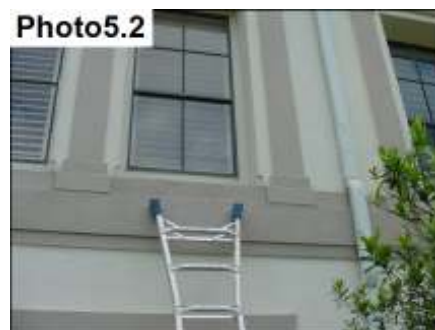
Some sealant separation noted

- Some sealant separation noted at window areas. See Detail #5.2 and #5.3 - Assess all windows for sealant separation and seal as needed.
- Seal all penetrations as needed. See Detail #6.2 and #6.3

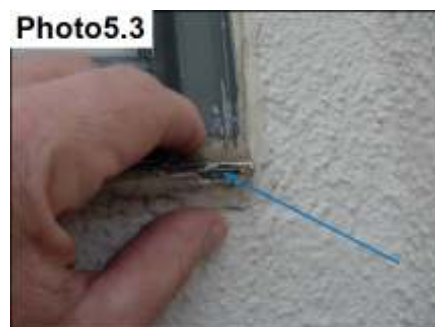
Some sealant separation noted

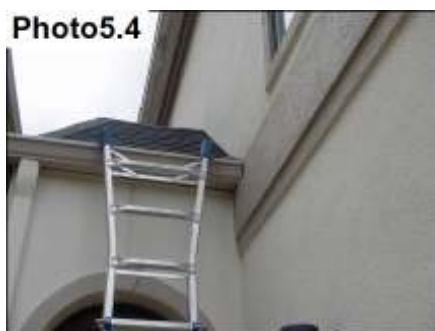
Kickout flashings are present and sealed

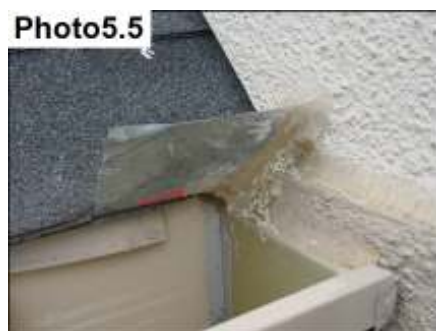
Kickout flashings are present and sealed

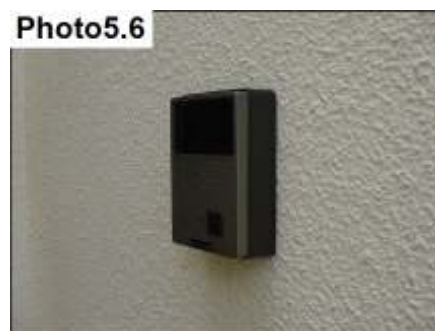
- Always maintain sealants at all windows, doors and penetrations using textured polyurethane type sealants. Reseal all areas as needed.
- Seal all penetrations as needed. Some are not sealed. See Detail #5.6

Seal all penetrations

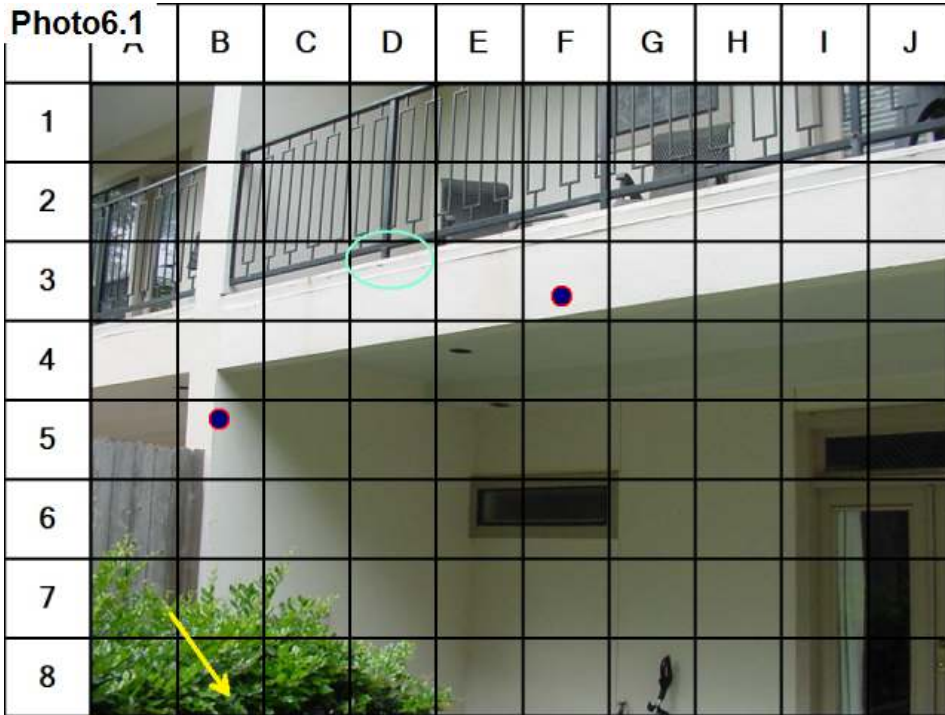
Grid Location	Item Description	Moisture Readings	Substrate Condition	Observations-Photo #6.1	Chapter Reference
				Always maintain sealants at all windows, doors and penetrations. Reseal all as needed.	Ch 3.1,3.2
B5 / F3	Wall Below Balcony and at bottom of beam	10% / 16%	Firm / Firm	Area where moisture probe was made below balcony and at bottom of beam.	
Yellow Arrow	Penetrations			Seal all penetrations as needed. See Detail #6.2 and #6.3	Ch 3.1
Circle	Balcony Bolts and Fasteners			Balcony bolts and fasteners lack sealants. See Detail #6.4 and #6.5 - Seal all balcony bolts and fasteners as needed.	Ch 3.1

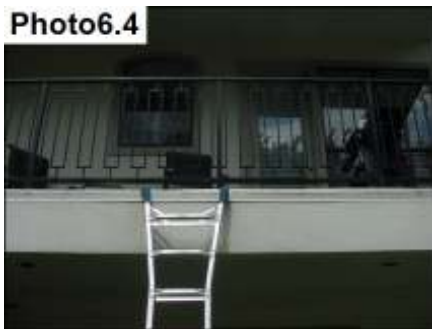
- Balcony bolts and fasteners lack sealants. See Detail #6.4 and #6.5 - Seal all balcony bolts and fasteners as needed.
- Exposed wood / substrate noted at door lower left and lower right. See Detail #7.2, #7.3 and #7.4 - Seal and adequately waterproof this area as needed.

Seal all railing bolts / fasteners

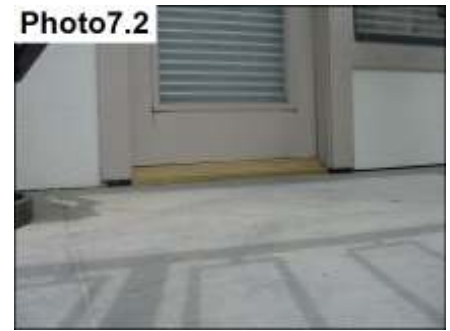
Exposed Wood noted here

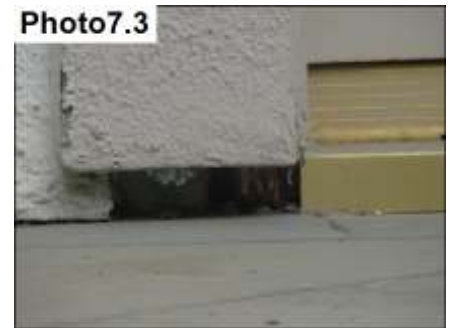
Exposed Wood noted here

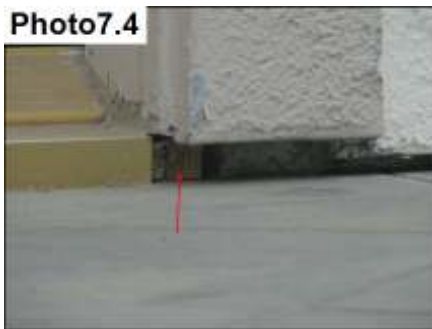
Exposed Wood noted here

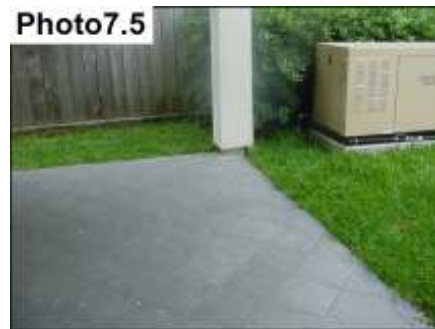
Column base is on a concrete footing

Grid Location	Item Description	Moisture Readings	Substrate Condition	Observations-Photo #7.1	Chapter Reference
				Always maintain sealants at all windows, doors and penetrations. Reseal all as needed.	Ch 3.1,3.2
Red Arrows	Exposed Wood / Substrate			Exposed wood / substrate noted at door lower left and lower right. See Detail #7.2, #7.3 and #7.4 - Seal and adequately waterproof this area as needed.	
Circle	Column Base			Column base is installed onto a concrete footing. See Detail #7.5 and #7.6 - This is a proper detail.

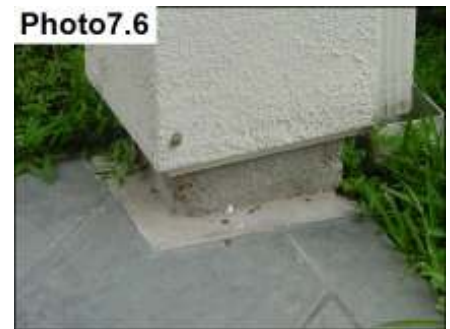
Column base is on a concrete footing

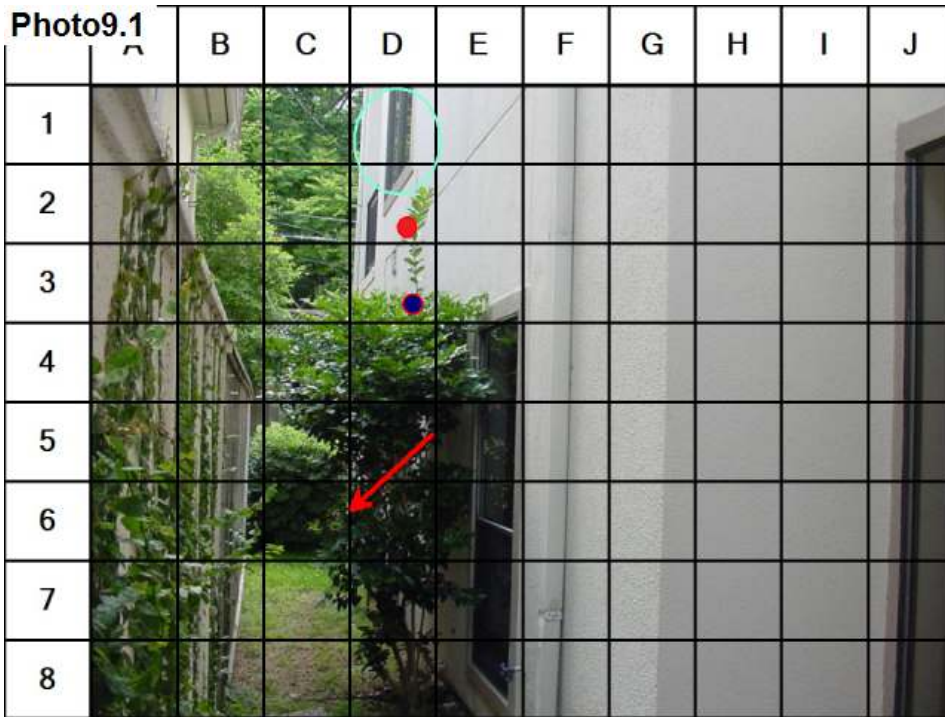
Grid Location	Item Description	Moisture Readings	Substrate Condition	Observations-Photo #9.1	Chapter Reference
.	.	.	.	Always maintain sealants at all windows, doors and penetrations. Reseal all as needed.	Ch 3.1,3.2
D2	Window Lower Middle	31%	Semi Soft	High moisture probe was made below window lower middle. Semi soft substrate noted.	
D3	Below Window	17%	Semi Firm	Area where moisture probe was made below window.	
Red Arrow	Penetrations			Seal all penetrations as needed. See Detil #9.2, #9.3 and #9.4	Ch 3.1
Circle	Window Mullions			Sealant separation noted at window mullions. See Detail #9.5, #9.6 and #10.1 - Seal all mullions on all mulled windows as needed.	Ch 3.2

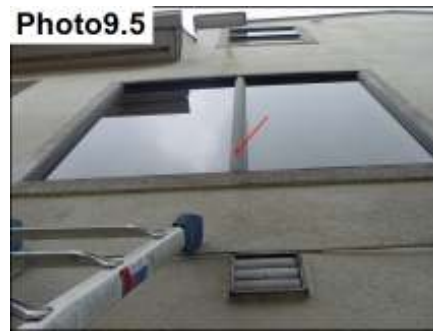
- Sealant separation noted at window mullions. See Detail #9.5, #9.6 and #10.1 - Seal all mullions on all mulled windows as needed.
- Sealant separation noted at this window. Assess all windows and seal / reseal all separated areas as needed. See Detail #12.2

Seal all mullion locations on all windows / Sealant separation noted

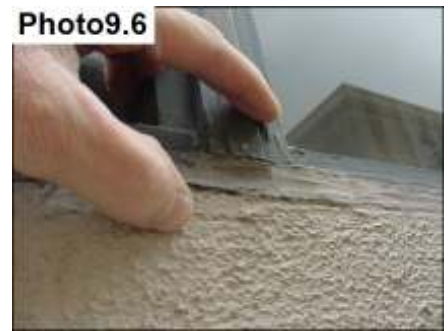
Seal all mullion locations on all windows / Sealant separation noted

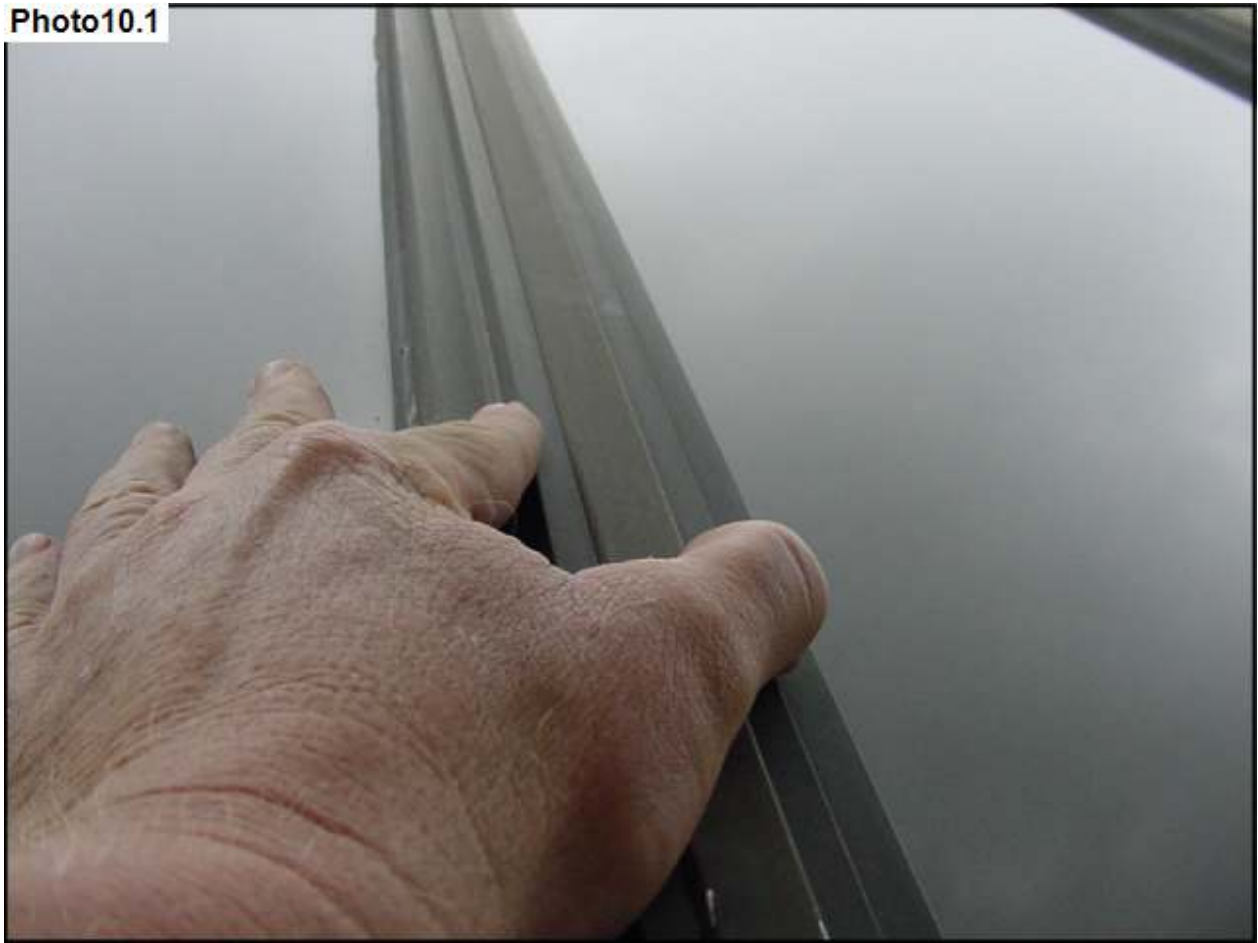
Photo10.1

Seal all mullion locations on all windows / Sealant separation noted

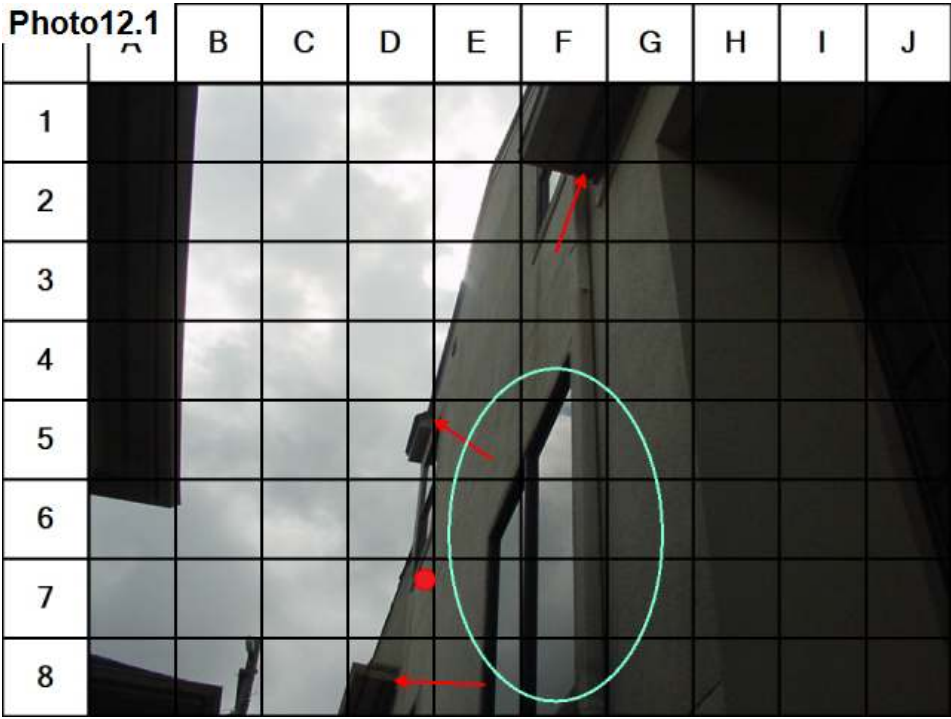
Grid Location	Item Description	Moisture Readings	Substrate Condition	Observations-Photo #12.1	Chapter Reference
.	.	.	.	Always maintain sealants at all windows, doors and penetrations. Reseal all as needed.	Ch 3.1,3.2
D7	Window Lower Left	28%	Semi Firm	High moisture probe was made below window lower left	
Circle	Sealant Separation			Sealant separation noted at this window. Assess all windows and seal / reseal all separated areas as needed. See Detail #12.2	
Re Arrows	Roof FLASHing Terminations			Roof flashing terminations lack sealants. See Detail #12.3 - Seal all roof flashing areas as needed.

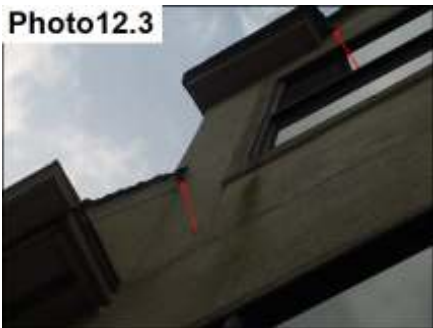
- Roof flashing terminations lack sealants. See Detail #12.3 - Seal all roof flashing areas as needed.
- Sprinkler overspray suspected in this area. Redirect all sprinkler heads away from stucco exterior. See Detail #13.2 and #13.3

Seal all flashing terminations

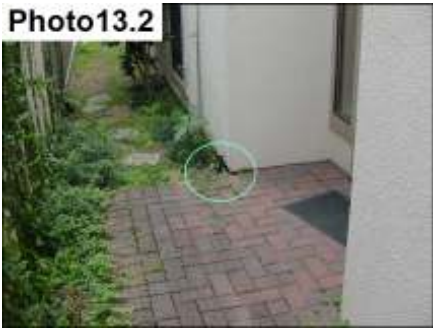
Sprinklers noted on this home

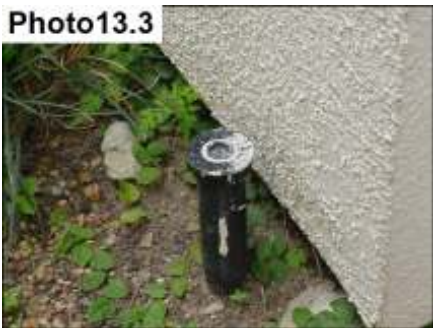
Sprinklers noted on this home

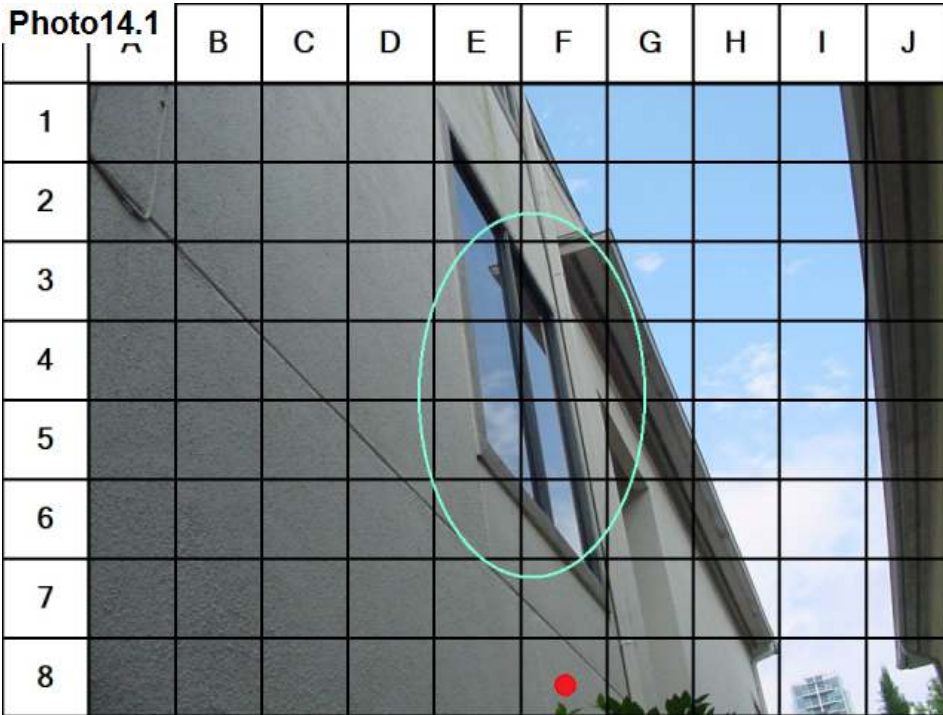
Grid Location	Item Description	Moisture Readings	Substrate Condition	Observations-Photo #14.1	Chapter Reference
.	.	.	.	Always maintain sealants at all windows, doors and penetrations. Reseal all as needed.	Ch 3.1,3.2
F8	Window Upper Middle	40%	Semi Soft	High moisture probe was made at window upper middle below mullid windows. Semi Soft Substrate Noted	
Circle	Mullions			Seal all mullions at windows. See Detail #14.2, #14.3 and #14.4	
Circle	Wet Glaze all Fixed Windows			Some of the windows are more exposed to the weather and glazing the window will help to decrease incidental moisture intrusion that may be occurring from the window pane itself. Glazing the window is defined as using a silicone sealant and sealing the glass window pane to the metal frame and the metal frame to the metal frame. See Detail #14.4

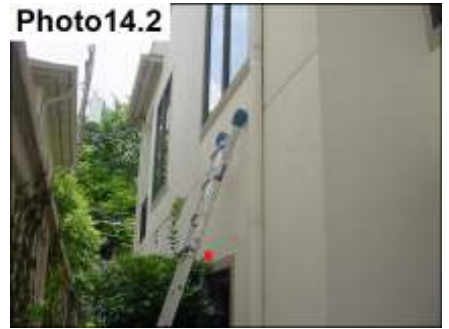
Clarification of Location / Window
 Upper Middle Below Mullid Window

- Seal all mullions at windows. See Detail #14.2, #14.3 and #14.4
- Some of the windows are more exposed to the weather and glazing the window will help to decrease incidental moisture intrusion that may be occurring from the window pane itself. Glazing the window is defined as using a silicone sealant and sealing the glass window pane to the metal frame and the metal frame to the metal frame. See Detail #14.4

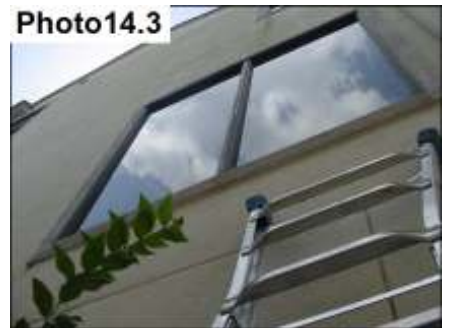
Clarification of Location / Window
 Upper Middle Below Mullid Window
