PROPERTY INSPECTION REPORT

Concerning: 2816 Newman Street, Houston, TX 77098
(Address or Other Identification of Inspected Property)

By: Samuel H. Sahagian, TREC #7669 06/03/2018
(Name and License Number of Inspector) (Date)

Home is approximately 3,200 sq. ft., 3 story and faces S for inspection purposes

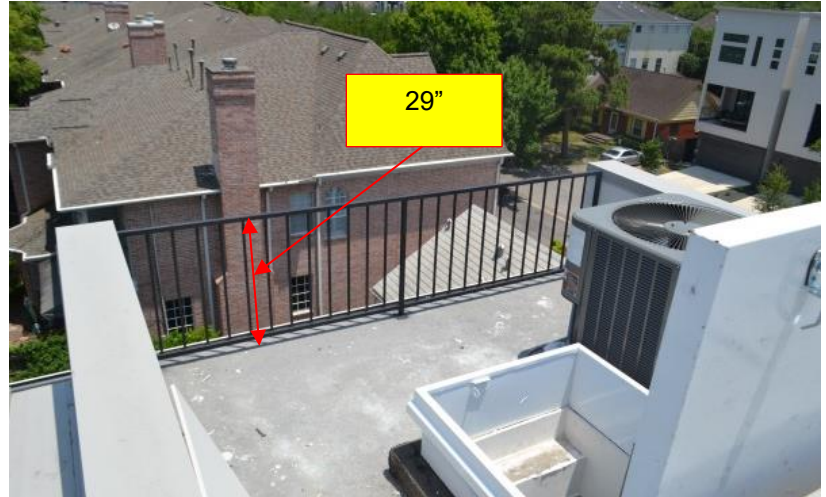
- Guardrails with drop-offs higher than 30 inches require 36" guardrails. This is a potential fall hazard. At a minimum, the client should be aware of this hazard on roof top hatch landing.
 - Information: Required guards at open-sided walking surfaces, including stairs, porches, balconies or landings, shall be not less than 36 inches (914mm) high measured vertically above the adjacent walking surface, adjacent fixed seating or the line connecting the leading edges of the treads – ref. R312.1.2 Height.

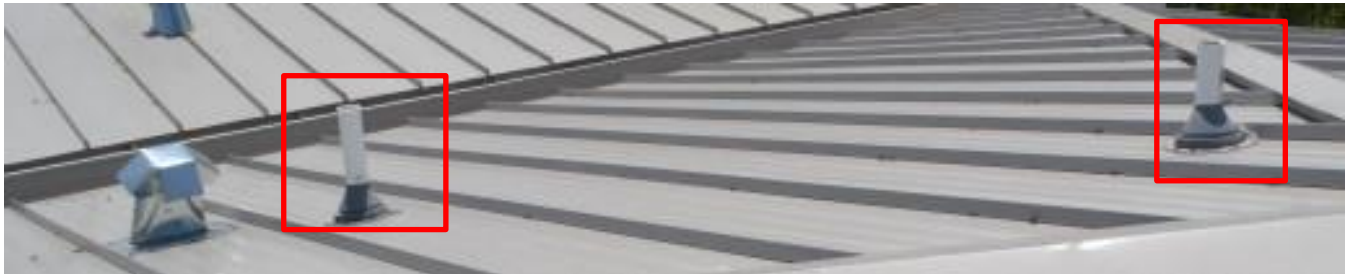
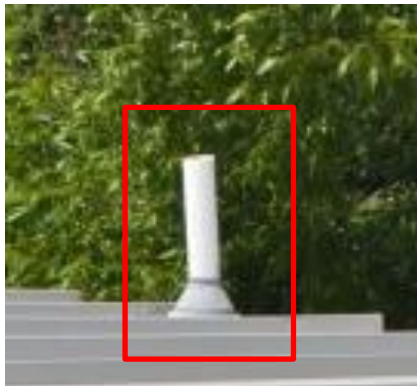
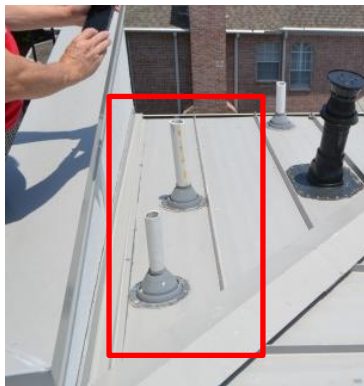
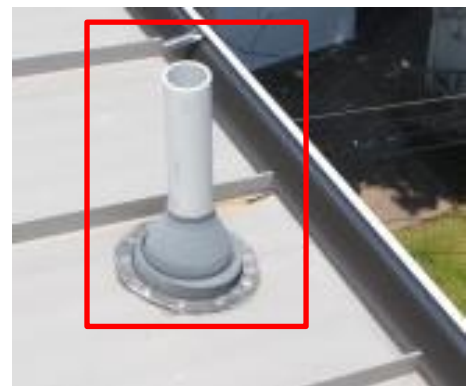
- The PVC sewer vent pipes above the surface of the roof had not been painted.
 - Information: The PVC pipes must be painted to protect the PVC from degradation by the ultra violet rays of the sun

- The flue pipes and roof jacks were not painted on rooftop.

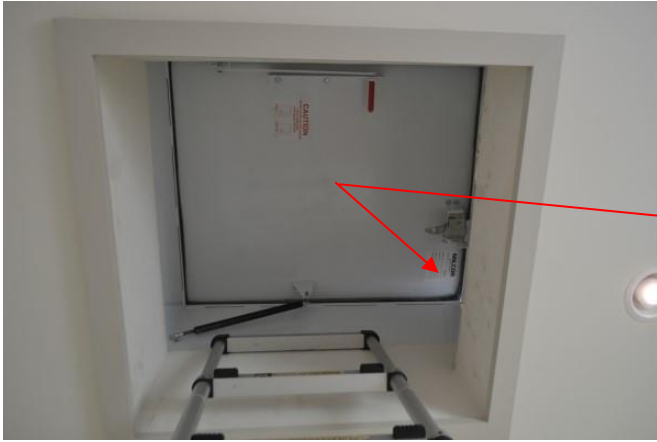
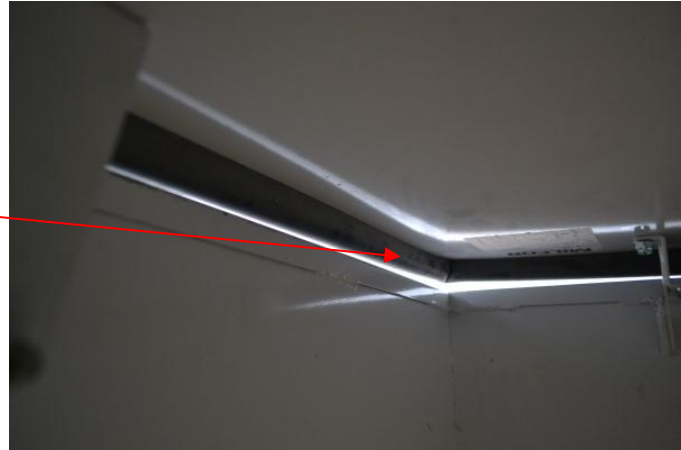
- Daylight gaps at roof hatch when closed. Properly repair to help prevent water intrusion during wind driven rain storms.

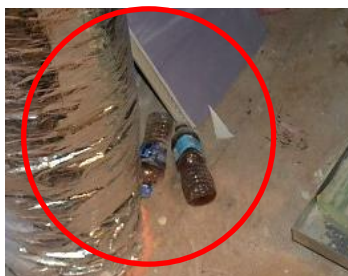
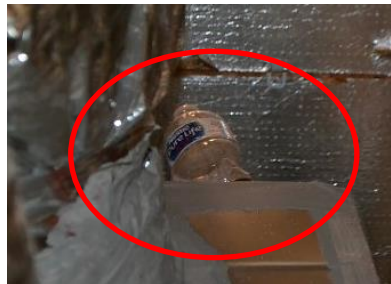
- Cosmetic: Remove trash from attic.

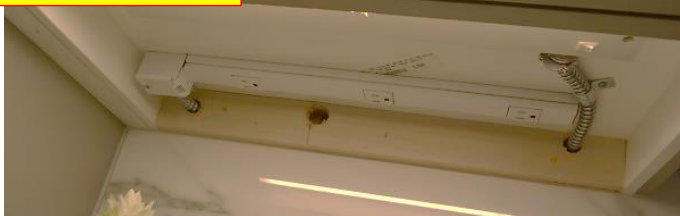
Under kitchen cabinet
far left side

- This is not a cosmetic inspection; however, some items noted may be cosmetic in nature or not yet finished out. Recheck and secure/seal around all wall penetrations at walls/ceiling and refinish blemishes at walls/ceiling around penetrations (such as at thermostat wire) at outlets, switches, other wall covers, under sinks at plumbing at walls/panels, utility room at exhaust vents, A/C registers, etc. and under sinks at cabinets, islands, wall, panel and shelf joints.

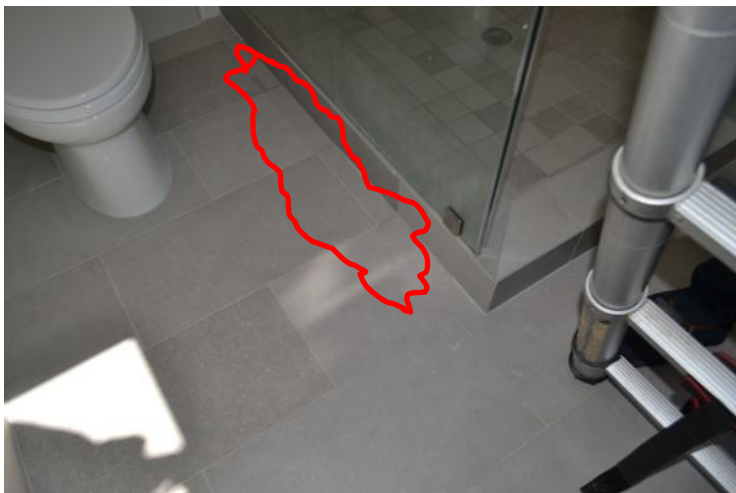
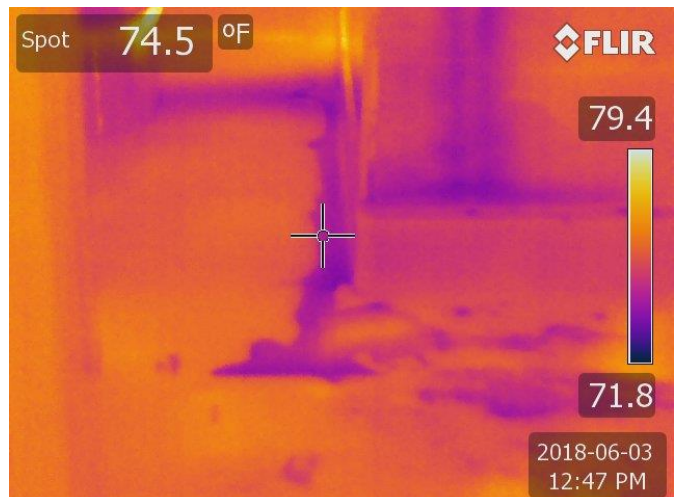
- Water leak at master bathroom glass wall partition. Find cause and repair as needed.

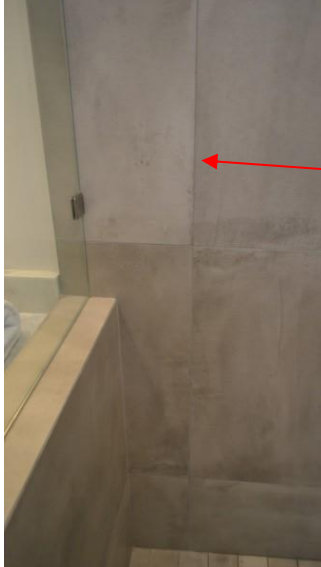
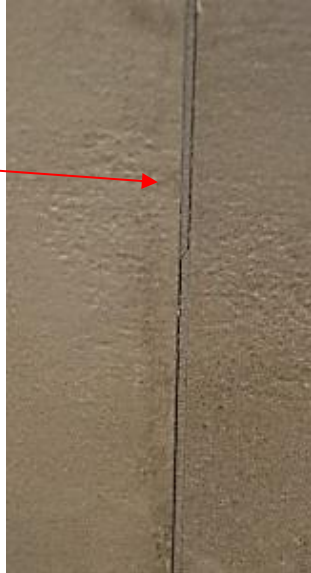
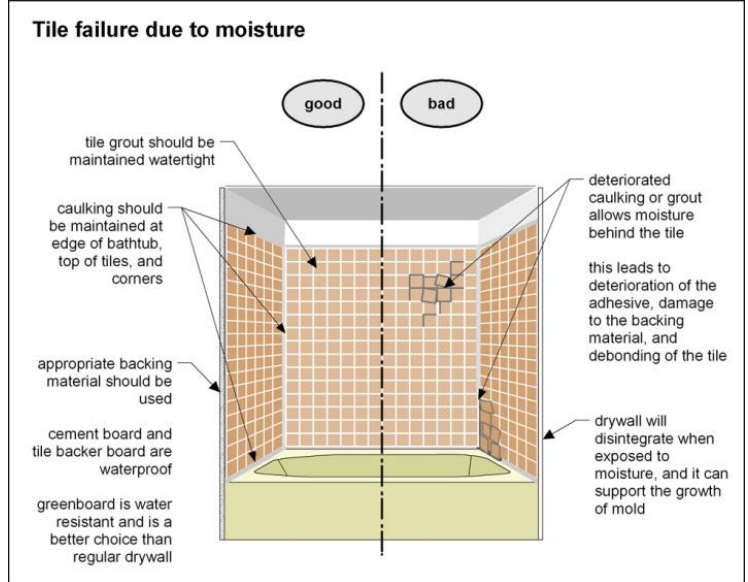
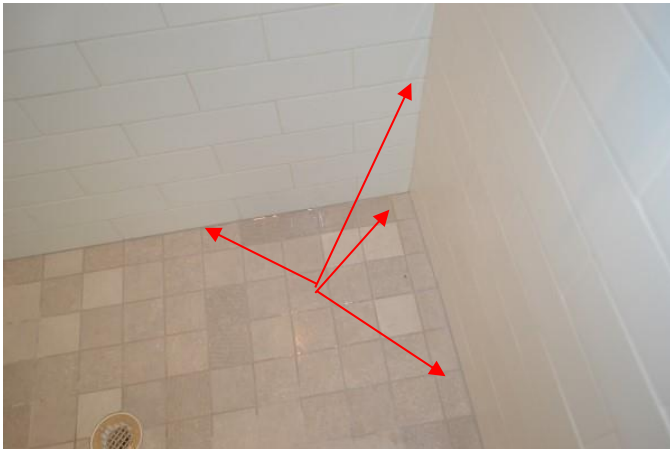
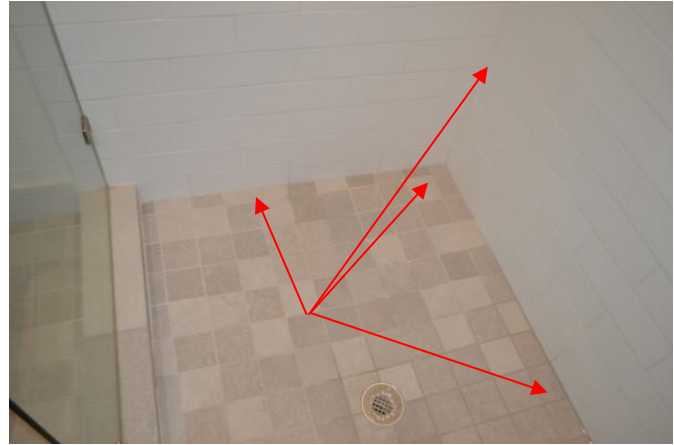
- Observed cracked tile in 2nd floor guest bathroom shower tile with gaps & cracks at grout at lower portion of shower walls. Also, gaps in master bathroom tile work. Properly repair/ re-grout as needed to help prevent water penetration behind shower wall.

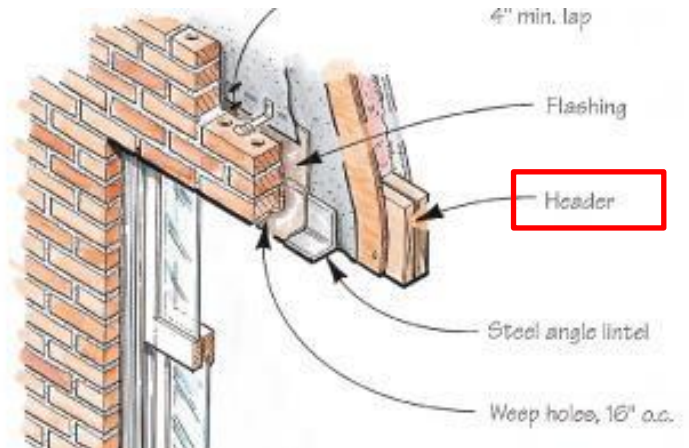
- We did not visually observe through wall flashing at steel lintels above garage, at 3rd floor balcony windows and at base of brick wall at 3rd floor balcony (brick sitting on steel lintels at base of wall). Note: if flashing is missing, the steel lintel will corrode over time and cause the expansion of steel lintels which in turn will cause gaps/separation of brick mortar due to expansion of corroded steel lintels.

- Information: Referenced Standard - Brick Manufacturers Assn., Tech Note 7A - Continuous flashing should be installed to cover the angle , Typical thickness of plastic flashings are 20 mil to 40 mil , Metals in contact with concrete or cinder walls and floors, cold-formed steel framing or other corrosive material shall be protected against external corrosion by a protective sheathing or wrapping or other means that will withstand any reaction from lime and acid of concrete, cinder or other corrosive material

6-Mil poly should be draped over the TOP of the lintel to be used as lintel flashing

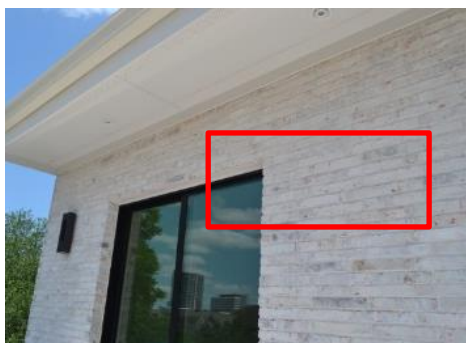
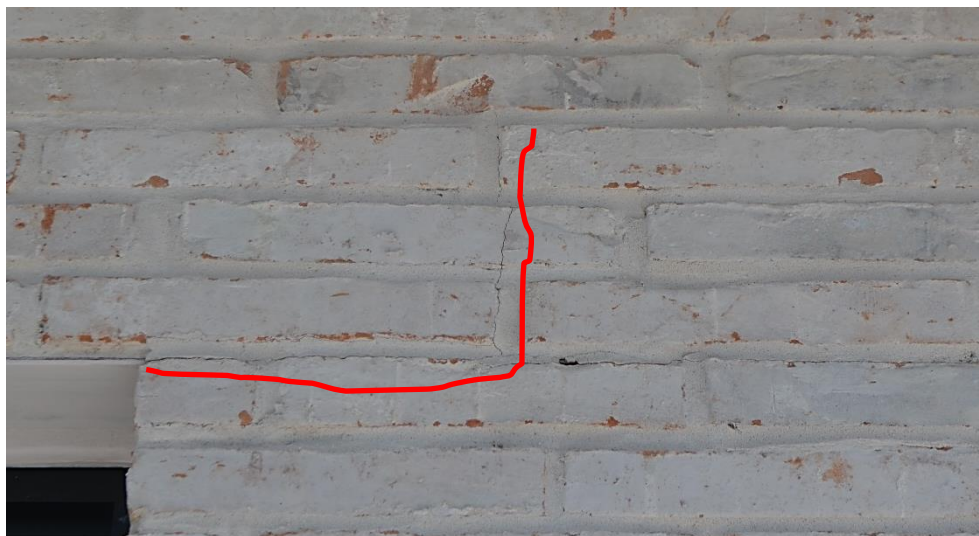
Above 3rd floor balcony left side door

- Observed vertical crack at brick veneer mortar joints above garage steel lintel and 3rd floor balcony over windows. Could not determine cause of cracks, possibly caused from settlement. The structural components of the wall/framing system are not accessible for inspection. Future movement is not predictable. Recommend monitoring over time for future movement.

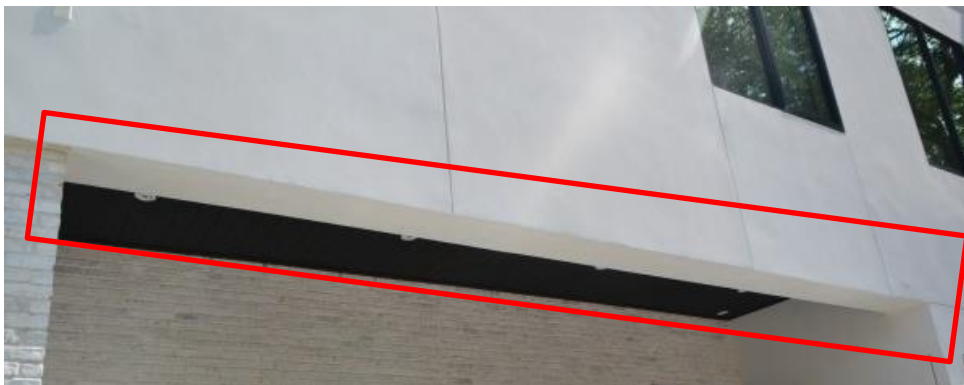
T4 - Termination at Cantilevered Wall

- Weep holes appear clogged with mortar above garage doors & windows, Weepholes must be cleaned to allow for the escape of any moisture that may have penetrated the masonry veneer. As moisture will adversely affect the integrity of the wall if not removed from the wall assembly.
 - Information: ref: IRC R703.7.4.2 Air space.

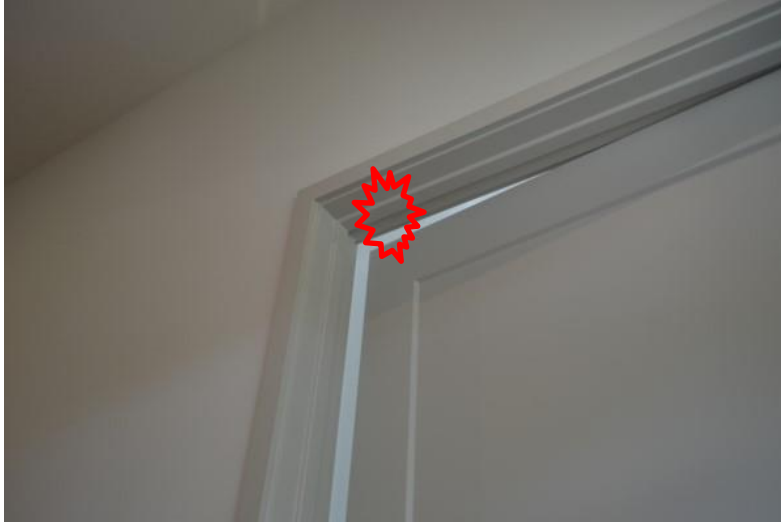
- Garage utility door missing door stop. Currently door handle hits drywall.
- 2nd floor W central bedroom door binding at top.

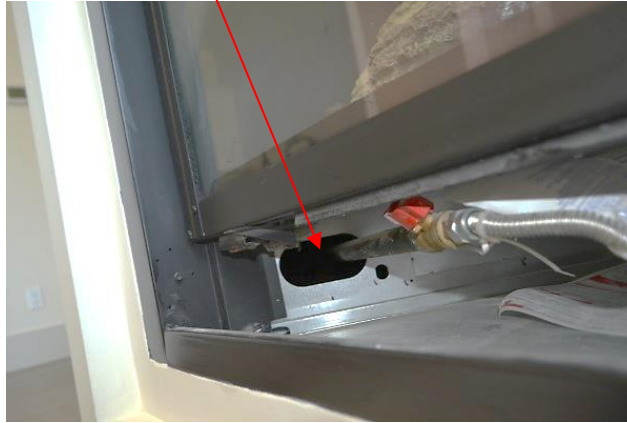
- Manufacturer recommends sealing holes/gaps under firebox where gas line penetrates firebox enclosure with non-combustible material for draft stop.

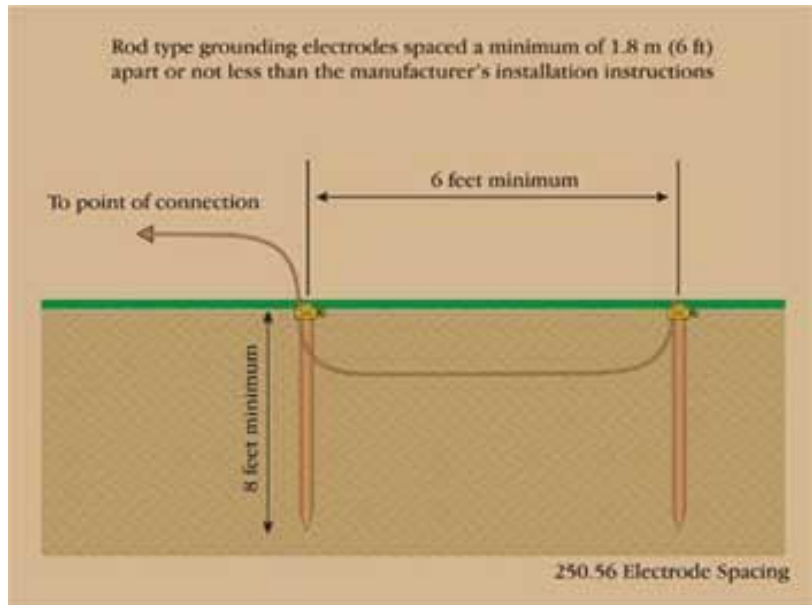
- Note that modern standard requires a second grounding electrode unless testing shows <25 ohms resistance at existing electrode. We did not observe supplemental electrode (Rod type grounding electrodes spaced a minimum of 6 feet apart)
 - Information: 250.52(A)(1) through (A)(4). NEC 250.56 where resistance needs to be 25 ohms or less.

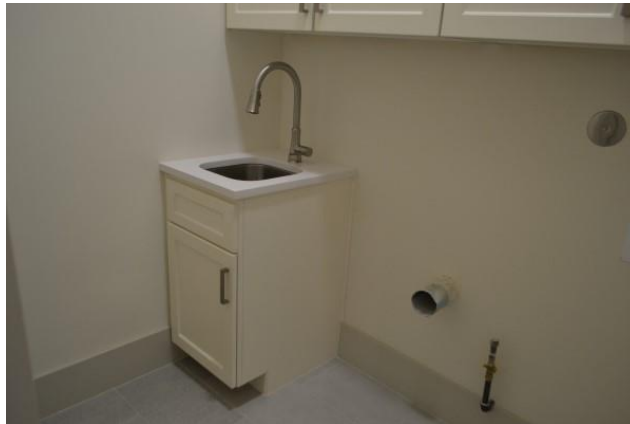
- Current building standards require Ground Fault Circuit Interruption (GFCI) protection at all but not limited to the following locations. All exterior outlets, bathrooms, kitchen counters, kitchen island, wet bar counters, whirlpool tubs etc... Missing or inoperative GFI protection will be listed below under Recommended Repairs as required by the Standards of Practice.
 - All bathrooms 1st 2nd & 3rd floor have no GFCI protection.
- No electrical outlet installed by laundry room sink.

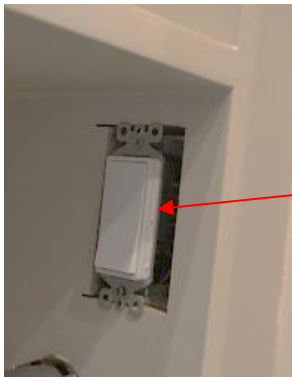
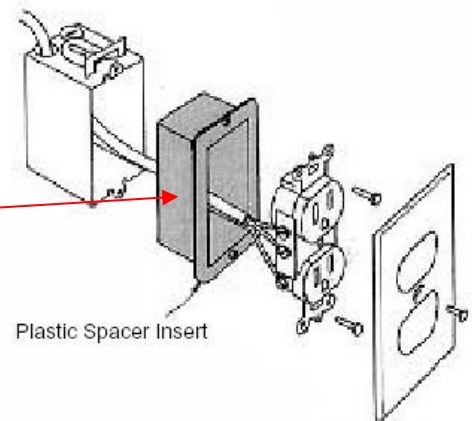
- We did not observe box extenders installed at master bathroom closet switch wood panel.
 - Information: In walls and ceilings constructed of wood or other **combustible material**, boxes shall be flush with the finished surface or project there from. Reference NEC 1993 - 370.20, Reference NEC 2008 - 314.20 & IRC E3806.5. (Microwave cabinet, under kitchen sink, under stove top and all kitchen counter tops).

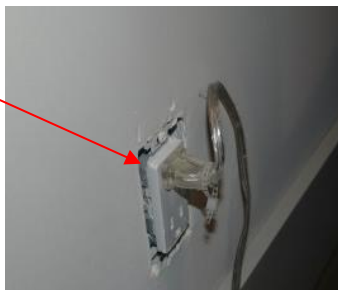
- Missing faceplate at outlet servicing 2nd floor family room W wall.

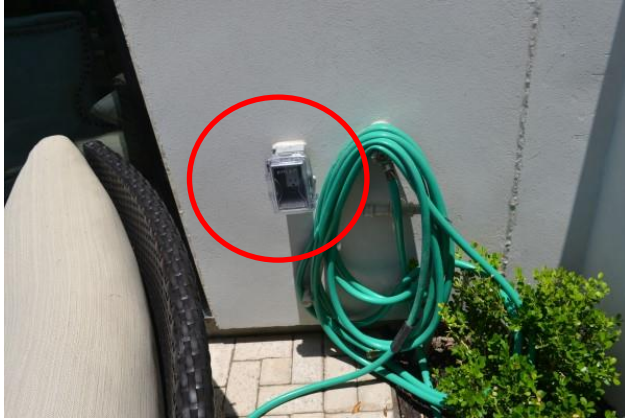
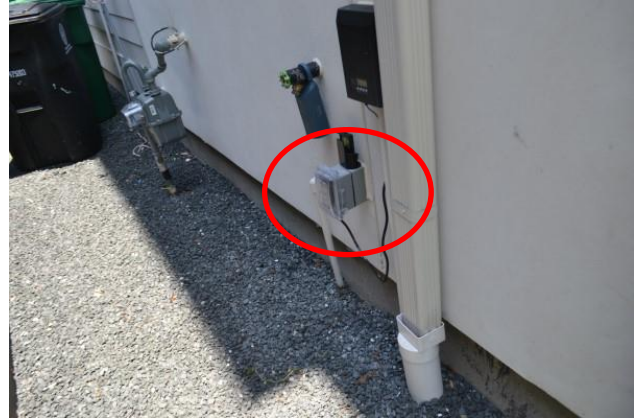
- No power at outlets servicing front & left sides of house. These should also be GFCI protected once they have power.

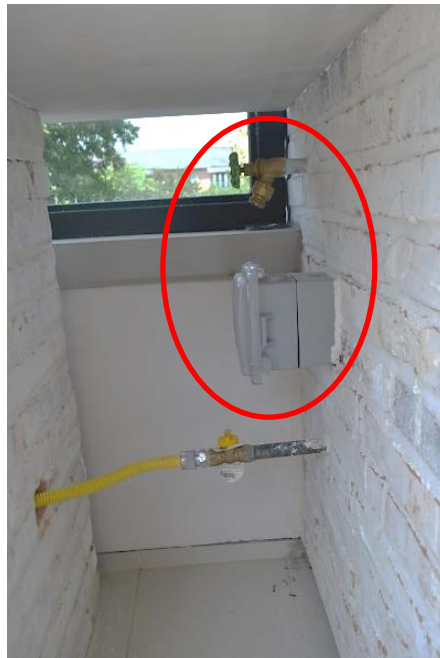
- Observed hose bib connection installed over electric outlet, also inaccessible.

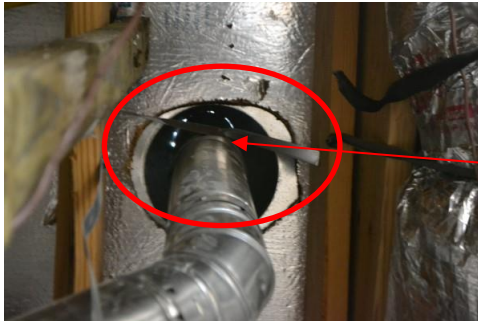
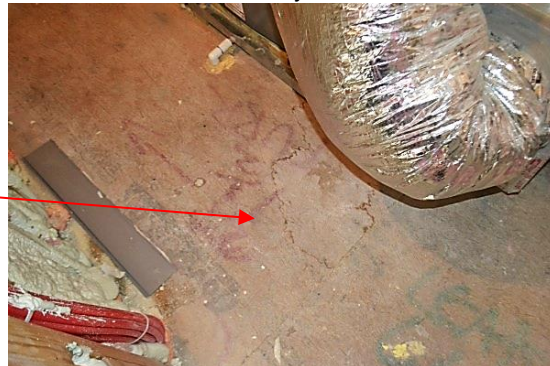
- Daylight gaps noted at flu pipe to collar connection at roof decking. Seal with proper fire rated sealant to help prevent water intrusion into attic during wind driven rain and/or storms. Currently water stain under flue pipe.

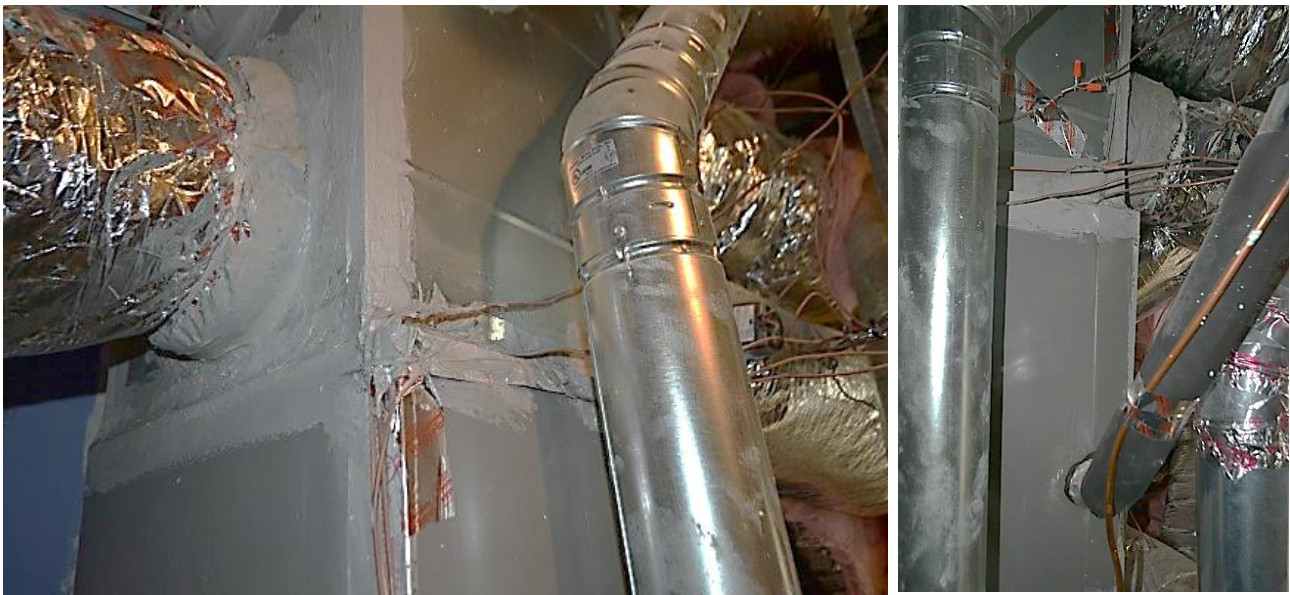
- 1st floor: Temperatures: at Return is 74 °F and temperature at supply registers is 61°F - 13 °F differential
- 2nd floor: Temperatures: at Return is 74 °F and temperature at supply registers is 62°F – 12 °F differential
- 3rd floor: Temperatures: at Return is 76 °F and temperature at supply registers is 62°F – 14 °F differential
 - Information: The acceptable operation range is between 16°F and 21°F (ΔT).

- The temperature drops measured across the evaporator coils were from 13°F for 1st floor, 12°F for 2nd floor and 14°F for 3rd floor, which is normally considered to be an indication that **the system is not operating in the acceptable range**. The evaporator coils should be cleaned and inspected for concealed damaged. The system should be serviced by an HVAC technician for proper operation and refrigerant levels.
 - Information: The acceptable operation range is between 16°F and 21°F (ΔT).
- Excess condensate on A/C plenum in attic, (water beading on plenum). Have HVAC technician find cause and properly repair as needed.

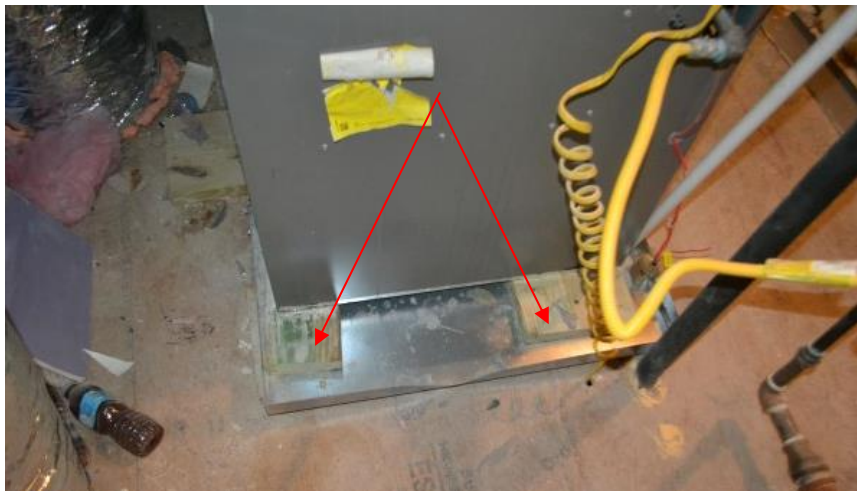
- Noted HVAC system sitting in pan, should be installed or raised on rubber footing
 - IRC M1411.3.3 Appliances, equipment and insulation in pans. Where appliances, equipment or insulation are subject to water damage when auxiliary drain pans fill, those portions of the appliances, equipment and insulation shall be installed above the flood level rim of the pan. Supports located inside of the pan to support the appliance or equipment shall be water resistant and approved.

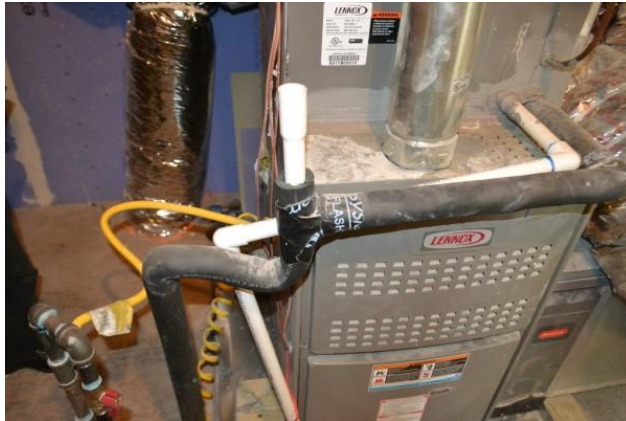
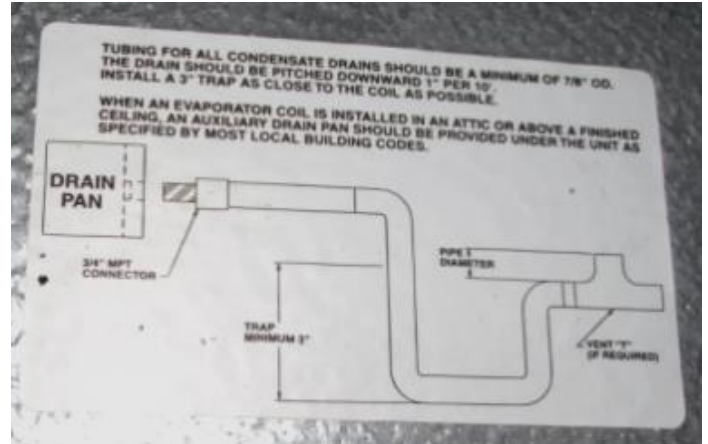
- We did not observe a trap at primary drain lines in accordance with manufacturer's (Lennox) installation instructions to help prevent conditioned air blowing into attic or into lavatory basin traps, this is to help in energy efficiency and to prevent gurgling sound at bathroom lavatory basin. Cleanouts should be downstream from traps

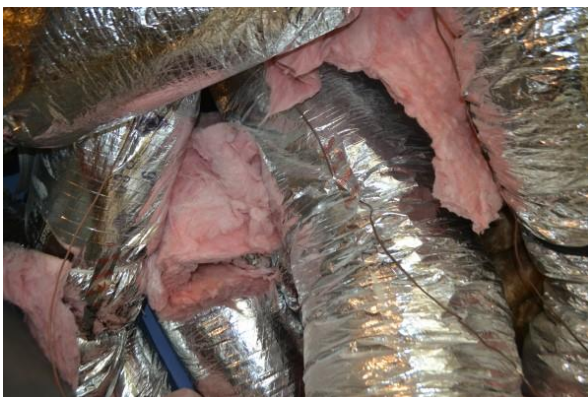
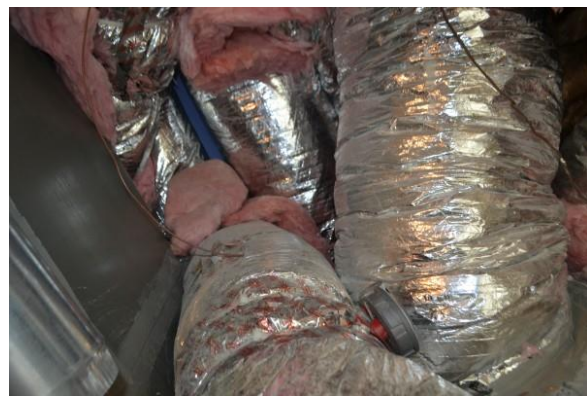
- One duct resting on top of another duct can create zones where condensation can occur. This moisture then drips into the insulation; reducing the R-value of the insulation; and may possibly create a potential microbial hazard condition. Flexible ducts are not designed to support the weight of another duct. The ducts should be separated, made as straight and tight as possible and the ducts should be properly supported. There should be a minimum of 1" clearance between ducts.

- Information: Air flow ducts in contact with each other or other insulation material generate sweating to ceilings at the point of contact with each other or other building materials. Clearance or separation from contact with each other by strapping with HVAC nylon strapping material prevents sweating. [ref: IRC M1601.2 factory made ducts; IMC 603.11 "provisions shall be made to prevent the formation of condensation on the exterior of any duct". **Where ducts are separated by insulation blankets condensation moisture is generally increased (as the insulation traps hot air against the cooler ducts).**

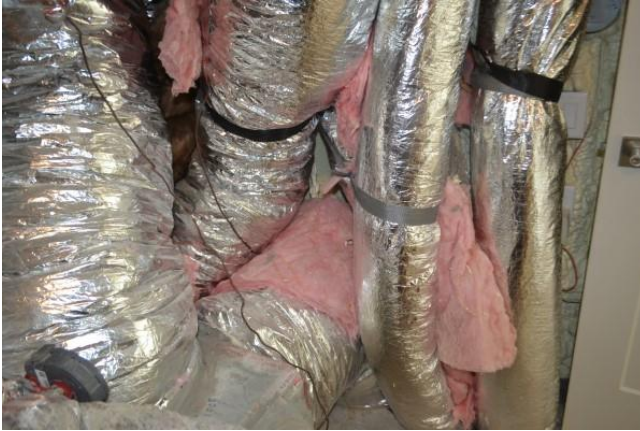
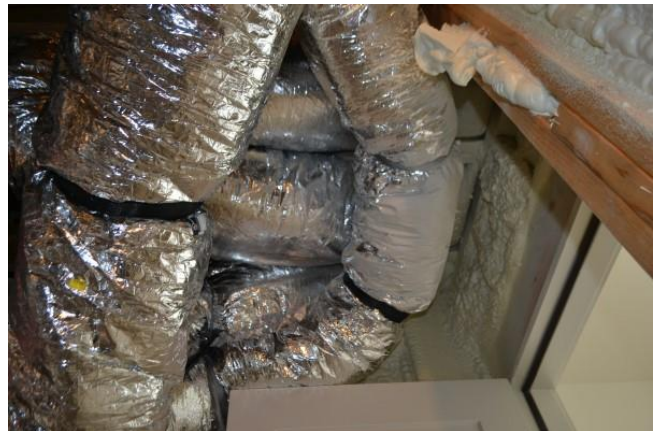
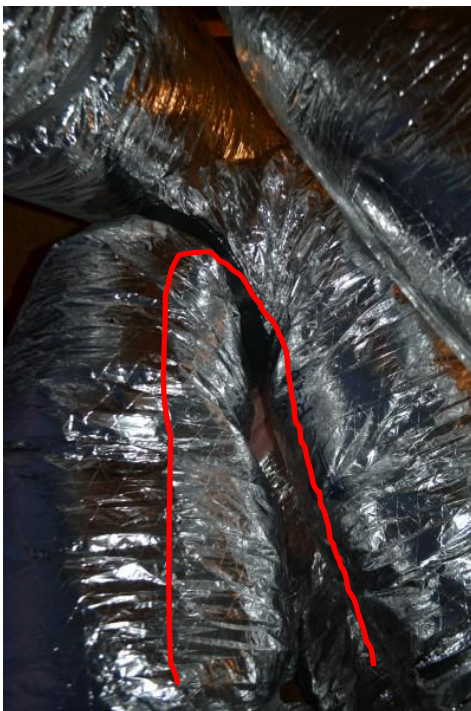
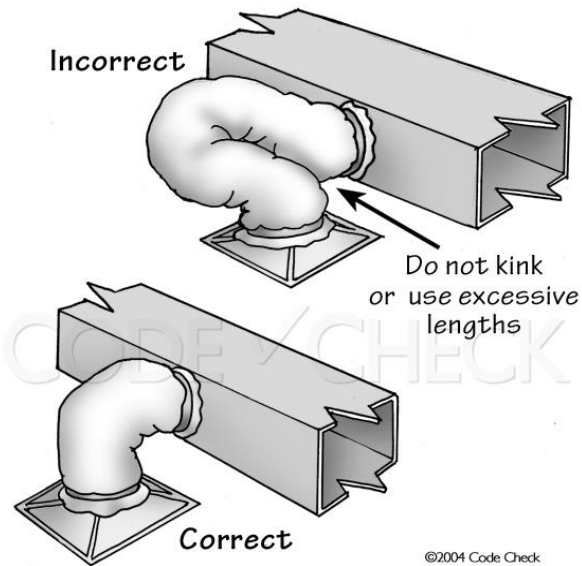
- Install duct fully extended, do NOT install in the compressed state or use excess lengths. Some flex duct observed to be inadequately supported in attic, droops excessively or lies on attic floor. This will noticeably increase friction losses. Avoid bending ducts across sharp corners or incidental contact with metal fixtures, pipes or conduits. Radius at center line of bend shall NOT be less than one duct diameter. If suspended, product shall be supported at no less than 5' intervals by hanger, saddle, or ceiling joist or other commonly used support of no less than 1-1/2" width at contact points with maximum permissible sag of 1/2" per lineal foot of spacing between supports to eliminate "snaking" drooping of flex duct. (Ref: Air Diffusion Council Flexible Duct Performance and Installation Standards).

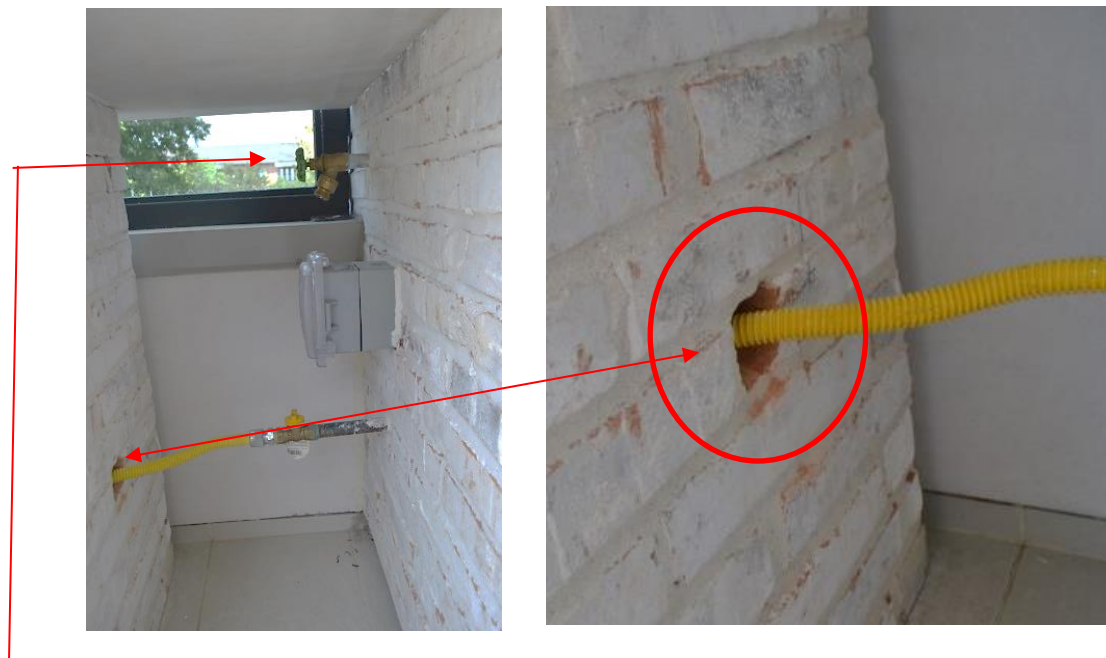
- 2nd floor guest bathroom has Hot & Cold reversed.
- Flex gas line under BBQ grill should not be extended through the side of brick. This should be metal hard piped in, then connected to flex pipe.

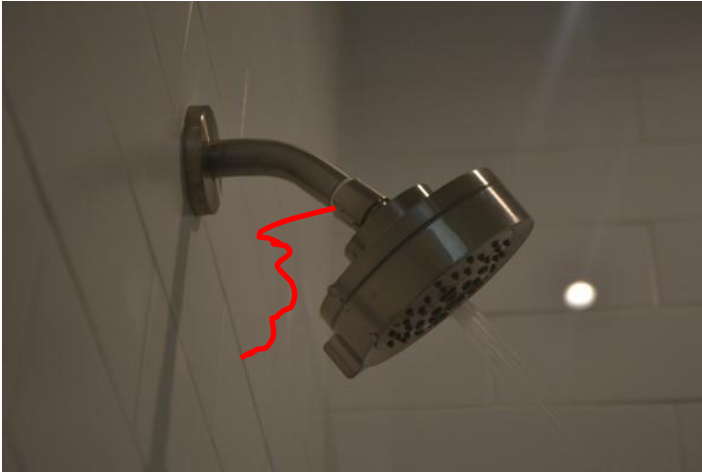
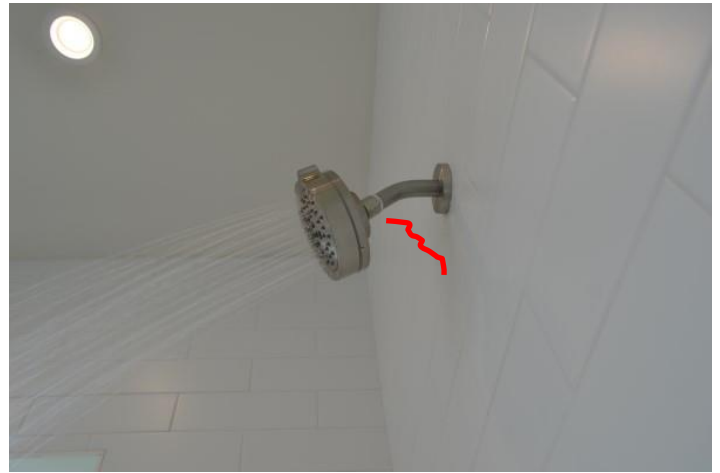
- Water leak at shower head connections in 2nd floor guest bathroom & in 3rd floor bathroom

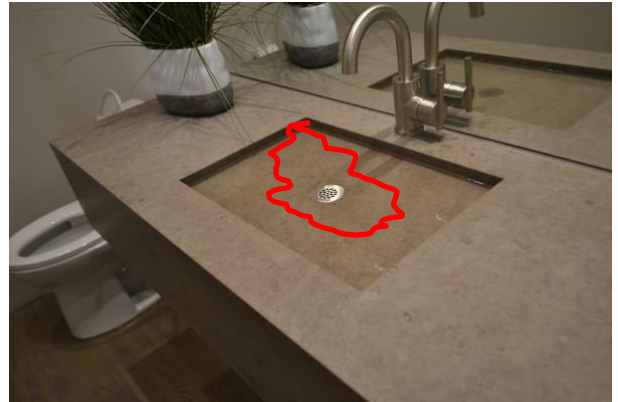
- Escutcheons were missing from supply and drain pipes. Escutcheons are plates used to seal the opening between the pipe and the wall. They are required as "rodent blocks". Escutcheons should be installed to seal the openings between the supply and drain pipes and the wall covering materials
- Slow drain in 1st floor guest bathroom lavatory basin.

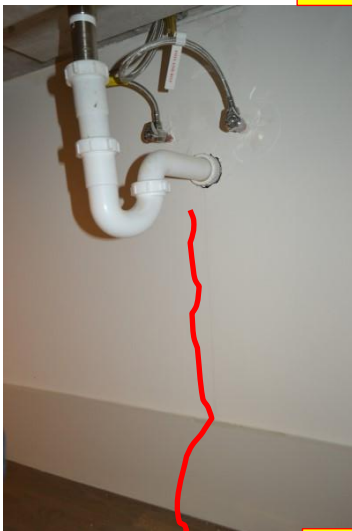
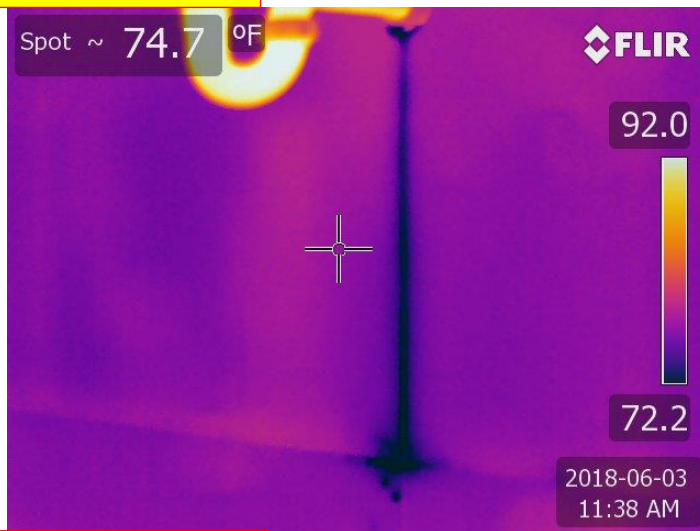
- Water leak under 1st floor guest bathroom lavatory basin, and 2nd floor master bathroom right side lavatory basin. Have plumber find cause of leak and properly repair as needed. Note: There may be hidden damage to the interiors of walls or under cabinet that was not readily detectable at time of inspection. Such damage may not be revealed until remodeling occurs.

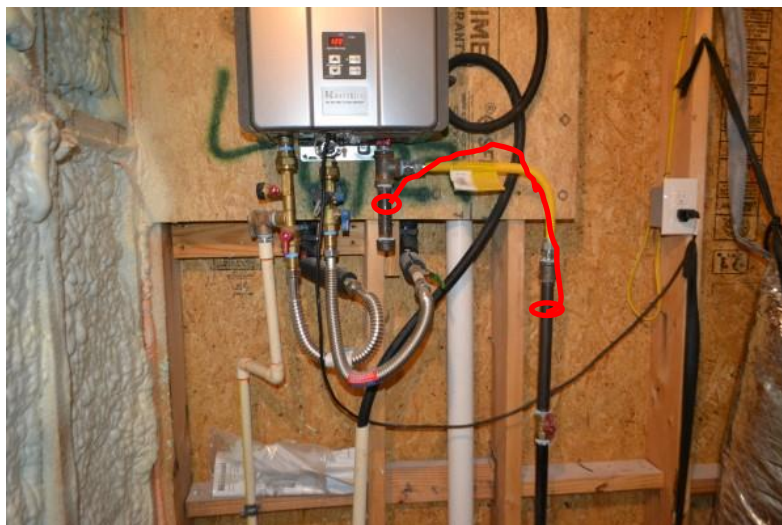
- Information: SECTION G2411 (310) ELECTRICAL BONDING. G2411.1 (310.1) Gas pipe bonding. Each above-ground portion of a gas piping system that is likely to become energized shall be electrically continuous and bonded to an effective ground-fault current path. Gas piping shall be considered to be bonded where it is connected to gas utilization equipment that is connected to the equipment grounding conductor of the circuit supplying that equipment. References: E3509.6, E3509.7 Bonding other metal piping

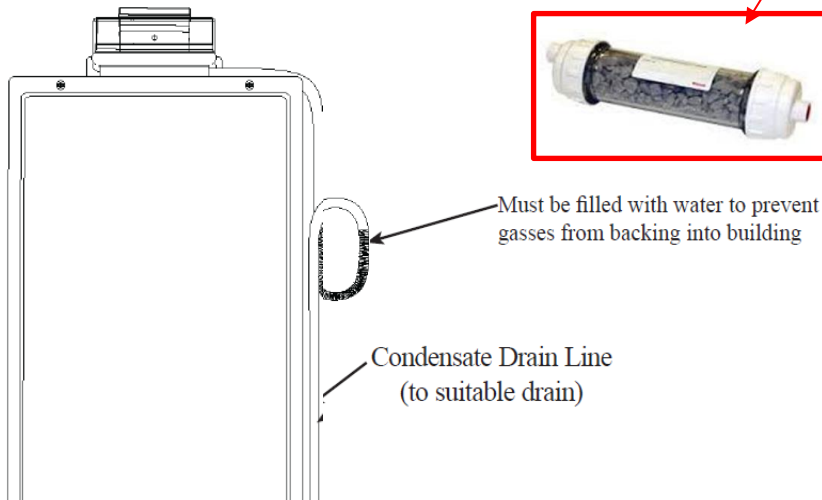
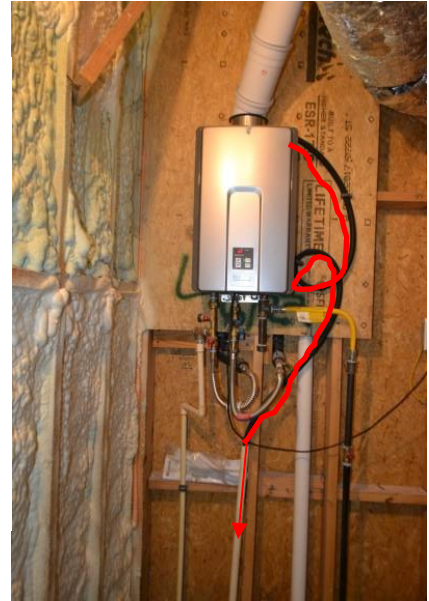
- Condensation drain line draining into drain pan. Condensate drain is acidic and should be draining into the house drainage system. Recommend installing condensate neutralization capsule filter/housing.

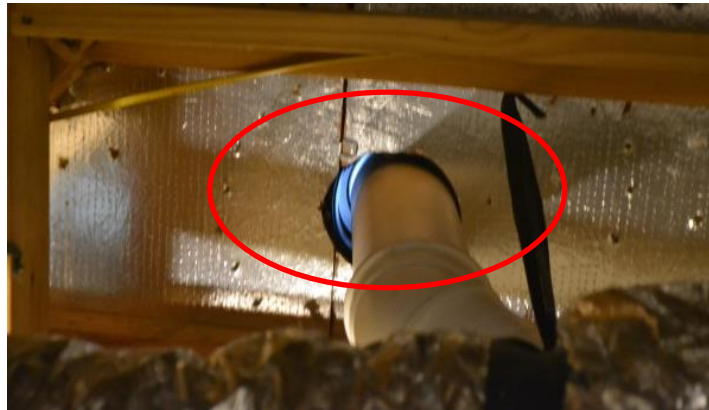
- Daylight gaps noted at flu pipe to collar connection at roof decking. Seal with proper sealant to help prevent water intrusion into attic during wind driven rain and/or storms.

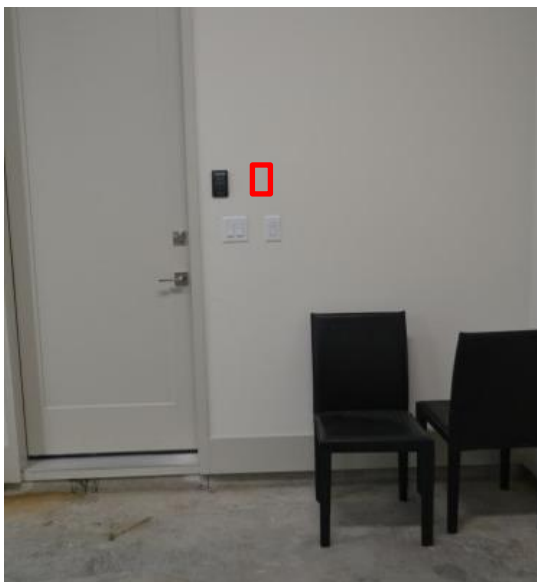
- We did not observe Warning Label next to wall button as required by manufacturer's installation instructions in single car garage. Warning information for child safety.

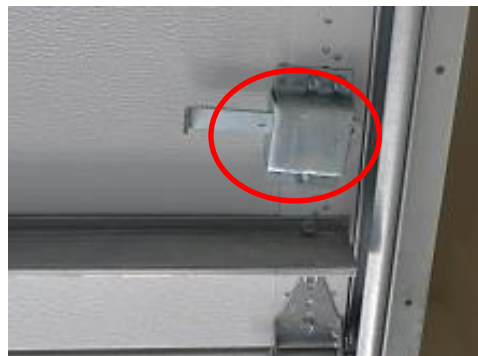
- Manual garage door lock should be disabled on garage doors with automatic openers.
