Exhibit B to Earnest Money Contract Between Robert Paul Mims & Katherine Ellen Crooks (Buyers) and Unicus Developments 6 LLC (Seller) Pertaining to Property at 2816 Newman St, Houston, TX 77098

Seller commitment to address Exhibit A.

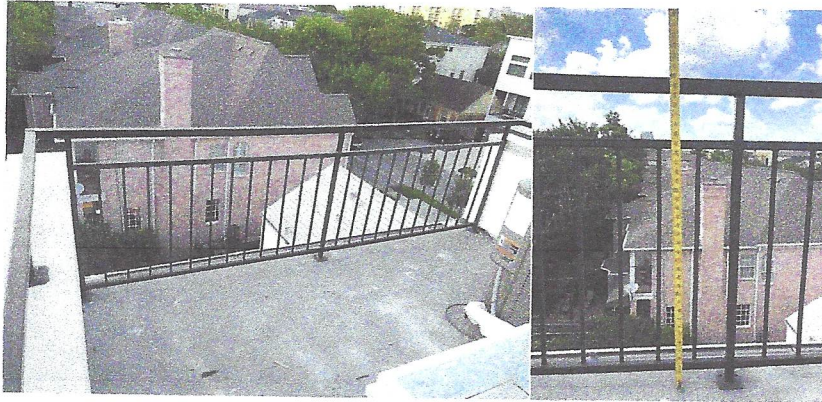
1. Additional guardrails have been added to perimeter. Total elevation now at 36" (see pictures)

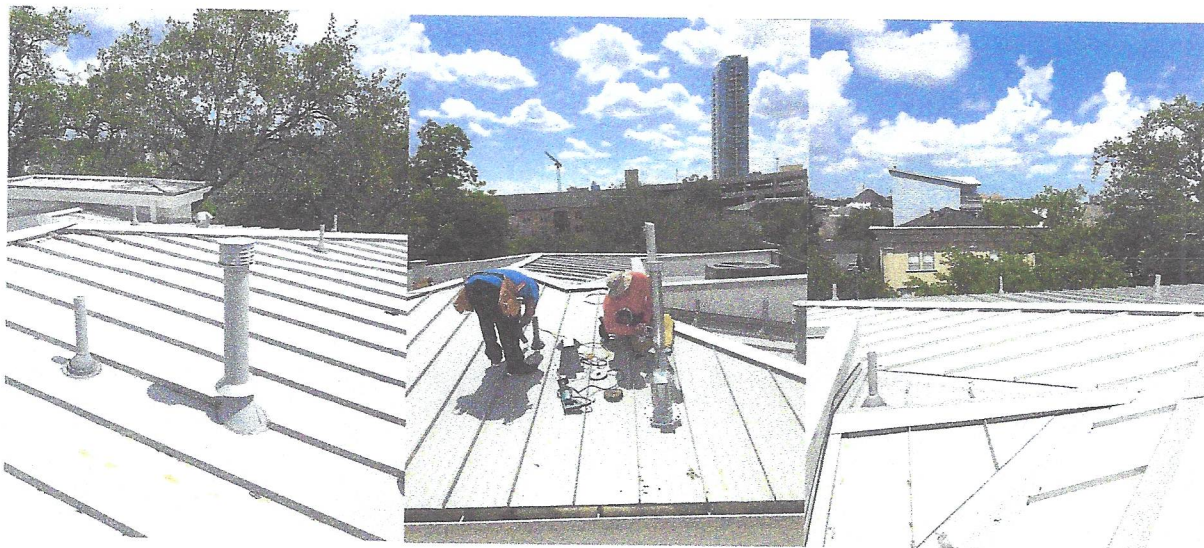
2. All Sewer, flue and roof jacks have been painted

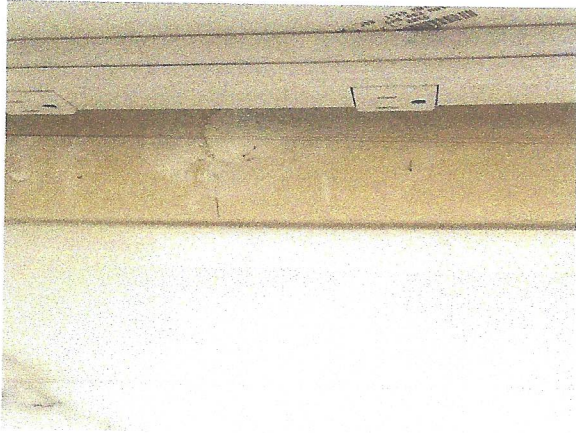
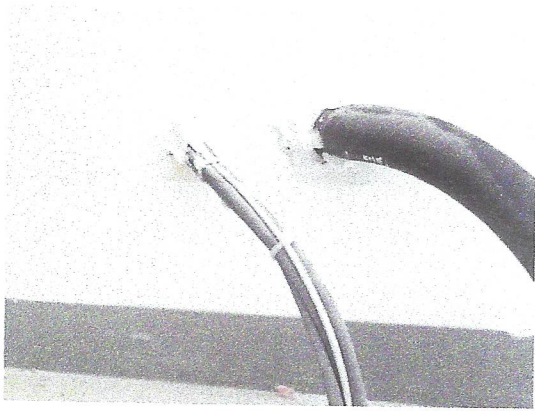
7. Completed (see pictures)

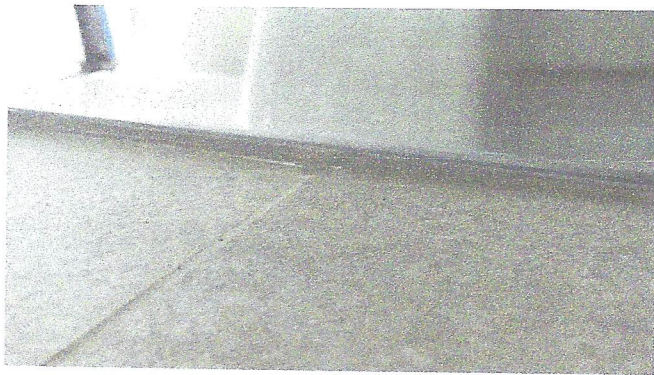
8. Minor gap existed between shower perimeter wall and glass partition. Additional silicon applied, and gap has been closed (see picture). The water leak was located at 3rd floor bathroom not master bathroom.

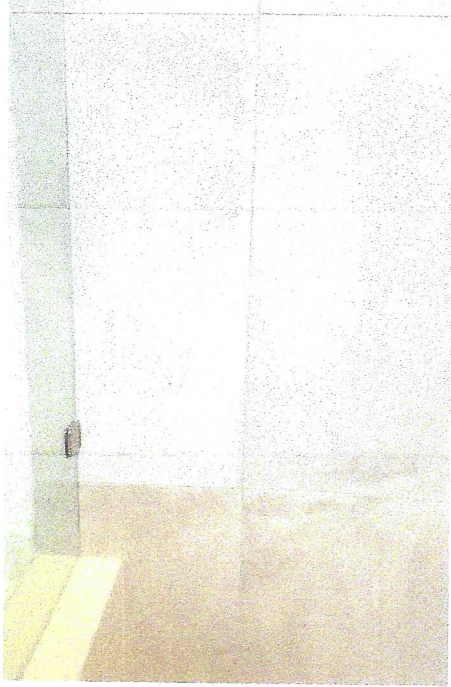
9. Master bathroom has been completed, all other areas to be completed

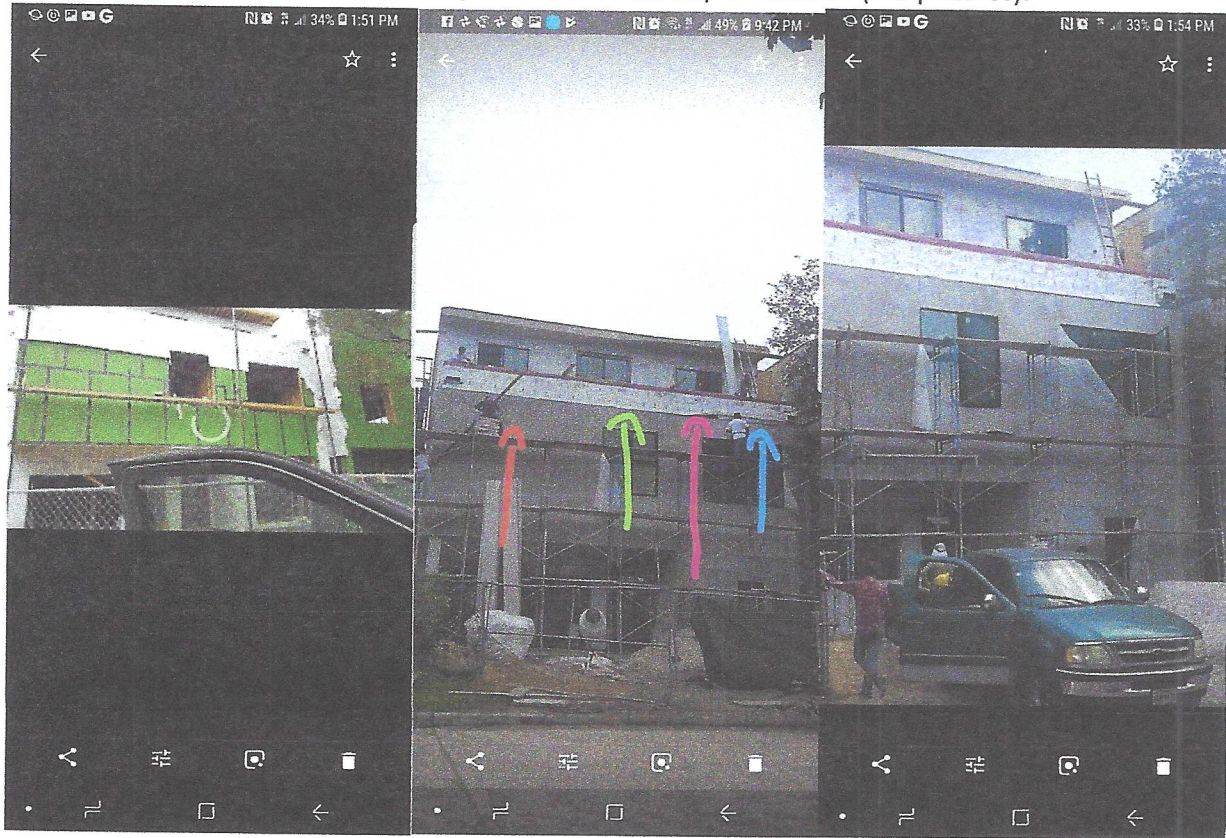
10. Wall flashing is installed as per requirements of the city of Houston (see pictures).

As per brick subcontractors, brick supplier and city of Houston Senior Inspector no flashing is required over lintel on top of widow / door openings.

Attached please see City of Houston record for brick tie inspection being approved on 07/12/2017. Based on inspection report performed by Vital Inspections, we requested opinion from Ellis Dorrance Senior Inspector for the City of Houston Public Works and Engineering Department, Mr. Dorrance confirmed our assessment that additional flashing is not necessary and provided his business card in case you want to discuss this issue further with him. It is important to note that Steel angle lintels have been primed before installation and life expectancy far exceeds +50 years.

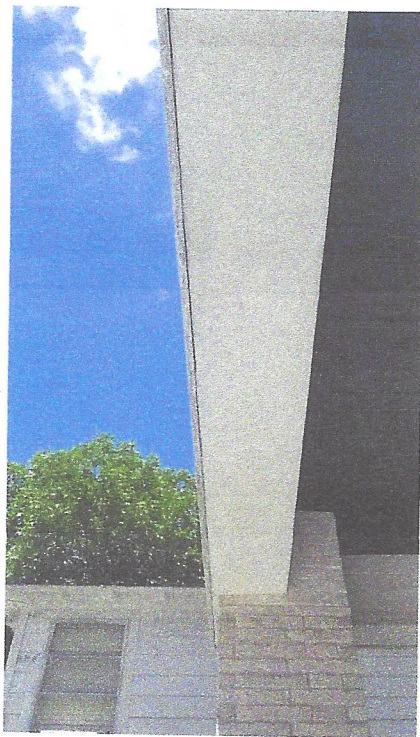
11. Weep wholes have been unclogged (see picture)

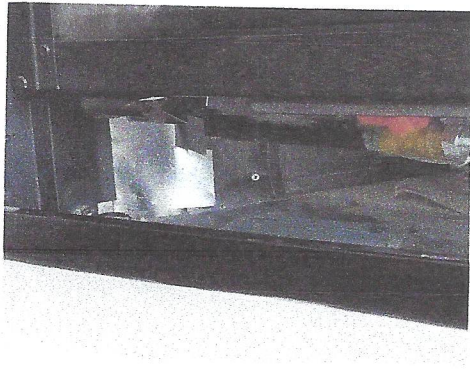
13. As per supplier of fireplace, perfection fireplace, this may be done but it is not required by manufacturer (see email from perfection fireplace). We have addressed adding metal piece to cover (see picture).

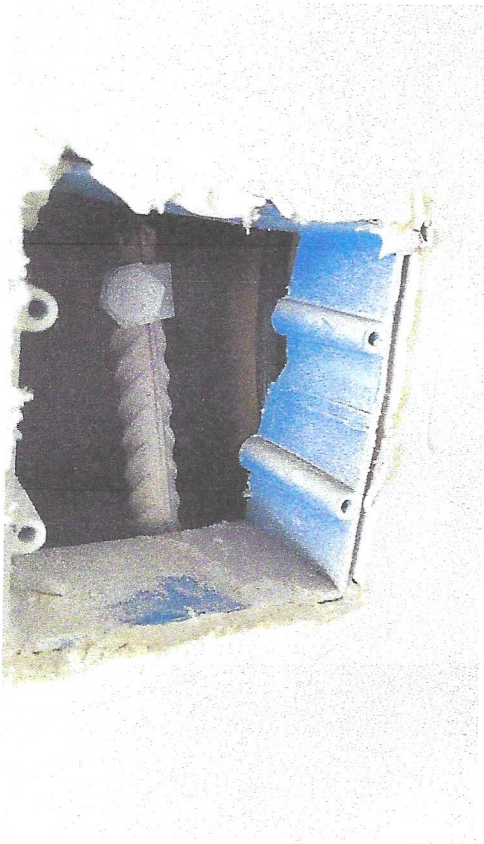
14. There is already a second ground that can be seen from inside the garage walls (see picture). One additional ground will be installed as per report recommendation

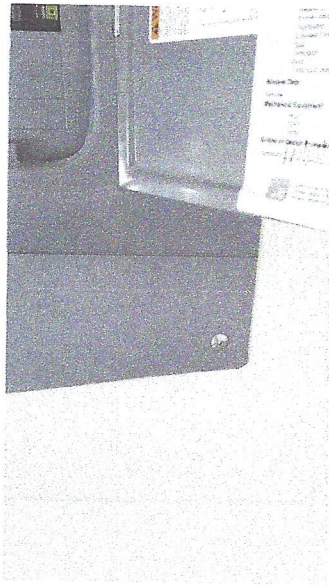
15. It has been completed (see picture)

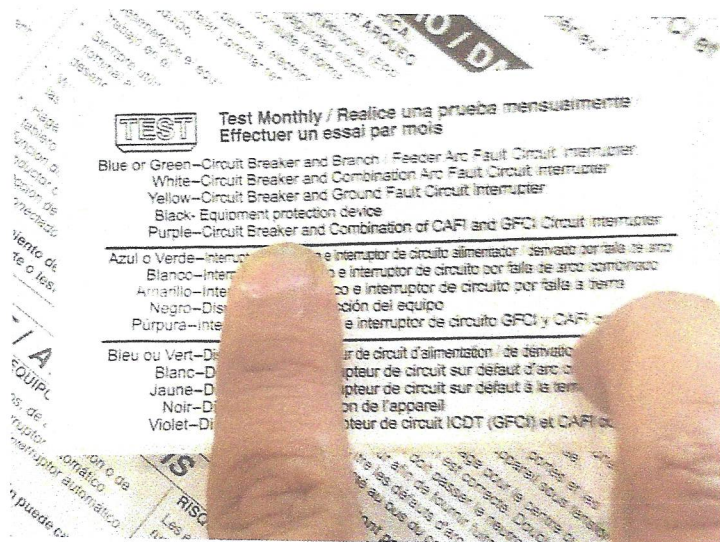
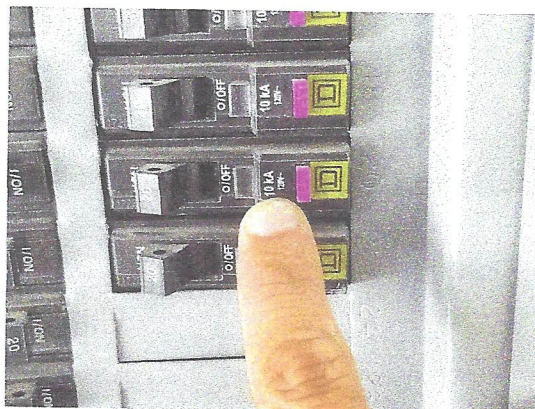
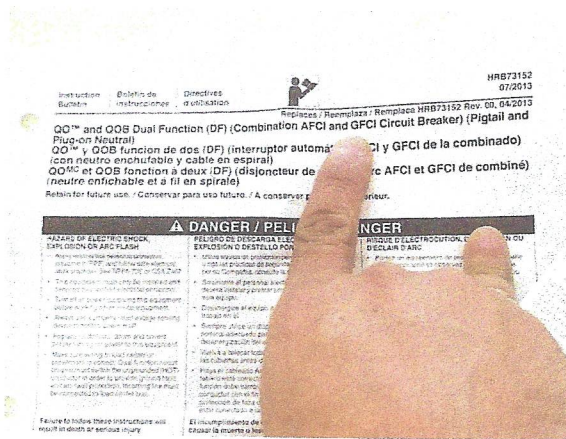
16. We have installed circuit breakers (purple in the breaker box) that are a combination of AFCI and GFCI therefore not requiring individual GFCI in areas listed in the report (see pictures)

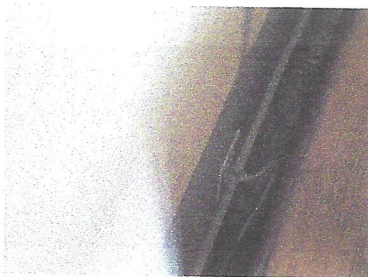
19. Is has been replace (see picture)

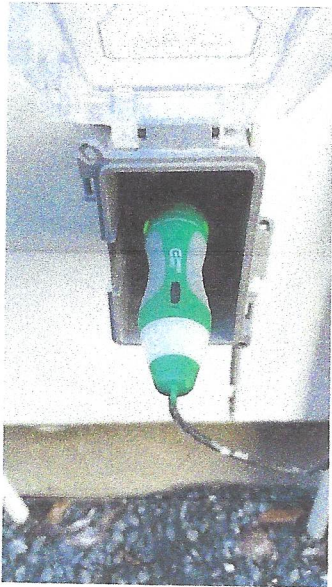
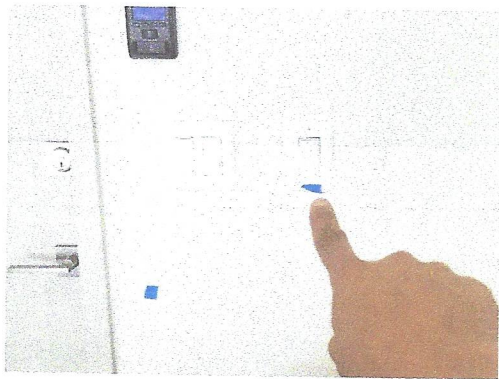
20. Power outlets already in place and with power. They are controlled by a switch by the garage door to the house and it might have been off (see pictures).

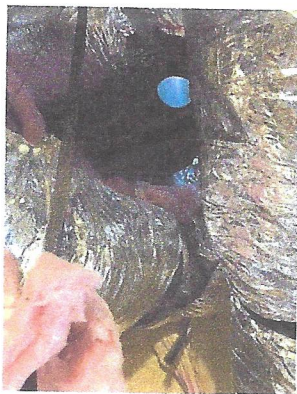
22. One additional opening has been added to the mechanical room (see picture)

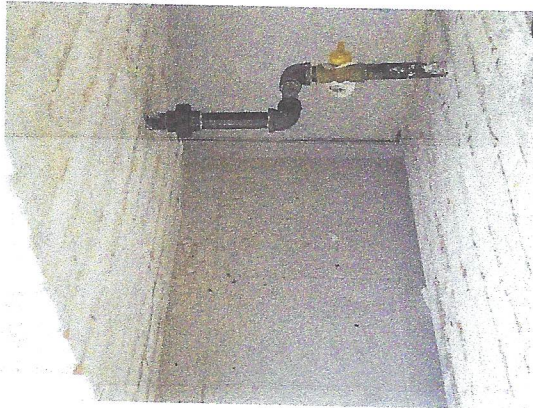
25. Completed (see picture)

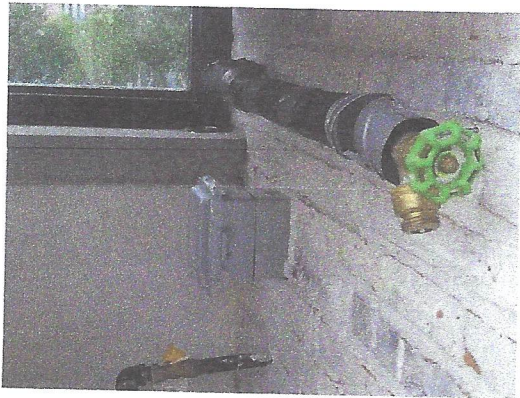
26. Corrected (see picture)

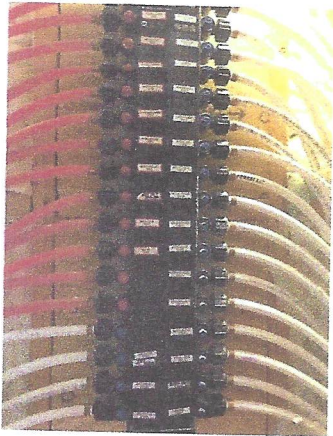
27. Pex crimps have been addressed (see picture)

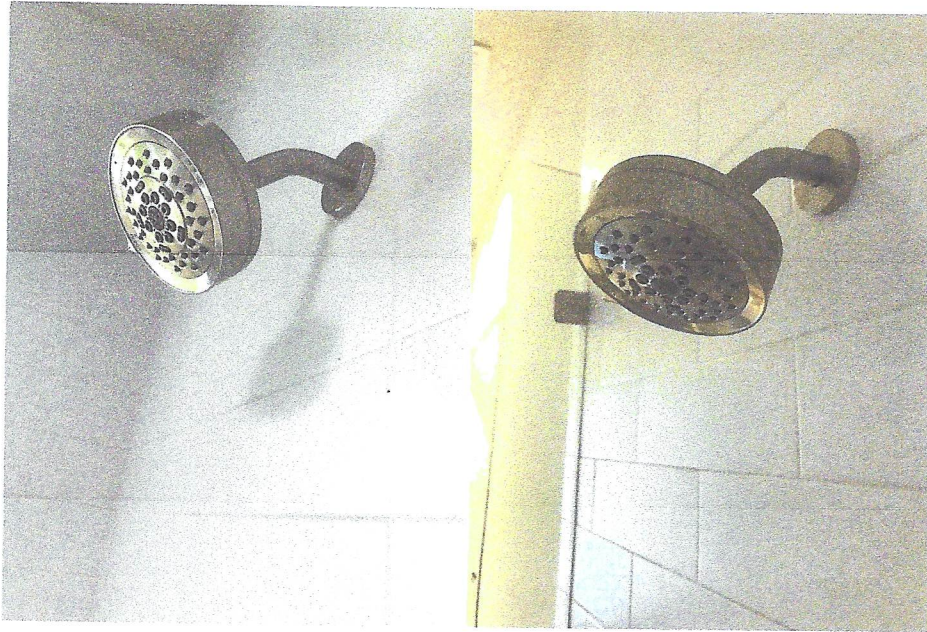
28. Water leaks at shower heads have been addressed (see pictures)

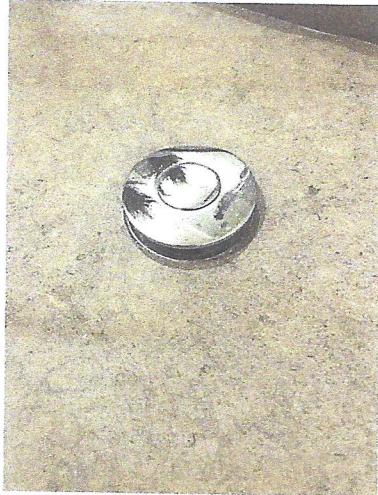
30. Missing escutcheon has been replaced (see picture) and it is draining properly.

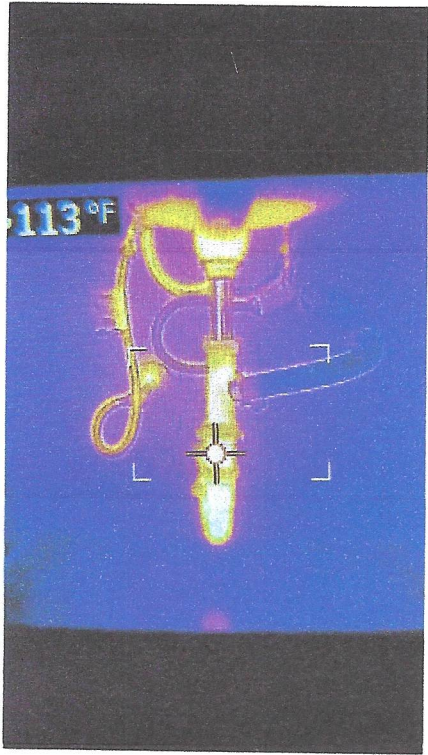
31. It has been repaired (see picture)

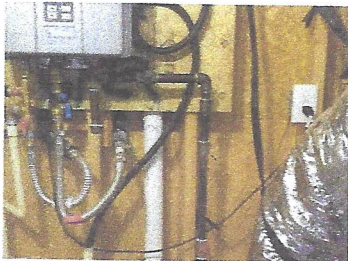
32. Bonding addressed (see picture). We will install condensate neutralization capsule (model installed does not require it see email from manufacturer)

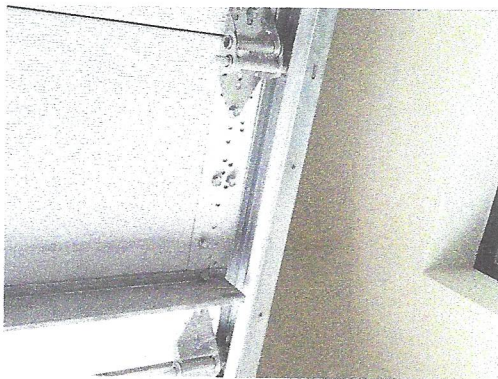
34. Label has been procured, if buyer deems important we can place by the garage door keypad. Manual lock has been disabled (we will provide to buyer in case they want to reinstall)

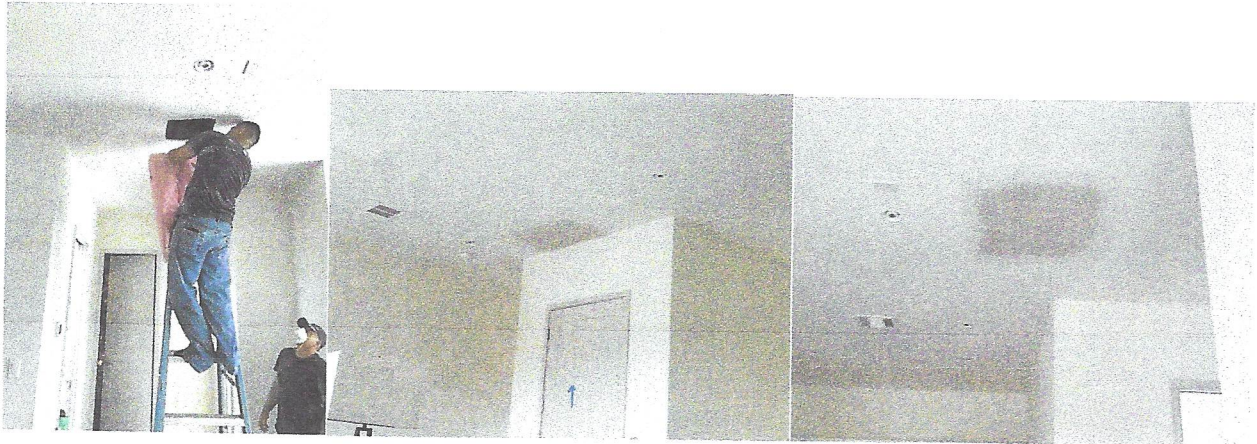
37. Insulation pieces have been replaced (See pictures)
