Property Inspection Report #190121AL-2816 Newman Street  
8616 Daffodil St. Houston, TX 77063

## PROPERTY INSPECTION REPORT

**Prepared For:** Rob & Ellen Blasio  
(Name of Client)

**Concerning:** 2816 Newman Street, Houston, TX 77098  
(Address of Inspected Property)

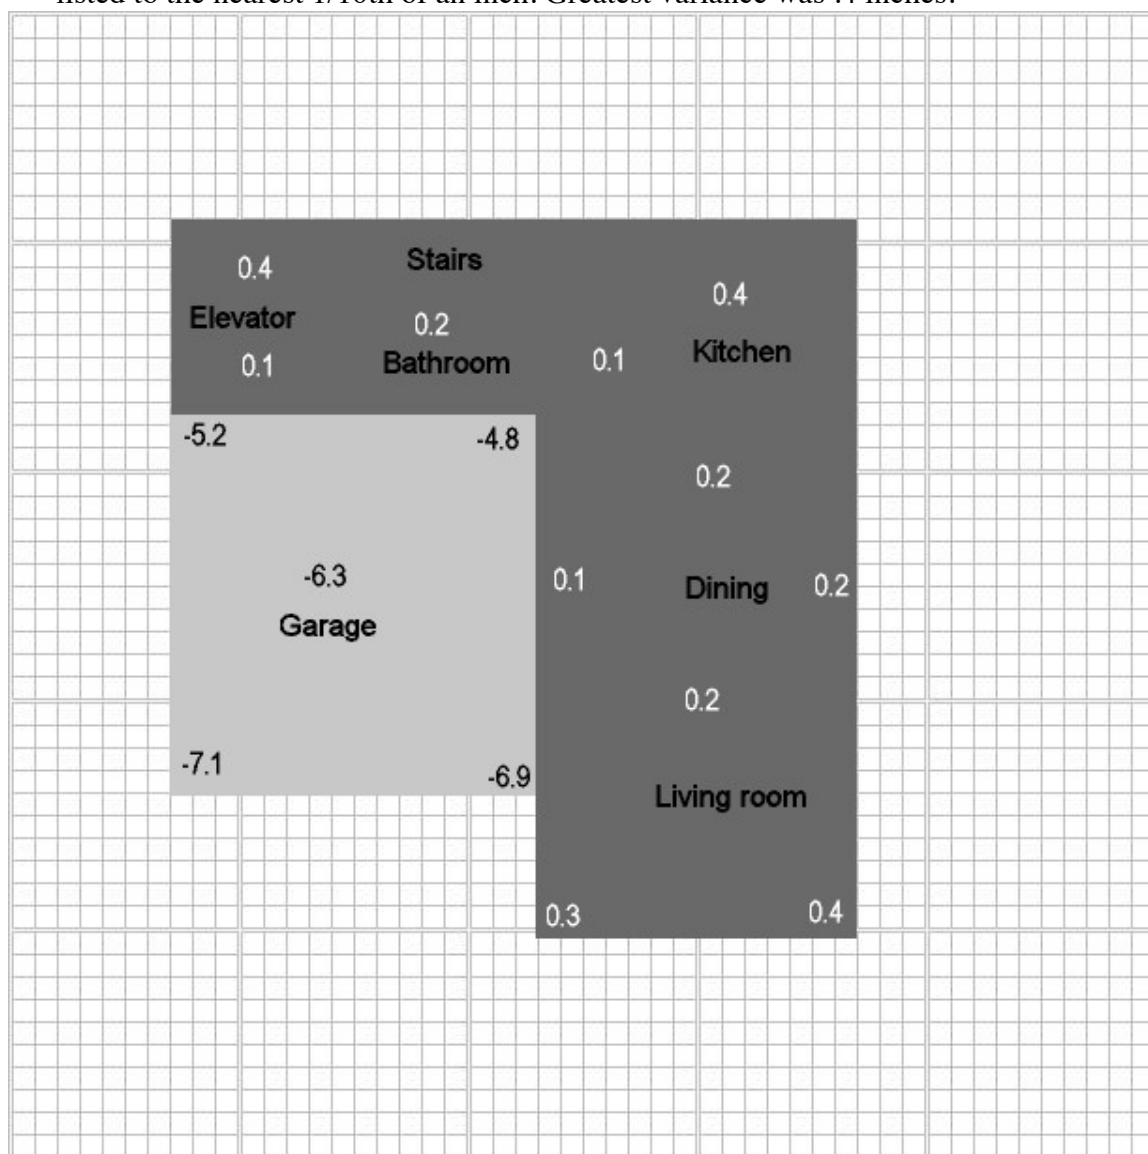
A foundation elevation survey was conducted during the inspection. The floorplan below represents data gathered using a Zip Level and adjusting for floor covering height differences. i.e. differences between tile, carpet and wood flooring. Measurements are listed to the nearest 1/10th of an inch. Greatest variance was .4 inches.

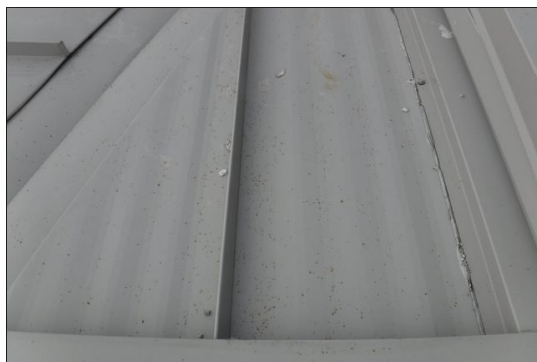
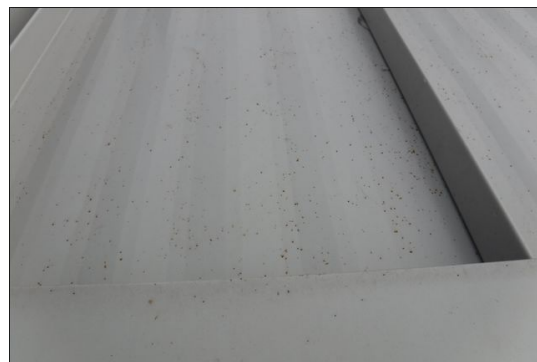
Rusting/pitting observed on metal roofing. Recommend further evaluation/ painting to prevent further corrosion.

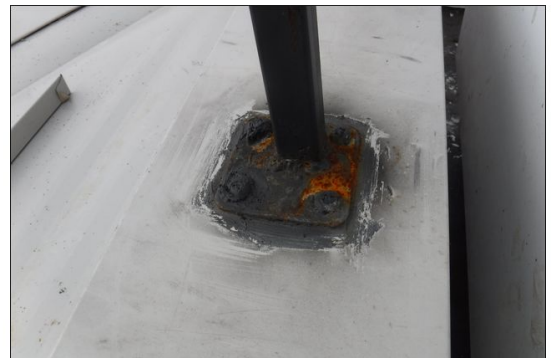
Observed railing bolted down to the top of the cap flashing on the balcony and roof surface. These penetrations are potential areas for water entry, recommend monitoring and maintaining sealant.

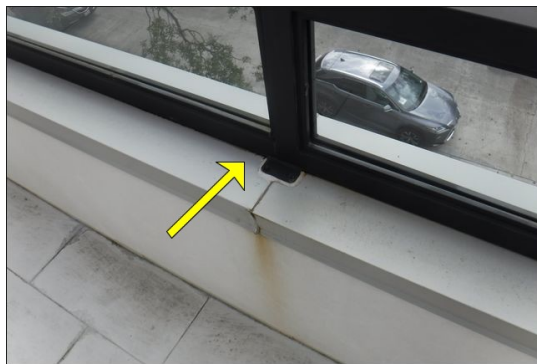
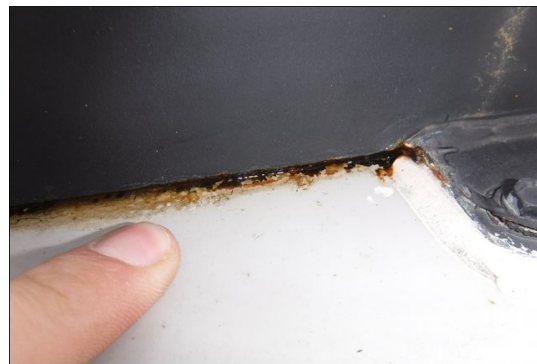
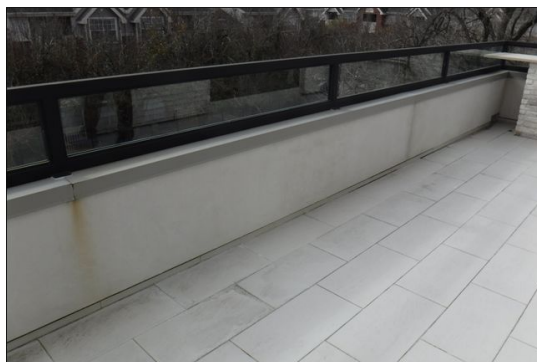
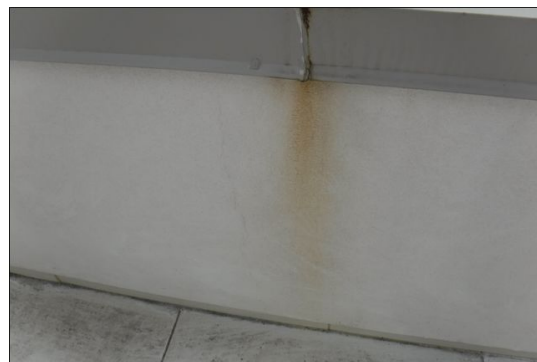
Observed areas of cap flashing on the terrace that are not properly sloped to shed water. It appears that the water is pooling around areas where the railing has been bolted down on top of the cap flashing. Observed rust and corrosion at these areas (running down wall), which may be potential areas of water penetration.

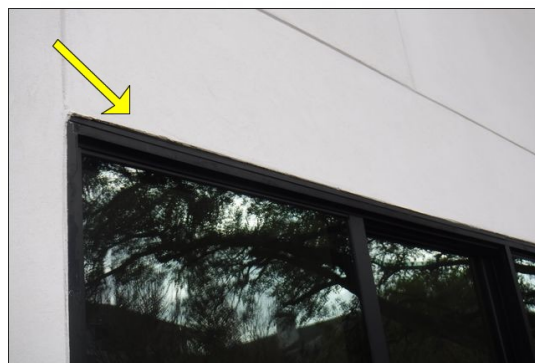
Head flashing missing over some windows / doors. Head flashing helps prevent water penetration. Without head flashing windows/ sealing must be maintained as the only defense against water penetration.

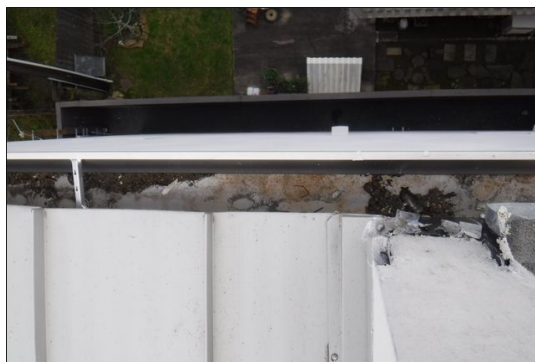
Need general maintenance, Clean out debris / resecure to fascia board / tilt toward drains, seal leaks, etc.

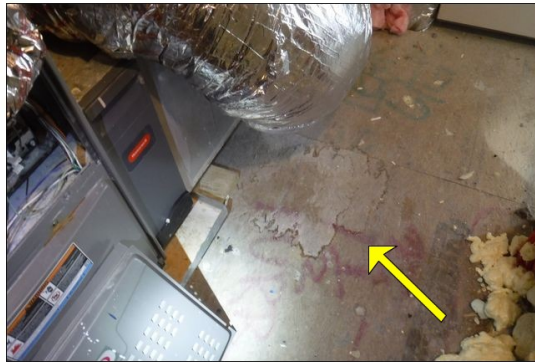
Water staining observed on attic floor decking near unit. No active leaks observed at time of inspection.

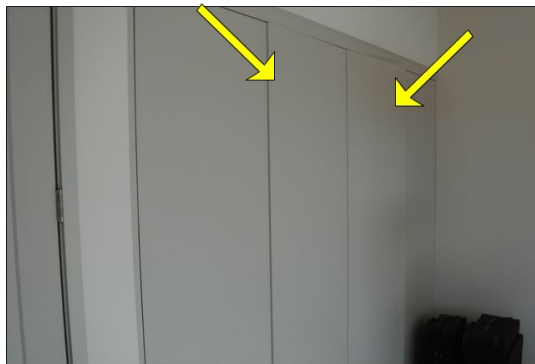
*Some of the cabinets in the bedrooms do not stay closed completely. Magnets do not appear strong enough to hold door shut.*

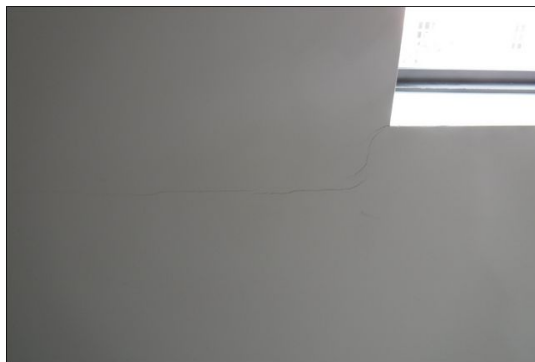
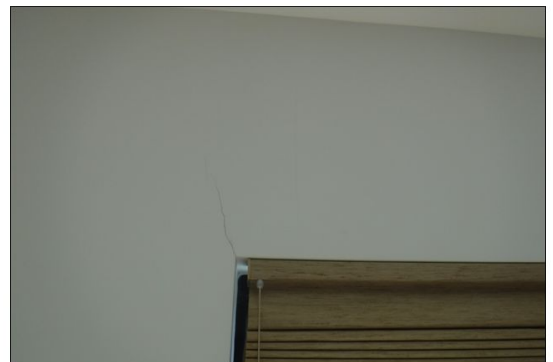
Cosmetic cracks and/or repaired cracks in sheetrock observed over some / many doors, windows, and/or corners.

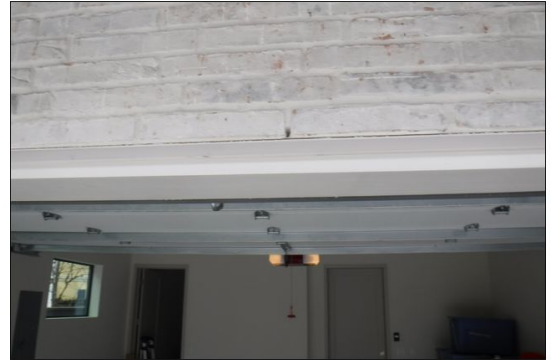
Sag in double header over garage door. Indication of improper/inadequate framing.

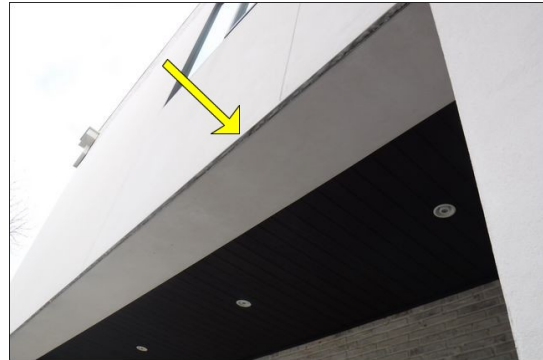
The weep screed at the bottom of the stucco wall appears to be sealed up which may prevent water from being able to drain out behind wall.

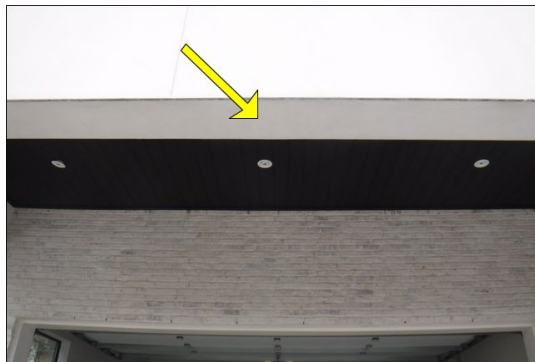
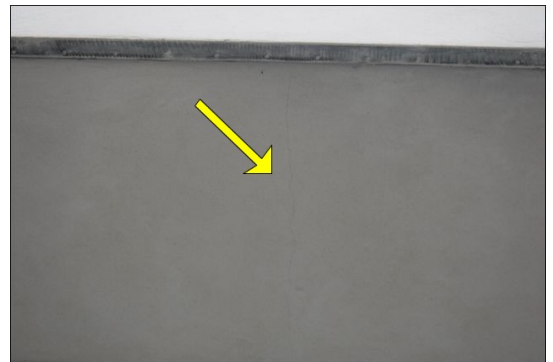
Crack observed at bottom side of stucco overhang over garage.

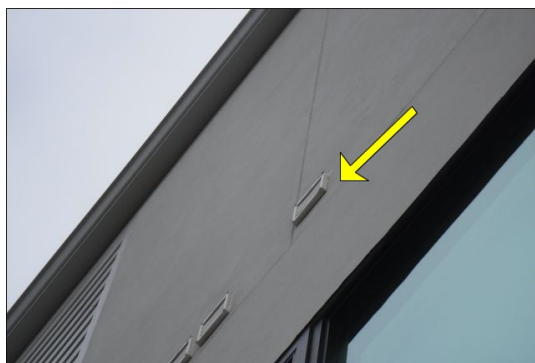
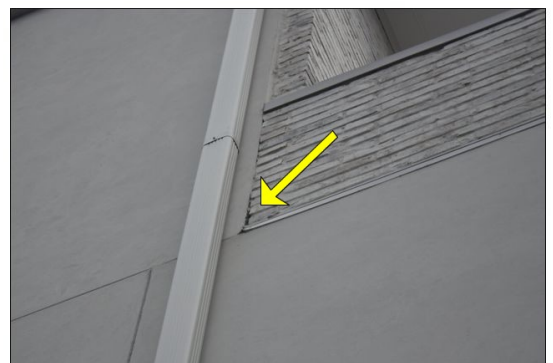
Possible water entry from joints and/or penetrations in stucco siding. Recommend sealing / caulking around all cracks and exterior siding penetrations including but not limited to light fixtures, electrical outlets/service panels, dryer, bath vents, etc.

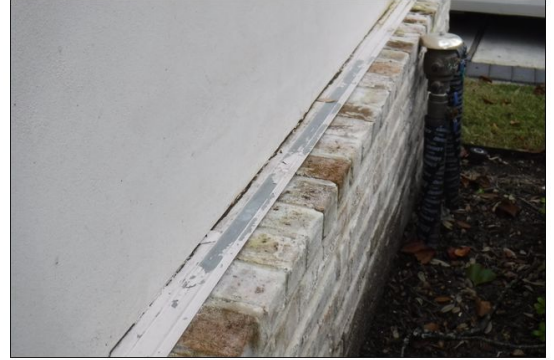
Recommend painting flashing at base of guard wall at front of house to prevent possible corrosion. Lower edge of flashing is not sealed down well.

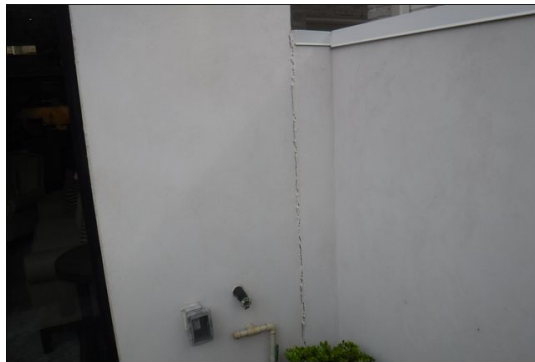
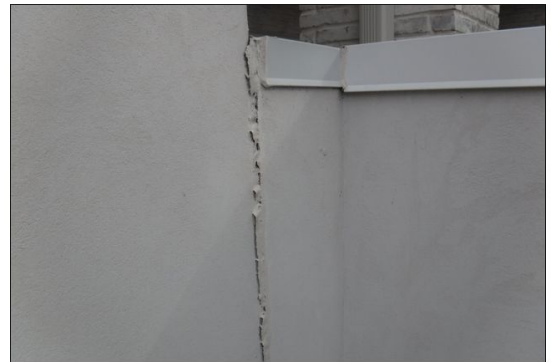
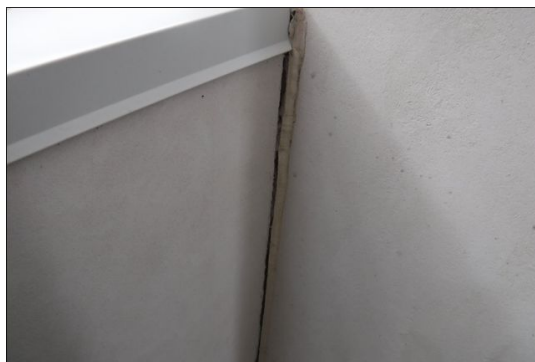
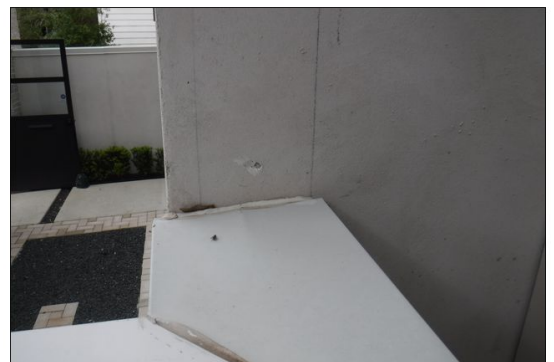
The guard wall at front of house at southeast corner is pulling away from structure. Large gap observed between wall and house that may allow water accumulation. Recommend repair.

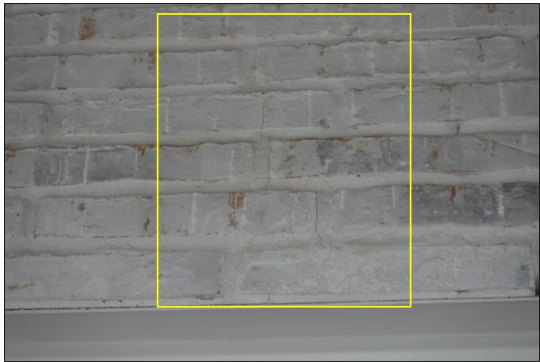
Cracks in brick veneer and/or repairs, one or more locations, Recommend buyer take photographs of cracks, their location, and width [ruler across the crack] with a high resolution camera that has a date stamp for future reference.

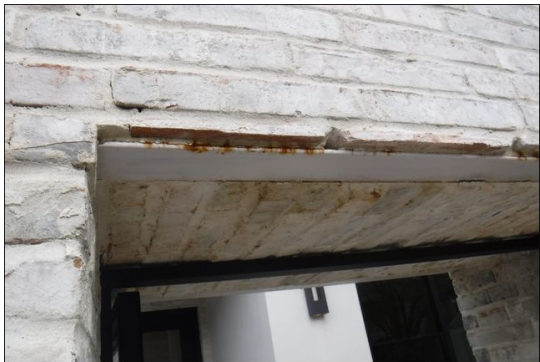
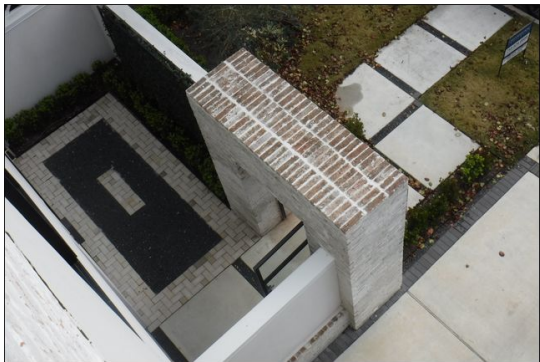
Metal lintel(s) over window/door openings are not flashed as required by current building standards. Ref: IRC 2003 Section R703.7.5 Stone and Masonry Veneer | Flashing.

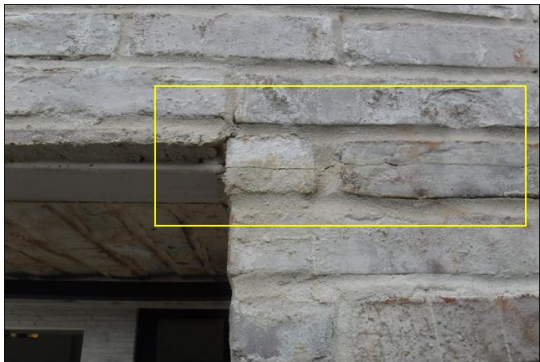
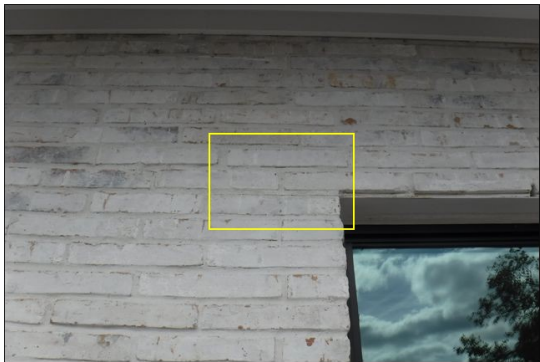
*Cracks at upper corners of windows is typical due to not enough space left at ends of steel lintel at time of construction to allow for expansion of metal.*

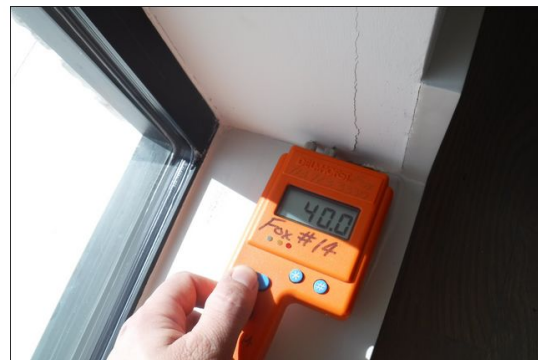
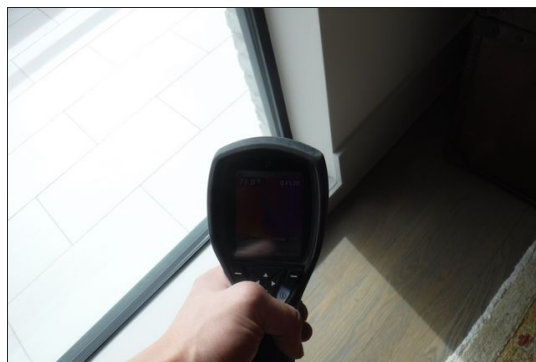
**Water penetration observed at the following location(s): at third floor fixed window. Recommend further evaluation/repair.**

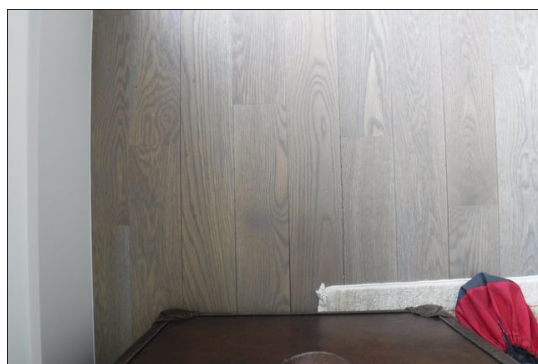
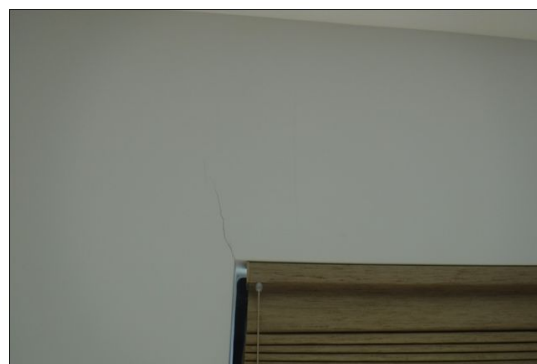
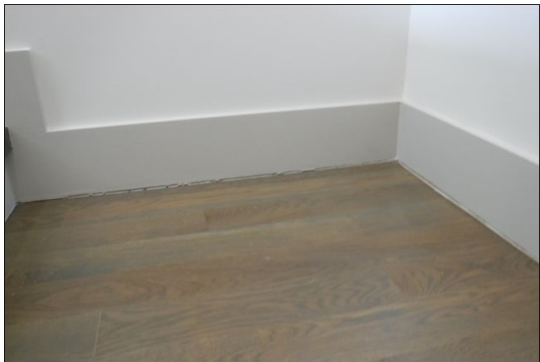
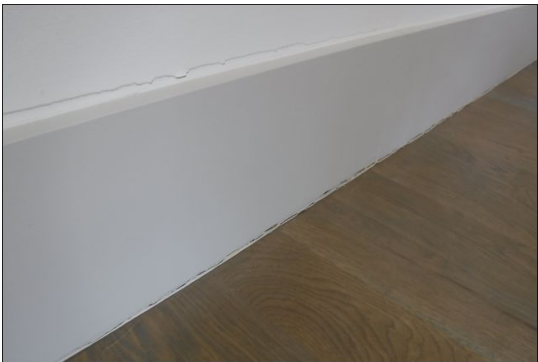
Not level upstairs, possibly/probably due to improper/inadequate framing. Observed a '.8' inch drop from the middle of the third floor to the exterior wall near the balcony door. Some distress/separation observed in the flooring and sheetrock and gaps observed at base of floor below baseboards at third floor staircase landing.

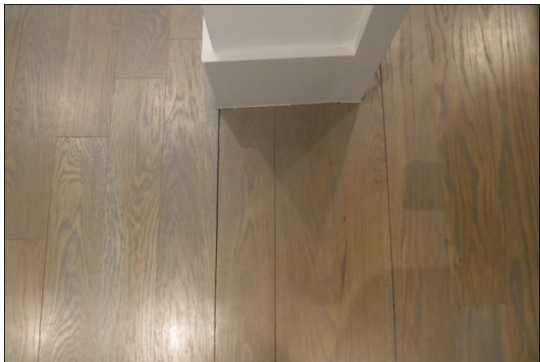
Some separation observed between wood planks at multiple locations; third floor near balcony door and first floor near kitchen.

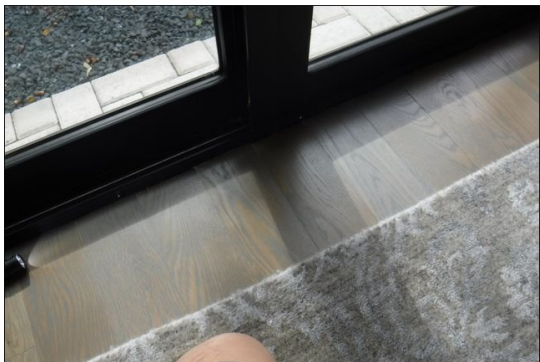
Water damaged wood flooring; near first floor sliding glass door. Flooring is cupped.

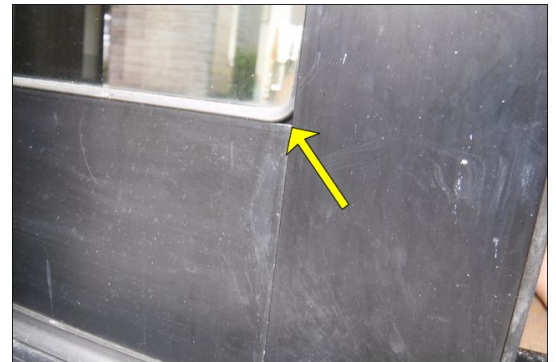
Observed water penetration though bottom corner of sliding glass door at first floor.

Recommend sealing exterior joints.

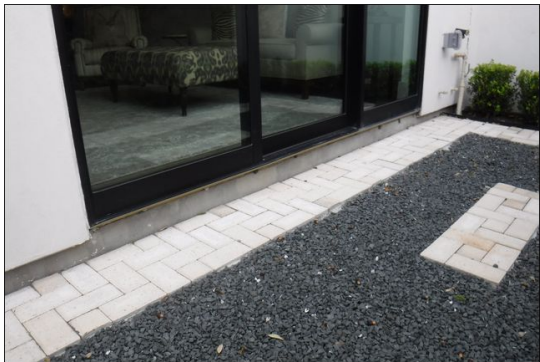
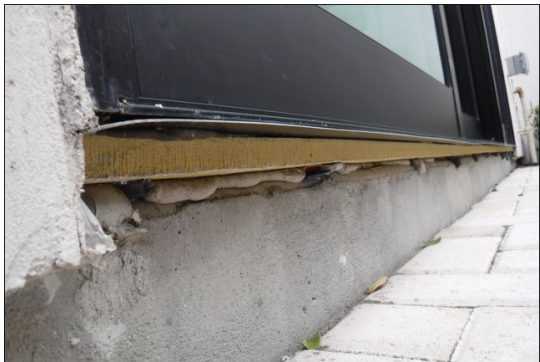
Did not observe door pan flashing at exterior door location(s). Properly installed door pan flashing helps prevent wind driven rain / water penetration from damaging interior building components. *High risk areas include exterior doors with little to no roof or balcony overhang protection from the elements. It is not uncommon for Fox Inspection Group inspectors to observe evidence of water penetration (water damaged wood flooring or water stained carpet tack strip) at second floor balcony doors. For additional information you may watch a 5 minute video on flashing where the first few minutes shows door pan flashing by copying and pasting this link*

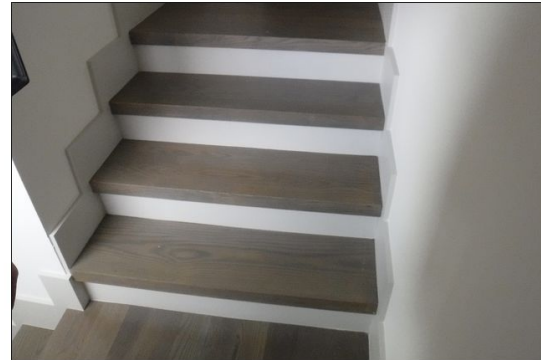
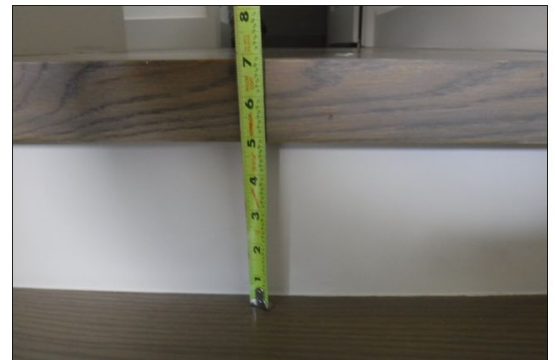
Stairway has tripping hazard, Risers are not same height along the entire height of steps.  
Stairway does not comply with current industry standard, (code). CABO 314.2 &  
UBC 1006.3 requires "The greatest riser height within any flight of stairs shall not  
exceed the smallest by more than 3/8 inch."

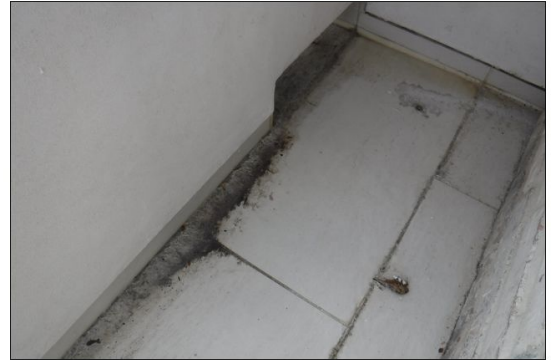
Some staining observed on balcony floor along wall, which may indicate pooling water. Recommend monitoring drainage after a heavy storm to ensure no water is left standing.

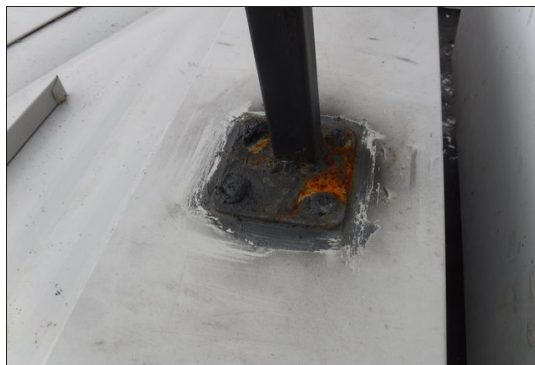
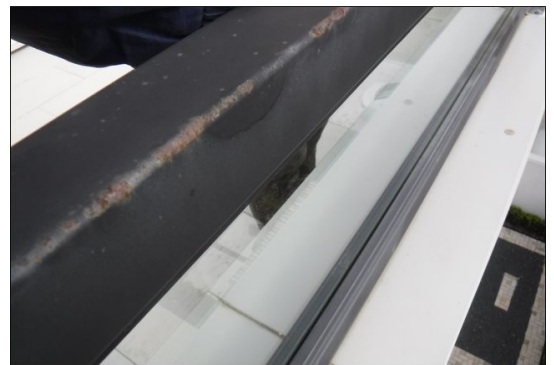
Rust/corrosion observed on iron railing at multiple locations (roof top and balcony).

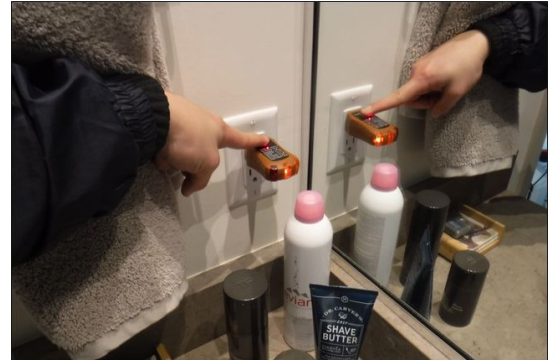
Did not observe GFCI protection of all outlets in required locations, including but not limited to the location marked below. This condition is a recognized safety hazard and is in need of repair.

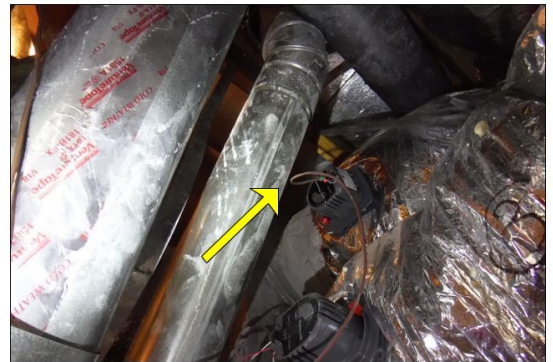
Recommend adjusting thermostat wiring away from heater exhaust vent.

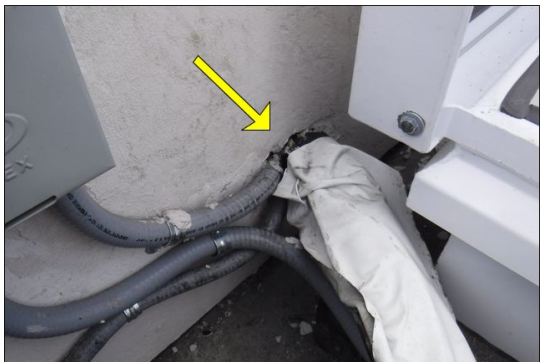
Recommend sealing exterior where AC lines enter house.

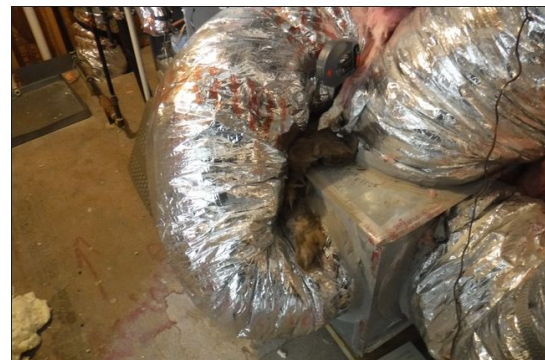
Some flex duct observed to be improperly routed with sharp bends and / or excess material in bends. Improper routing increases frictional loss in the duct and reduces heating and cooling efficiency. Radius at centerline of the bend should be no less than the diameter of the duct.

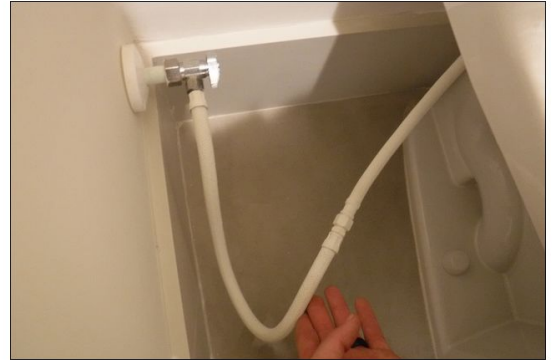
Observed 2 water lines amateurishly tied together at master bathroom commode in order to clear the distance. The water supply line is normally located directly behind the commode.

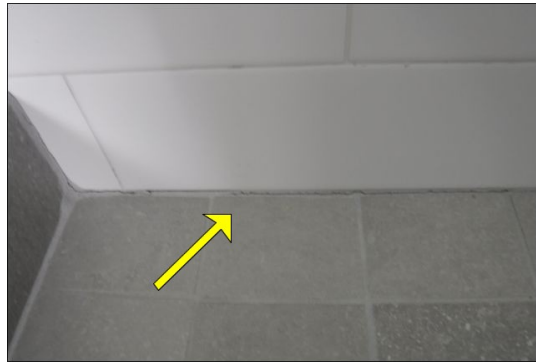
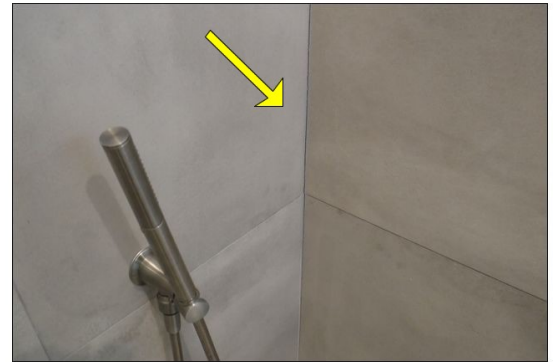
Grout / caulking needed at vertical tile corners, cracks in tile and/or mortar between tiles, to prevent water entry behind wall.

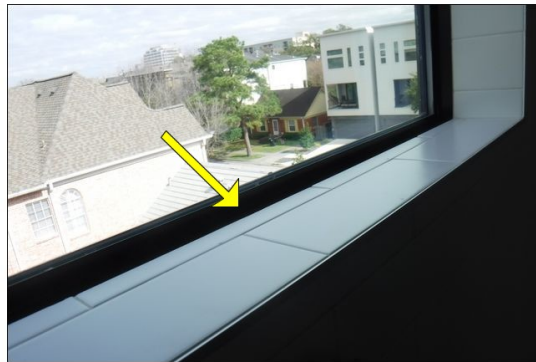
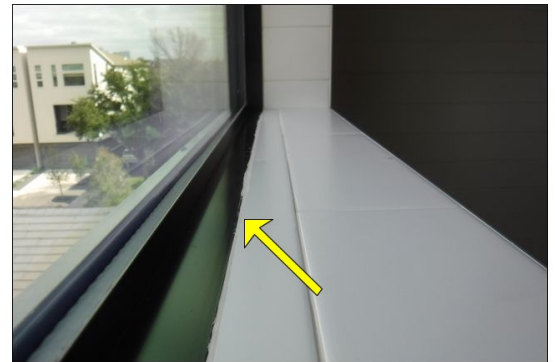
Observed level or improper sloping of shower window sill tile, sill should slope towards interior of shower not back towards window frame.

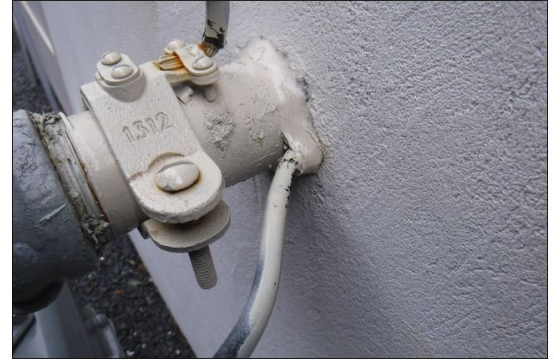
Gas piping not sleeved as it passes through masonry wall as required by Code [CABO 2608.3] IRC 2603.3.

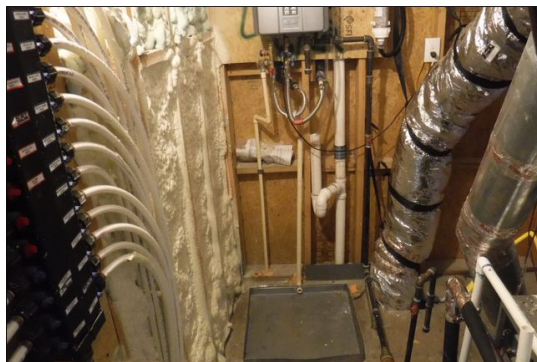
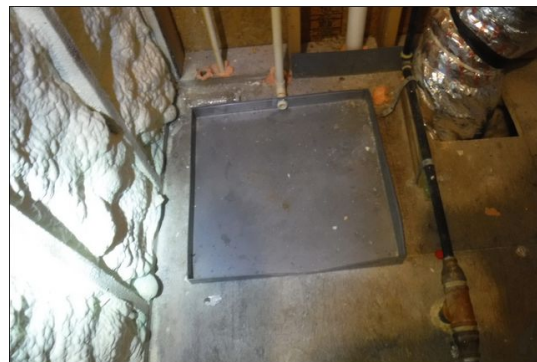
Drain pan is located far below unit and may not catch all water from potential leaks.  
Drain pan is not secured properly in place.

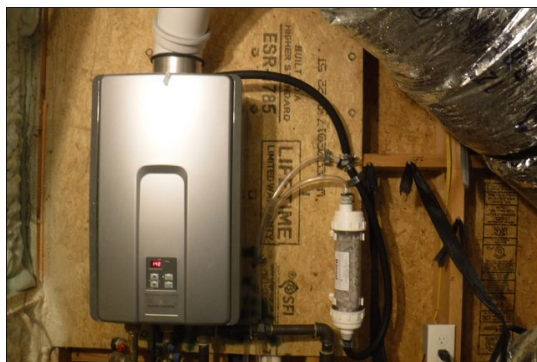
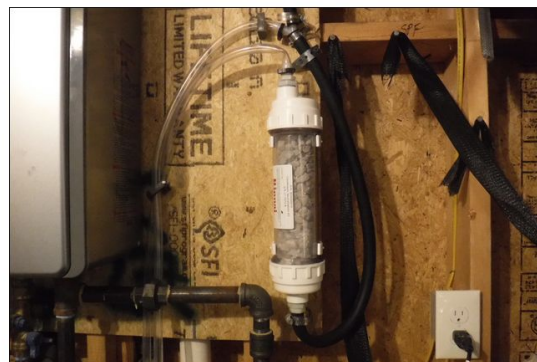
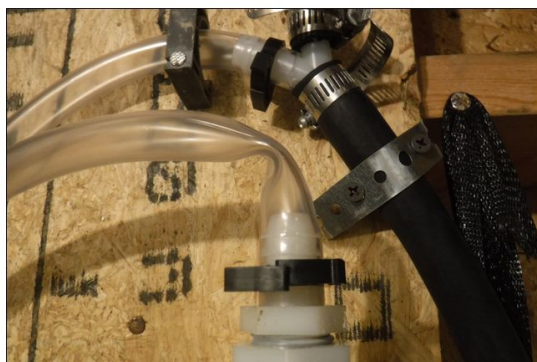
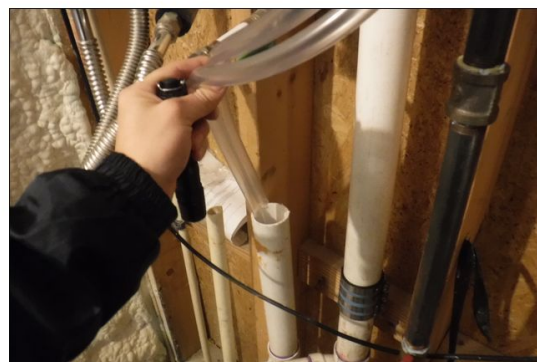
The condensate drain line and components do not appear to have been installed properly to allow for proper drainage. Hose is missing required drip loop and the line is crimped at one or more locations and not properly secured in drain. Recommend further evaluation by a qualified professional.

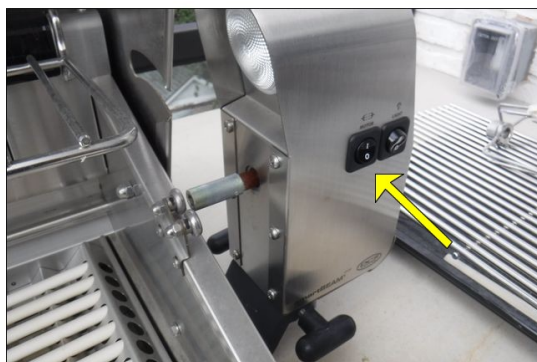
The rotisserie motor is not operational.
