Response to Fox Inspection Jan 21/2019

2816 Newman St.

Inspection report repaired items:

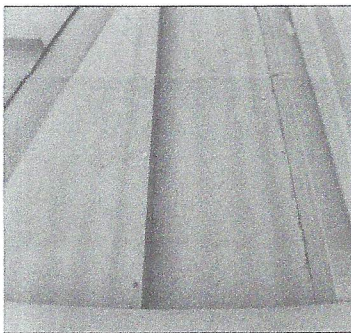
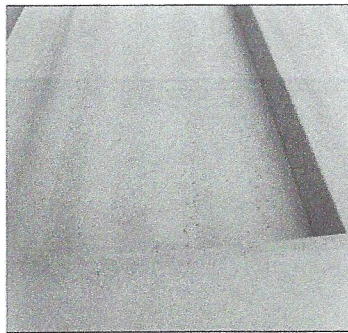
pg 5 of 43

Rusting/pitting observed on metal roofing. Recommend further evaluation/ painting to prevent further corrosion.

Repaired- rust removed and applied paint.

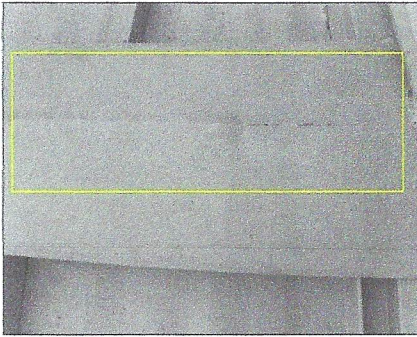
pg 6 of 43

Ridge cap is damaged/deformed at one or more areas on roof surface; possibly from foot traffic.

Repaired- ridge cap replaced

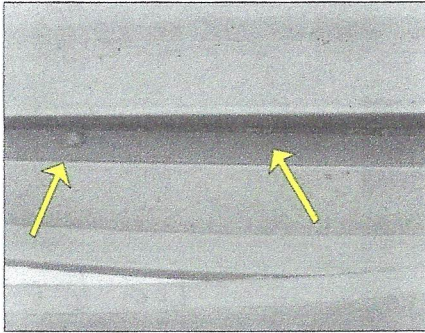
pg 6 of 43

Recommend clearing debris from roof surface to allow for proper water drainage.

Repaired- debris removed

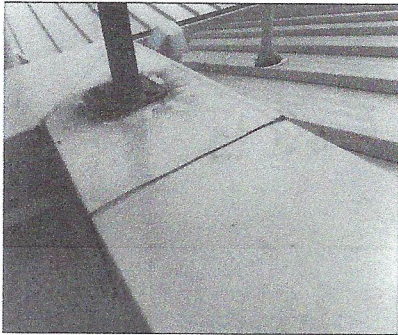
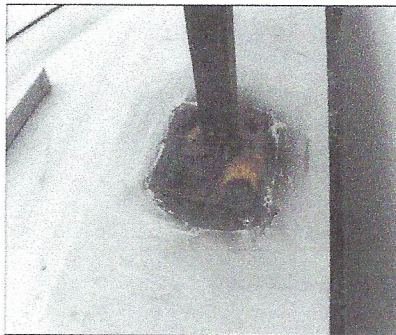
pg 6 of
43

Observed railing bolted down to the top of the cap flashing on the balcony and roof surface.

Repaired- resealed part of home maintenance

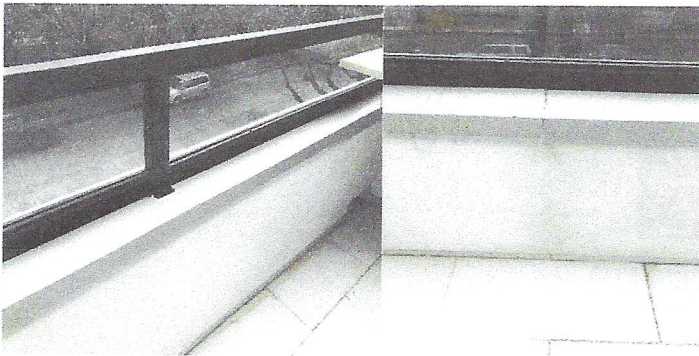
pg 6 of
43

Observed areas of cap flashing on the terrace that are not properly sloped to shed water

Repaired- rust removed part of home maintenance

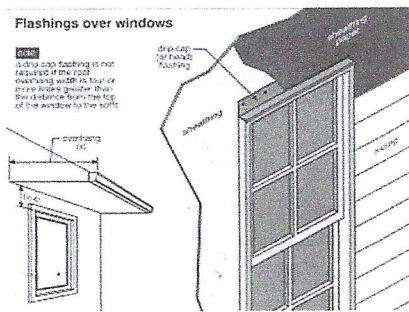
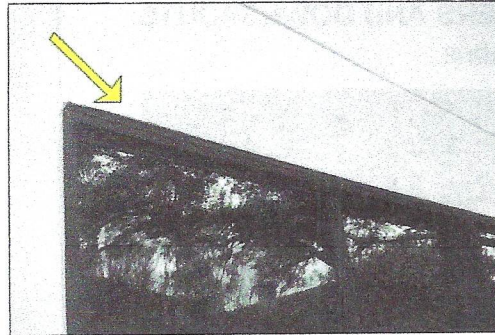
pg 7 of 43

Head flashing missing over some windows / doors.

Not repaired- head flashing present over all windows

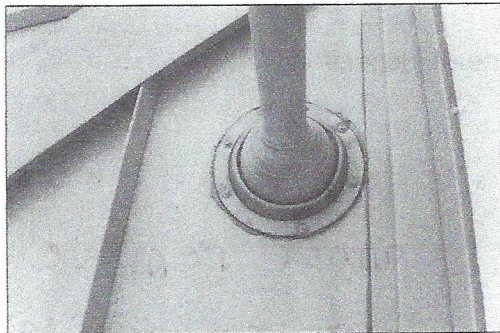
pg 8 of 43

Rubber gasket of drain waste vent is inverted.

Repaired- gasket re-inverted

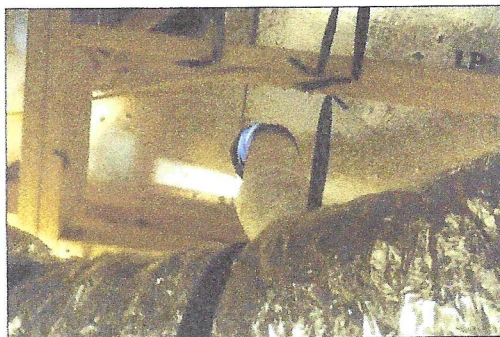
pg 8 of 43

Daylight observed in attic around water heater exhaust vent penetration.

Not repaired- daylight furnace cap normal from open pipe, no water intrusion

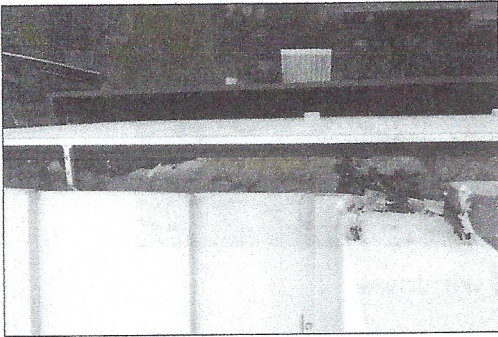
Clean out debris

Repaired – cleaned and secured

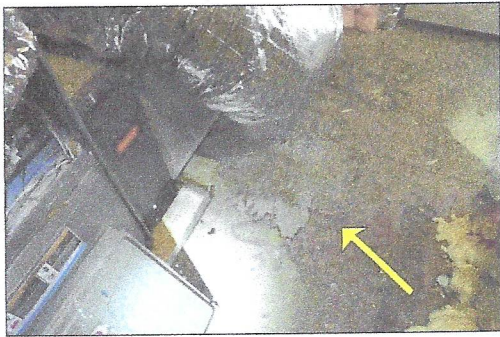
Water staining -No active leaks observed at time of inspection.

Not repaired- not an active leak

cannot remove stain
but no active
leak

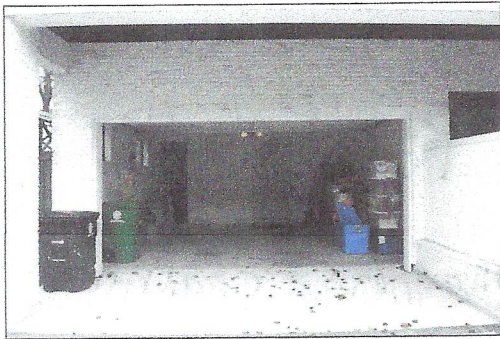
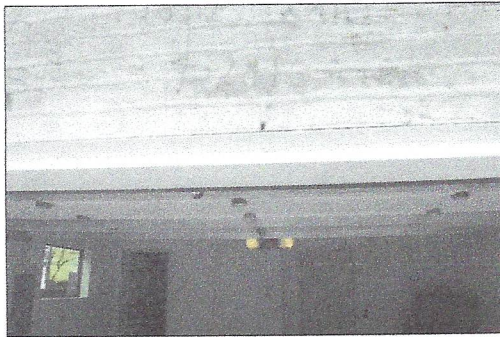
pg 11 of 43

Sag in double header over garage door.

Not repaired- brick and lintel level, mortar crack fixed

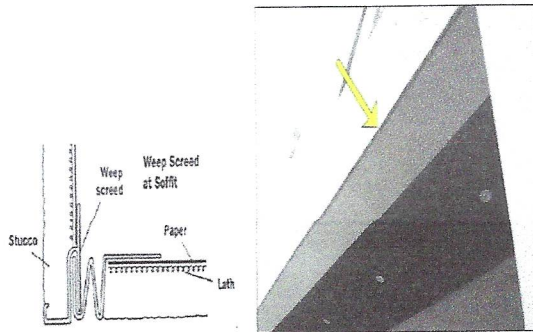
pg 11 of 43

The weep screed at the bottom of the stucco wall appears to be sealed up

Repaired – opened and cleaned

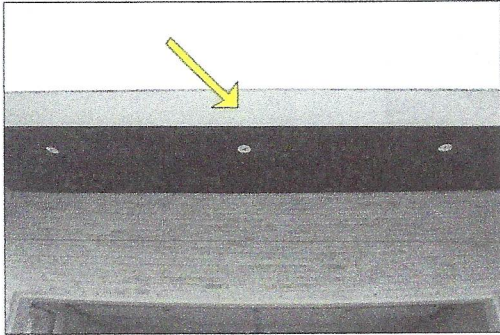
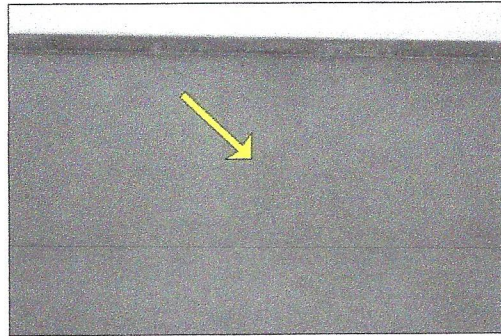
Pg 12
of
43

Crack observed at bottom side of stucco overhang over garage.

Repaired- all cracks fixed due to settlement

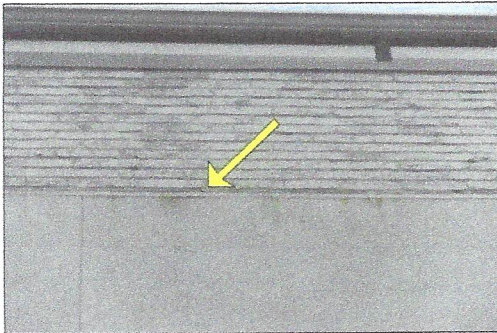
Rust/corrosion observed below flashing at top of stucco wall at front of house.

Repaired- - all rust cleaned

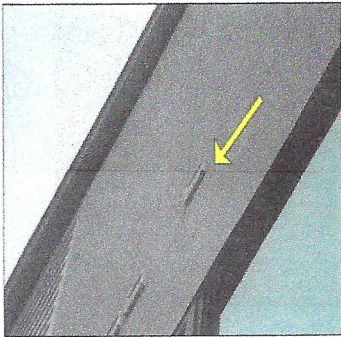
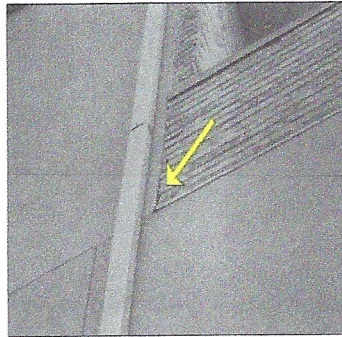
pg 12 of 43

Possible water entry from joints and/or penetrations in stucco siding

Repaired- all areas sealed part of home maintenance

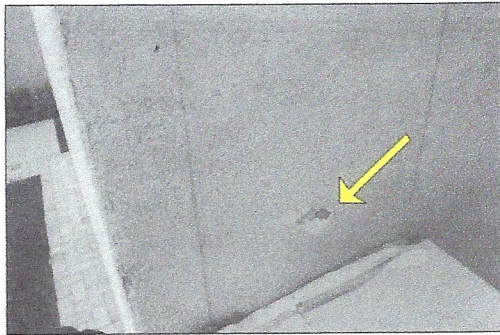
pg 13 of 43

Stucco finish is damaged at top of guard wall at southeast corner of house.

Repaired – all stucco fixed

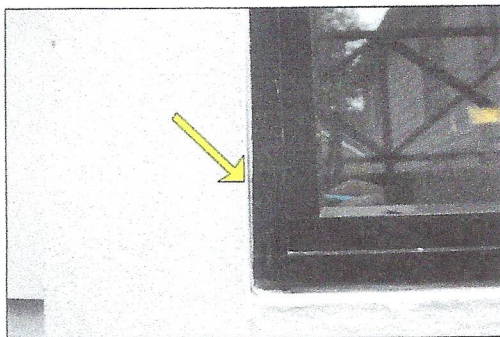
pg 13 of 43

Caulking deficient around one or more windows

Repaired – window recaulked part of home maintenance

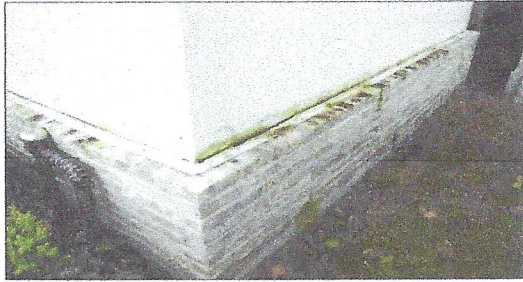
Pg 13 of 43

Staining observed on side of guard east side of front guard wall, possibly due to lack of sunlight.

Repaired- cleaned part of maintenance

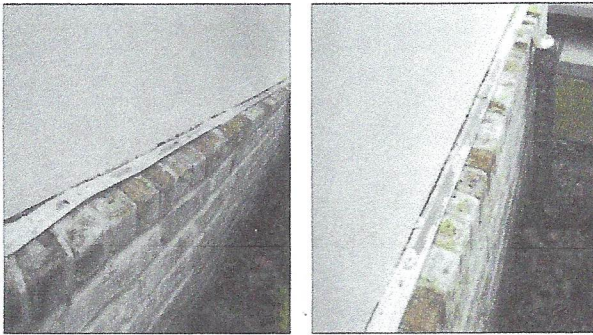
Pg 14 of 43

Recommend painting flashing

Repaired – painted part of home maintenance

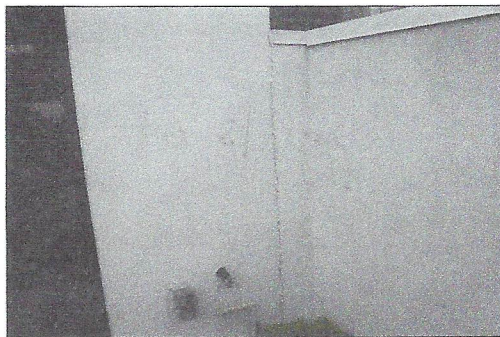
Pg 14 of 43

The guard wall at front of house at southeast corner is pulling away from structure. Large gap observed between wall and house that may allow water accumulation.

Repaired – stucco wall fixed due to settlement

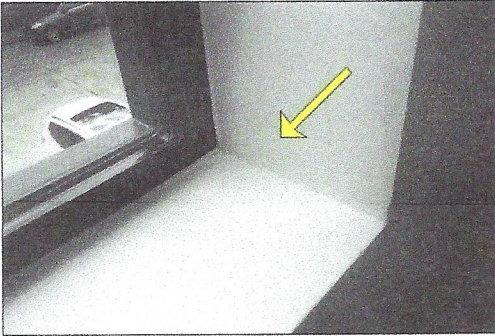
pg 16 of 43

Water stains

Repaired -no evidence of damaged, painted

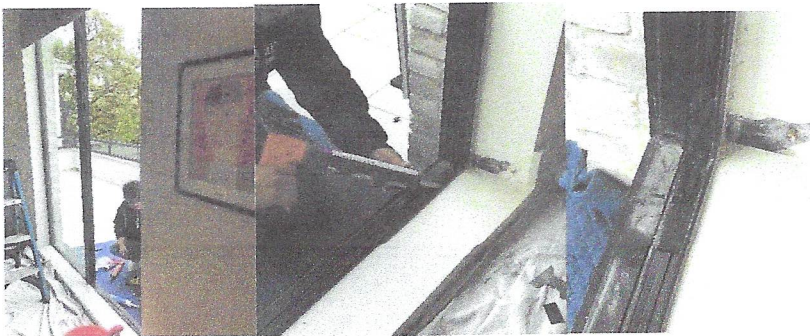
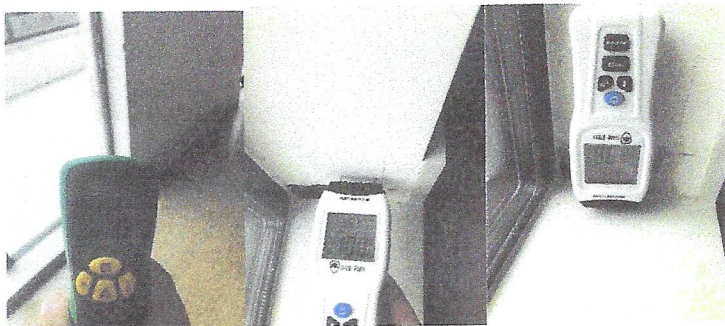
Pg 16 of 43

Water penetration observed at the following location(s): at third floor fixed window.
Recommend further evaluation/repair

Repaired – water coming thru the glass, glass removed and resealed see pics below

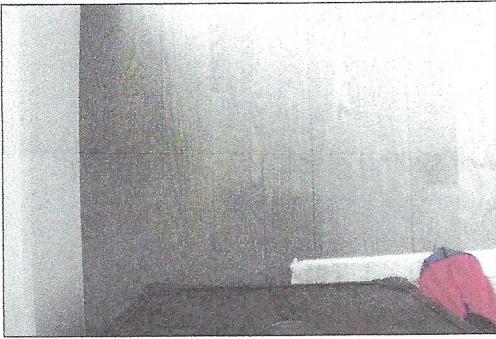
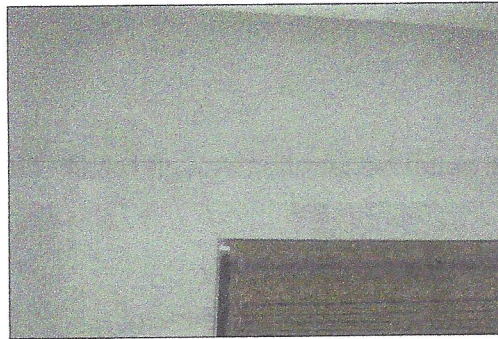
pg 17
of 43

Gaps observed at base of floor below baseboards at third floor staircase landing.

Repaired – all gaps and sheetrock cracks fixed due to settlement

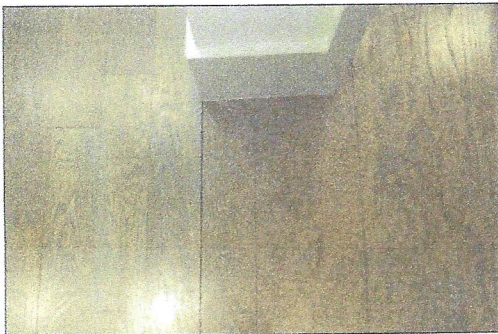
pg 18 of 43

Some separation observed between wood planks at multiple locations; third floor near balcony door and first floor near kitchen.

Repaired- all floors fixed

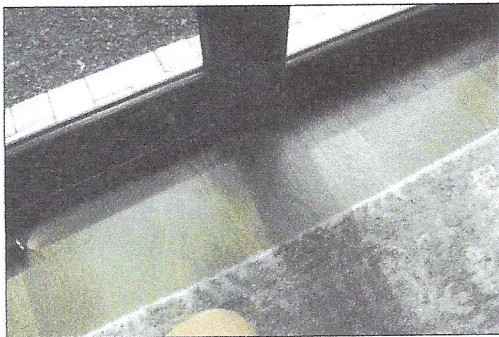
pg 18 of 43

Water damaged wood flooring

Not repaired – not coping, no water damaged

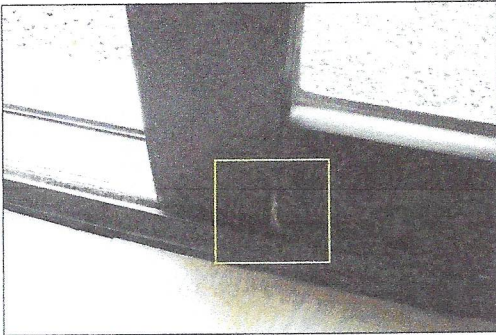
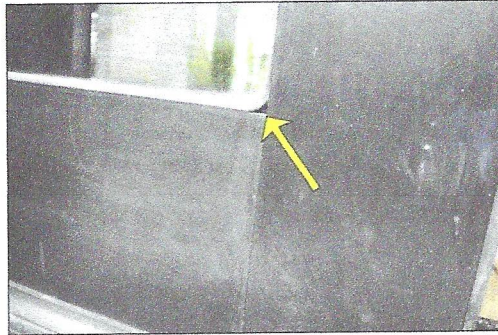
Pg 19 of
43

Observed water penetration though bottom corner of sliding glass door at first floor.

Repaired- resealed door jambs

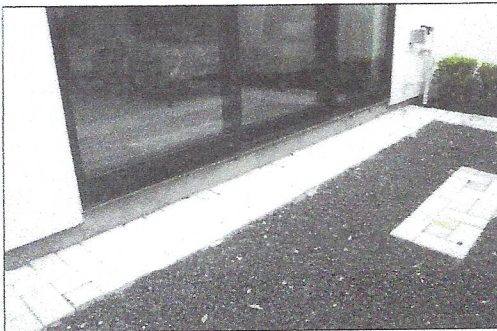
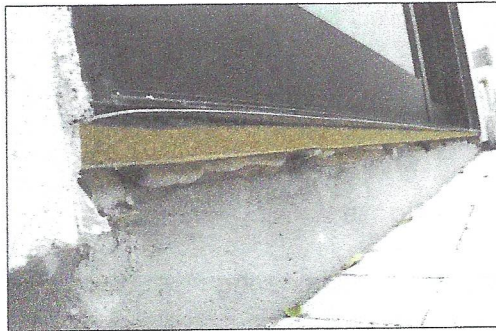
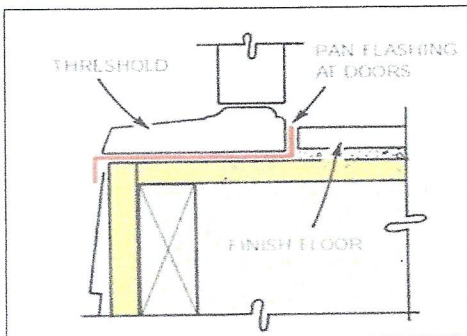
Pg 20 of 43

Did not observe door pan flashing at exterior door location

Not repaired- door pan is presented. We added concrete board to made it finished

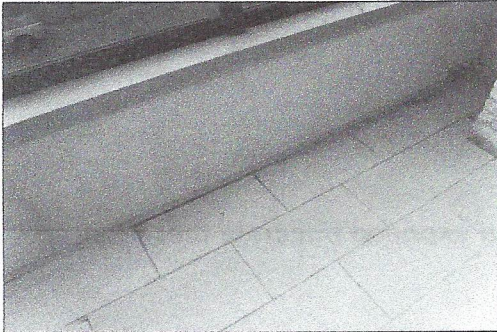
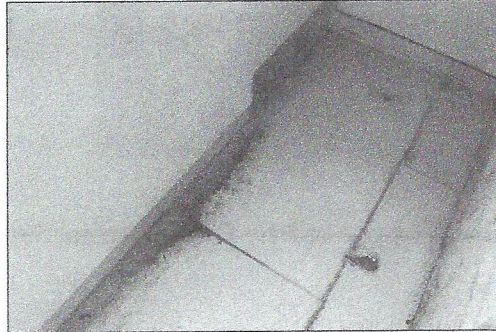
pg 22 of 43

Some staining observed on balcony floor along wall

Repaired- pressure washed dirt part of regular home maintenance

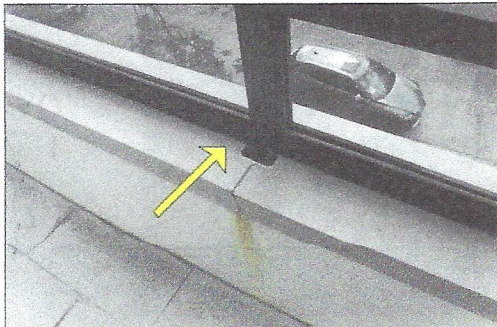
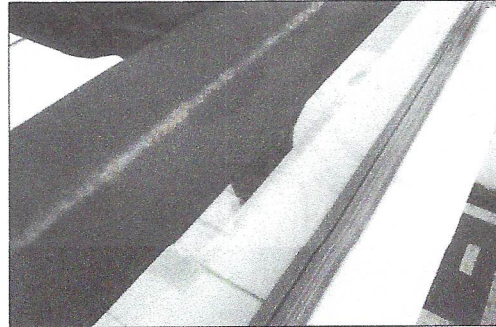
pg 22 of 43

Rust/corrosion observed on iron railing at multiple locations

Repaired- all painted part of regular home maintenance

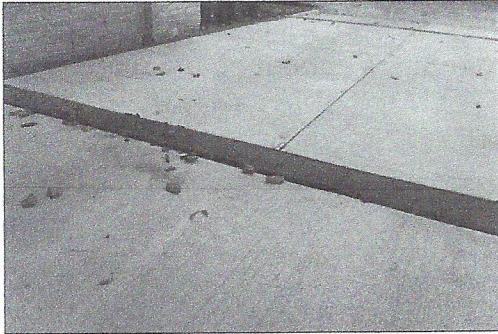
Pg 22 of 43

Tripping Hazard(s), walks and/or driveways are uneven.

Not repaired- approved by COH standards, and exposed concrete moves and settles.

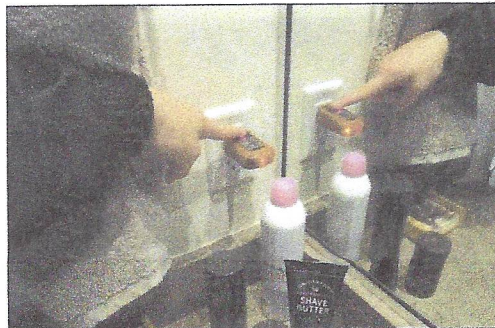
Pg 25
of
43

Did not observe GFCI protection of all outlets in required locations, including but not limited to the location marked below. This condition is a recognized safety hazard and is in need of repair.

Not repaired- gfci at breakers panels per 2012 COH codes and regulations

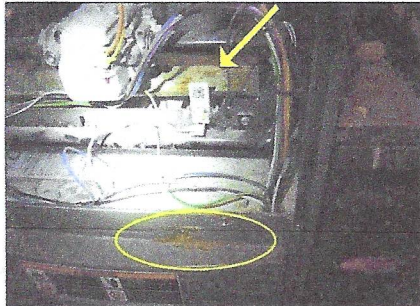
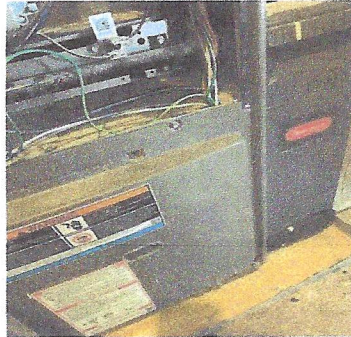
pg 27 of 43

Some rust/corrosion observed inside of heater cabinet

Repaired – removed rust

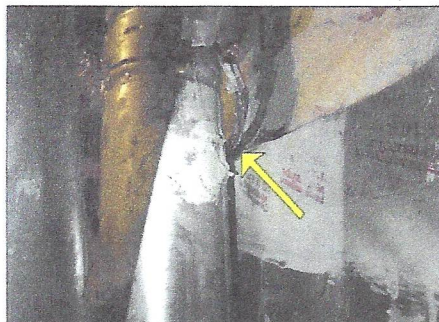
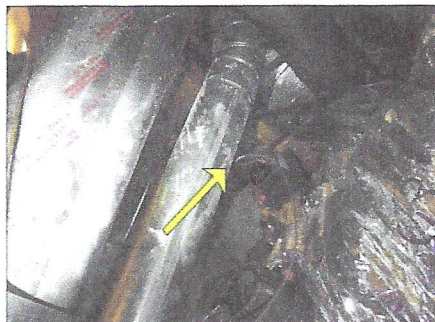
pg 27 of 43

Recommend adjusting thermostat wiring away from heater exhaust vent.

Repaired – moved away

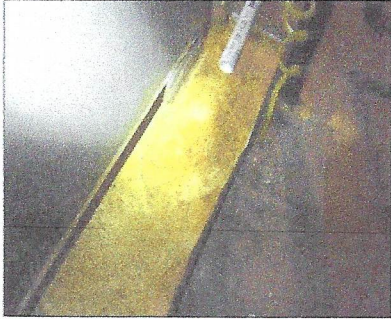
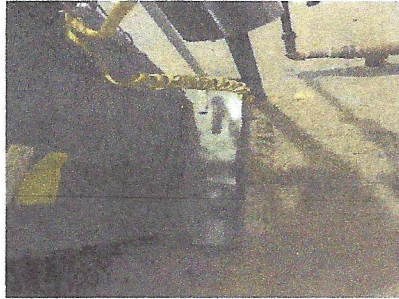
pg 29 of 43

Secondary drain pan is rusted;

Repaired – rust removed

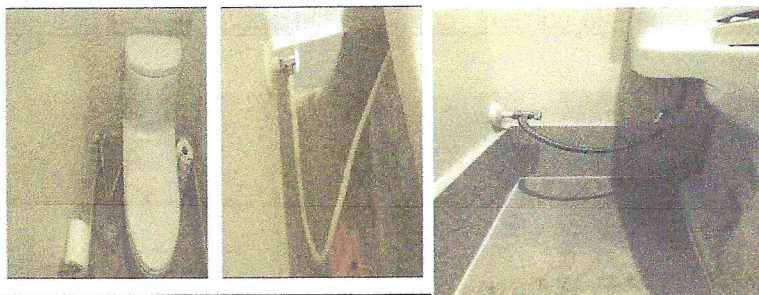
Pg 31 of 43

Observed 2 water lines amateurishly tied

Repaired – removed one line

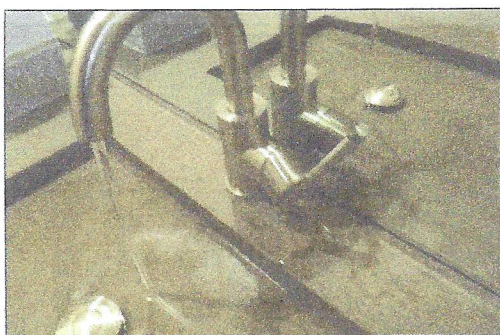
Pg 31 of 43

The faucet handle at the first floor bathroom hits the mirror.

Not Repaired- part of design approved by COH standards

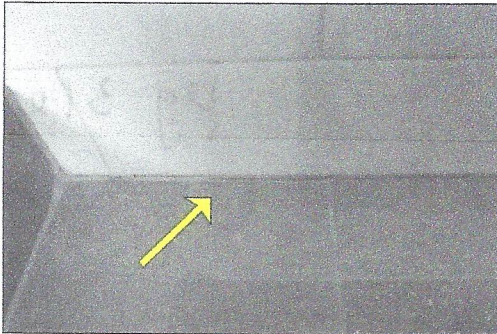
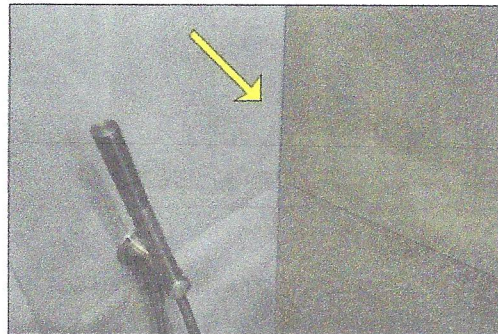
pg 32
of
43

Grout / caulking needed at vertical tile corners, cracks in tile and/or mortar between tiles

Repaired – caulked with silicon grout

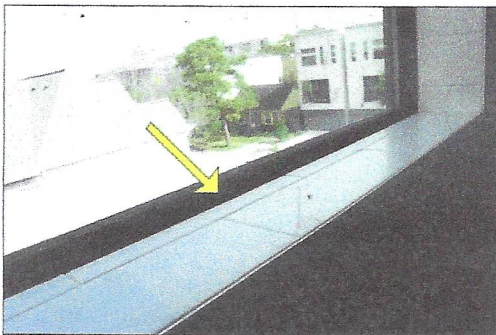
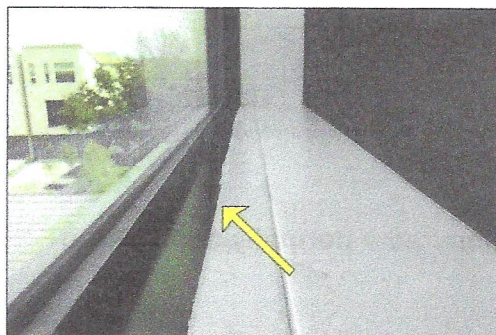
pg 32
of
43

Observed level or improper sloping of shower window sill tile, sill should slope towards interior of shower not back towards window frame.

Not repaired- tested and not ponding water
Gas piping not sleeved

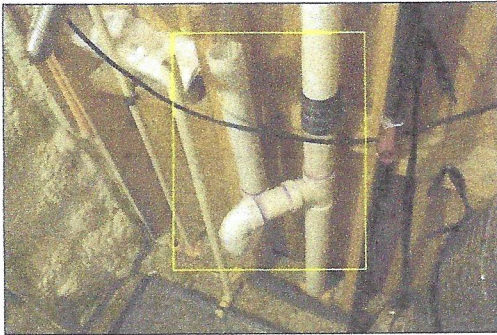
Open drain observed in attic, below water heater, which may allow sewer gases to enter into attic if P-Trap dries out.

Not Repaired - trap had water

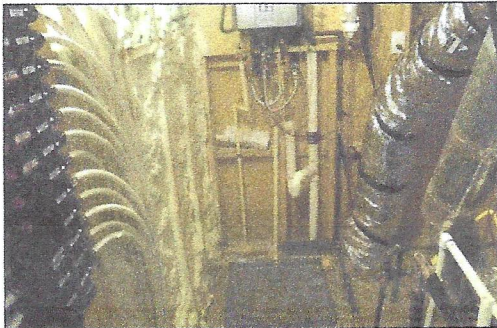
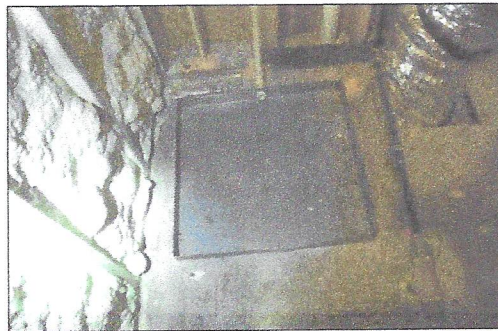
Pg 35 of 43

Drain pan is not secured properly in place.

Repaired- secured

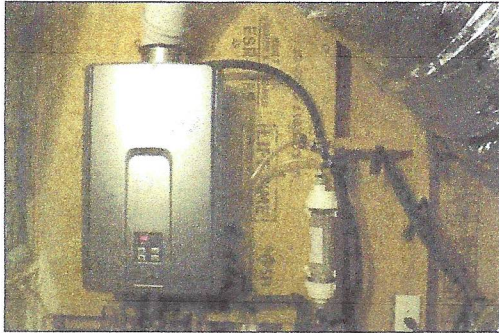
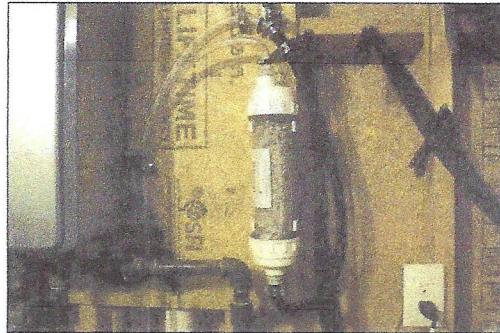
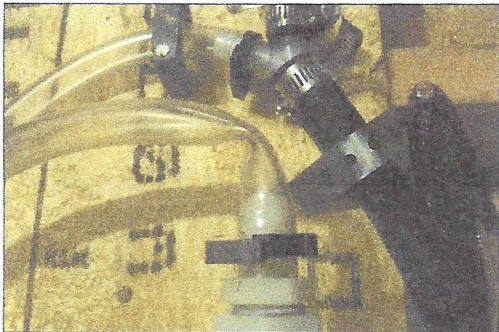
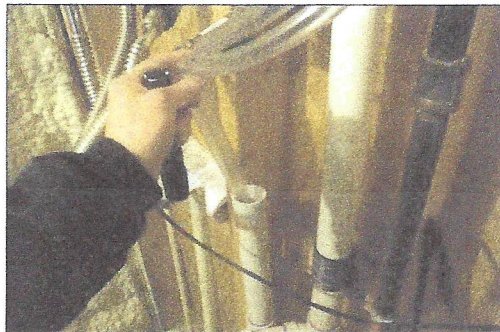
Pg 35
of
43

The condensate drain line and components do not appear to have been installed properly to allow for proper drainage

Repaired- lines uncrimped and loop fixed

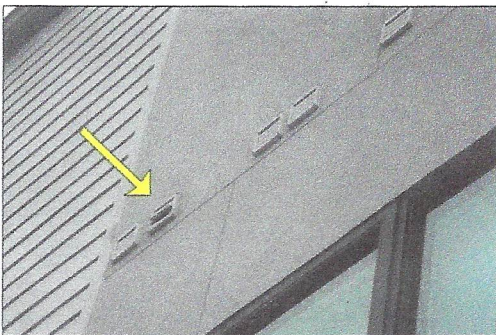
Pg 37 of
43

Flappers stuck open on one or more vents

Repaired- flappers replaced

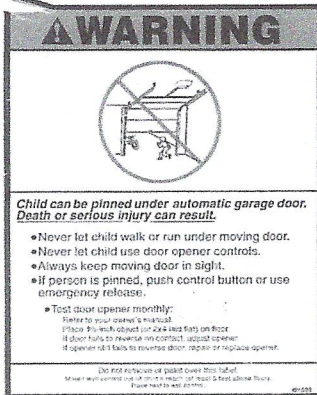
Pg 37 of 43

Missing required safety sticker / decal next to operator button.

Repaired- sticker installed

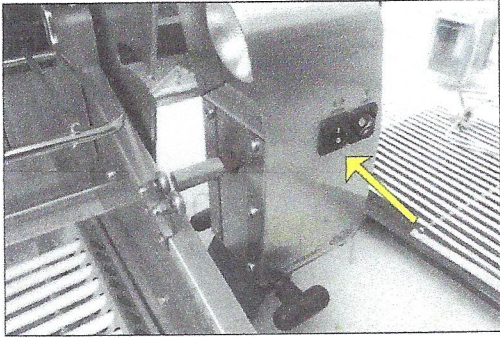
pg 39 of
43

The rotisserie motor is not operational.

Repaired – serviced and repaired

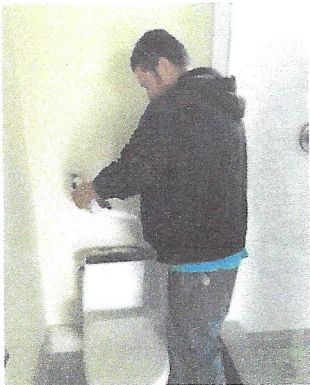
Third Floor Commode, pg 20 of Newman report and page 31 FOX report
- repaired, was not flushing properly due to water levels, adjusted by plumber Feb 20, 2019
