# Home Inspection Report

11 S Brook Pebble Ct  
Spring, Tx 77380

## PROPERTY INSPECTION REPORT

**Prepared For:** Don Daniels  
**Concerning:** 11 S Brook Pebble Ct Spring, Tx 77380  
**Inspection Date:** 04/11/2017

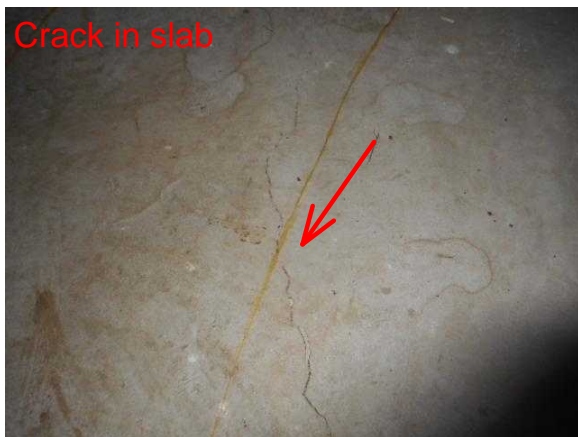
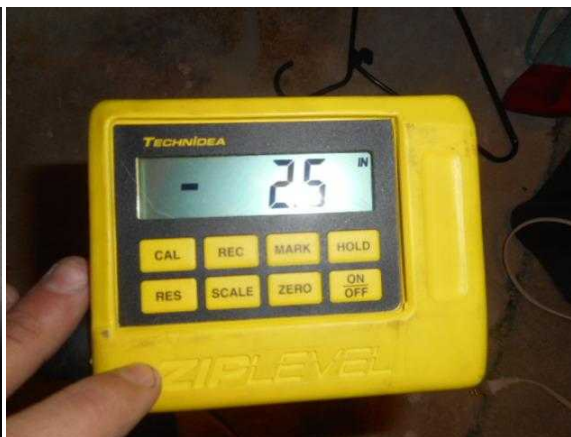
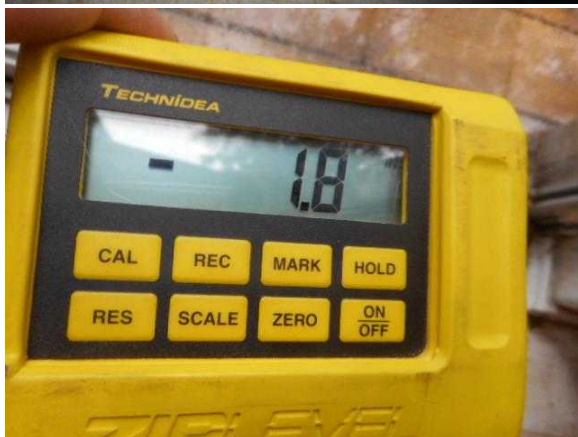
-The foundation shows signs of excessive movement. Further review should be undertaken by a competent foundation specialist.

-2.5 inches of drop was measured at the master closet. (Front of home). -1.8 inches in the kitchen ( rear of home).

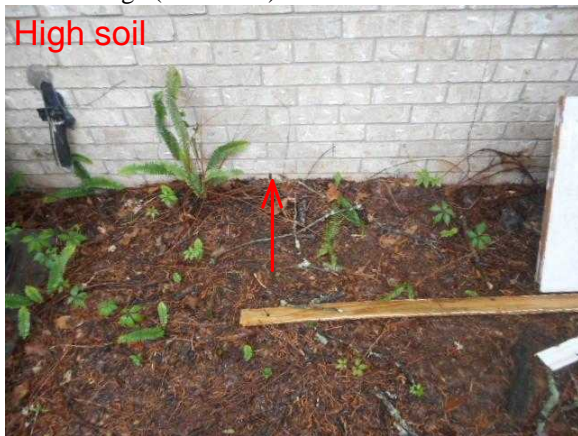
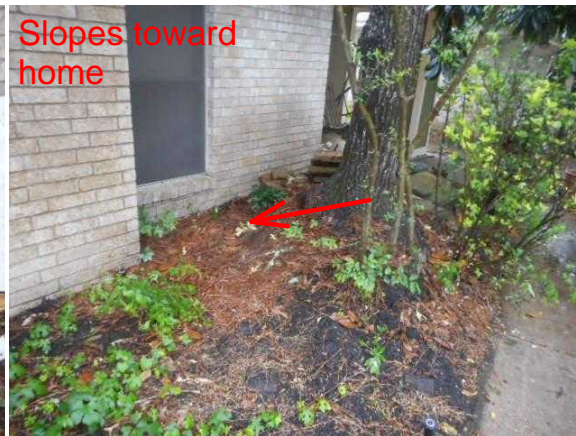
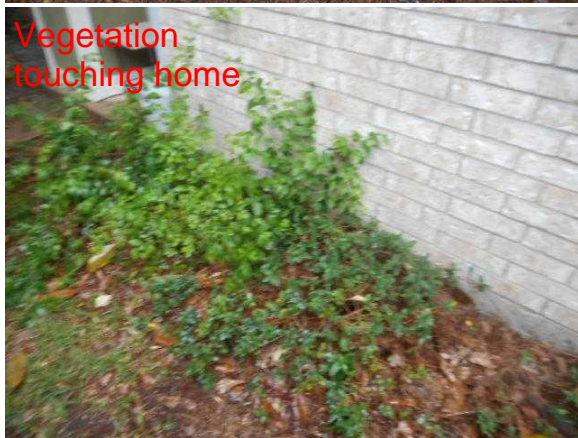
B. Grading and Drainage (continued)

-General grading improvement are needed to improve drainage away from the home in areas. Grading should be performed in a way that water does not stand near the foundation and that rain falling on the lot drains away from the home.

-High soil was observed. This condition is conducive to water and insect entry and should be repaired.

-Vegetation against the exterior wall of the home should be removed to prevent water damage and insect entry. Vegetation near or touching the home can be attractive to termites.

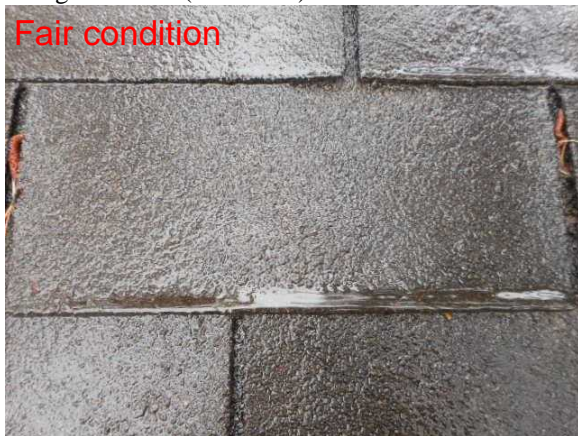
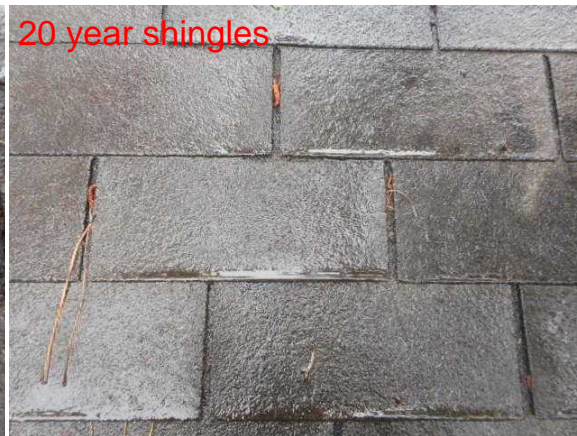
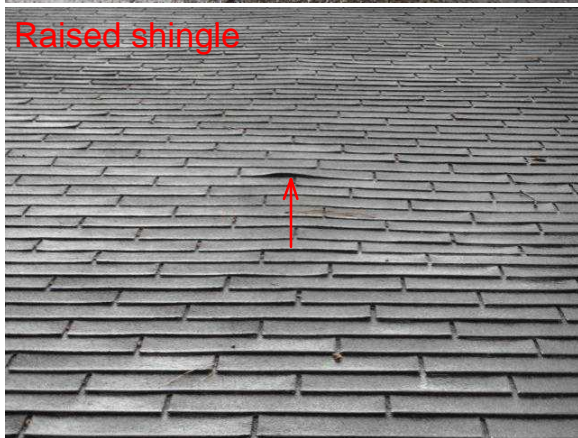
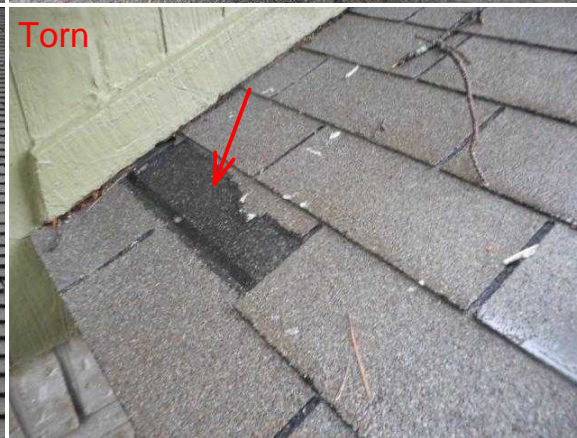
C. Roof Covering Materials (continued)

-The roof surface appears to be in fair overall condition. The roof was inspected during a rain storm. This greatly limits the extent of the roof inspection.

-Raised shingles were observed. These are caused by nails that are not properly secured and have backed out.

-Damaged shingles were observed.

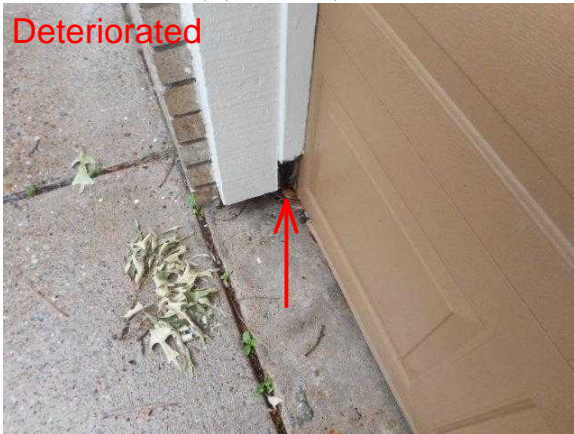
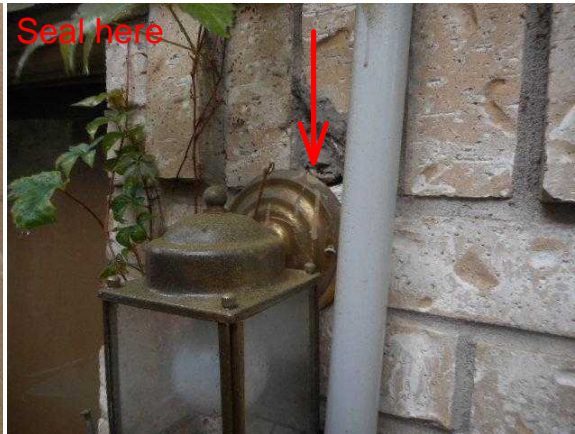
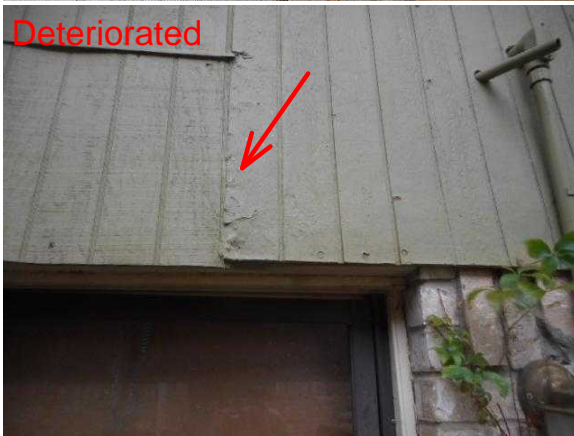
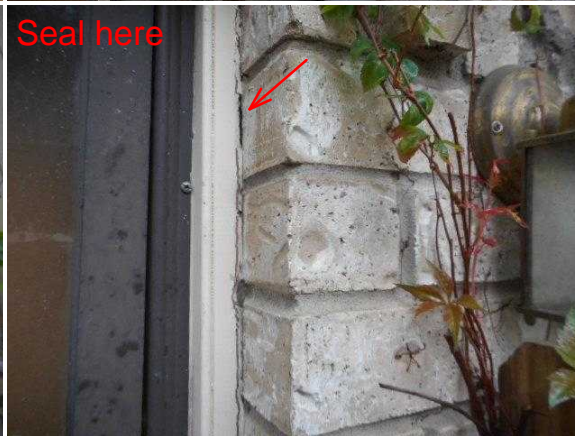
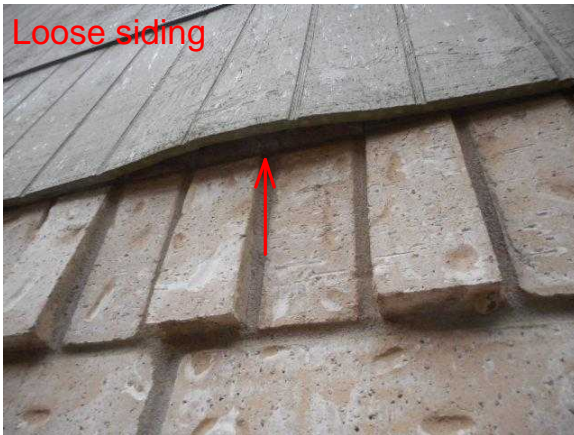
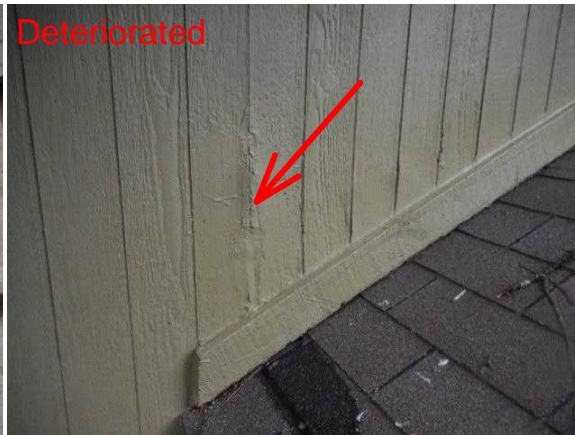
E. Walls (Interior and Exterior) (continued)

- Deteriorated siding and trim were observed at the exterior of the home. Much of the siding has previously been replaced.
- Caulk improvements are needed at the window/brick areas, at exterior lights and at expansion joints.
- Some of the siding that has been replaced is loose. Gaps should be sealed.
- Drywall cracks were observed throughout the home as a result of structural movement.

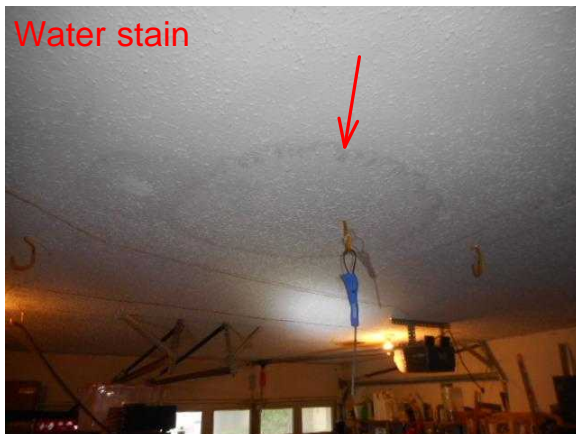
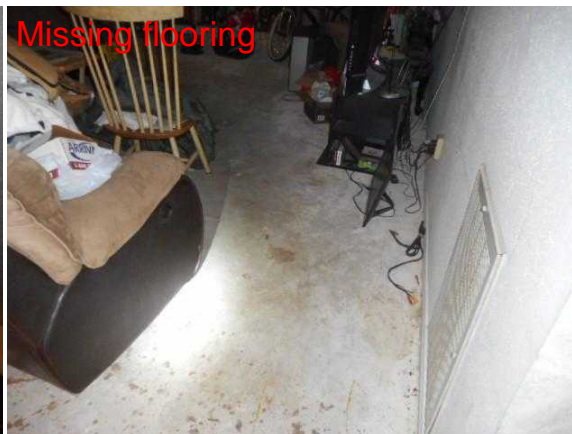
-Water stains were observed at the ceiling in the garage. Stains appear to be caused by previous AC leaks. Stains were further inspected with a moisture meter and no high amounts of moisture were observed.

-Much of the flooring throughout the home has been removed or is damaged.

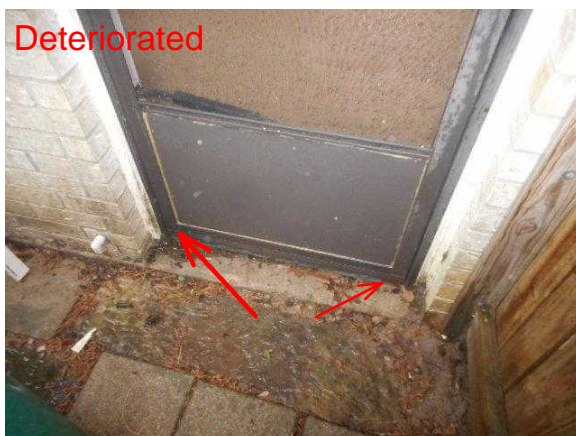
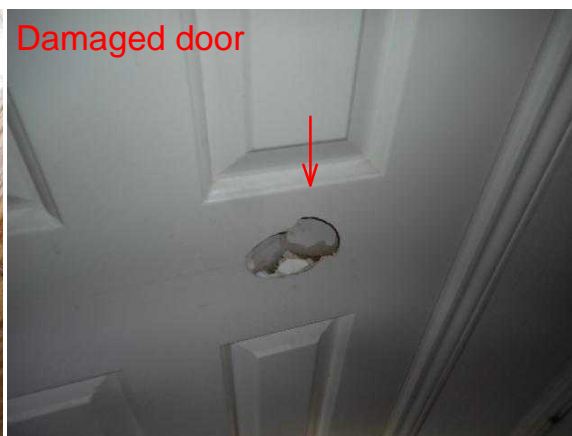
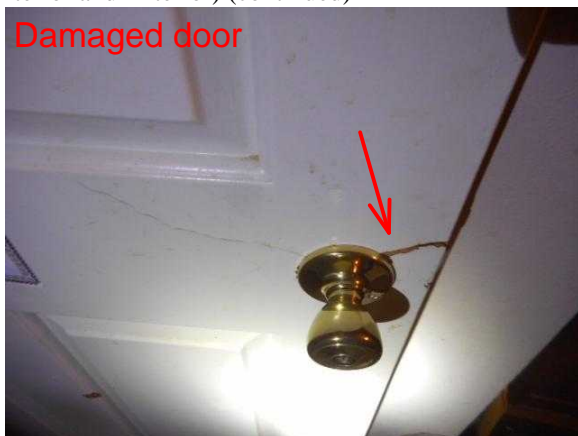
-The exterior door and door frame at the side of the garage is deteriorated. Repair or replacement is recommended.

-Various doors throughout the home rub at the frame when closing. Adjustments should be made as needed.

-The exterior door to the garage is not fire rated. All exterior doors are required to provide a twenty minute fire barrier. This is a safety hazard and should be corrected.

-Several doors throughout the interior of the home are cracked and damaged.

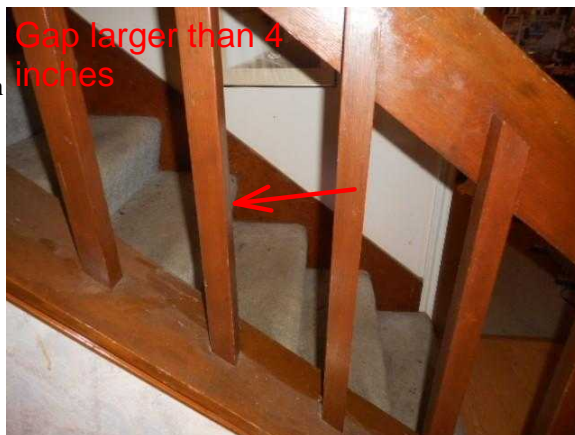
-The handrails at the stairs and at the catwalk railing have large gaps in them. Handrails should have gaps no larger than 4 inches. This is a safety hazard and should be repaired.

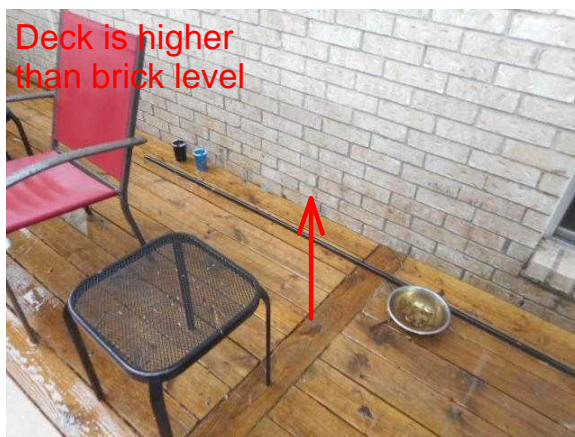
-The wood deck at the rear of the home is installed higher than the level of the brick/siding. This installation conceals the wall in this area making it a possible entry point for water and/or wood destroying insects.

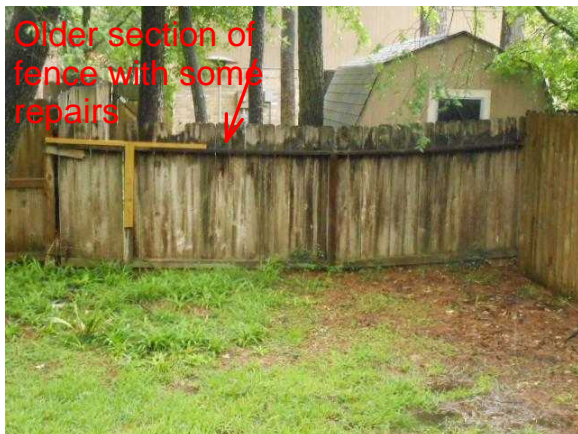
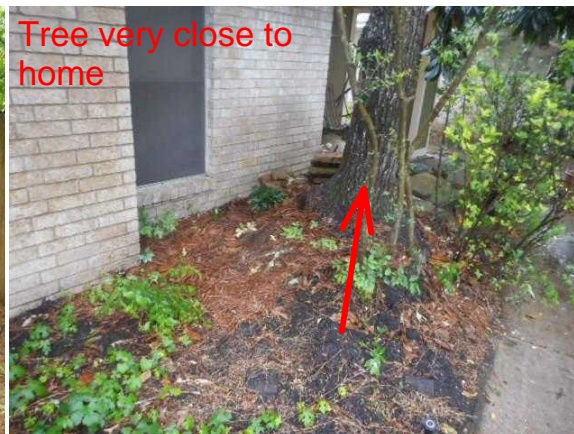
-The fence is damaged and has missing and/or loose pickets at one section of the rear fence.

-There are several trees very close to the home. Trees this close to the home can lead to movement of the soil and the foundation. This should be monitored over time.

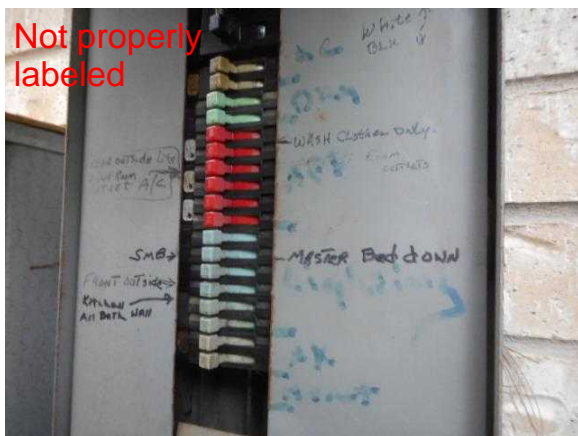
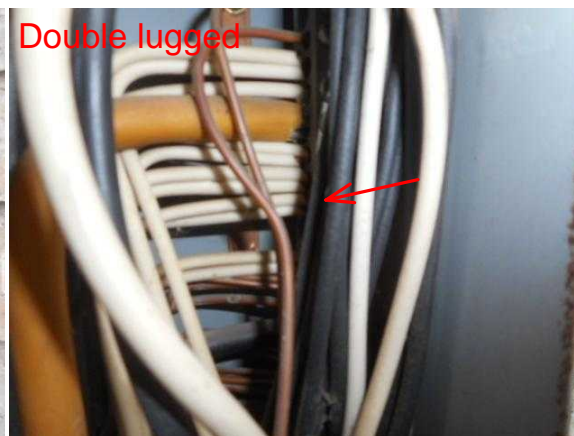
-The labeling is not present or confusing. This is a safety hazard and should be corrected.

-Double lugging was observed at the neutral bus bar. It is considered a safety hazard to place more than one conductor under each screw.

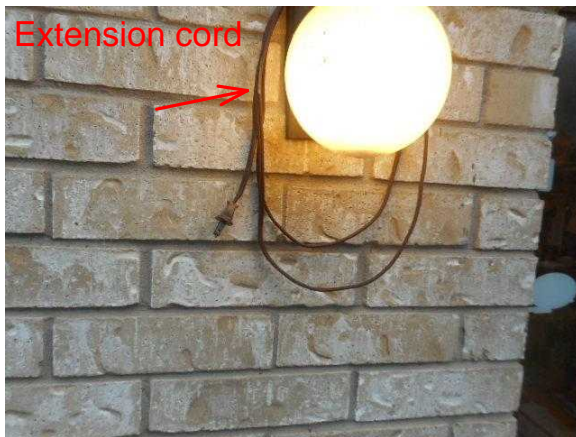
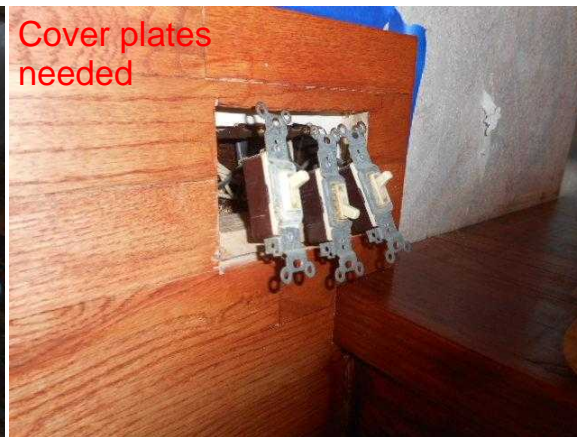
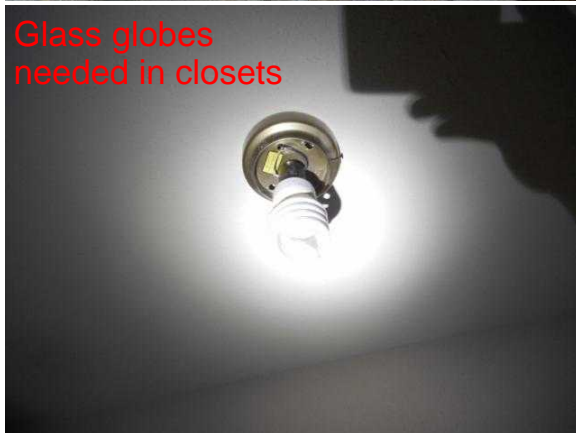
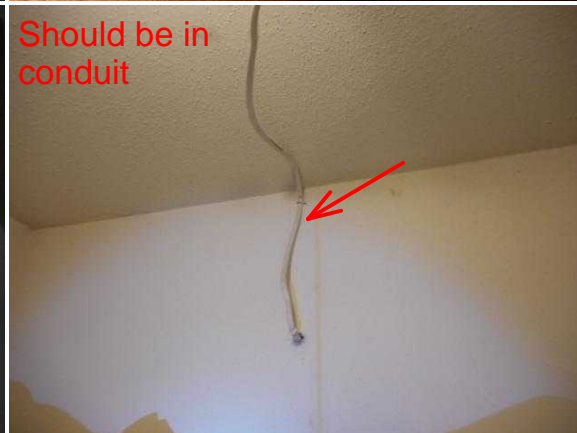
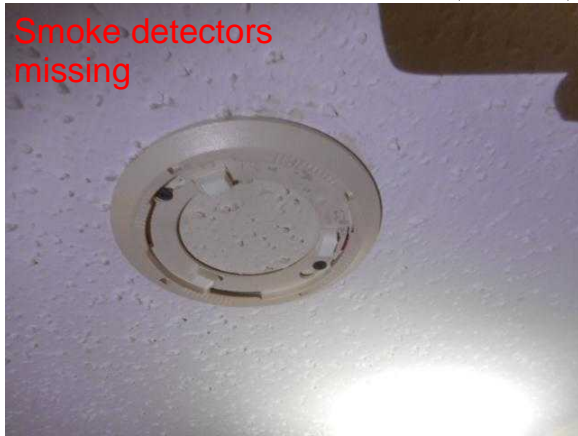
- GFCI (ground fault circuit interrupt) outlets are not installed in all required locations. GFCI outlets are required in all wet areas including the exterior, garage, kitchen and bathrooms.

- Closet lights are installed without glass globes around them. Due to clothes and others combustible items that are typically stored in closets, this is considered a fire hazard and should be corrected.

- Numerous light bulbs were missing or inoperative at the time of inspection. The fixtures were not verified to be working as intended.
- Smoke detectors are not installed in all required areas. Smoke detectors are required in every bedroom, outside of every bedroom and on every level of the home.

- Several smoke detectors throughout the home were inoperative when tested.
- Wiring was observed to be installed improperly without conduit at the inside of the home. This is a safety hazard and requires correction.

- Cover plates should be installed over switches and receptacles.
- Extension cords have been installed as permanent wiring. This installation is incorrect and is a safety hazard.

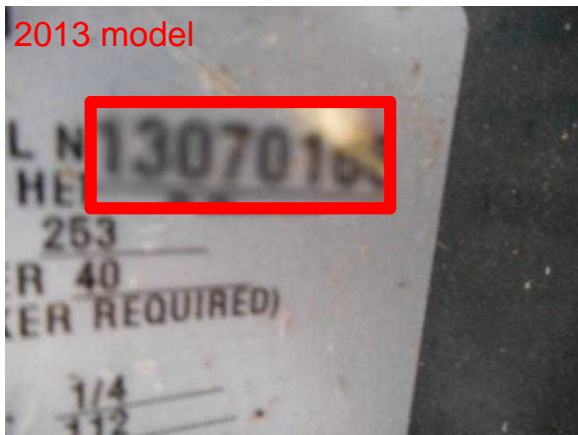
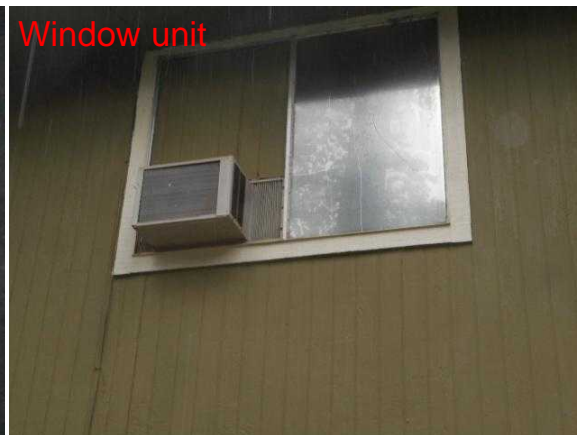
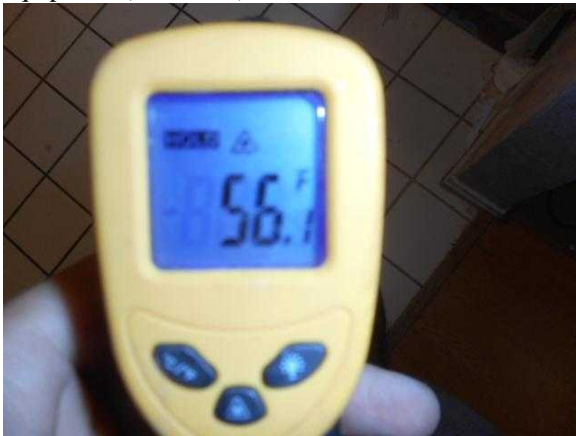
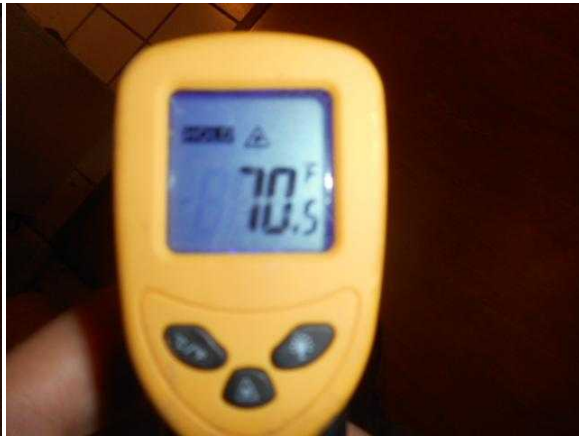
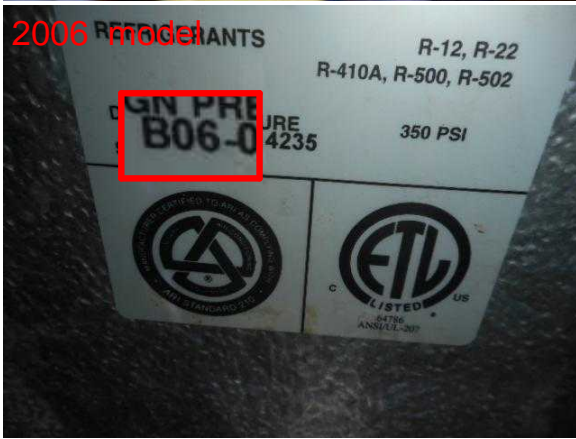
NOTE: The condensing unit (at the outside) is 4 years old. The coils are 11 years old.

-A window unit is installed This suggest that the central air conditioning in not sufficient to cool the home. NOTE: The owner stated that due to family situations some occupants preferred much cooler rooms and others preferred much warmer. This is the reason they installed the units.

-The temperature drop measured across the coil was 14 degrees F and is considered lower than normal. A qualified air conditioning contractor should be called to service the system.

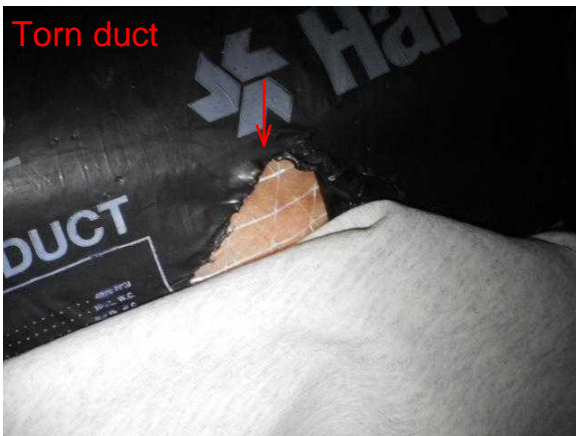
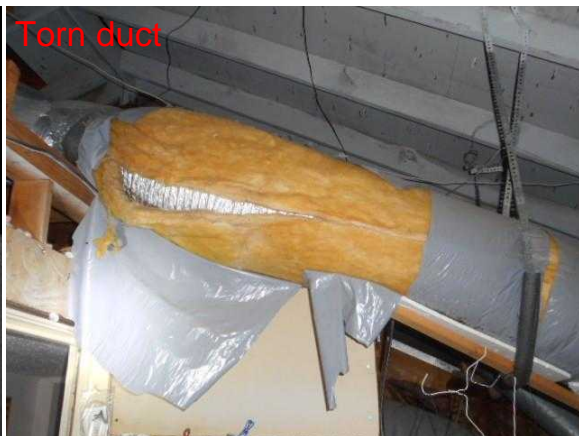
C. Duct Systems, Chases, and Vents - Comments: Insulated flex,  
-Torn duct work should be repaired.

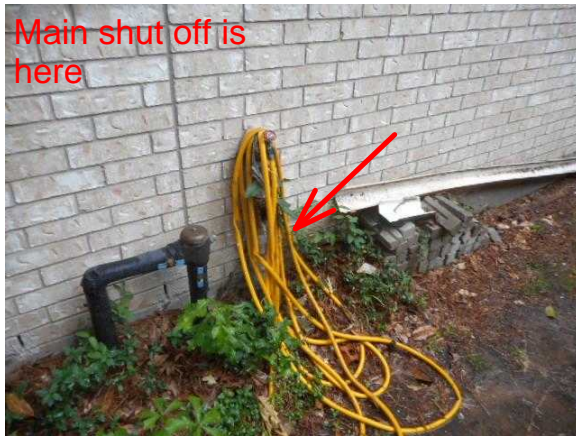
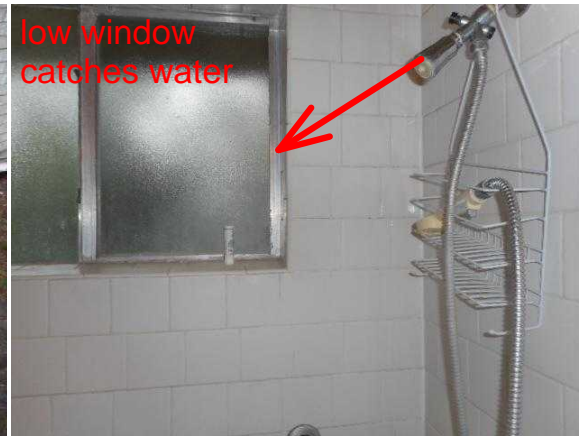
- The toilet is loose at the floor.

-A low window was observed in the shower stall. Low windows can catch water from the shower head and allow water to enter behind the wall.

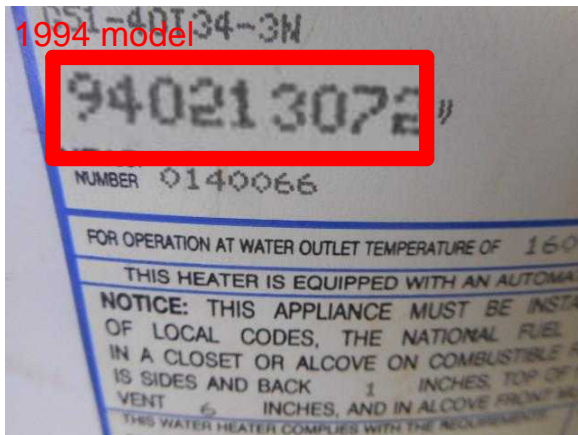
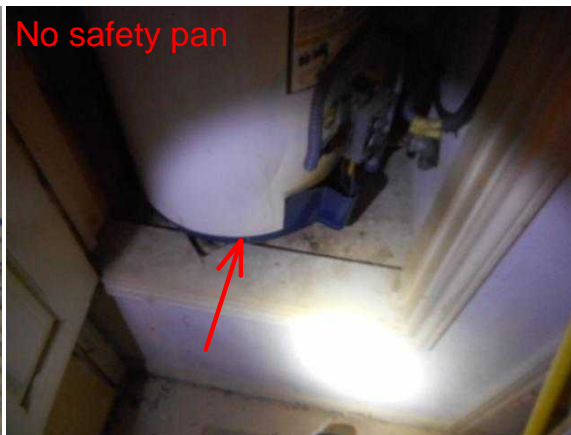
-The water heater is operating past its expected life span. Replacement will be needed in the near future.

-There is no safety pan installed under the water heater. When installed inside the home a safety pan is highly recommended.
