**N****Noles Inspections LLC**

**INSPECTION REPORT**

Property Address: 2506 Potomac Drive #B, Houston, TX 77057  
Inspection Date: 06/12/2019  
Inspection Number: 20190612-2  
Inspection Type: REI-7-5

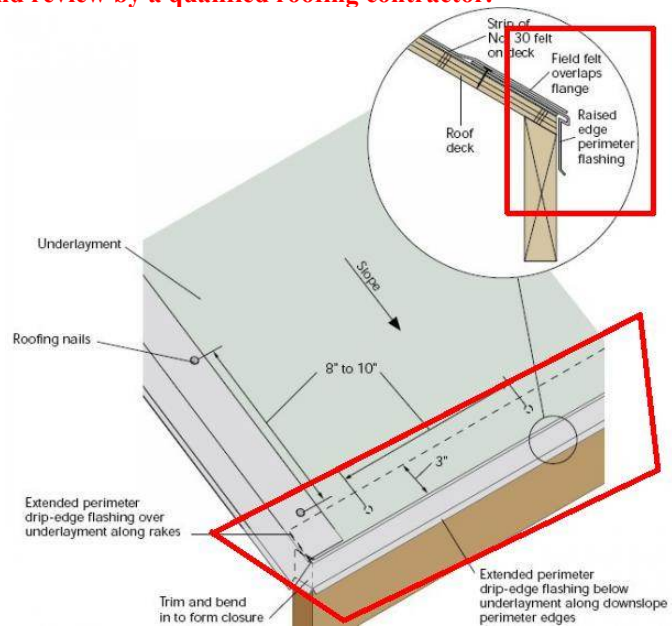
**The roofing paper underlay was either short or installed under the drip edge around the eave of home. The roofing paper underlay should be on top of drip edge at the eave and under rake edge to avoid moisture penetration; recommend review by a qualified roofing contractor.**

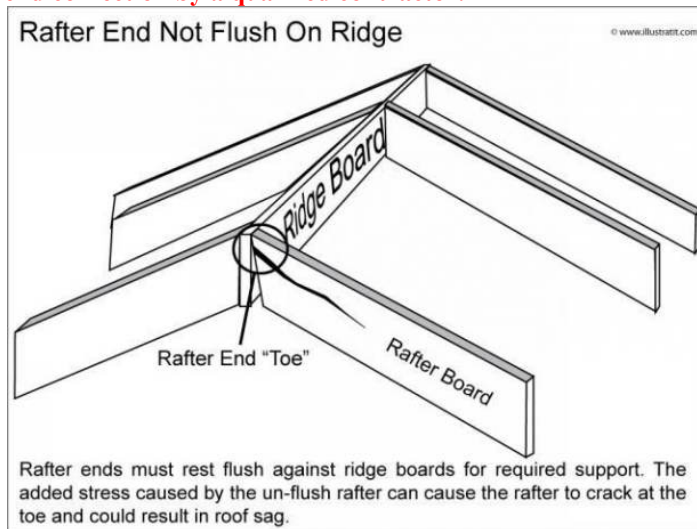
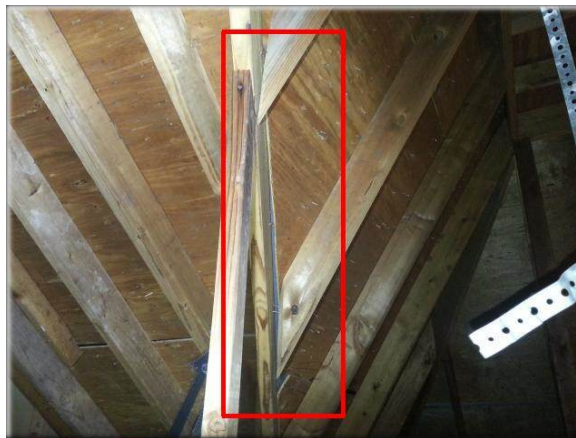
**Rafter cheek cuts on various hip, Ridge Beam or valley rafters are not angled properly and tight against the hip or valley rafter; recommend correction by a qualified contractor.**

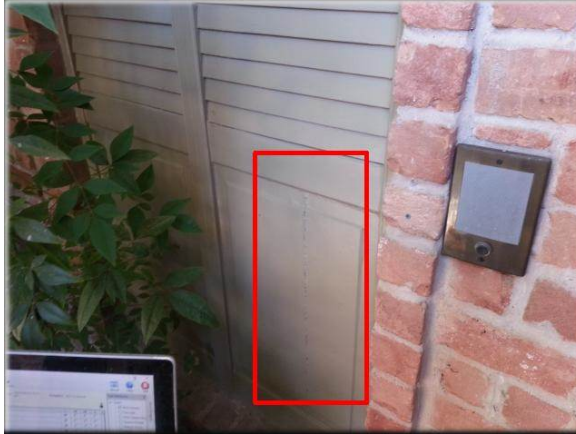
**Seal the gap in the window shutter at the front porch.**

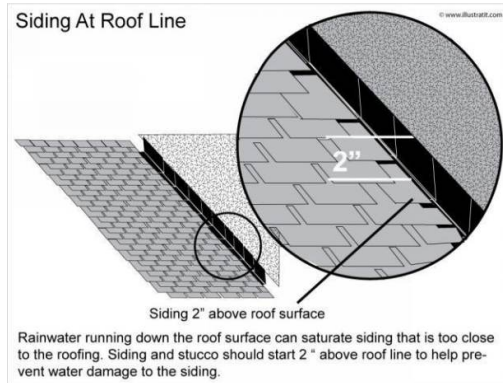
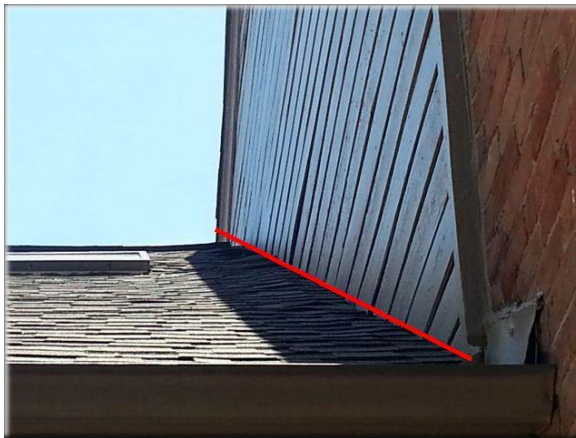
**The siding has inadequate clearance between the lower edges of the siding and roof, where it intersects the roof plane. Normal clearance required is between 1 1/2 and 2 inches. See example below:**

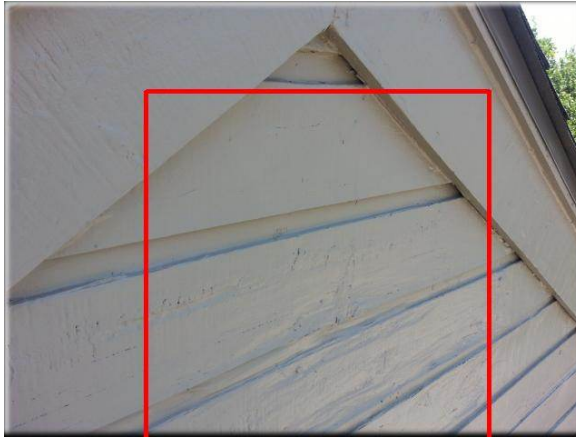
**The siding is moisture damaged. Location - Left and middle of the roof; recommend repairs/replacement as needed to help prevent moisture intrusion.**

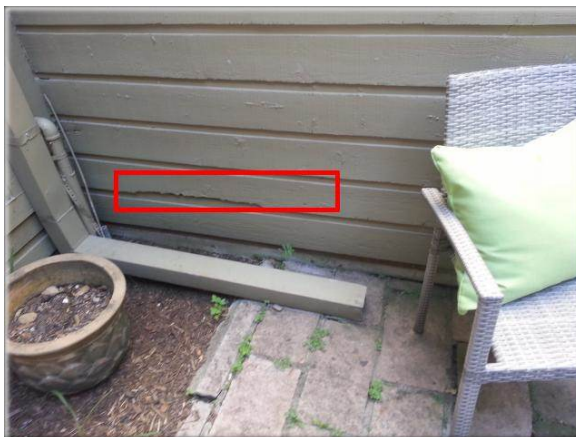
**The siding is moisture damaged. Location - various areas of the Rear Exterior; recommend repairs/replacement as needed to help prevent moisture intrusion.**

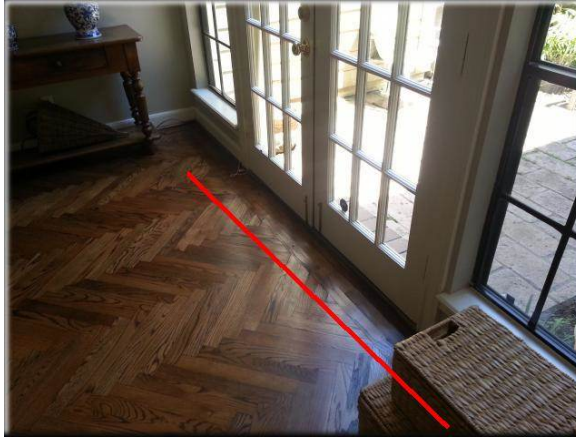
**The wood floor is cupping at the rear porch/living room. The door appears to leak which is a common cause of wood floor damage. Repair should occur to the door, weather stripping and wood floor by a qualified contractor.**

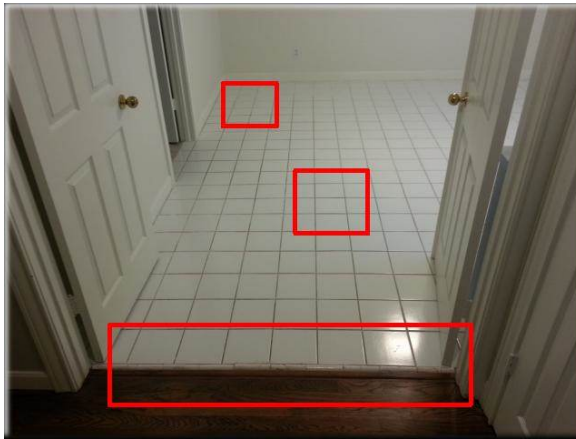
**Observed cracked or damaged tiles on the floor in the upstairs front right bedroom; recommend repairs as needed.**

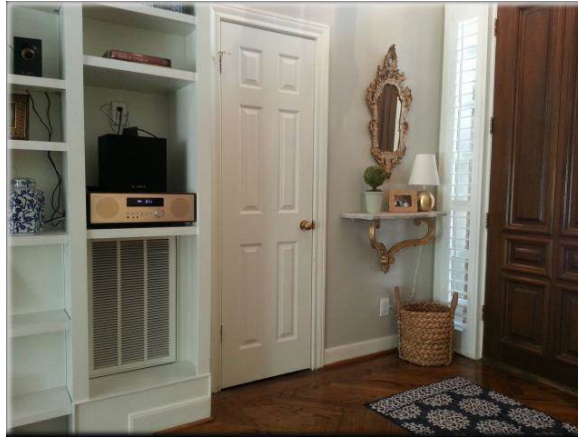
**The door does not latch properly in the Entry Closet; recommend adjusting the strike plate for proper operation at minimum.**

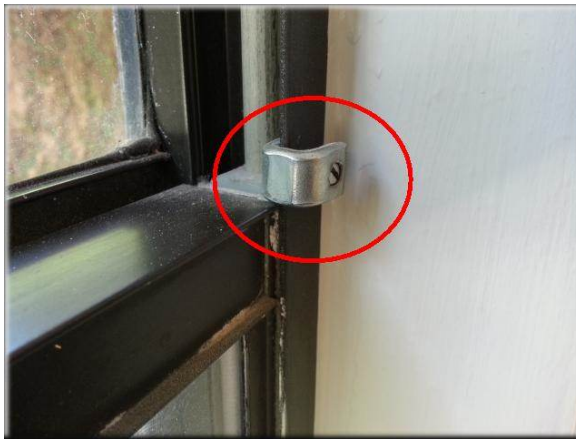
Windows in the home that have added window locks installed are considered A FIRE/EMERGENCY EXIT HAZARD; recommend removing screws or window locks for safety reasons. These locks are not removed by the inspector. Recommend having the seller remove to allow for window testing. These were present at multiple windows.

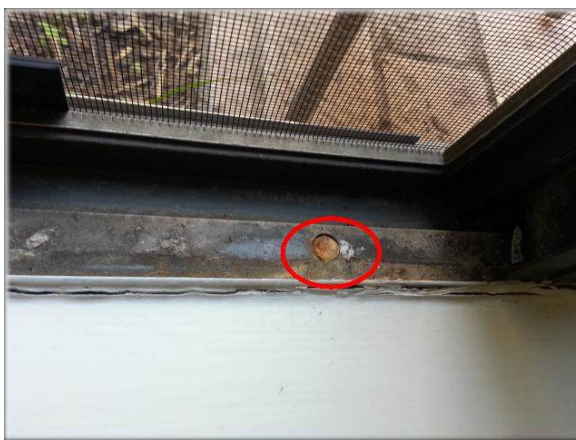
The alarm sensors are installed in the bottom of the window frame, by drilling a hole through the frame, contrary to the window manufacturer. This can allow moisture entry through the hole and into the wall cavity if the seal breaks. Recommend periodic review and sealing if necessary to prevent moisture entry into the wall cavity.

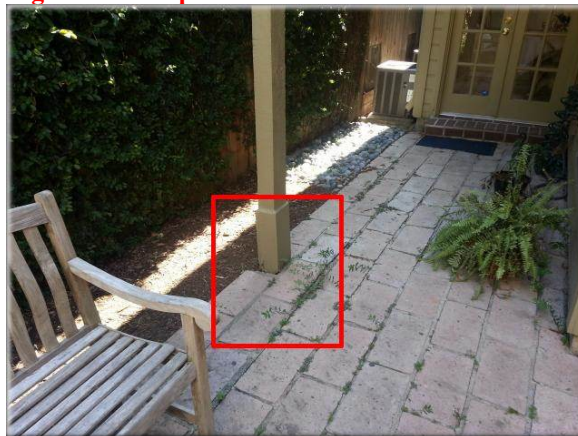
**Post deterioration is occurring at the rear patio.**

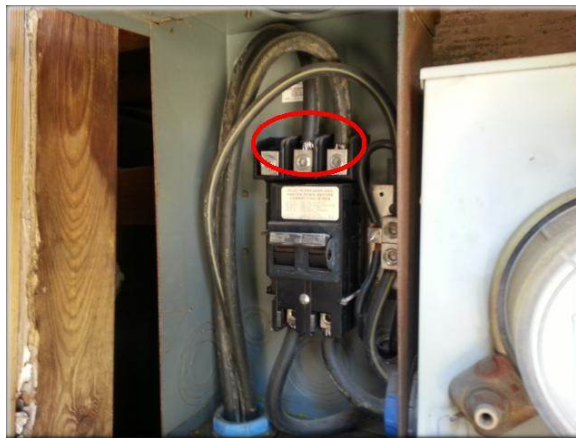
**(simple maintenance for an electrician) Anti-oxidizing compound was not used for the service wire connections to the main breaker in the main panel. Most manufacturers recommend using a corrosion inhibiting compound like, Blackburn CONTAX paste, Burndy Pentrox paste, and Pen-Union CUAL-AID. Anti-oxidizing compound is recommended by NECA/AA 104-2000 and National Electrical Installation Standard published by the National Electrical Contractors Association, which calls for anti-oxidant in section 3.1.2(c) of that standard or follow the manufacturer recommendation, This is a common problem found with aluminum connections in the service panels inspected; recommend contacting a licensed electrician for opinion.**

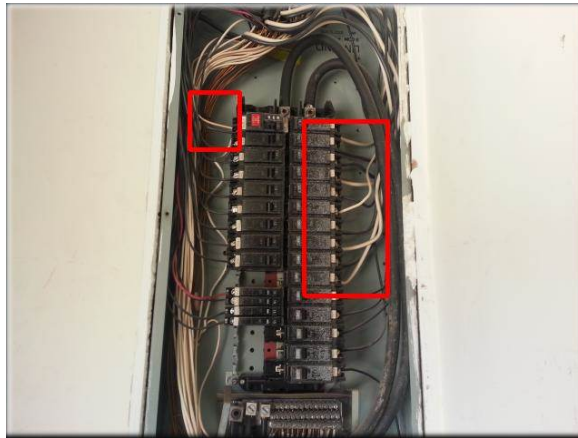
**(simple maintenance for an electrician) Some white insulated wires in the breaker box are being used as “hot” for the 240 volt circuits. This is a common wiring practice, but the white insulated “hot” wire should be permanently identified at each end to indicate its use as hot. Normally black or red paint/plastic tape may be used to identify these wires as “hot”.**

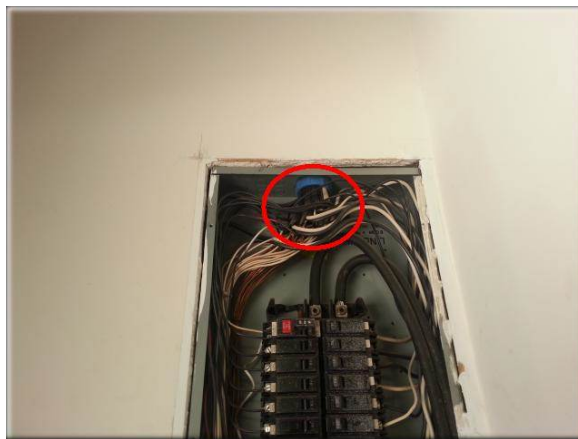
**All of the home electrical wires are funneled through a single opening in the main service panel. Section 312.5C of the National Electrical Codes states each cable shall be secured to the cabinet, cutout box, or meter socket enclosure with approved cable clamps. The reasoning is that any smoke or fire inside the panel is confined or at least restricted from passing through the knockout openings. This is a common wiring procedure found in most installations. There are still some City/Municipal electrical inspectors that tend to condone this arrangement against what the NEC stated in the code. Repair of this condition would require considerable work and cost. If so desired, a licensed electrical contractor can be consulted for more specific information.**

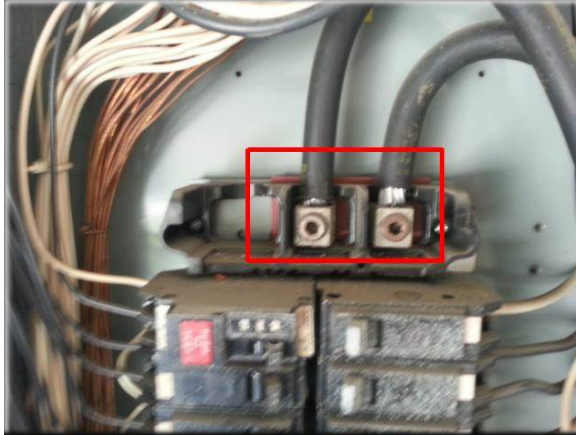
**(simple maintenance for an electrician) Anti-oxidizing compound was not used for the service wire connections to the main breaker in the main panel. Most manufacturers recommend using a corrosion inhibiting compound like, Blackburn CONTAX paste, Burndy Pentrox paste, and Pen-Union CUAL-AID. Anti-oxidizing compound is recommended by NECA/AA 104-2000 and National Electrical**

**Installation Standard published by the National Electrical Contractors Association, which calls for anti-oxidant in section 3.1.2(c) of that standard or follow the manufacturer recommendation, This is a common problem found with aluminum connections in the service panels inspected; recommend contacting a licensed electrician for opinion.**

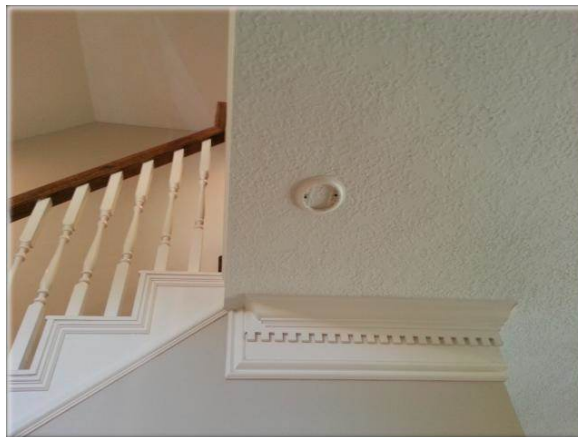
**The smoke detector is missing in the entry and 1st floor; recommend replacing for safety.**

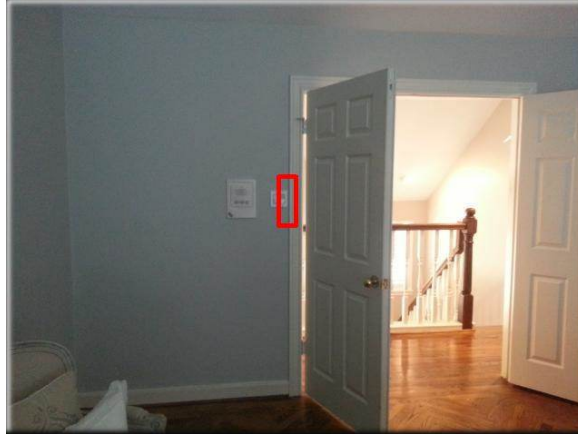
**The light switch in the master bedroom is damaged and should be replaced by a licensed electrician.**

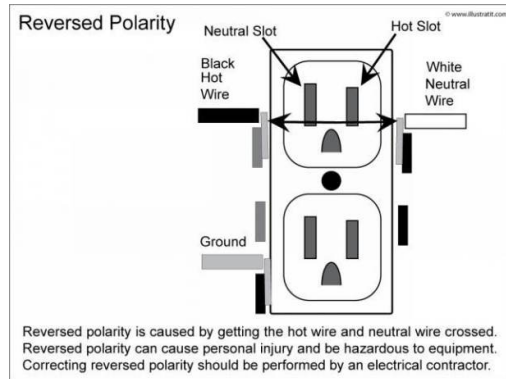
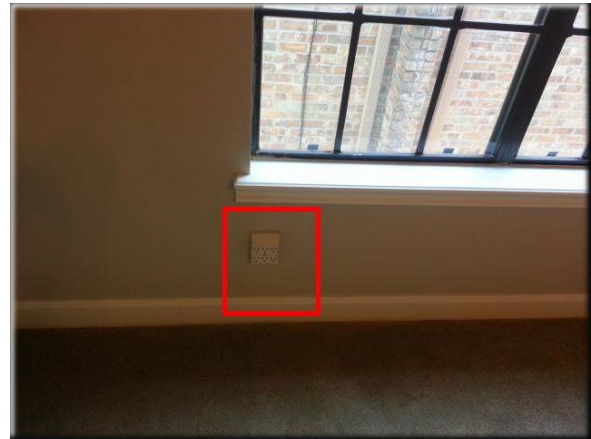
**At least one electrical outlet in the Upstairs right rear bedroom shows reversed polarity. Reversed polarity (hot and neutral wires reversed) is corrected by minor wiring adjustments at the affected receptacles; recommend repairs by a licensed electrical contractor. Do not use plug extenders as this can be a fire hazard.**

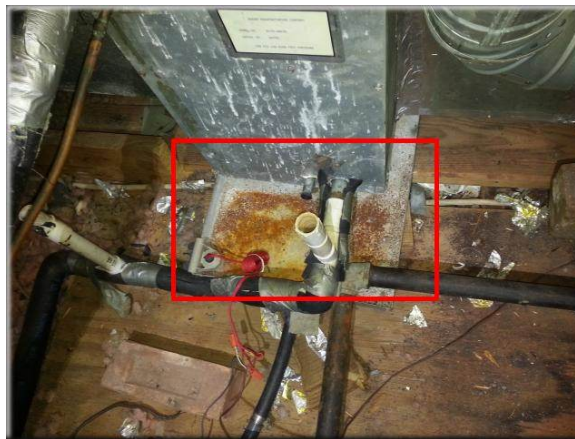
**Rust stains observed in the emergency overflow pan under the Attic evaporator coil. Unable to determine if leak is present at A/C coil condensation pan/drain line, clogged condensate drain line or if due to previously corrected problem; suggest client consult with seller to determine if or when repairs were completed or a qualified contractor should be called for further review.**

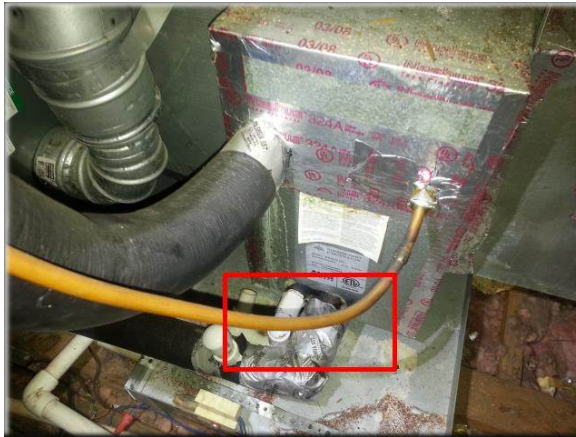
The liquid line for the rear attic evaporator coil was too hot to touch. Recommend further review by a licensed HVAC contractor.

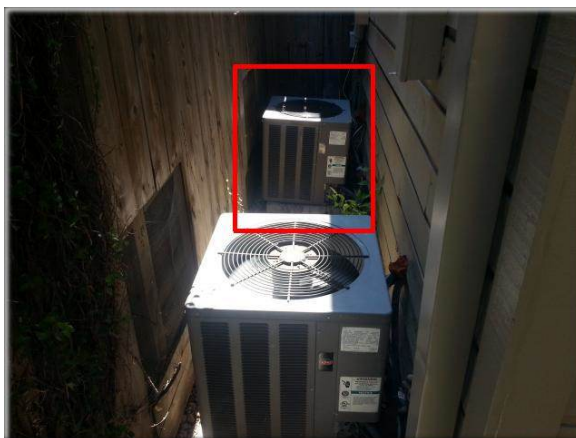
The condenser unit was not level at the time of the inspection. Excessive uneven settlement can cause fractures in refrigerant line fittings and loss of refrigerant.

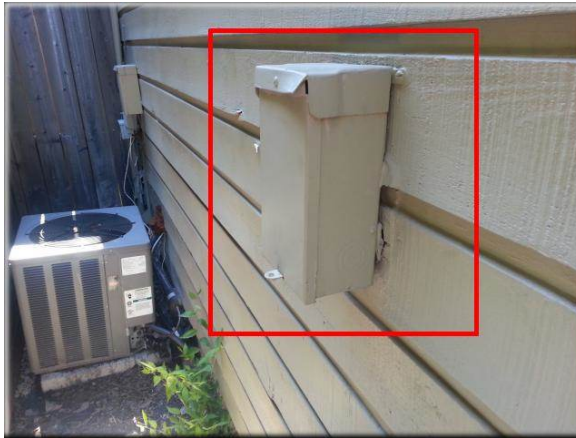
Condensing unit disconnect is loose from the wall and was painted shut.

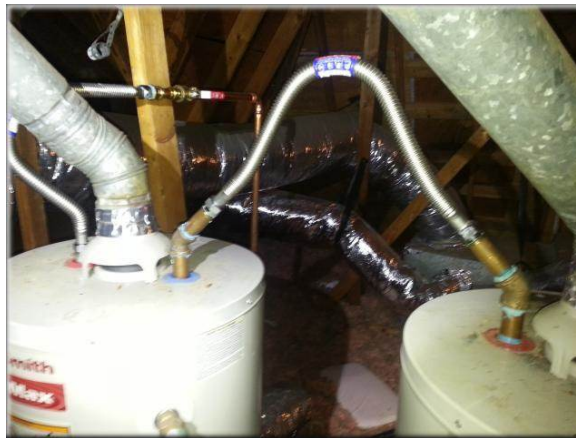
The water heaters are plumbed in series, which causes the first water heater to do most of the work and the second water heater to act more as a storage tank. When the water heaters are replaced, ask the plumber about installing them in parallel for better efficiency.

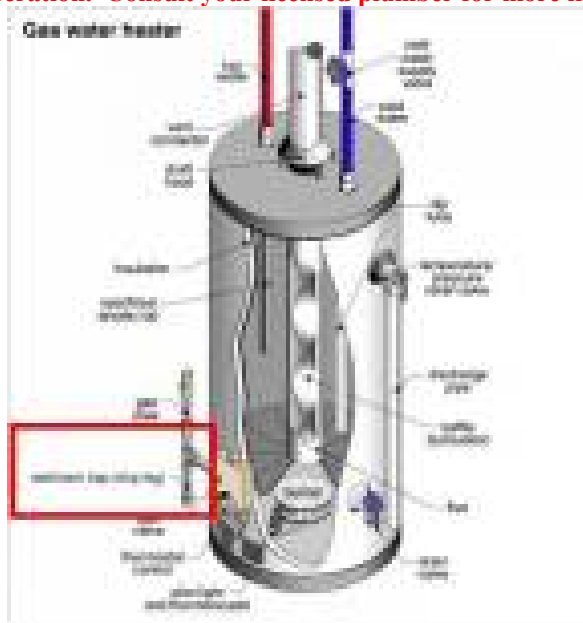
Fuel type is gas with shut-off valve for the water heater. A sediment trap is not installed on the gas line for this appliance; recommend installing drip leg to help prevent moisture or debris from affecting combustion and burner operation. Consult your licensed plumber for more information and repair.

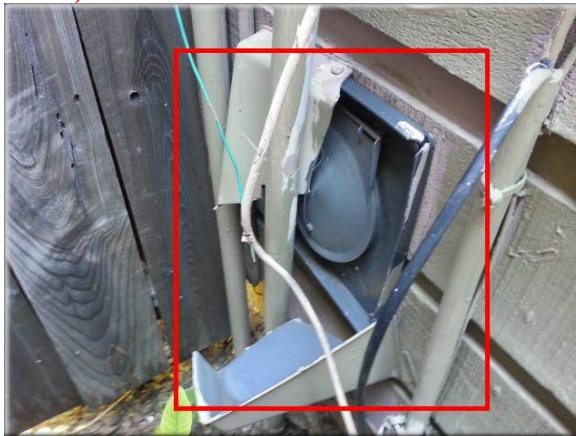
**What appears to be the exhaust termination for the downdraft vent is blocked/broken and not venting as intended. (right rear of the home)**
