PROPERTY INSPECTION REPORT

ADDRESS: 751 Lakeside Wimberley, TX 78676
PREPARED FOR: Randy Betz
DATE: 5/23/2019
BY: Gary Thompson
Professional Real Estate Inspector
TREC #5414

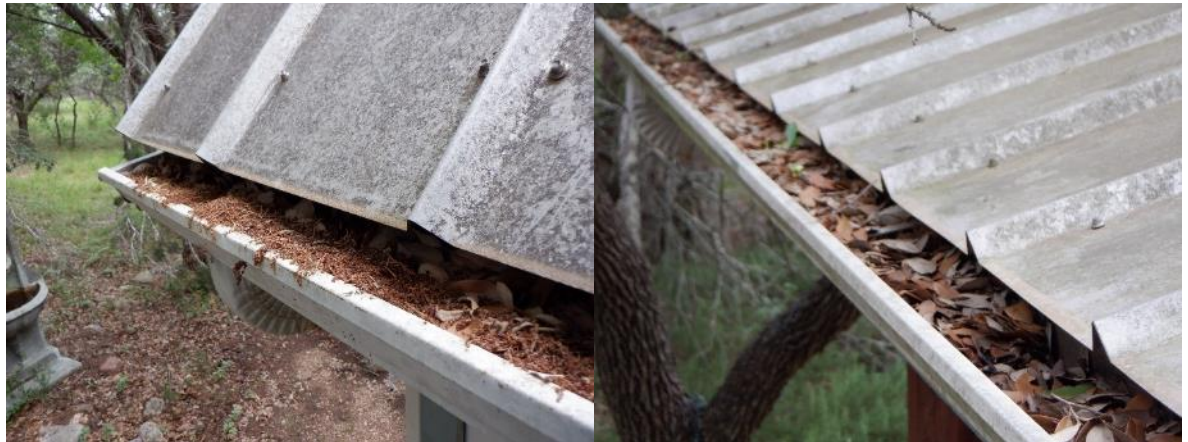
- Gutters need to be cleaned out to ensure proper drainage.
- Additional gutters are recommended to help with site drainage.
- There is slope toward the front of the house where the deck is up over the bottom of the siding and stone veneer. The slope of the driveway and the walkway to the front door looks like it will run water right toward the house. Some leaves have built up in areas at the front left that look like signs of standing water. Drainage should be monitored with changes made as needed. Contact a specialist for further evaluation and repairs as needed.

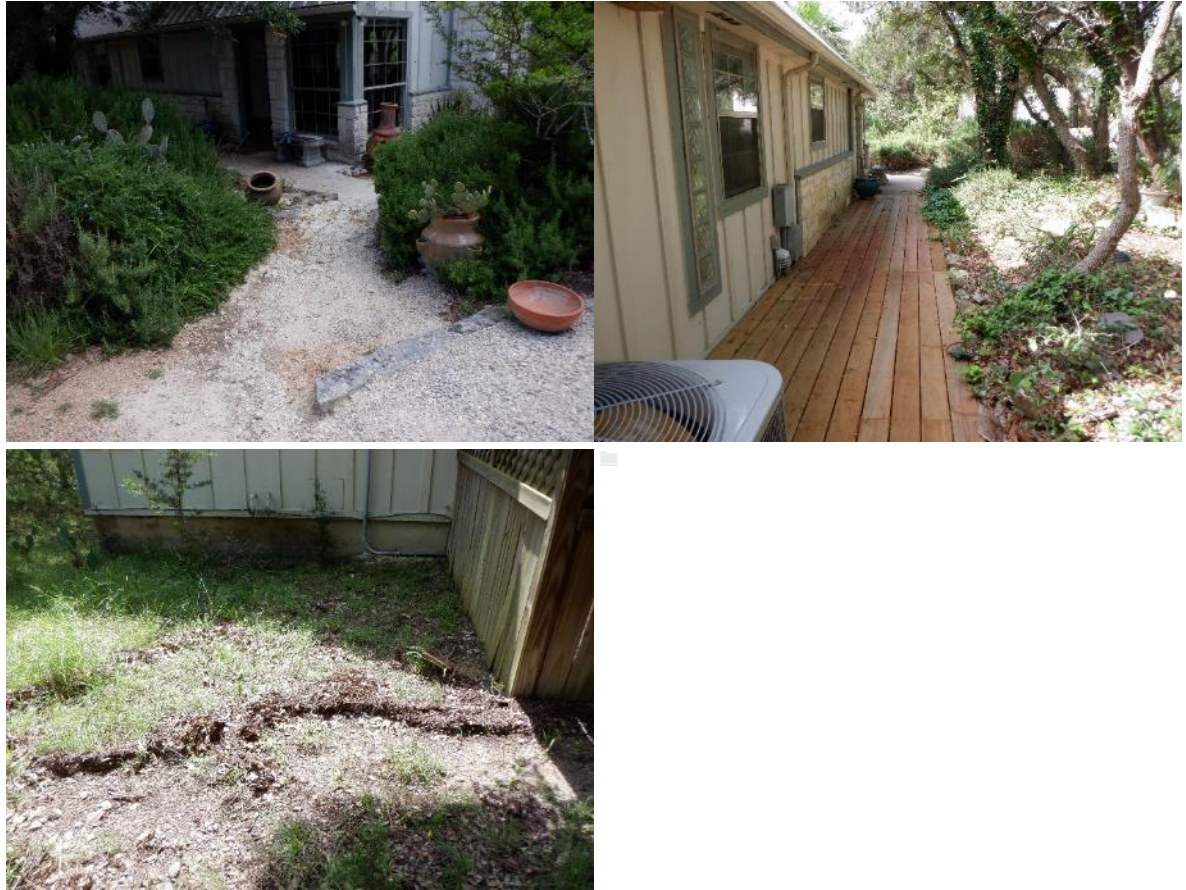
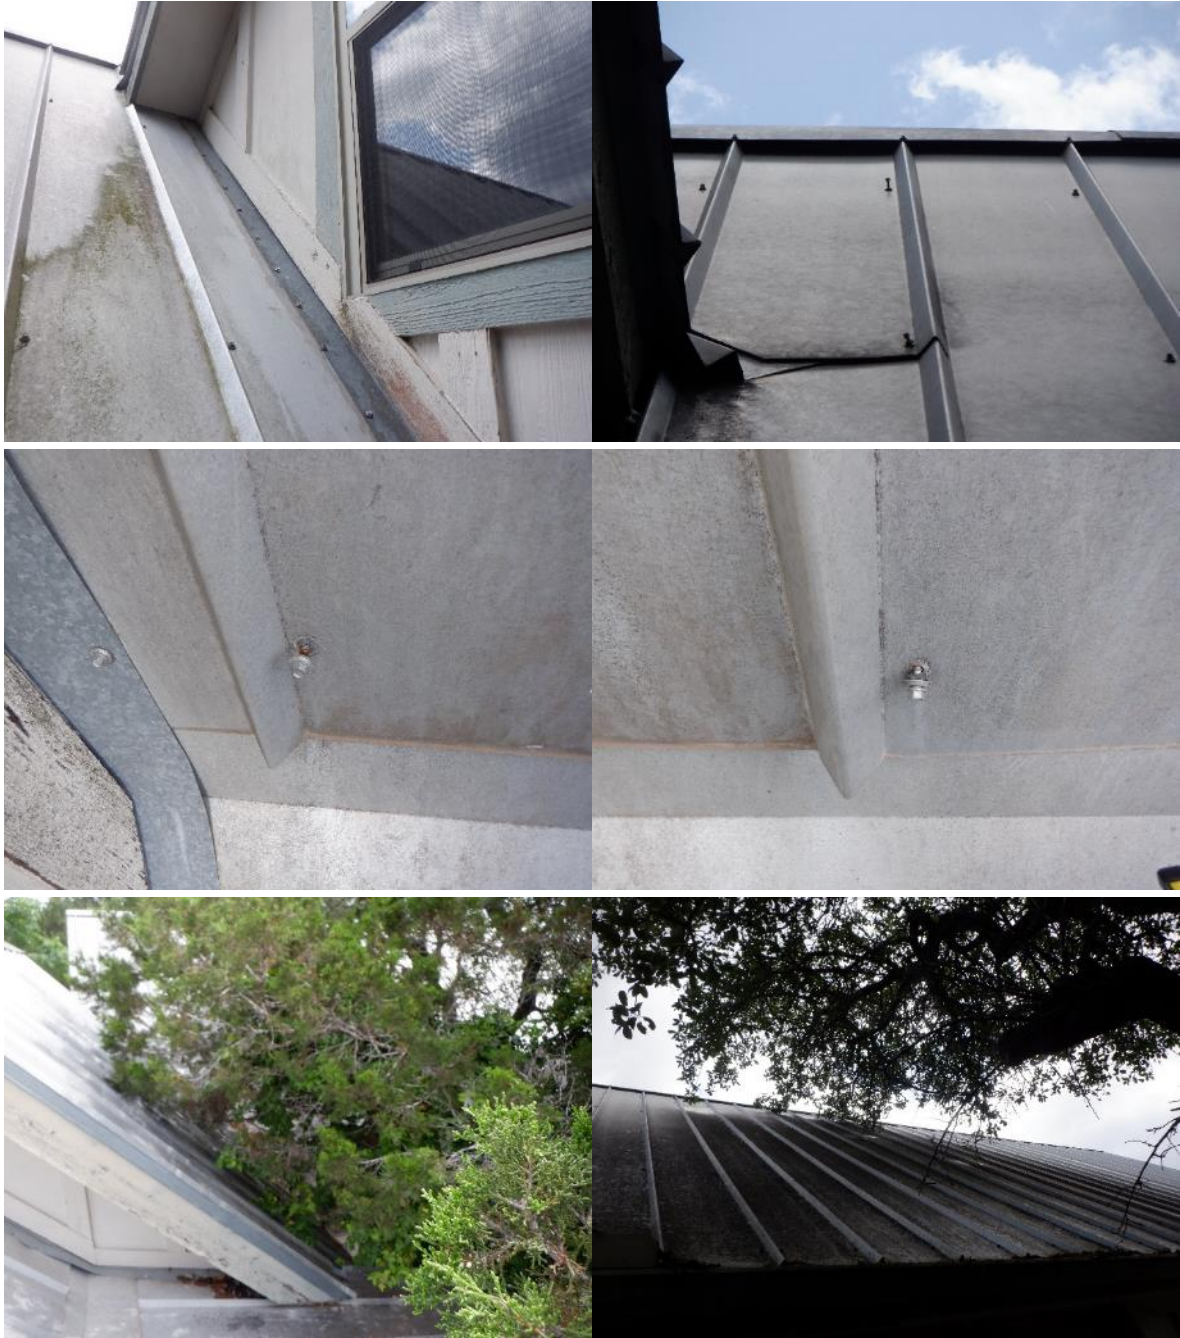
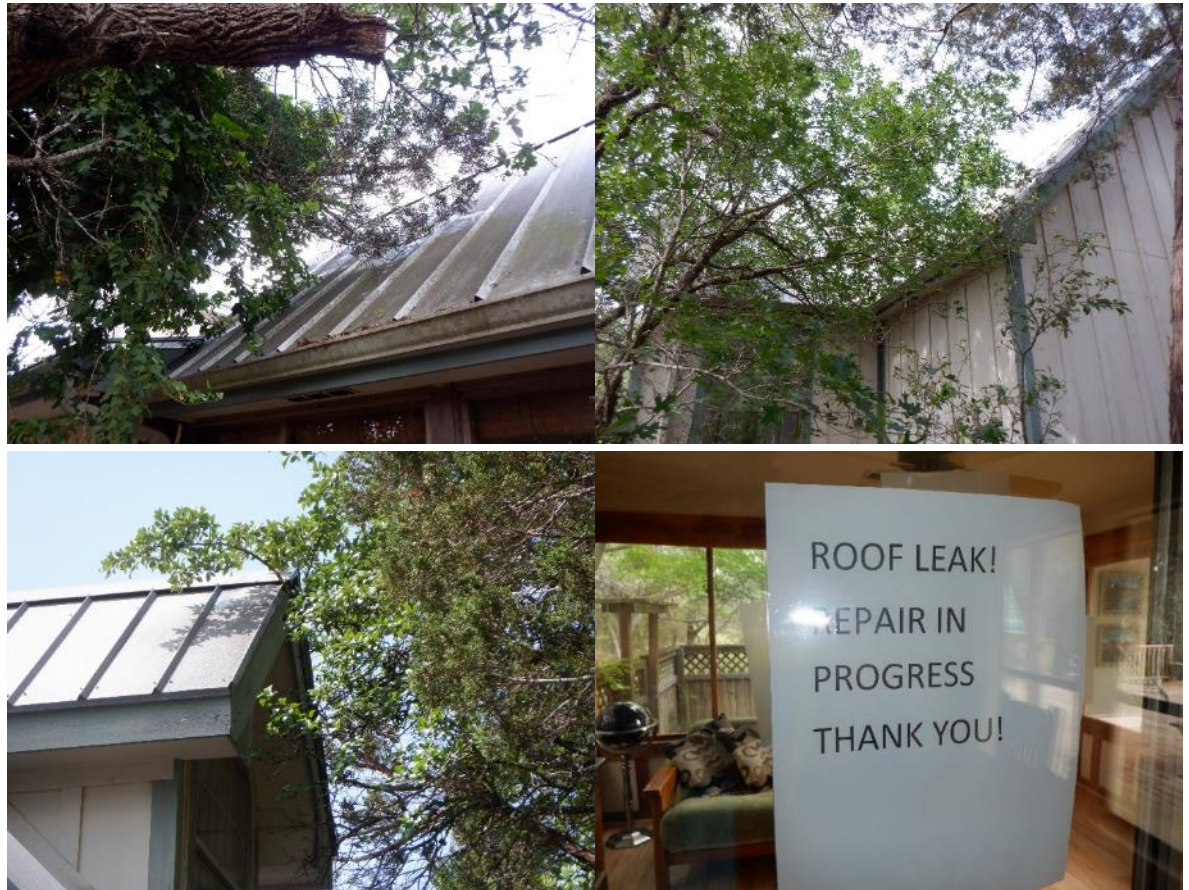
- There appears to be an active leak over the room to the left of the dining area. Roof decking is rotted in the attic over this area. This appears to be from leakage at the flashing where this part of the roof meets the sidewall of the house. There is also a window in this area that could be contributing. Contact a roofer for further evaluation and repair as needed.
- Metal roofing screws have backed out of their holes in scattered areas. These should be reset or replaced as needed. This will be an ongoing maintenance item. Recheck periodically.
- Tree limbs are touching the roof in several areas. Limbs should be kept trimmed back away from the roof and exterior walls.
- Contact a roofer for further evaluation and repairs as needed.

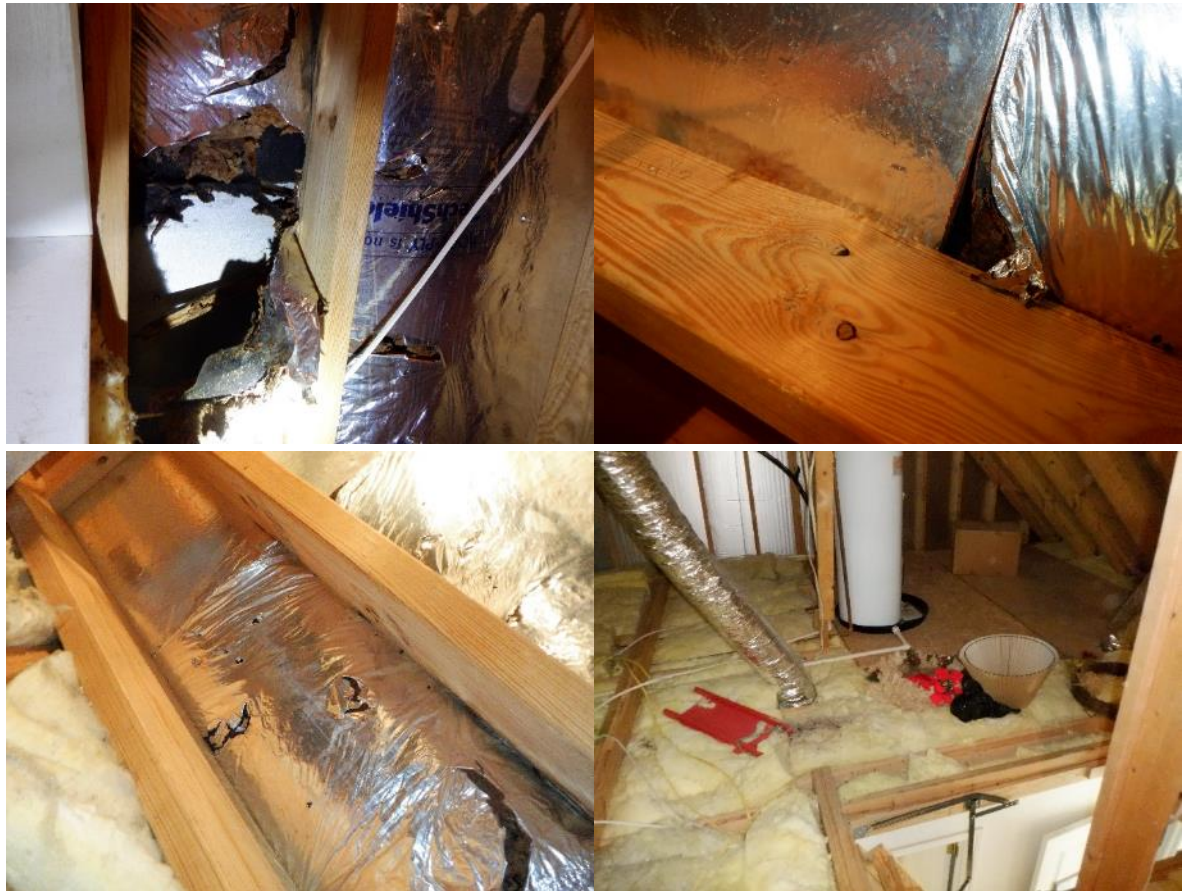
- Roof decking is rotted in the attic off of the upstairs bedroom. This appears to be due to leakage from the sidewall flashing or window near this area.
- Sixteen separate 16-d nails or ¼"x3" lag screws should be used to securely attach the pull-down ladder to the hatch opening. Proper fasteners are needed.
- There should be continuous, solid flooring at least 24" wide from the attic access point over to the service side of the HVAC units and water heater. There are some gaps in flooring in both attics.

- Droppings were noted in both attics. Nothing looked particularly fresh. I recommend this be further evaluated by a pest specialist.
- Note: Moisture stains may indicate water penetration. Inquire with owner for any repairs. Repairs may or may not have corrected the conditions which can change with time and weather. Monitor and repair any active leaks promptly.

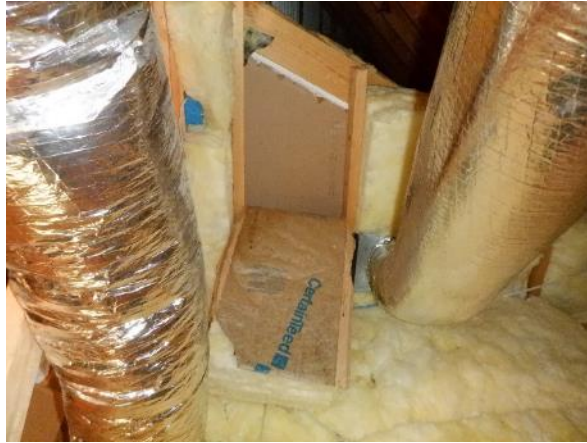
- Rolled batt-type insulation observed in the attic accessed through the pull-down stairs with an approximate depth over conditioned spaces of 6-10".
- One vertical batt has fallen down in the attic accessed through the pull-down stairs. The piece of insulation probably just needs to be resecured.
- There is no insulation in the attic accessed through the door in the upstairs bedroom. The room under this area is conditioned, so insulation is needed.

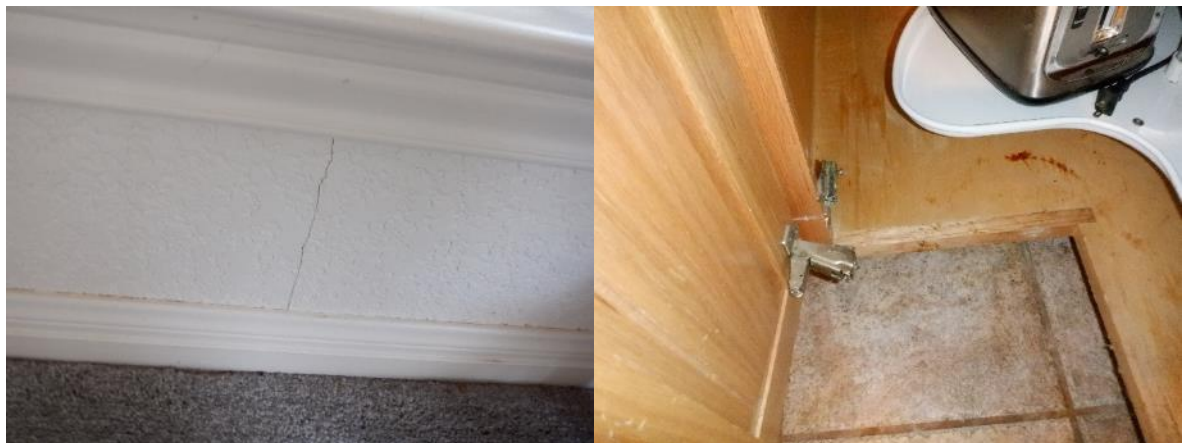
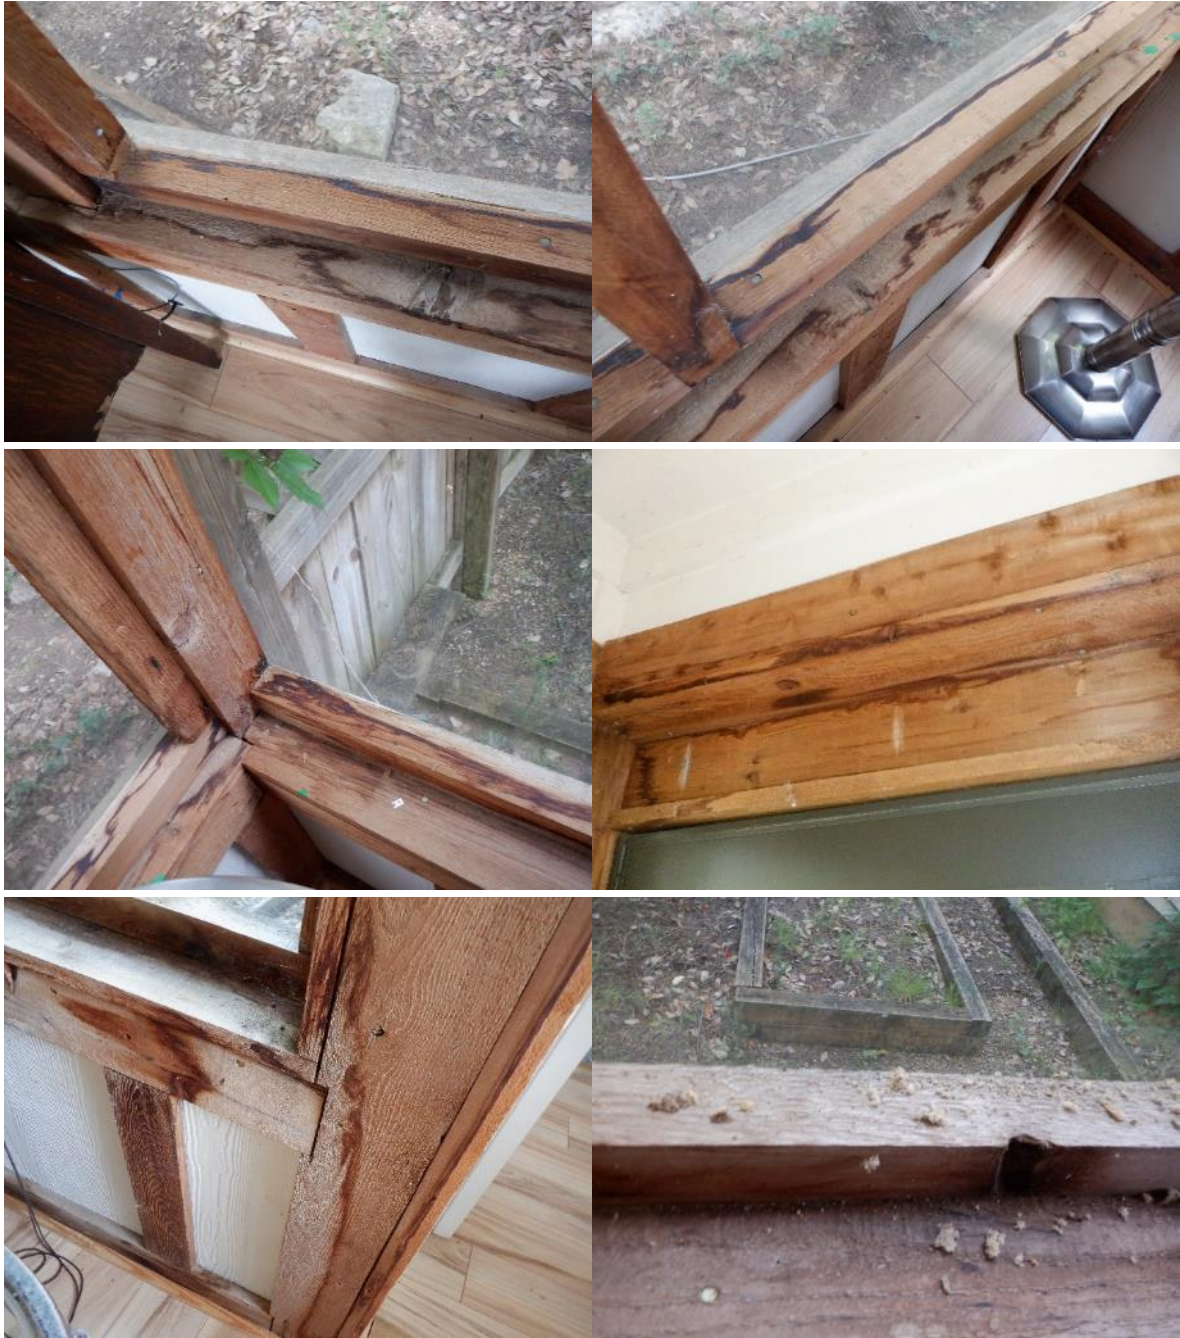
- A small tape joint crack was noted under a window at the side of the back bedroom. This should be monitored but appears primarily cosmetic in nature.
- One hinge is not connected at a kitchen cabinet door.
- There are water stains on the wood around the windows in the room to the left of the dining area. This could be due to leakage or possibly condensation. Contact a specialist for further evaluation.
- What looks like frass was noted at a window in the room to the left of the dining room and at the side window in the upstairs bedroom. This should be further evaluated by a pest specialist.
- There are water stains on the wall at the back of the cabinet under a sink in the shared bathroom. This may be from an old plumbing leak or may be related to the unsealed access panels on the front exterior wall.

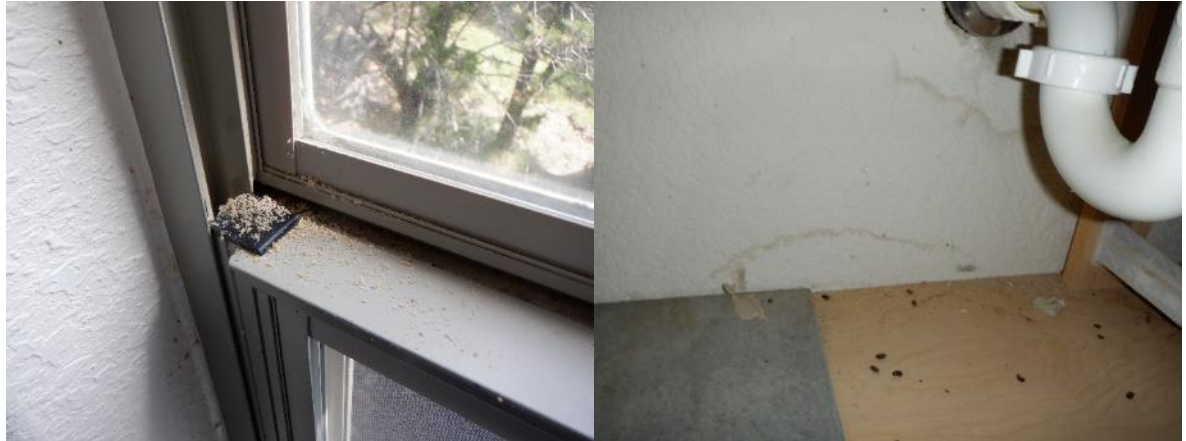
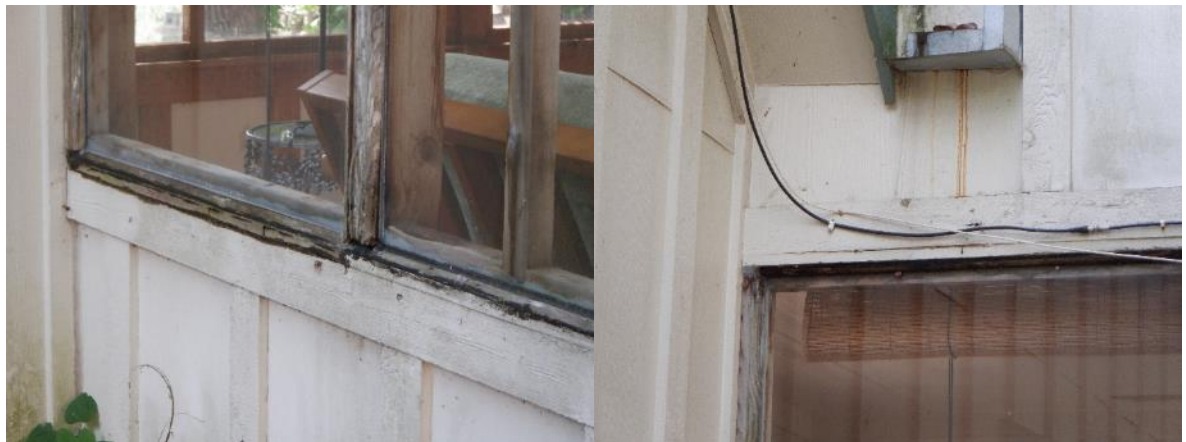
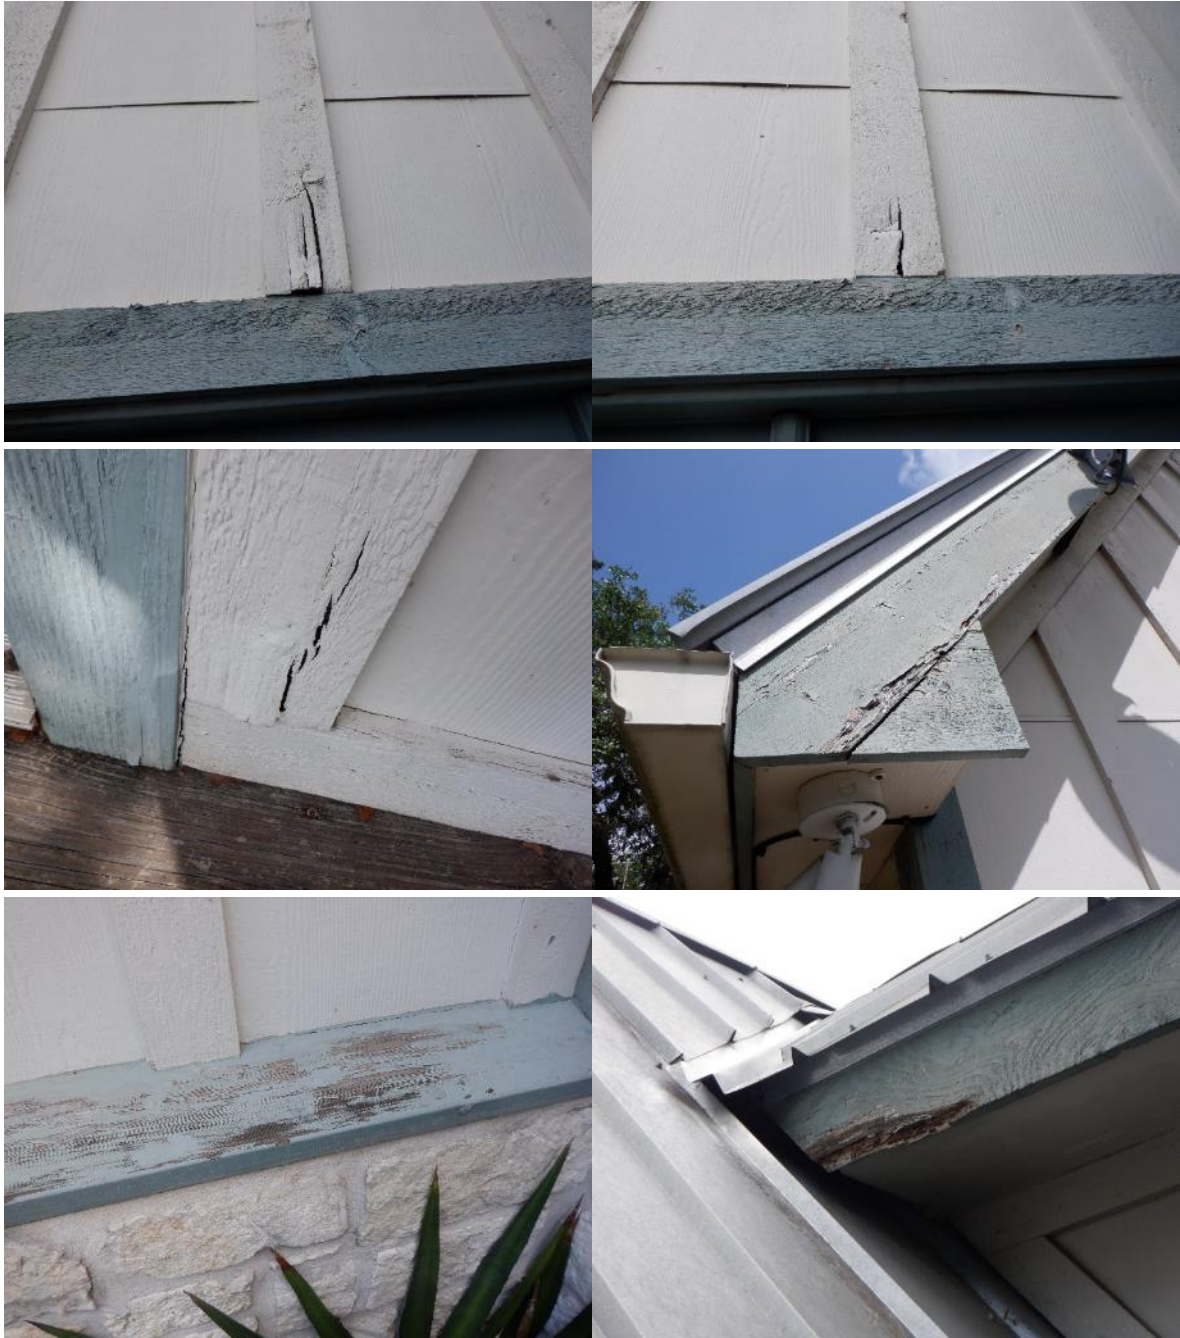
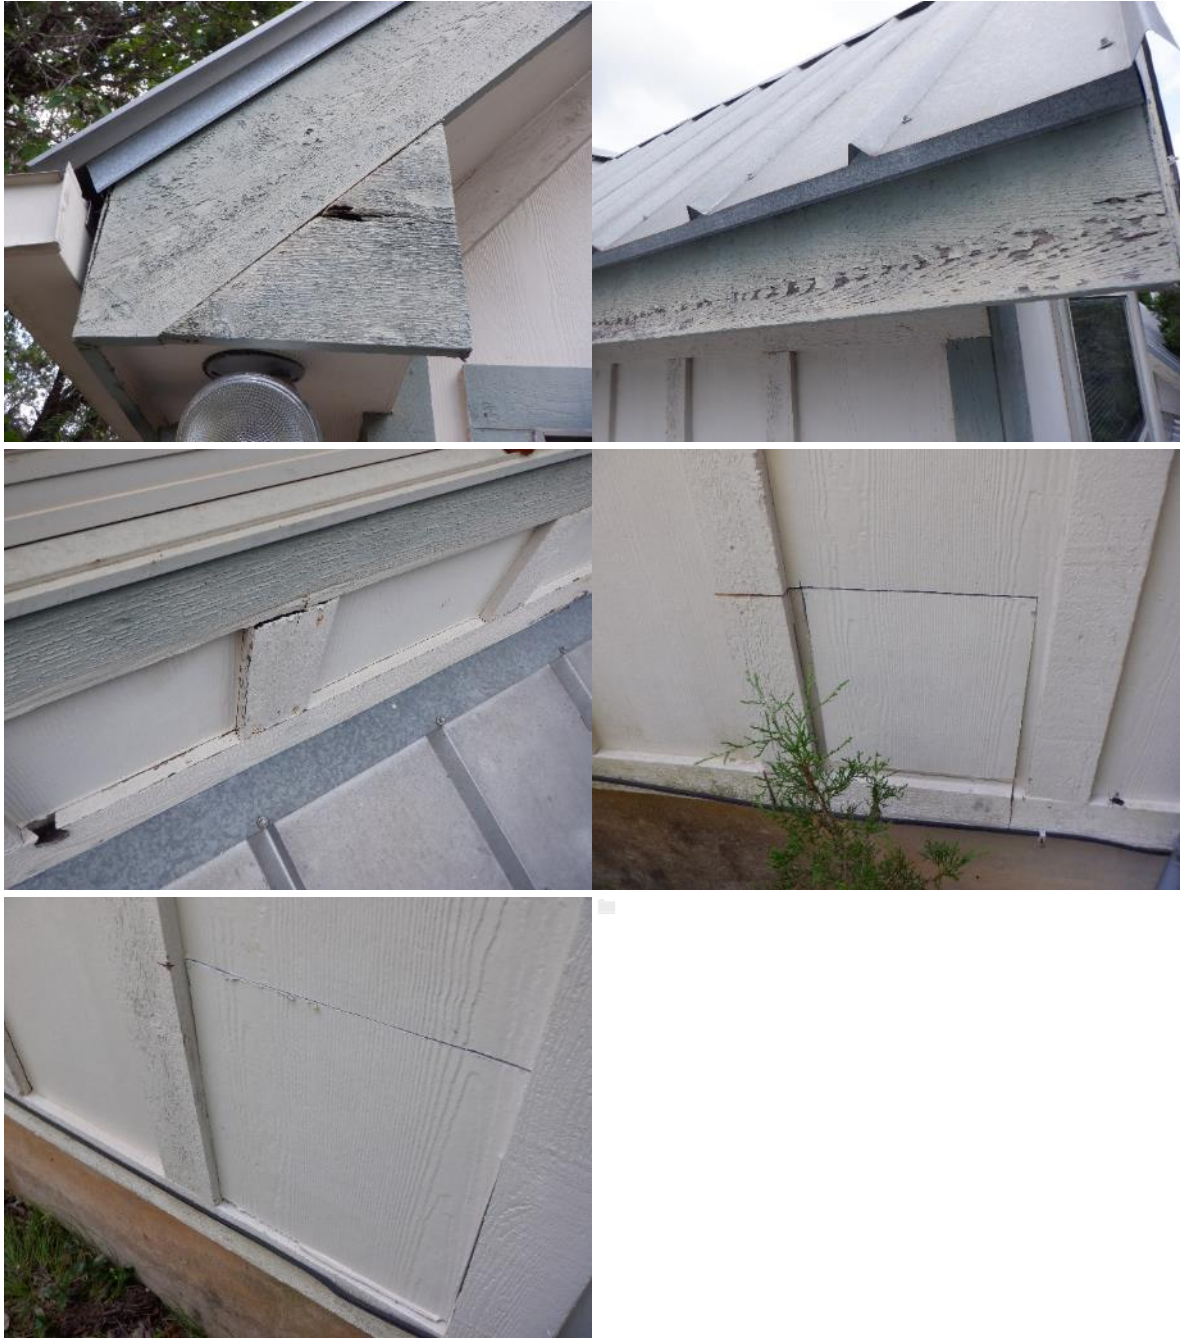
- There are scattered areas of rot or deterioration, wear and peeling paint on trim and siding around the house. This was mostly noted on trim and battens. General maintenance is needed.

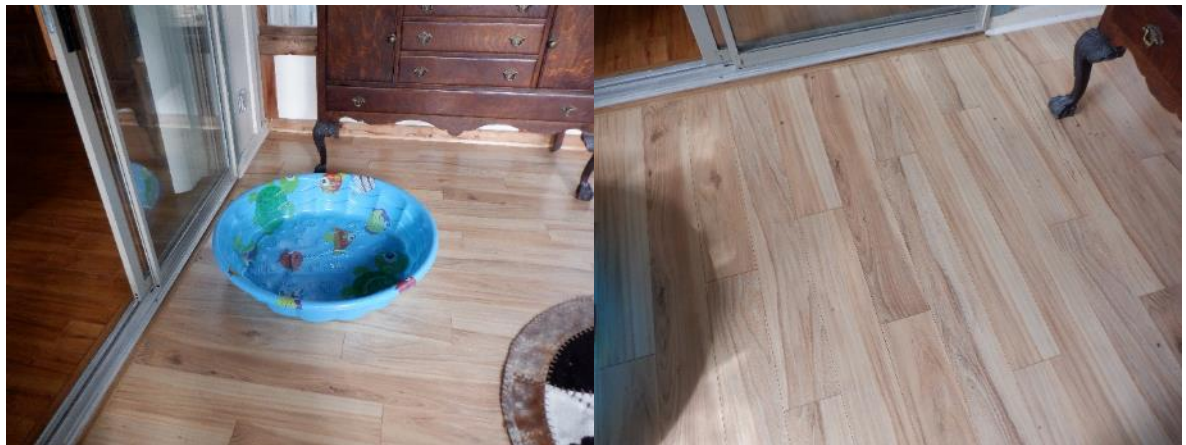
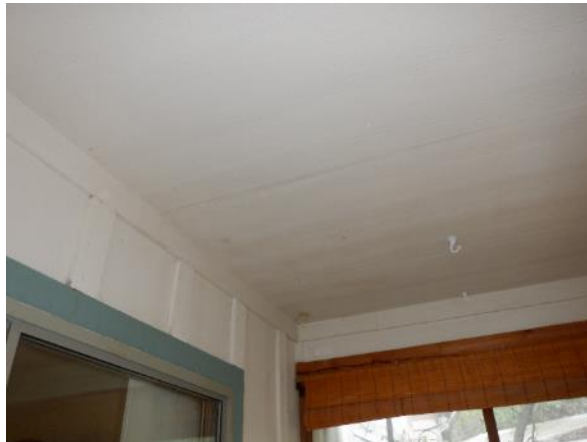
- I was advised that the floor in the room to the left of the dining area has been wet due to the active roof leak. A small kid's pool has been put down as a precaution. The flooring should be further evaluated as it dries out and may need replacement.
- Carpet and trim inside the back bedroom exterior door appear water damaged due to a leaking door.
- There is a tape joint crack on the ceiling at the top of the stairs. This should be monitored but appears primarily cosmetic in nature.
- Note: Moisture stains may indicate water penetration. Inquire with owner for any repairs. Repairs may or may not have corrected the conditions which can change with time and weather. Monitor and repair any active leaks promptly.

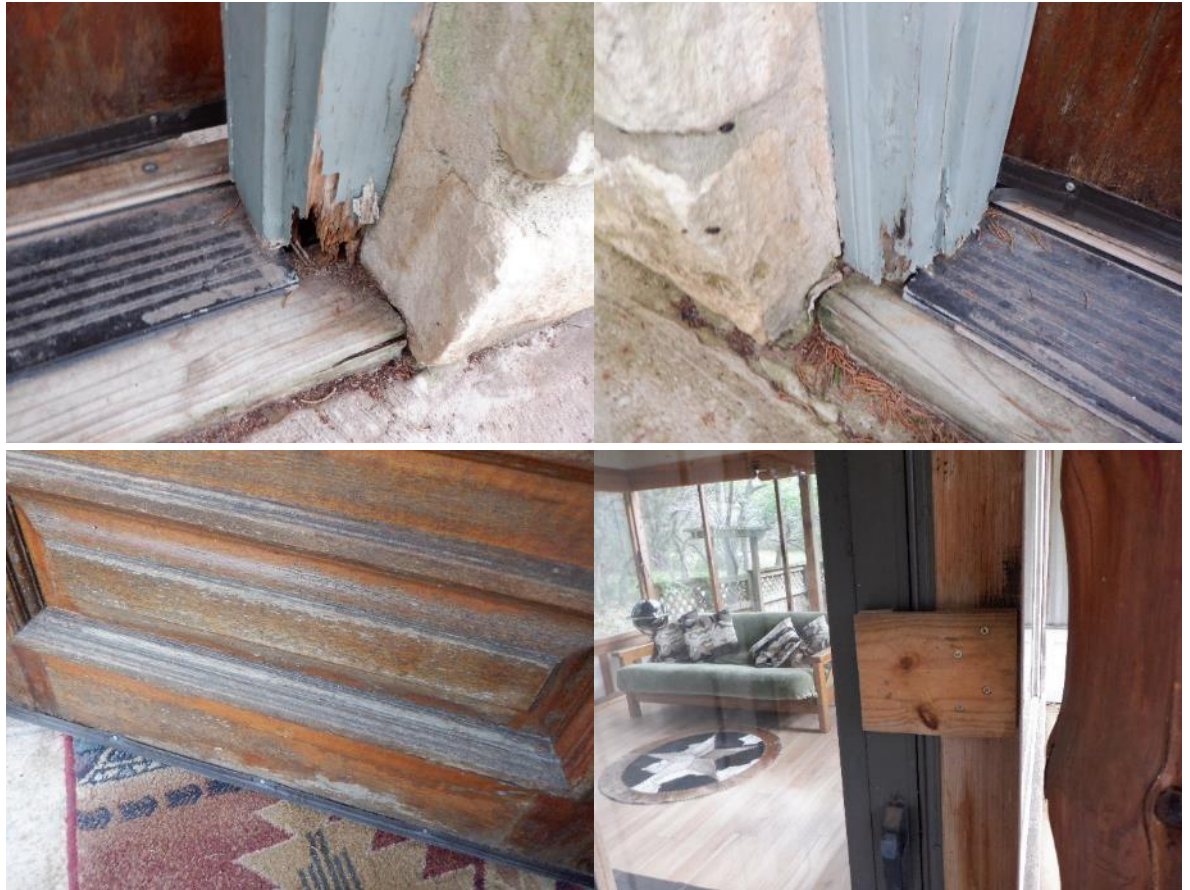
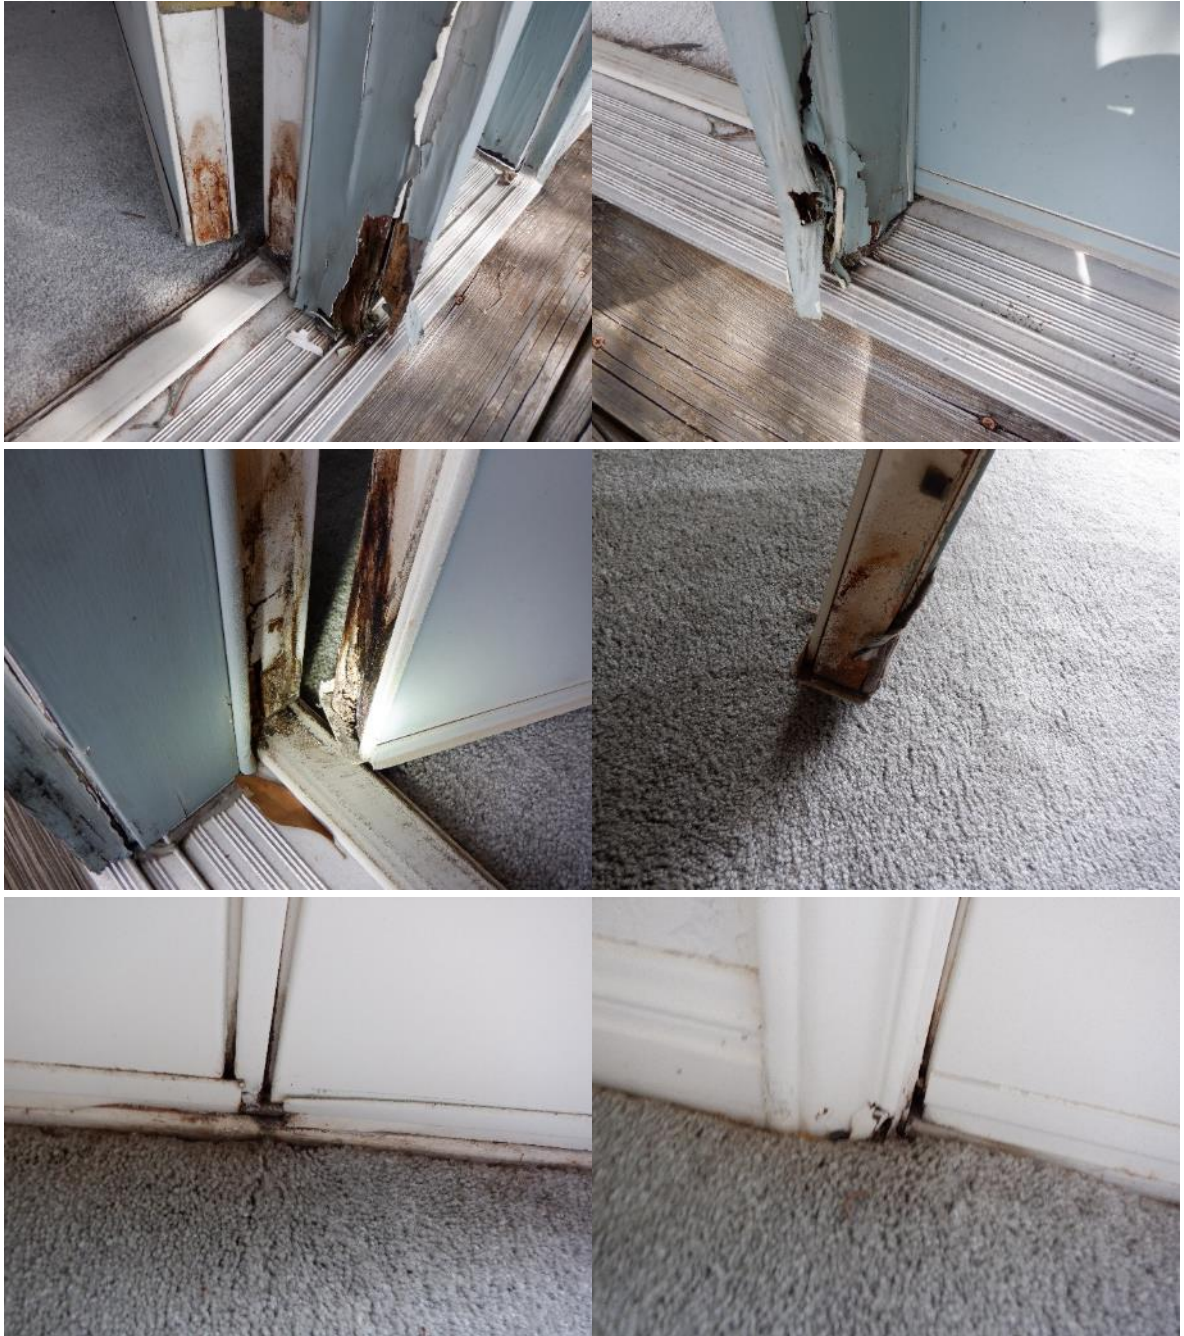
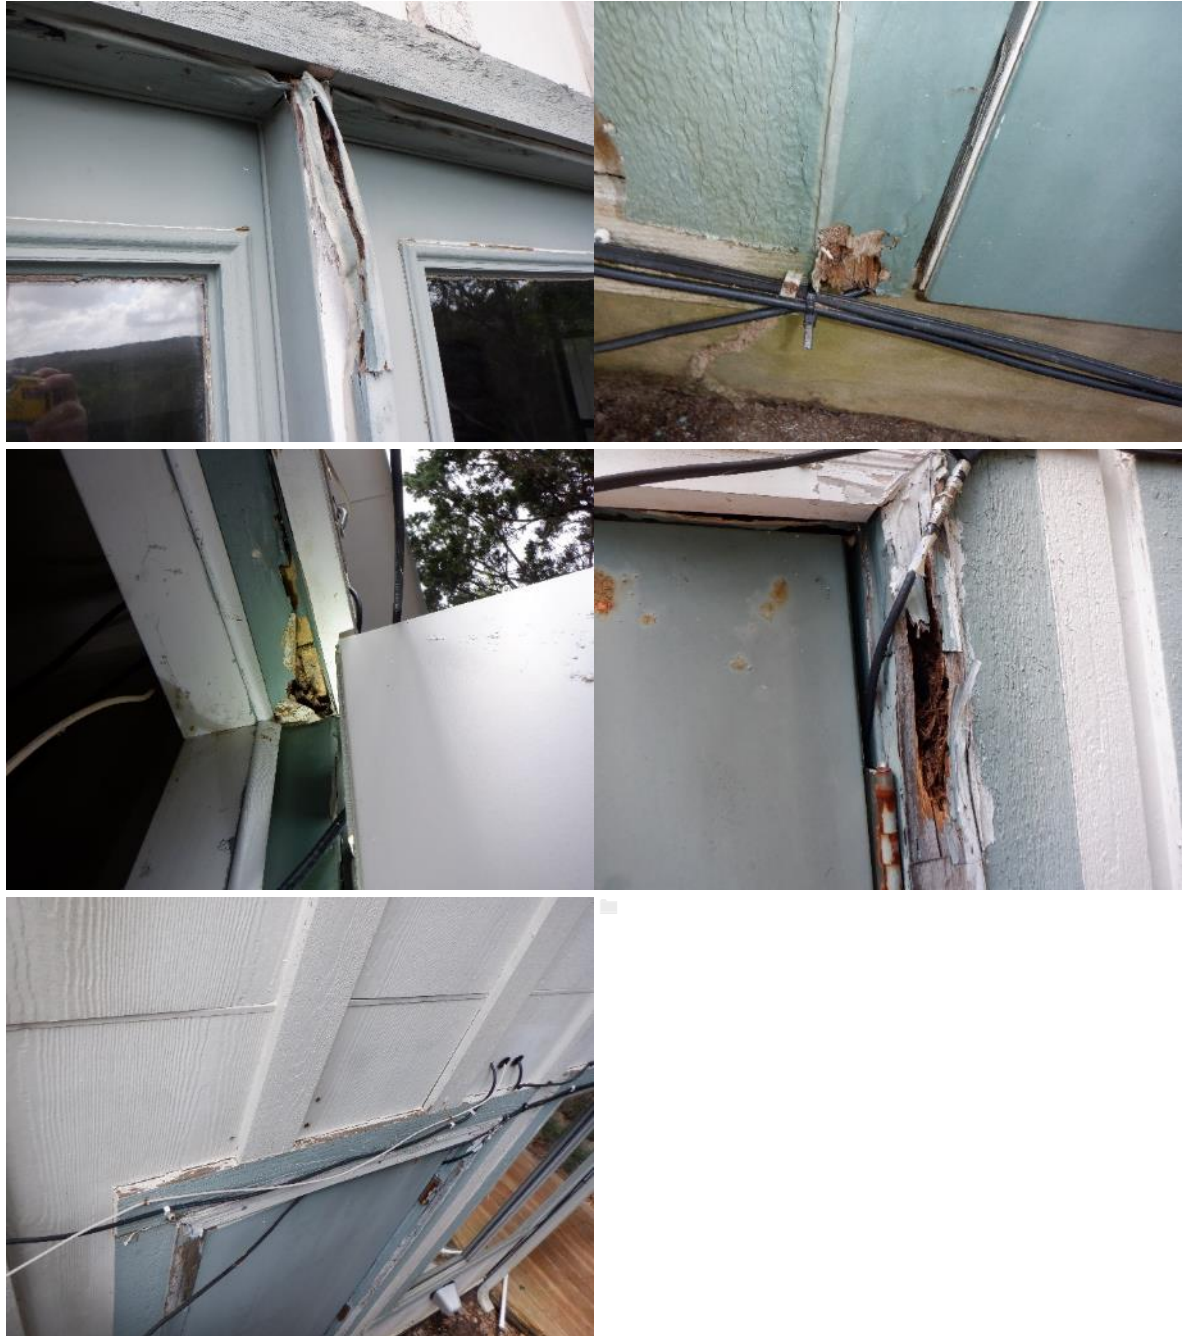
- The front door rubs the frame. Adjustment is needed. The frame and trim on the outside of this door is rotted at the bottom. The door is worn and in need of maintenance.
- The exterior door in the room to the left of the dining area is sealed shut and was not opened.
- The exterior door unit (door, frame and trim) in the back bedroom is rotted and in need of replacement. It looks like this door has been leaking. Carpet and trim inside this door shows signs of water damage.
- The water heater closet door and trim are rotted. There is rot over the door indicating leakage at the top. There is no visible z-flashing over this door or over any of the windows.

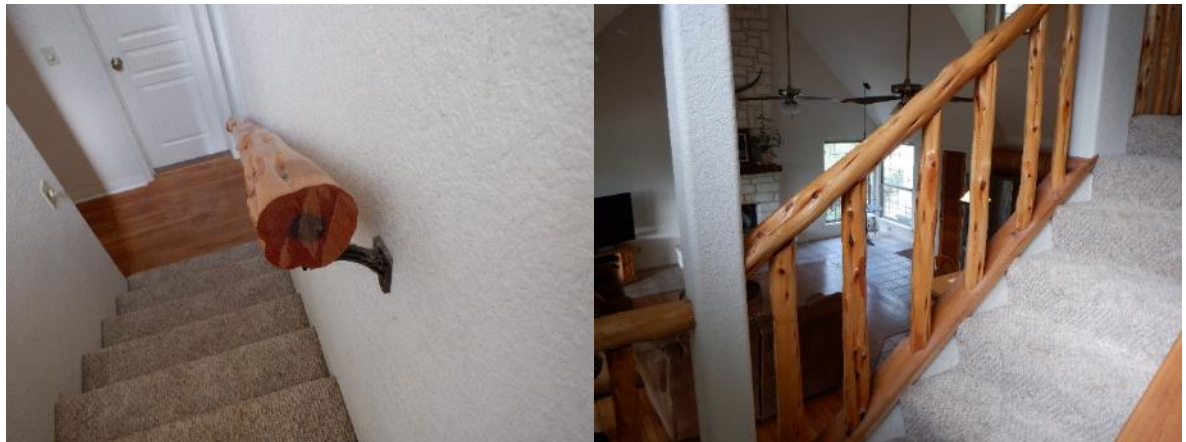
- The ends of the handrail should return to the wall to prevent clothing from hanging and presenting a trip hazard. This handrail is too big around to be grippable by modern standards. Circular handrails should have a diameter of between 1 1/4" and 2" by modern standards.
- Openings in railings at the stairs and at the top of the stairs should not allow passage of an object greater than 4" in diameter.
- The railings and bottom tread are loose at the stairs that run to the left from the back deck.

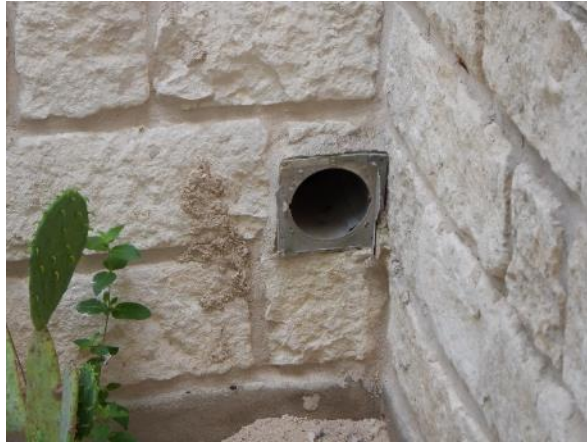
- The visible part of the flue is dirty. I recommend it be cleaned and further evaluated by a specialist.
- The cover for the fireplace air intake is missing.
