PROPERTY INSPECTION REPORT

ADDRESS: 751 Lakeside Wimberley, TX 78676
PREPARED FOR: Randy Betz
DATE: 5/23/2019
BY: Gary Thompson
Professional Real Estate Inspector
TREC #5414

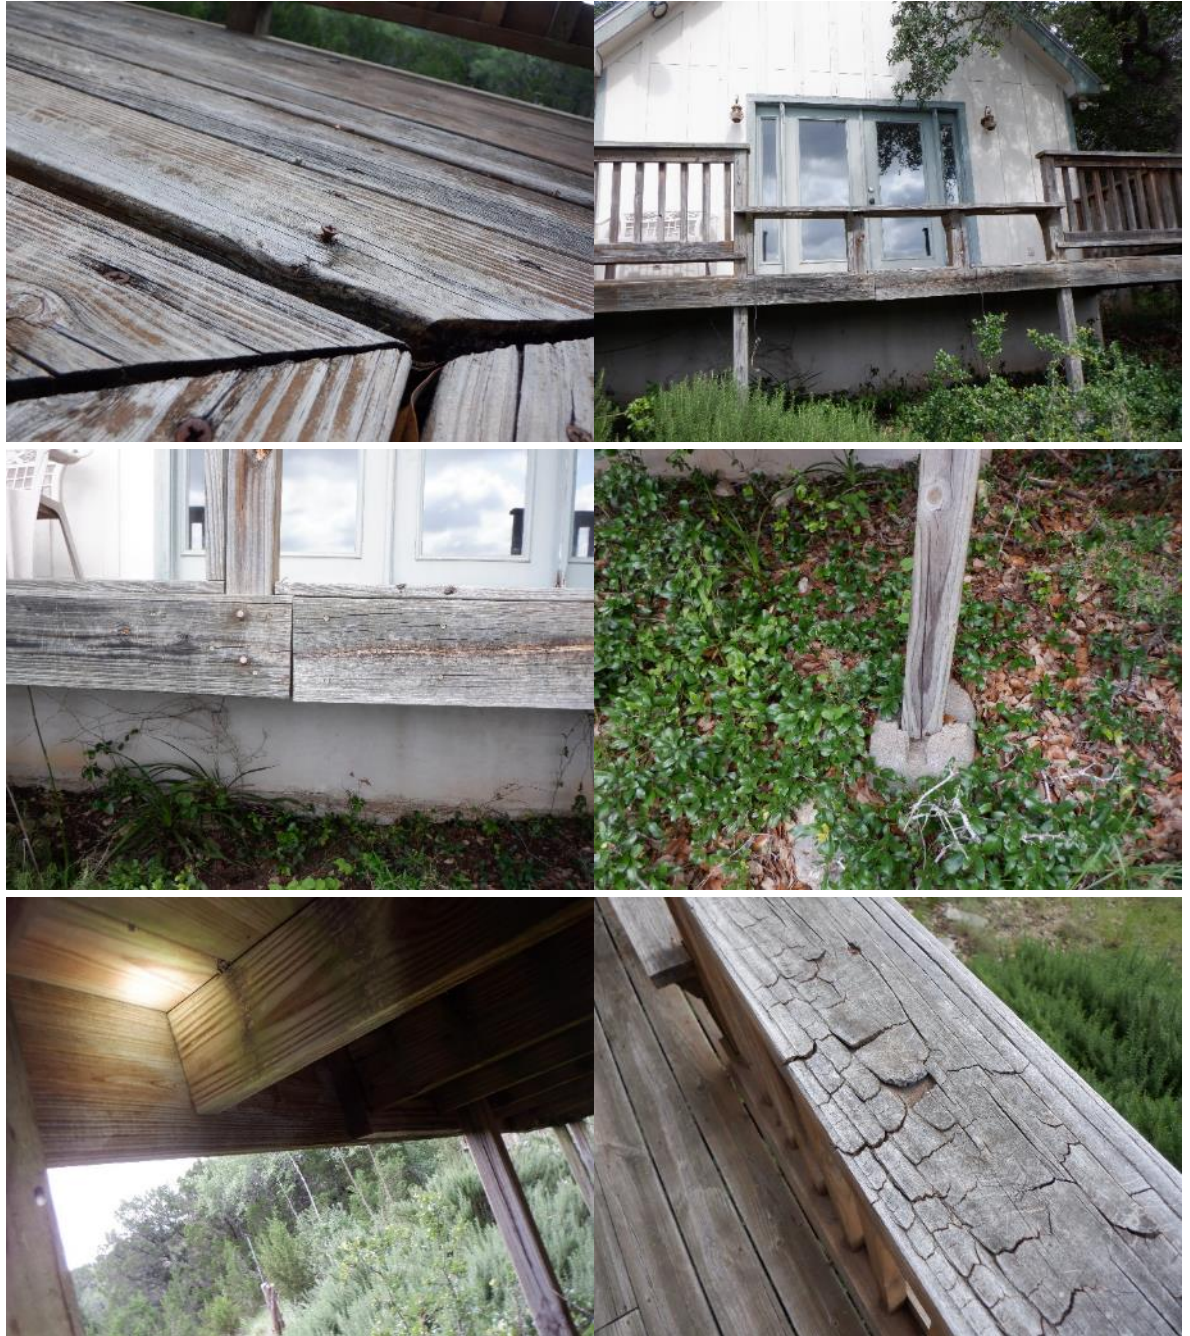
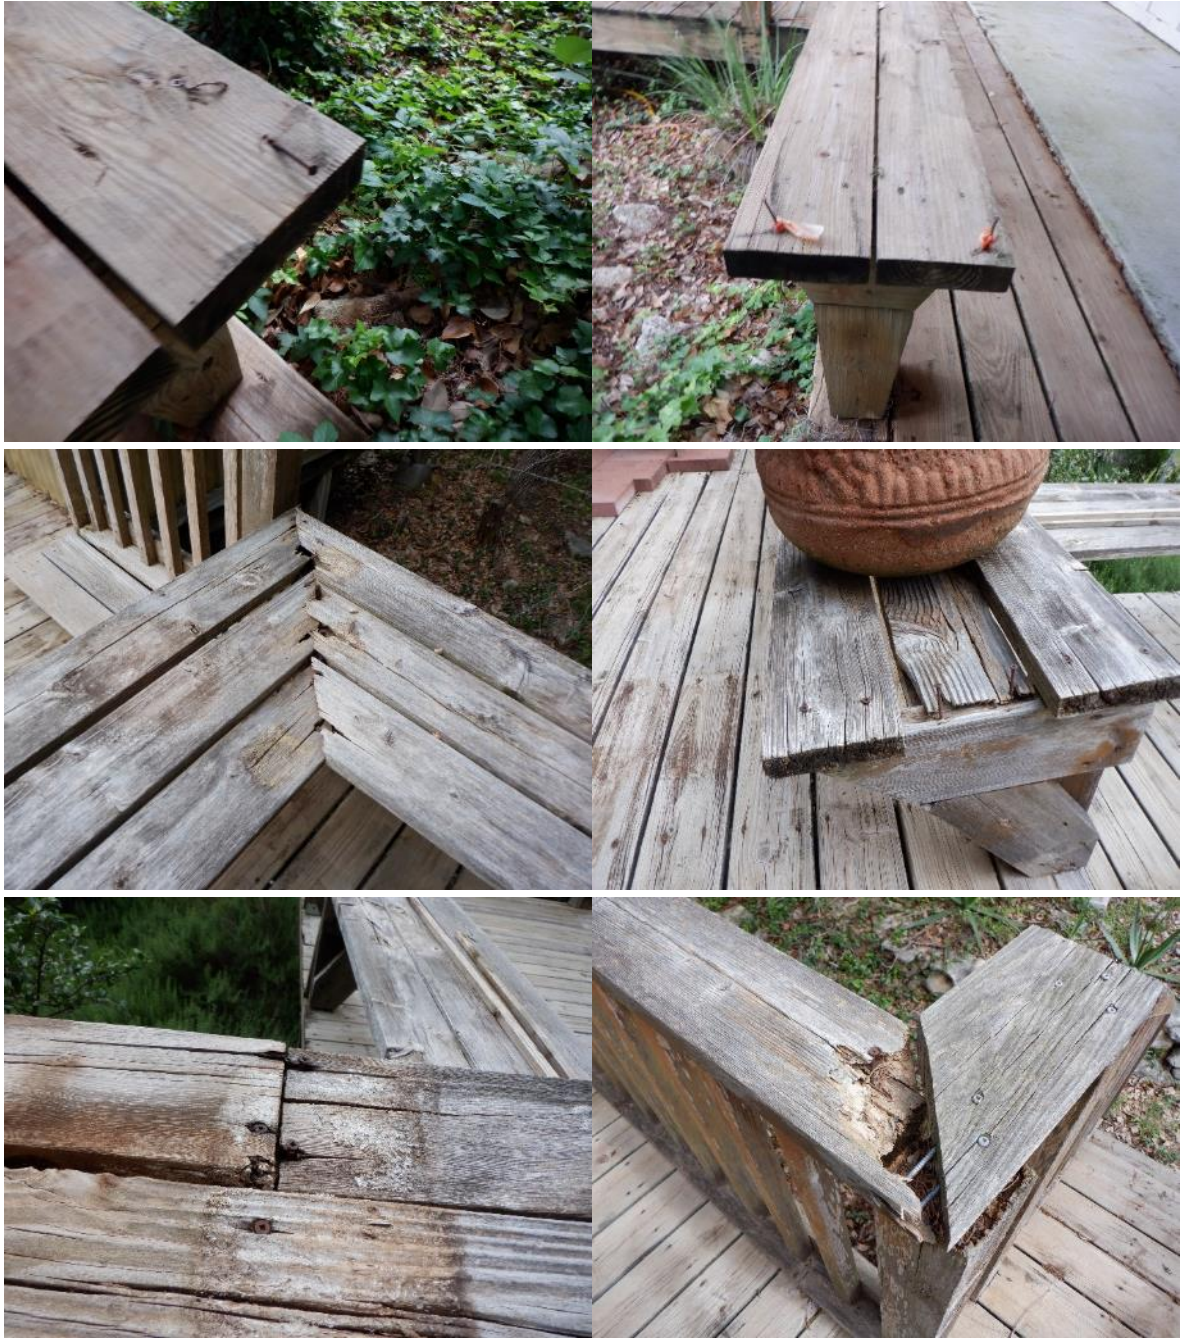
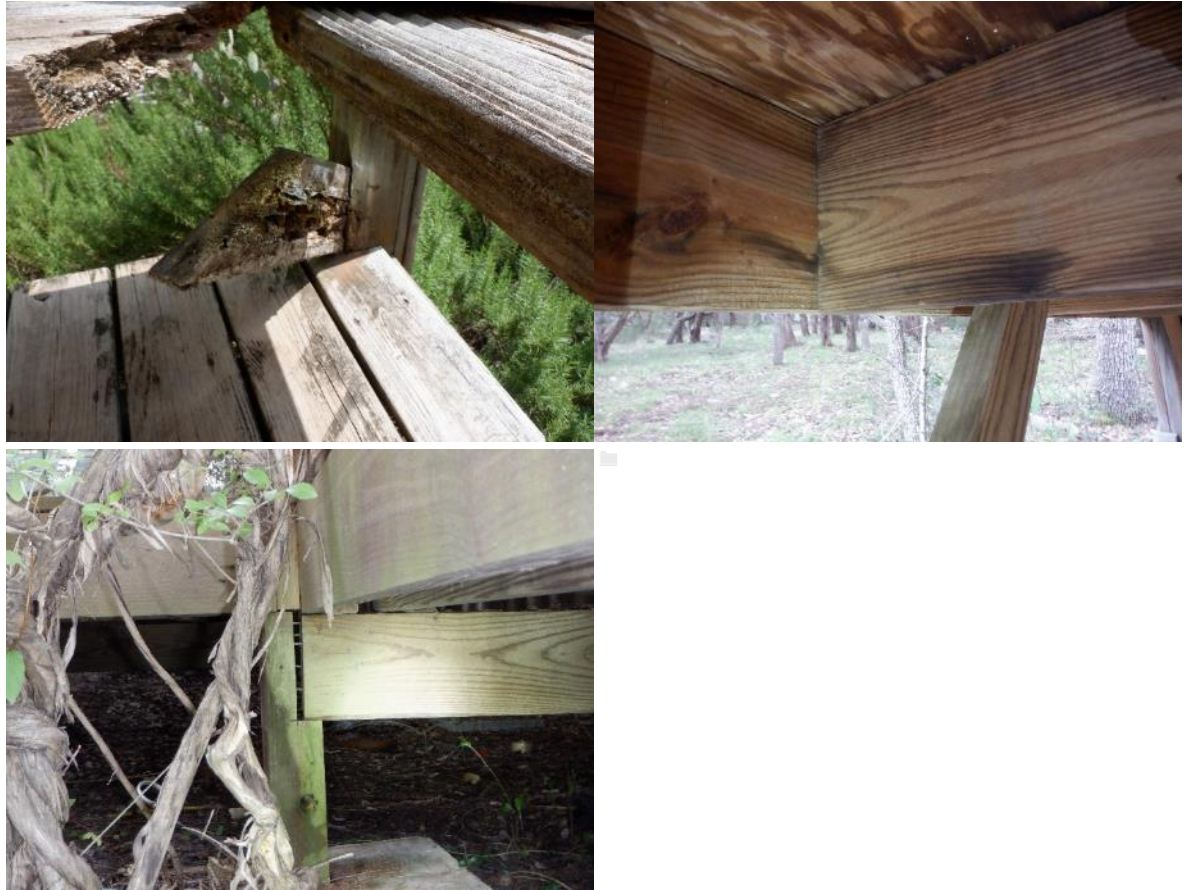
- Some deck posts are on precast pads that appear to just be sitting on the ground. Poured concrete piers and footings would be preferable.
- The decks have scattered worn areas, warps and protruding fasteners.

- Railings are rotted in some areas.
- Protruding nails at some benches present a safety hazard.
- Benches in areas 30" or more above grade should have a railing at least 34" high along the back. Openings in railings should not allow passage of an object greater than 4" in diameter.

- Several of the benches are rotted to the point that replacement is needed.
- Joist hangers have been used on some areas but are needed in others.
- Additional support posts are recommended at seams in the ridge joist.

- Some separations were noted at deck framing.
- Extensive repairs are needed. Contact a specialist for further evaluation and repairs as needed.
- Note: The greenhouse was not inspected.

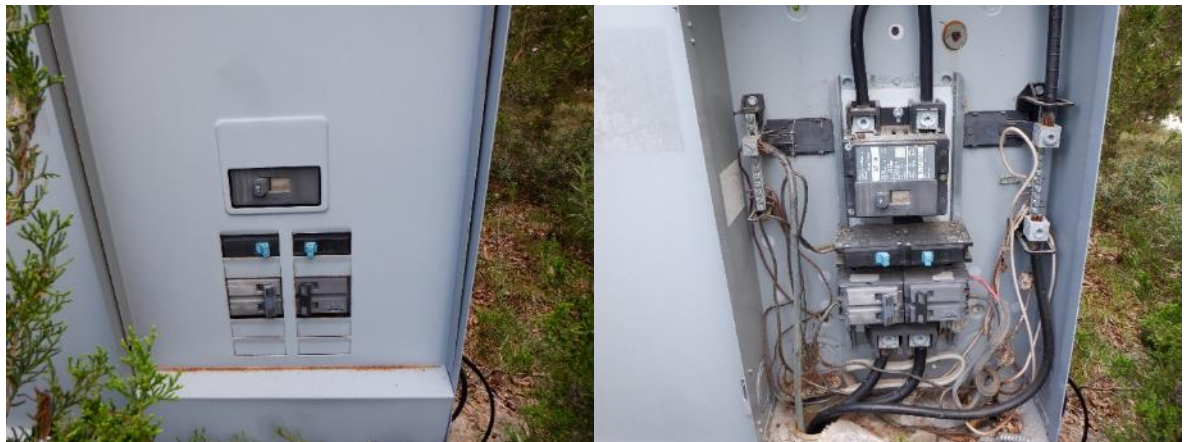
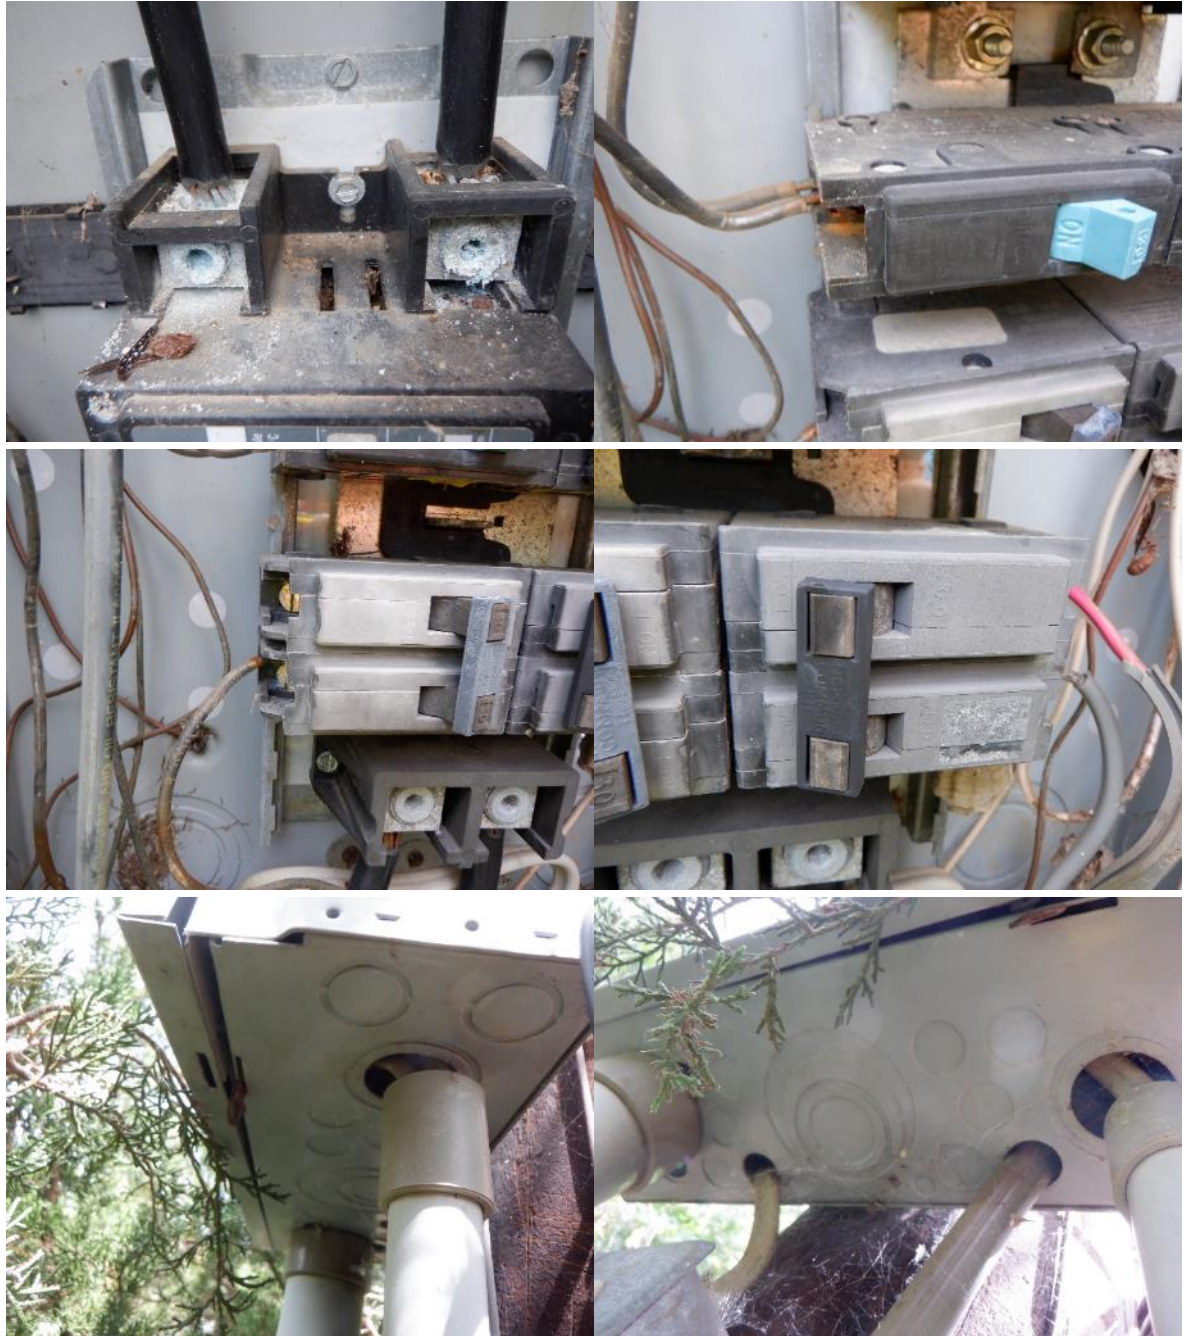
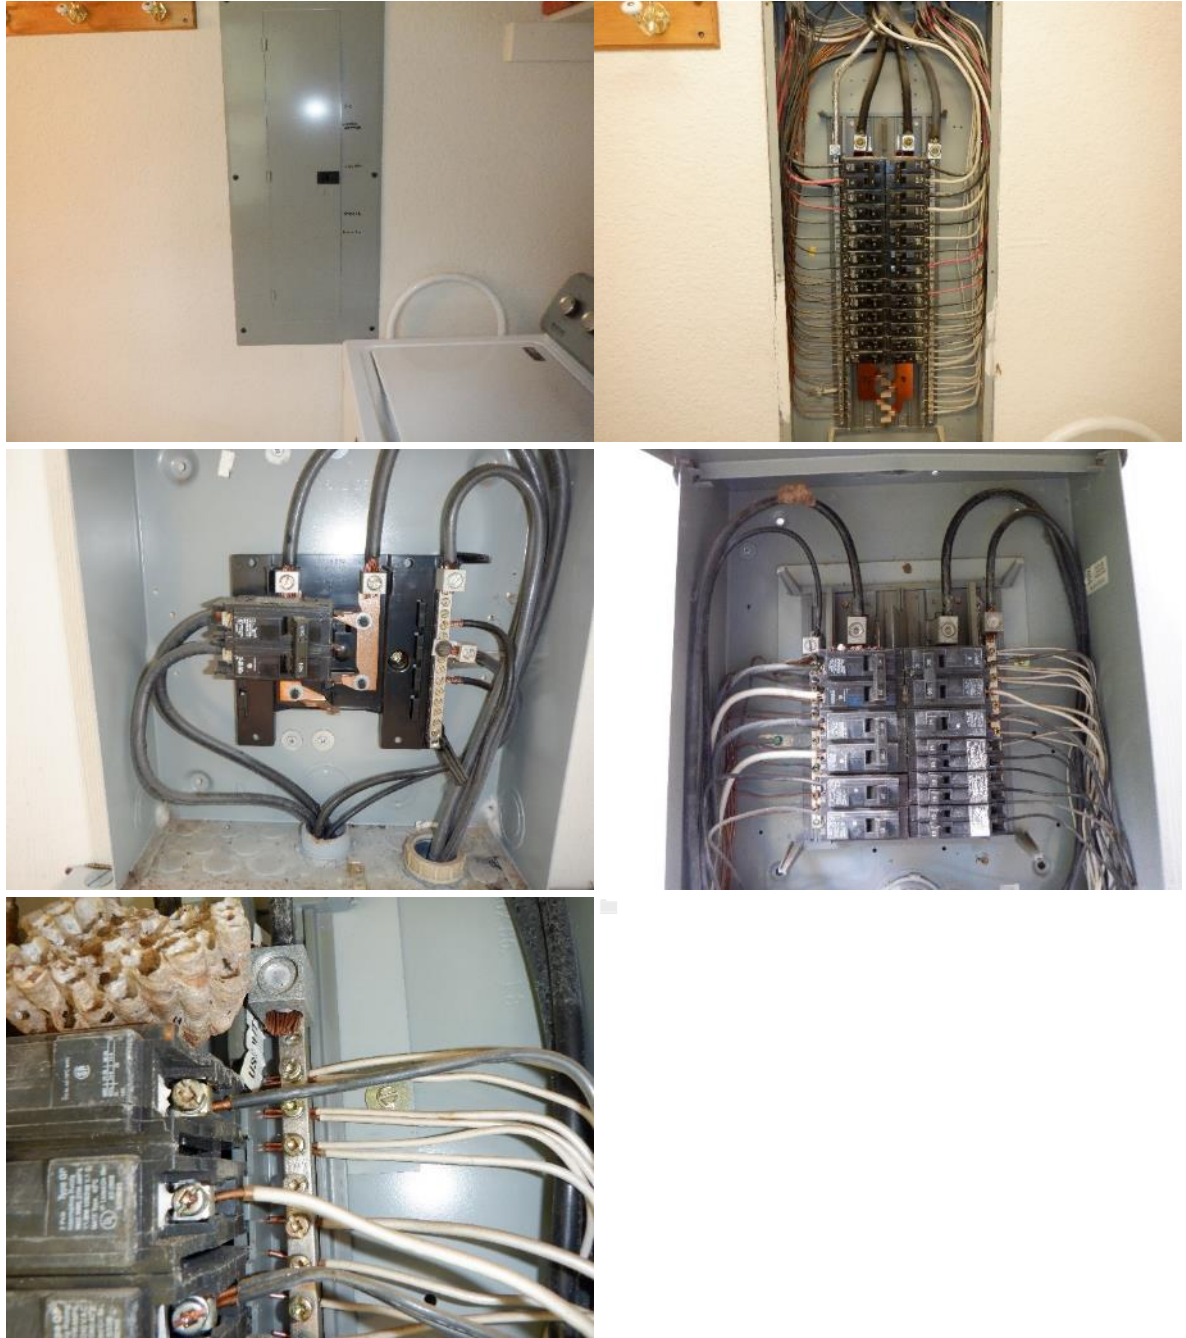
- The main panel is on the utility pole. Some lugs in this panel are corroded. This should be further evaluated by a licensed electrician. There is a double-tapped breaker in the panel. This is where two wires are connected to a breaker intended for use with only one wire. This presents an increased risk of a loose connection. The double-tapped breaker is a 30 amp 110. Wires connected to this breaker look like they should be connected to 20 amp breakers. I could not tell what one wire feeds, but the other feeds the outlet under the panel. There is a 30 amp 240 breaker in this panel with only one wire attached. If this is a 110 circuit, then using a 110 breaker would be more appropriate. Wasp nests should be removed from the panel. Proper bushings or cable clamps are needed where some wiring passes through the bottom of the panel. One run of conduit under the panel is not properly attached to the panel leaving a gap. The amp rating on one breaker in this panel is not legible. This should be evaluated by an electrician. The breakers are not labeled.

- Many breakers are not labeled. All should be accurately and legibly labeled.
- White wires connected to breakers should be re-identified with red tape at each end to indicate they are used as hots instead of neutrals.

- The connection to a grounding electrode was not visible and not confirmed.
- Contact a licensed electrician for further evaluation and repair as needed.

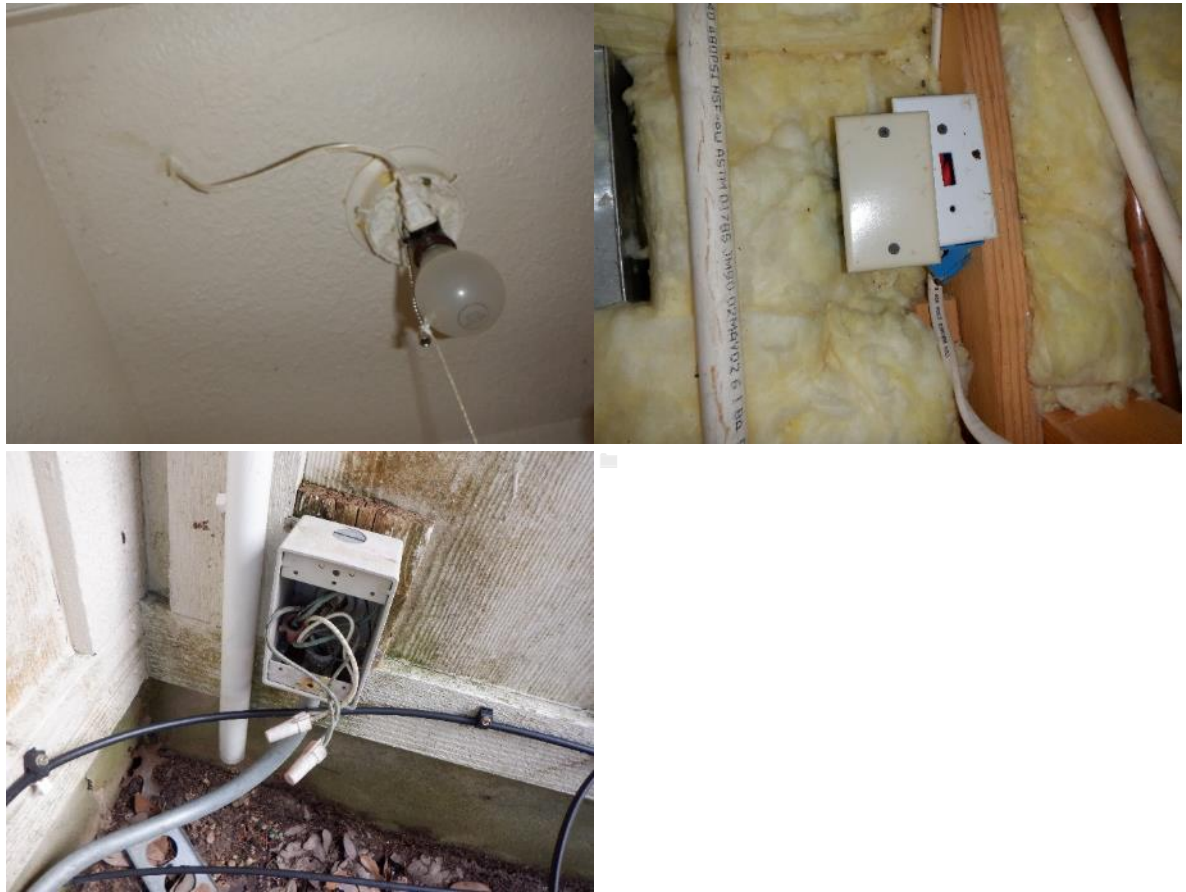
- The light outside the pantry closet uses a cord that runs through the sheetrock into the pantry where it plugs in. This type of cord should not pass through a wall or partition.
- There is a junction box in the left side attic that uses two separate plates as a cover, one of which has an opening. A properly sized dead front plate should be used.
- There is an open junction box on the exterior near the water heater closet door. A cover plate is needed.
- The cable running to the outlet under the main panel does not appear appropriate for exposed exterior use.

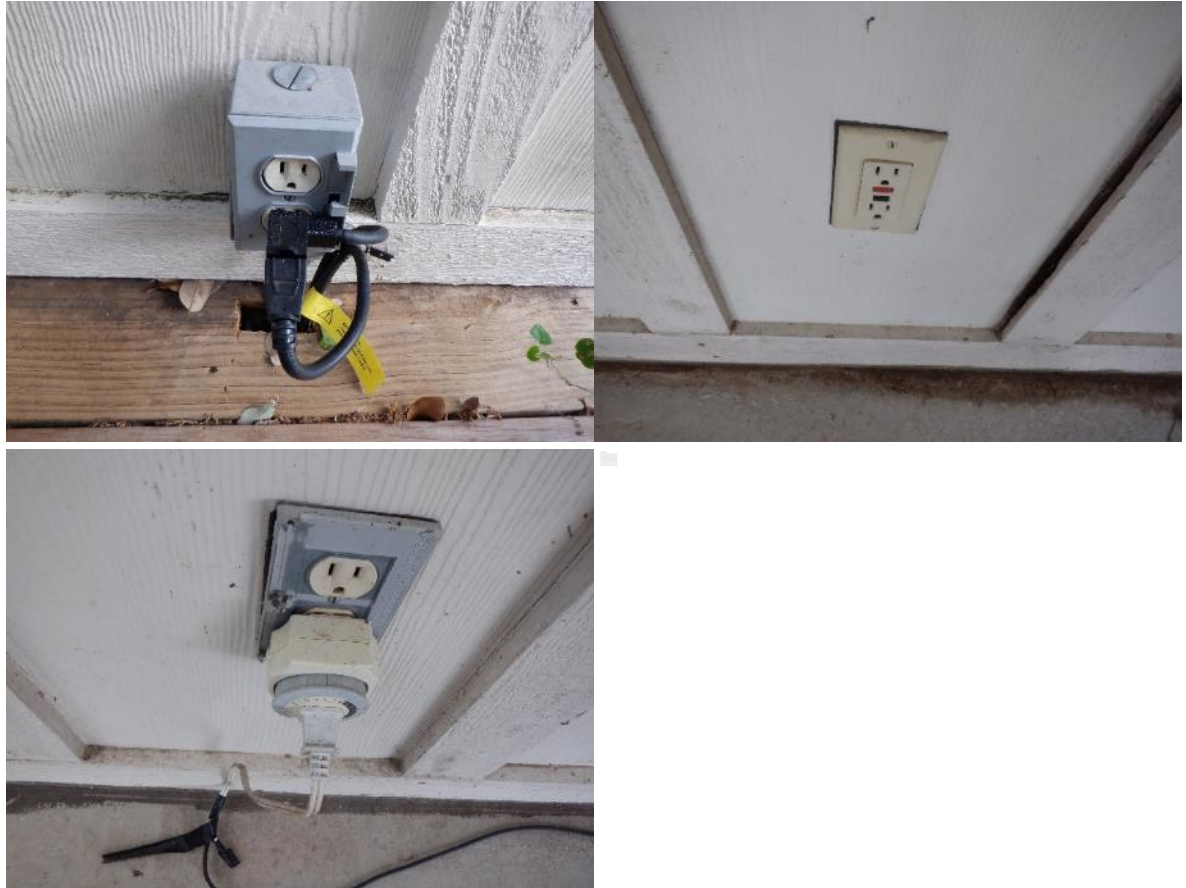
- Ground Fault Circuit Interrupter (GFCI) protection is required at all exterior, garage, bathroom and kitchen countertop outlets, and at outlets within 6' of any other sink or wet area. GFCIs are designed to provide accidental shock protection in these areas. GFCI protection is not provided at most of the exterior outlets or at the shared bathroom outlet by the door to the front bedroom. The only GFCI protected exterior outlets are the ones at the back concrete patio area. There is a GFCI outlet on the front exterior wall near the front door, but it is either defective or miswired. It is tripped and will not reset. There is another GFCI outlet on the exterior at the right side of the back bedroom area, but it

does not trip when tested with a receptacle tester or when the test button on the outlet is pressed. This is also defective or miswired.

- All exterior outlets need cover plates appropriate for exterior use. Hinged covers are broken off of some, and some have plates intended for interior use.

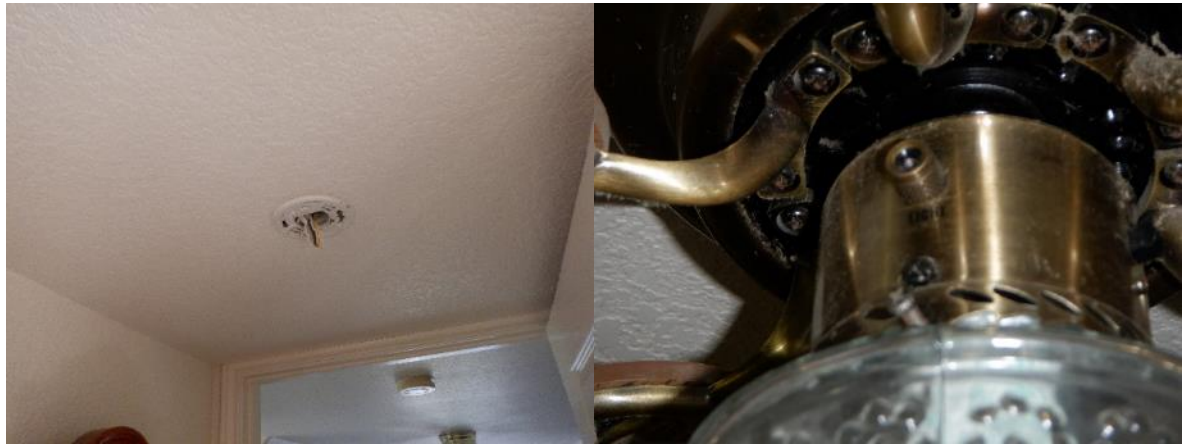
- There should be a smoke detector in each bedroom and in the space outside each sleeping area. Some smoke detectors have been removed.
- There is no pull chain for the light at the ceiling fan in the bathroom off of the dining room.

- The ceiling fan in the back bedroom is noisy.
- I was not able to locate a switch to operate the water heater closet light.
- The pantry closet light does not work. One back patio fixture does not work, and there are several bad bulbs in the others. At least one of the exterior corner bulbs does not work. There is a missing bulb in the fixture over the sink in the bathroom off of the dining room. There are two bad bulbs in the fixtures over the shared bathroom sinks. New bulbs should be installed to be sure that the fixtures are working properly.

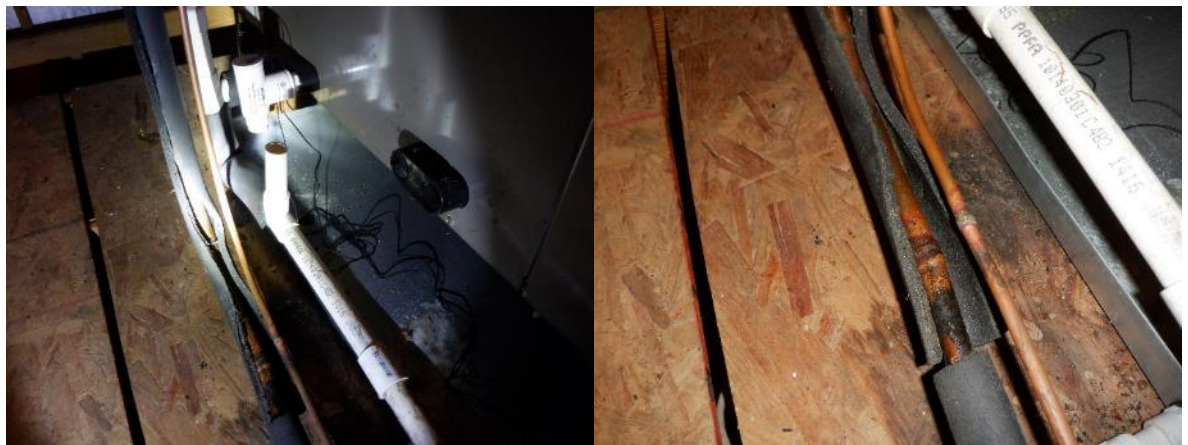
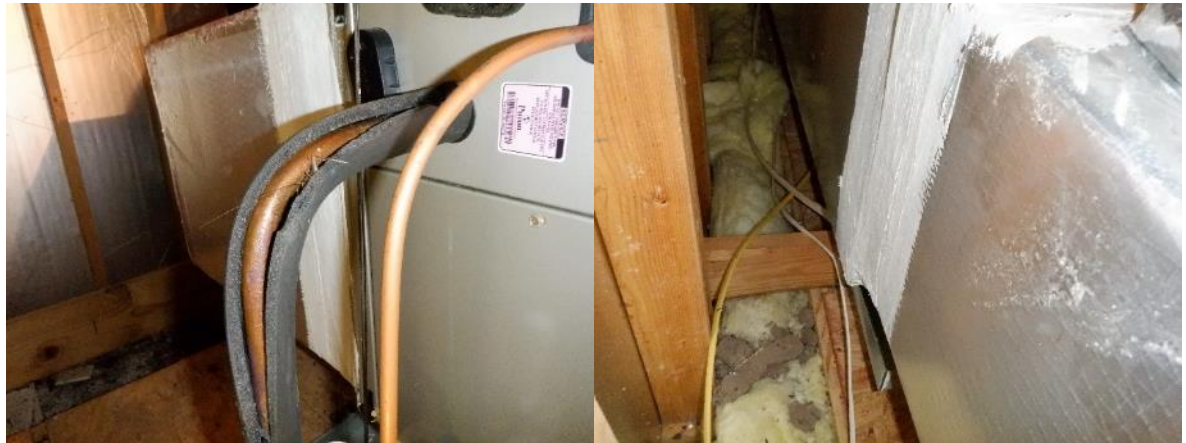
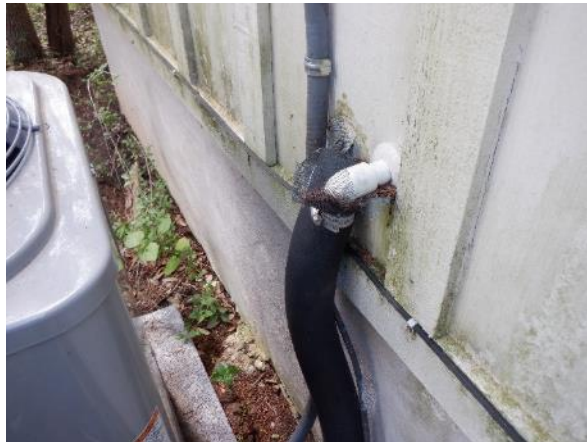
- There should be an electrical disconnect adjacent to the air handler in the attic accessed through the small door in the upstairs bedroom. The main condensate drain line in the attic by this unit should be insulated. Split or damaged refrigerant line insulation by this unit should be replaced.
- The pan should extend at least 1.5" beyond each edge of the air handler. The back of the air handler in the attic accessed through the pull-down stairs sticks out past the edge of the pan.
- The main condensate drain pipe for the left side unit drips at the edge of the foundation. It should be extended to get water away from the edge of the foundation.

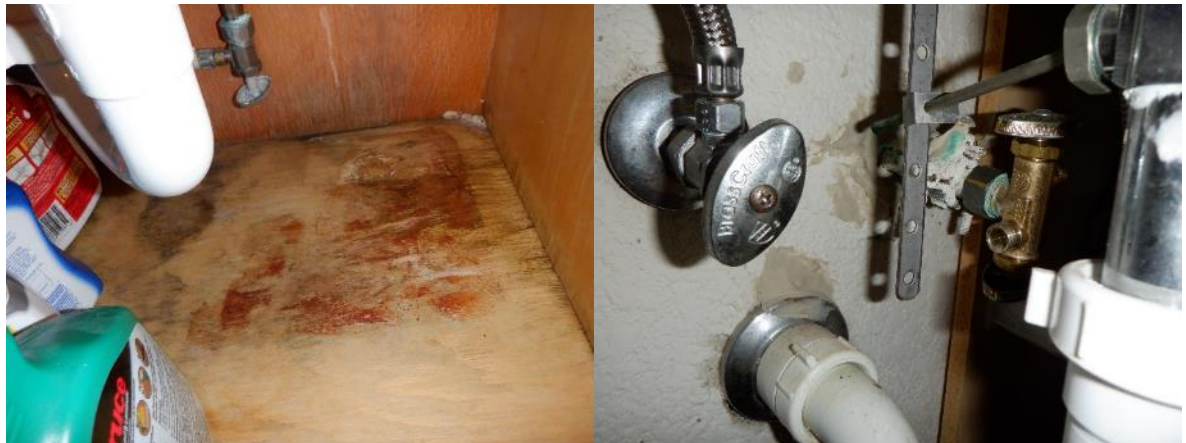
- There is some discoloration on the cabinet under the kitchen sink. No active leakage was visible. This may be due to a prior leak or spillage under the sink.
- One of the sinks in the shared bathroom drips.
- The cold water shut off valve under the upstairs sink was off when I arrived. I opened it for testing and found that it drips. I closed the valve and verified that it was no longer leaking before leaving.
- Note: One of the shut off valves under a sink in the shared bathroom is now abandoned. Supply to that sink comes from a shut off valve under the other sink.

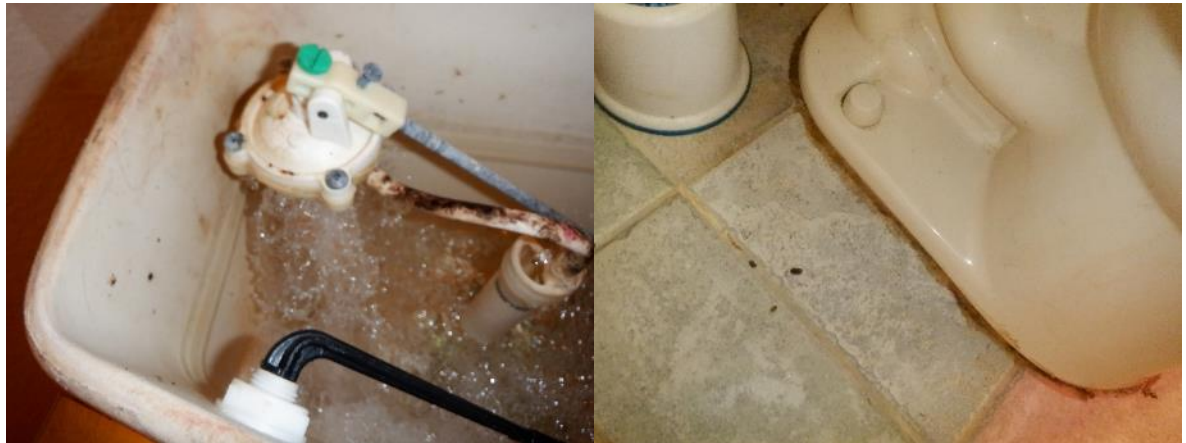
- The toilet in the bathroom off of the dining room works, but it refills around the top of the fill valve instead of through the refill tube.
- There is some discoloration around the base of the shared bathroom toilet, but no active leakage was visible after several flushes.
- The shut off valve under the upstairs bathroom toilet was closed when I arrived. I opened it for testing and then closed it again before leaving.

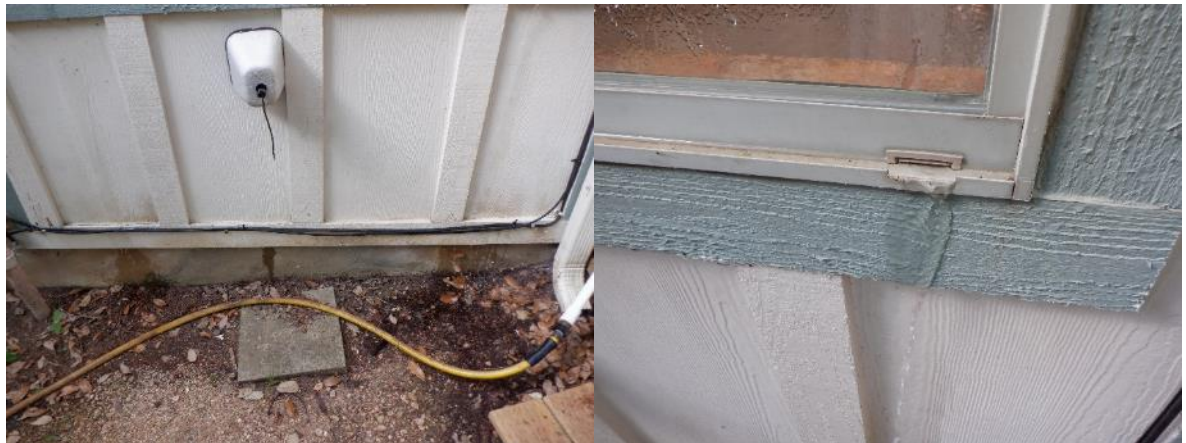
- There is a large window in the enclosure of the bathroom off of the dining room. Water from the shower head hitting this window runs out the window's weep holes as intended but also drips out from under the siding on the exterior. Water may be leaking into the wall cavity under the window. There are two windows in the shared bathroom enclosure with glass blocks. I did not get any leakage at the side window, but when water hits the window on the wall opposite the shower head it drips down outside from behind the siding. These should be further evaluated and repaired as needed by a specialist. Some tear out may be needed for further assessment.

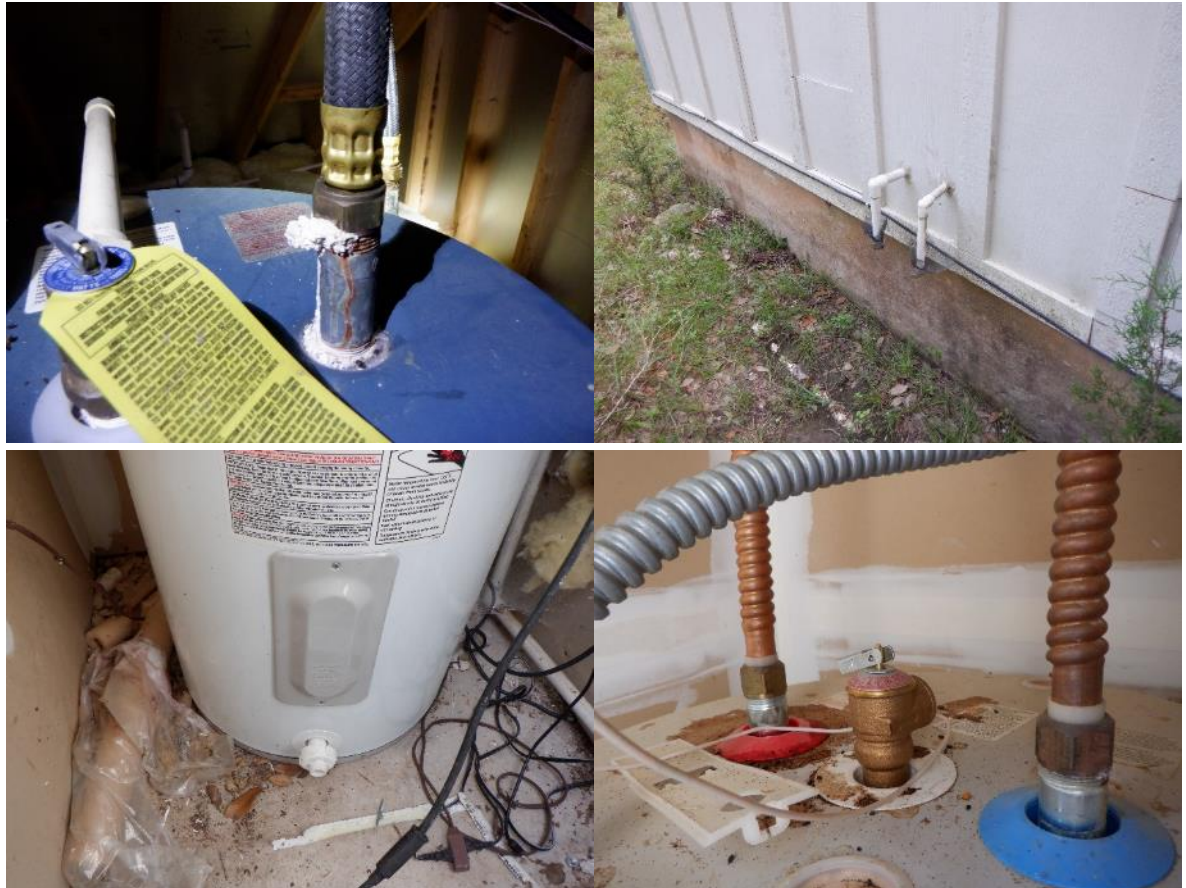
- There is a 30 gallon water heater in the attic over the shared bathroom. This water heater was manufactured in 2002. It is at or near the end of its expected useful life. There are mineral deposits and rust on one of the fittings over the unit. This should be further evaluated and repaired as needed by a

- There is a 40 gallon water heater in an exterior closet. There should be a drain pan piped to the exterior under the water heater. There should be a drain line attached to the temperature-pressure relief drain valve. It should run to a safe, visible place near the ground on the exterior.
- There should be an electrical disconnect adjacent to each water heater.

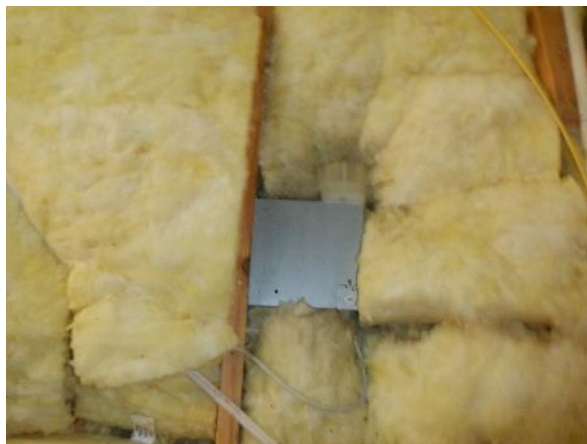
- Bathroom exhaust fans should vent to the exterior. These units vent to the attic.

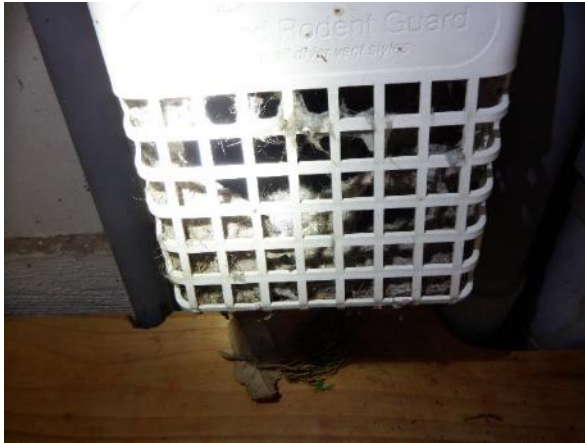
- The bird and rodent guard is clogged with lint and should be cleaned or removed.
