# *TOC Home Inspections*

## Property Inspection Report

1614 Droxford Dr, Houston , Tx 77008

Date of Inspection: 9/29/2015 Time: 10:00 AM Sunny and 71 Degrees

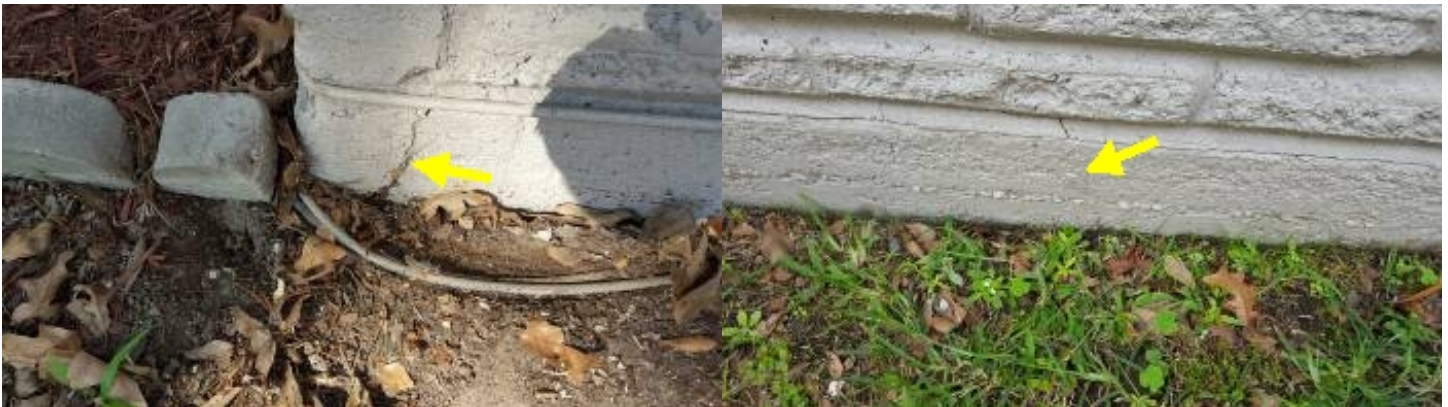
Corner or Wedge crack - This is a common condition to observe with slab on grade foundations. These cracks develop as a result of the expansion of the brick veneer when it is warmed by the sun. - Recommend sealing with an approved material to prevent further / future moisture penetration. NOTE: Cracks that extend into the ground, should have the soil removed and be properly patched and sealed to prevent this from being a means for wood destroying insects to enter the house left rear corner and left front corner of foundation

Observed a vertical cracks in the foundation on the left and right sides of the foundation. I did not observed any shifting, deflections in the Foundation, Walls or at the windows. At the time of the inspection. It is this inspector's opinion that the foundation of the house appears to be performing its intended function. As discussed this cracks should be patched and monitored in the future for further activity.

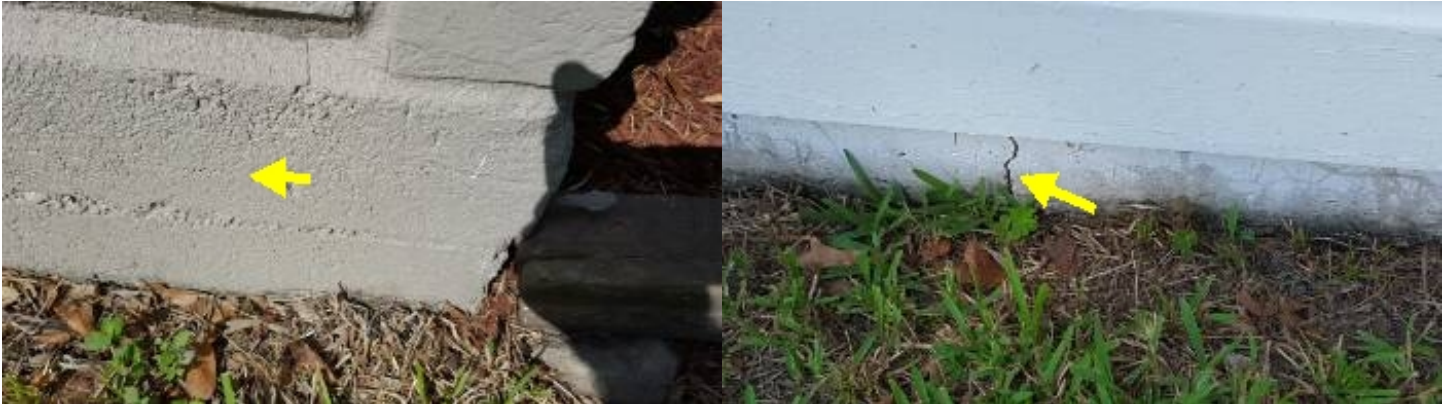
Corner or Wedge crack - This is a common condition to observe with slab on grade foundations. These cracks develop as a result of the expansion of the brick veneer when it is warmed by the sun. – Recommend sealing with an approved material to prevent further / future moisture penetration. NOTE: Cracks that extend into the ground, should have the soil removed and be properly patched and sealed to prevent this from being a means for wood destroying insects to enter the house left rear corner and left front corner of foundation

Observed a vertical cracks in the foundation on the left and right sides of the foundation. I did not observed any shifting, deflections in the Foundation, Walls or at the windows. At the time of the inspection. It is this inspector's opinion that the foundation of the house appears to be performing its intended function. As discussed this cracks should be patched and monitored in the future for further activity.

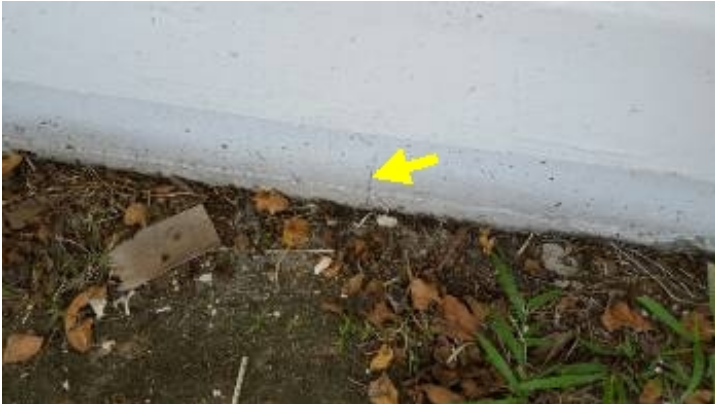
Observed a vertical cracks in the foundation on the left and right sides of the foundation. I did not observed any shifting, deflections in the Foundation, Walls or at the windows. At the time of the inspection. It is this inspector's opinion that the foundation of the house appears to be performing its intended function. As discussed this cracks should be patched and monitored in the future for further activity.

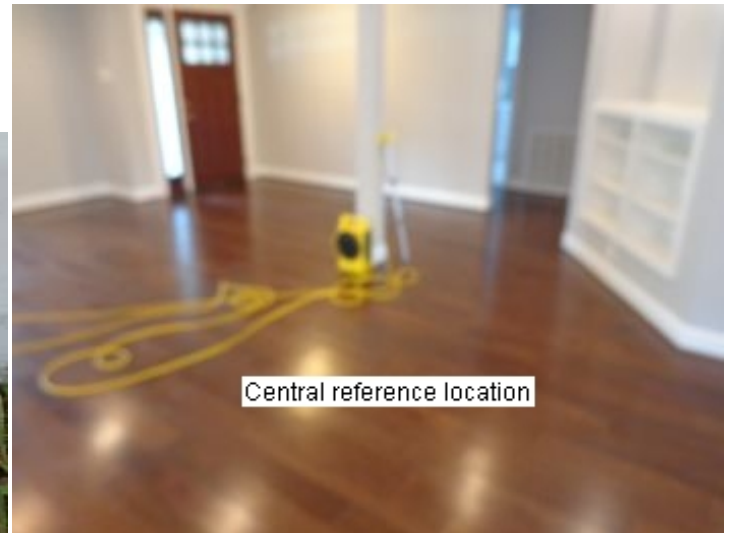
"Foundation level check - Base measurement is taken from the approximate central location of the house - At the left side of the Family room  
Level reference is 0.00 - Left front corner is - 0.07 inches of deviation, Left rear corner is + 0.09 inches of deviation, Right rear corner is - 0.00 inches of deviation, Right front corner has - 0.00 inches of deviation. - Level readings are within acceptable limits and I observed no problems at time of inspection

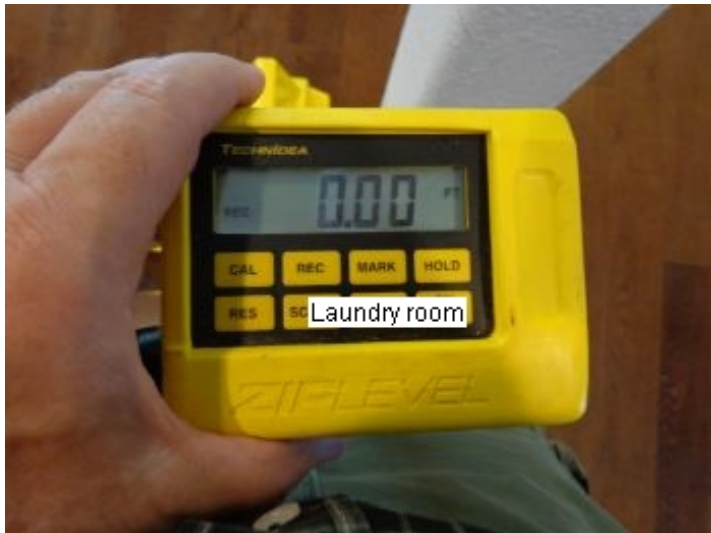
"Foundation level check - Base measurement is taken from the approximate central location of the house - At the left side of the Family room

Level reference is 0.00 - Left front corner is - 0.07 inches of deviation, Left rear corner is + 0.09 inches of deviation, Right rear corner is - 0.00 inches of deviation, Right front corner has - 0.00 inches of deviation. - Level readings are within acceptable limits and I observed no problems at time of inspection

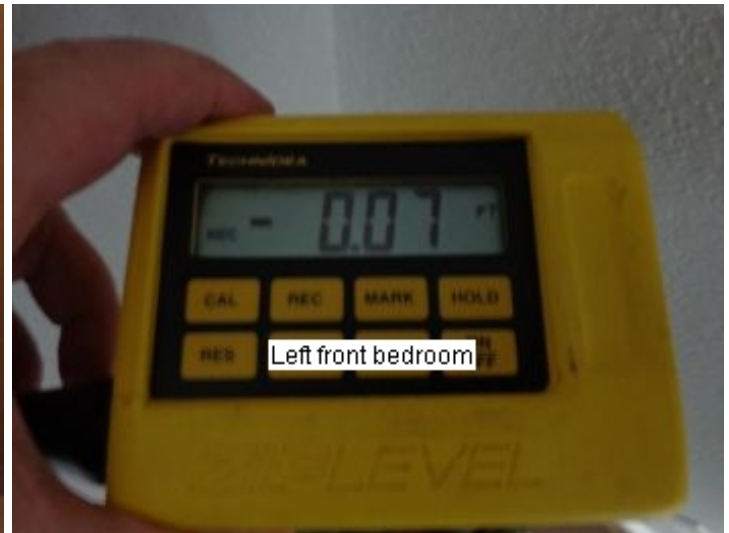
"Foundation level check - Base measurement is taken from the approximate central location of the house - At the left side of the Family room

Level reference is 0.00 - Left front corner is - 0.07 inches of deviation, Left rear corner is + 0.09 inches of deviation, Right rear corner is - 0.00 inches of deviation, Right front corner has - 0.00 inches of deviation. - Level readings are within acceptable limits and I observed no problems at time of inspection

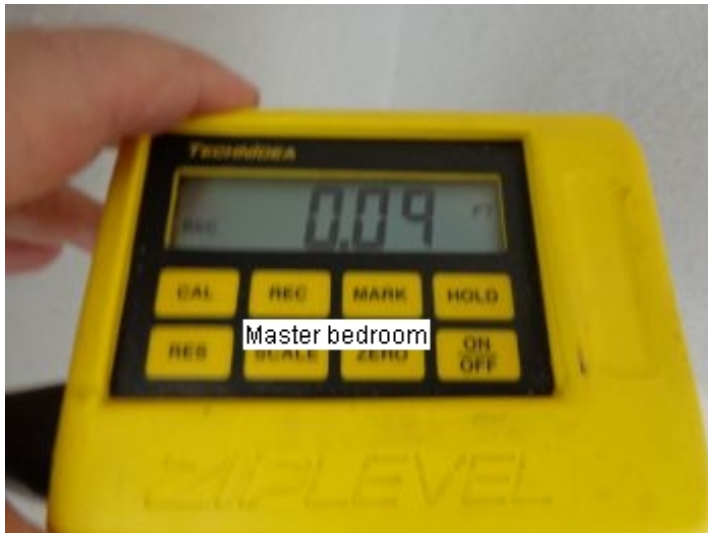
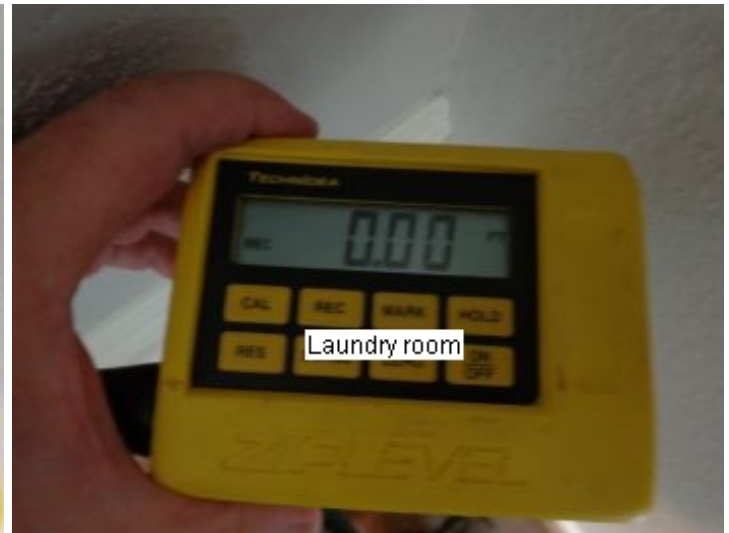
"Foundation level check - Base measurement is taken from the approximate central location of the house - At the left side of the Family room

Level reference is 0.00 - Left front corner is - 0.07 inches of deviation, Left rear corner is + 0.09 inches of deviation, Right rear corner is - 0.00 inches of deviation, Right front corner has - 0.00 inches of deviation. - Level readings are within acceptable limits and I observed no problems at time of inspection

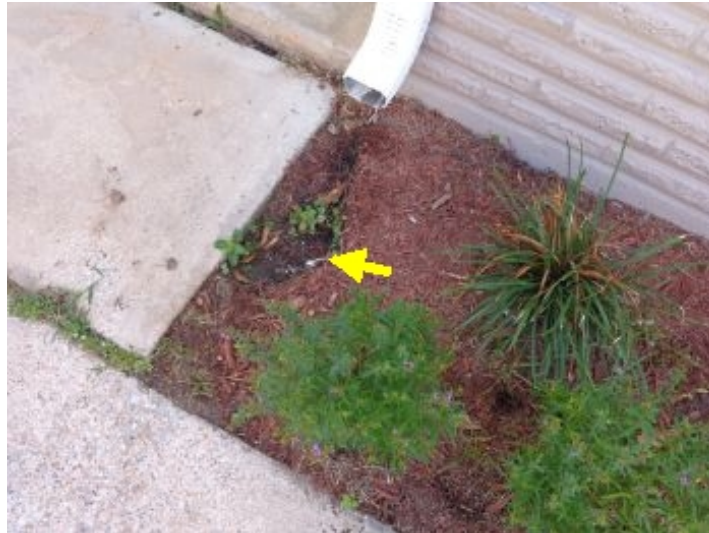
Ponding of water at foundation due to missing gutter down spouts missing deflectors or splash blocks. to route the water away from the foundation. Recommend filling depressions & establishing proper drainage. Top soil should be at least 4" below brick line or bottom of siding & sloped away from the foundation. -

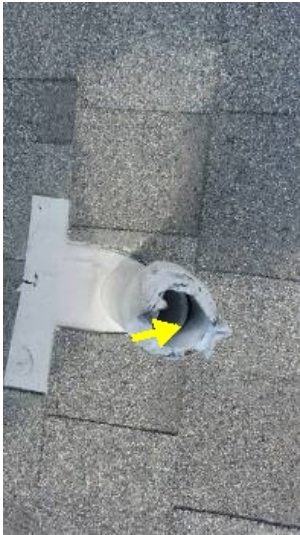
Lead covering the top of the plumbing vent pipe/stack or flashing is damaged. Open area allows water to enter between flashing and pipe down into roofing members or down into the attic insulation. Water intrusion into roofing members will aid in premature end of roof lifespan or water could drip down into the attic insulation and cause more damage. - Recommend repair. - 2 locations on the right side of the roof and 1 on the rear center of roof

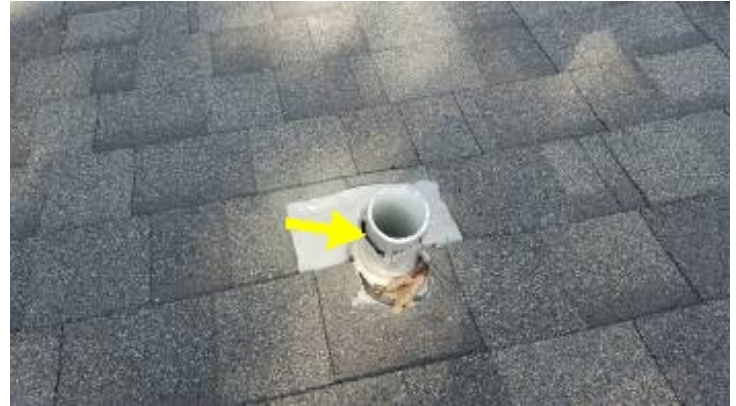
Lead covering the top of the plumbing vent pipe/stack or flashing is damaged. Open area allows water to enter between flashing and pipe down into roofing members or down into the attic insulation. Water intrusion into roofing members will aid in premature end of roof lifespan or water could drip down into the attic insulation and cause more damage. - Recommend repair. - 2 locations on the right side of the roof and 1 on the rear center of roof

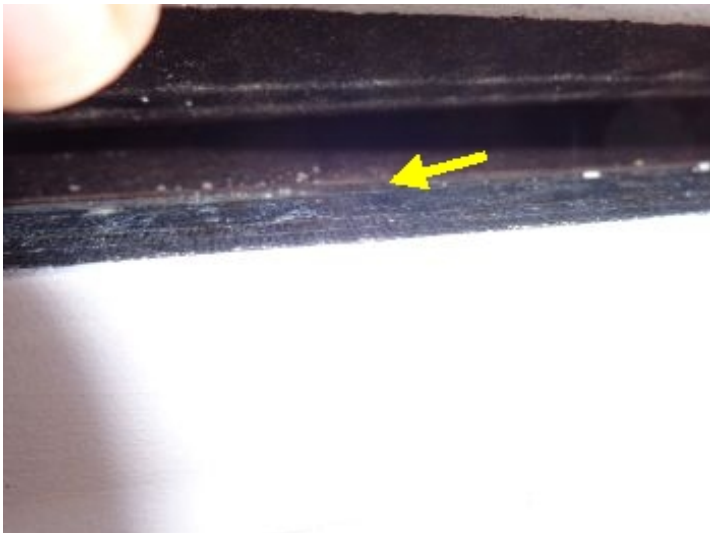
Felt paper is NOT installed over the top of the eave drip edge. Note: Proper installation is - Under the drip edge on the rake of the roof, and over the drip edge at the eaves.

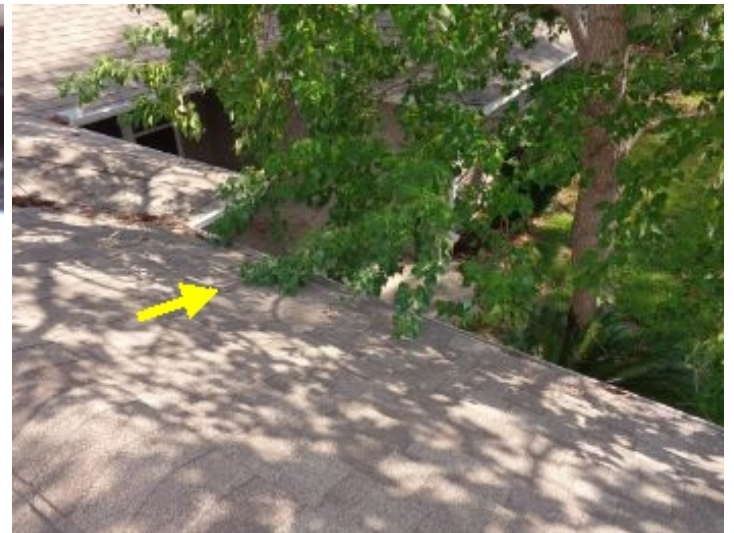
Tree branches are in contact with the roof surface. Recommend trimming tree branches away from all roof surfaces a minimum of three feet. Various locations on the roof. - House and detached garage.

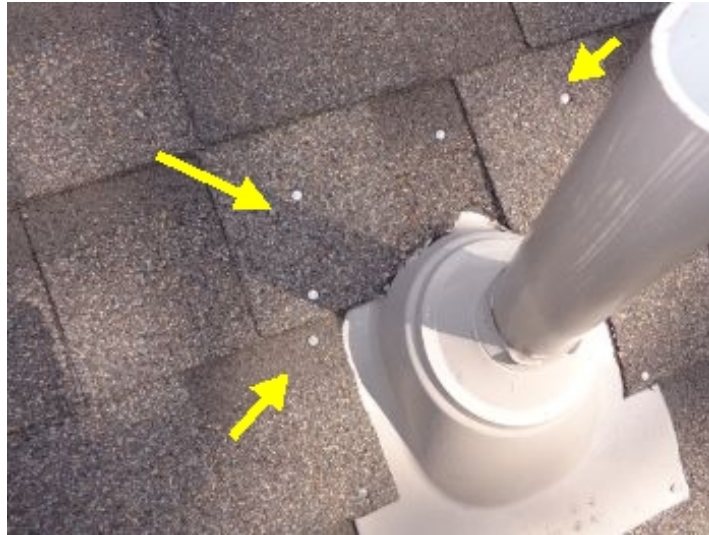
Nail heads are exposed and missing roofing sealant. – Plumbing Vent. - Roofing sealant can protect against moisture intrusion. Water running down the roof can seep in around the nails into the roof decking, attic and or interior space causing damage. NOTE: Do not use a (Silicon) based caulk. It has a chemical based reaction to the shingles and will damage the shingles. Use only a roofing sealant/mastic. - Above the Master bathroom

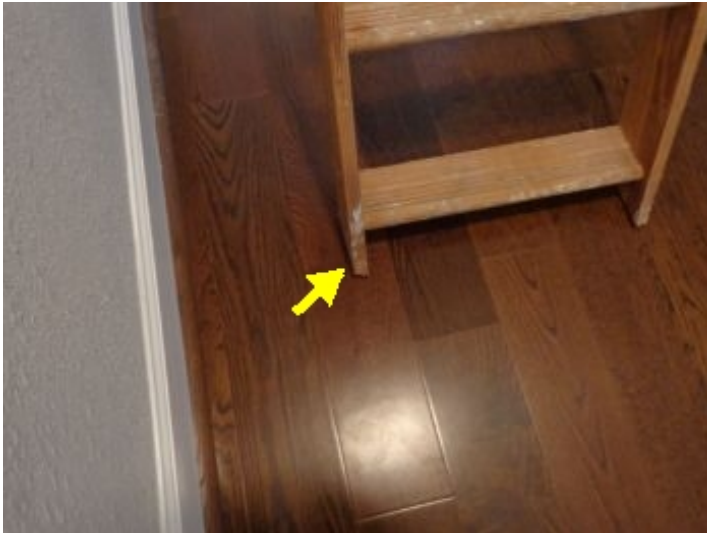
Attic access ladder - It is recommended that pads be installed at the base of the stairway unit "legs", to prevent wood flooring damage.

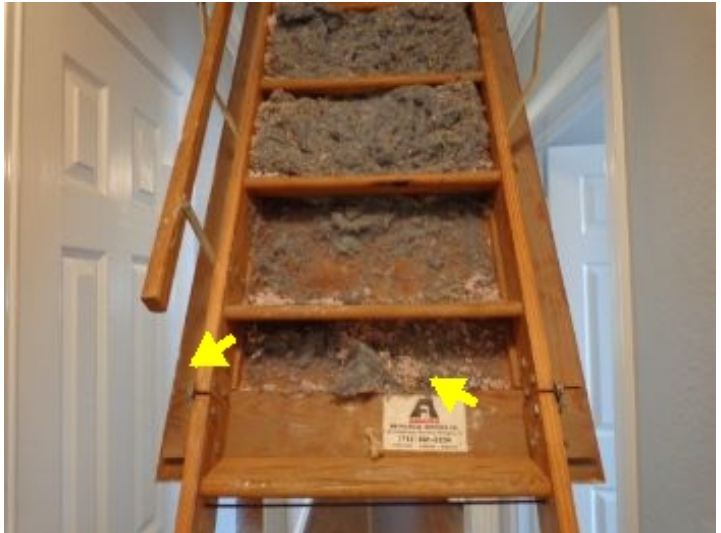
Attic access ladder - Insulation displaced on door - I recommend replacing with Foam board type material sometimes works better as it will not slide down or move when ladder is being used etc. Also adding weather stripping around the edge - To improve energy efficiency.

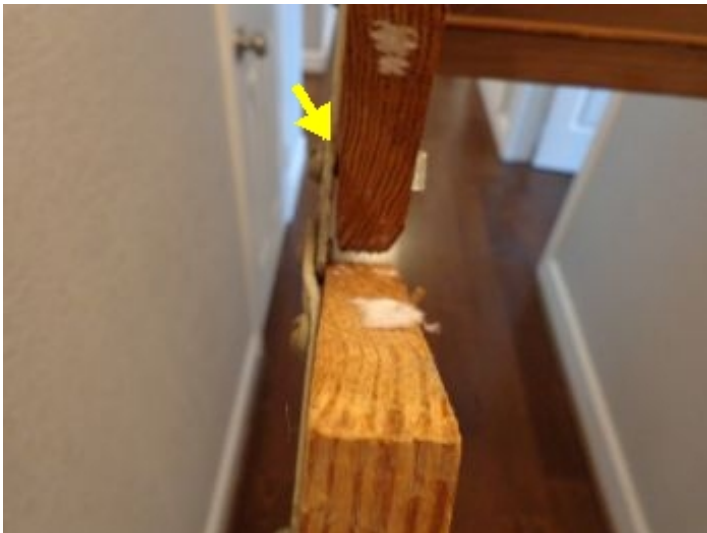
Attic access ladder - Hardware is loose, damaged or missing. - Recommend repair before using for safety. Periodically inspection of the metal brackets and hardware is needed as they tend to loosen. Tighten as needed.

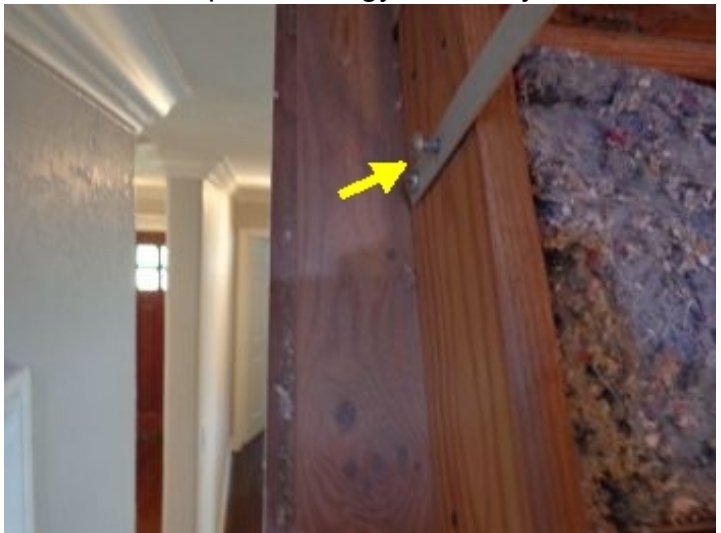
Attic access ladder - Hardware is loose, damaged or missing. - Recommend repair before using for safety. Periodically inspection of the metal brackets and hardware is needed as they tend to loosen. Tighten as needed.

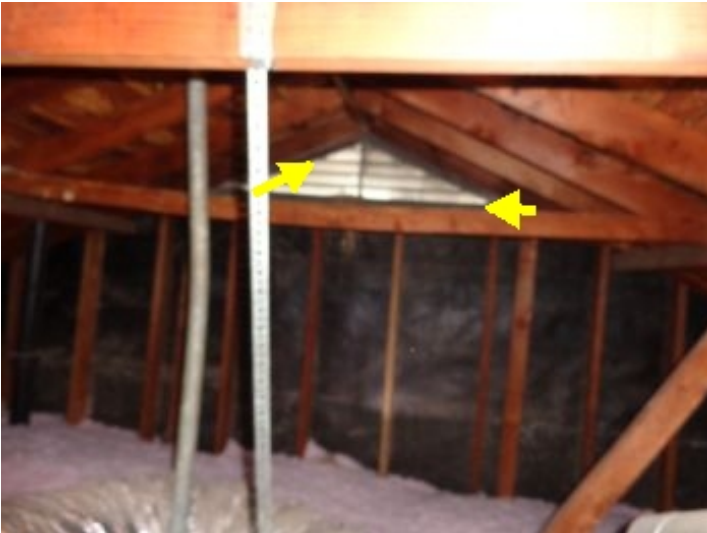
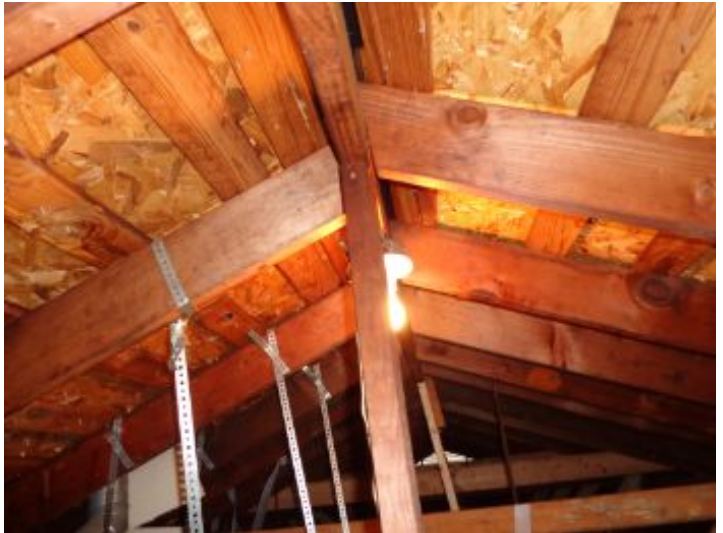
Gable vent screen has hole/s in it or is damaged - Recommend correcting, to help prevent insects and/or rodents from entering attic - Left and right sides of the attic.

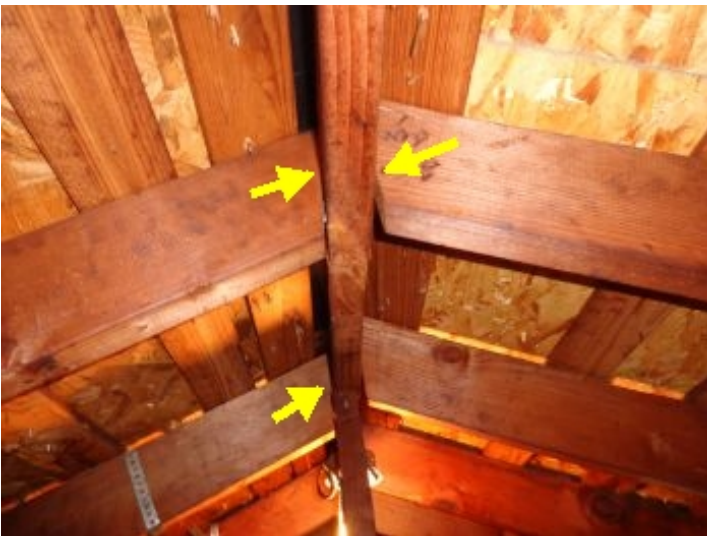
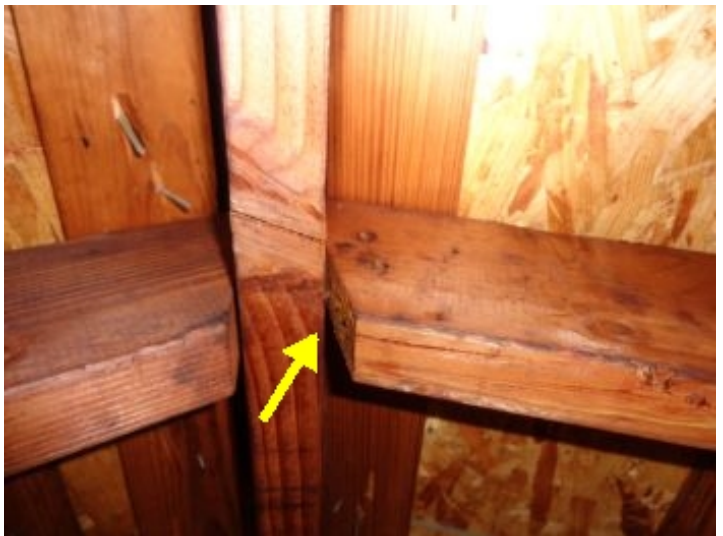
Rafters to ridge beam have a gap in in them and are not solidly braced.

Ridge beam is not the full size of the rafters. Under todays code the ridge beam should be no less than the size of the rafters.

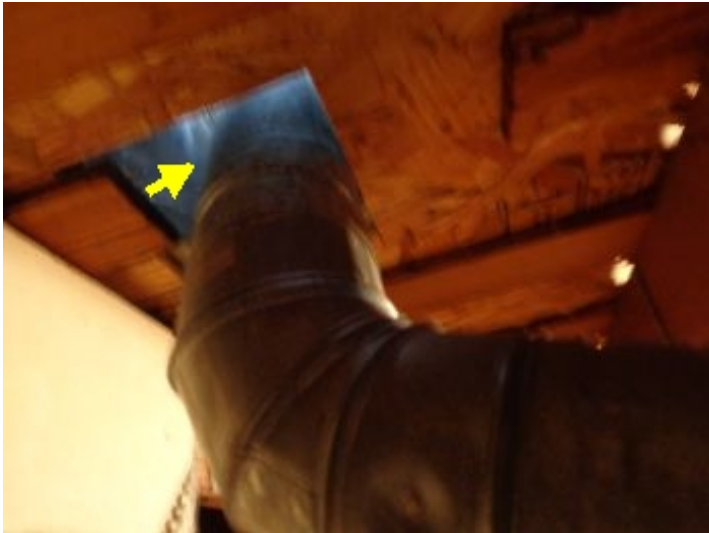
Exhaust vent for Heating system/s has daylight coming thru exhaust roof vent. The roof exhaust vent needs to be sealed at the roof decking. - To prevent carbon monoxide/combustion gases from reentering attic.

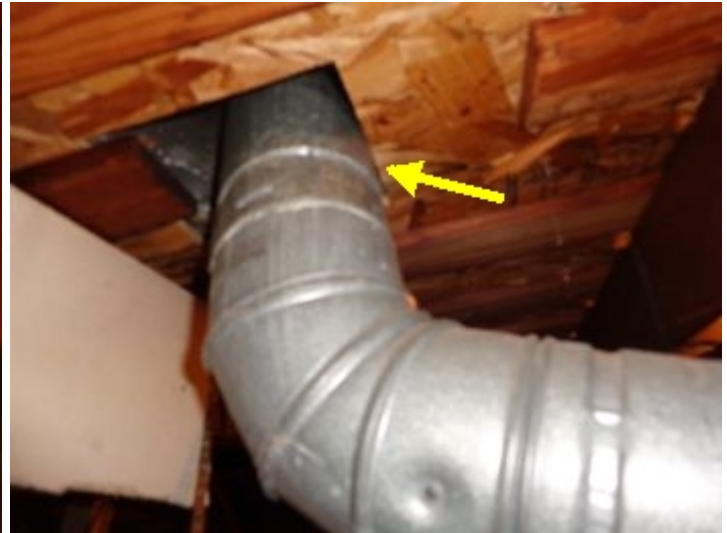
Exhaust vent for the Heating system/s is in contact with the roof decking/roof covering material - Should have 1 inch clearance minimum for fire safety. -

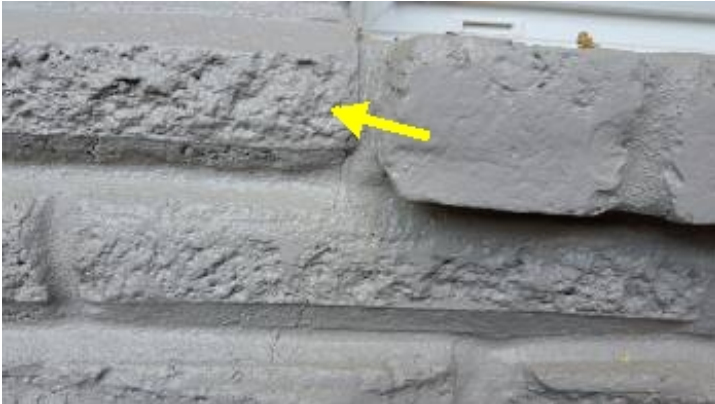
observe damage brick right side of house next to the kitchen window

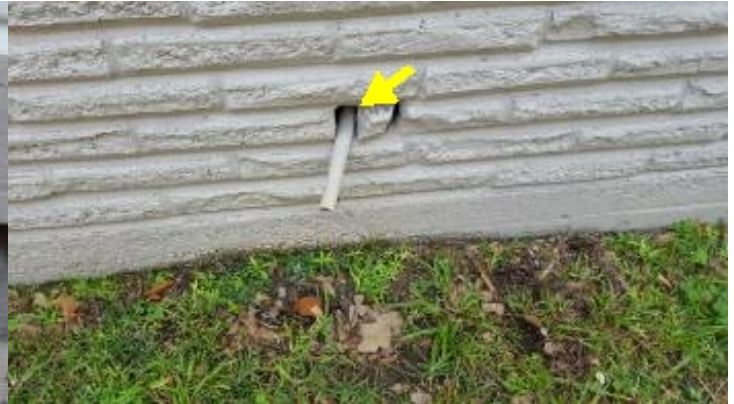
Hole in exterior wall with drain line running thru it is not caulked and sealed - left side of the house.

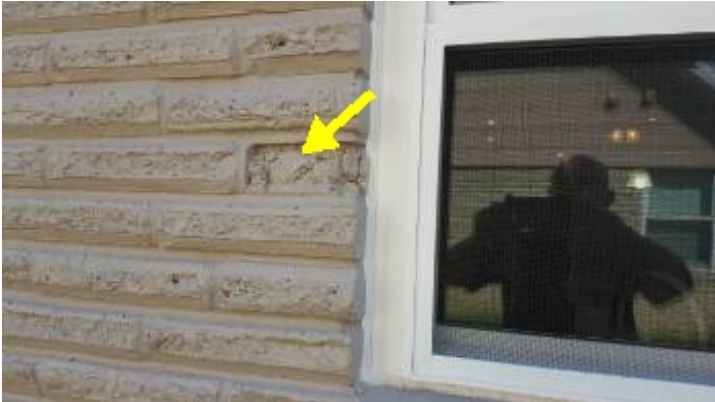
observe damage brick right side of house next to the kitchen window

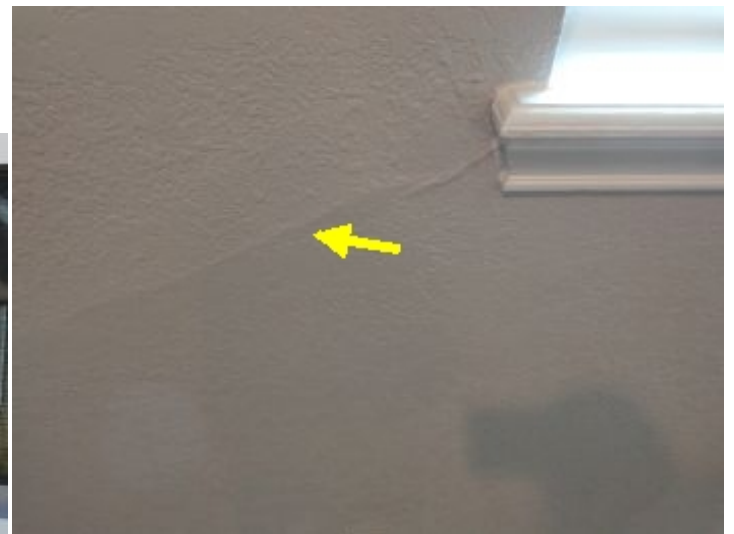
Note: Observe previous sheet rock crack has been patched and repaired and painted Master bedroom left wall

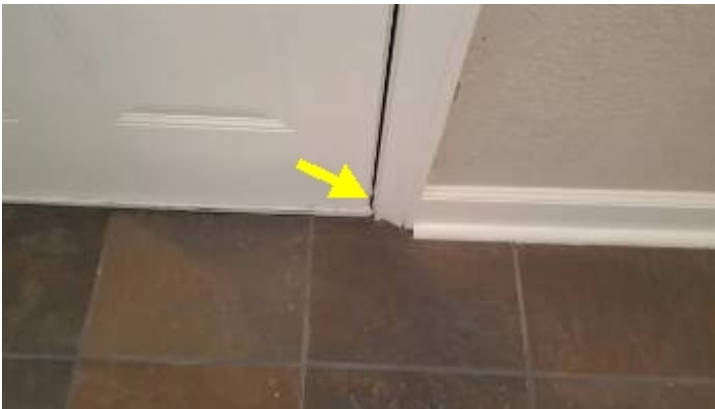
Weather strip is not sealing/damaged, could observe light entering from the exterior - at the Rear access/egress entry door to the garage and rear patio - Recommend correcting to improve energy efficiency.

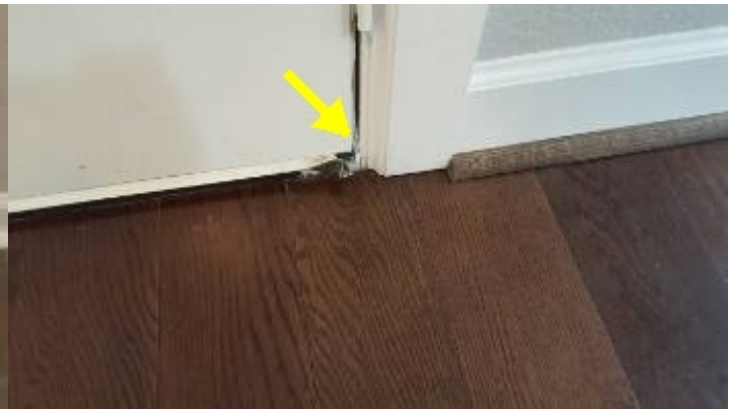
Weather strip is not sealing/damaged, could observe light entering from the exterior - at the Rear access/egress entry door to the garage and rear patio - Recommend correcting to improve energy efficiency.

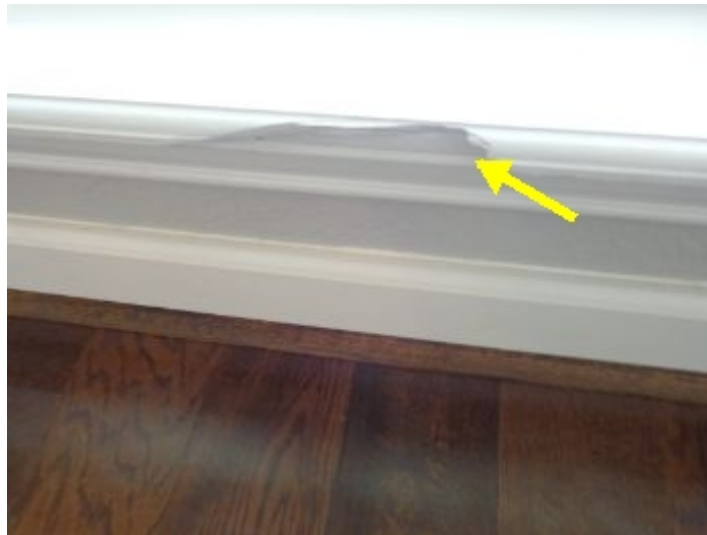
Damaged window sill - Formal room

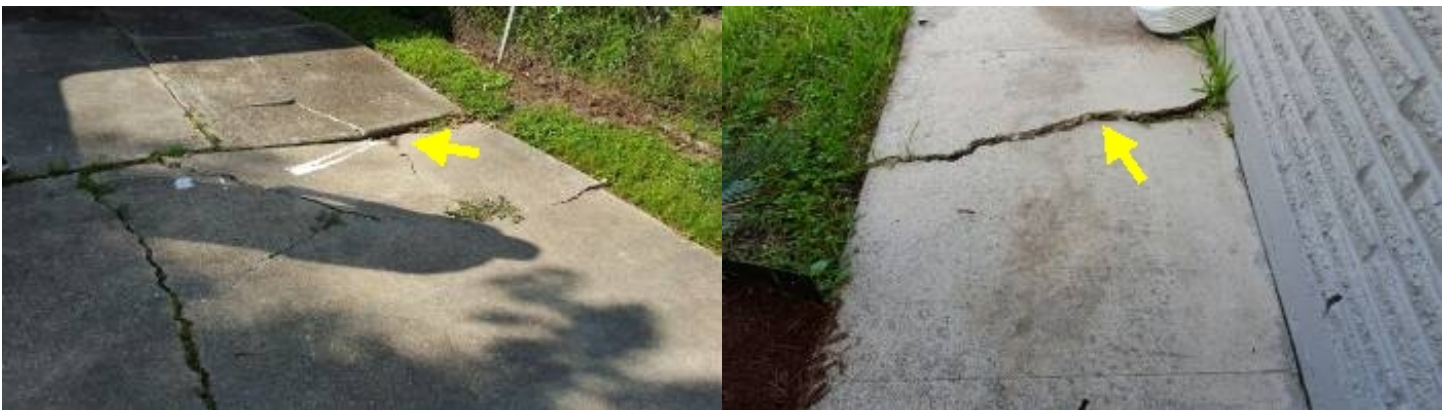
Driveway is cracked and damaged with uneven sections - Greater than 1" difference. This is considered a potential tripping hazard. - Recommend repair.

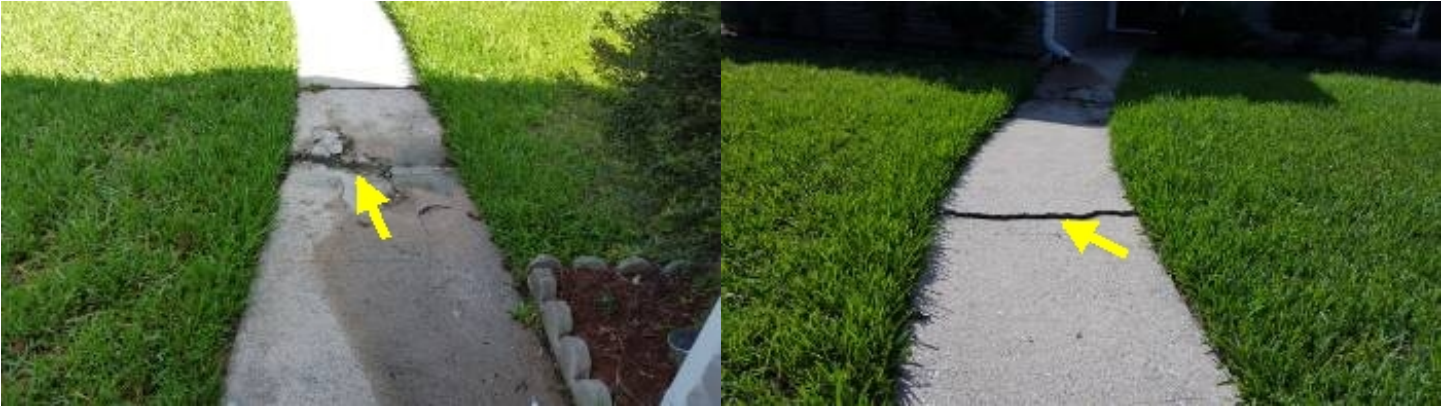
Walkway to the front entry - Damaged or raised/uneven sections - Greater than 1" difference, is considered a potential tripping hazard. - Recommend repair.

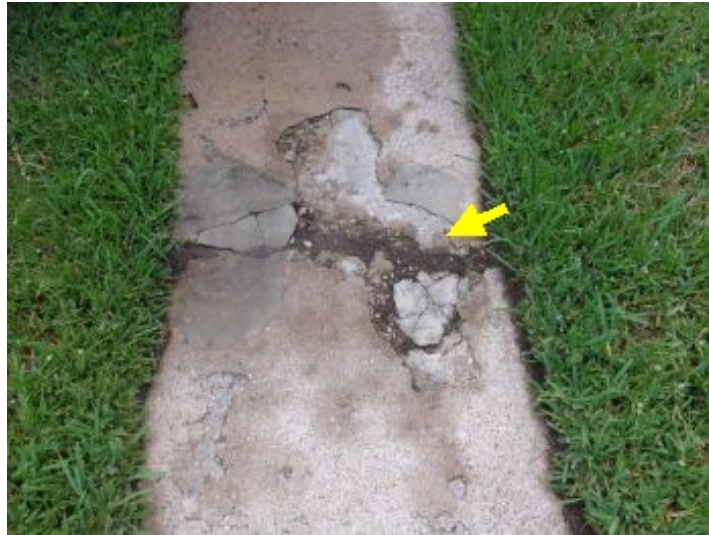
Walkway to the front entry - Damaged or raised/uneven sections - Greater than 1" difference, is considered a potential tripping hazard. - Recommend repair.

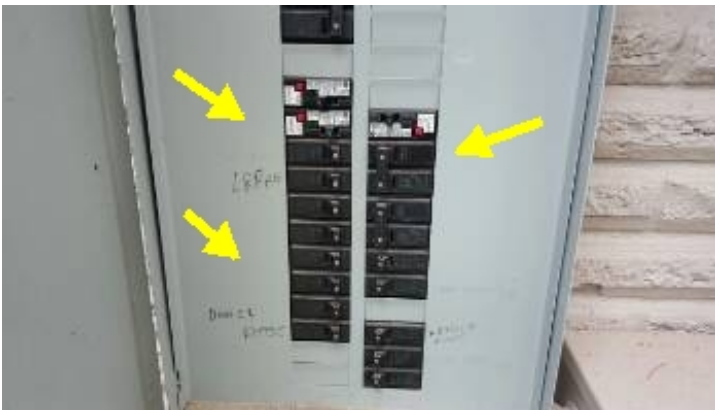
Label all circuit breakers - Panel board circuit breakers are not completely labeled, or the labeling has faded. – Recommend clearly labeling all circuit breakers.

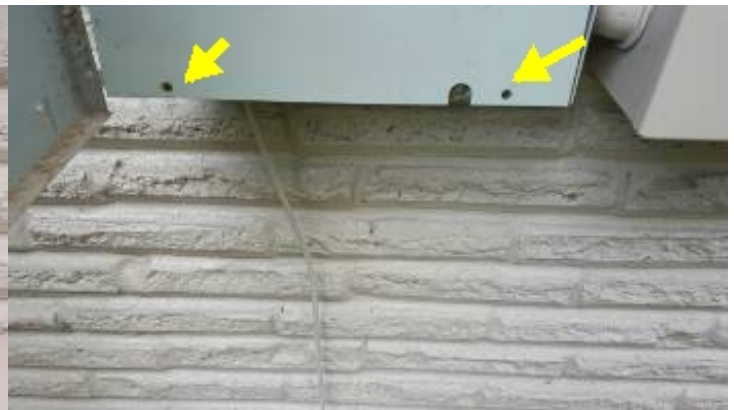
Screws missing for dead front cover plate – Note: Screws should have a flat tip, not pointed

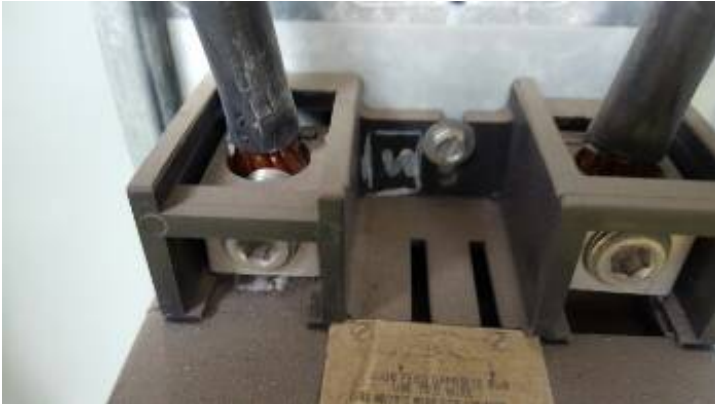
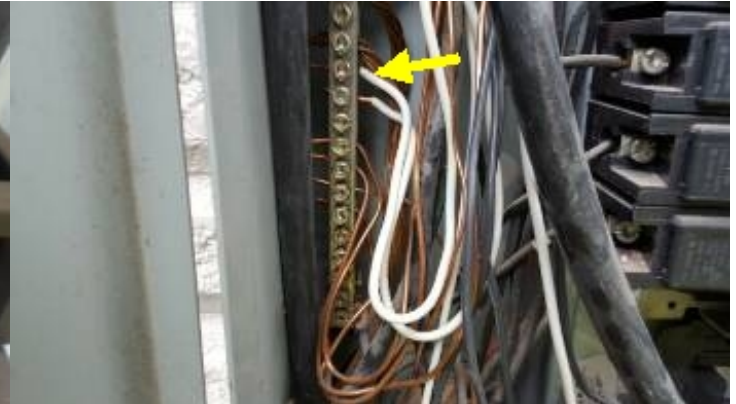
White "Neutral" and ground wires on the the same bonding bar. Should be on a separate bars, under todays rules.

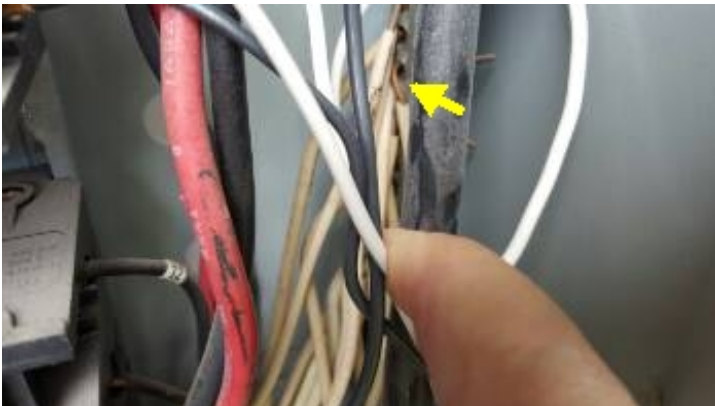
White "Neutral" wires are double lugged under individual screw terminals on the neutral bus. Per the NEC, "each neutral requires individual termination." The neutral conductors should be separated so that only one conductor is connected to each screw terminal on the neutral bus.

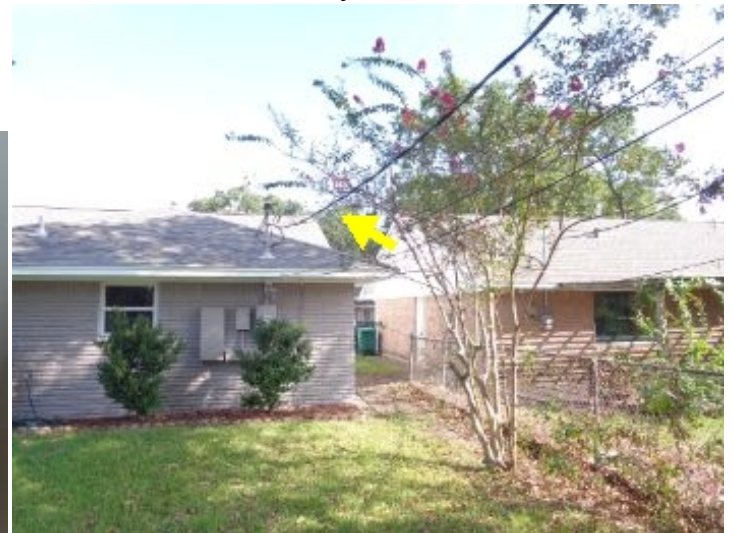
Aerial Electrical service wires - coming to the house and at the house are less than 10 feet from the ground. This not permitted for safety. Recommend raising for safety.

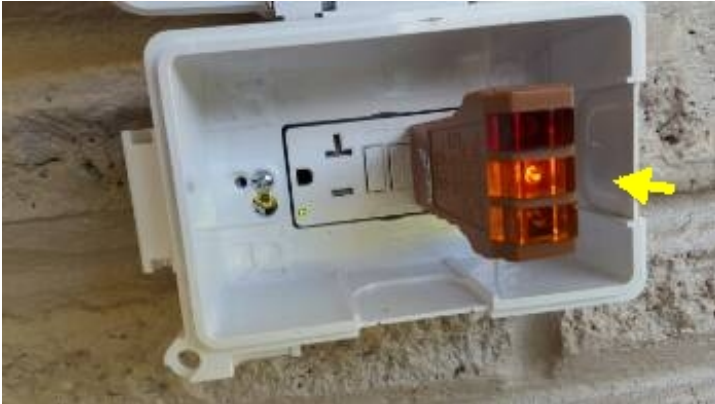
Receptacle/s test and open ground - Recommend correcting for safety - front exterior receptacle and left front bedroom front wall on the left.

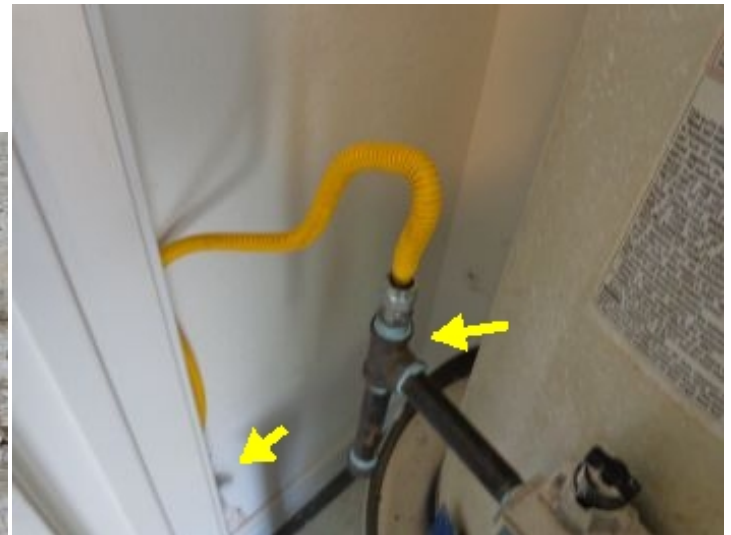
CSST is missing bonding ground. Under today's rules it should be bonded to ground at both ends for safety. CSST - Corrugated Stainless Steel Tubing (CSST) is a yellow, flexible, metal gas tubing used to supply Natural gas or propane to gas appliances and HVAC systems for both residential and commercial structures. Since 1990 The Texas State Fire Marshall, in conjunction with the National Association of State Fire Marshalls (NASFM), has launched a safety campaign in Texas to bring awareness as to the importance of properly bonding CSST. The campaign encourages property owners that are aware CSST has been installed on their property to contact a licensed electrical contractor to determine if the gas system is properly bonded. For further information regarding this safety campaign, please visit [www.csstsafety.com](http://www.csstsafety.com). - HVAC heating and Water heater

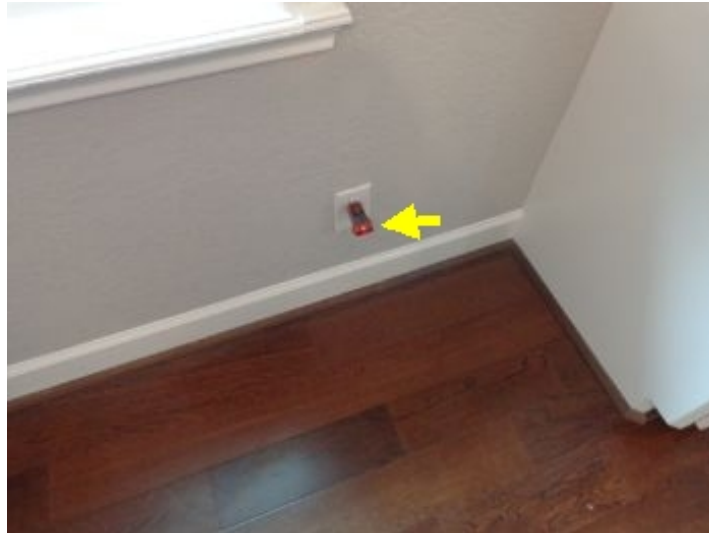
Receptacle/s test and open ground - Recommend correcting for safety - front exterior receptacle and left front bedroom front wall on the left.

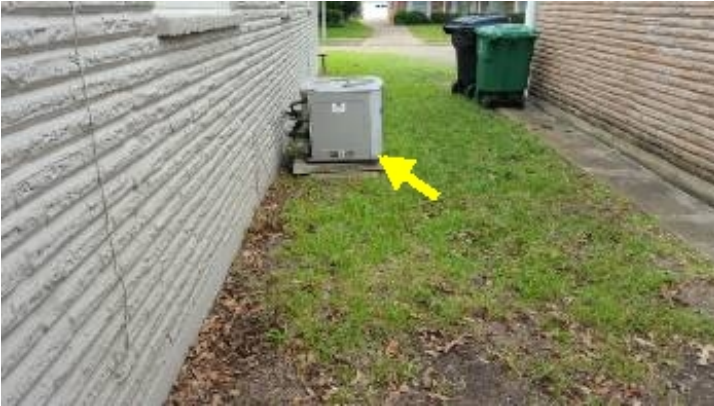
Exterior condensing unit pad is not level -  
Recommend correcting to prevent damage to the  
unit/s

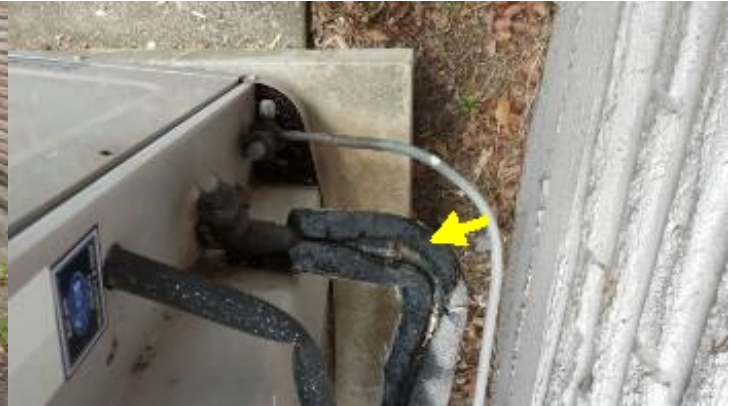
Exterior condensing unit - Insulation on the low  
pressure line is not completely insulated/taped  
and sealed -

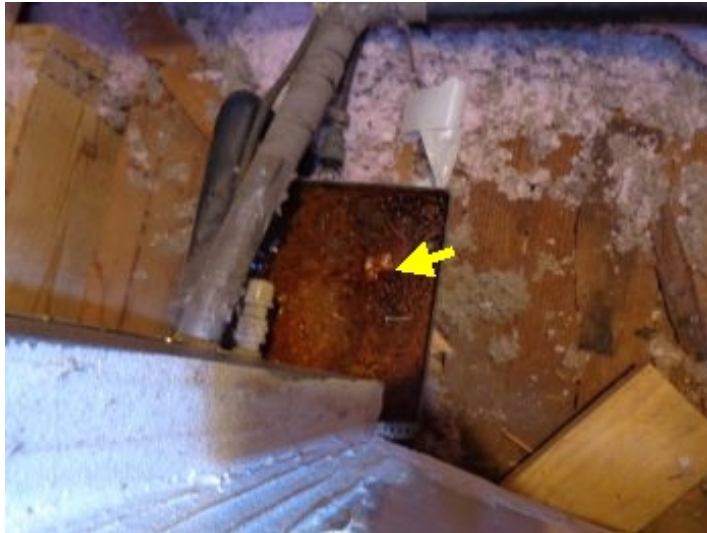
Water and rust was detected in the auxiliary/secondary drain pan under the coil box in the attic area.  
This condition can cause severe damage if the safety pan was to overfill. A licensed HVAC  
technician should address this situation as soon as possible.

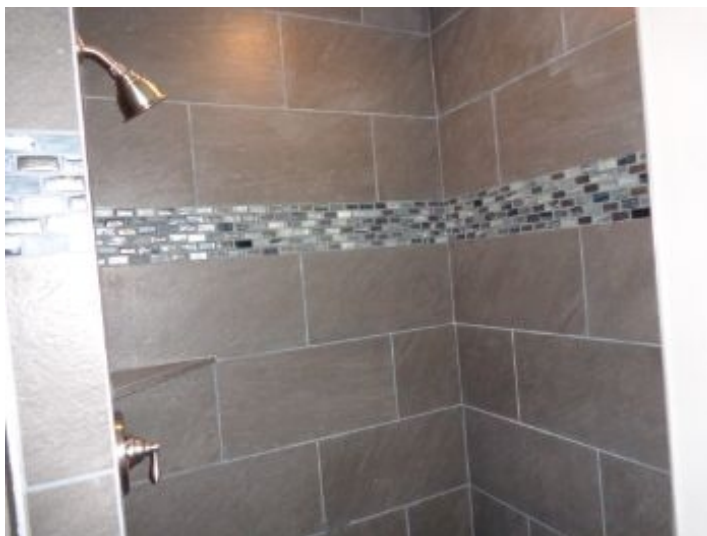
Shower inclosure is missing - Recommend adding to prevent water from splashing out onto the floor and possibly becoming a hazard and also the wall next to the window has a chance of becoming wet and does not appear to be water resistant green board drywall.

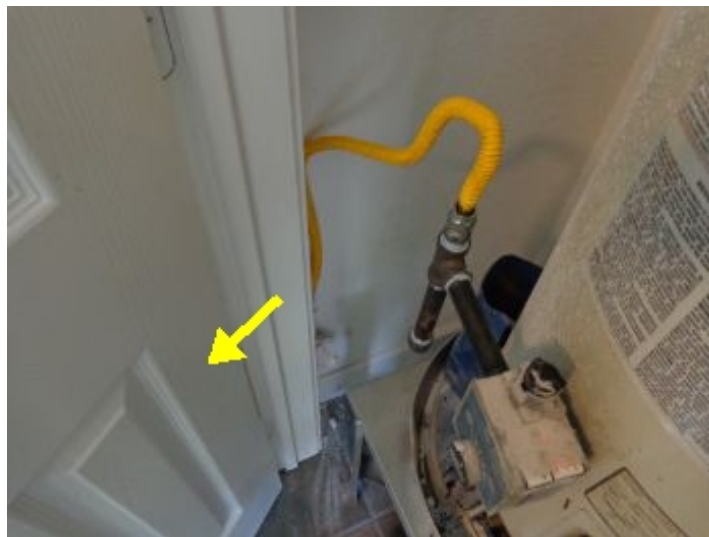
Missing fresh air ventilation to the water heater - Should have fresh air vented from the outside or a proper sized louvered door to the closet. Louvered vent sized according to the manufactures requirements.

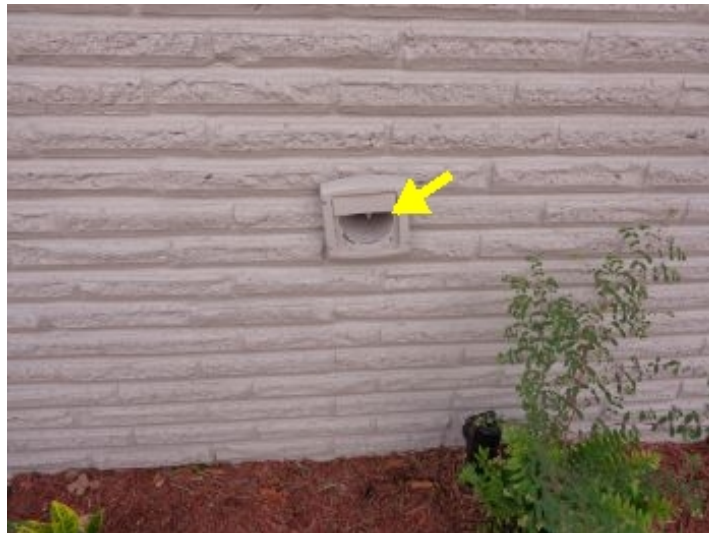
Exterior dryer vent cover - is damaged
