September 13, 2017

PROPERTY INSPECTION REPORT

Concerning: 2870 Oakdell Tr, New Braunfels, TX 78130
(Address or Other Identification of Inspected Property)

By: B. J. Lange, Lic #20796 09/13/2017
(Name and License Number of Inspector) (Date)

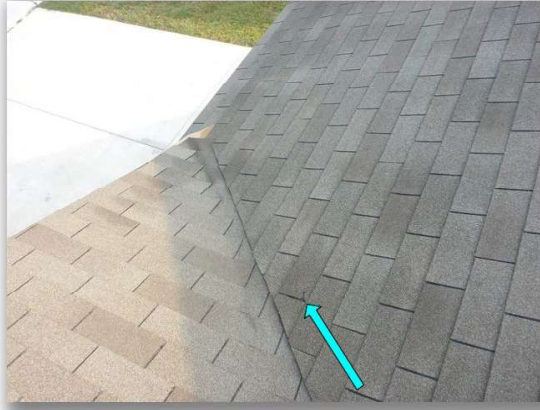
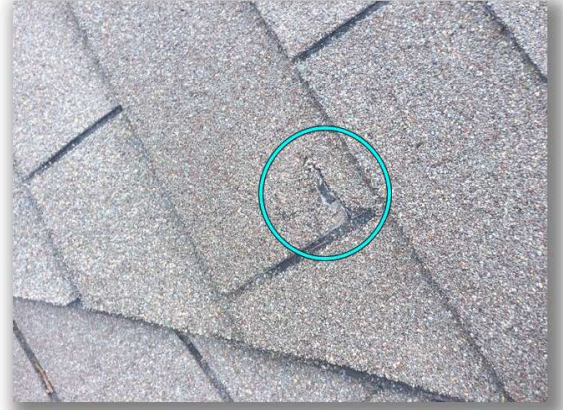
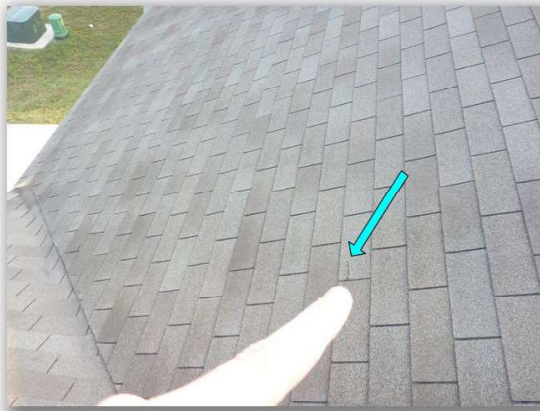
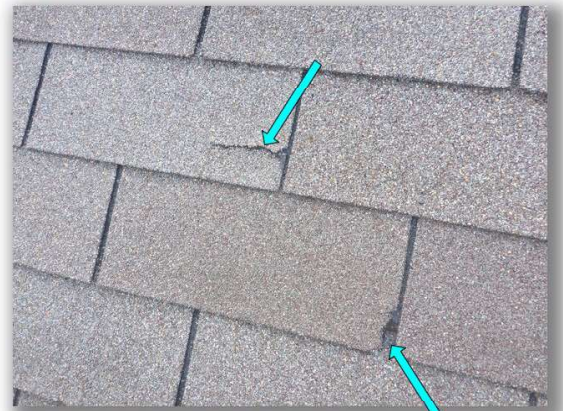
- Damaged shingle(s) were observed on the north side of the roof structure. Repair.

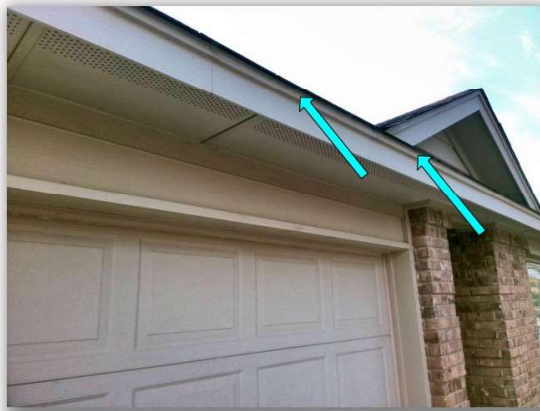
- Drip edge flashing missing. Repair as necessary.

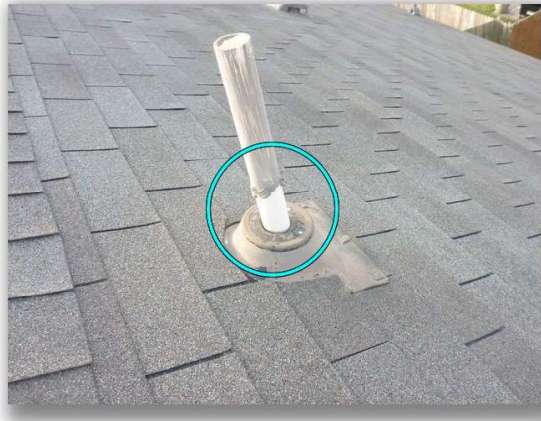
- One or more of the roof level plumbing vent stack flashing details that need repair. i.e: have rubber that is pushed down, need sealant. The existing condition could allow water penetration at this point. Repair.

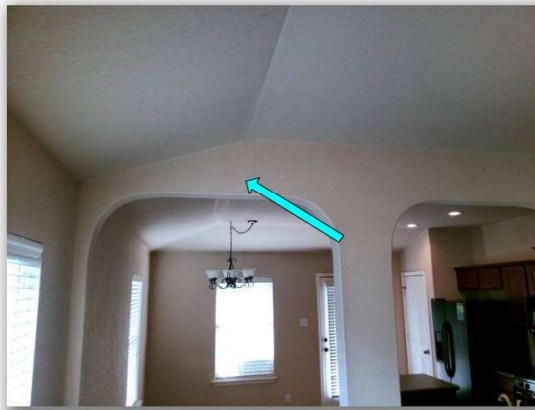
- **Note:** There is evidence of painting and patching to the interior finish and prior interior finish repairs. This condition could limit the Inspectors visual observations and ability to render accurate opinions as to the performance of the structure.

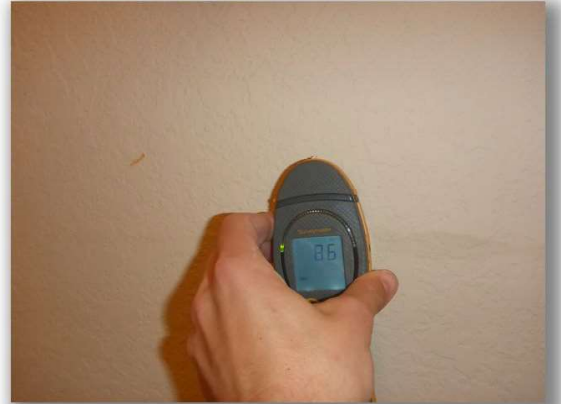
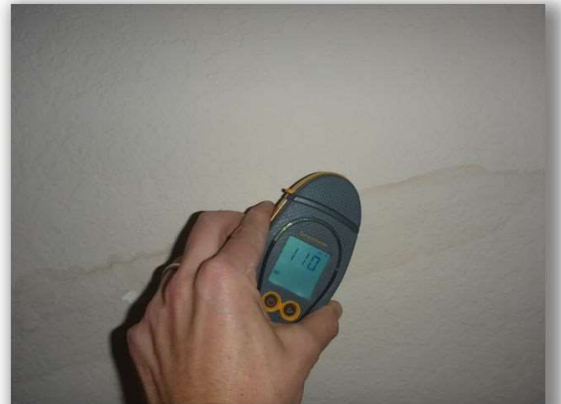
- Water stains/moisture damage/bubbling paint/evidence of water intrusion observed on the walls in the laundry room, hallway closet. The cause and remedy should be further evaluated and corrected as necessary.
- Protimeter (moisture meter) did NOT indicate a high moisture reading in the laundry room, hallway closet.

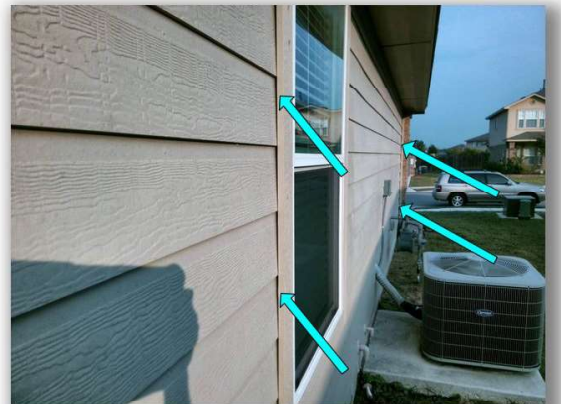
- Caulking improvements are recommended between the exterior cladding/siding junctures &/or trim junctures. It is recommended to use an elastomeric caulking.

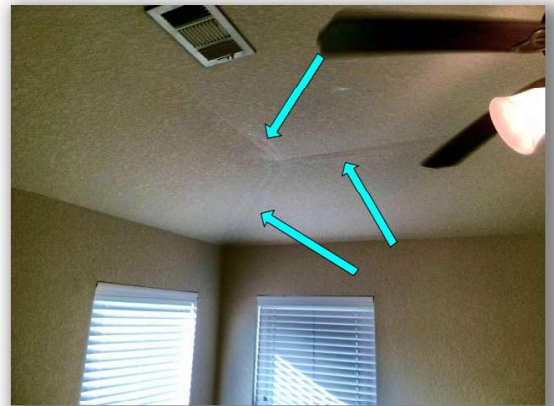
- **Note:** There is evidence of painting and patching to the interior finish and prior interior finish repairs in the kitchen, master bedroom. This condition could limit the Inspectors visual observations and ability to render accurate opinions as to the performance of the structure.
- Ceiling joint cracks were observed in the kitchen, master bedroom.

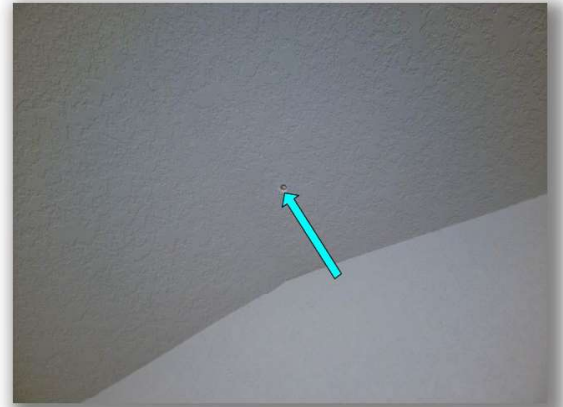
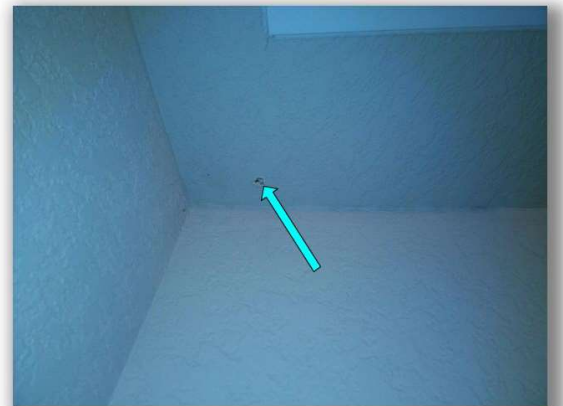
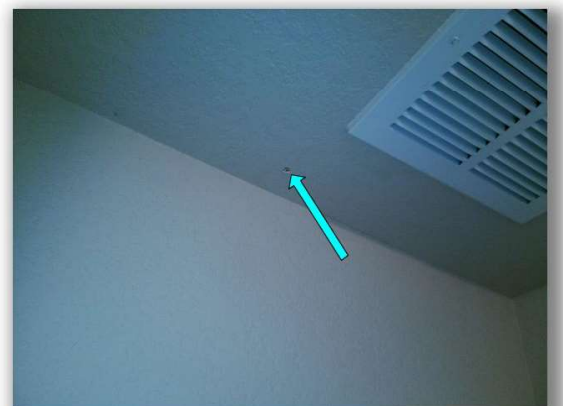
- Nail heads were observed to be pushing through the interior finish in master bedroom, side middle bedroom, front corner bedroom, hallway.

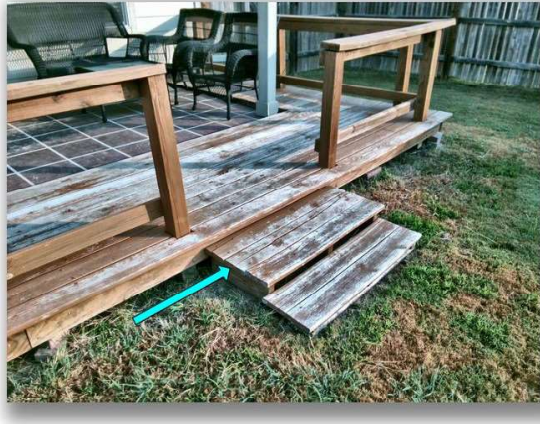
- The step is loose and repairs are necessary for reasons of safety.

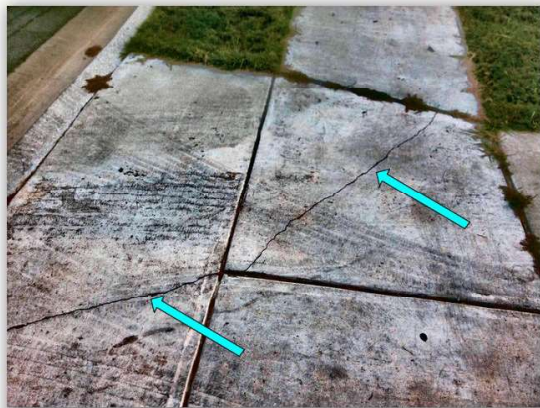
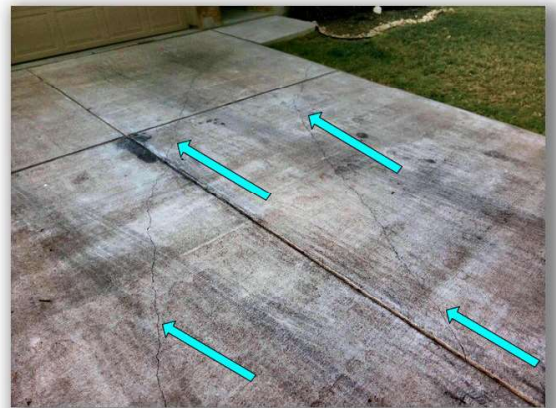
- Cracks and/or deficiencies were observed in the driveway.

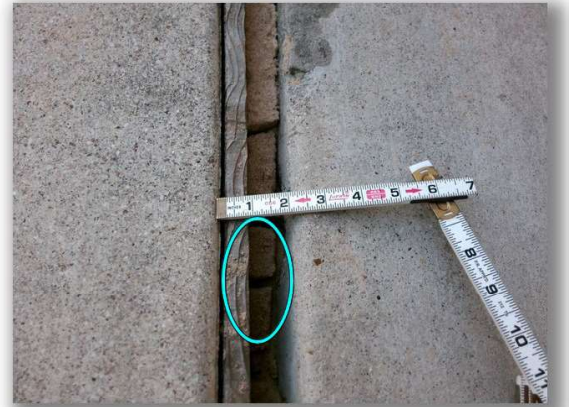
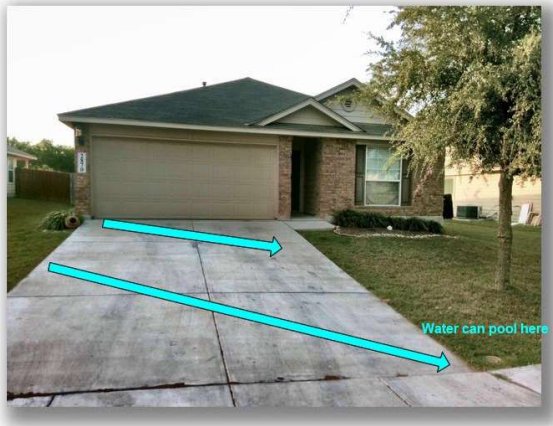
- The driveway appears to have settled more than normal. Repairs are recommended to improve drainage/further damage of driveway.

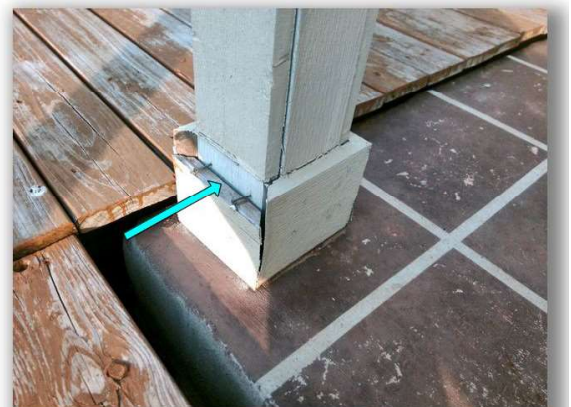
- One or more of the porch support posts have some deterioration, rot, and/or damaged at the base of the post.

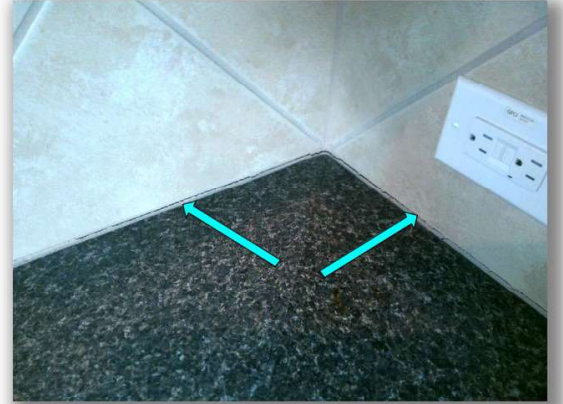
- Deteriorated caulking/sealant at junctures. Re-sealing recommended.

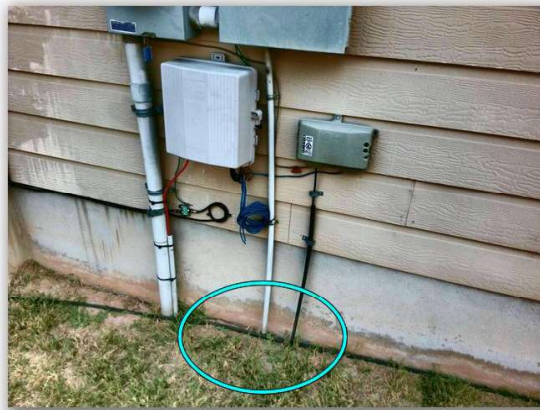
- The connection to the ground electrode rod is below finished grade and/or not easily visible. The connection should be made above finished grade or with an approved clamp listed for burial.

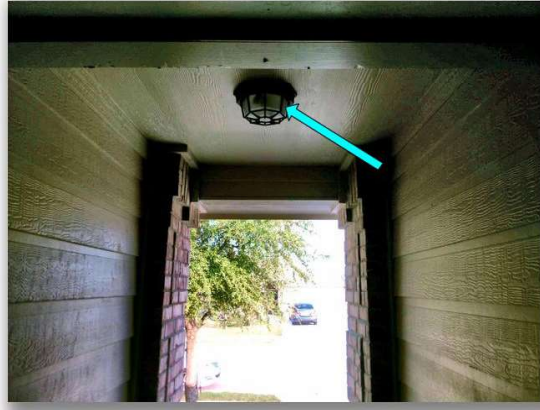
- Light flickering in front porch. Repair as necessary.

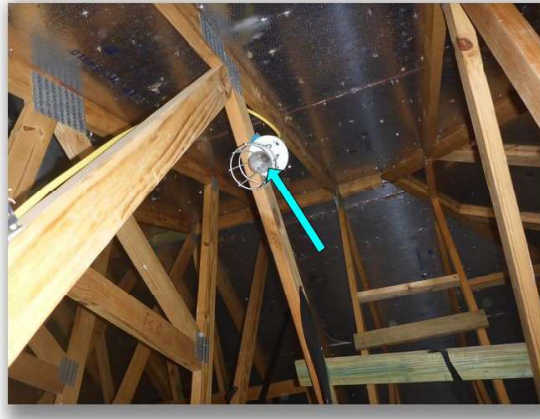
- One or more of the light fixtures appear to be inoperative in the attic. This may be due to a bad bulb or some other unknown condition. This condition should be further evaluated and corrected as necessary.

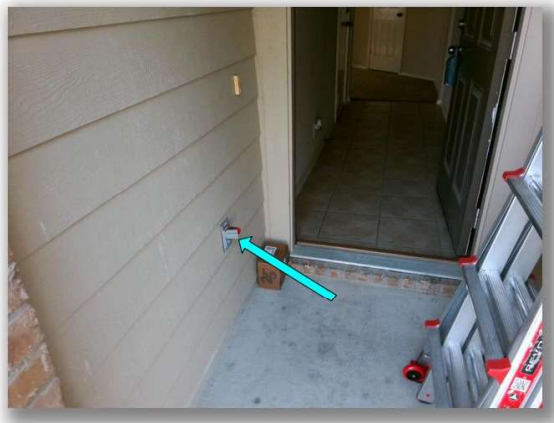
- No ground fault circuit interrupter (GFCI) protection was observed at the exterior outlet(s) or the receptacles were not labeled as such. Under current electrical standards, all of the exterior receptacles, all kitchen counter top receptacles, all bathroom receptacles, all wet bar countertop receptacles, all laundry room sink countertop receptacles, all garage non-appliance dedicated receptacles, all unfinished basement receptacles, all soffit receptacles, all crawlspace receptacles, and all pool lighting should have GFCI protection. Note: Depending on the age of the home, GFCI's may not have been a requirement at the time of construction. This can be checked further by consulting your local municipality.

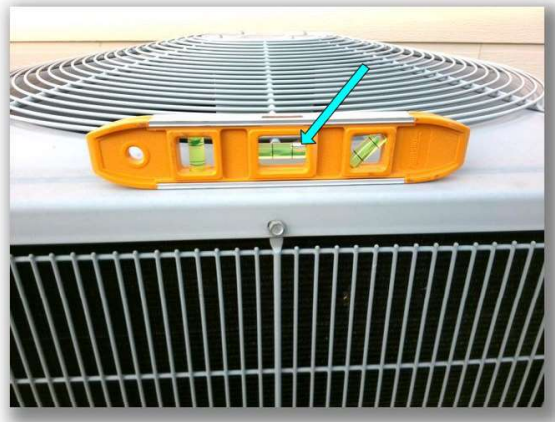
- The outdoor unit of the air conditioning system is out of level. It is recommended that the outside condenser/coils be within 1-inch of level.

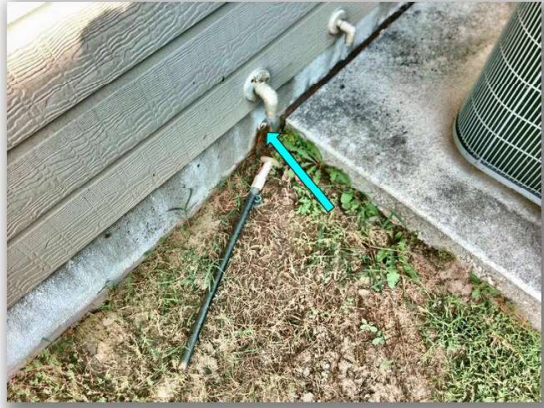
- **Note:** The primary condensate drain line is terminated next to the exterior foundation perimeter beam. It is recommended that the drain line terminate further away from the foundation beam or to an approved waste system.

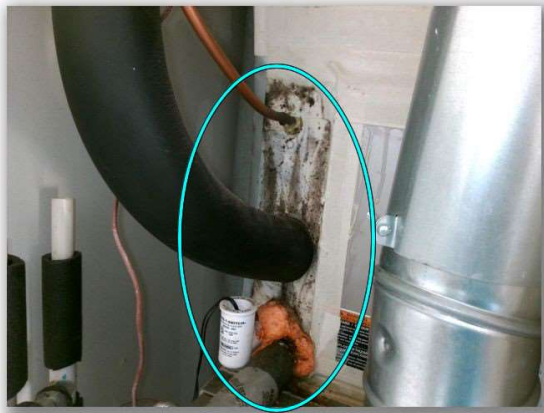
- There was an unknown dark mold like substance observed at the air handler. Evaluation of this substance is beyond the scope of this inspection. If any concerns exist on the type and/or nature of this substance, we recommend further evaluation by a professional in the Air Quality sampling field.

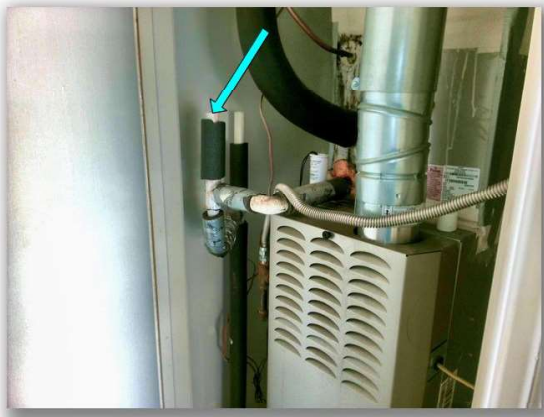
- Debris and/or restrictions found in primary drain line. Recommend drain line be kept free of debris/flushed so it drains properly.

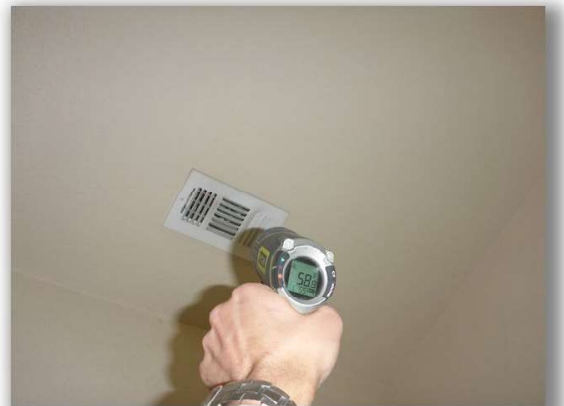
- >5 degree difference in register's air temperature in the master bathroom compared to other registers in the house. Recommend further investigation/repair as necessary.

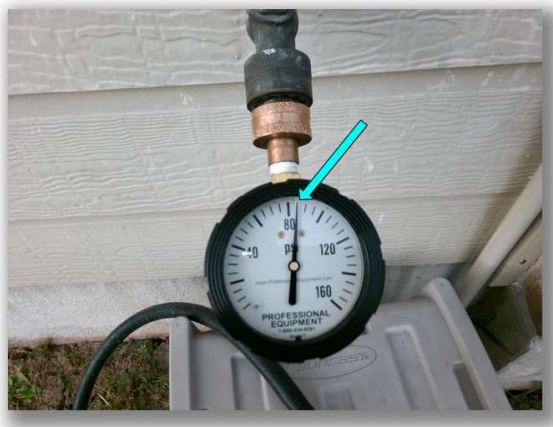
- The water pressure was observed to be above 80 psi at the time of this inspection. Under current plumbing standards the maximum water pressure should be 80 psi. This condition should be further evaluated and corrected as necessary and may require the installation of a pressure reducing valve next to the meter if it is not already equipped with one.

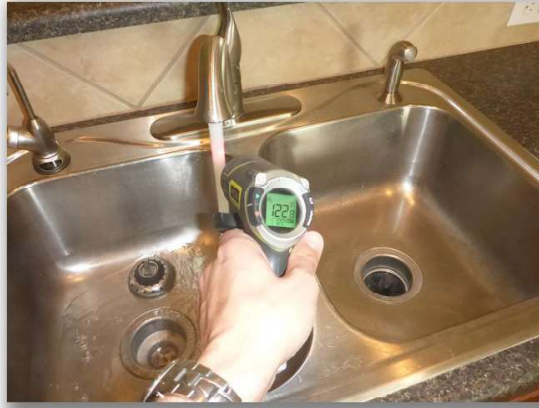
- Water temperature reading at faucet was greater than 120 deg. F. This reading is a potential safety hazard as it can increase the chances of scalding. It is recommended to set the setting to 120 deg. or less.

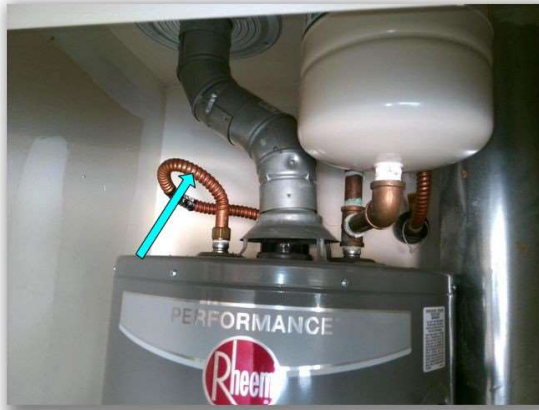
- Insulation missing at water connections. More information can be found at: http://www.energycodes.gov/sites/default/files/documents/cn_residential_hot_water_piping.pdf

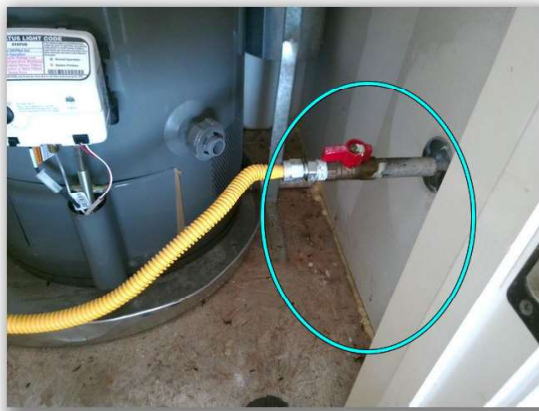
- The water heater gas supply line is not equipped with a sediment trap just before the gas appliance connector. This condition does not meet current installation requirements and should be corrected.

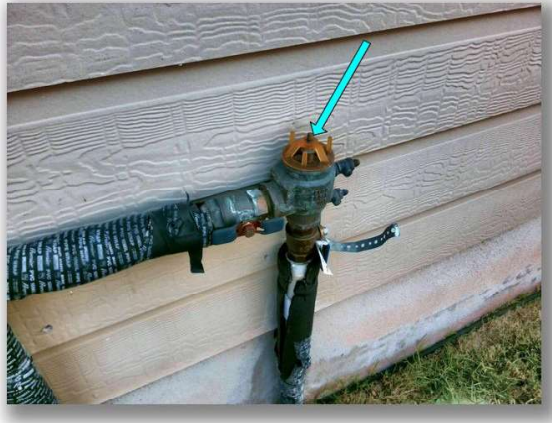
- Hardware appears to be missing at backflow for sprinkler. Repair as necessary.
