GCH Inspections, LLC

Property Inspection Report

1042 W 23rd St, Unit D, Houston, TX 77008

Date of Inspection: 4/22/2018 Time: 1:00 PM

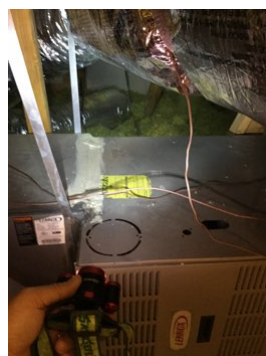
- Could not access all areas of the attic due to limited space, insulation over rafters, hidden wires, duct work all made access to all areas unsafe to inspect further.

Unable to safely access

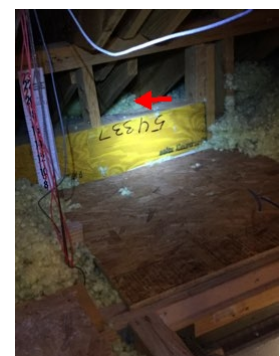
- Unable to determine if house has proper ventilation due to insulation in soffits. Recommend having soffits cleared.
- Observed some gypsum board loose, I was unable to get close to determine is fully sealed to adjustment.

Blocking soffit vent

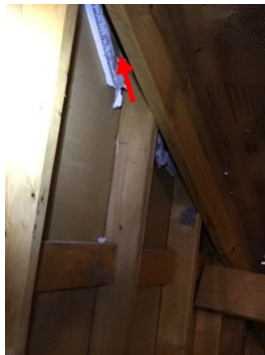
Unable to verify if sealed completely

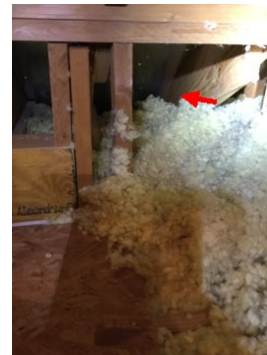
Blocking soffit vent

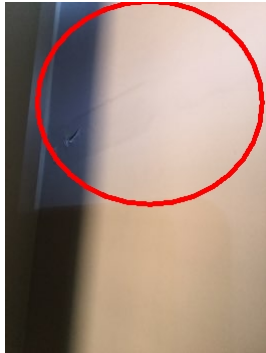
- Observed a moisture stain in the water closet of master bathroom. Moisture meter indicated there is a high concentration of moisture. Recommend a qualified contractor to determine conditions behind wall and leak source.

Moisture stain in Master Water Closet.

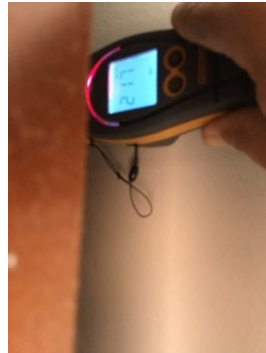
Moisture meter reading wet location

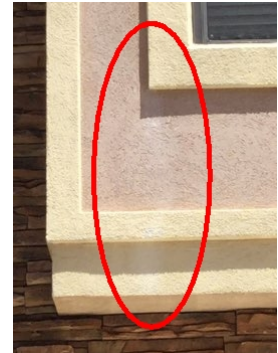
White efflorescence

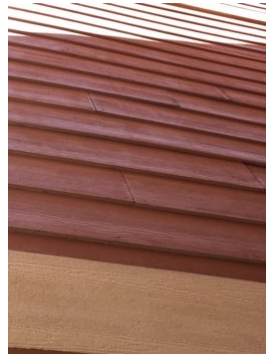
- Observed deteriorated sealant on siding in multiple areas, recommend sealing end joints.
- One or more locations on the exterior cladding showed evidence of paint peeling, fading, blistering and/or cracking and repairs should be considered.

End joints missing sealant

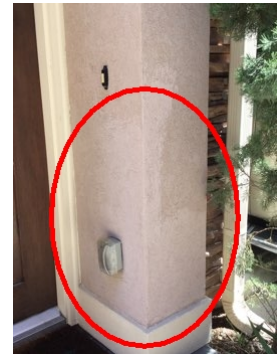
- Observed what appears to a previous repair on stucco by front door. Unable to determine if repair is adequate.

Possible previous repair

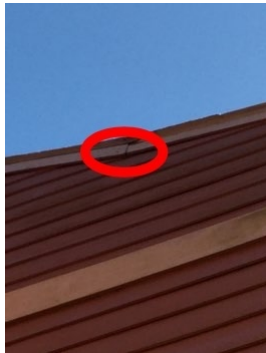
- Deterioration was noted on roof trim on the back of home, recommend replacing all deteriorated trim. Unable to determine the condition of the underlying materials.

Appears deteriorating

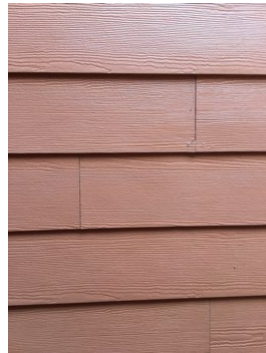
End joints missing sealant

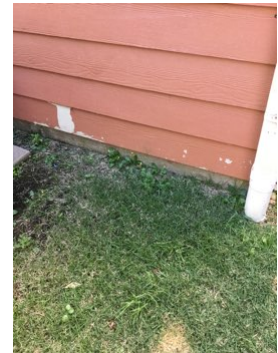
Paint peeling

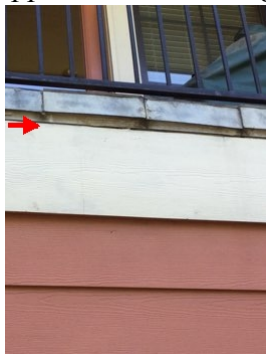
Missing head flashing

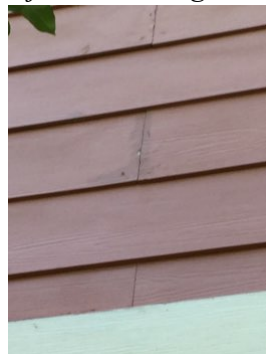
Possible moisture stain

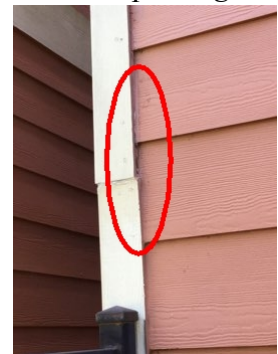
Sealant deteriorating

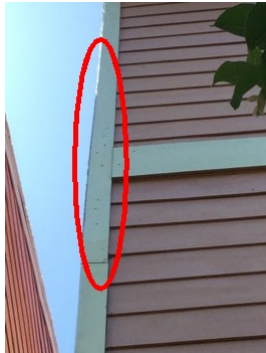
- Observed both over driven nails that with out sealant protecting nail heads from rust. Recommend a qualified siding installer review and repair.
- Observed plumbing penetration under bathroom sink is not sealed. Recommend sealing this area to maintain fireblocking.

Exposed nail heads

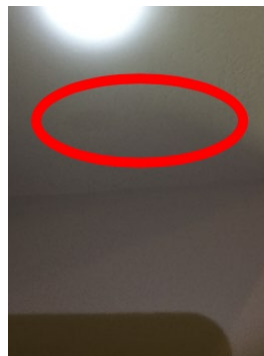
Possible water stain

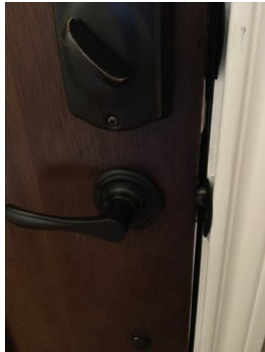
- Observed front door with weather stripping not sealing correctly. Recommend repair to prevent moisture and or insects into home.
- Observed washer blocked laundry room door from closing.

Daylight

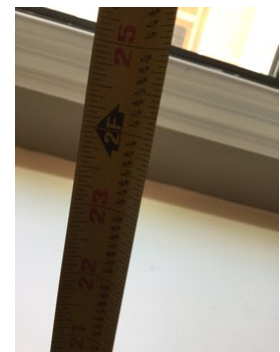
Less than 24 inches

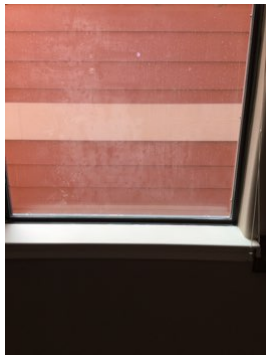
Unable to verify safety glass

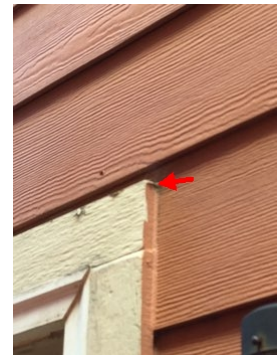
Unable to see head flashing

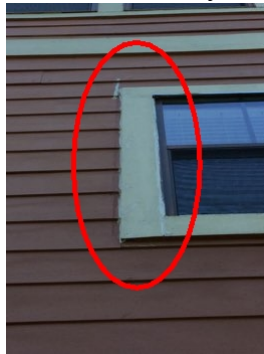
Sign of previous repair

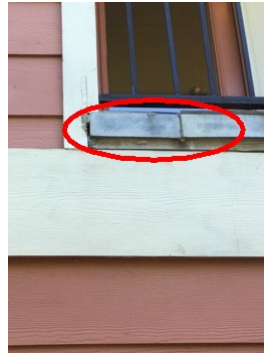
- It was observed that corrosion resistant flashing is needed at the point of attachment from the deck to the structure to avoid water penetration
- Observed balcony sealant is deteriorating at the edge. Recommend a qualified contractor repair.

Sealant deteriorating

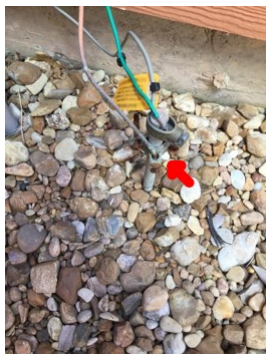
- Observed wrong type of clamp was used for the grounding rod. The correct clamp is just above the pipe clamp. Recommend a licensed electrician review and repair as necessary.

Wrong clamp

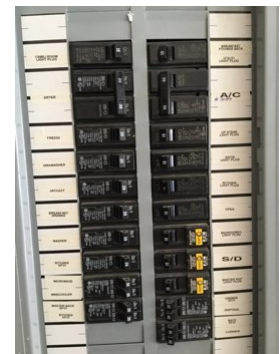
Labeled, no master shut off

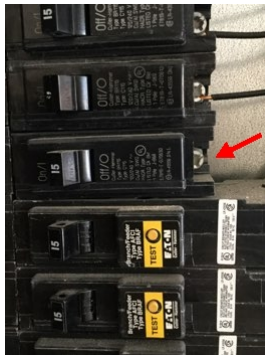
Not connected

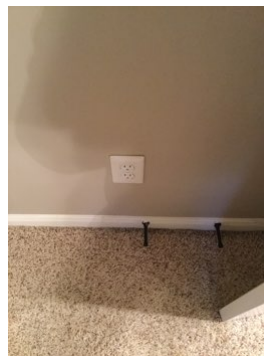
Loose wall plate

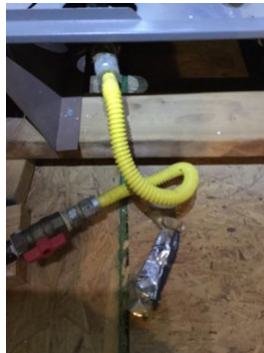
Missing drip leg and bonding

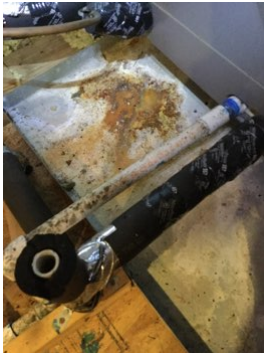
- Rust and/or corrosion was noted in the condensate drip pan
- Observed primary drains access with out a caps. Recommend next time AC is serviced have caps added.

Rust

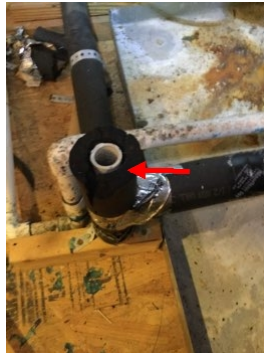
Missing cap

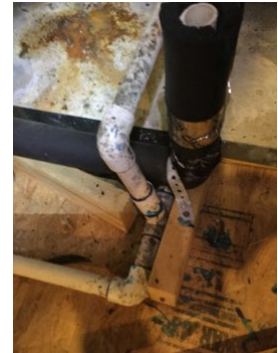
Possible organic growth

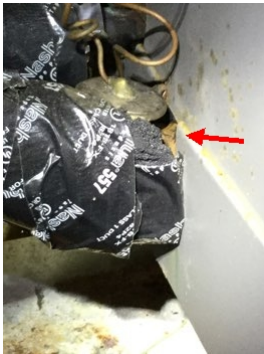
Rust at evaporator

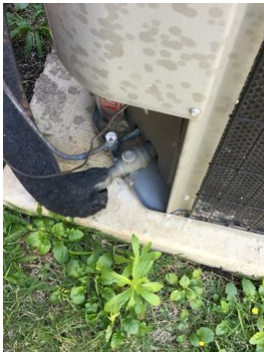
- Observed access port caps are not the locking type.

Missing locking caps

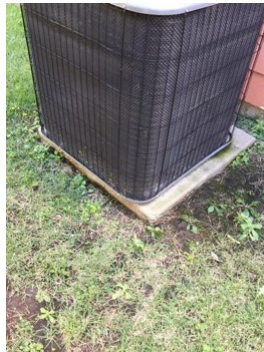
Fins dirty slight damage

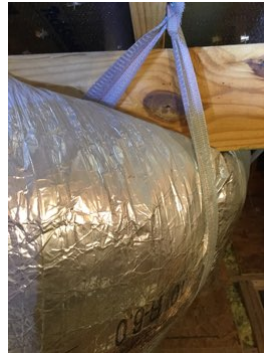
- Observed duck work touching framing which can cause moisture to build up on AC unit. Recommend a licensed HVAC technician review and adjust straps.

Touching framing

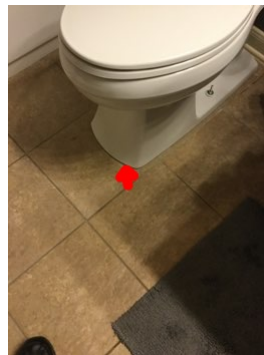
Missing sealant

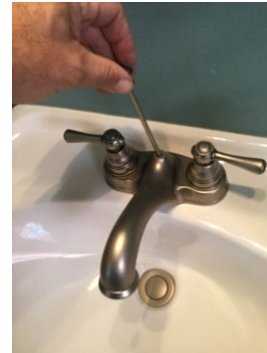
- Observed sink stoppers and linkage not functioning. Recommend repair.
- Observed kitchen sink faucet sprayer not recoiling back into the housing. This is for your information.

Linkage broken

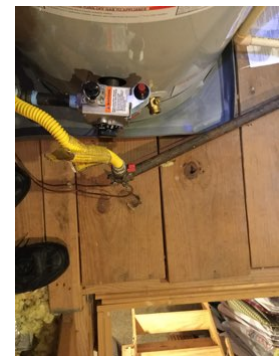
Not adequate work space

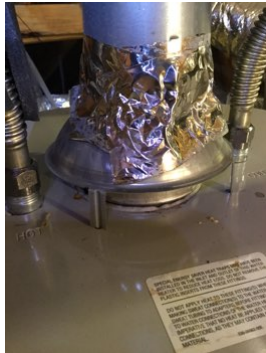
Improper connection

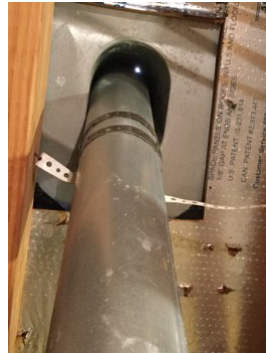
Daylight

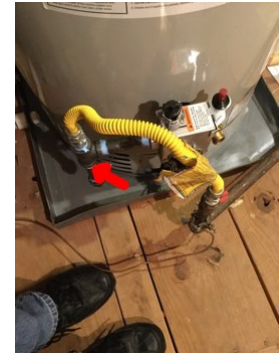
Unable to verify if properly bonded

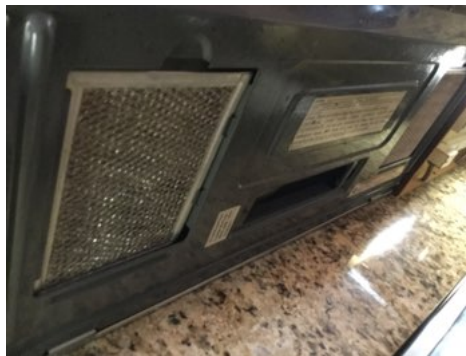
- The range hood was functional at the time of the inspection
- Self filtering unit with fan
- One or more of the light bulbs was burned out

Light not functioning

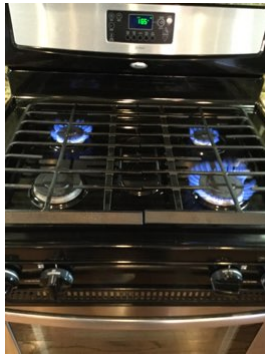
Left front not functioning
