General Structural Initial Foundation Inspection

10004 Robin
La Porte, Texas 77571

July 2, 2019

Re: 10004 Robin – La Porte, Texas

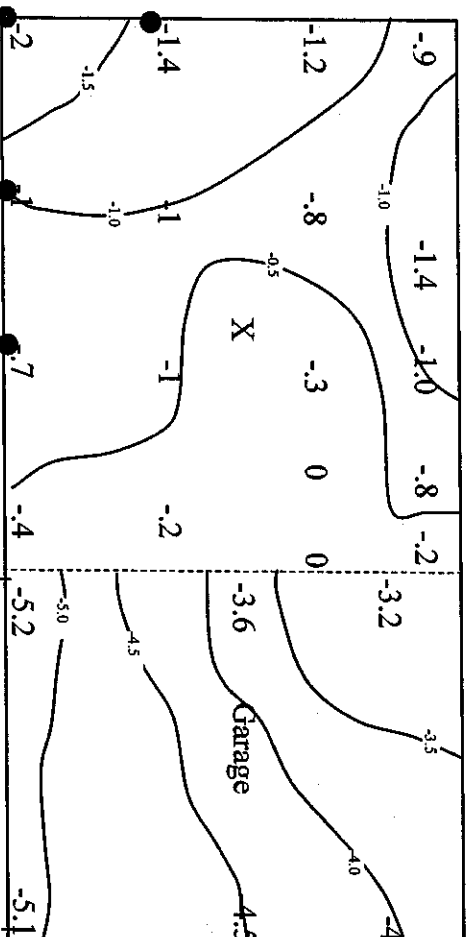
The only area where the floors deflect down exceeding the tolerance of 1/16" per foot is at the front left corner of the structure. Other areas are within tolerances with minimal minor deviations.

X = Approximate location of base unit

● = piling locations

Install 4 double concrete pilings driven to a substantial point of refusal, or 40 feet, whichever comes first at approximate 8 foot centers in the locations shown at the left front of the structure. The specifications are included in this report.
