Your Inspection Report

1715 Nantucket Drive
Houston, TX 77056

INSPECTION DATE:
Friday, February 1, 2019

RE: Report No. 1156
1715 Nantucket Drive
Houston, TX
77056

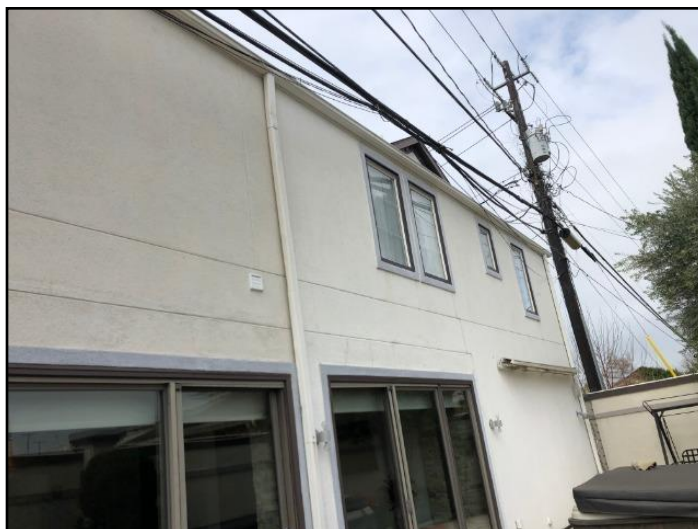
Roof inspection limited/prevented by: • Power lines were too close to roof's edge.

Power lines

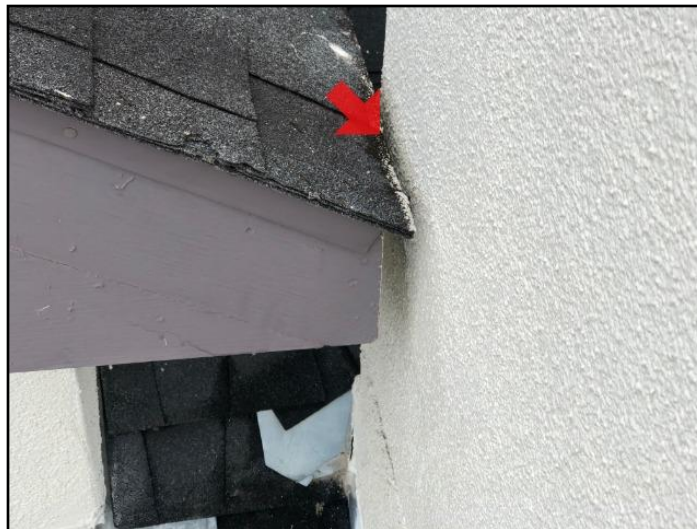
Location: On Roof

Roof terminates

Task: Evaluate and Address as Needed

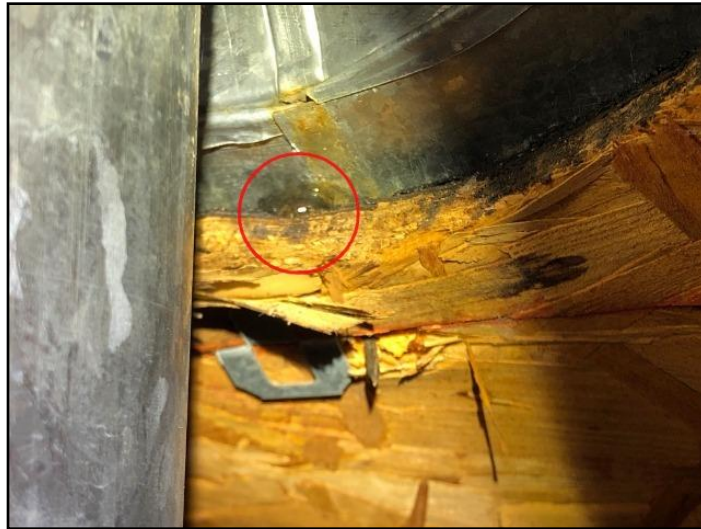
2. **Condition:** • [Leak](#)

Leak observed in furnace vent flashing.

Leak observed in furnace vent flashing

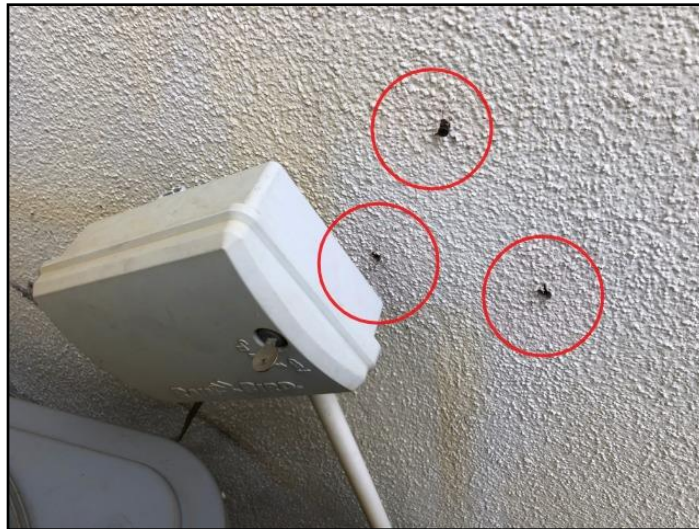
Location: Rear Exterior Wall

4. Condition: • Holes observed. Recommend sealing.

Holes observed

Task: Evaluate and Address as Needed

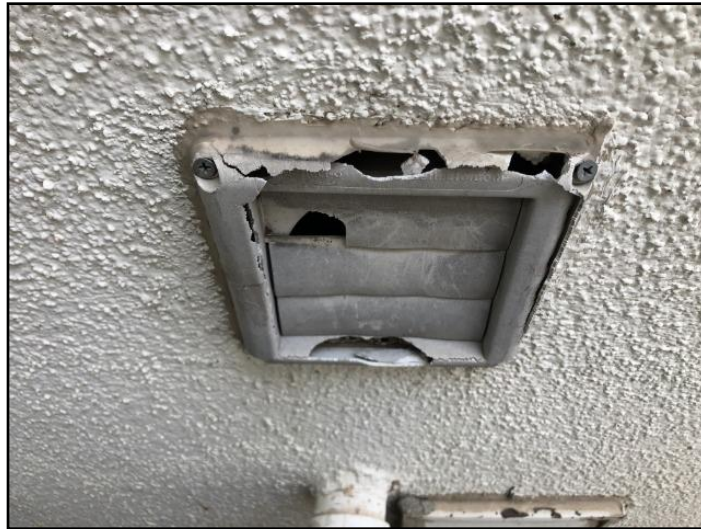
Location: Rear Exterior Wall

5. Condition: • Cover damaged

Cover damaged

Task: Evaluate and Address as Needed

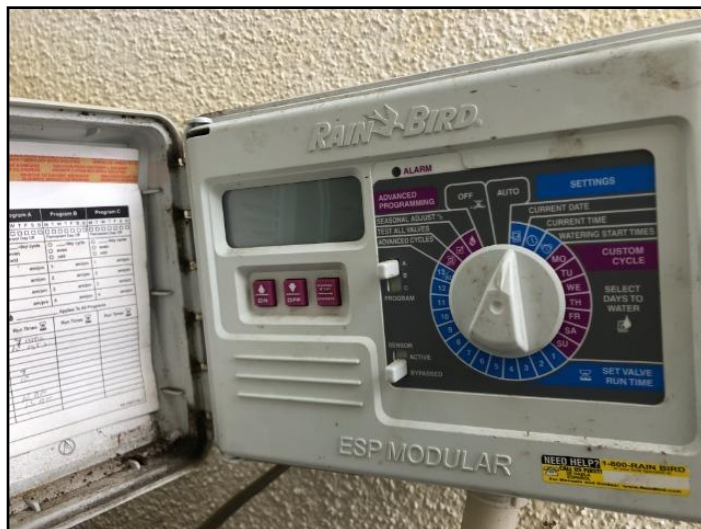
6. Condition: • Controller was inoperative.

Controller was inoperative

Task: Evaluate and Address as Needed

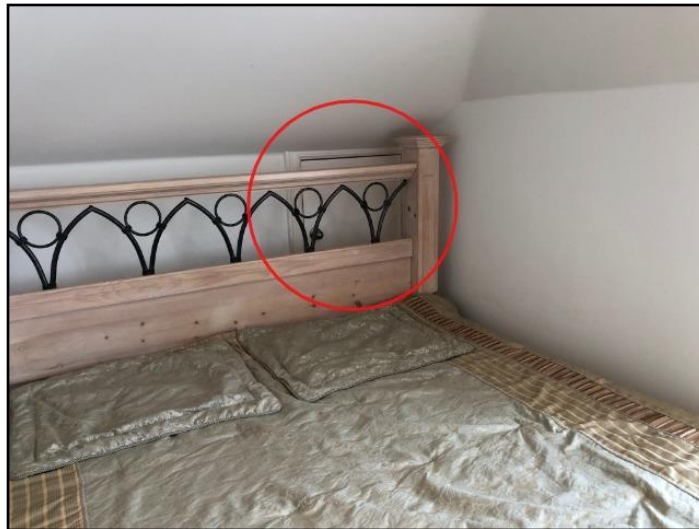
Attic space on third floor had no access due to furniture.

No access

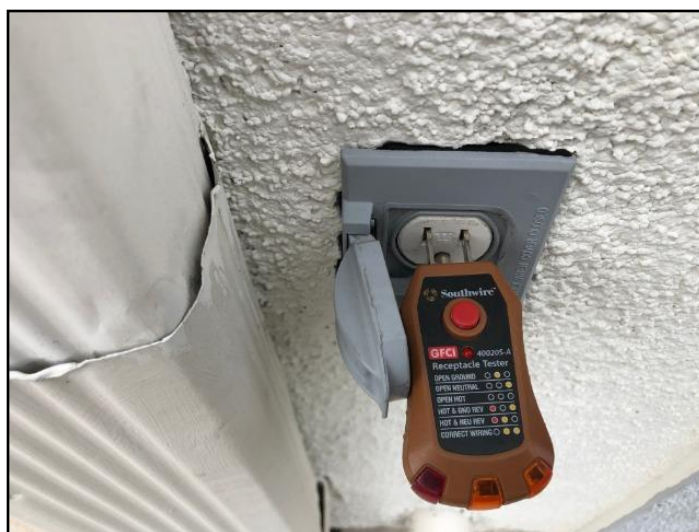
Inspection limited/prevented by: • Could not test outlet tester would not fit do to cover.

Could not test

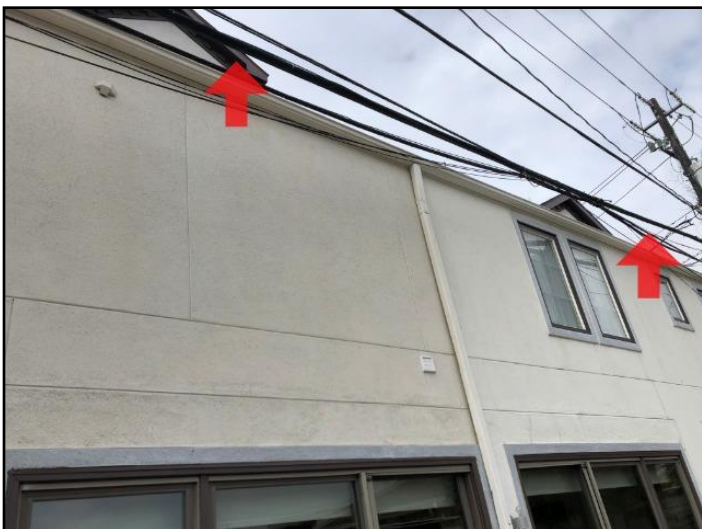
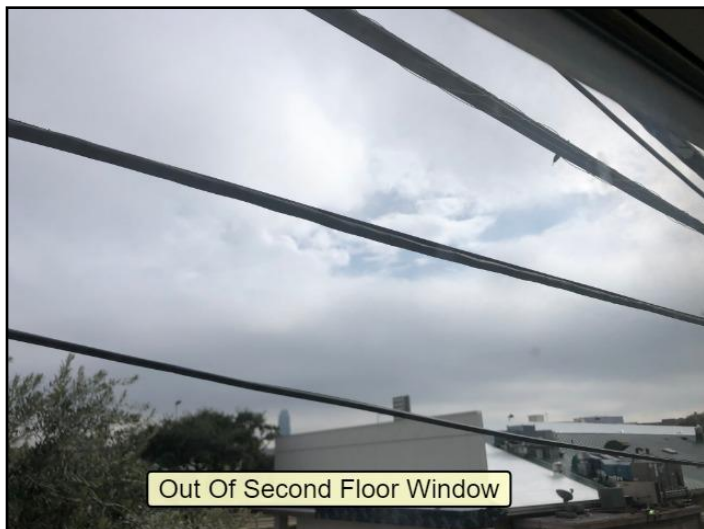
Location: Edge Of Roof

9. **Condition:** • [Inadequate window or door clearance](#)

Inadequate window or door clearance

Task: (Hazard) Evaluate and Address as Needed

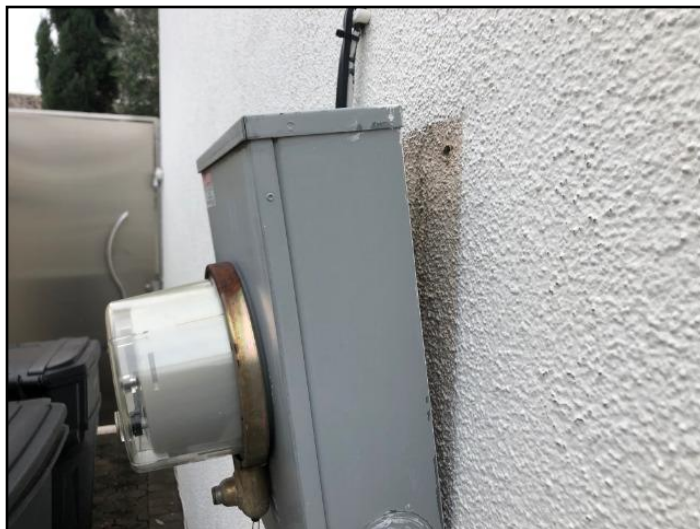
Location: Exterior Wall

10. Condition: • [Not well secured](#)

Not well secured

Task: Evaluate and Address as Needed

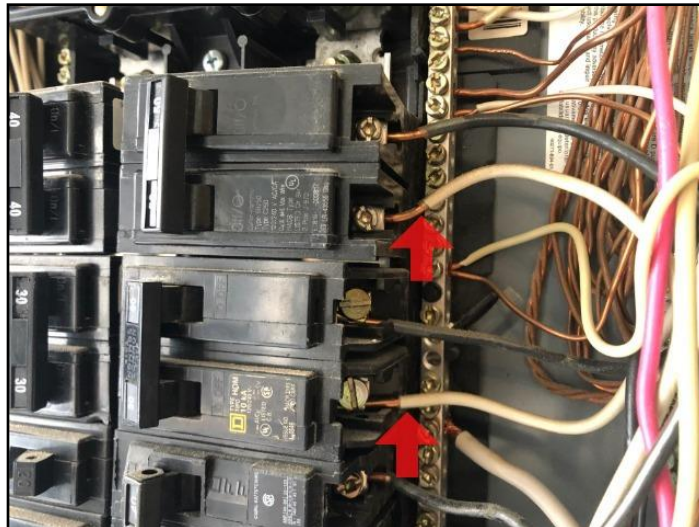
Location: Breaker Panel

12. Condition: • White wires connected to breakers. These wires should be identified as hot by red or black electrical

White wires connected to breakers. These...

Task: Evaluate and Address as Needed

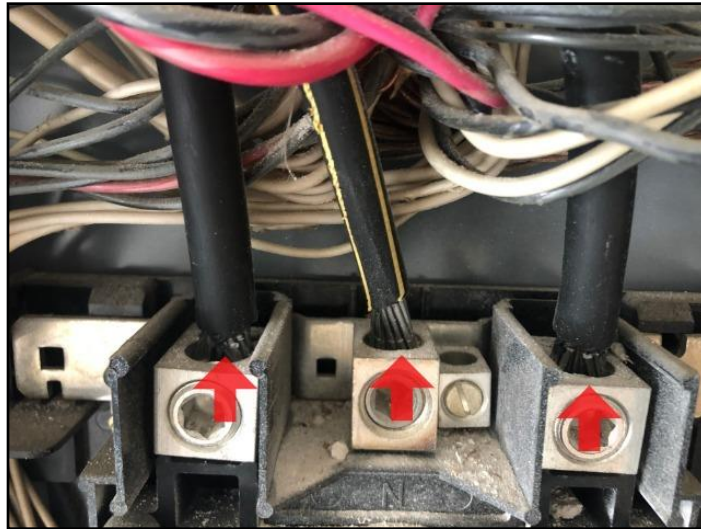
Location: Breaker Panel

14. Condition: • [Anti-oxidant missing on aluminum wire](#)

Anti-oxidant missing on aluminum wire

Task: Evaluate and Address as Needed

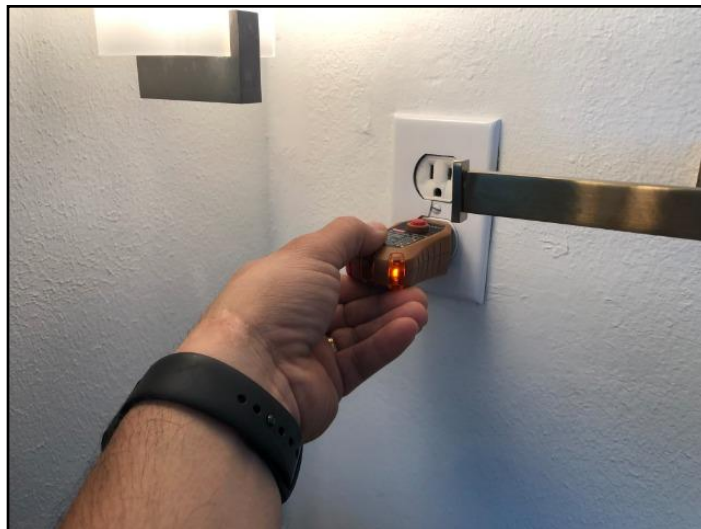
Location: Master Bathroom

15. Condition: • Lights on receptacle tester flicker when moved around and GFCI does not respond every time when pressed. Also lights in first floor flicker when testing this outlet.

Lights on receptacle tester flicker

Task: Further Evaluation by a Licensed Electrician is Recommended

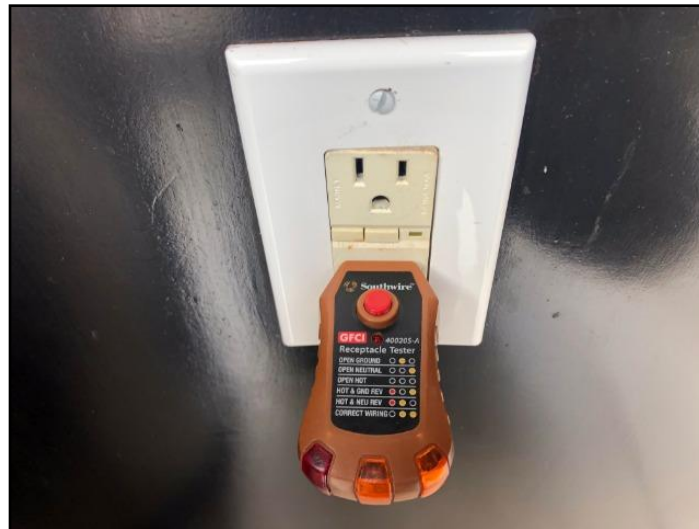
Location: Kitchen Island

16. Condition: • [Inoperative](#)

Inoperative

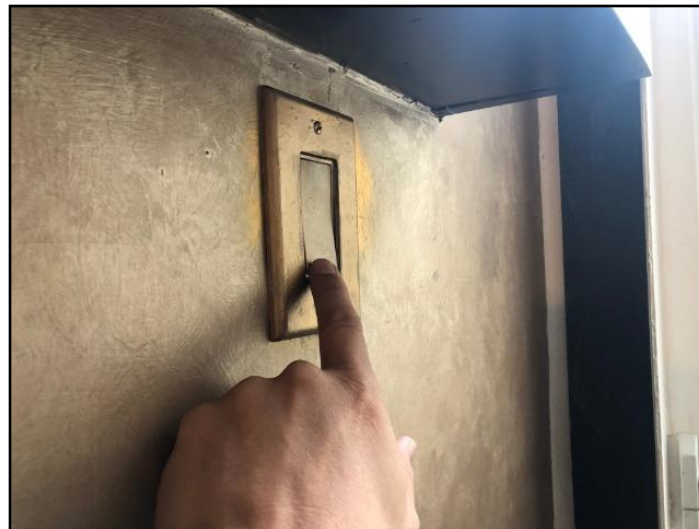
Location: Living Room

18. Condition: • [Inoperative](#)

Inoperative

Task: Evaluate and Address as Needed

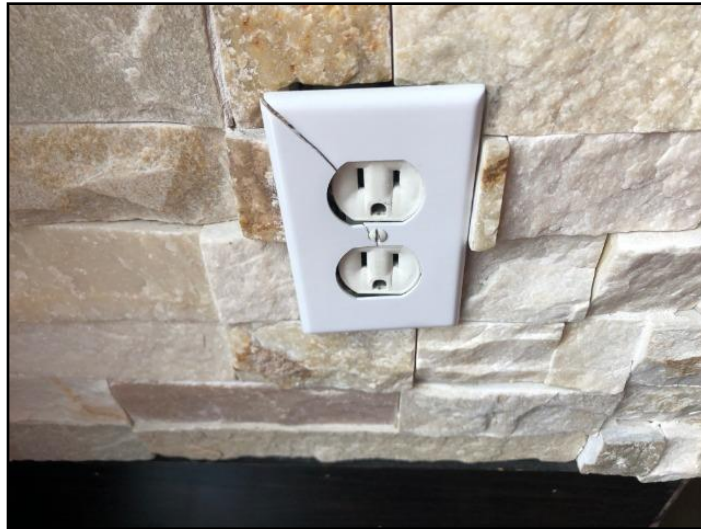
Location: Living Room

19. Condition: • For outlet (receptacle) is damaged

For outlet (receptacle) is damaged

Task: Evaluate and Address as Needed

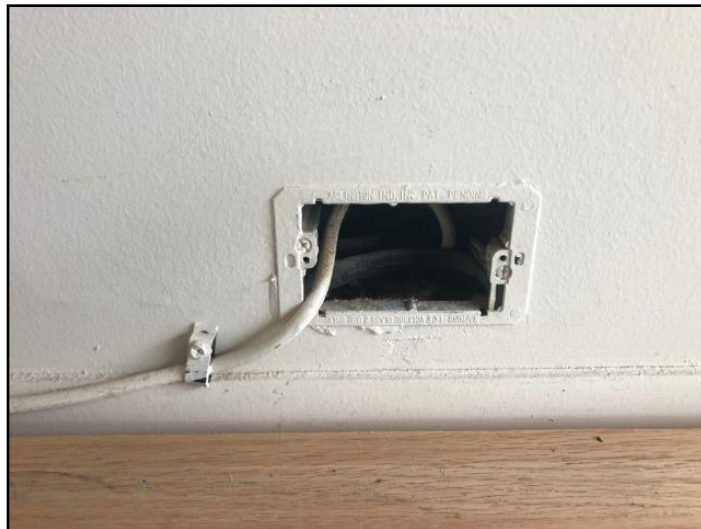
Location: Garage

20. Condition: • For junction box is missing

For junction box is missing

Task: Evaluate and Address as Needed

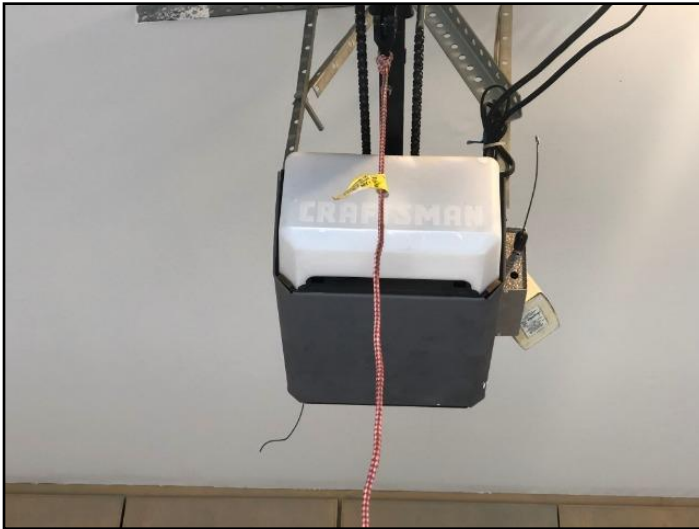
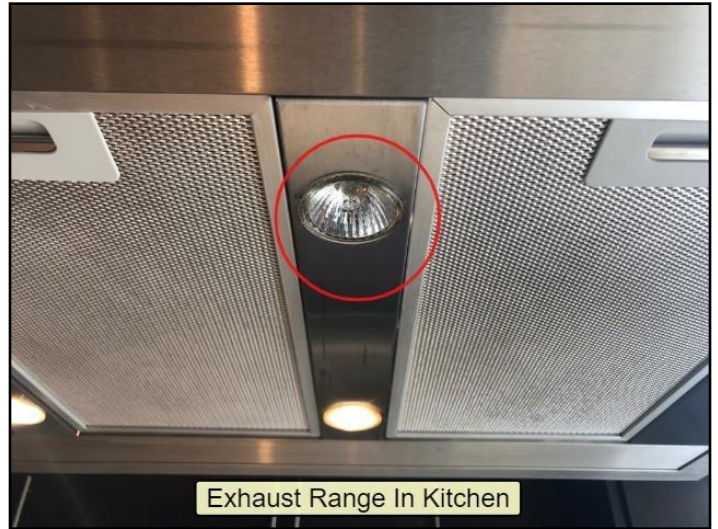
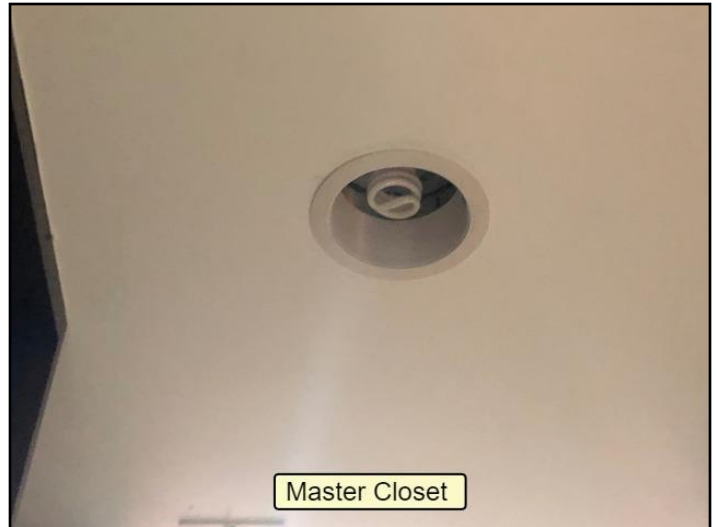
21. Condition: • [Inoperative](#)

Inoperative

Replacing bulbs is recommended to make sure fixture is fully operative.

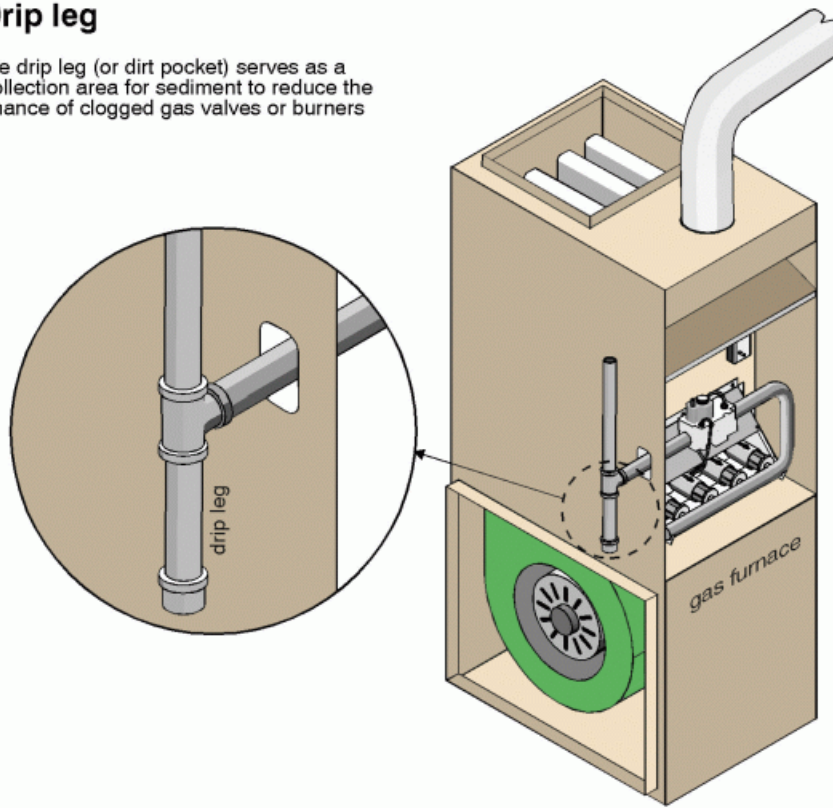
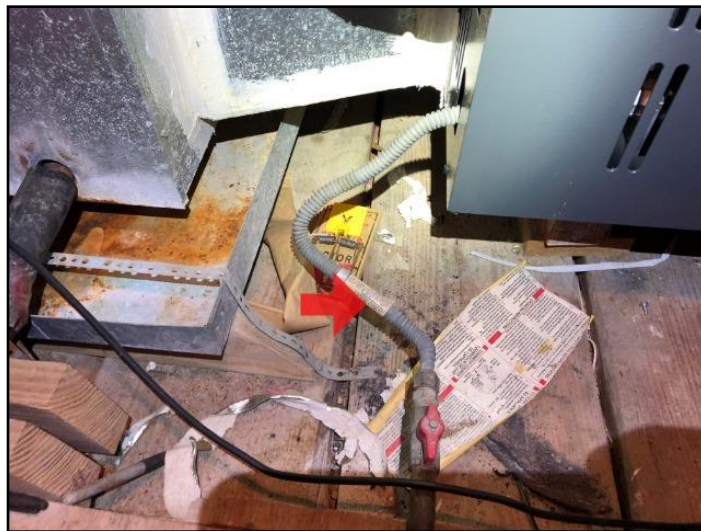
22. Condition: • [No drip leg \(sediment trap, dirt pocket\)](#)

the drip leg (or dirt pocket) serves as a collection area for sediment to reduce the chance of clogged gas valves or burners

No drip leg (sediment trap, dirt pocket)

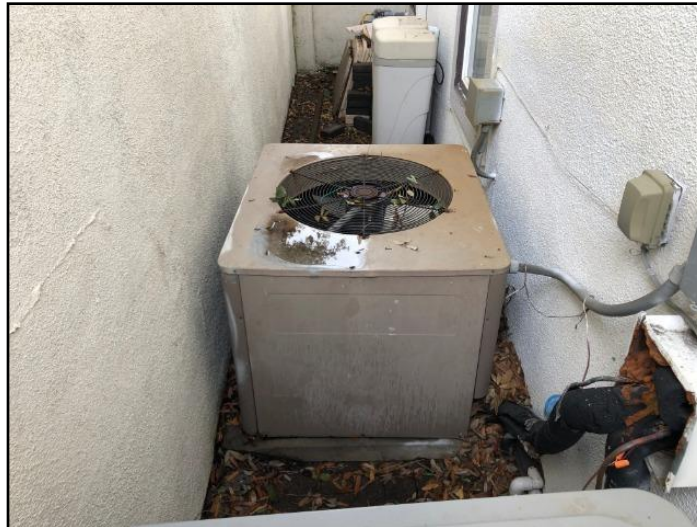
Location: AC Unit

23. Condition: • Service air conditioner

One of the units appears to be an original unit, Service (scheduled maintenance) is recommended.

Service air conditioner

Task: Further Evaluation by an HVAC Company is Recommended

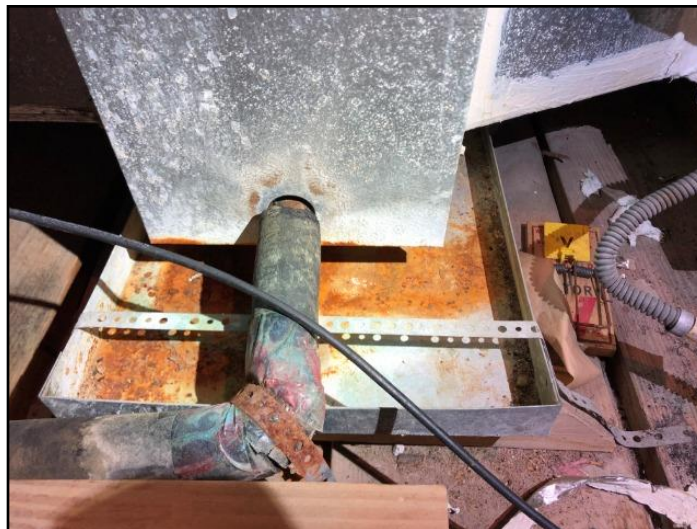
Location: Attic

24. Condition: • [Rust or holes in pan](#)

Rust on pan observed.

Rust or holes in pan

Task: Evaluate and Address as Needed

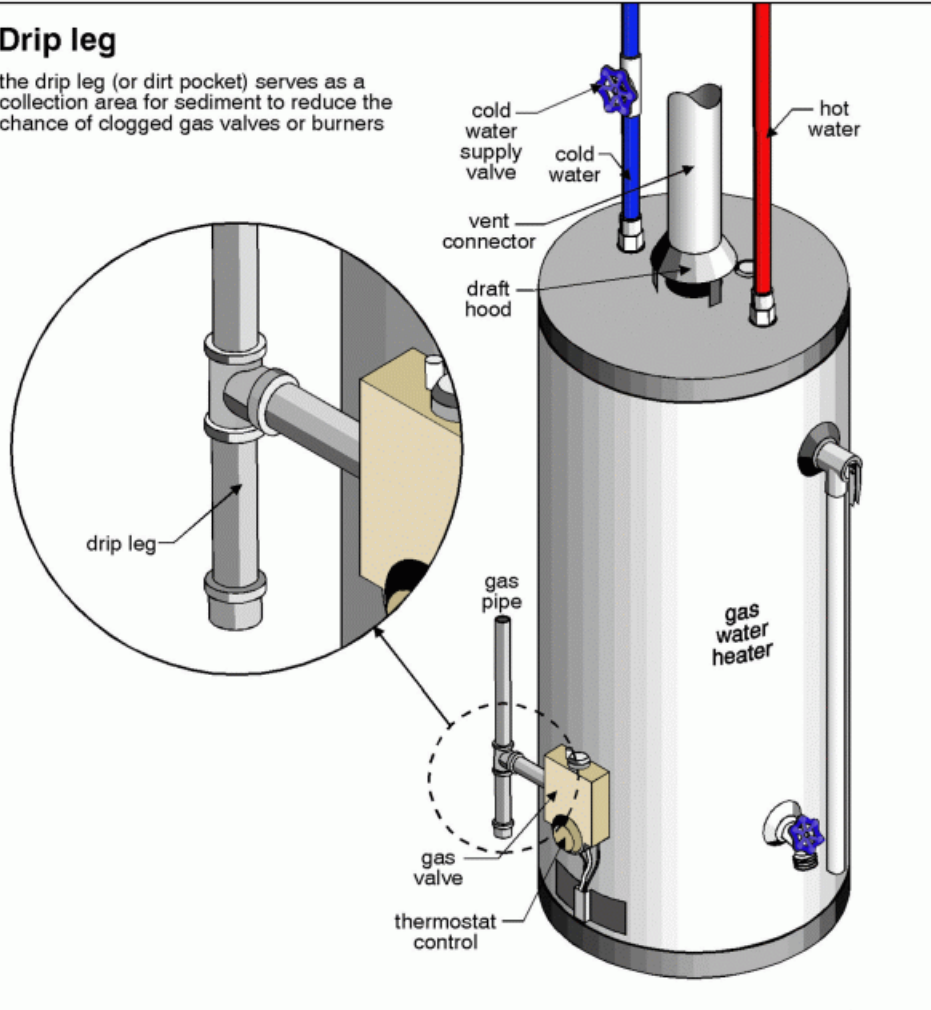
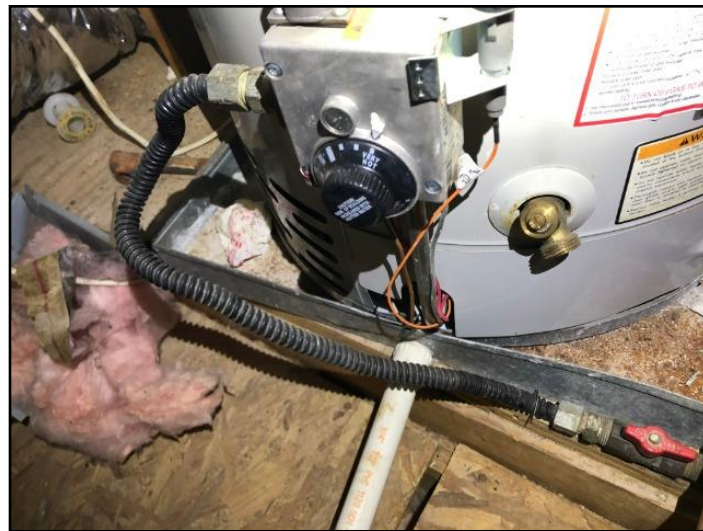
26. Condition: • [No drip leg \(sediment trap/dirt pocket\)](#)

the drip leg (or dirt pocket) serves as a collection area for sediment to reduce the chance of clogged gas valves or burners

No drip leg (sediment trap/dirt pocket)

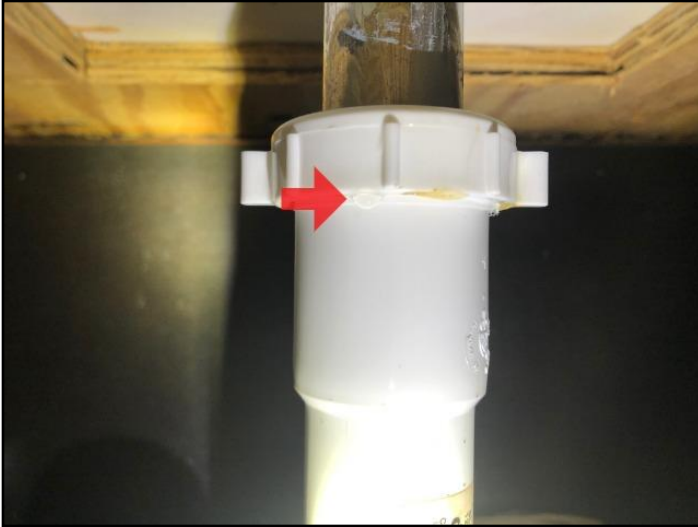
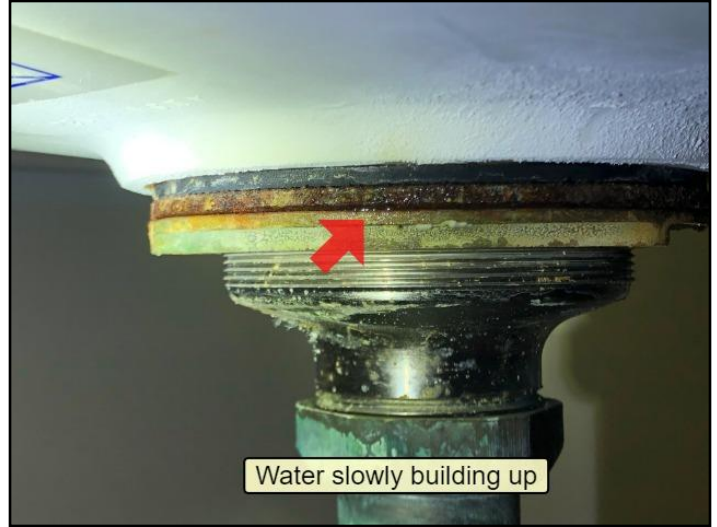
Location: First Floor Half Bathroom

27. Condition: • [Leak](#)

Leak

Task: Evaluate and Address as Needed

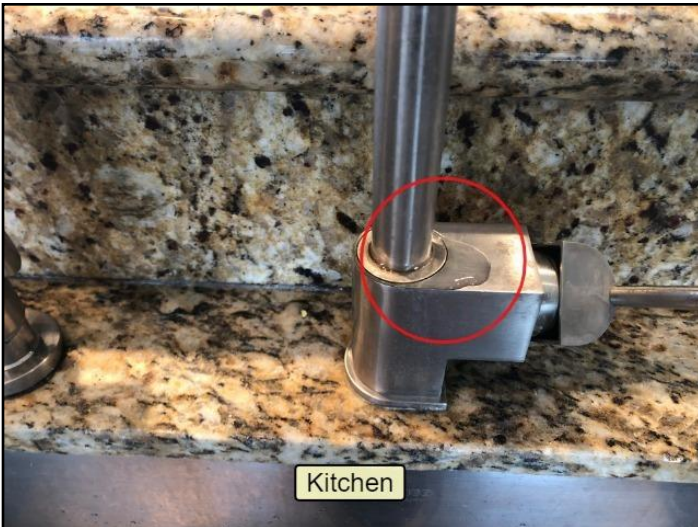
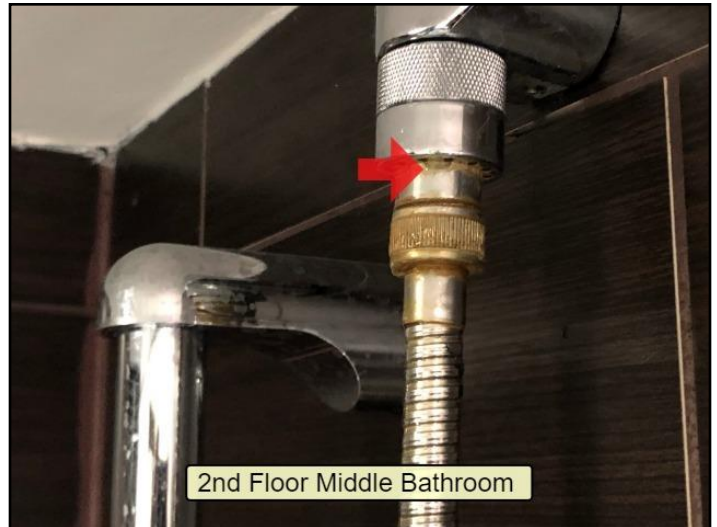
Location: Multiple

28. Condition: • [Drip, leak](#)

Drip, leak

Task: Evaluate and Address as Needed

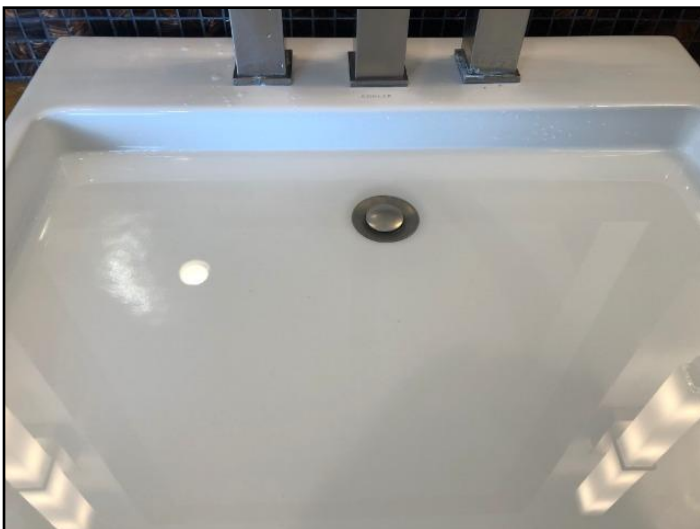
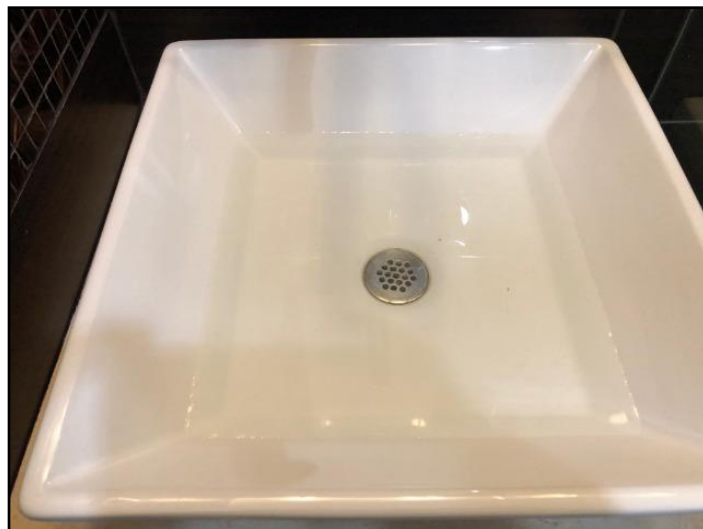
Location: Master Bathroom Left Sink and 3rd Floor Bathroom

29. Condition: • [Slow drains](#)

Slow drains

Task: Evaluate and Address as Needed

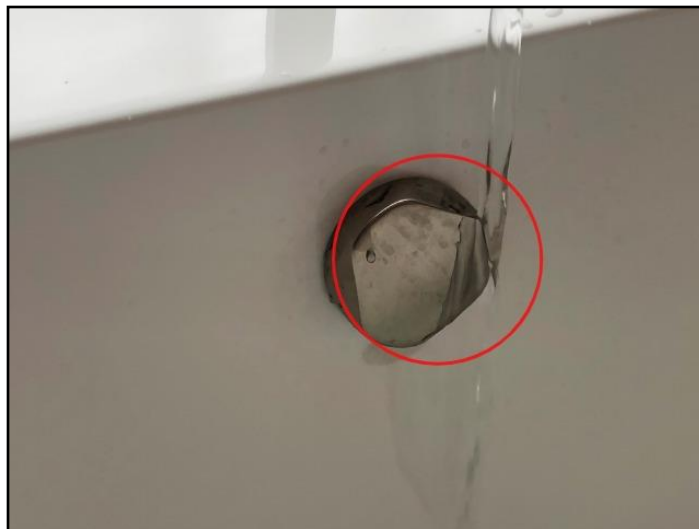
Location: Master Bathroom

30. Condition: • Water from bathtub fixture directly falls on overflow and I could not verify if leakage is present.

Falls on overflow

Task: Evaluate and Address as Needed

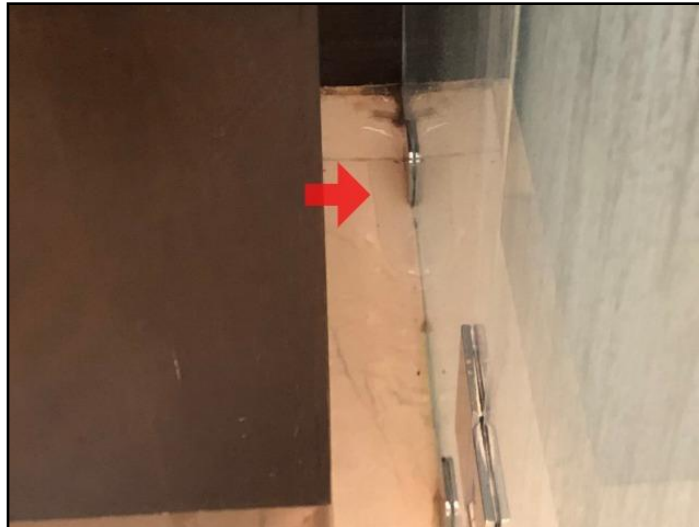
Location: Third Floor Secondary Bedroom

31. Condition: • [Leak](#)

Leaking out of enclosure at the bottom.

Leak

Task: Evaluate and Address as Needed

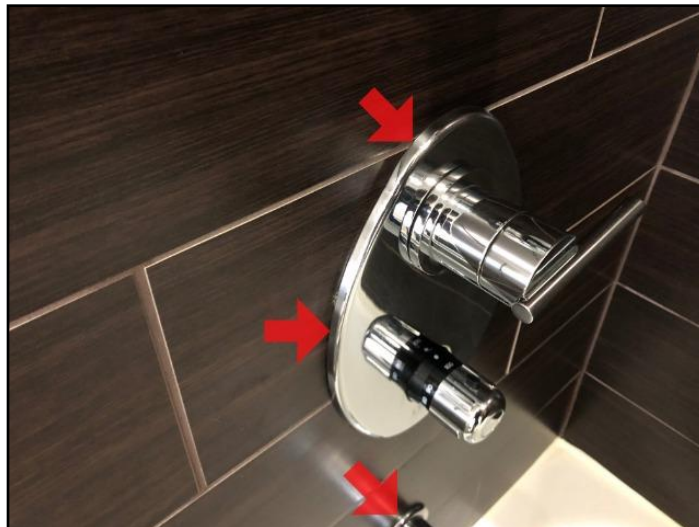
Location: Multiple

32. Condition: • [Caulking loose, missing or deteriorated](#)

Caulking loose, missing or deteriorated

Task: Evaluate and Address as Needed

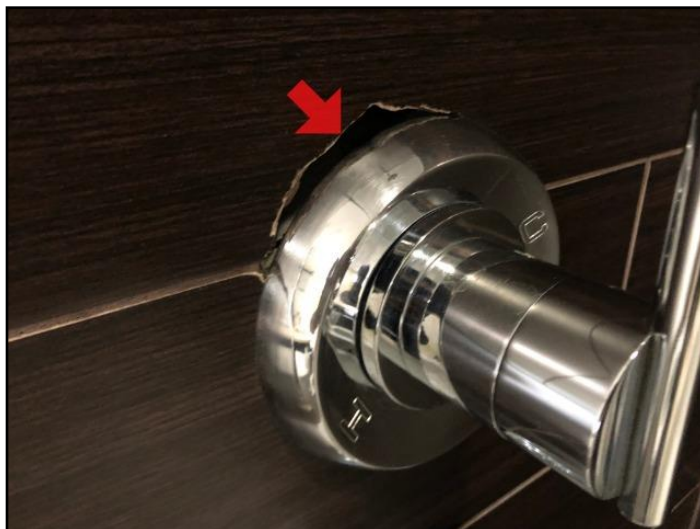
Location: Second Floor Secondary Bathroom

33. Condition: • Gap around faucet fixture observed. Fixtures in shower/bath enclosures should be caulked.

Gap around faucet fixture observed

Task: Evaluate and Address as Needed

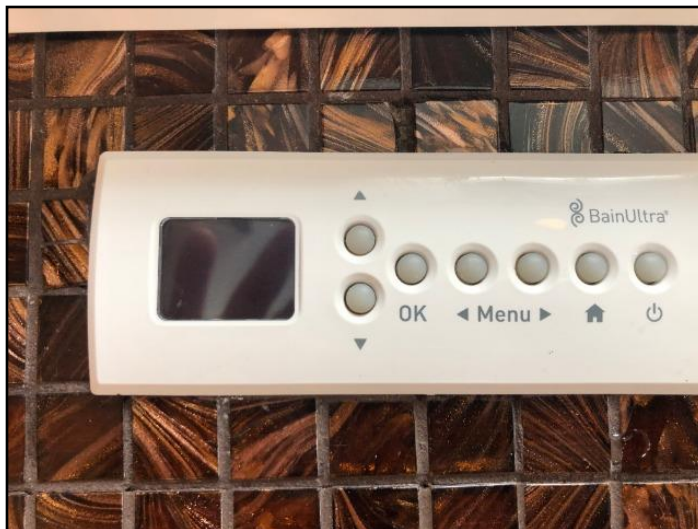
Location: Master Bathroom

34. Condition: • Control for whirlpool bath is not functioning as intended, display does not work. Difficult to operate.

Control for whirlpool is not functioning

Task: Evaluate and Address as Needed

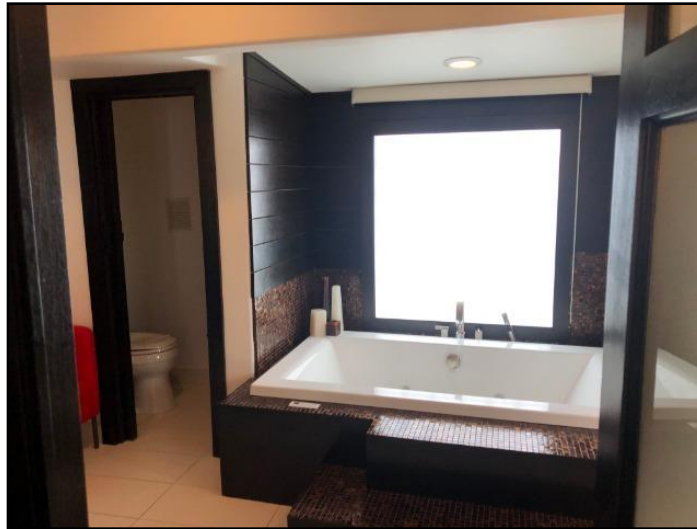
Location: Master Bathroom

35. Condition: • No GFCI (Ground Fault Circuit Interrupter)

No GFCI was found for Whirlpool bath.

No GFCI (Ground Fault Circuit Interrupter)

Task: (Hazard) Evaluate and Address as Needed

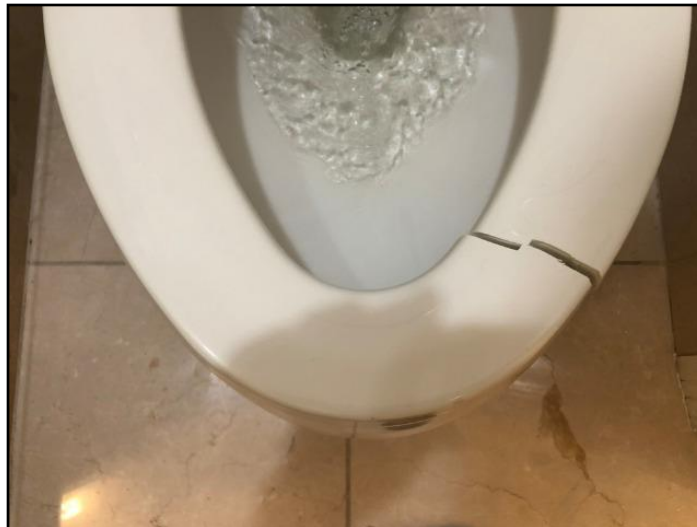
Location: Third Floor Secondary Bedroom

36. Condition: • [Broken or cracked tank lids, bowls or seats](#)

Broken or cracked tank lids, bowls or seats

Task: Evaluate and Address as Needed

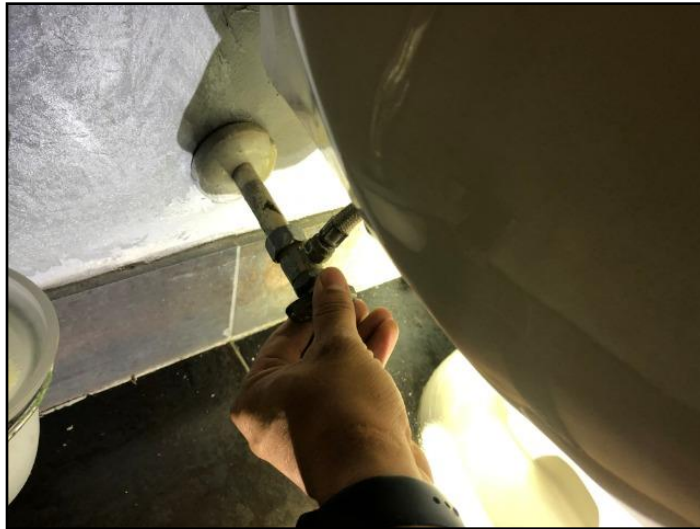
Location: First Floor Half Bathroom

37. Condition: • [Shutoff valve missing or inoperative](#)

Could not turn water supply to toilet open handle is loose.

Shutoff valve missing or inoperative

Task: Evaluate and Address as Needed

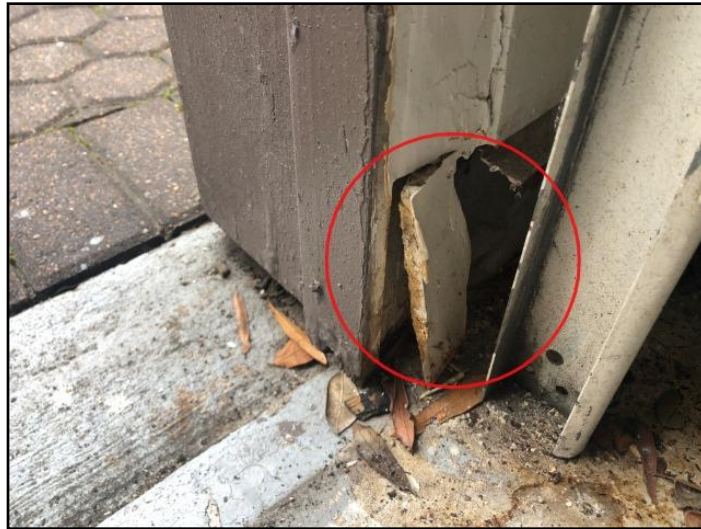
Location: Garage

40. Condition: • Typical flaws

Typical flaws

Task: Evaluate and Address as Needed

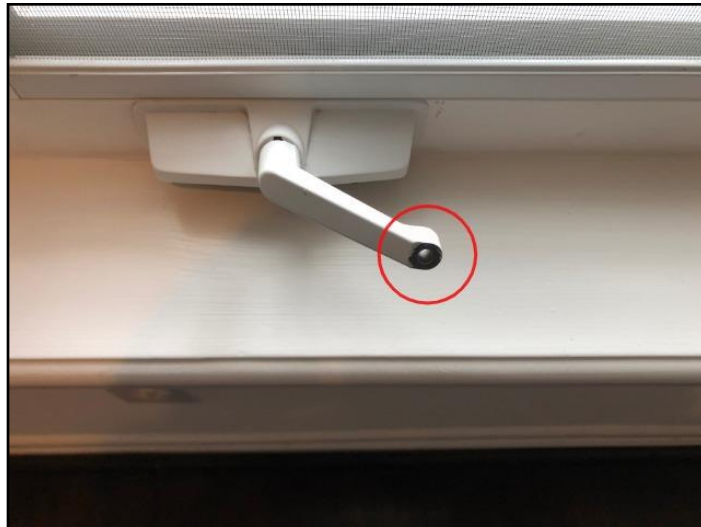
Location: Multiple

41. Condition: • [Missing](#)

Missing knob observed.

Missing

Task: Evaluate and Address as Needed

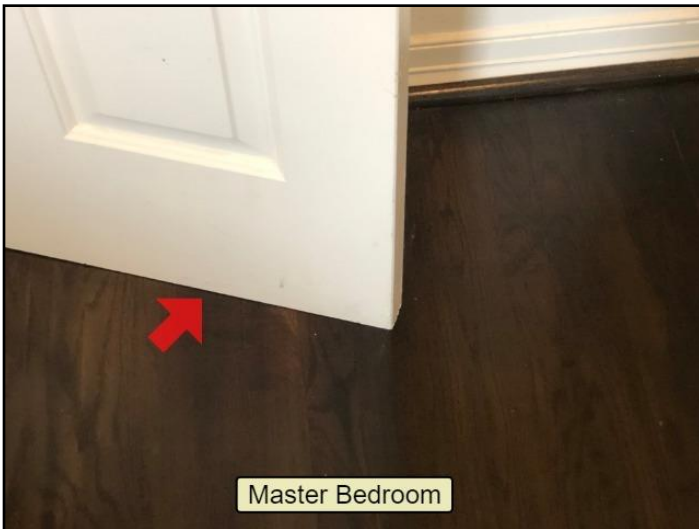
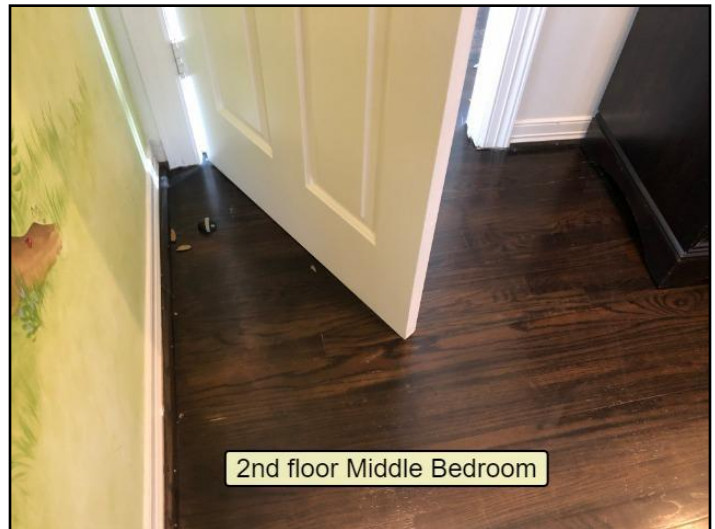
42. Condition: • [Stiff](#)

Stiff

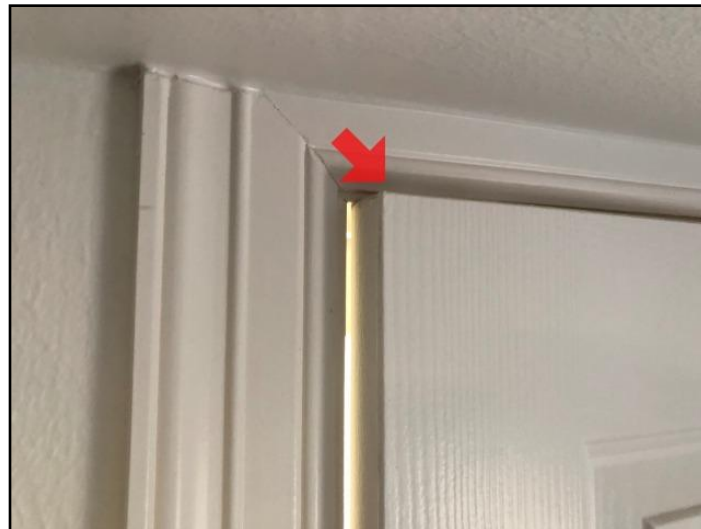
Location: Front Second Floor Secondary Bedroom

43. Condition: • [Stiff](#)

Stiff

Task: Evaluate and Address as Needed

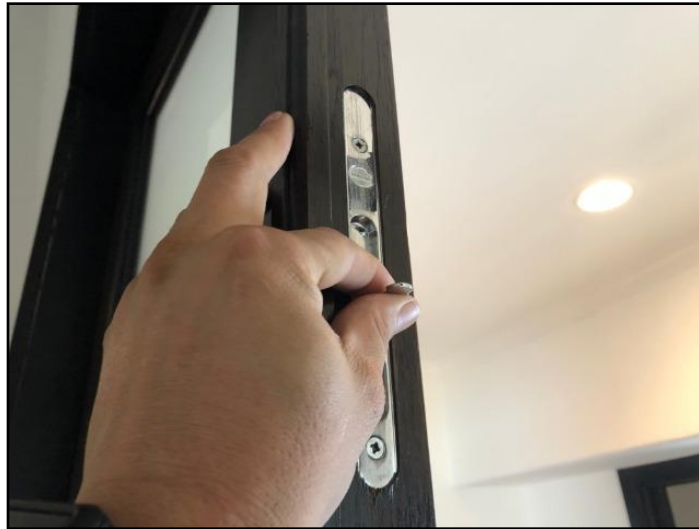
Location: Master Bathroom

44. Condition: • Lock mechanism faulty

Lock mechanism faulty

Task: Evaluate and Address as Needed

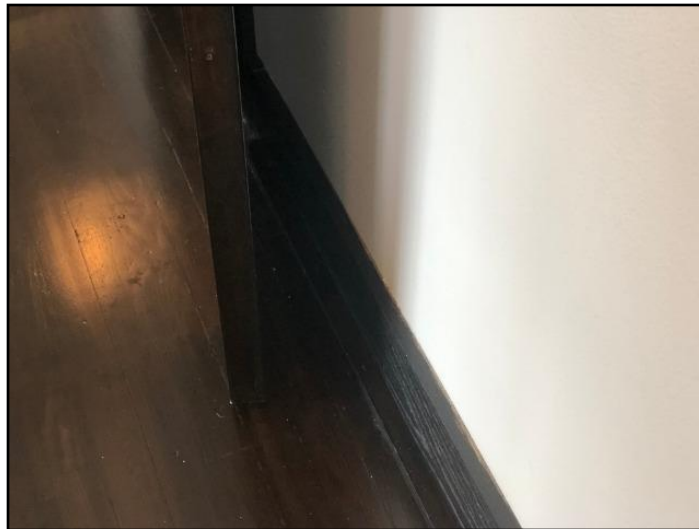
Location: Multiple

45. Condition: • [Doorstops missing or ineffective](#)

Doorstops missing or ineffective

Task: Evaluate and Address as Needed

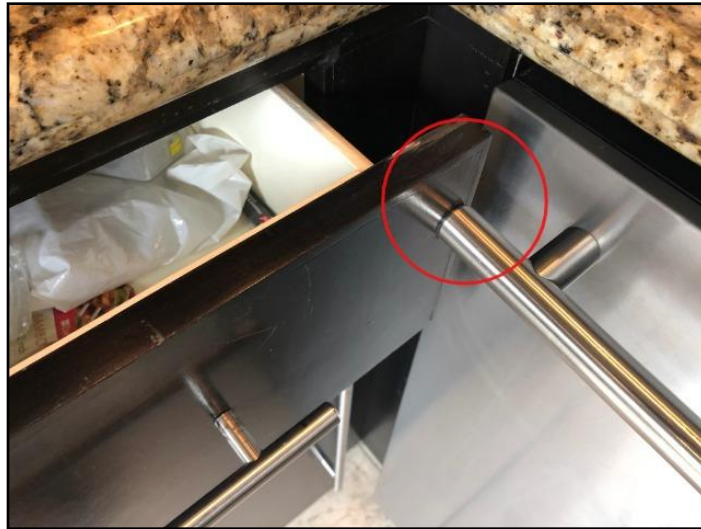
Location: Kitchen

46. Condition: • Drawer does not fully open.

Drawer does not fully open.

Task: Evaluate and Address as Needed

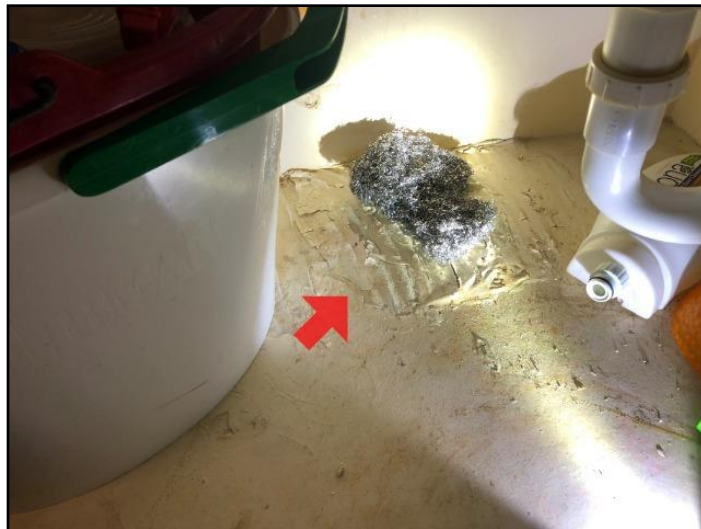
Location: Utility Room

47. Condition: • Note: Evidence of prior water contact.

Note: Evidence of prior water contact.

Task: Evaluate and Address as Needed

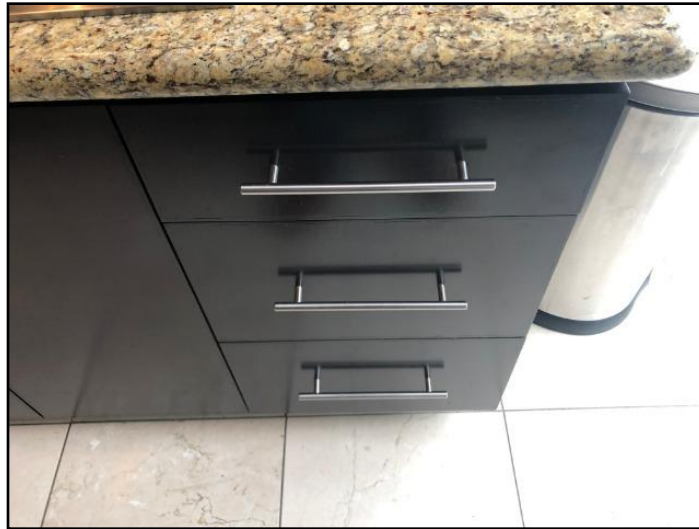
48. Condition: • [Stiff or inoperative drawers](#)

Stiff drawers observed

Stiff or inoperative drawers

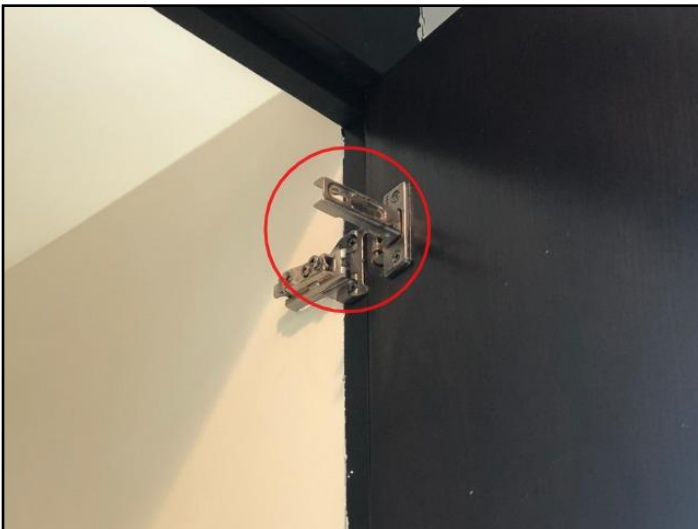
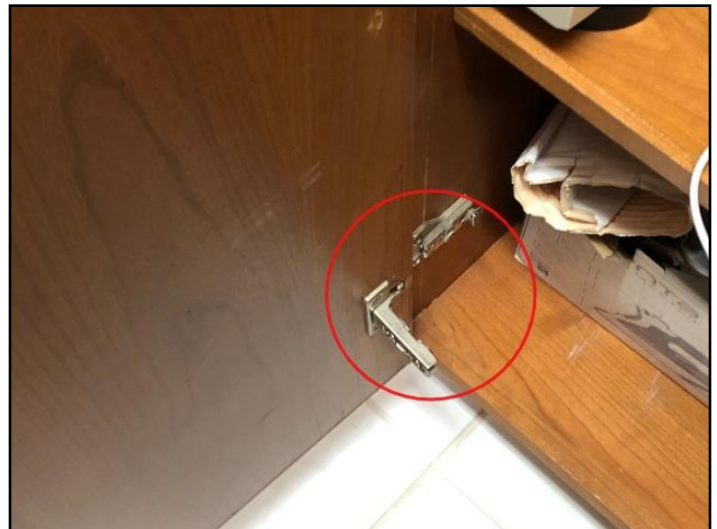
Location: Kitchen Next To Sliding Door Top Cabinet ans Utility Room

49. Condition: • [Pieces missing or loose](#)

Pieces missing or loose

Task: Evaluate and Address as Needed

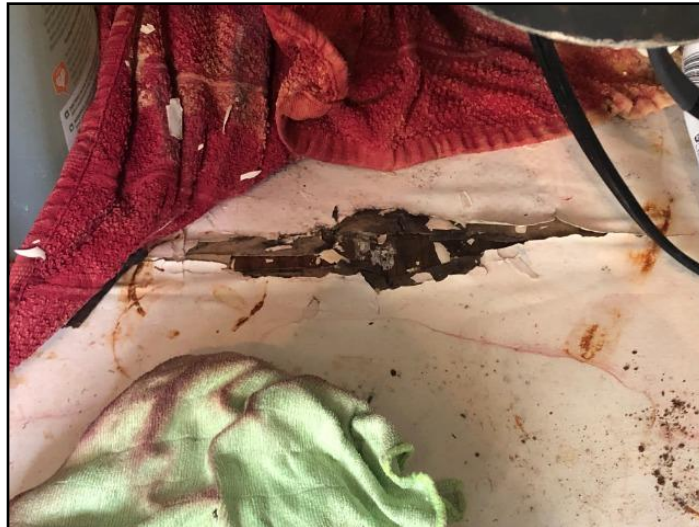
Location: Kitchen

50. Condition: • [Water damage](#)

Water damage

Task: Evaluate and Address as Needed

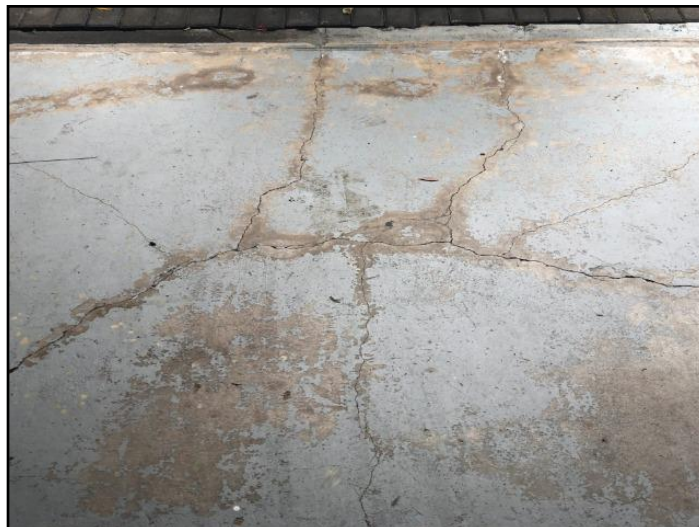
Location: Garage

51. Condition: • [Cracked](#)

Hairline cracks observed in garage floor. Typically from normal settling.

Cracked

Task: Evaluate and Address as Needed
