WILLCOX INSPECTIONS LLC™

PROPERTY INSPECTION REPORT

Concerning: 1505 Detering, Houston, TX 77007
(Address or Other Identification of Inspected Property)

By: Shavauna Higgins Professional Inspector #3472 08-17-16
(Name and License Number of Inspector) (Date)

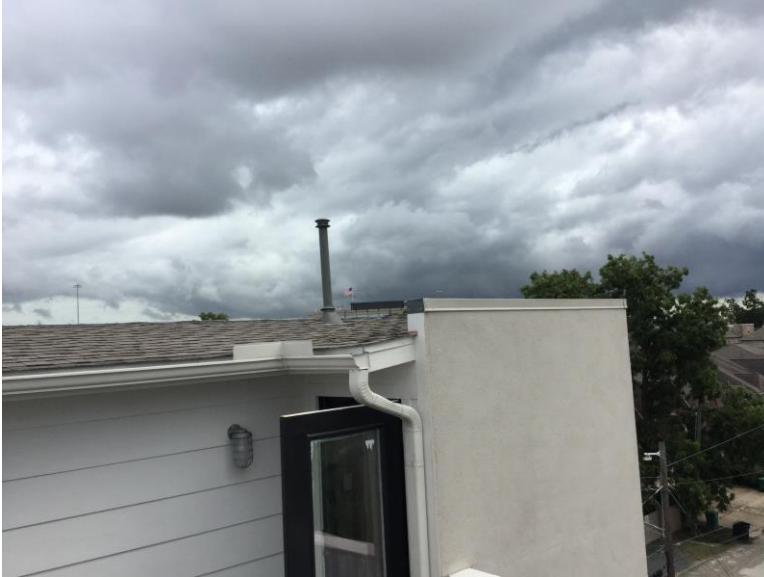
Information: Composition shingles are not currently manufactured for use on roofs with a slope of less than a three inch rise in a twelve inch run. Composition shingles can be used on a roof with a two inch rise in a twelve inch run provided that thirty pound felt is installed under the shingles. Under no condition can composition shingles be used on a roof with a slope of less than three in twelve. It appeared as though composition shingle application on portions of the roof are incorrect and the shingles should be replaced with proper roofing materials designed for low sloped roofs. This does not mean that these areas of the roof are currently leaking or that they may develop leaks in the near future. This is to advise you that the roof covering materials are being improperly used.

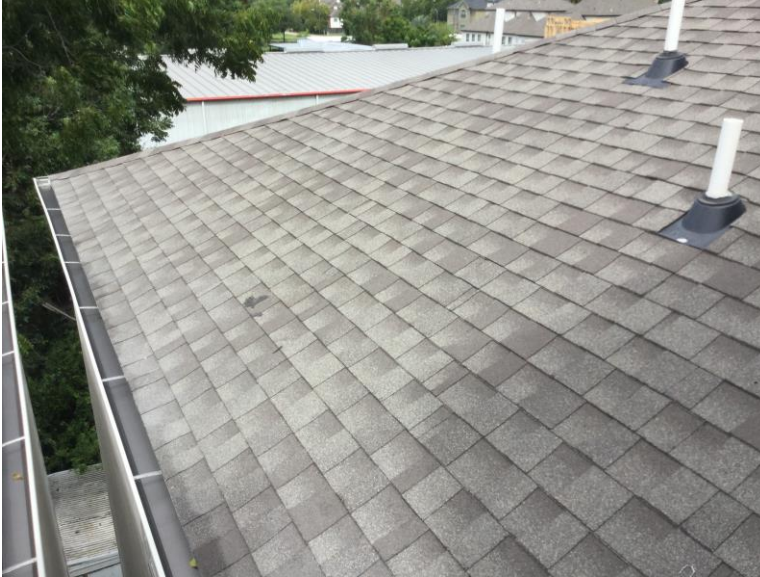
Information: The PVC pipes must be painted to protect the PVC from degradation by the ultra violet rays of the sun. The lack of protection from the ultra violet rays of the sun can cause the PVC pipes to crack and break.

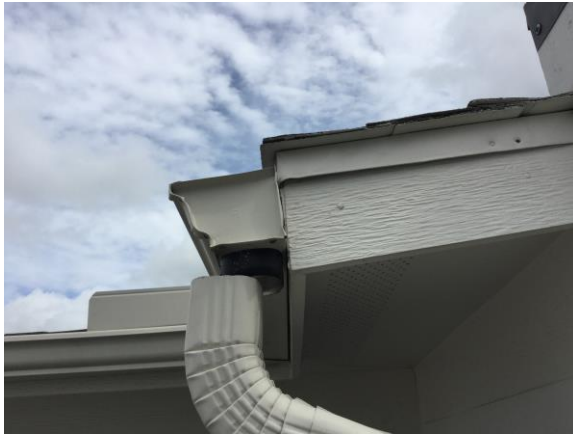
Deficiency: Some of the downspouts on the guttering system were not connected or were loose.

Information: The gutter system should be connected should be properly secured to the structure.

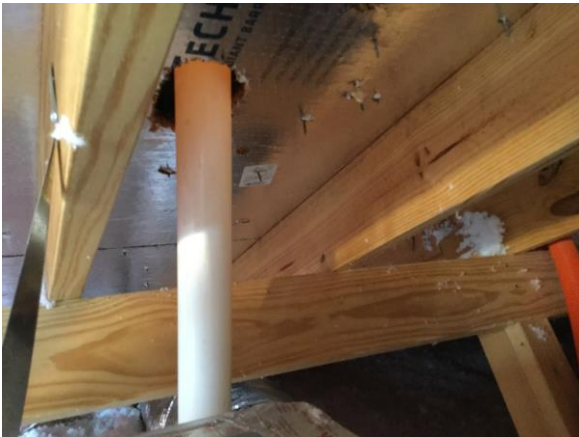
Deficiency: The sewer vent pipe penetrations of the roof deck appeared to be sealed with neoprene roof jacks. Water from rains was observed running down the pipe at some penetrations.

Information: These jacks should be repaired or replaced.

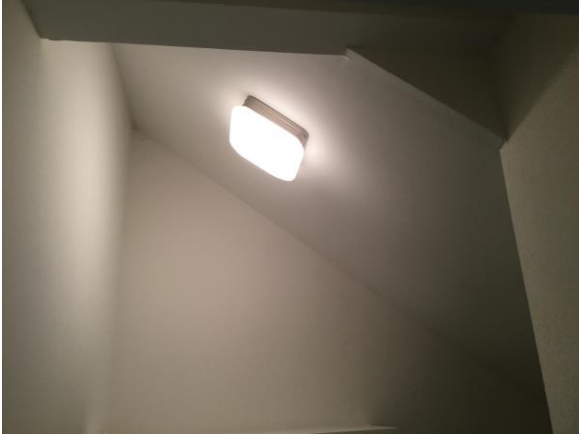
Information: Staircases are required to be fireblocked on the underside of the staircase and at the top and bottom of each flight. Fireblocking is required in these areas to slow the speed of a fire and to keep the staircase standing and usable for as long as possible in the event of a fire. This requirement is made to give the people in the upper stories of the house a chance to escape. Proper firestopping should be provided for safety.

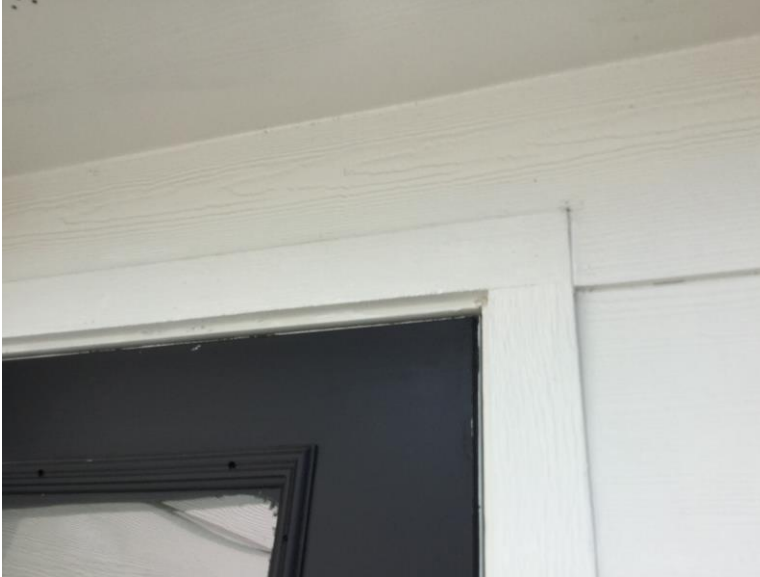
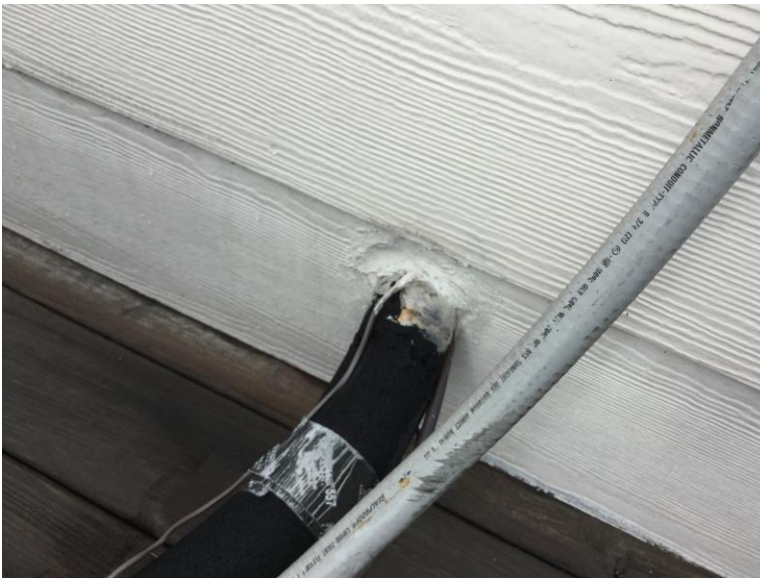
Information: Metal flashing, called “Z” flashing, should have been installed during construction of the structure. Z flashing is cut into the frame siding and covers the top piece of trim to prevent water from entering the trim or window frame. Z flashing is meant to prevent water penetration, not to act as a drain after water penetration has occurred. Proper Z flashing materials should be installed to prevent water penetration.

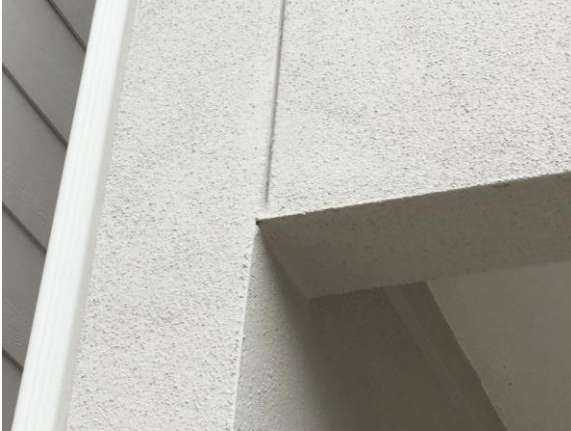
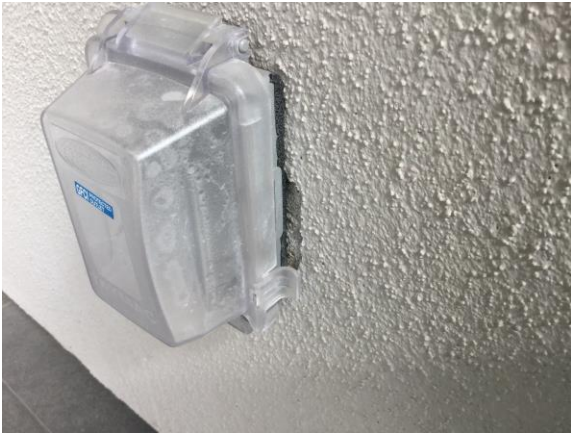
Deficiency: Portions of the cladding system were stucco veneer. Proper flashing and drain plane terminations were not visible in all required areas such as wall penetrations and wall terminations. While metal flashing was installed, for example, above the windows there were no drain planes installed at the flashing. Wall termination drains were installed in some areas, but were blocked and did not appear to be effective. Flashing is intended to prevent water infiltrating the wall system and to allow water created from condensation in the wall to escape the wall system. Water held in the wall sheathing and/or framing can and may cause deterioration of the wooden members of the house and the growth of harmful microbial organisms and these organisms can affect the indoor air quality of the house.

Information: Historically, few stucco clad homes were ever constructed in the Greater Houston area. When houses did not have central air conditioning there was no means for nature to produce condensation in the wall system. When homes were equipped with central air and heat, the walls were not insulated to the degree that the house was sealed or substantially sealed. When air and water are easily exchanged from the outside atmosphere even if water condensed in the wall cavity there was little chance of the house being labeled a “sick building” as mold spores were also readily exchanged with the outdoor atmosphere. In recent years, stucco has become a popular cladding material in the Greater Houston area. Unfortunately, the only stucco masons available to us came from the desert climates. If there is less than 10 inches of rain per year and when the indoor air has a higher water content (higher humidity) than the outside air, water flows from the interior, wetter living space to the outside (drier) atmosphere. Again, there is little danger of water being trapped in the wall system or of molds developing.

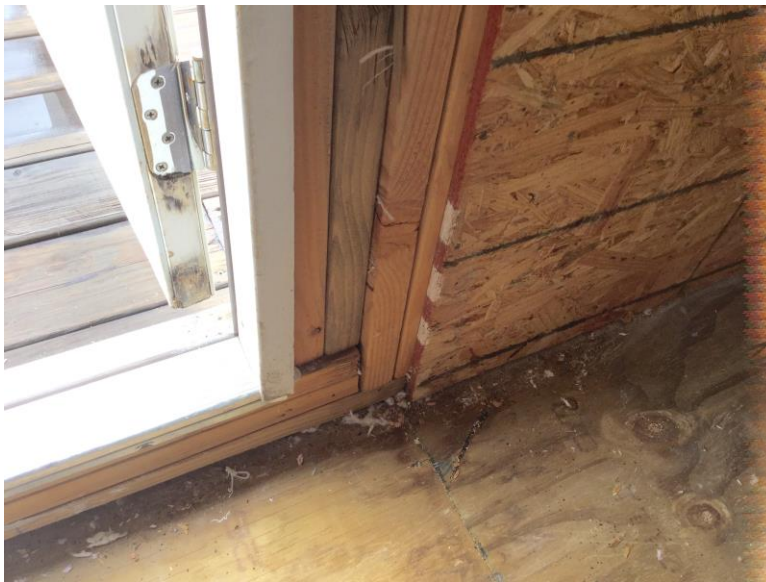
Deficiency: Water damage was noted at portions of the exterior doors and related components (including interior) at the balcony.

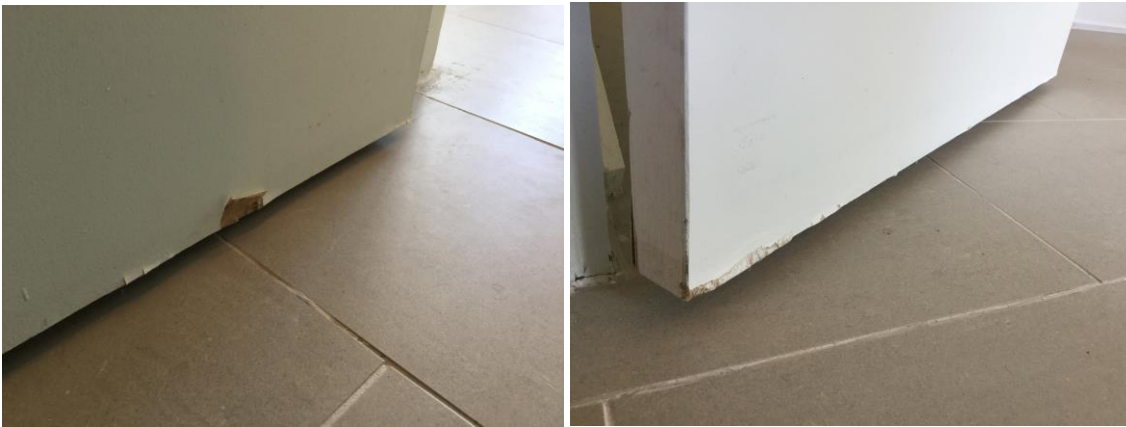
Deficiency: Some of the interior doors were damaged.

Information: Repair or replacement of the doors is recommended.

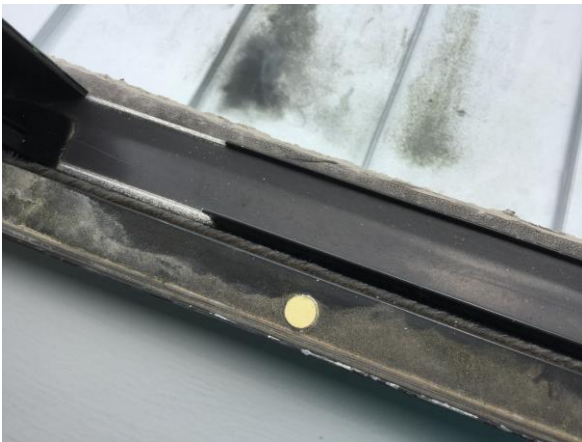
Deficiency: The window frames had been drilled to allow passage of the conductors for the alarm sensors.

Information: Many window manufacturers do not allow the frames of their windows to be damaged or altered in any way. Holes drilled through the window frames may have voided the window manufacturer's warranty. You should determine if the warranty on these windows is still valid.

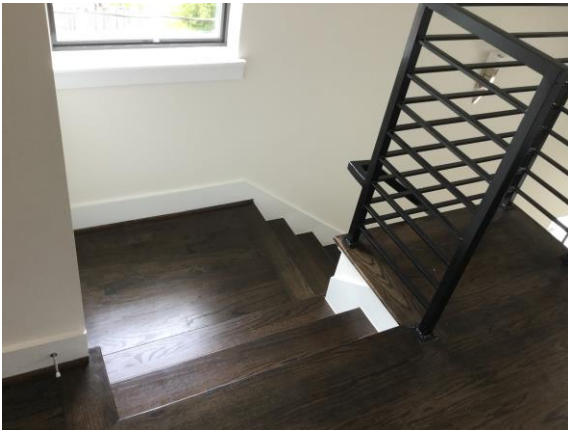
Deficiency: A guardrail was not observed on a portion of the 3rd floor.

312.1 Guards required.

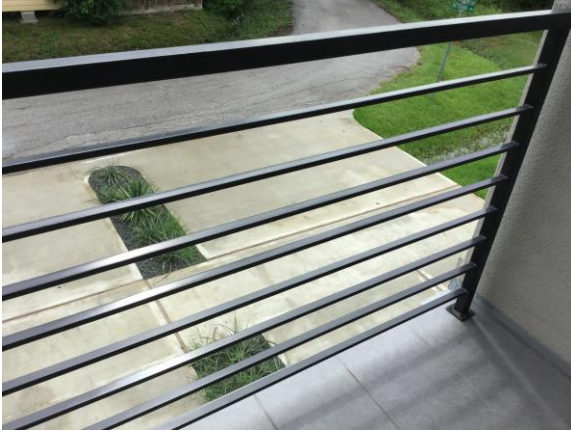
Deficiency: The exterior guardrails may create a ladder effect.

Information: The IRC prohibits the use of guardrails on porches or staircases that create a ladder effect. The guardrails appeared to create such an effect. You are advised that this type of guardrail creates a hazard, particularly to small children who may climb the railing.

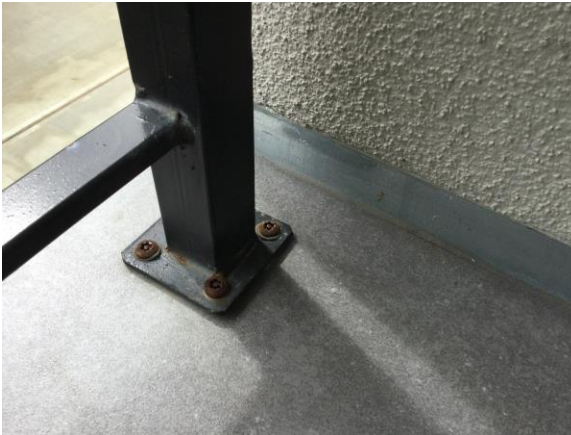
Information: If the bolts penetrated the water proofing system the water proofing system will ultimately leak. The method of attachment of the bolts should be determined. If the water proofing system has been compromised the water proofing system should be replaced.

Deficiency: Ponding water and deflections were observed in portions of the upper balcony wood deck materials.

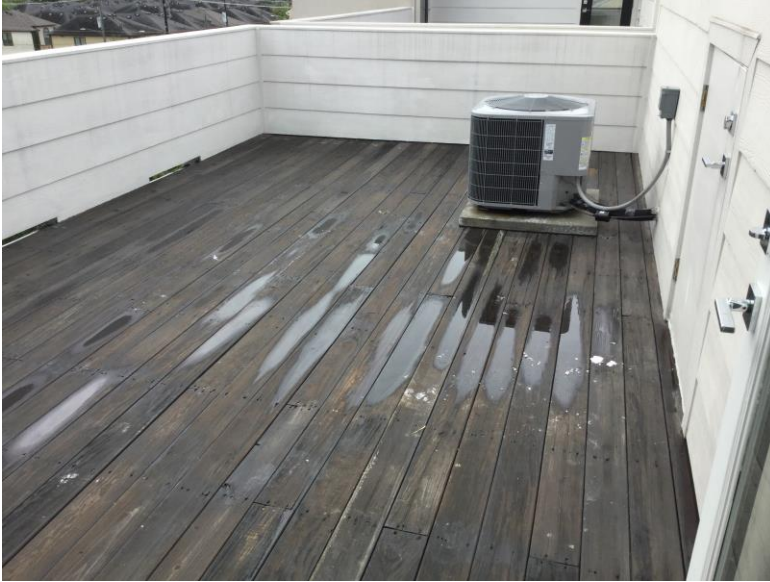
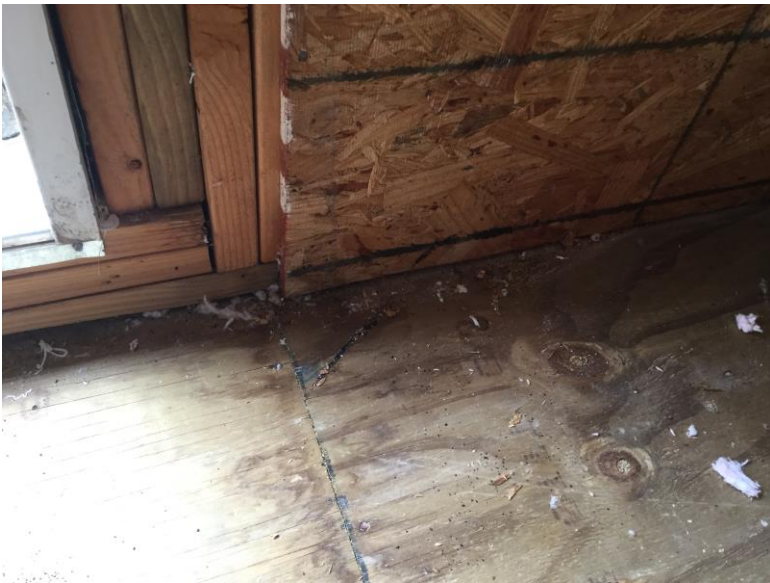
Deficiencies: Water damaged and/or wet (to the touch) materials were observed on the attic interior common wall for the HVAC equipment room / attic. The wet materials were not limited to the area near the exterior door. A properly sloped pan and water-proof methods used beneath the deck could not be observed at the time of the inspection.

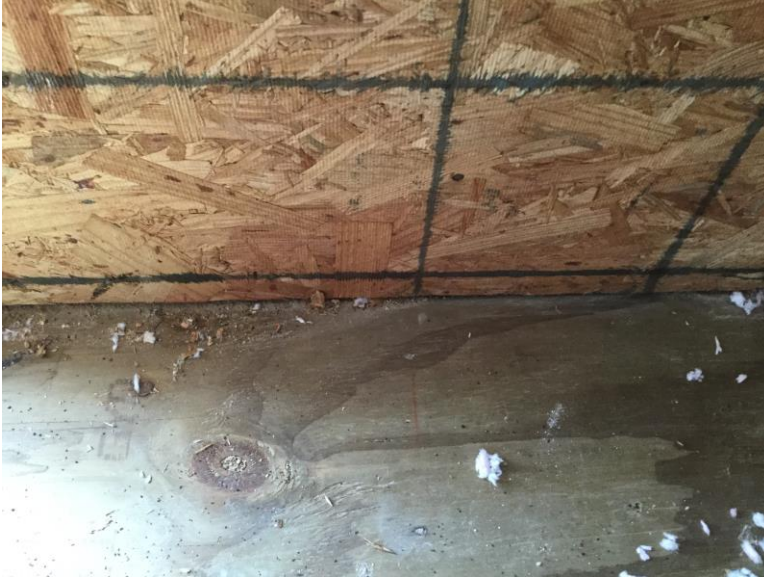
Information: Pans beneath decked areas should be adequately sloped to allow for swift water removal toward scuppers. A scupper is an opening in a wall that allows water to drain from the pan beyond the surface of the exterior wall finish to prevent interior water penetration. Scuppers should be properly sized and installed to minimize the risk of interior water penetration.

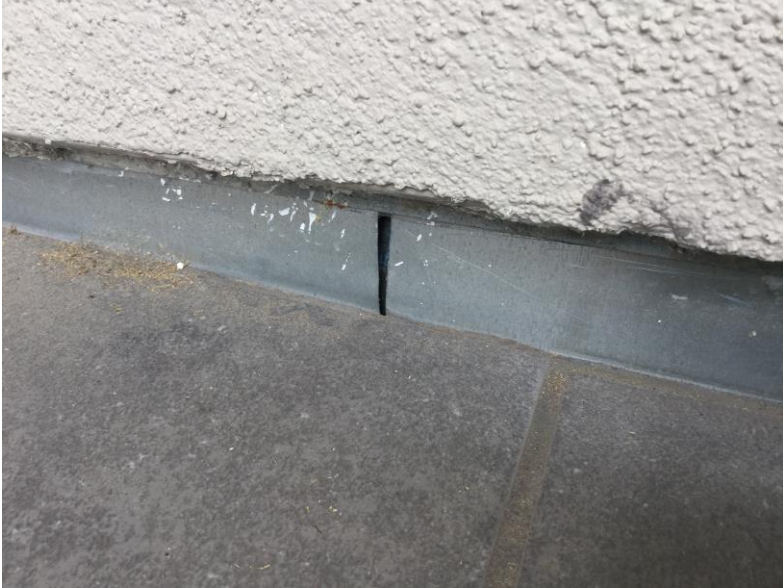
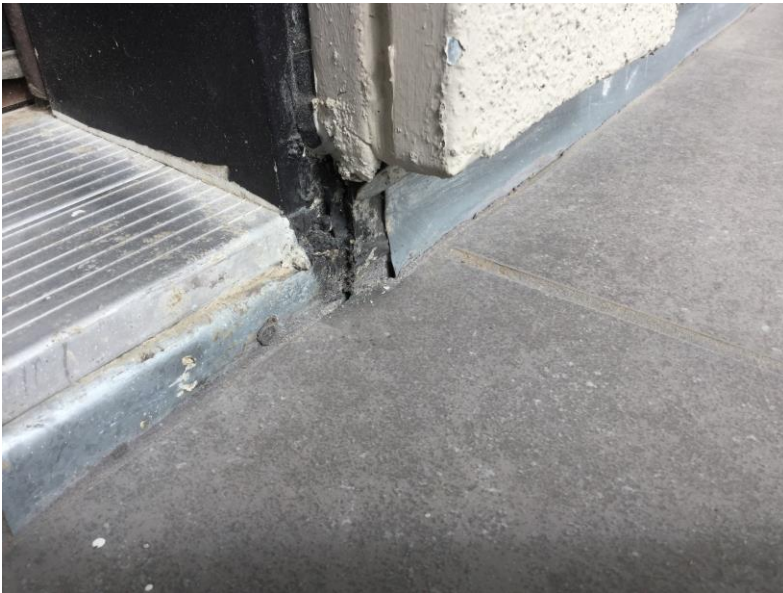
Information: The balcony surface must be sloped to drain water completely off the balcony and over the edge of the balcony for drainage. Water standing on the surface of the balcony will ultimately cause the balcony to leak.

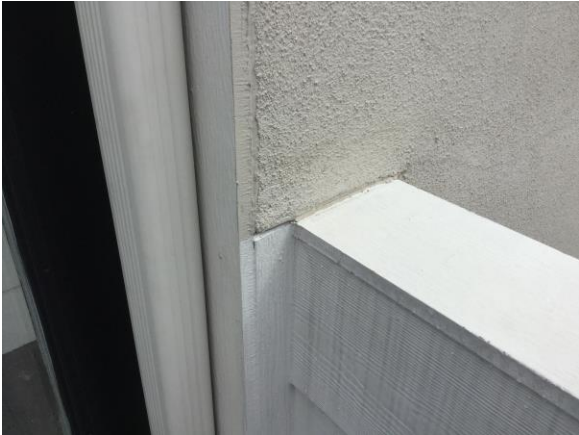
Deficiency: There were no parapet caps on top of the wood fiber products balcony guard rail walls.

Information: All masonry materials absorb water. The tops of all masonry walls that are exposed to the elements are required to be covered with a water proof material. Parapet caps should be installed to prevent water penetration. Wood fiber products materials are not manufactured for use horizontally. The wood fiber products material should be replaced with materials approved for horizontal installation. Proper parapet caps should be installed to reduce the chances of water penetration.

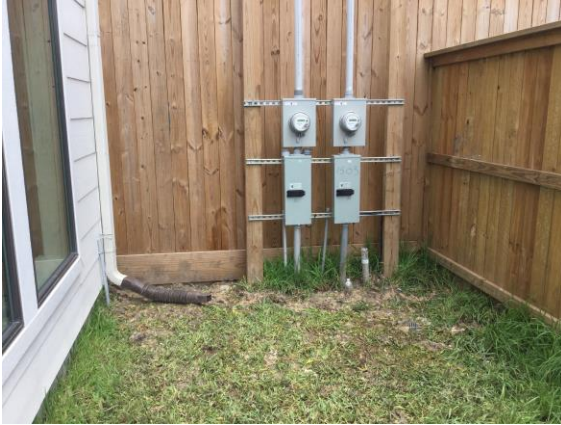
Information: The panel board was located on an upright structure on the right side of the home. The panel board had a 200 Amp main disconnect. The listed information for the box was not visible at the time of the inspection. Due to weather conditions at the time of the inspection, the exterior panel board was not opened for inspection. No further information could safely be provided at the time of the inspection.

The conductors to the sub panel in the garage were Aluminum. The branch circuits into the home were copper.

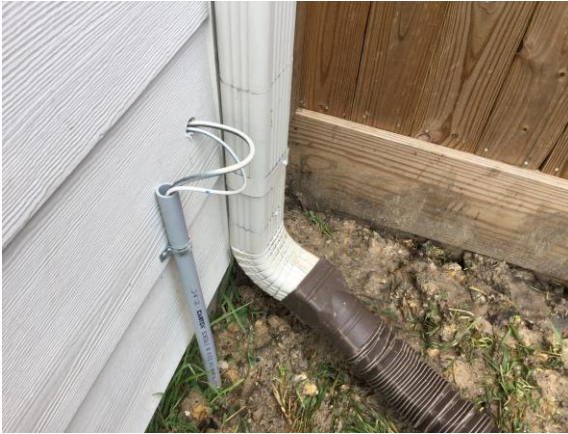
Deficiency: Exposed wiring was observed on the right exterior of the home.

Information: All wiring junctions should be properly sealed in closed junction boxes. Open wiring junctions and junction boxes are considered to be a fire hazard. This is an unsafe condition. All unsafe conditions should be remedied.

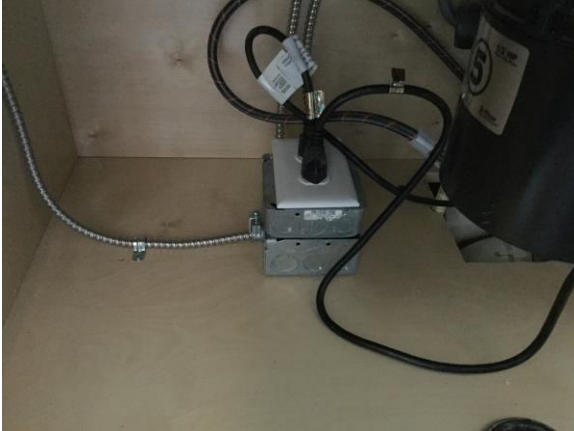
Information: The National Electric Code and the IRC prohibit the installation of electrical receptacles in the face up position on kitchen and bathroom counter tops to prevent debris and water from entering the receptacle. While the installation of the receptacle in the face-up position under the kitchen sink may not violate the exact provisions of the codes, it violates the intent of the codes in my opinion. It is my opinion that the receptacle should be moved to the side wall to reduce the possibility of water or debris entering the receptacle.

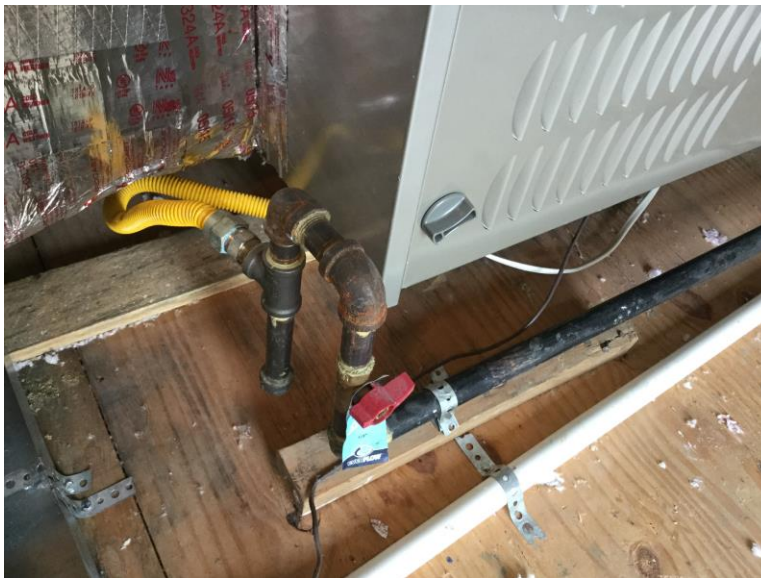
Deficiency: The upper furnace had not been placed into service at the time of the inspection.

Information: The unit should be placed into service and tested for proper and safe operation prior to the termination of any due diligence investigation period.

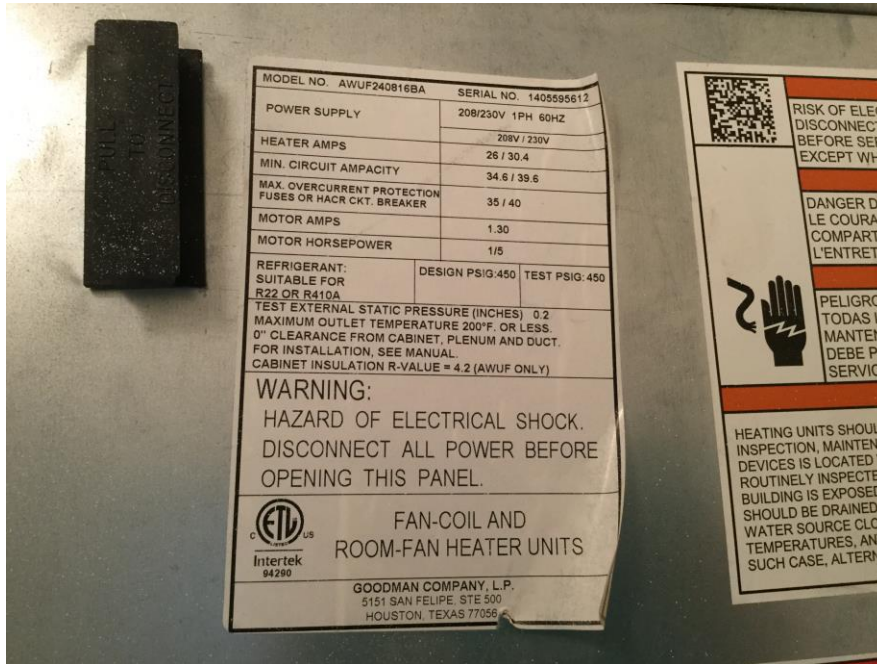
Deficiency: The cover panel was missing for the interior downstairs equipment.

Information: The missing cover panel should be replaced for proper operation of the system and equipment.

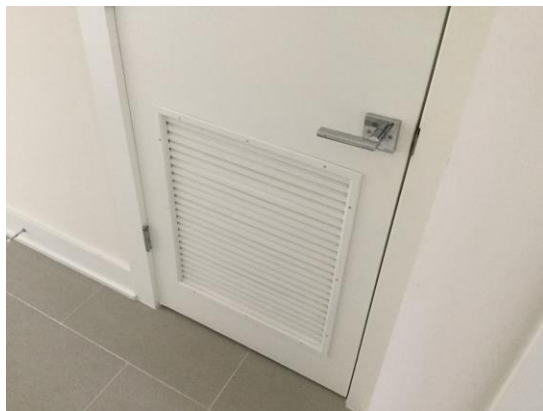
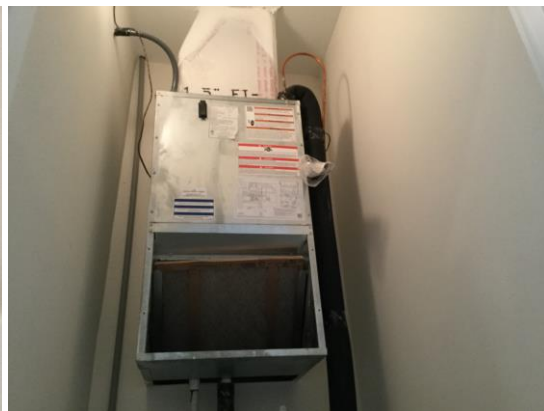
Information: Return air openings should not be obstructed. Although openings were observed in the door, in my opinion, the closed door will deprive the HVAC system of return air. Failure to provide adequate return air prevents the air conditioning and heating systems from operating properly and from operating efficiently. All return air chases should be verified as being at least adequate for each HVAC system.

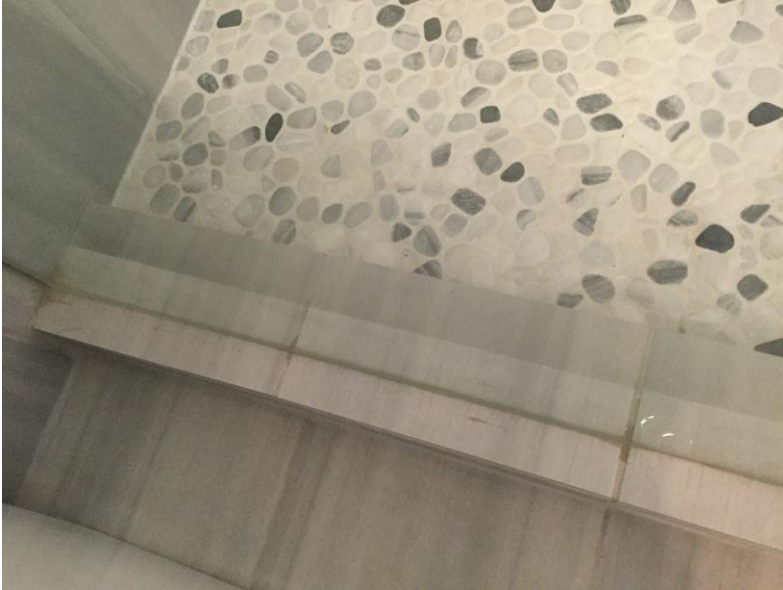
Information: Water appeared to have flowed out of the shower stall where the ends of the glass panels are caulked against the tile. The enclosure should be properly sealed to prevent leaks.

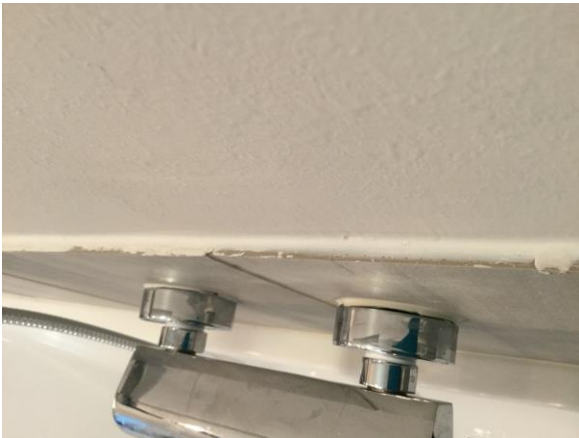
Deficiency: There were gaps in the caulk at the fixture penetrations in bathrooms. The most notable, in my opinion was in the master bathroom.

Information: The bathtub/tile junctions should be re-caulked.

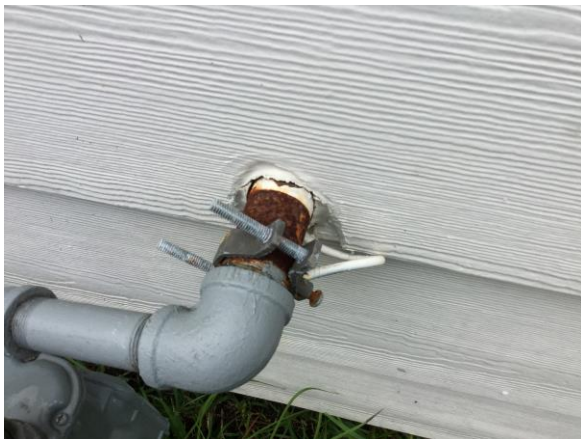
Deficiency: The natural gas pipe supply pipe penetration through the outside wall is required to be sleeved so that no friction between the veneer and the gas pipe can develop and so that corrosives from the outside wall cannot attack the gas pipe. The sleeve is also required to protect the pipe should differential foundation movements occur. Corrosion was observed on the piping.

Information: Friction between the outside wall and the pipe can cause the pipe to be damaged. The penetration of the gas pipe through the outside wall should be sleeved for safety.

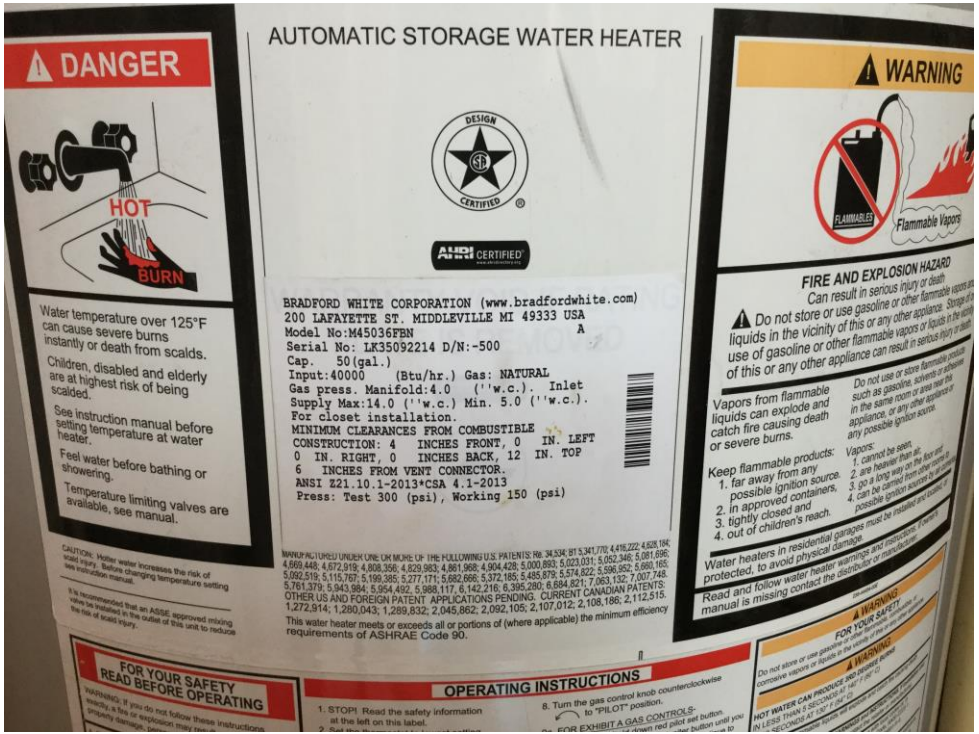
Deficiency: The tank was damaged.
