## PROPERTY INSPECTION REPORT

**Concerning:** 3611 Windbriar Ct., Houston 77068

**By:** Greg Genser – TREC Professional Inspector License #2962 6/17/19; 1:45-6:15pm

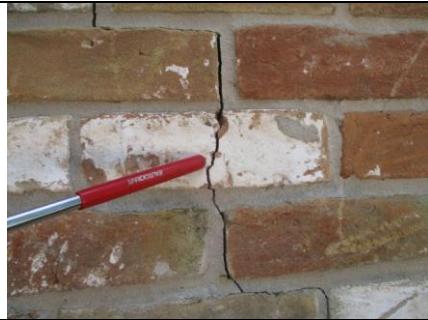
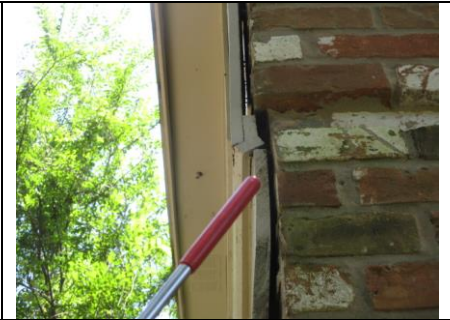
1. **Deficient:** Exterior brick cladding crack was observed at some locations. Exterior trim separation from brick was observed at the NE corner.

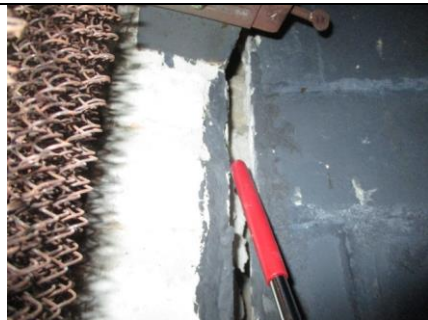
2. **Deficient:** Evidence of separation-settlement to the fireplace and chimney was observed.

2<sup>nd</sup> floor elevation fireplace about 1" separation.

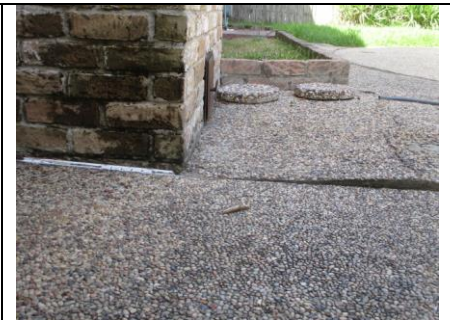
1<sup>st</sup> floor elevation interior brick separation from crown molding

Fireplace and flatwork settlement

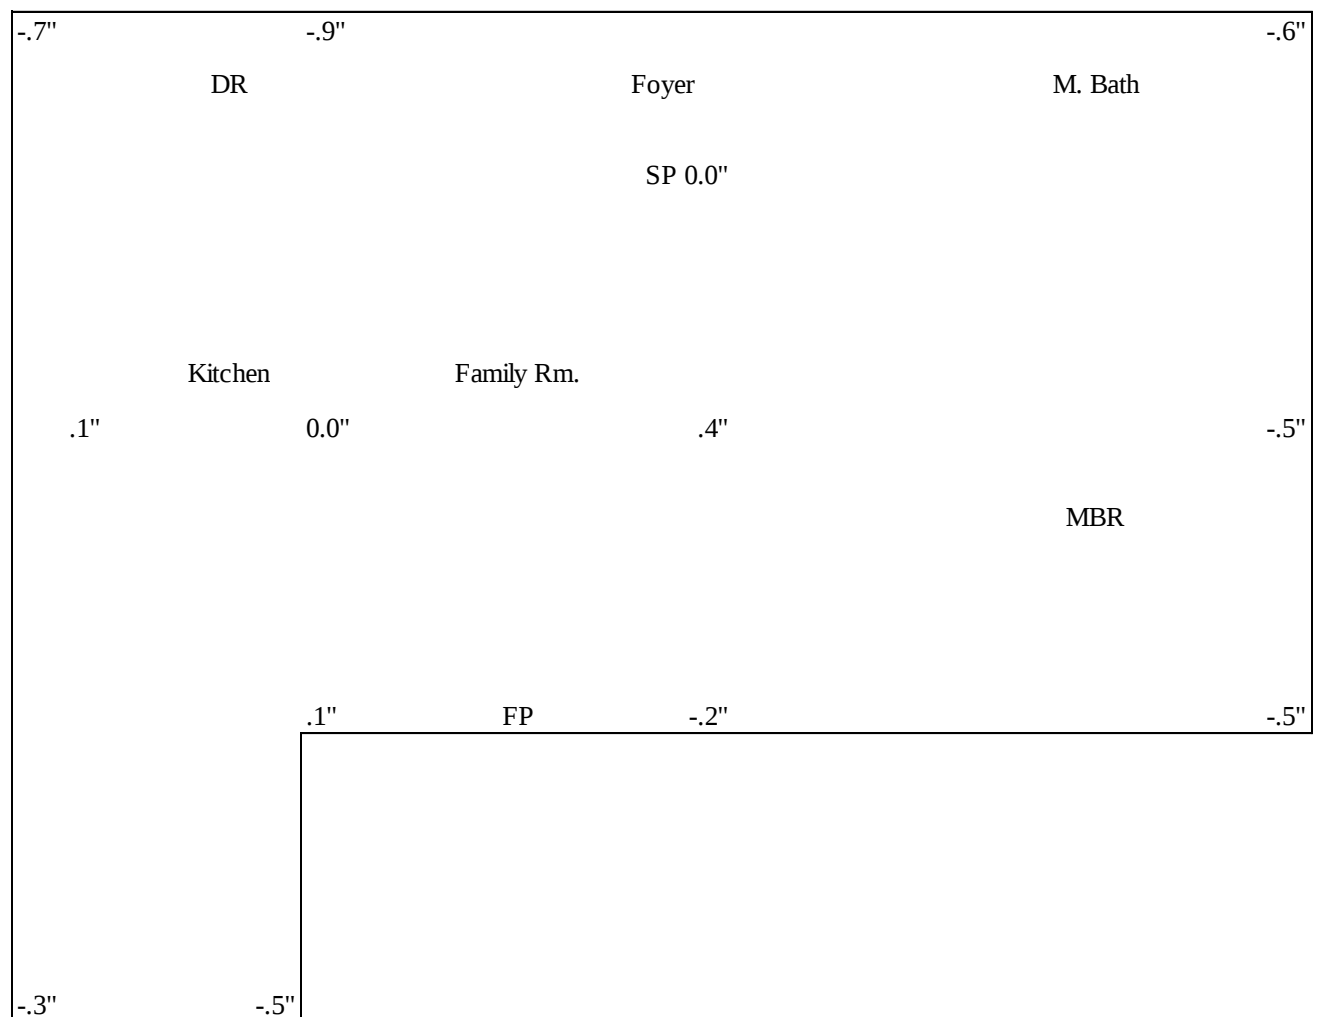
**Foundation Elevation Survey**

**Foundation performance:** In the inspector's opinion, the foundation does not appear to be performing its intended function, as evidence of deflection-differential movement with the foundation was observed. A Foundation Elevation Survey (FES) was performed. The greatest foundation elevation variance measured is 1.3 inches. See FES on page 6 for details. The following was observed but may not be all-inclusive.

Information: Survey not to scale. A Smart Leveler was used to take a random sampling of measurements. Measurements shown do not adjust for floor coverings differences. Measurements are in 1/10-inch. Starting Position (SP) = 0.0". Greatest foundation variance measured is 1.3 inches.

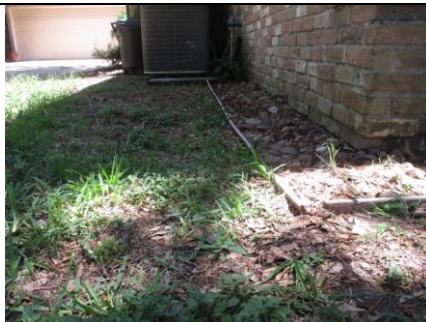
2. **Deficient:** Improper grade-slope and evidence of improper surface water drainage to property was observed at some locations. Proper site drainage is important in preventing erosion, water ponding and possible failure of a foundation system.

Grade-slope incorrect; one of several locations

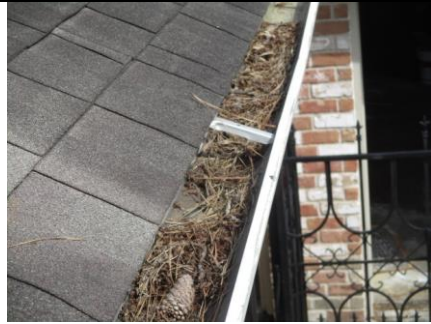
3. **Deficient:** Debris was observed in gutter that should be removed to allow for proper water collection and discharge. Installation of a leaf guard should be considered to prevent further gutter obstructions. Gutter downspout does not extend several feet away from the foundation perimeter at some locations. Proper drainage is important in preventing erosion, water ponding and possible foundation failure.

Pine needles in gutter

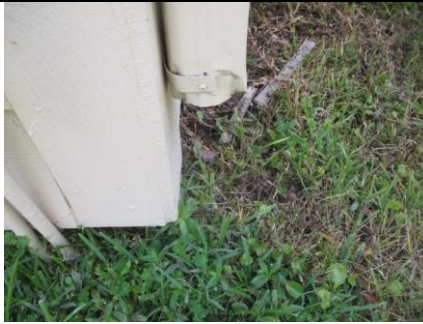
Downspout does not extend away from foundation; one of some locations

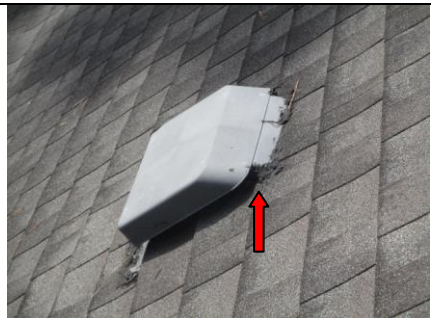
1. Information: According to seller's disclosure notice, roof cover is 10 years old. Evidence of repair to roof cover-penetration-flashing was observed at some locations. Additional information about repairs should be obtained from homeowners.

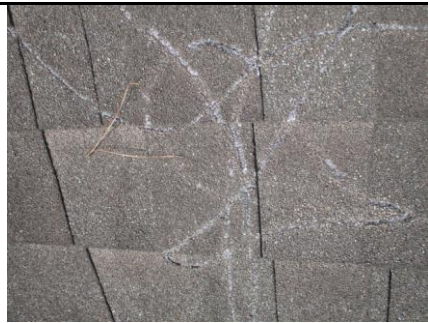
2. **Deficient:** Deterioration to the roof cover was observed; as evidenced by shingle damage, aggregate-granule lose and lack of adhesion. Shingle adhesion is important in preventing shingle uplift, blow-off and water penetration.

Shingle damage

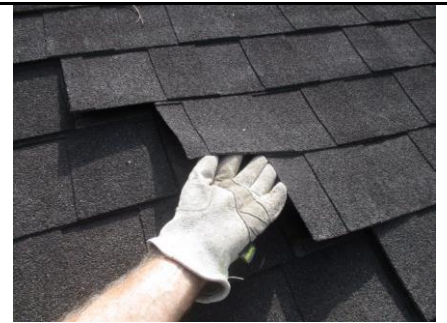
Lack of adhesion

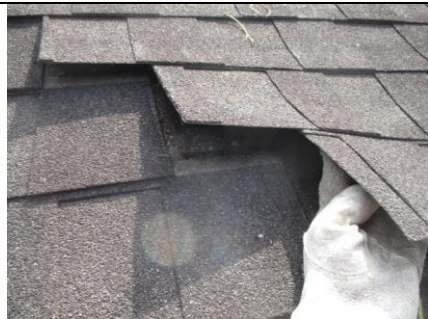
3. **Deficient:** By random observation, shingle fastening is incorrect at some locations. Proper fastening is important in preventing shingle uplift, blow-off and water penetration. See illustration below for example of proper nail installation.

Shingles not fastened at edge

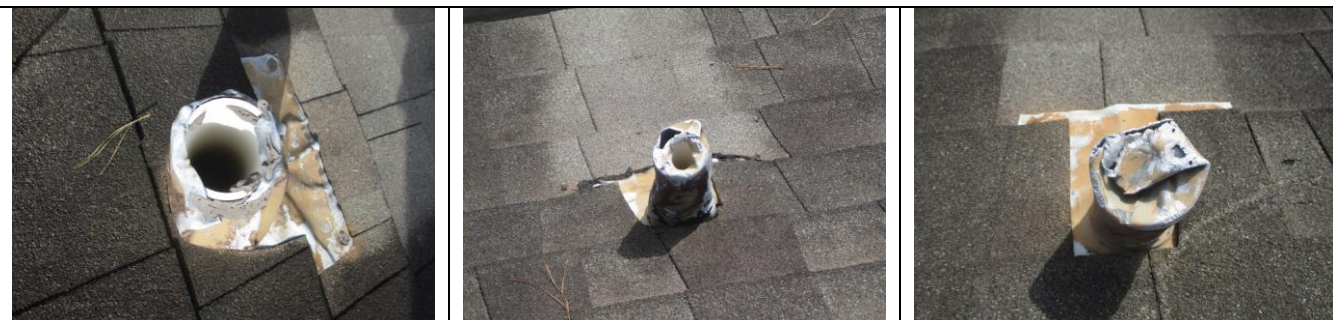
5. **Deficient:** Plumbing vent pipe roof jack (boot) seal is damaged-incorrectly installed at some locations. A proper seal is important in preventing water penetration into the building.

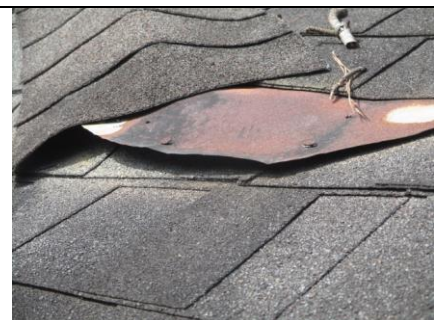
6. **Deficient:** Flashing is loose-corroded at one or more locations. Proper flashing installation is important in preventing water penetration into the building.

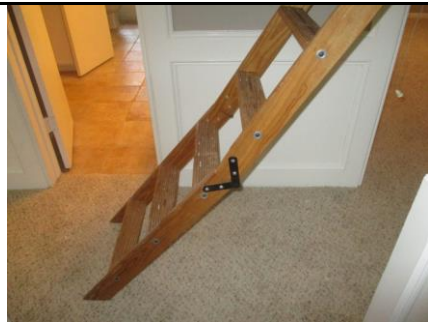
Stairway opens incorrectly

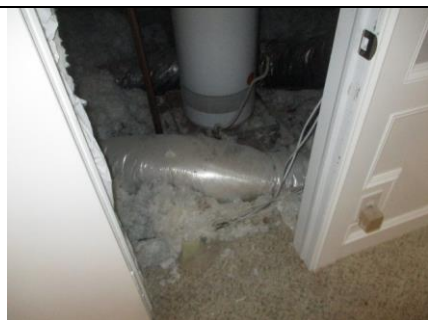
Walkway not installed

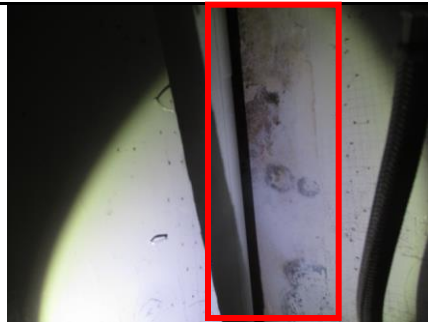
Water damage behind dishwasher

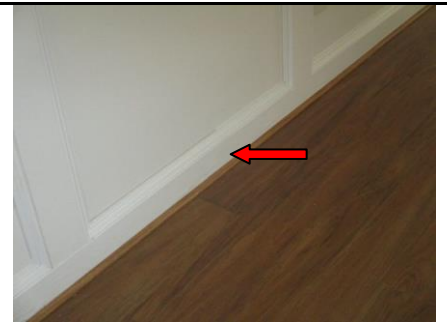
Water damage in family room

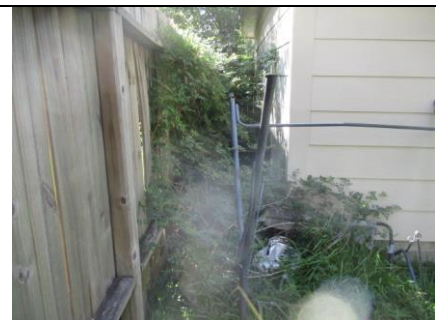
9. **Deficient:** Due to vegetation, exterior west side of the garage is excluded from inspection.

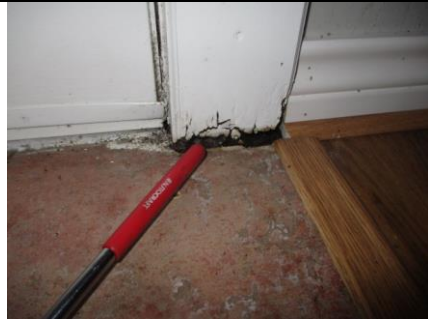
Water damage; evidence of water penetration at master bedroom door

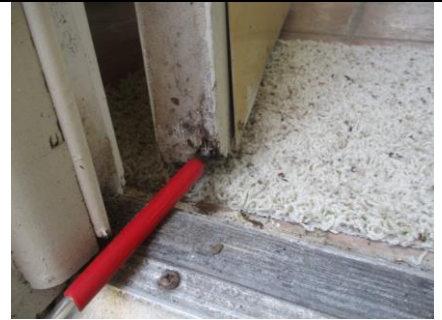
Water damage at breakfast room door

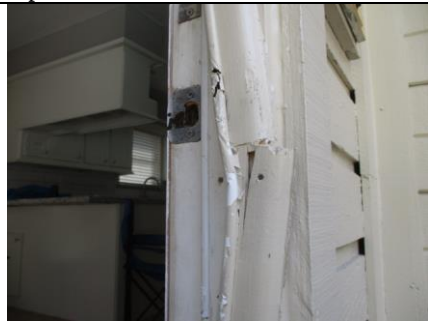
Trim damage at breakfast room door

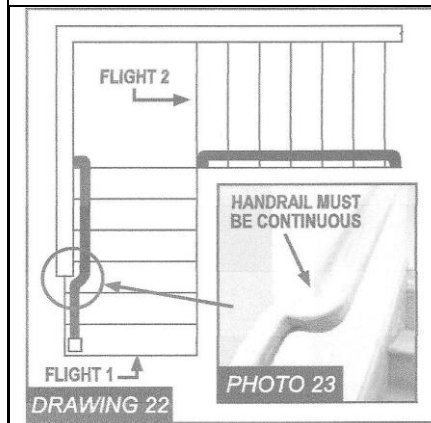
2. **Deficient:** Handrail is incorrect.

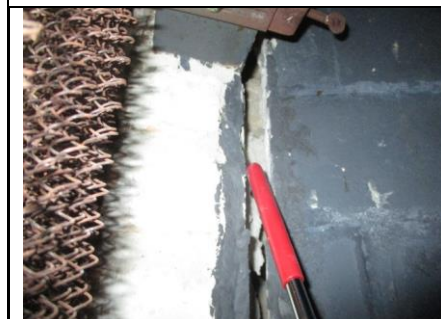
1. **Deficient:** Evidence of separation within both fireplaces was observed. See section 1A for additional information. Open joints within fireplaces are not sealed. Properly sealed fireplace is an important safety requirement.
- Information: An approved sealant with a 300°F minimum rating should be installed.

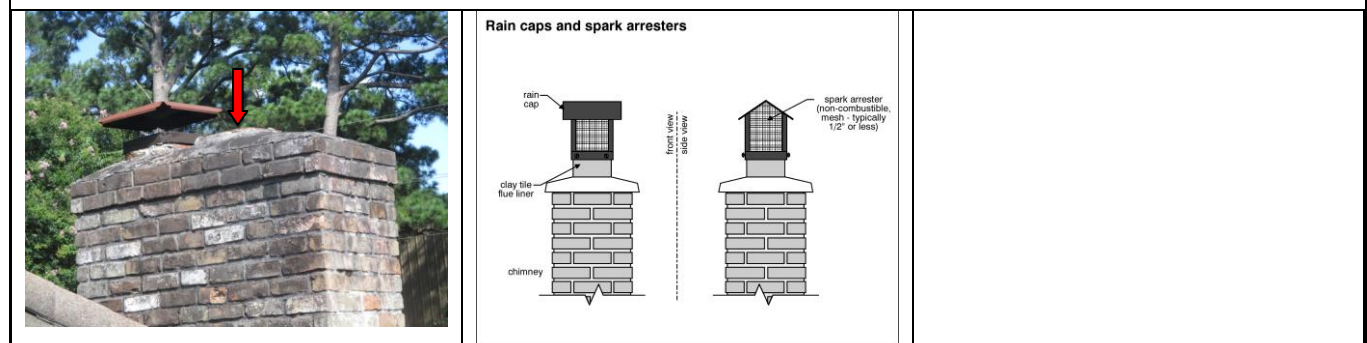
6. **Deficient:** Rain cap-spark arrestor is not installed on top of 1 of 2 chimneys. Rainwater will enter chimney and fireplace. I heard birds inside 2<sup>nd</sup> floor elevation chimney. 2<sup>nd</sup> floor elevation fireplace damper did not operate as intended.

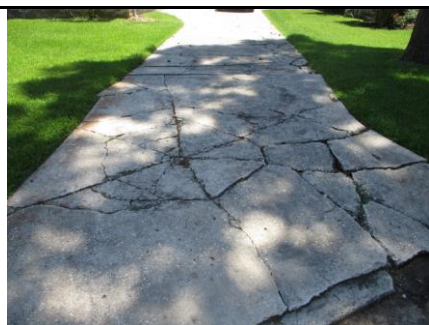
Driveway damage

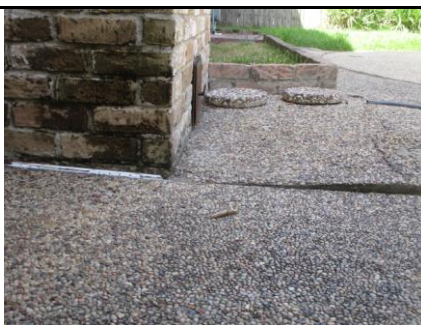
Walkway damage

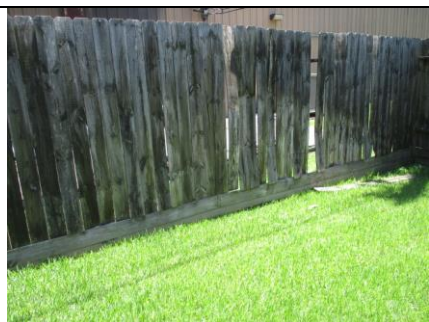
2. **Deficient:** Property fence is damaged-in poor condition at many locations.

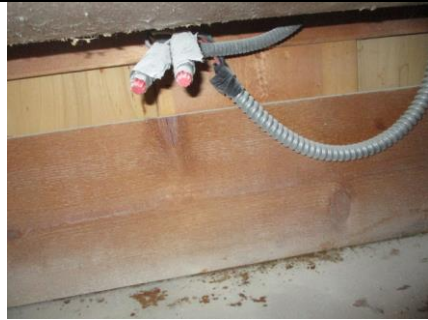
Exposed conductors beneath cooktop

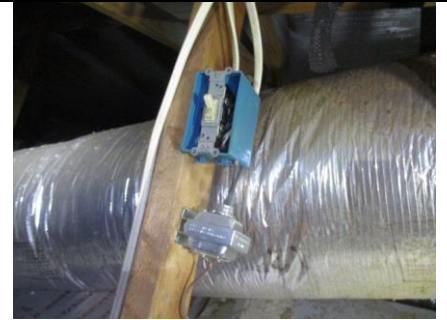
No cover & loose transformer in attic

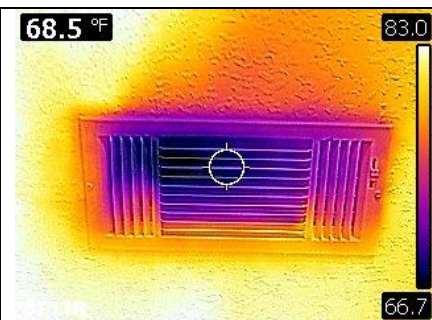
2. **Deficient:** Poor air flow to the game room was detected.

With thermal imaging, air temperature detected about 68.5°F.

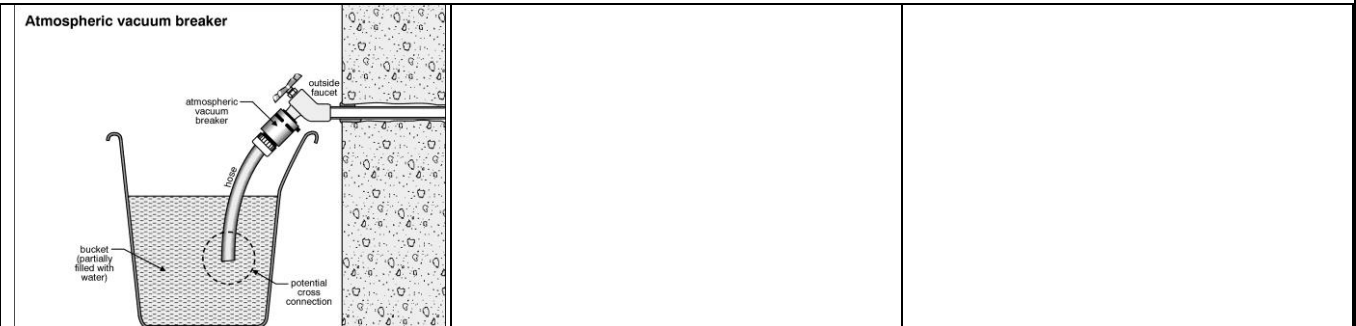
8. **Deficient:** Atmospheric vacuum breaker is not installed at outdoor water faucets. An atmospheric vacuum breaker is an important health safety requirement.  
Information: An atmospheric vacuum breaker is designed to prevent any connection between potable and wastewater.

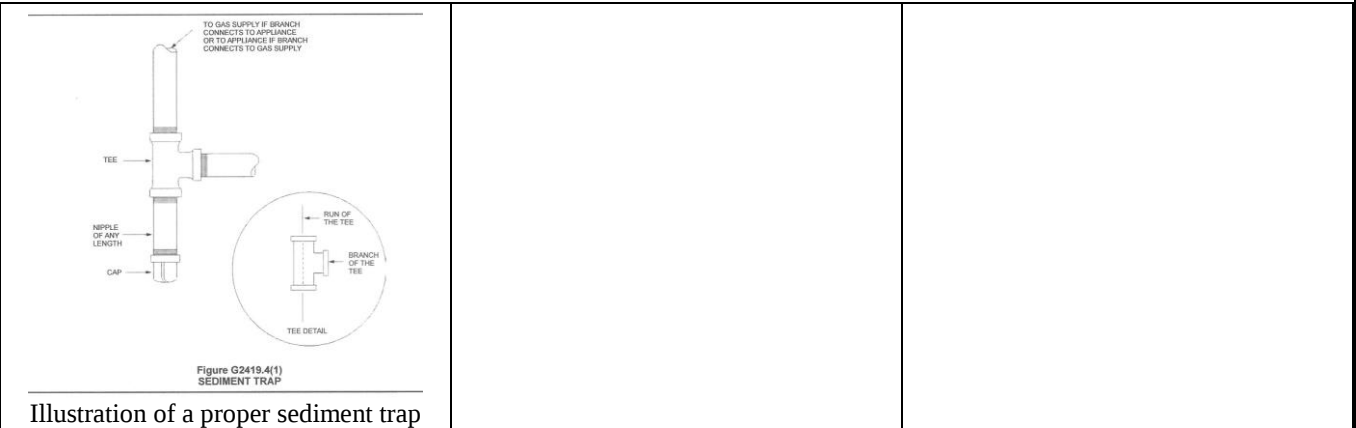
9. **Deficient:** Gas distribution system sediment trap is not installed at the water heating equipment-central heating equipment.

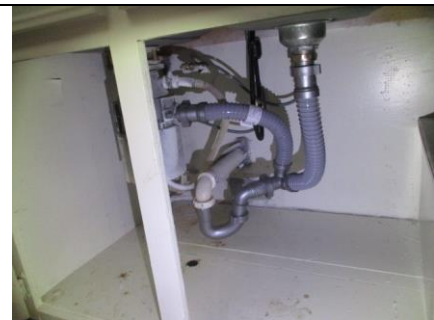
1. **Deficient:** In the inspector's opinion; due to age of system and evidence of foundation deflection-differential movement, client should perform due diligence and have the underground drain system thoroughly examined by a qualified plumber that specializes in underground leak detection prior to the expiration of any time limitations such as an option period.
2. **Deficient:** Main drainpipe clean out was not located. An accessible clean out should be provided that extends above finished grade.
3. **Deficient:** Kitchen – Drainpipe installation is incorrect.

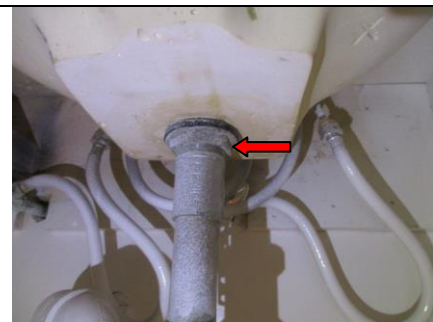
6. **Deficient:** Master bathroom – Wastewater leakage occurred from the left sink drainpipe. One sink drainpipe trap arm is incorrect.

Leak

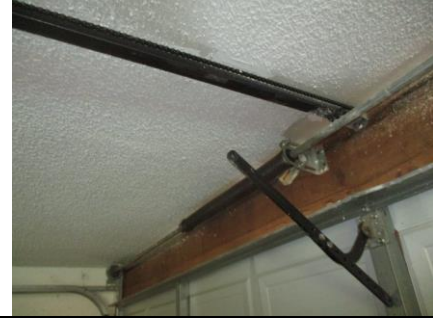
1. **Deficient:** Equipment is apart from the garage door; power supply is unplugged and equipment is not operational.  
Information: This defect was not listed in the seller's disclosure notice.

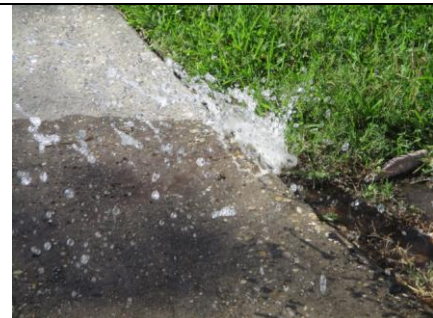
2. **Deficient:** Each zone within the control panel is not labeled-identified. A rain sensor device is not installed. This device is important for water conservation.
3. **Deficient:** Some spray heads are damaged. One or more spray heads are in need of adjustment.  
Information: Direct water spray onto the exterior cladding should be avoided.

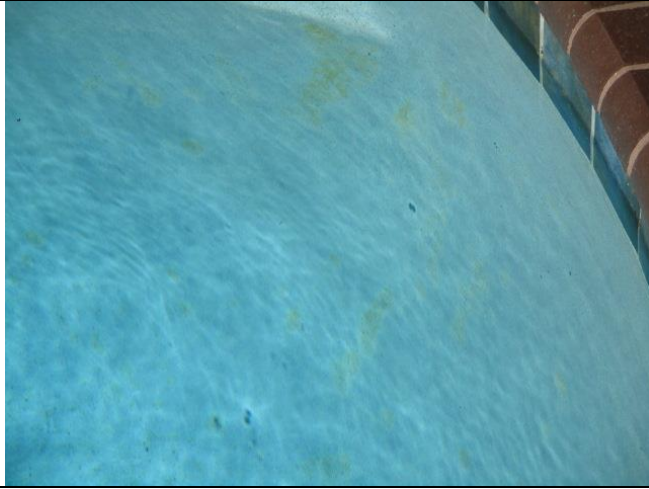
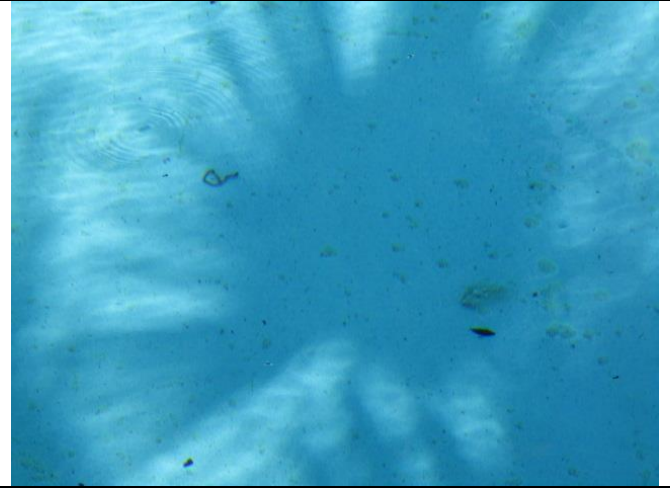
1. Information: Water chemical testing was not performed and is excluded from all inspections.
2. **Deficient:** Swimming pool plaster surface is damaged-discolored at some locations.

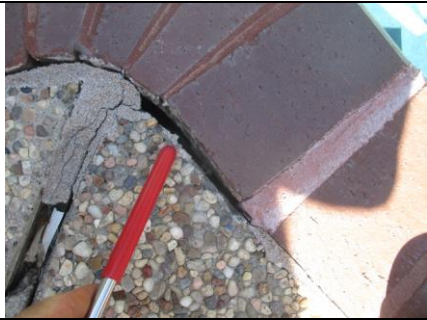
3. **Deficient:** Coping mortar joint is damaged-open at some locations.  
Information: A sealant should be installed to prevent direct water penetration through the open joint.

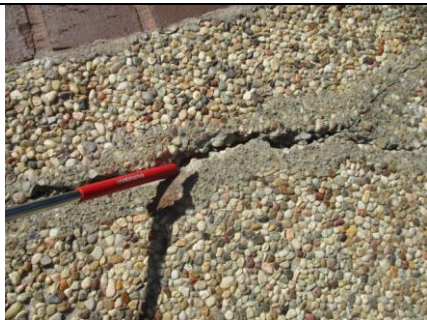
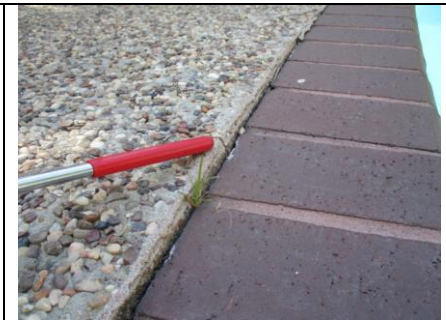
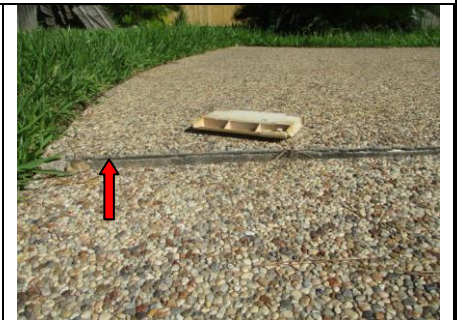
4. **Deficient:** Concrete deck cracking, heaving and settlement were observed at some locations.
