Protective
Environmental
Engineering
Services, Inc.

RE: Mold Remediation Clearance Inspection – Upstairs Bathroom Wax Ring Leak 12403 Gentlebrook Drive, Pearland, TX, 77584, PEESI No: 020218

Protective Environmental Engineering Services, Inc. (PEESI) completed a mold remediation clearance inspection of damage from an Upstairs Bathroom wax ring leak in your home at **12403 Gentlebrook Drive, Pearland, TX, 77584.** This inspection was completed on February 2, 2018 to determine success of remediation

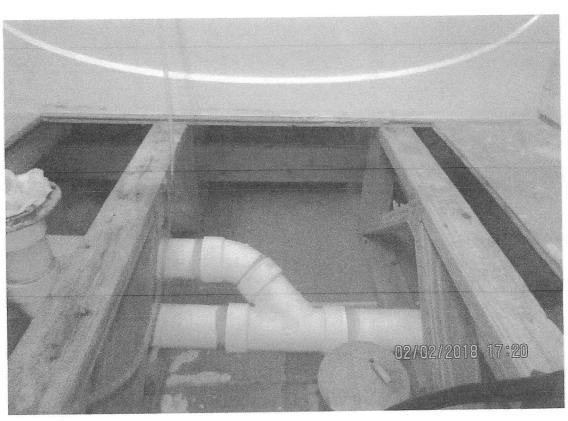
Photograph 2 – Upper Bathroom location of the leaking wax ring and damage

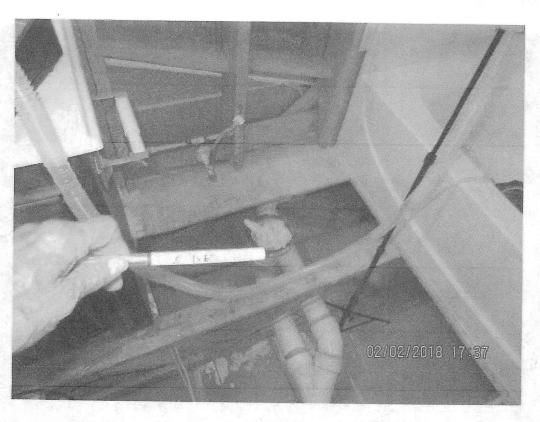
Photograph 3 – Swab sample S-1-E was taken from structural members and the floor deck

PASS VERY CLEAN

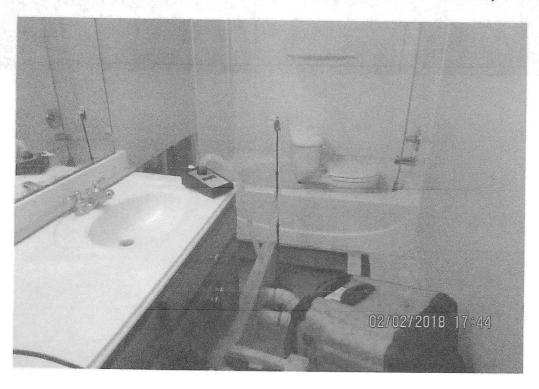
Photograph 4 – Sample A-1-E was taken here from the Upstairs Bathroom

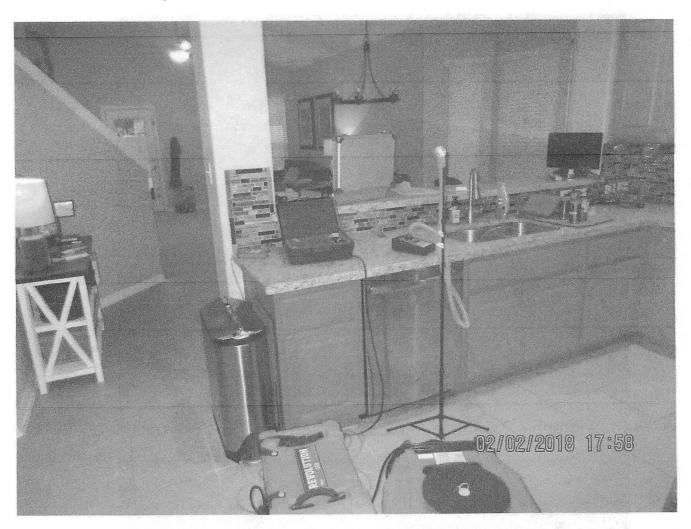
Photograph 5 – Indoor air sample A-2-E taken from the Kitchen beneath the commode wax ring
