Checkmate Home Inspections

Property Inspection Report

12595 Royal Springs Road, Conroe, TX 77303
Inspection prepared for: Kayla Mathews
Real Estate Agent: Lindsey Latham - JLA Realtors

Date of Inspection: 7/3/2019 Time: 9:00 AM
Age of Home: Built 2007 Size: 1,063 Sq. Ft.
Weather: Overcast, Warm
Home Faces East
Location: 30° 25' 11" N, 95° 24' 16" W
Elevation 242'

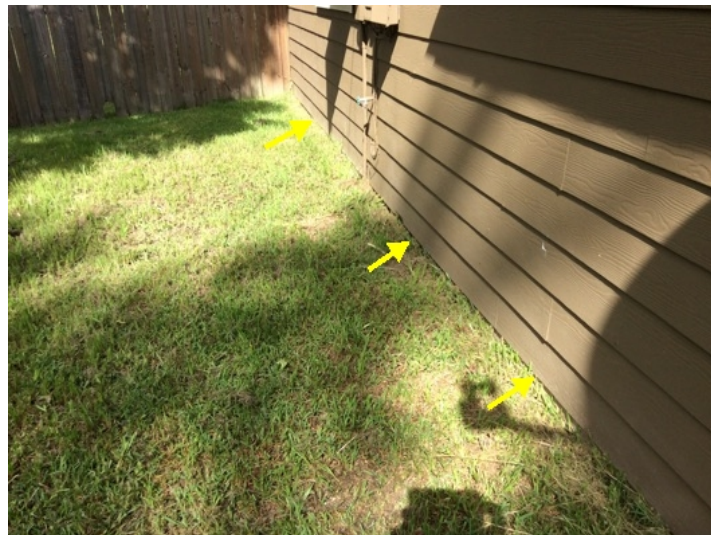
- The building site had minor slope.
- No drains and/or drainage system observed
- No gutter systems were observed and should be considered

Earth to siding distances should be no less than 6 inches to facilitate viewing the foundation

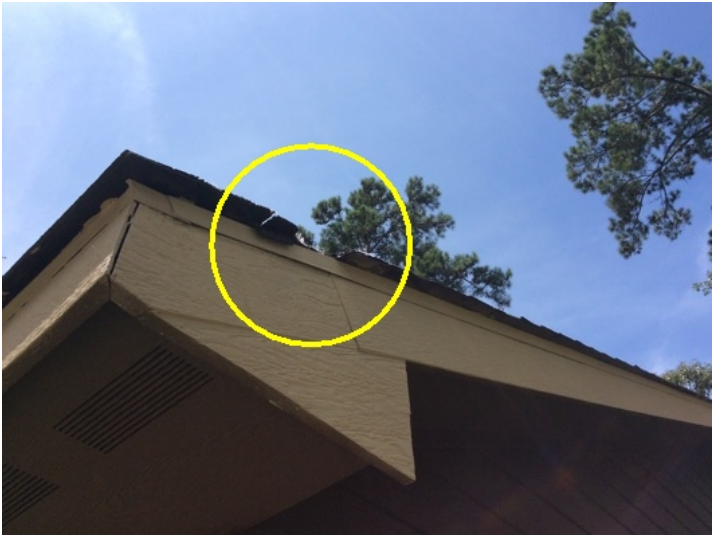
- Ridge vents were noted at the time of the inspection
- Near the front of the house, damage to the roof shingles was noted.
- The home was not equipped with gutters

Roofing damage

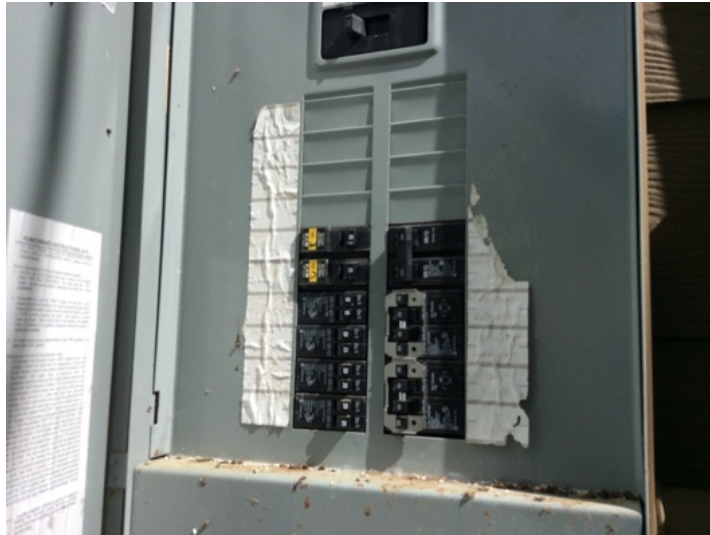
- Service entrance wiring is overhead
- **The service panel is NOT completely and/or properly labeled. All breakers must be specifically identified as to appliances, lighting and receptacles**

Electric service panel is improperly labeled

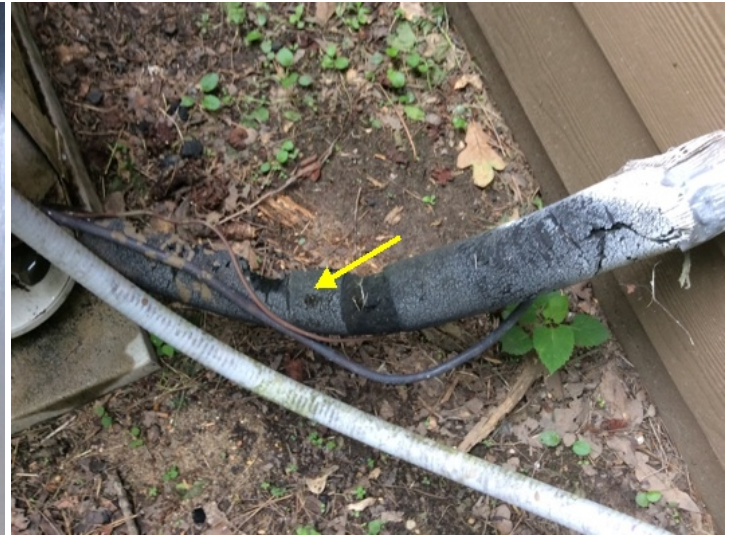
- The Cooling differential calculations were recorded as follows: 71° Cooling return temperature, 49° cooling supply temperature, = Calculated cooling differential 22°.
- The installed AC unit uses R22 refrigerant. Freon (a trade name, known as R22) refrigerant is being phased out and is being changed to Peron (referred to as 410A / a non-ozone-depleting-refrigerant) and is a Federal Law. While these older systems can still be serviced, when the current supply of R22 is depleted, replacement of the HVAC system is the only option. You can check www.epa.gov for additional information
- Insulation for refrigerant lines is damaged at the outside unit, and should be replaced.

Insulation on the air-conditioning lines should be replaced

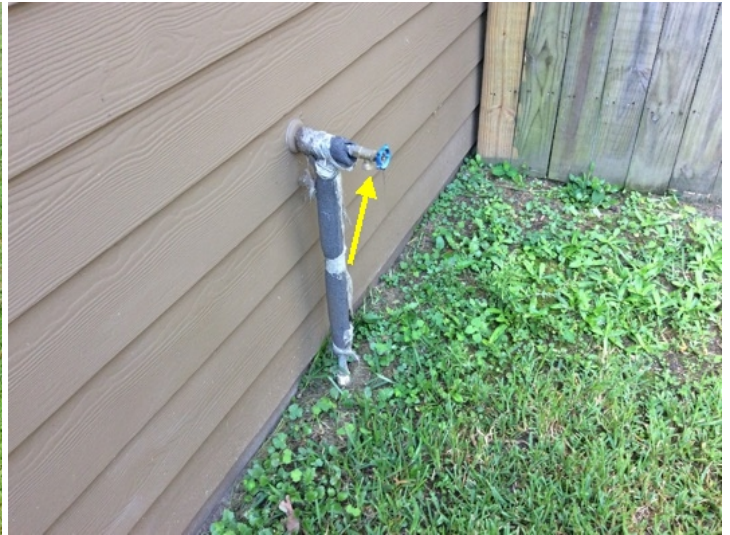
All exterior hose bibs require an anti-backflow device

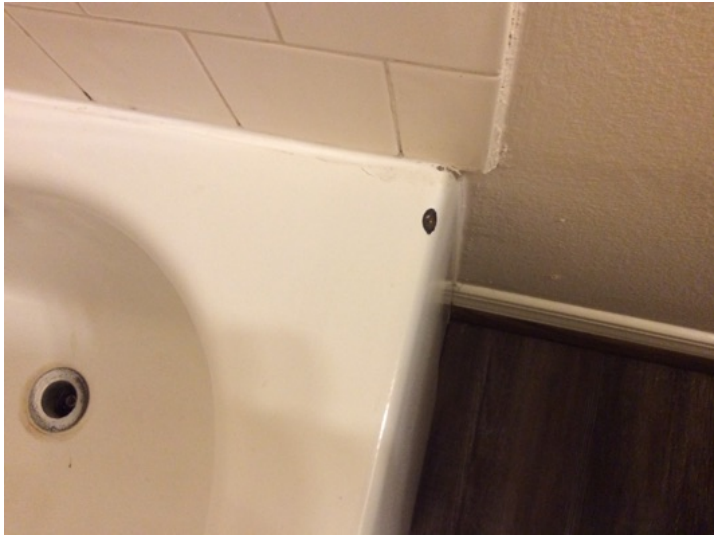
- Master bathroom
- Hall bathroom {1st floor}
- The home water was supplied from a public source.
- The static water pressure was observed at 41# psi
- The commodes were observed to be the older {3-5} multi gallon models
- The PEX domestic hot and cold water manifold is located in a front bedroom closet.
- One or more of the exterior water hose bibs {faucets} was not equipped with a back flow and/or anti-siphon {vacuum breaker} device. An anti-siphon device prevents unsanitary water from being pulled back through a garden hose and/or lawn sprinklers and contaminating the household water system
- The hall bathroom sink faucet is missing the aerator which controls the flow. This causes water to spray on to the adjoining wall.
- Porcelain damage was observed in the tub/shower area

Porcelain chipped hall bathroom

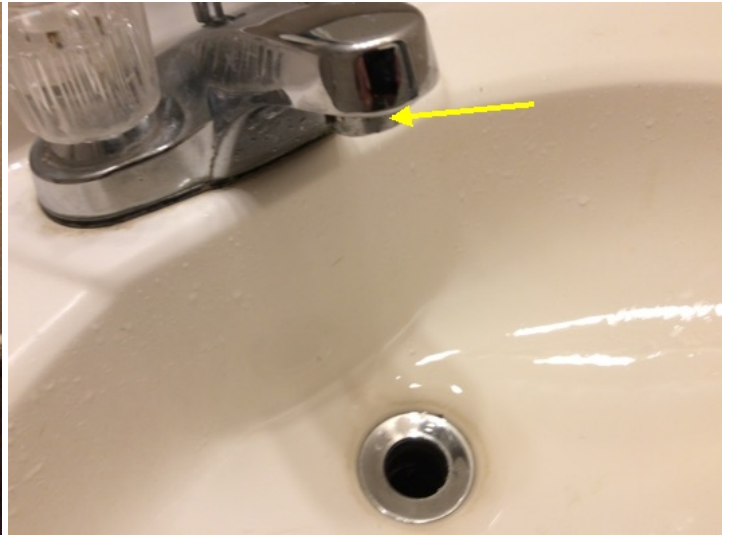
Missing aerator on the hall bath faucet causes water to splash all over the adjoining wall

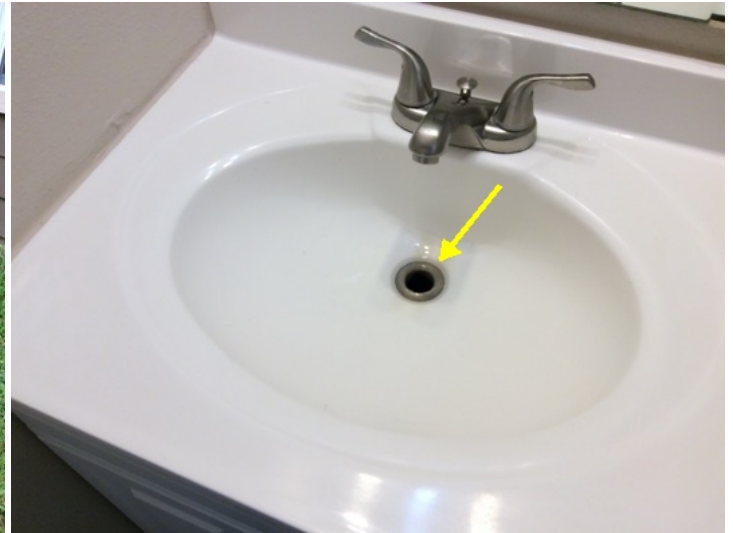
- The exterior main cleanout was located at the front of the structure
- Both bathroom sink basins in the house are missing a workable sink stopper.

Basin stoppers in both bathrooms are missing

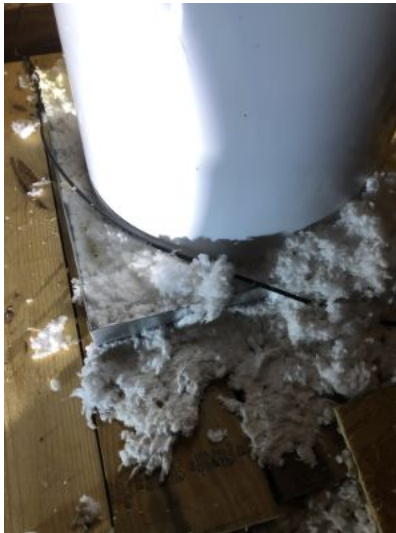
- The water heater and its components were found to be performing and in satisfactory condition at the time of the inspection
- The water temperature at the faucet locations was noted to exceed the {120 degree} scald limit and adjustments on the temperature control are recommended
- The water heater drain pan has been sprayed with the blown in insulation and it is potentially clogged.

insulation blown into the water heater drain pan

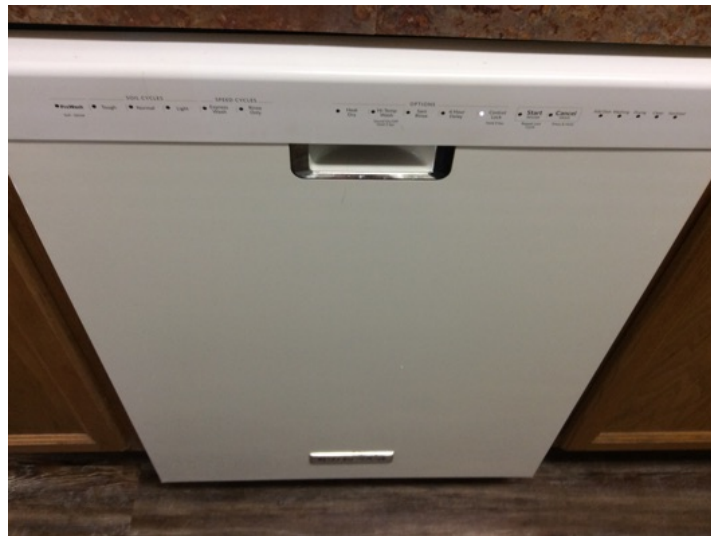
- The dishwasher did not operate when tested, consult with the seller about servicing the unit. It is recommended that appropriate repairs be made.

The KitchenAid dishwasher appears to be nonfunctional

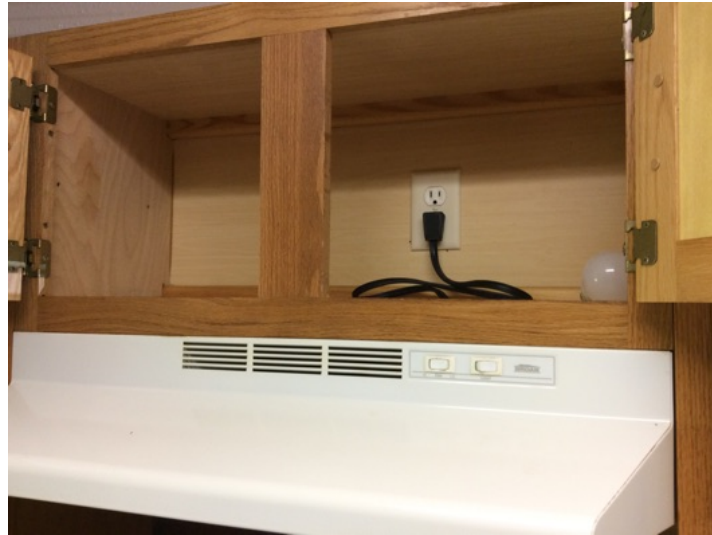
- The range hood was functional at the time of the inspection
- The range hood is of the ventless design. Particular attention should be paid to be aware of the need for regular cleaning of the range hood screens.

Range hood is a non-vented type

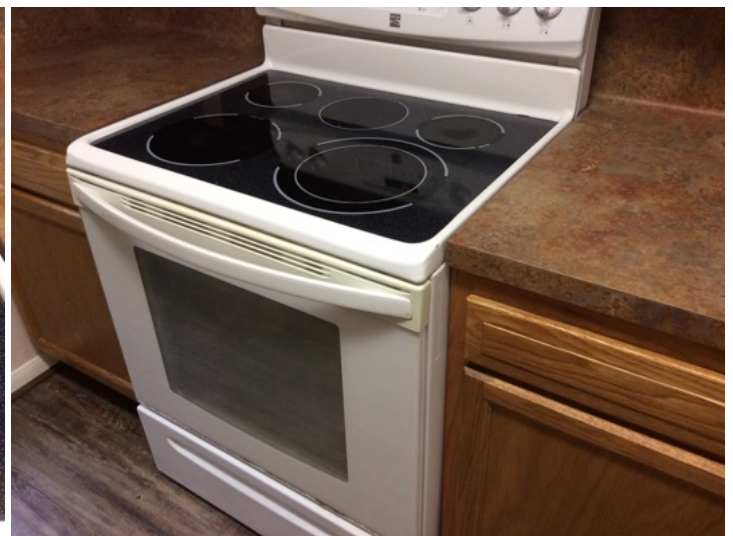
Anti-tip device not installed on the freestanding stove

Page 17 Item: D	Ranges, Cooktops, and Ovens	<ul style="list-style-type: none">• Anti-Tip devices became a UL (Underwriters Laboratories) safety standard requirement in 1991.• Anti-tip bracket is missing from range installation. All free-standing, slide-in ranges include an anti-tip device and is essential in the safe operation of the range. It provides protection when excess force or weight is applied to an open oven door
Page 18 Item: H	Dryer Exhaust Systems	<ul style="list-style-type: none">• The exterior dryer vent should be a minimum of {6'} from the HVAC condensing unit to avoid lint buildup on the coils• No backdraft damper door observed on the dryer vent
Page 19 Item: I	Other	<ul style="list-style-type: none">• The refrigerator/freezer has a damaged freezer compartment which promotes the formation of ice near the freezer door.

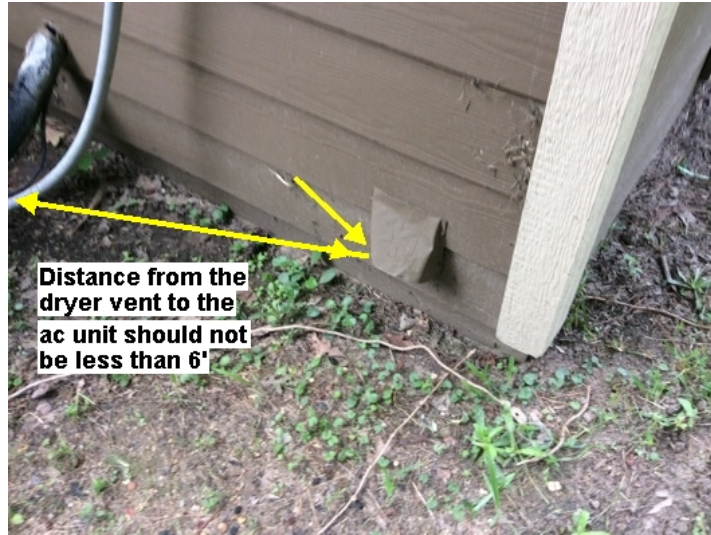
- The exterior dryer vent should be a minimum of {6'} from the HVAC condensing unit to avoid lint buildup on the coils
- No backdraft damper door observed on the dryer vent

Dryer vent is the non louvered type

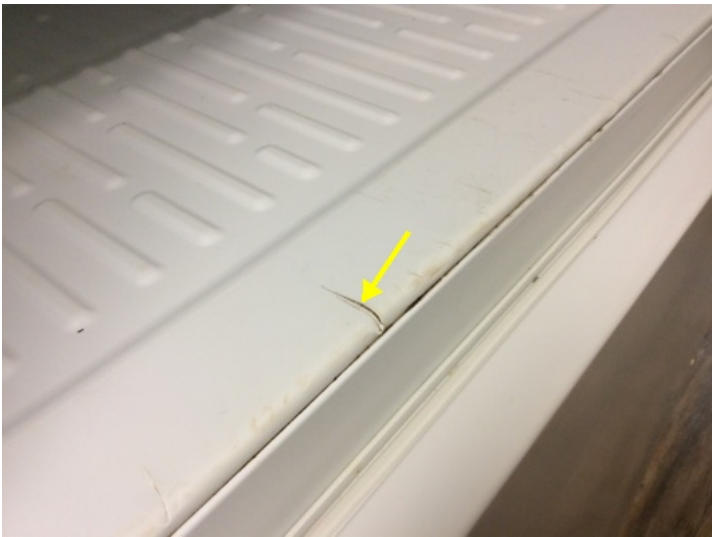
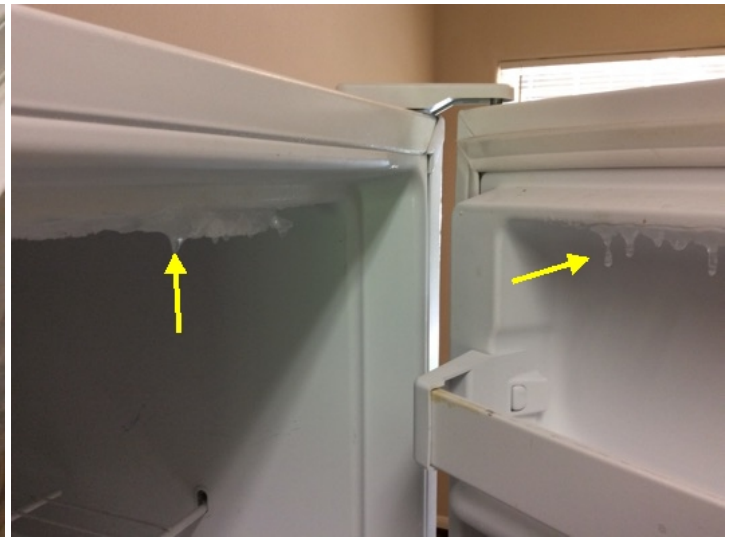
- The refrigerator/freezer has a damaged freezer compartment which promotes the formation of ice near the freezer door.

The gasket in the freezer compartment of the refrigerator is damaged and allows ice to form around the edge
