## PROPERTY INSPECTION REPORT

**Concerning:** 11942 GREENGLEN DR., Houston, TX 77044  
(Address or Other Identification of Inspected Property)

**By:** Stephen Perry, Lic #7854 07/16/2019  
(Name and License Number of Inspector) (Date)

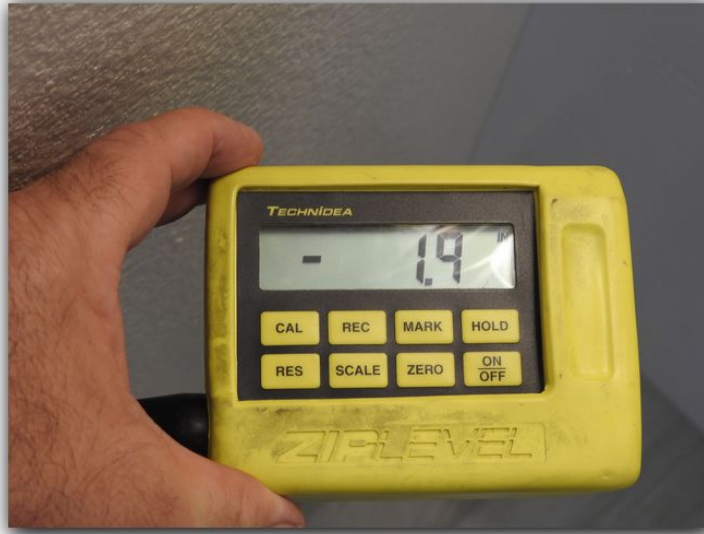
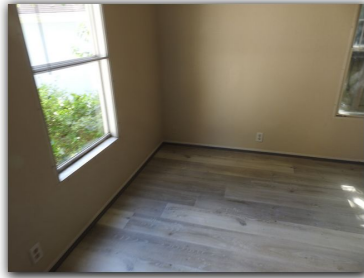
- Floors not level
- Deteriorated Pier/Beam Condition
- Separations between trim and siding
- Cracks in wall(s) and / or ceiling, recently patched/textured and painted over.
- Door / window frames out of square, some doors hard to close and some windows loose at the frame

**PIERS HAVE SETTLED AND LEANING; IN NEED OF REPAIR.**

- Signs of structural movement noted; suggest that an expert in this field be consulted for further evaluation of the structure and to provide suggestions as to what, if any, corrective actions should be taken. Recommend evaluation by a Structural engineer/foundation expert.

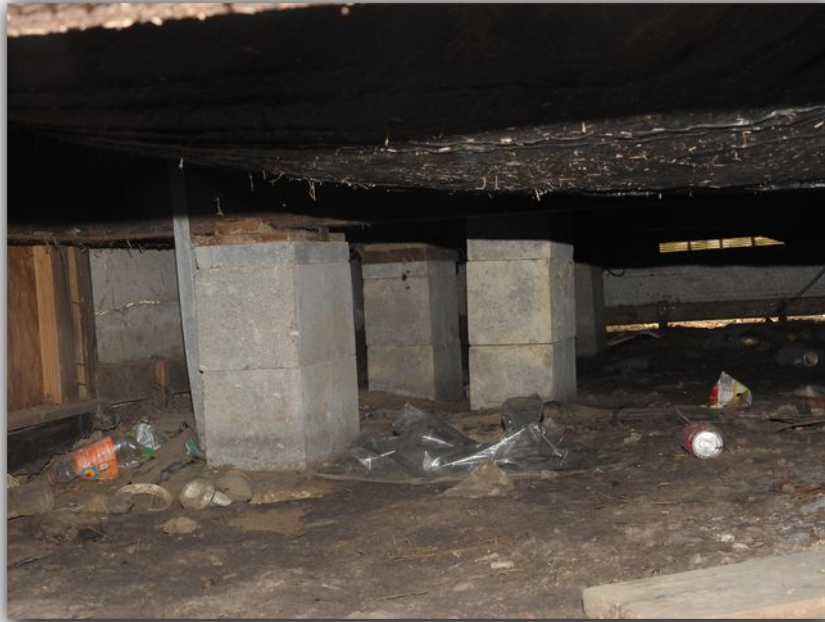
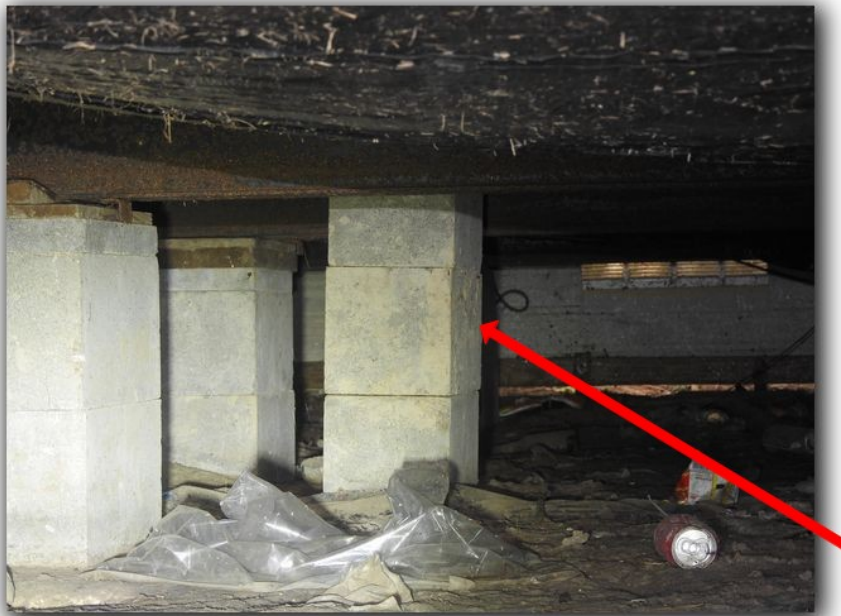
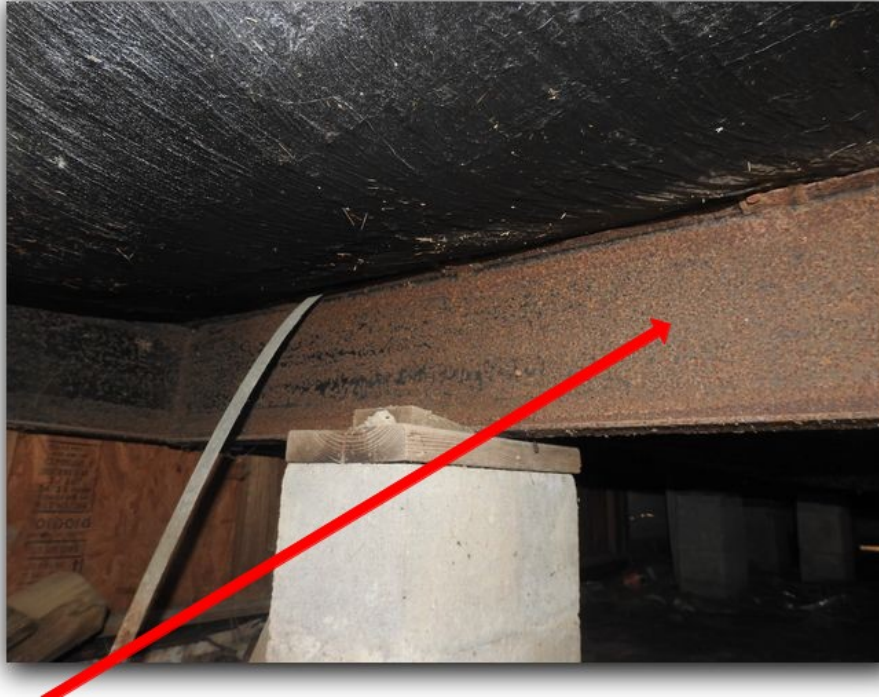
- **THE HOME IS BUILT ON A STEEL FRAME AND SUPPORTED BY CMU BLOCK PIERS, SIMILAR TO MANUFACTURED HOME CONSTRUCTION. THE STEEL FRAME IS RUSTED IN SOME LOCATIONS AND NEEDS REPAIRS AND ANTI CORROSIVE PAINT APPLIED.**

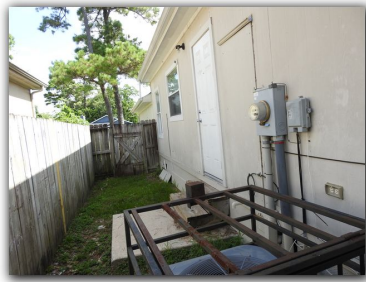
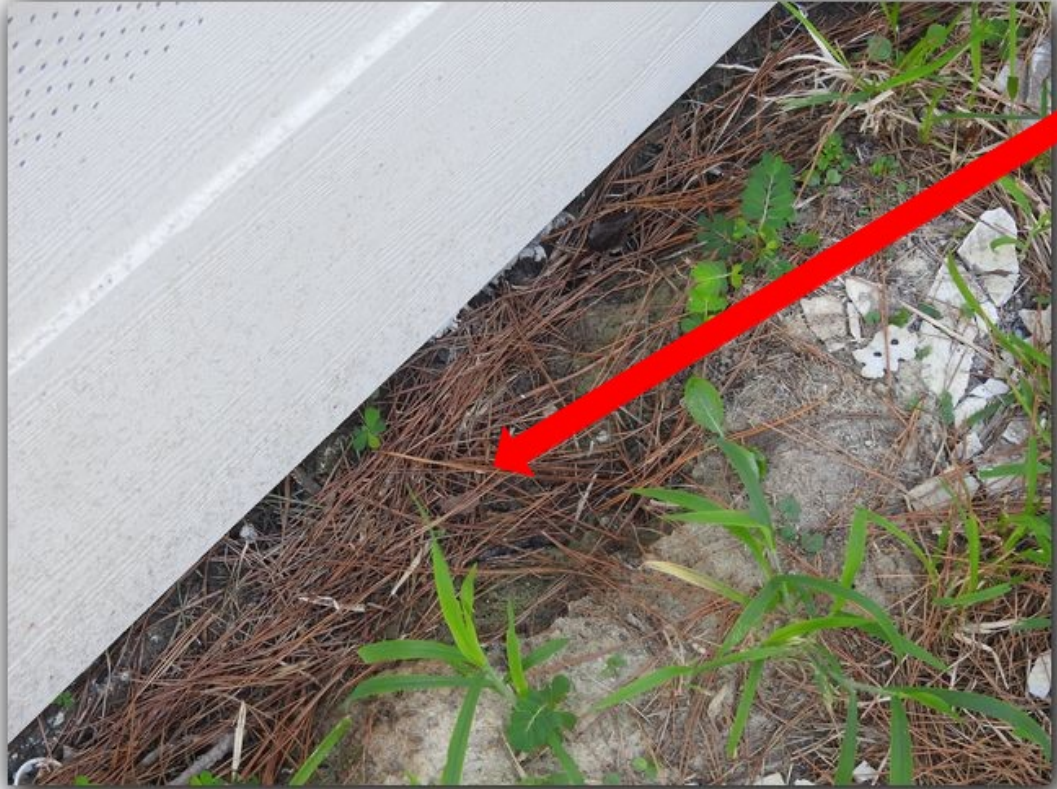
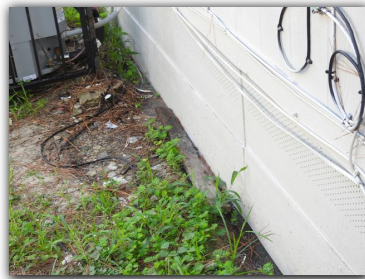
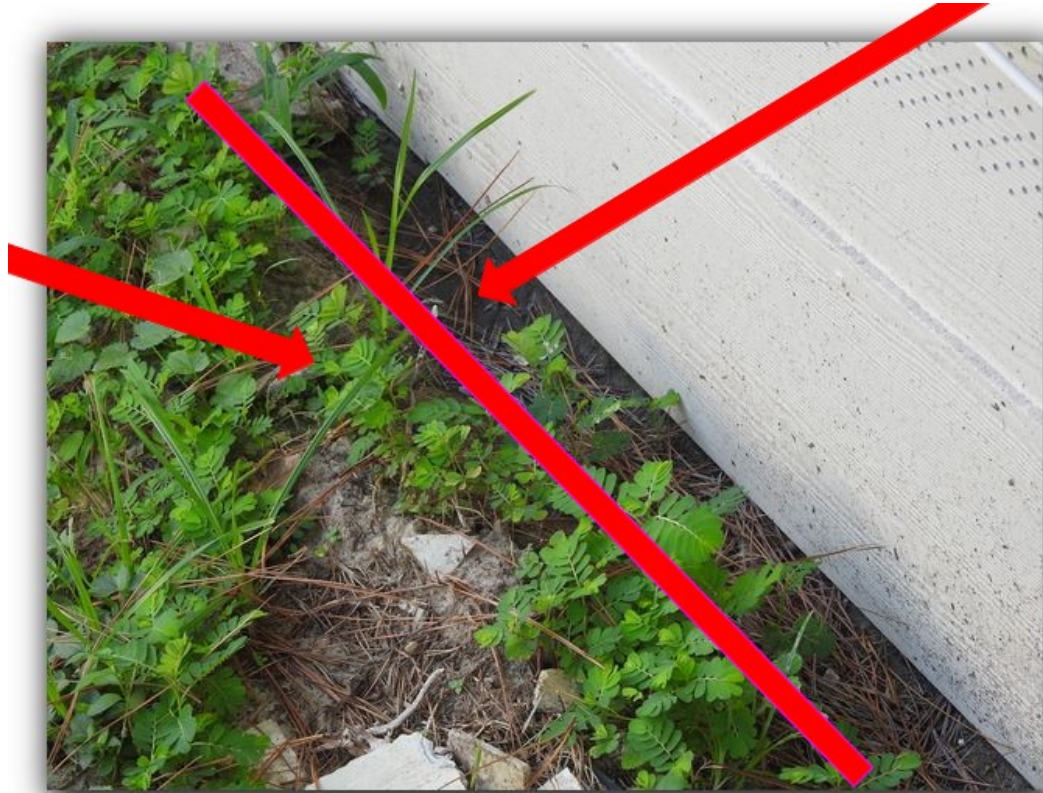
- Improper drainage from foundation**
- Erosion or ponding next to foundation**
- Run off intrusion into crawl space**
- Inadequate grading clearance to exterior wall surface**
- Grade slopes toward the structure**

- Soil / lot conditions suggest further evaluation by appropriate professional, i.e.. watering program, drains, etc.**
- **Recommend evaluation and improvements to the grading surrounding the home and also under the home to prevent ponding near and under the home that can affect foundation performance. Recommend French drain system be installed and other improvements for improved drainage such as rocks/gravel around the home perimeter and under home as well.**

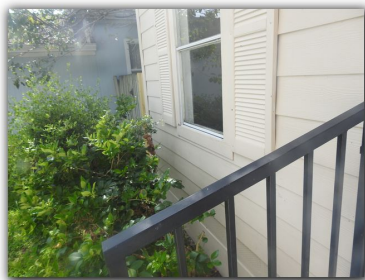
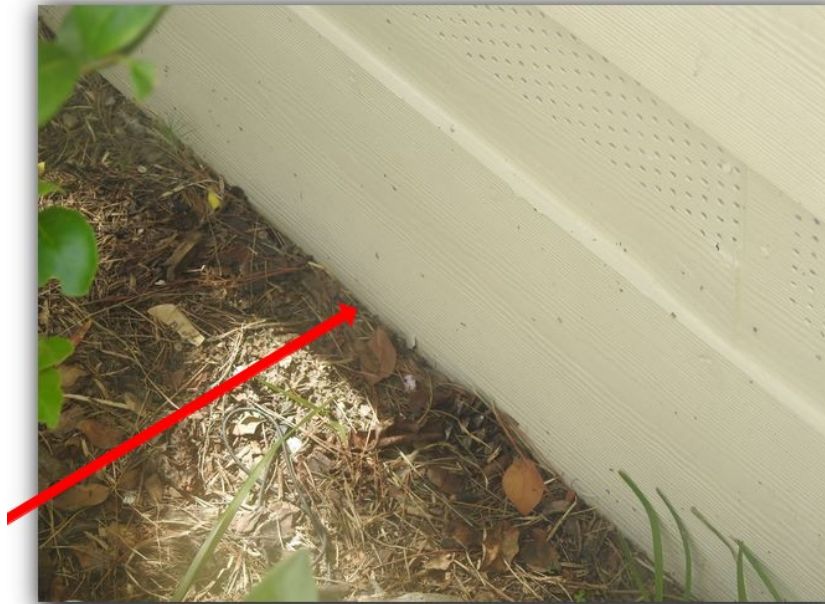
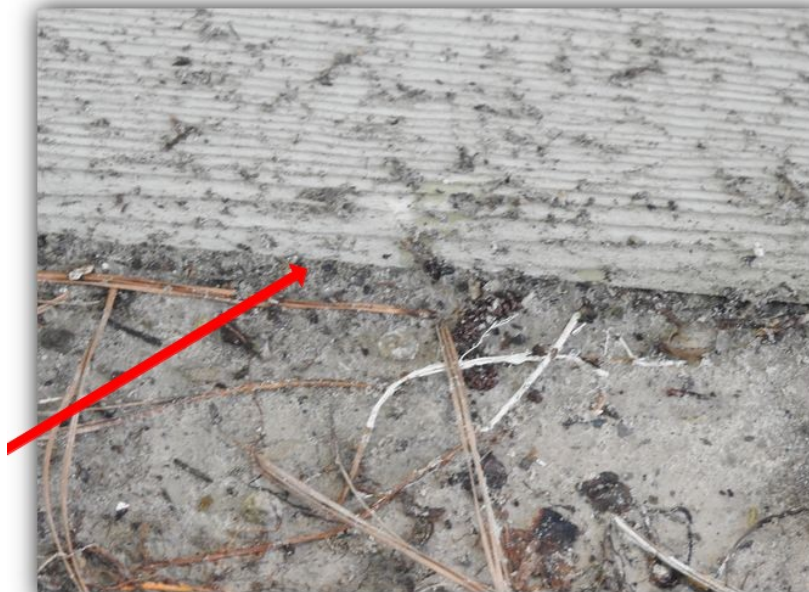
- Inadequate grading clearance to exterior wall surface. There should be a 4" inch minimum clearance from the bottom of the brick and the grading, 6" inches from the bottom of wood siding. Recommend improvements by a landscape and irrigation expert.

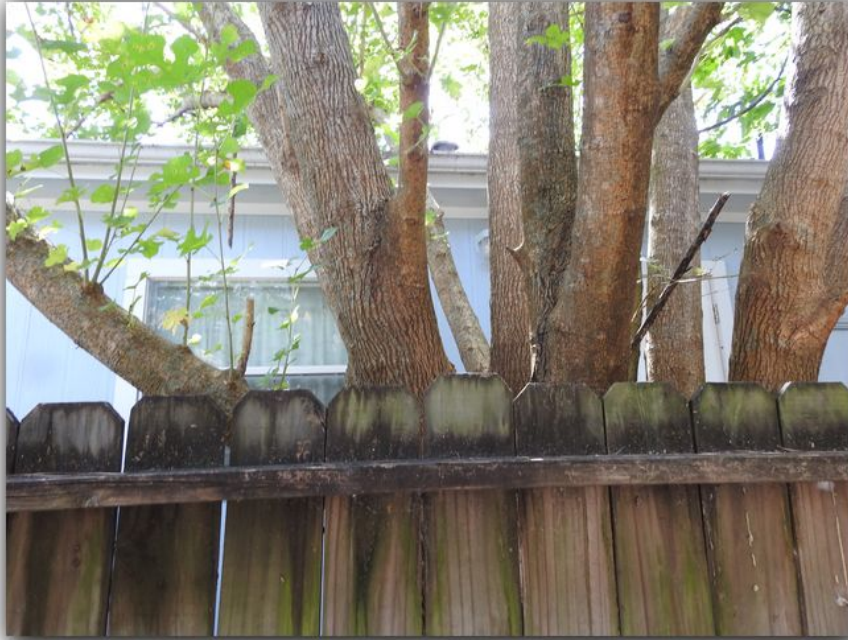
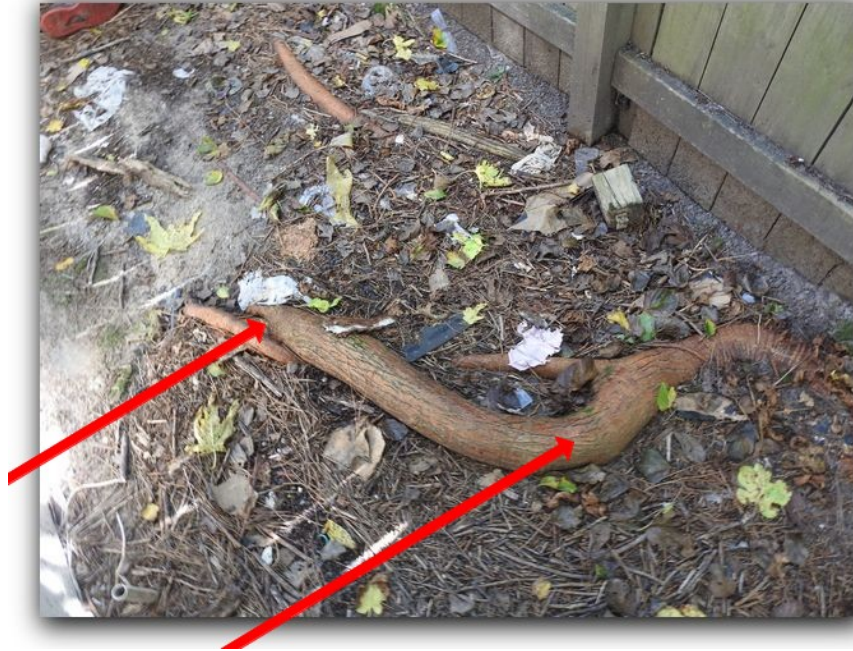
**Trees/heavy foliage close to structure; recommend that the trees and shrubs close to the home have a root barrier system installed or roots pruned back between the home and tree. trees close to the home and large roots from trees and shrubs growing underneath the home can affect foundation performance.(Neighbors tree, but has roots growing under the home and needs a root barrier system installed)**

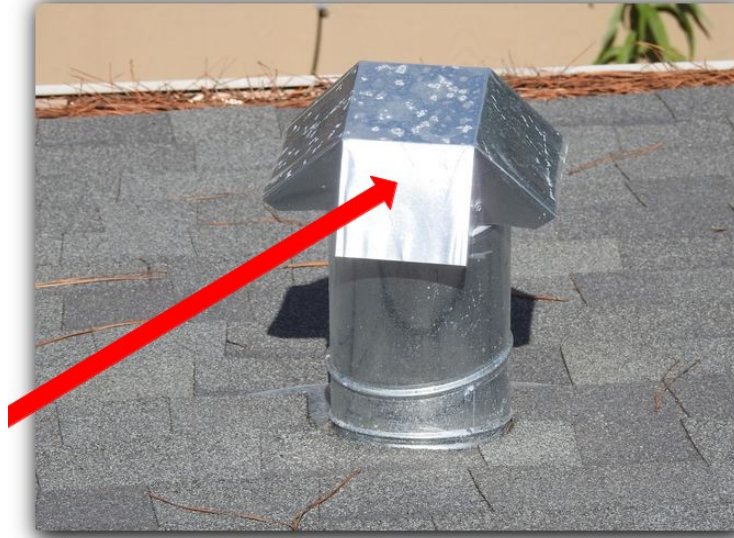
- **DEFICIENCY- THE NEW ROOF VENT NEEDS TO BE PAINTED**

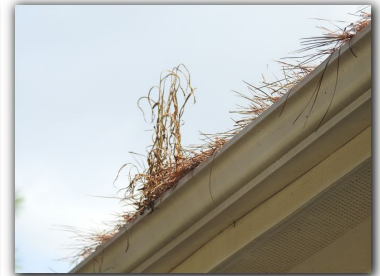
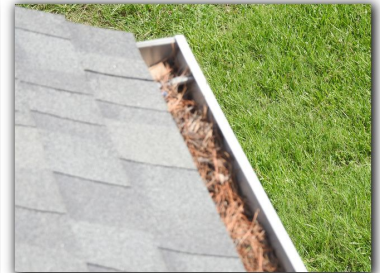
- **DEFICIENCY- GUTTER FILLED WITH LEAVES AND DEBRIS AND PLANTS GROWING INSIDE; NEEDS A GOOD CLEANING. RECOMMEND GUTTERS TERMINATE TO A FRENCH DRAIN SYSTEM AS WELL FOR IMPROVED DRAINAGE.**

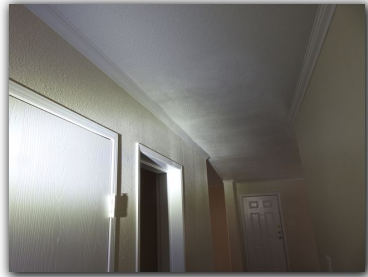
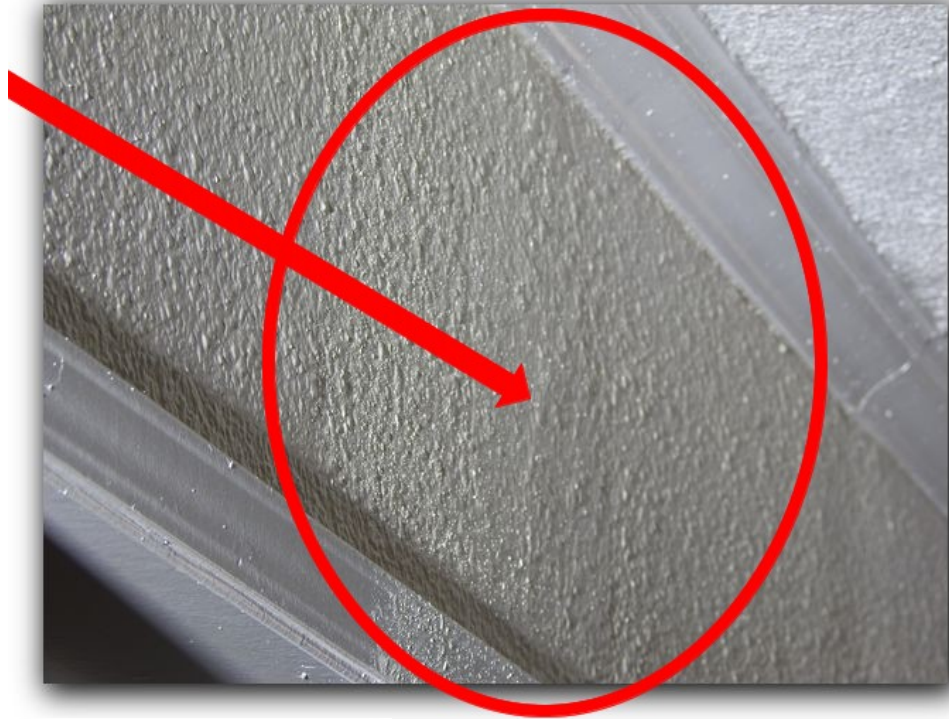
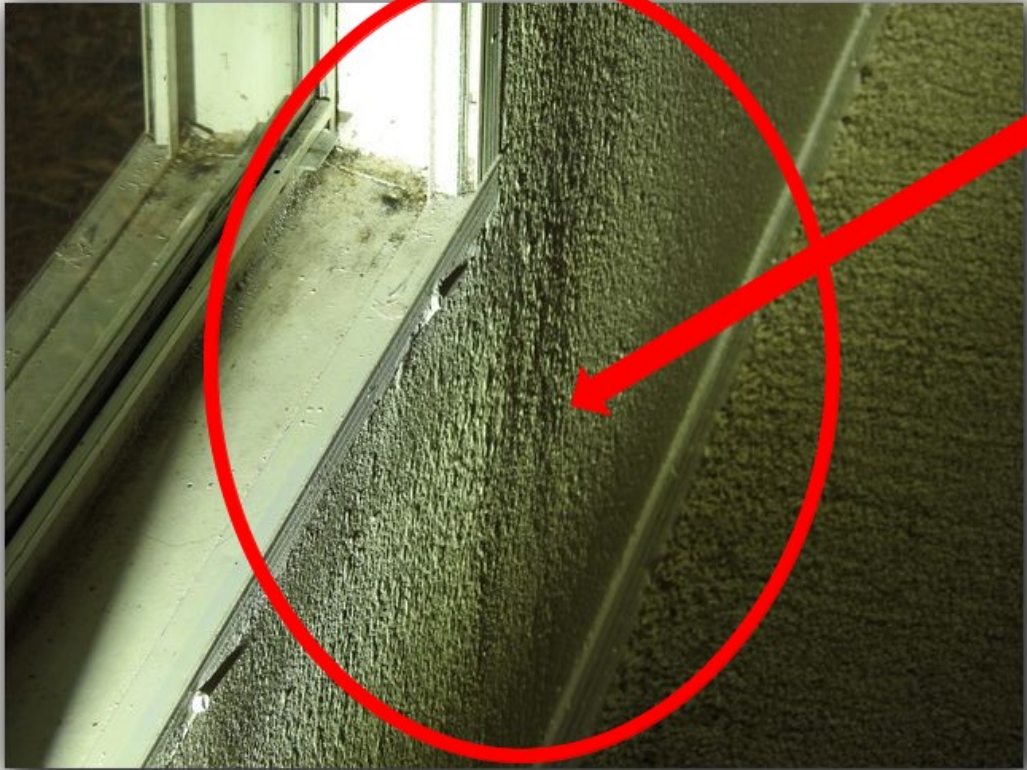
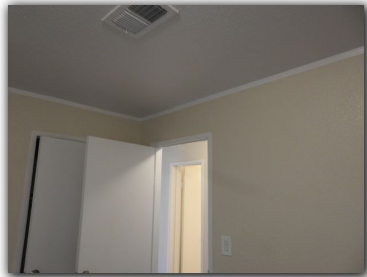
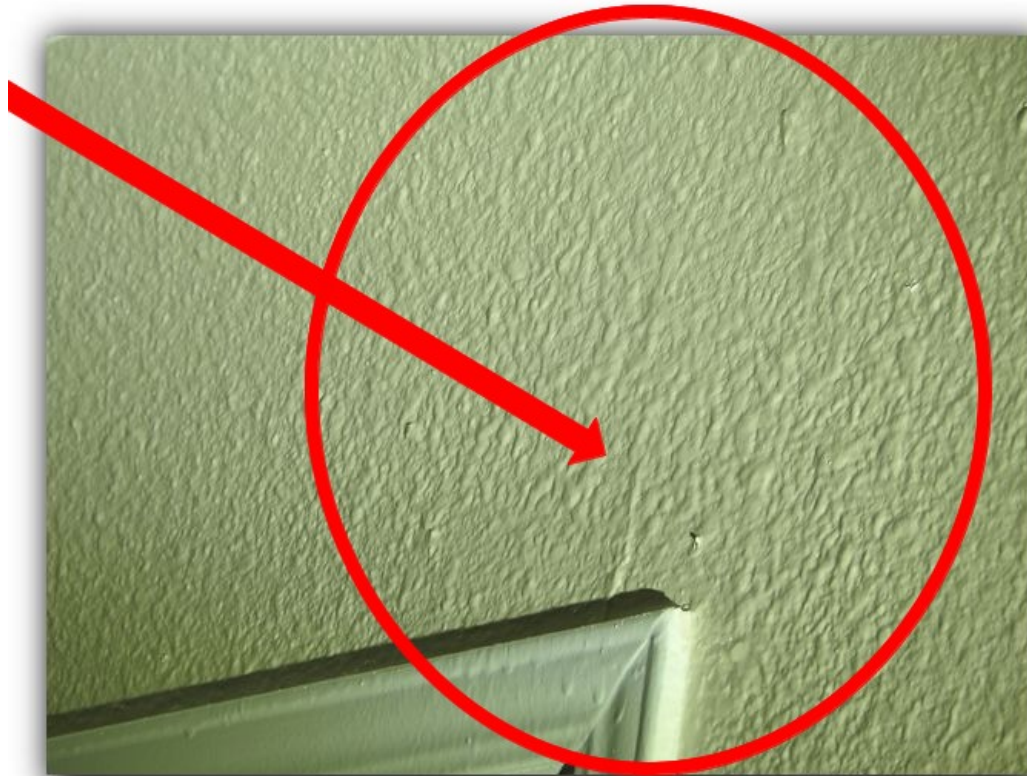
- **RECENTLY TEXTURED WALL/CEILING AND RECENTLY PAINTED OVER SETTLEMENT CRACKS AS WELL COMMON WITH STRUCTURAL SETTLEMENT THAT NEEDS EVALUATION BY A FOUNDATION EXPERT/STRUCTURAL ENGINEER.**

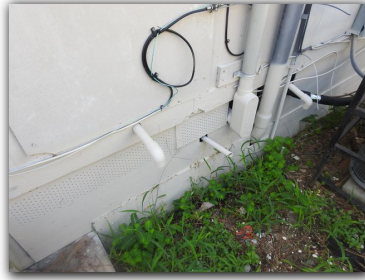
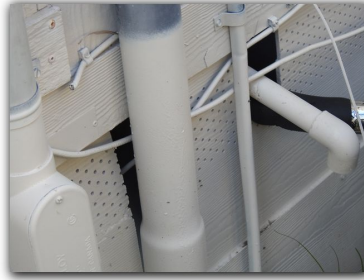
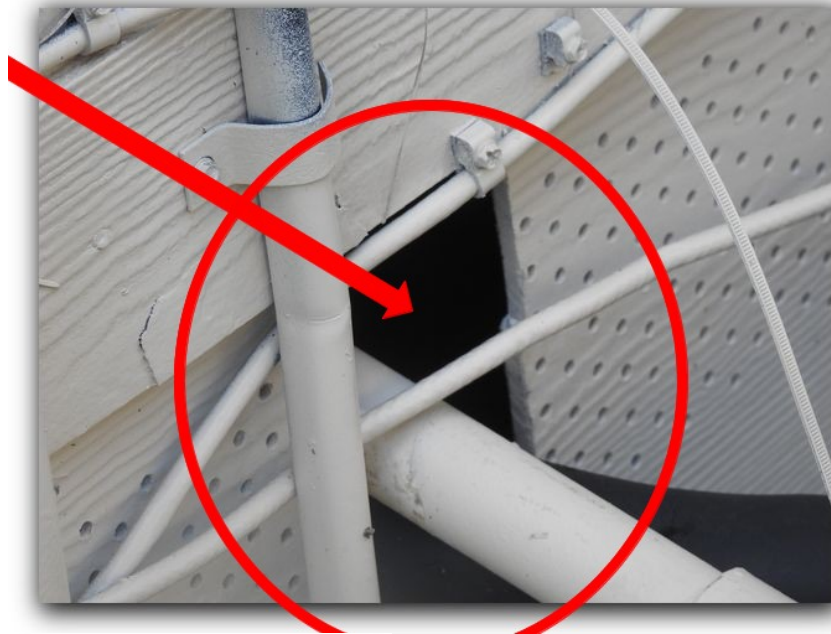
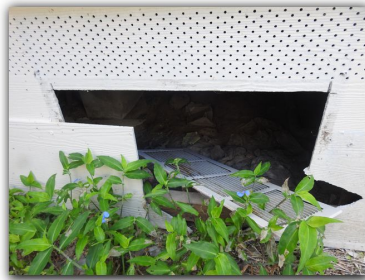
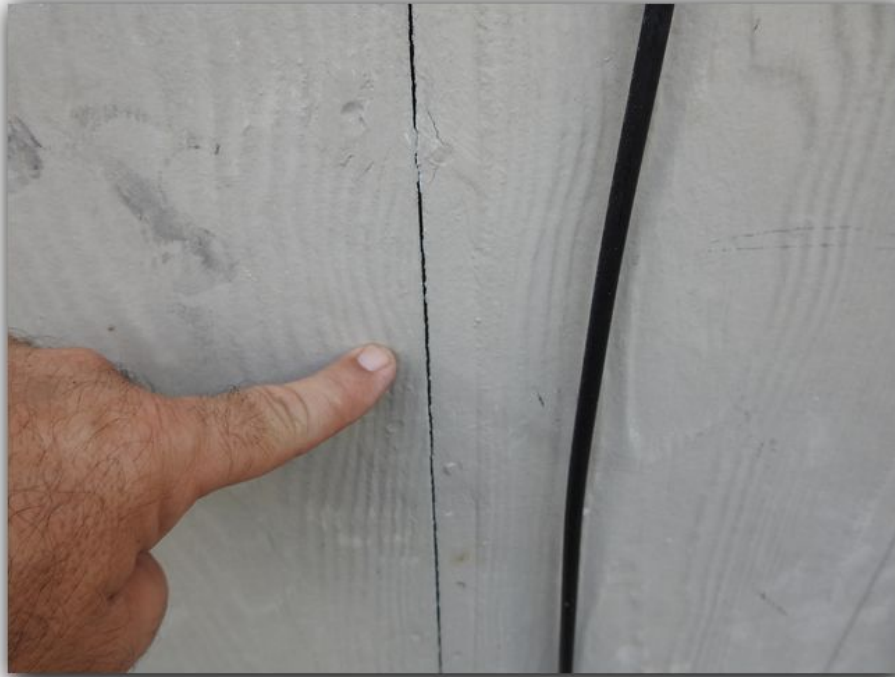
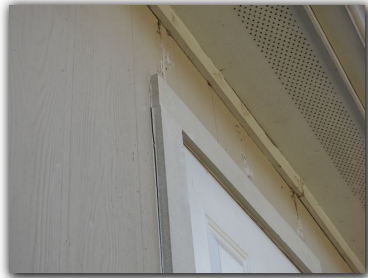
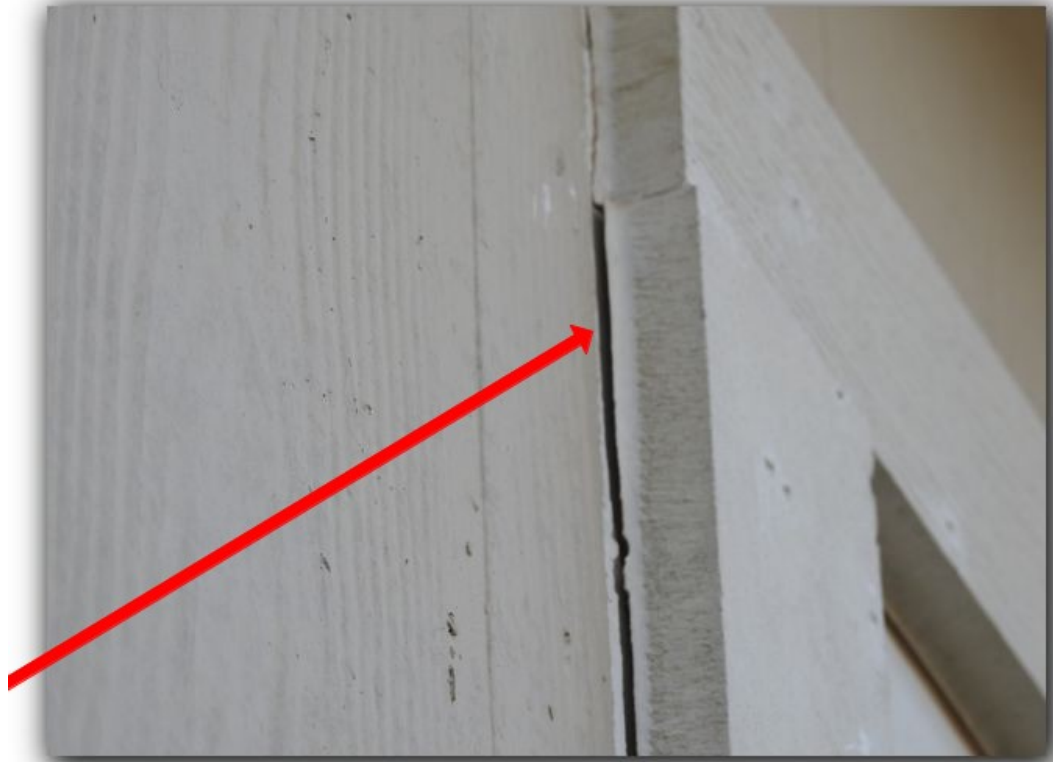
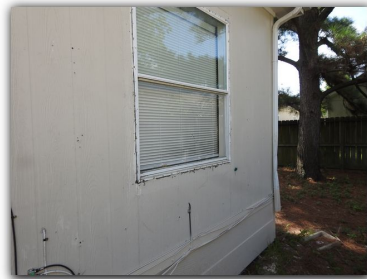
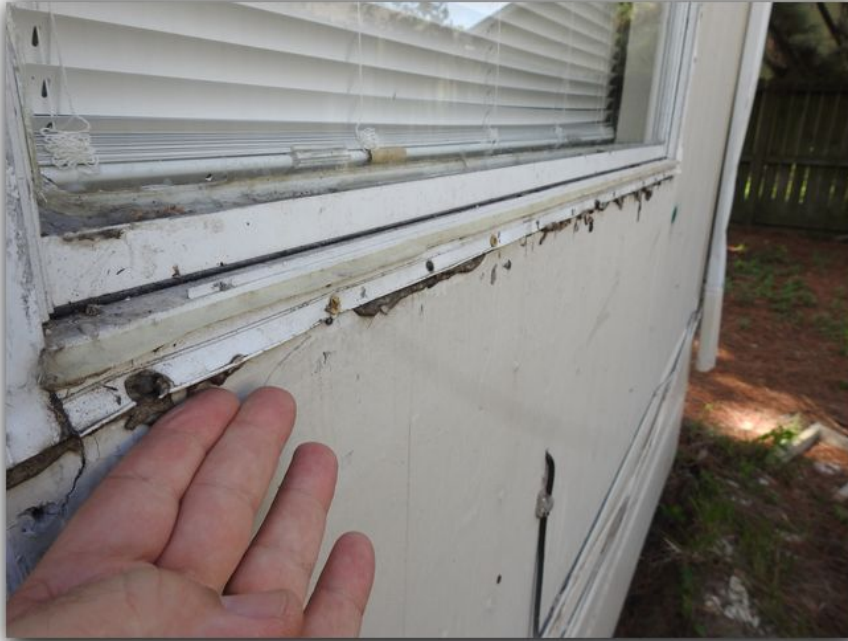
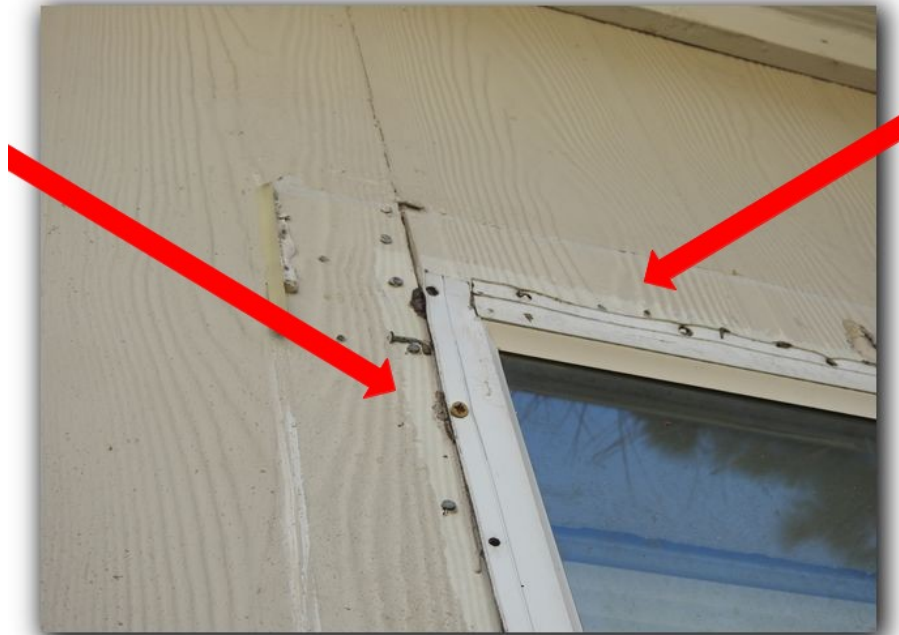
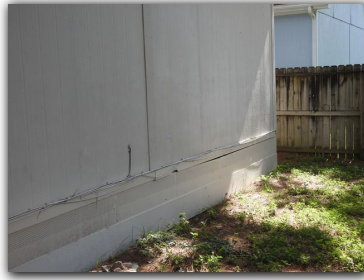
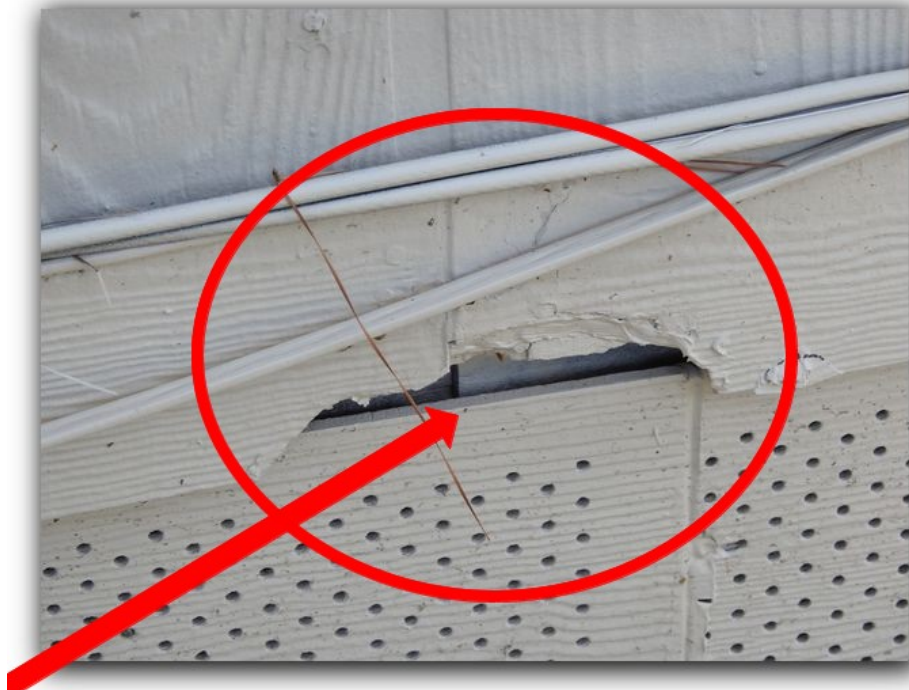
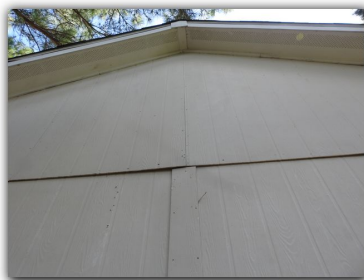
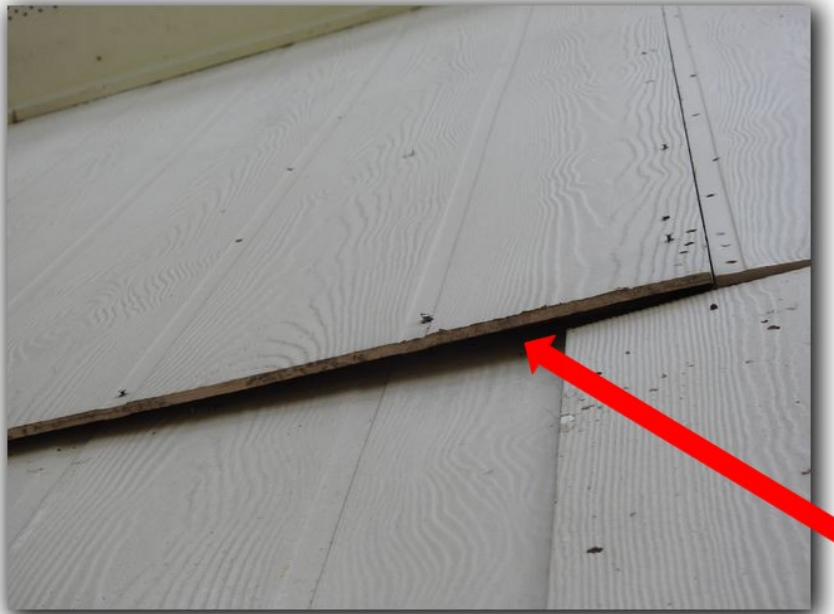
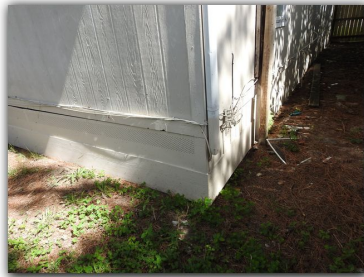
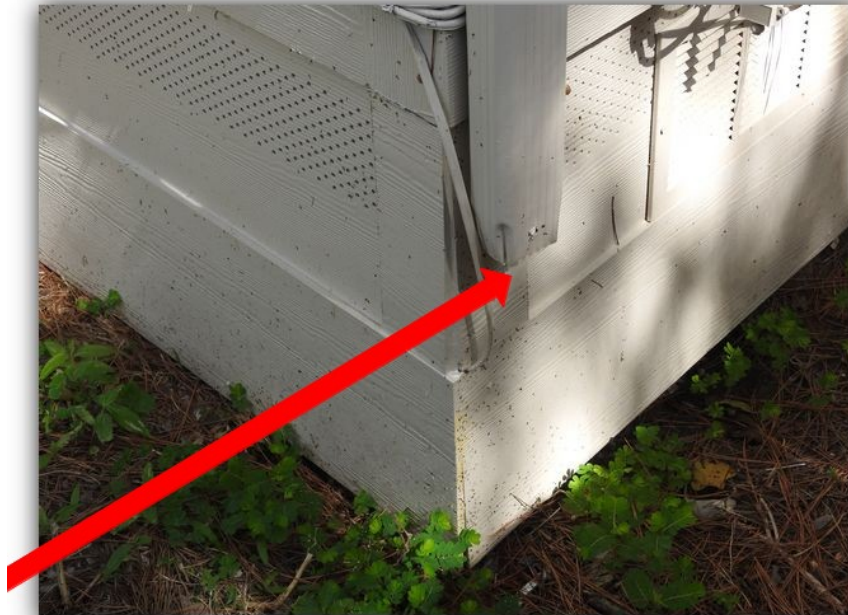
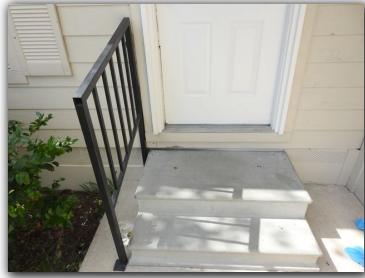
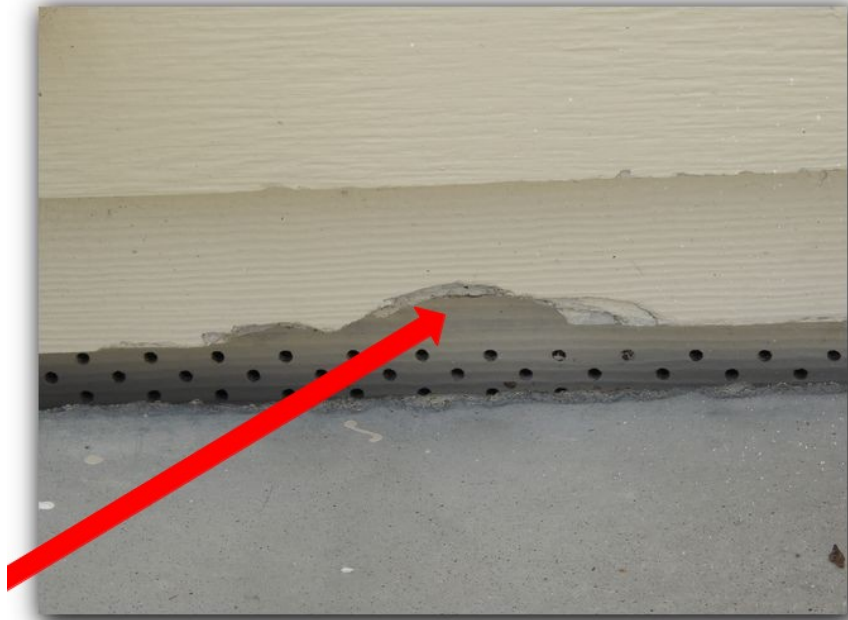
- **THERE IS SOME LARGE OPENINGS IN THE WALL EXTERIOR SIDING THAT NEEDS REPAIRS, MISSING WINDOW TRIM, SOME OPENINGS IN THE TRIM AND SIDING, SOME DAMAGED SIDING, LARGE OPENINGS IN THE SKIRT AT THE CRAWL SPACE THAT COULD ALLOW VERMIN UNDER THE HOME. IN NEED OF REPAIRS TO THE SIDING AND TRIM.**
- **SOME SEPARATIONS IN THE SIDING/TRIM THAT IS COMMON WITH STRUCTURAL SETTLEMENT.**

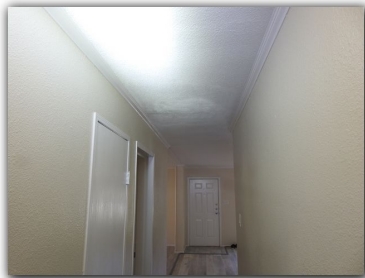
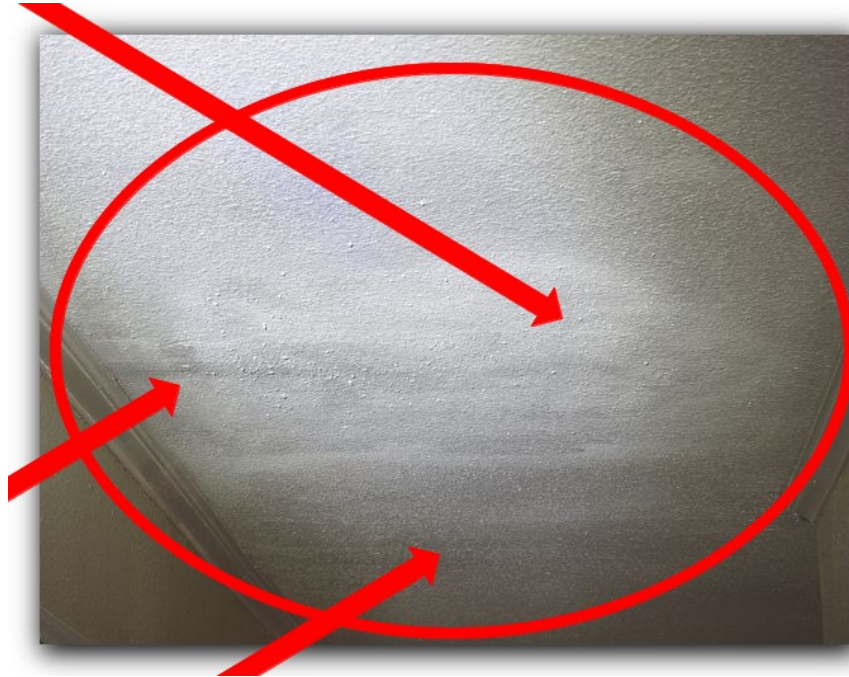
- **LARGE AREA OF PATCHWORK IN THE HALLWAY THAT APPEARS TO BE POSSIBLE PATCHED CRACKS. RECOMMEND EVALUATION AND REPAIRS.**

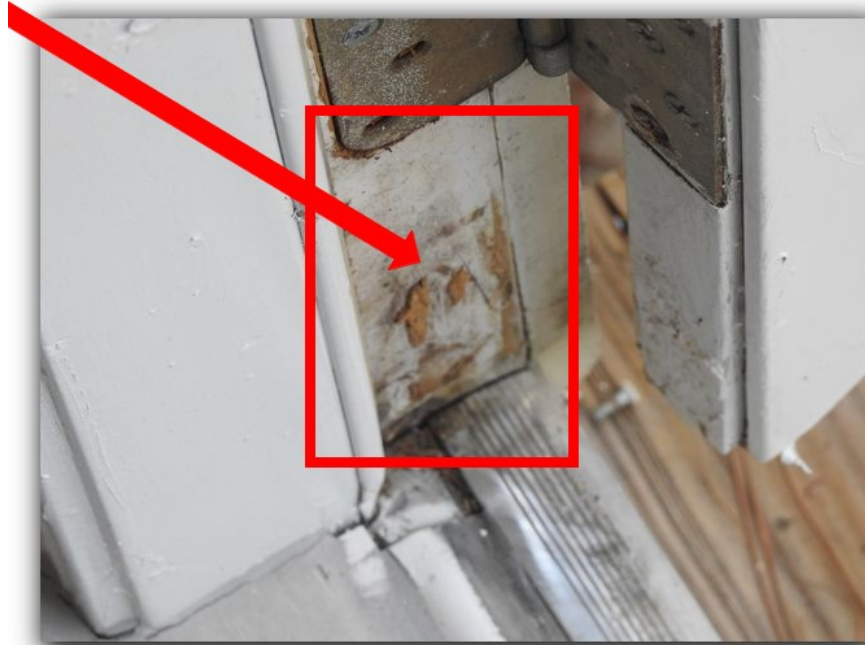
- **THE BOTTOM OF THE EXTERIOR DOOR FRAMES AT THE LOWER JAMBS NEEDS TO HAVE SMALL SQUARE FOAM RUBBER WEATHER STRIPS THAT DO PREVENT THE INSIDE JAMB FROM BECOMING ROTTED FROM WATER PENETRATIONS**

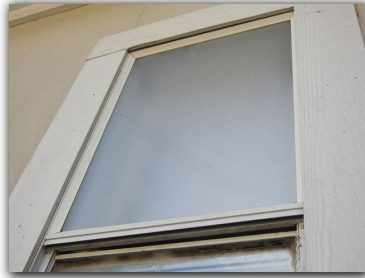
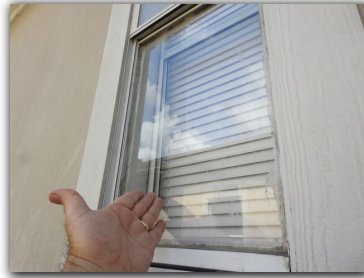
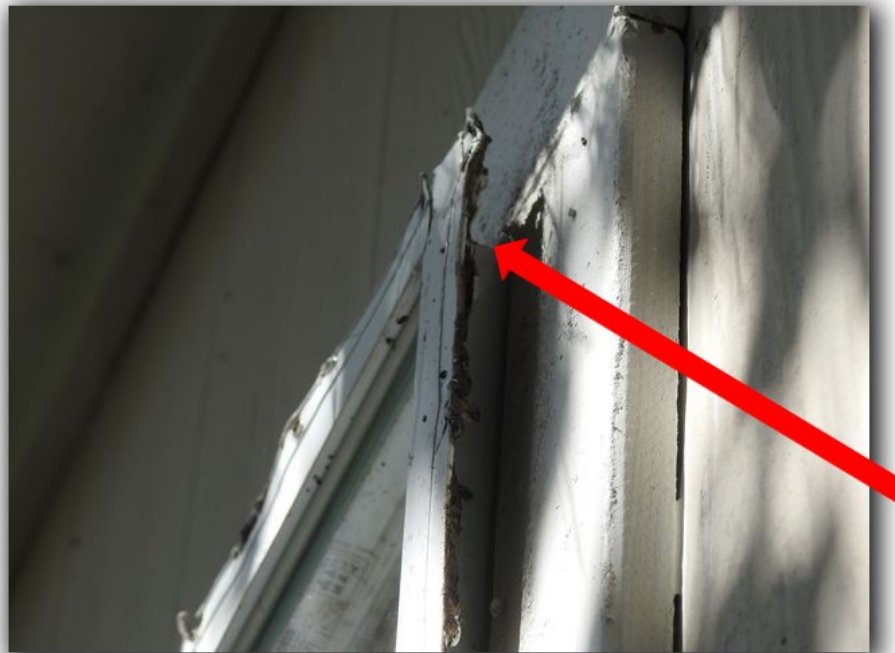
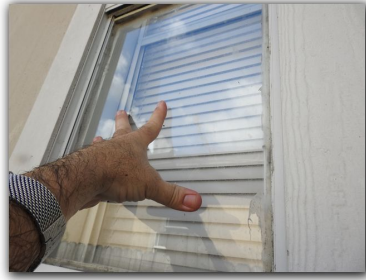
- **OVERALL THE WINDOWS ARE OF LOW QUALITY, POORLY INSTALLED, DAMAGED, LOOSE HARD TO OPEN, NOT CALKED OR SEALED, AND WOULD RECOMMEND COMPLETE WINDOW REPLACEMENT WITH PREFERABLY INSULATED GLASS WINDOWS.**

- Some windows are difficult to open or close**
  - Some glass panes are loose, damaged or missing**
- One window on the back left bedroom is coming loose at the wall and frame; in need of repairs.**

- Some window lift supports are loose, damaged or missing**
- Some window / door screens are damaged or missing**

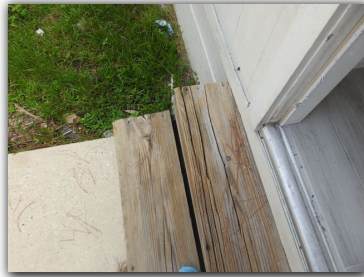
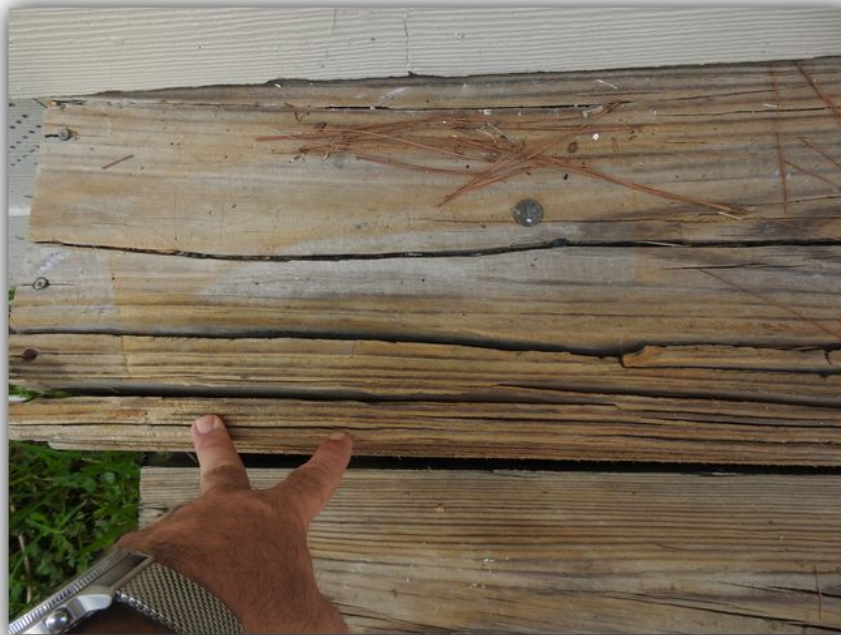
**Structural deficiencies;rotted damaged tread/steps at the back porch that needs repairs and would recommend hand railing as well.**

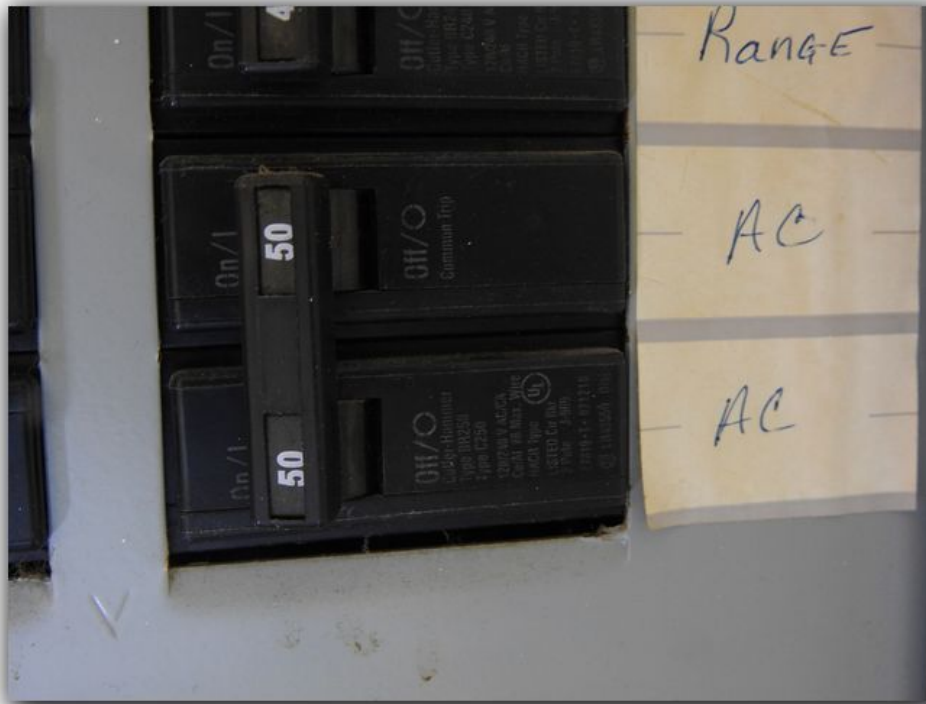
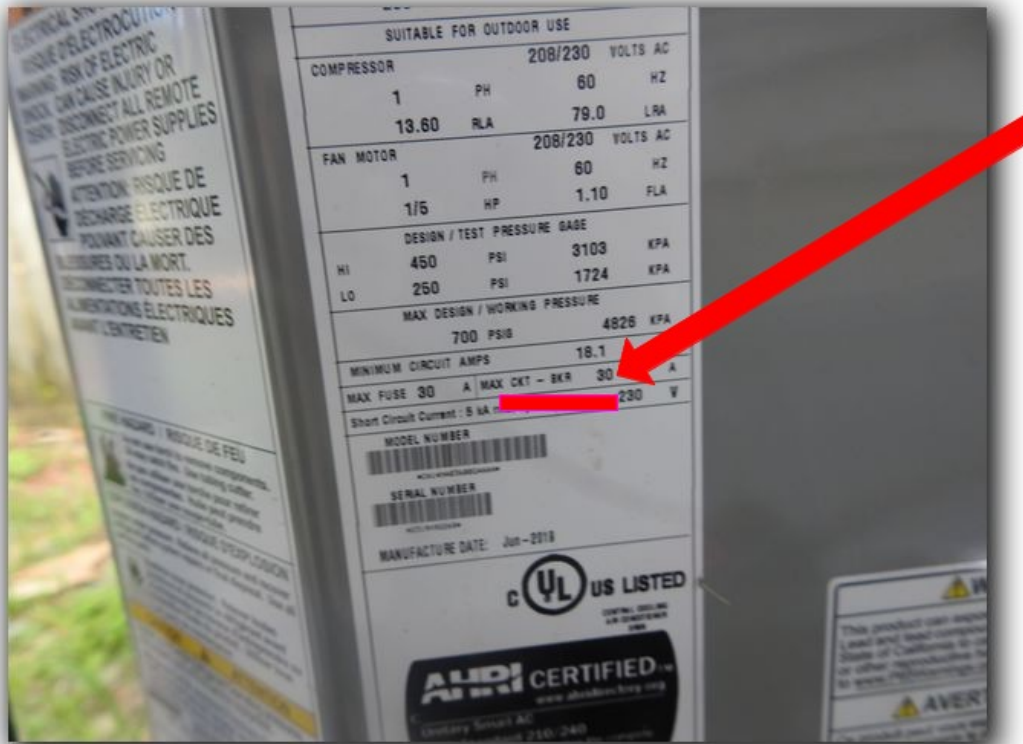
**A/C condensing unit #1:**

**Specifies max amp breaker of 30 and a 50 amp breaker is in use**

**IN NEED OF REPAIR BY AN ELECTRICIAN**

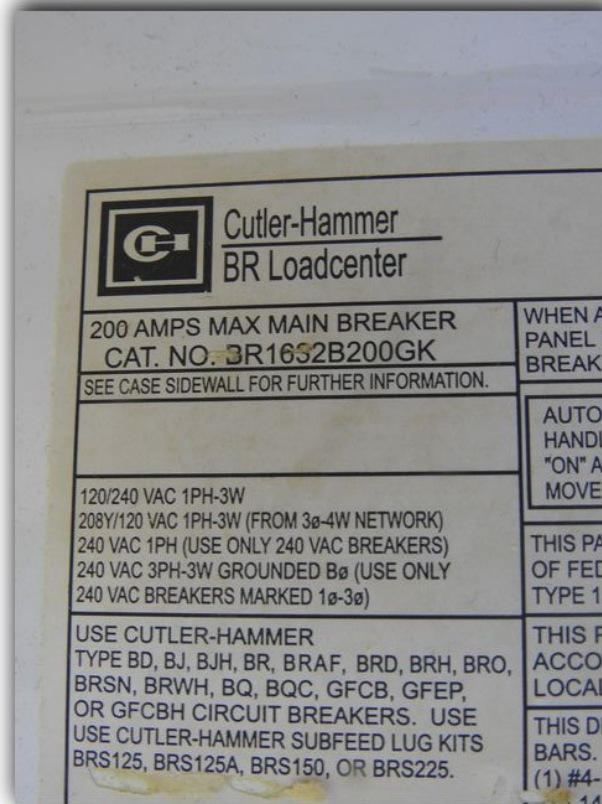
200 AMP "CUTLER HAMMER" SERVICE PANEL LOCATED IN THE LAUNDRY ROOM

- **THERE IS NO AFCI PROTECTION IN ALL THE REQUIRED LOCATIONS.** AFCI (ARC FAULT CIRCUIT INTERRUPTION) PROTECTION PROVIDES FIRE SAFETY PROTECTION. **NOW REQUIRED FOR NEW CONSTRUCTION** IN BEDROOMS, GAME ROOMS, PARLORS, LIBRARIES, DINING ROOMS, HALLWAYS, CLOSETS, SUN ROOMS AND SIMILAR AREAS.

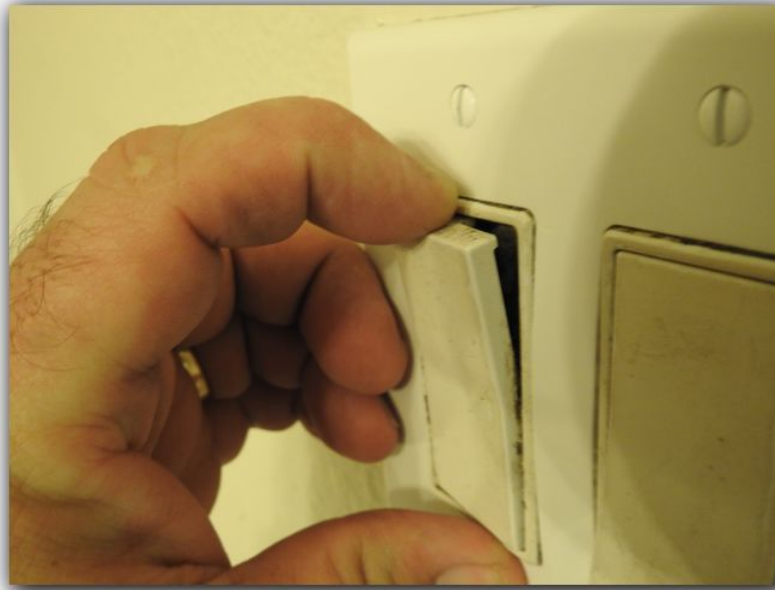
- **DAMAGED HALL BATH LIGHT SWITCH NEEDS REPLACEMENT BY AN ELECTRICIAN**

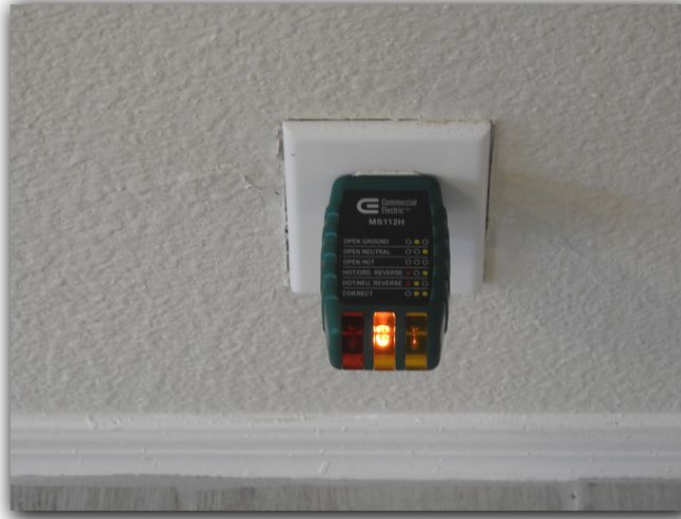
**Lack of Ground/Bonding at: \_\_\_\_\_**  
**THE OUTLET IN THE BREAKFAST AREA SHOWS OPEN GROUND AND IN NEED OF REPAIR BY AN ELECTRICIAN.**

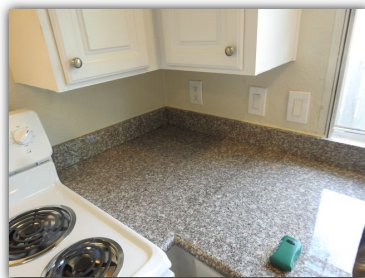
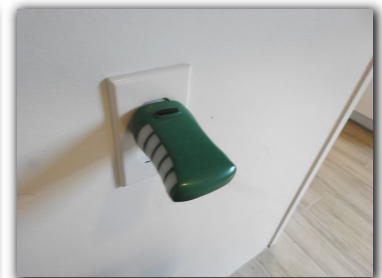
**•THE KITCHEN GFCI IS NOT FUNCTIONING AND WILL NOT RESET; IN NEED OF REPAIR OR REPLACEMENT BY AN ELECTRICIAN.**

- THE KITCHEN GFCI OUTLET WHEN TESTED DID NOT RESET AND HAS NO POWER PRESENT FOR THE CIRCUIT; WILL REQUIRE GFCI OUTLET REPLACEMENT BY A LICENSED ELECTRICIAN.**
