## PROPERTY INSPECTION REPORT

**Concerning:** 11942 GREENGLEN DR., Houston, TX 77044  
(Address or Other Identification of Inspected Property)

**By:** Stephen Perry, Lic #7854 07/16/2019  
(Name and License Number of Inspector) (Date)

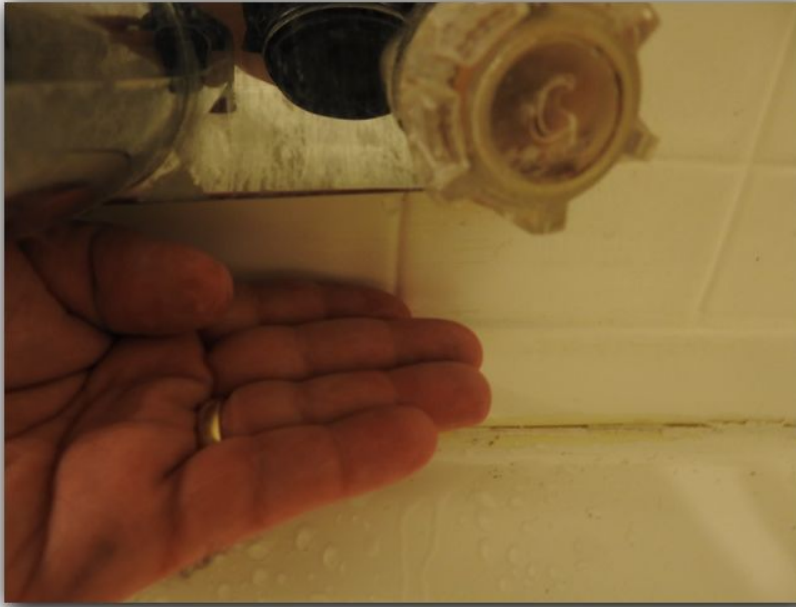
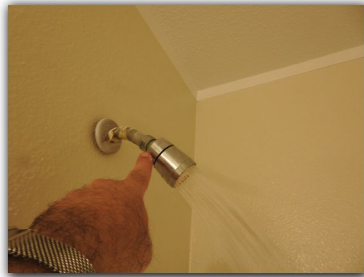
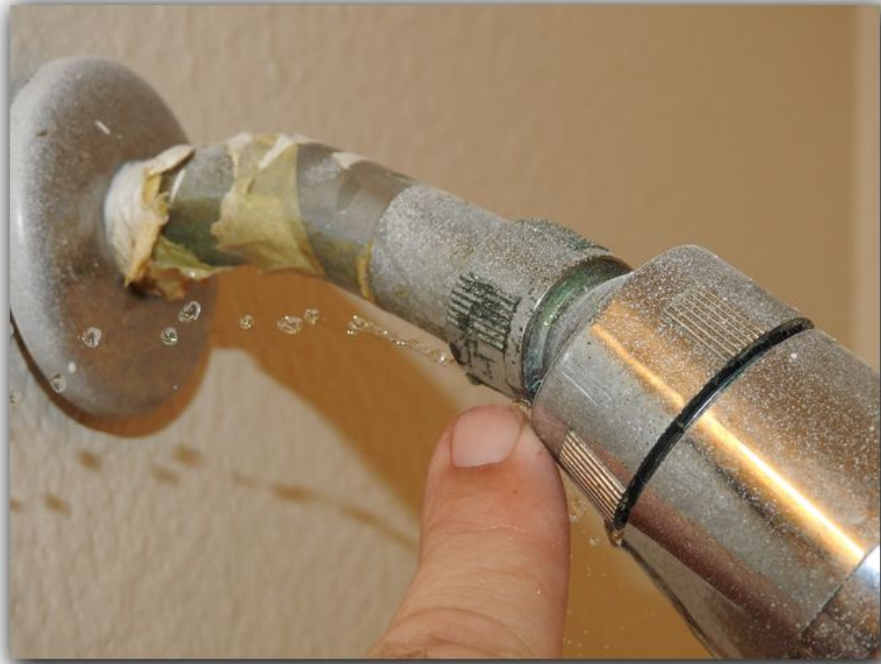
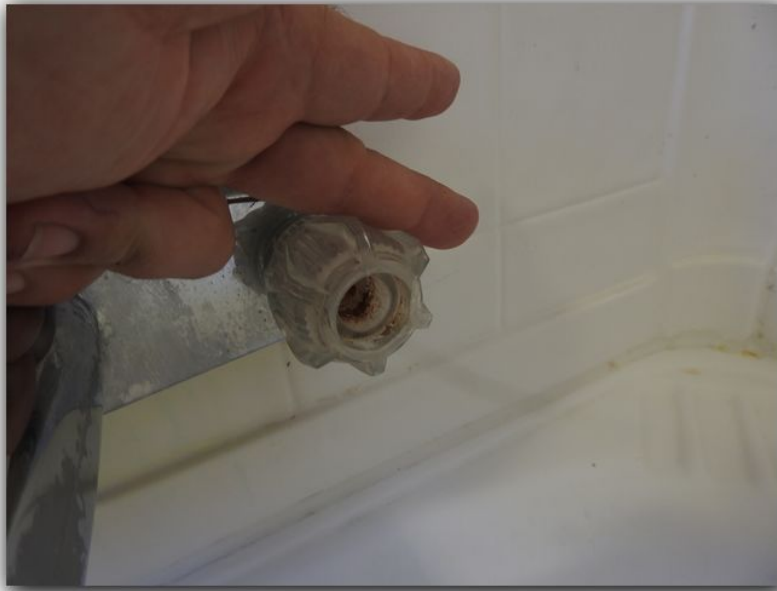
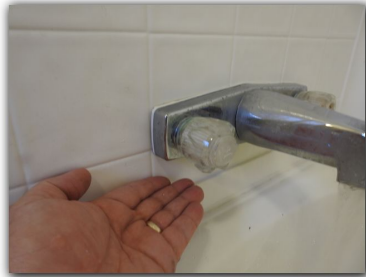
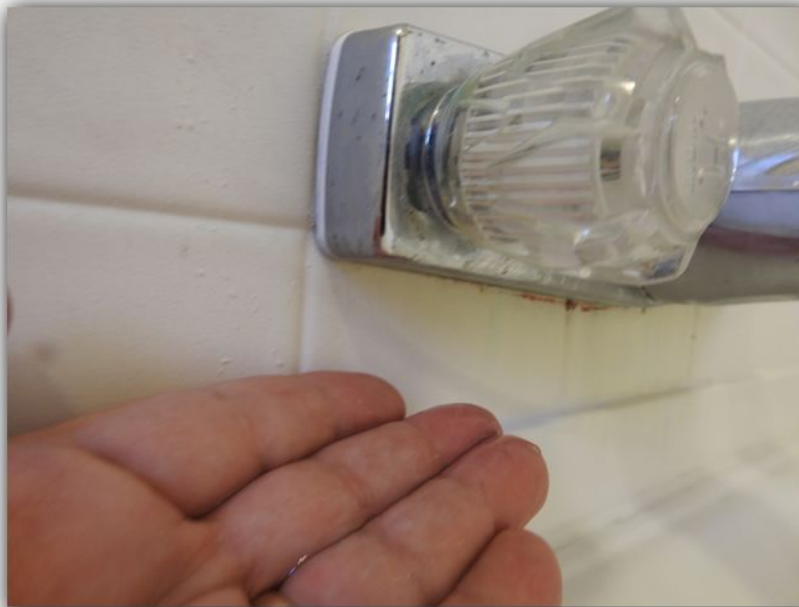
- **BOTH THE BATHROOMS HAVE TUB FIXTURES THAT ARE LOOSE, DAMAGED, COLD WATER HANDLE IN MASTER JUST SPINS BUT DOES NOT TURN ON, LEAKS AT BOTH LOCATIONS AND LOOSE INSIDE THE WALL AT THE HALL BATH. THE FIXTURES ARE VERY LOW QUALITY AND IN POOR CONDITION AND LEAKING, NEED TO BE REPLACED BY A PLUMBER.**
- **HALL BATH SHOWER HEAD LEAKS AND IN NEED OF REPAIR OR REPLACEMENT.**

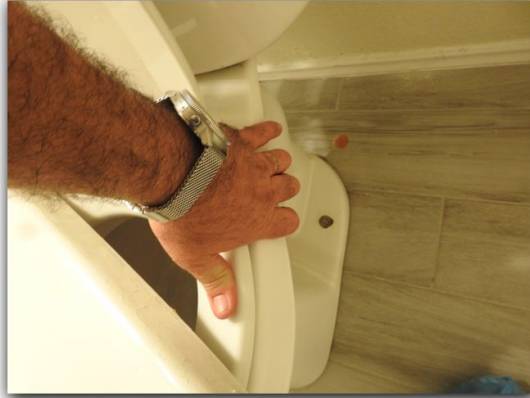
- Loose at floor mounting, both bathrooms**

- **TOILETS NEED CALKING AT THE BOTTOM AND FLOORING**

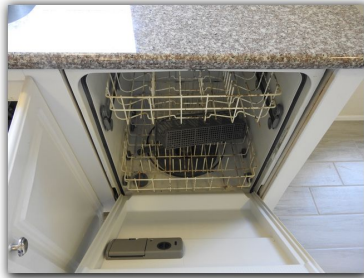
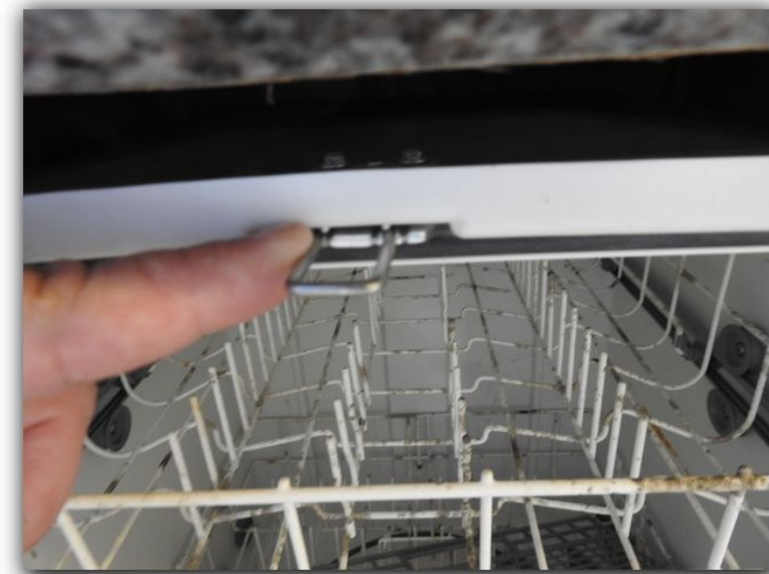
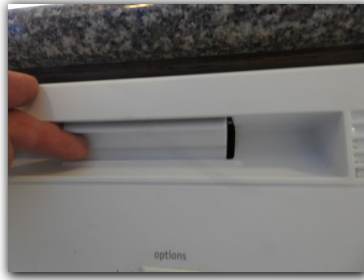
**Inoperative unit(s), recent unit but the door latch is broken and will not operate until fixed by an appliance repair person**

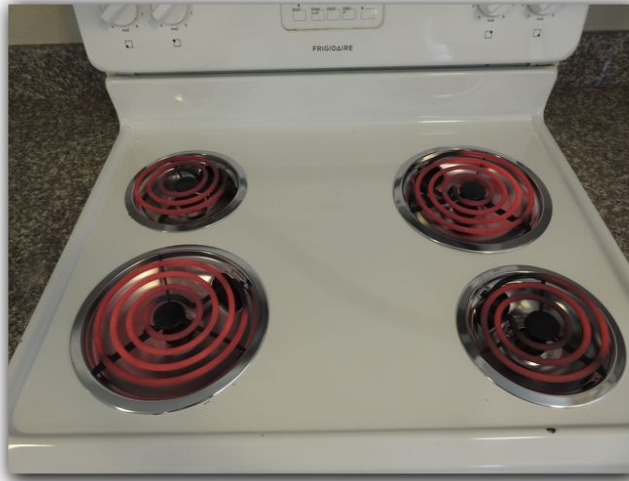
**Absence of anti-tilt device**, required for child safety
