Enclosed is the report of the visual inspection that was conducted on the structural foundation of the residence located at 6817 Hazen, Houston, Texas, 77074 by Taylor Sealy, PE. This inspection was conducted for you on the date of June 7, 2007.

FOUNDATION INSPECTION REPORT

6817 Hazen
Level readings

6817 Hazen
Pile layout

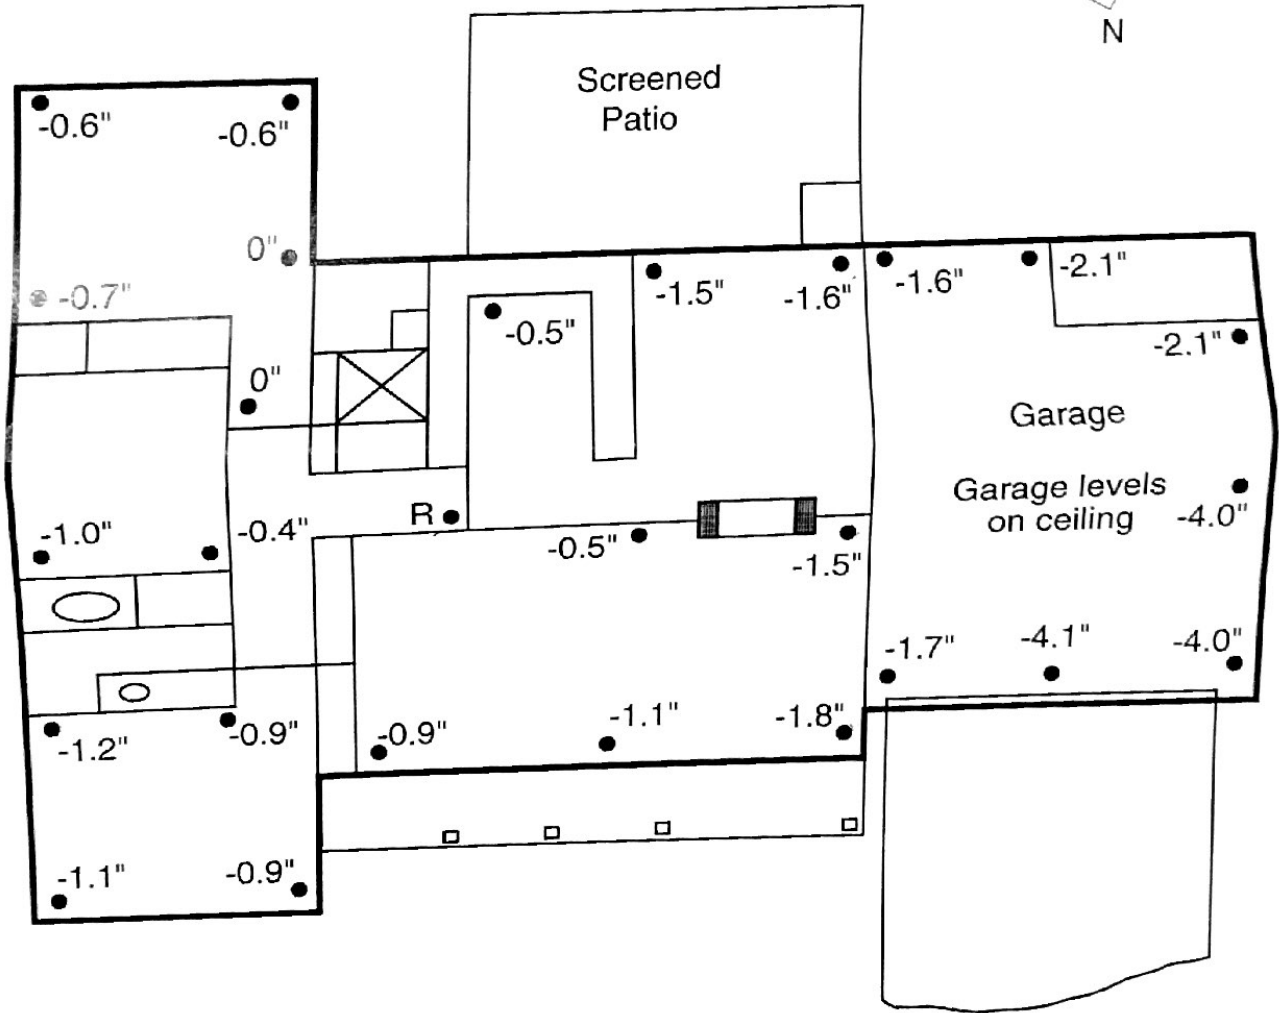
The foundation of this residence was observed to have incurred deflections which caused damage to other structural components. The level deviations were measured using an electronic version of a waterlevel, either a Stanley Compulevel or a Ziplevel by Technidea in this case, and the results have been superimposed upon an attached sketch. Compensation was made for variations in the height of the floor coverings so that the measurements shown should reflect the relative height of the top of the concrete slab. From this sketch, it can be seen that the slab was measured to be level within approximately 4.1" from the high point to the low point. Based upon my experience, this is more than would normally be expected for a house of this size, with a more typical average usually being in the range of about 1.5". That also is the recommended slab construction tolerance given by the American Concrete Institute. The majority of the house was relatively level with the exception of the garage. The low level readings were noted on the west end of the garage, and especially around the northwest corner. Levels in the garage were taken on the ceiling. Not counting the garage, the house would be level within approximately 1.8", which is not much beyond the new construction tolerance of 1.5". However, some sheetrock cracks and door misalignments were noted around the bedroom wing hallway. We observed no exposed slab reinforcement steel or honeycombing in the edge of the slab. Large cracks were not observed in the visible part of the foundation grade beam. As far as cracks which may be present in the grade beam it should be understood that cracks can be extremely difficult to see and could possibly be detected by the client at some time after the inspection has been completed. Since cracking is a normal property of brittle materials such as concrete, neither the author nor Sealy Engineering assume any responsibility whatsoever should cracks be found which were not mentioned. It is our opinion that other indications are more important in determining whether a house has a foundation problem since cracks may be present in slabs due to shrinkage or minor movements. A hole in the ground was noted next to the foundation just outside of the utility room in the garage and is likely due to breaks in that underslab cast iron sewer lines which are causing washout of the soil there.

In my opinion, the settlement of the outer end of the garage part of this foundation are of sufficient magnitude such that leveling is suggested. While settlement resulting in door misalignments and sheetrock cracks was noted in the bedroom wing, that is not bad enough there at this time to warrant foundation repairs in my opinion, although the possible causes of the movement there should be determined and eliminated. This could include damaged and deteriorated sewer lines or tree roots extending under the foundation and withdrawing moisture from the soil. It is also my opinion that restoration of foundation integrity in the garage can best be accomplished through the correct application of driven piles. Piles tend to be "self-testing" as far as capacity due to the method of installation. This is true as long as any hard upper clay layer, such as occurs in summer, is penetrated. This usually requires a penetration of at least 10' unless sandy soils are involved. The attached sketch shows a reasonable arrangement for the piles. This information may be used by the client for the process of obtaining bids for this work. It is important to understand that this arrangement is based upon our engineering judgement; however, the warranty will be provided by the contractor who is solely responsible for the work and should, therefore, make the final selection. Any prospective contractor should be given a complete copy of this report in order that they may understand the goals desired here. The client may wish to resolve any significant differences between our suggestions and the recommendations made by the contractor. In any case, neither the author nor Sealy Engineering assumes any responsibility whatsoever for the results of the work of the contractor.

The drawing at the end of this report is provided to aid in determining the condition of the foundation. "R" on the drawing represents the reference point from which all other level readings are taken and it is arbitrary. Changes in floor coverings such as the transition from carpet to tile etc. are taken into consideration when taking level readings. Taking the largest positive reading and adding the largest negative reading will give the overall levelness of the structure. Generally, when new houses are finished, a certain amount of slope is built in. This slope is generally in the range of 1.5 inches for the average size house. Level readings are valuable not only as a diagnostic tool but can be used as a reference for any suspected foundation movement that may occur in the future. Readings can also verify the stability of a house. Please note that the scale of the drawings can change with faxing or copying of the original sketches.

Based upon the observations made during this inspection, it is our opinion that sufficient foundation unlevelness is present around the garage such that leveling there is needed as described herein. While settlement was evident in the bedroom wing resulting in misaligned doors and sheetrock cracks, it is not bad enough there to result in the need for foundation repairs, although the cause or causes of the settlement should be determined and eliminated. This should include testing of the underslab cast iron sewer lines and deep cutting of any roots extending to the house and under the foundation. The deteriorating wood floor for the rear screen patio needs to be replaced with a properly constructed concrete slab well attached to the existing house foundation. That slab should contain grade beams, as the house foundation would, and should have at least 6" of slab showing above existing grade if possible.

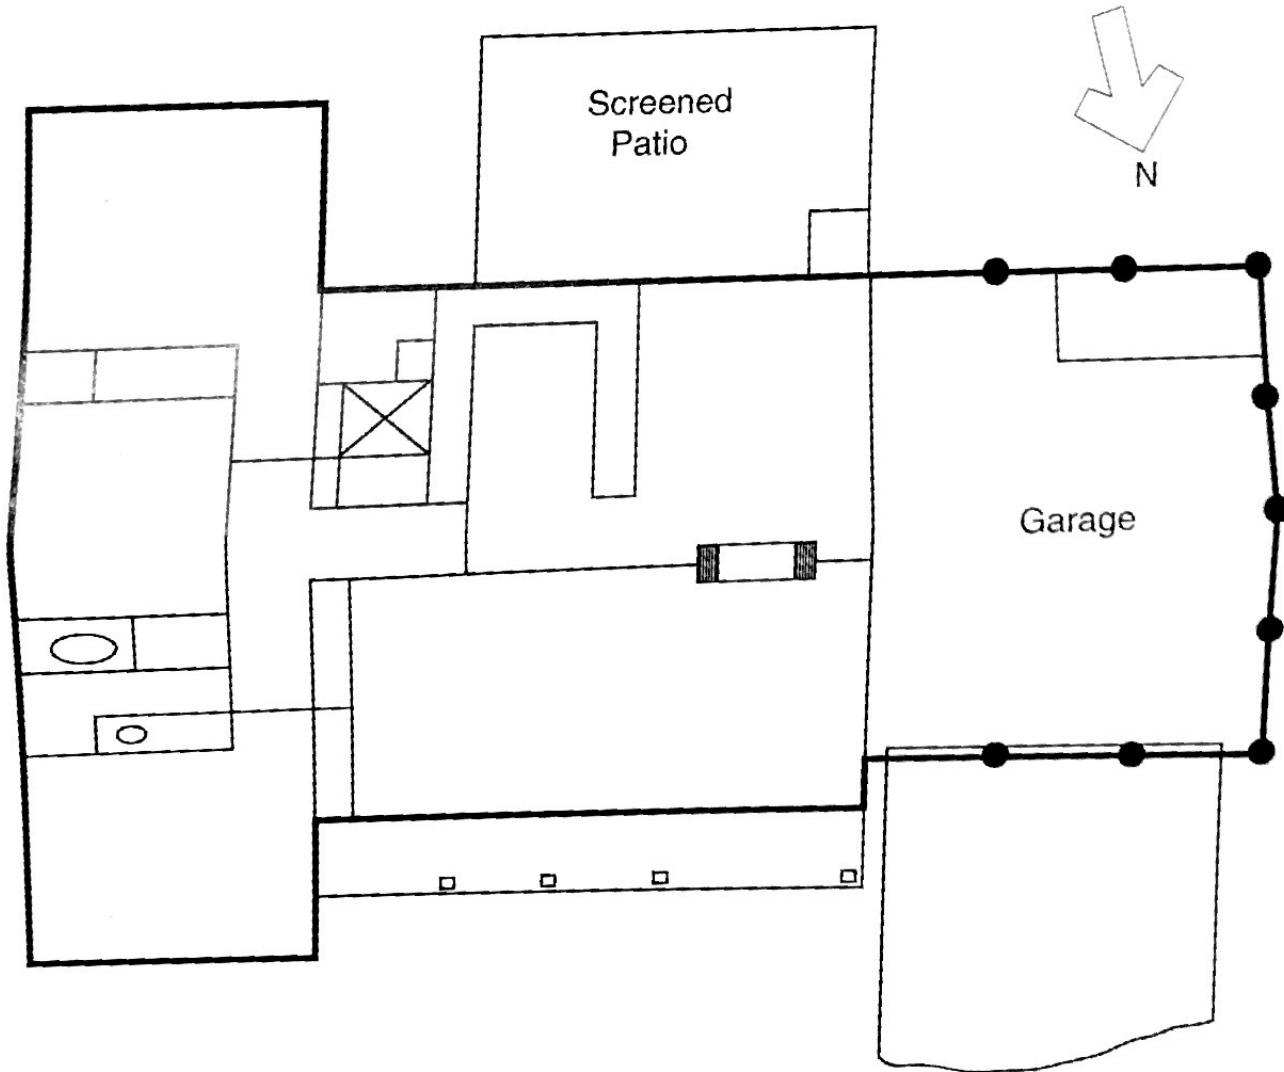
● = Approximate piles needed to level foundation.
Existing piles/piers may be reused if desired.
