PROPERTY INSPECTION REPORT

Concerning: 6000 Reims Rd #2204, Houston, TX 77036

By: Ning Xue 06/16/2019

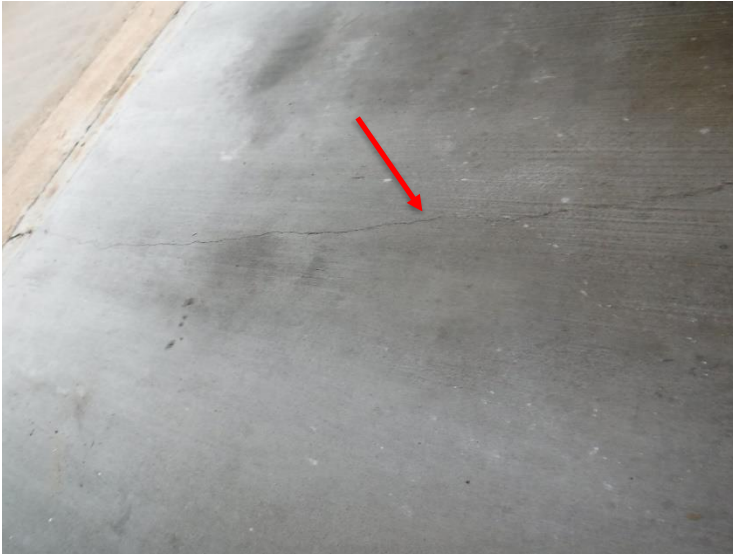
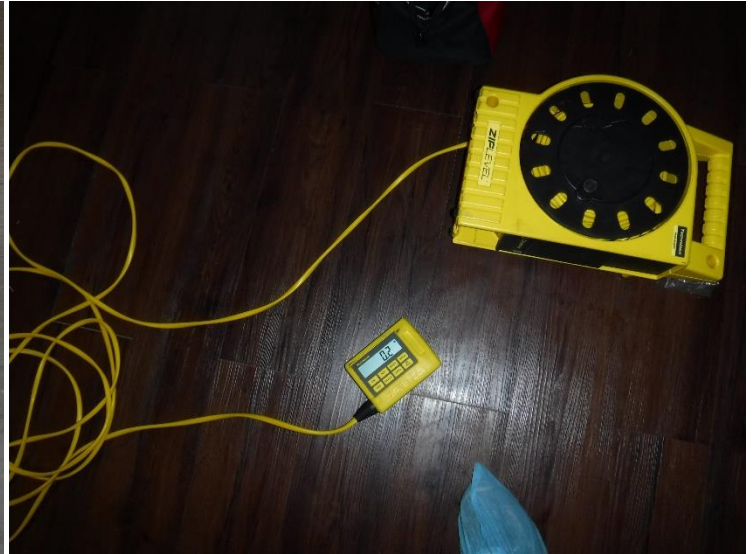
- a. *Observed concrete cracks on patio slab and garage floor; It is apparent that this house had experienced distress in the forms of unlevelled foundation slab; it was found that the slab is generally sloped from the center of the living room (along the east-west axis) to the front of the house with a sudden drop of approx. one inch over a span of roughly 10 feet by using Ziplevel; American Society of Civil Engineers (ASCE) standards deem that 1 inch over a 15-foot span is acceptable given your house's age and location; recommend reporting to HOA to have this common element repaired and properly sealed to prevent further deterioration;*

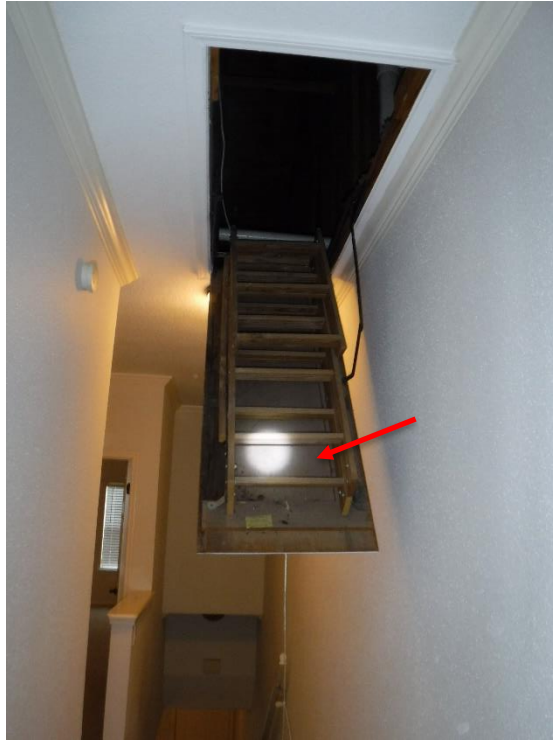
- a. Attic access ladder missing insulation; the attic entry point is a break in the thermal envelope of the home, so the heat can transfer through this opening; recommend adding insulation to improve energy efficiency;

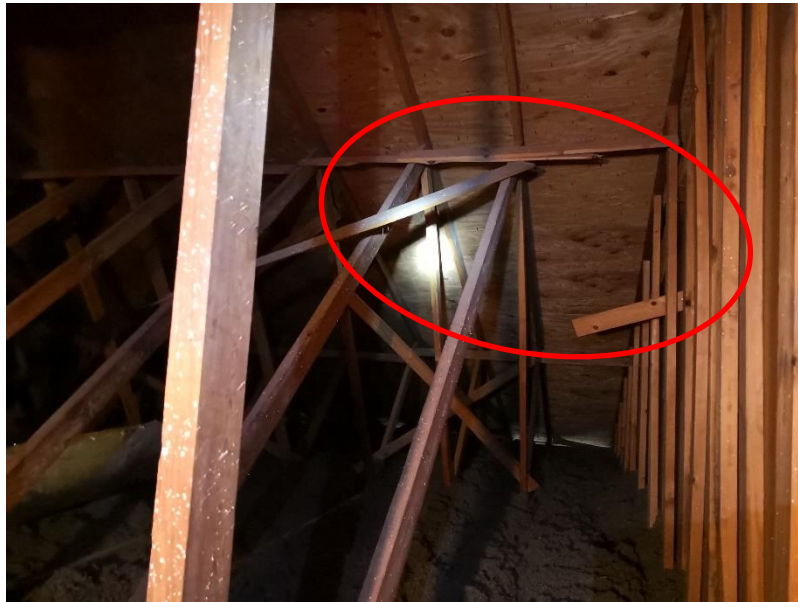
- b. Purlin braces are spaced and sized improperly, and some deflections and cracking of the purlin were visible; It is recommended that a qualified roofer be contacted to further evaluate and repair as needed; Photo is representative of the issue and may not include all locations;

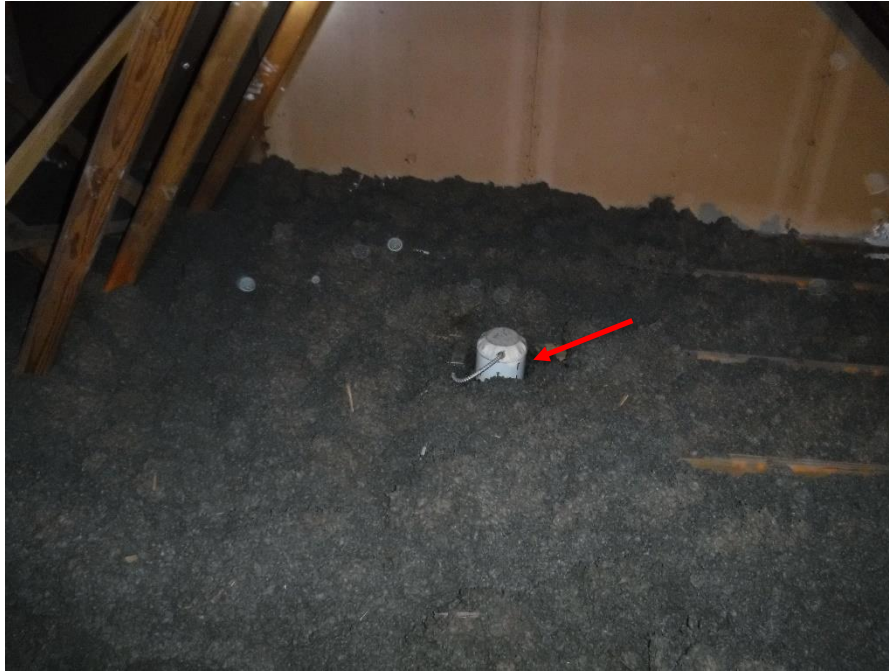
- c. *The inspector noted non-IC rated light fixtures are in contact with insulations; recommend correction to keep the insulation at least three inches away to prevent the insulation gets overheat and cause a fire in the roof space;
Photo is representative of the issue and may not include all locations;*

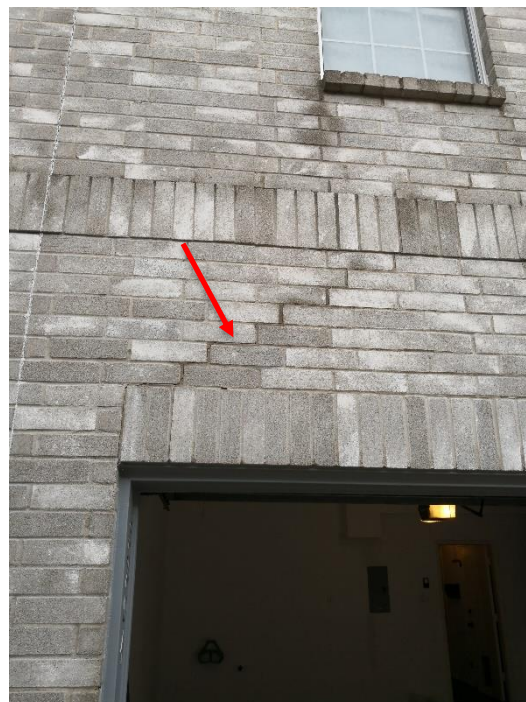
- a. *Noted sign of past repairs on step cracks on the east-side brick walls; it is the inspector's opinion that these*

cracks might be signs of past foundation differential movement; recommend continuing monitoring and reporting to the HOA if these cracks keep developing;
Photo is representative of the issue and may not include all locations;

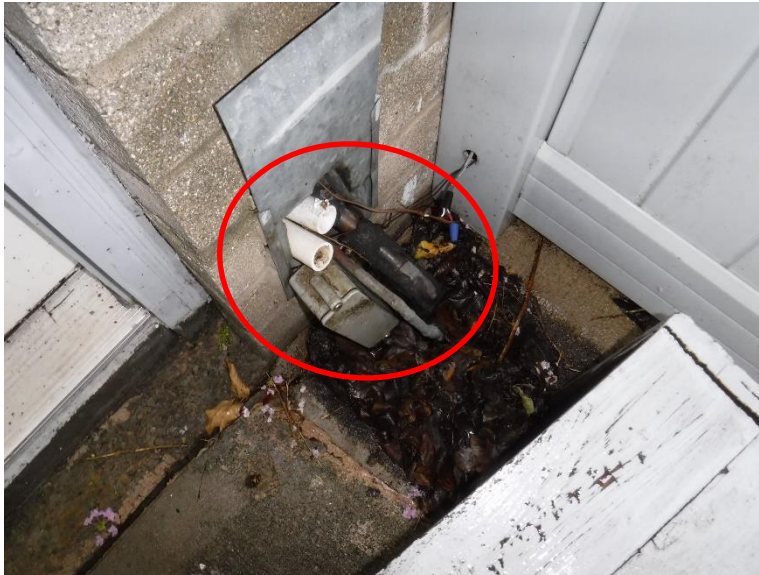
- b. Need sealing / caulking around all holes, openings (expansion joints, windows, door thresholds, etc.) and exterior wall penetrations to prevent water/critter entry; including but not limited to the above location, electrical panel, dryer vent, bath and range top vents, light fixtures, etc.; Also recommend replacement of deteriorated insulation on the refrigerant (suction) line;

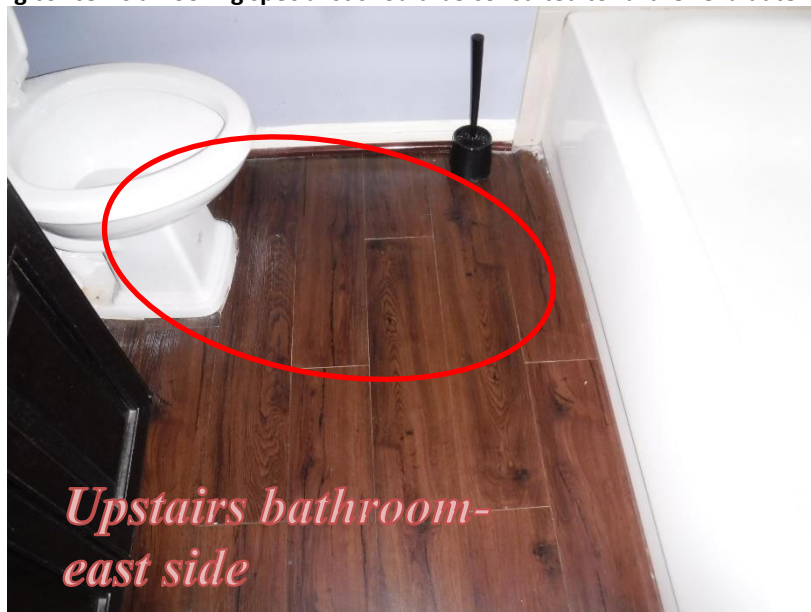
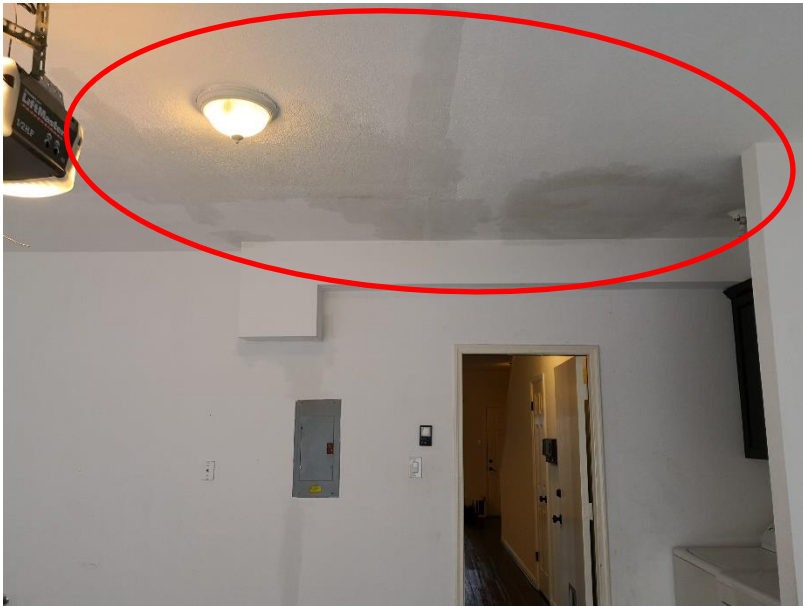
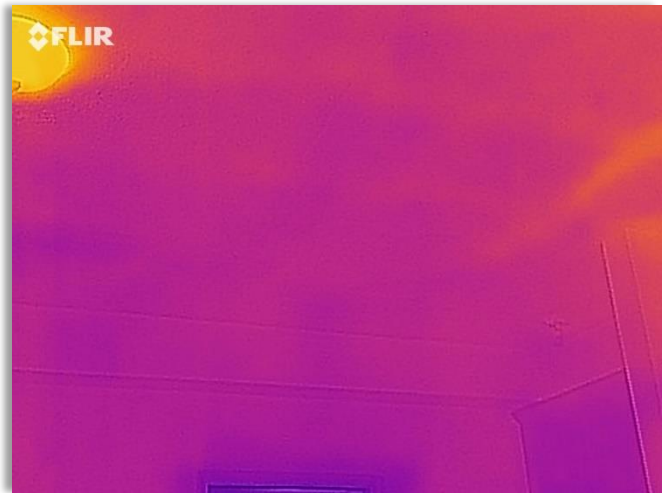
- a. *The inspector spotted a water stain on the ceiling of the garage, possibly an evidence of water damage from upstairs bathroom(east-side); but the inspector did not detect active leaking at time of the inspection; The inspector also noticed uneven floor surrounding the toilet at the east-side upstairs bathroom; recommend following up with the seller for more information and continue monitoring;*

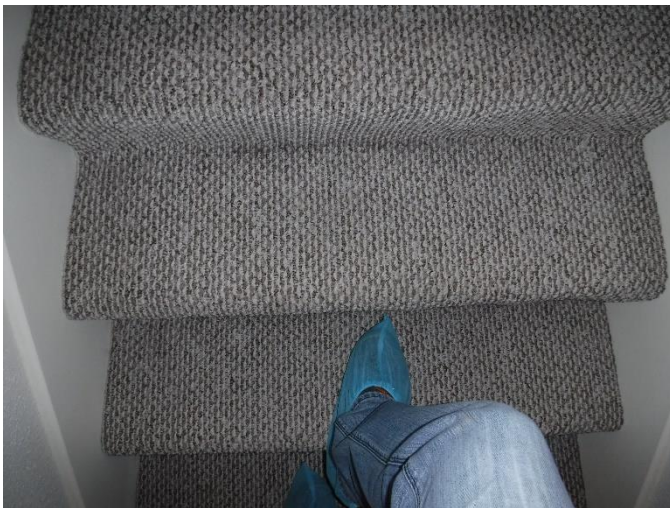
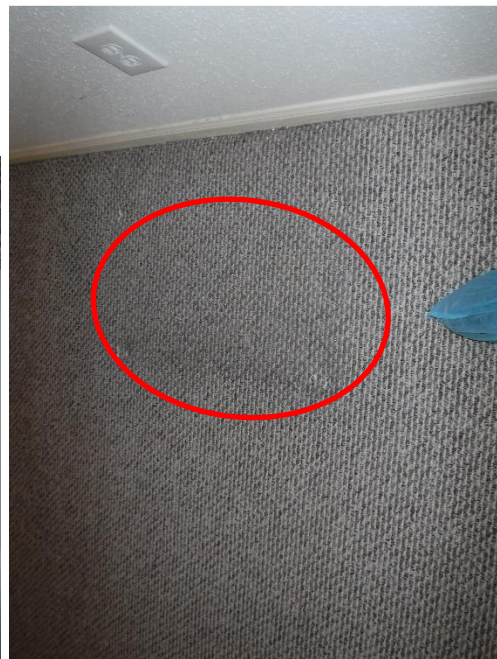
- b. *Carpeted floor on the stairs squeaks when walked upon in a normal manner; Sub-floor unevenness has to be the number one reason for this phenomenon; this is a common issue with many homes and can usually be corrected by installing proper type fasteners into the floor; recommend repair; The inspector observed stains at various locations on the carpeted areas; recommend deep cleaning prior to the closing; Photos are representative of the issue and may not include all locations;*

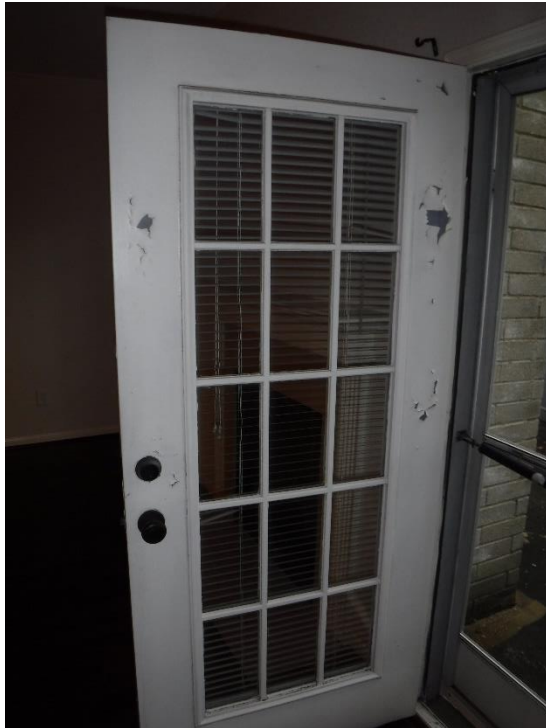
a. Sign of moisture damage and peeled paint observed on the patio door; recommend repair and re-paint;

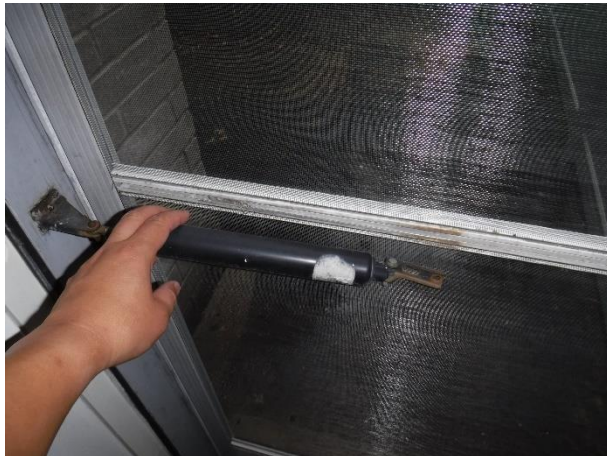
b. The pneumatic screen door closer is detached from the door; recommend repair/replacement;

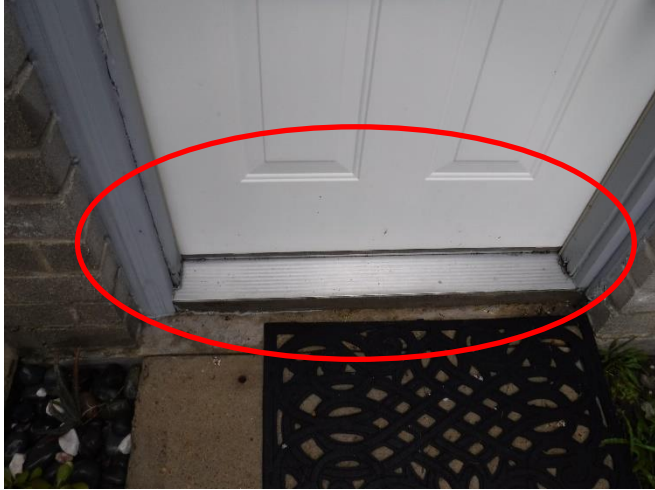
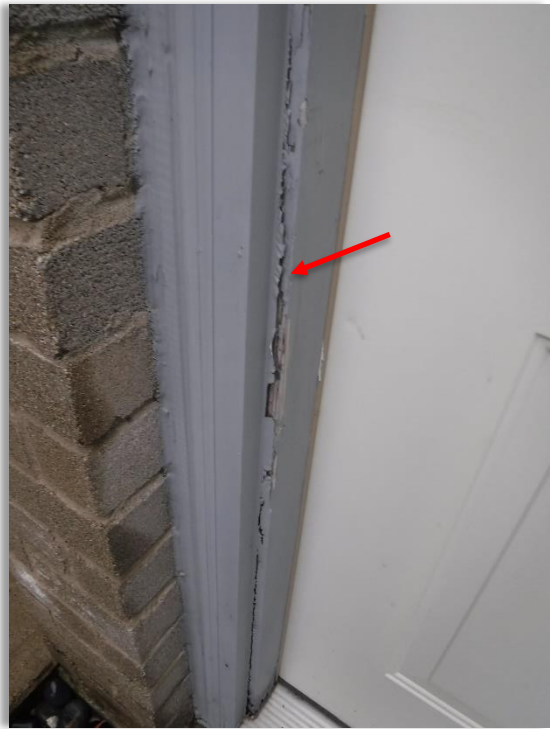
c. Sign of moisture damage and rot wood observed on the front door's jambs; recommend repair and re-paint;

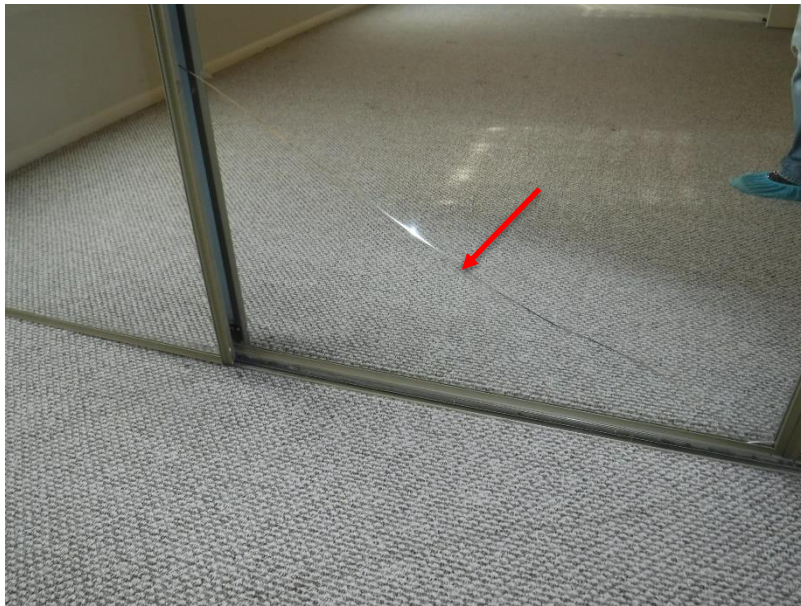
d. Crack noted on closet sliding door at the upstairs bedroom (east side); recommend replacement;

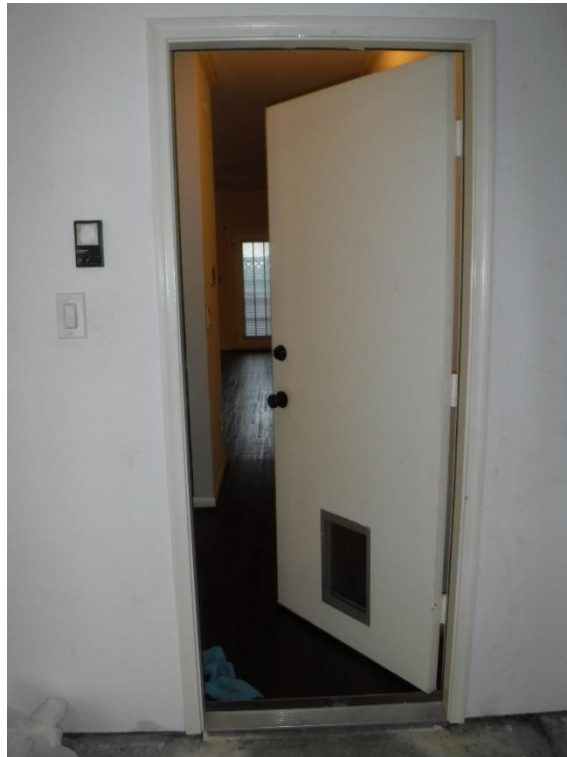
- e. *It is recommended that a self-closing mechanism to be installed on the garage door to prevent vehicle exhaust fumes from entering living space; in addition, the solid wood door should be no less than 1 3/8" and fire-rated (20 mins.);*

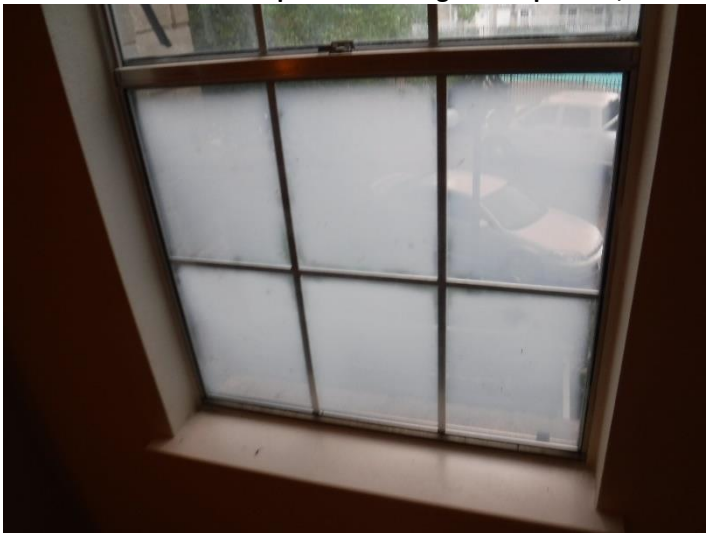
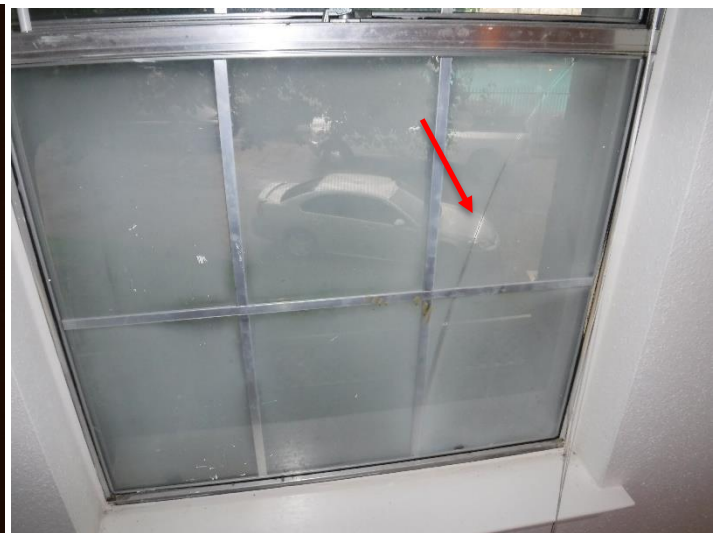
- a. *All four upstairs bedroom bottom windows have appeared to have lost their seal; This has resulted in discoloration developing between the panes of glass and can cause the glass to lose its insulating properties; one window at the upstairs bedroom (west-side) has a cracked pane; these glasses should be repaired or replaced;
Photos are representative of the issue and may not include all locations;*

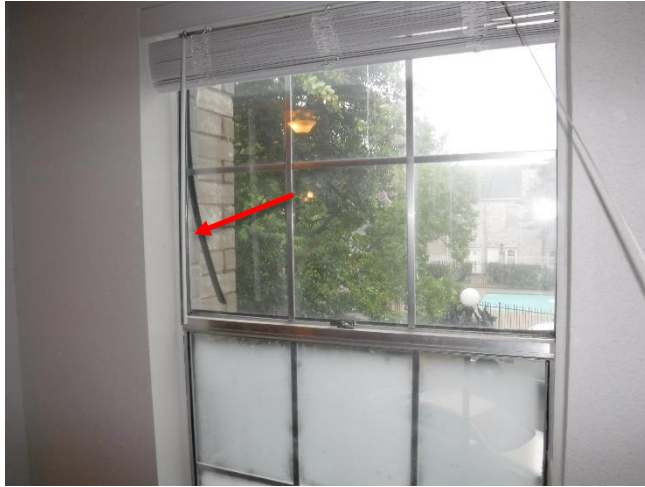
- b. *Deteriorated weather stripping was noted at various locations; Recommend installing new weather stripping;
Photo is representative of the issue and may not include all locations;*

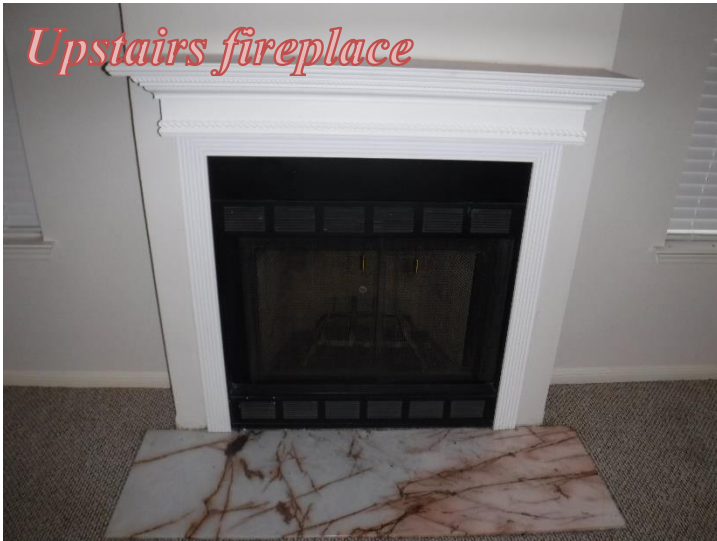
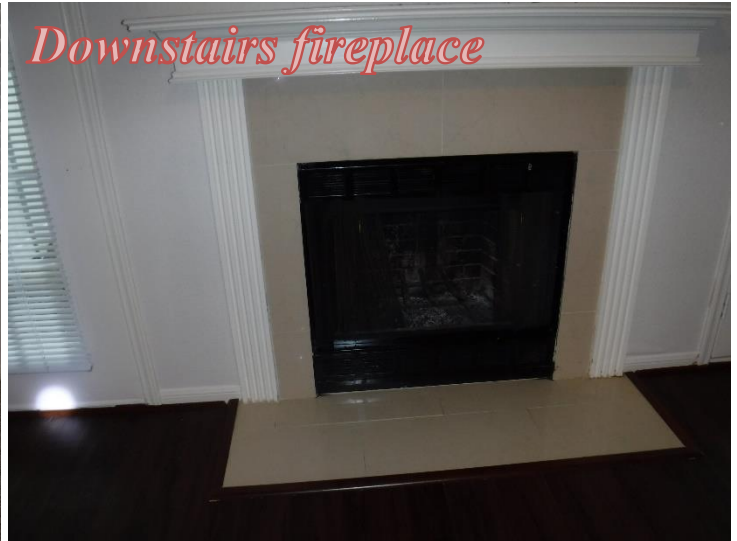
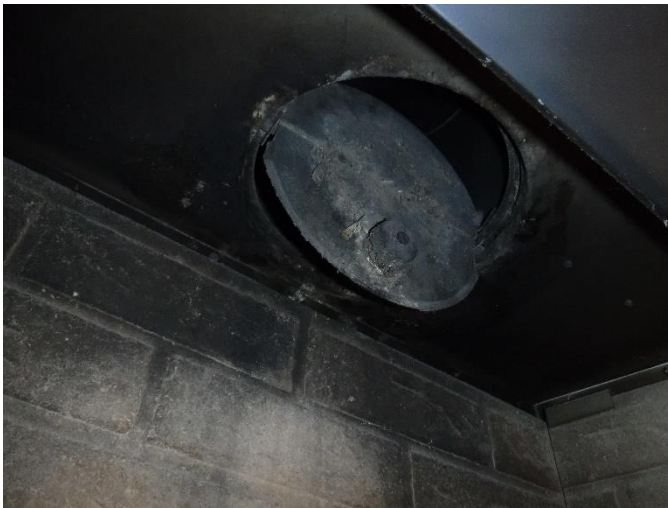
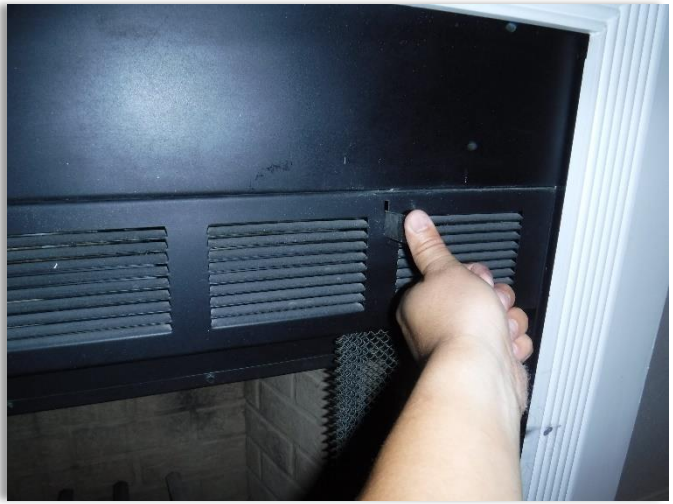
a. The chimney damper (upstairs firebox) could not stay closed, recommend repair/adjustment of the push knob by a qualified specialist;

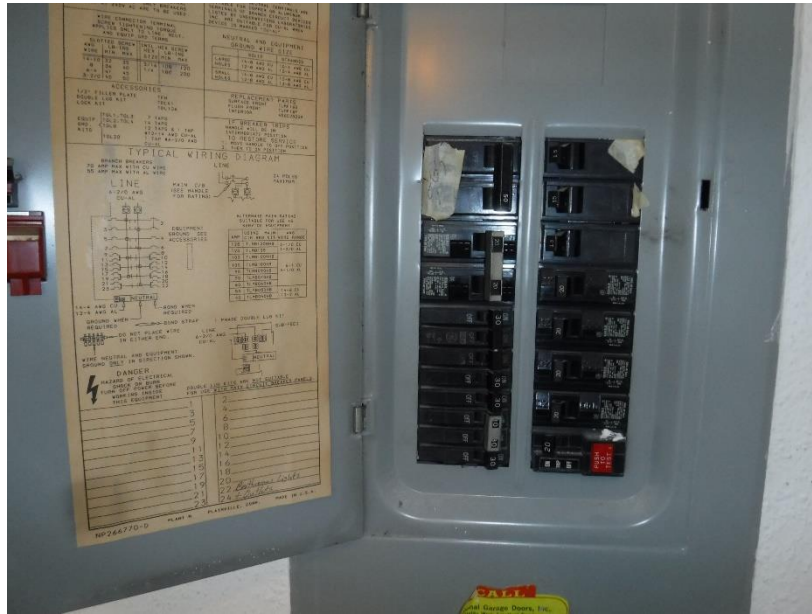
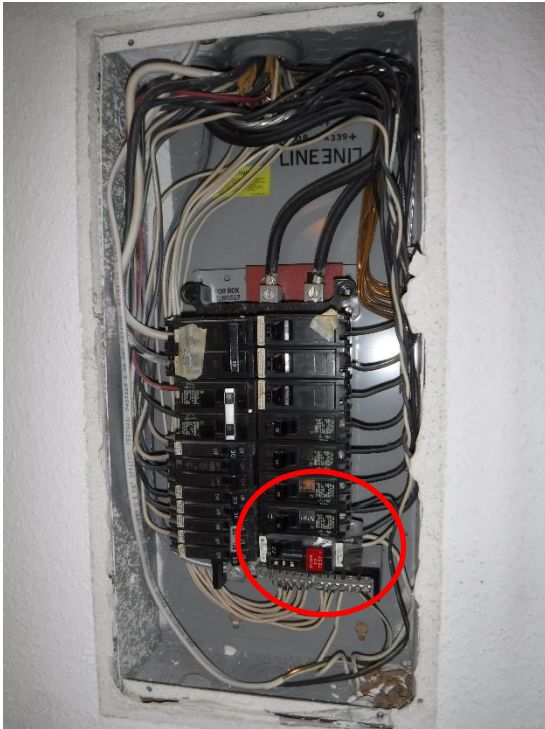
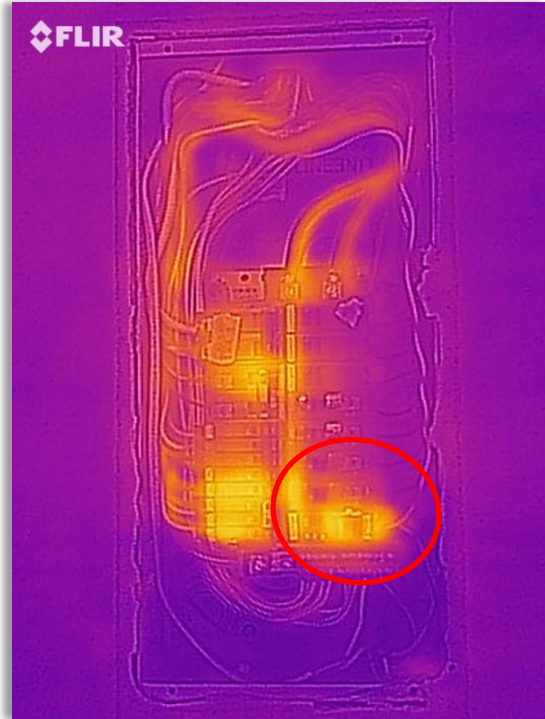
- a. "Double tapping" --two wires connected to a circuit breaker, observed in the breaker panel (marked location); that circuit breaker appears to have some sort of heat anomaly on it as seen using a Flir Infrared camera at time of the inspection; These breakers may not be rated for double-tapping. Therefore, further evaluation by a licensed electrician is advised;

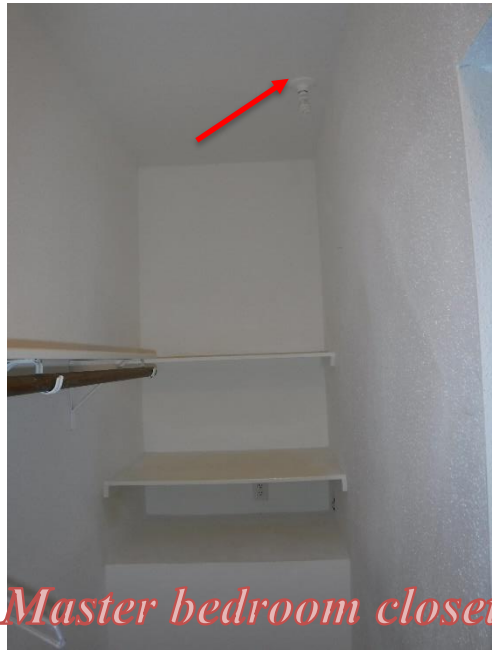
Master bedroom closet

a. The lights at above locations were faulty at time of the inspection; suggest replacing light bulbs and verifying fixture for proper operation prior to closing;

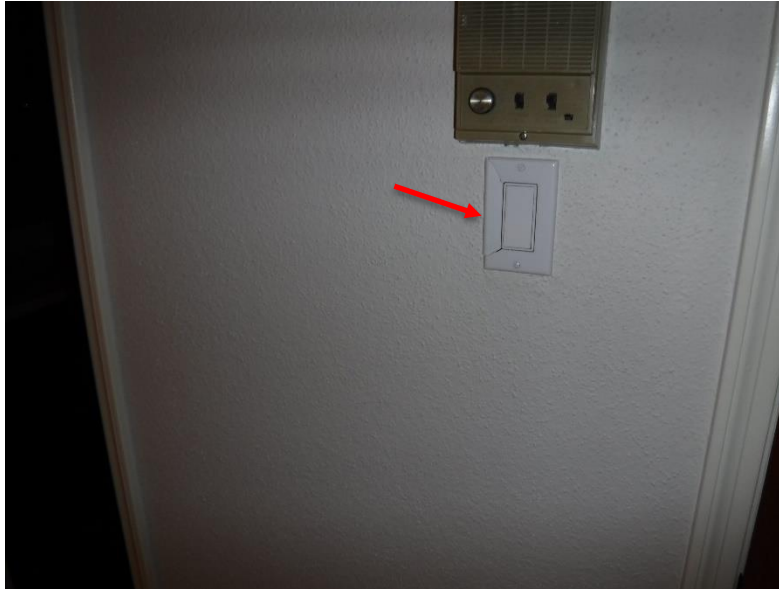
- b. *Noted one switch by the kitchen has a damaged cover plate; recommend repair by a licensed electrician to prevent shocking hazard;*

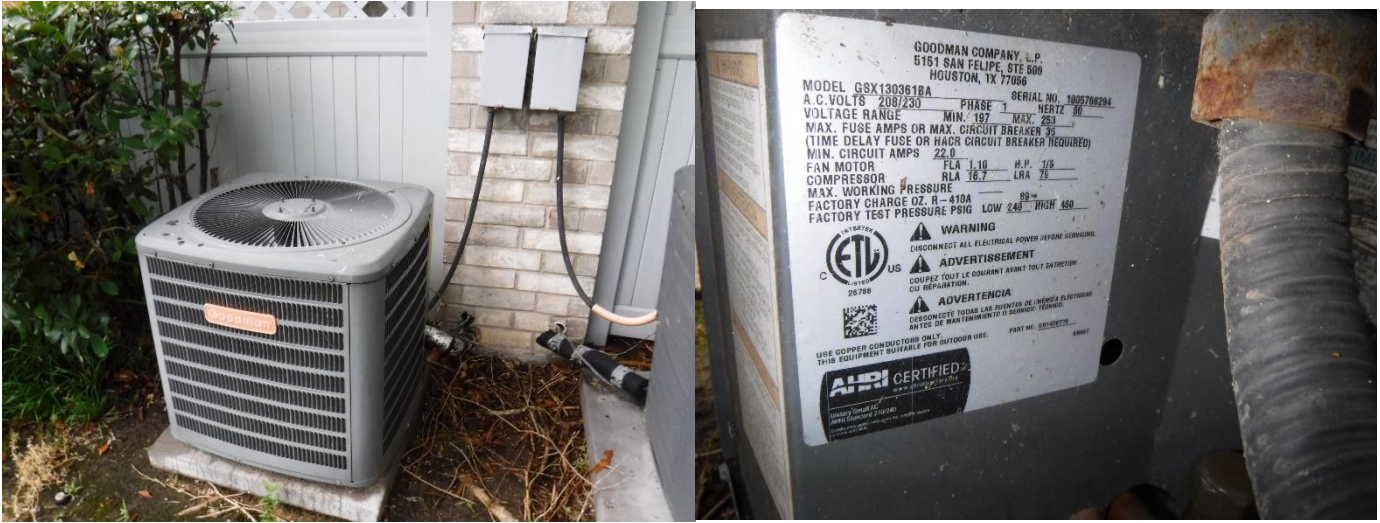
- a. The temperature drops measured were within considered typical (14-21 degrees °F) which is supposed to be measured between the return air and supply air within close proximity of the related coils of the system being evaluated; it indicates that the A/C system performed adequately at the time of this inspection; recommend replacement of filters regularly on all air intakes, this will help keep the system running efficiently;

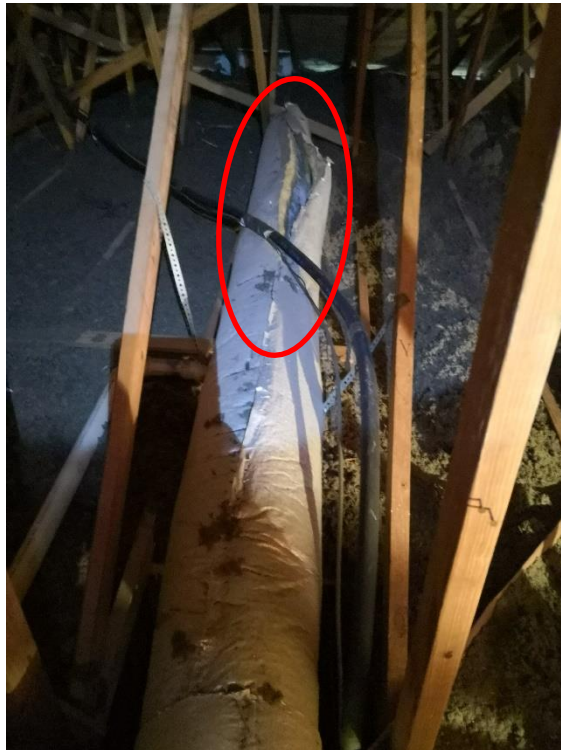
- a. Air ducts were placed on the attic floor and deteriorated insulations falling off of the ducts noted at various locations; recommend having the air ducts strapped and re-insulated; Photo is representative of the issue and may not include all locations;

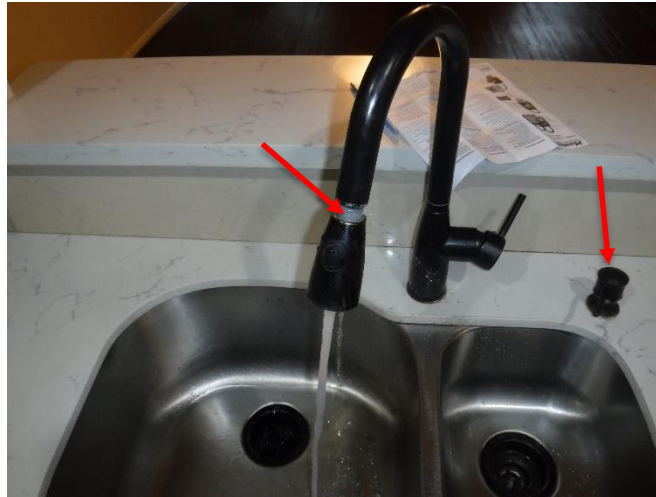
- a. *The kitchen faucet is leaking water at marked location when tested; and the soap dispenser is damaged; it is recommended that a qualified plumber be contacted to further evaluate and repair/replace as needed;*

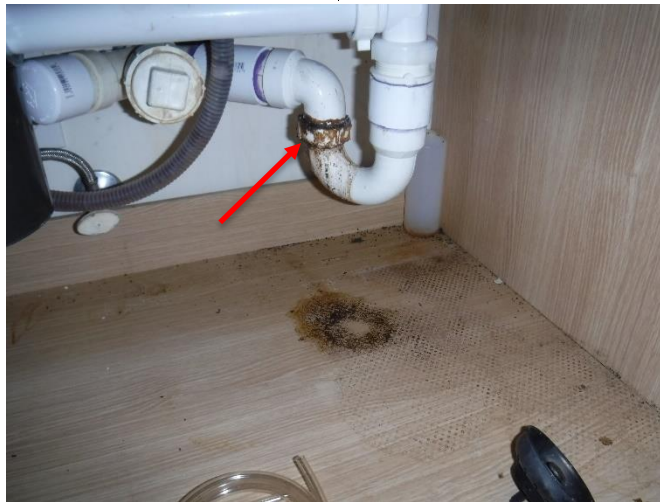
- b. *The kitchen sink's drain pipe is leaking at time of the inspection; it is recommended that a qualified plumber be contacted to repair at a timely manner;*

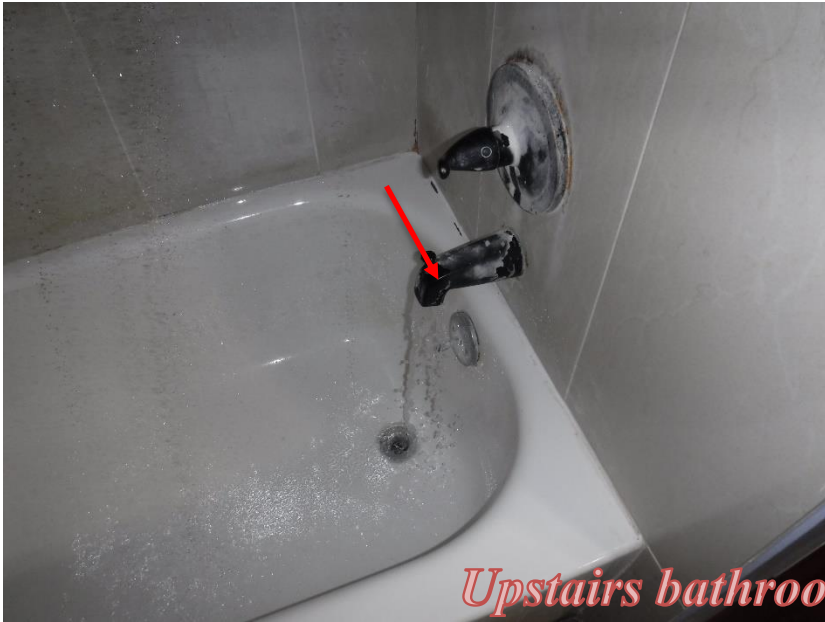
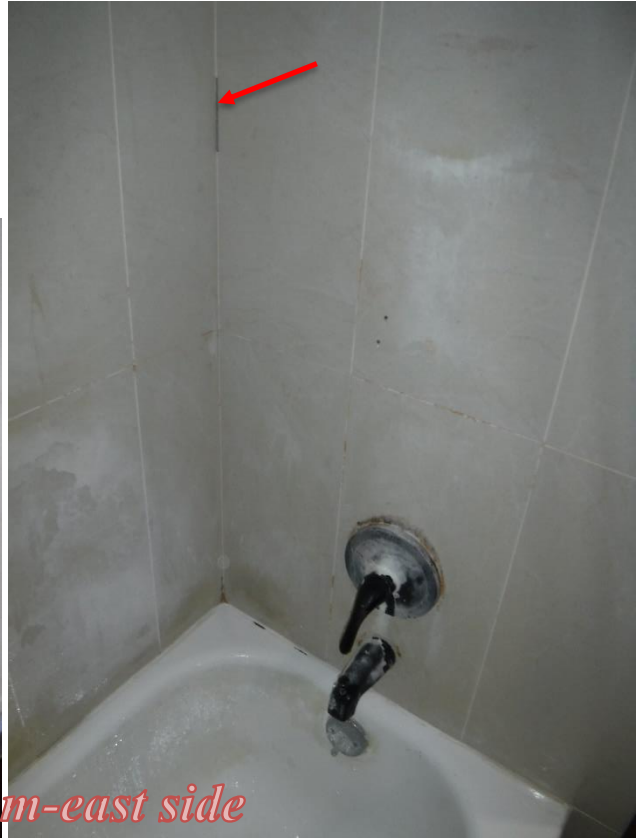
Upstairs bathroom-east side

- c. *The shower diverter leaks water when the shower is on; it is recommended that a qualified plumber be contacted to further evaluate and repair as needed; also recommend removal of calcium deposits from shower heads and faucets; suggest re-grout marked location at the bathroom tile seams; There is no exhaust fan present at the downstairs guest bathroom; Photo is representative of the issue and may not include all locations;*

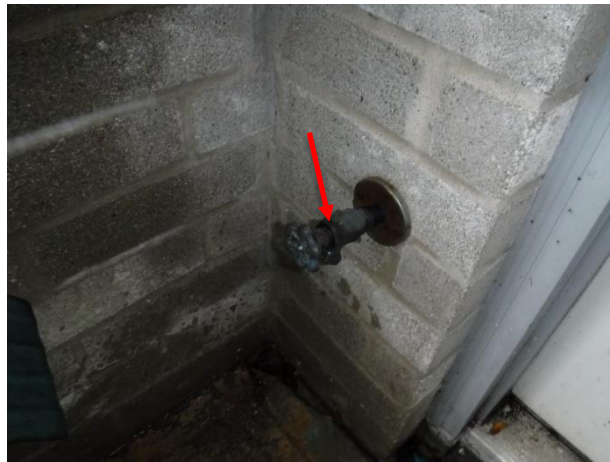
- d. *Recommend adding insulations on all exposed water pipes and adding vacuum breakers to exterior hose spigots/faucets; the faucet in the garage is inoperable at time of the inspection; recommend repair by a licensed plumber; Photo is representative of the issue and may not include all locations;*

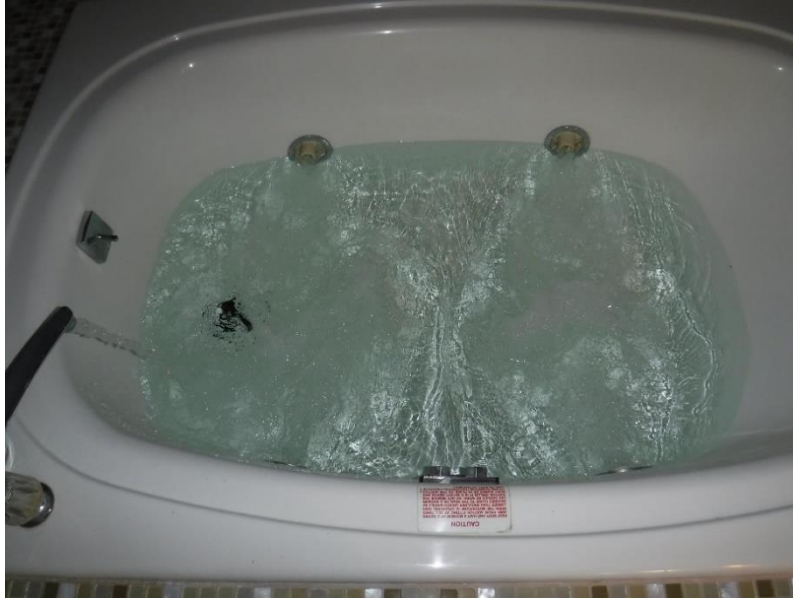
- a. The whirlpool jets of this hydro-tub were running in one and only mode –pulsating, at time of the inspection; recommend obtaining the operating manual and/or further evaluation by a licensed plumber to make sure the filter is not clogged;

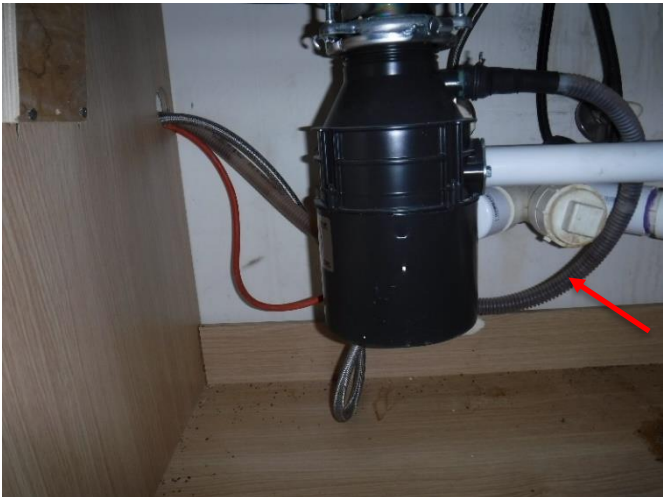
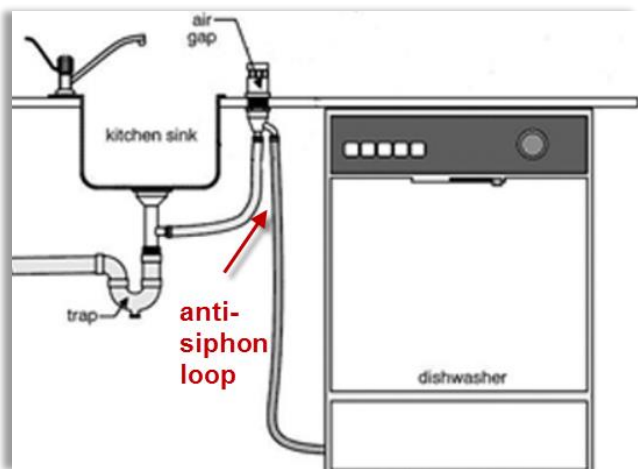
- a. Dish washer drain line missing anti-siphon loop; recommend correction by a licensed plumber;

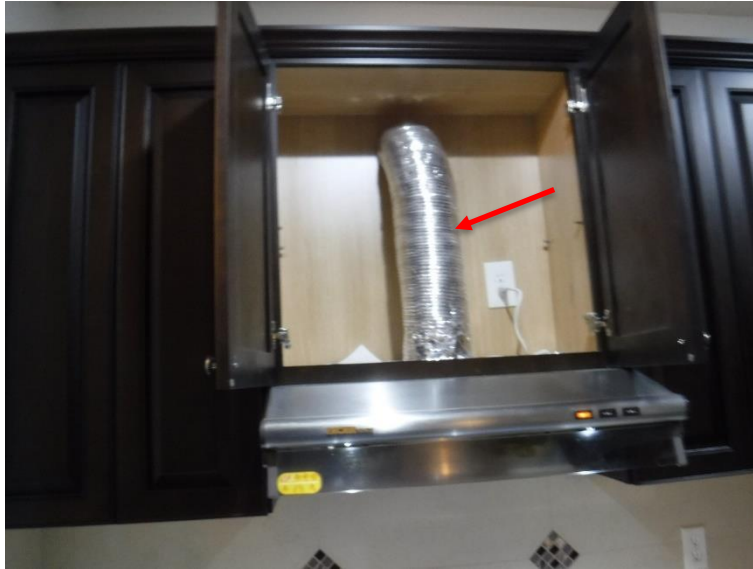
- a. *The inspector noted inappropriate material is used for range hood ducting; this type of flexible duct does not have a smooth interior surface, cooking waste will build up on the ridges/irregularities and become a combustion-fire hazard; recommend removal and replacement with proper materials;*

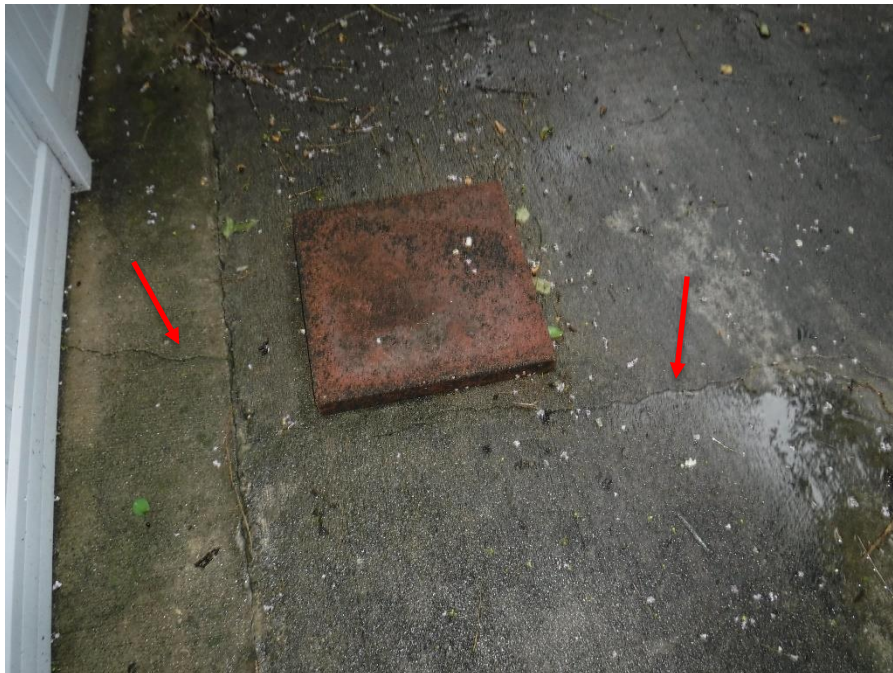
a. Observed concrete cracks on patio slab; reference to the "Foundation" section for more information;

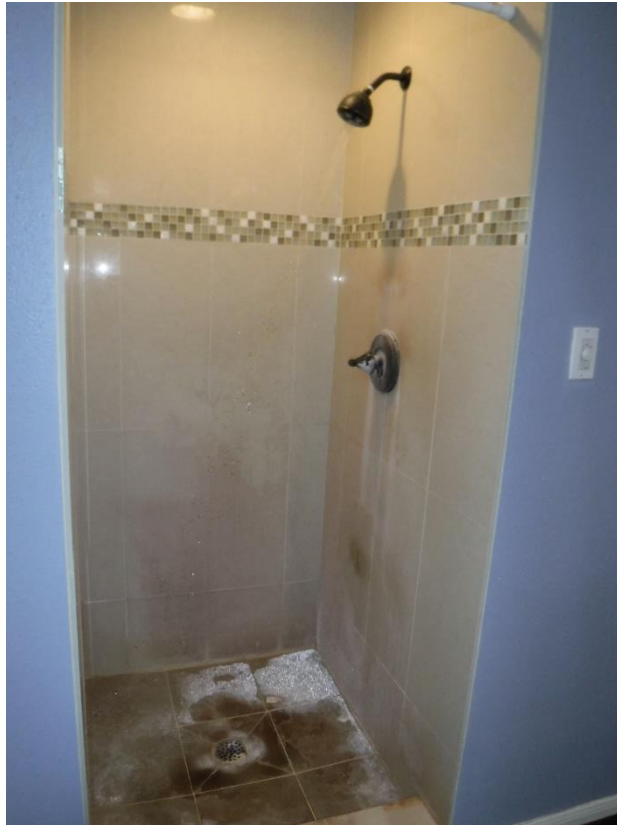
b. Recommend scrub calcium deposits off of shower walls and floor;
