PROPERTY INSPECTION REPORT

Report#: 03917

Concerning: 50 Hideaway #50, Friendswood TX 77546

08/01/19

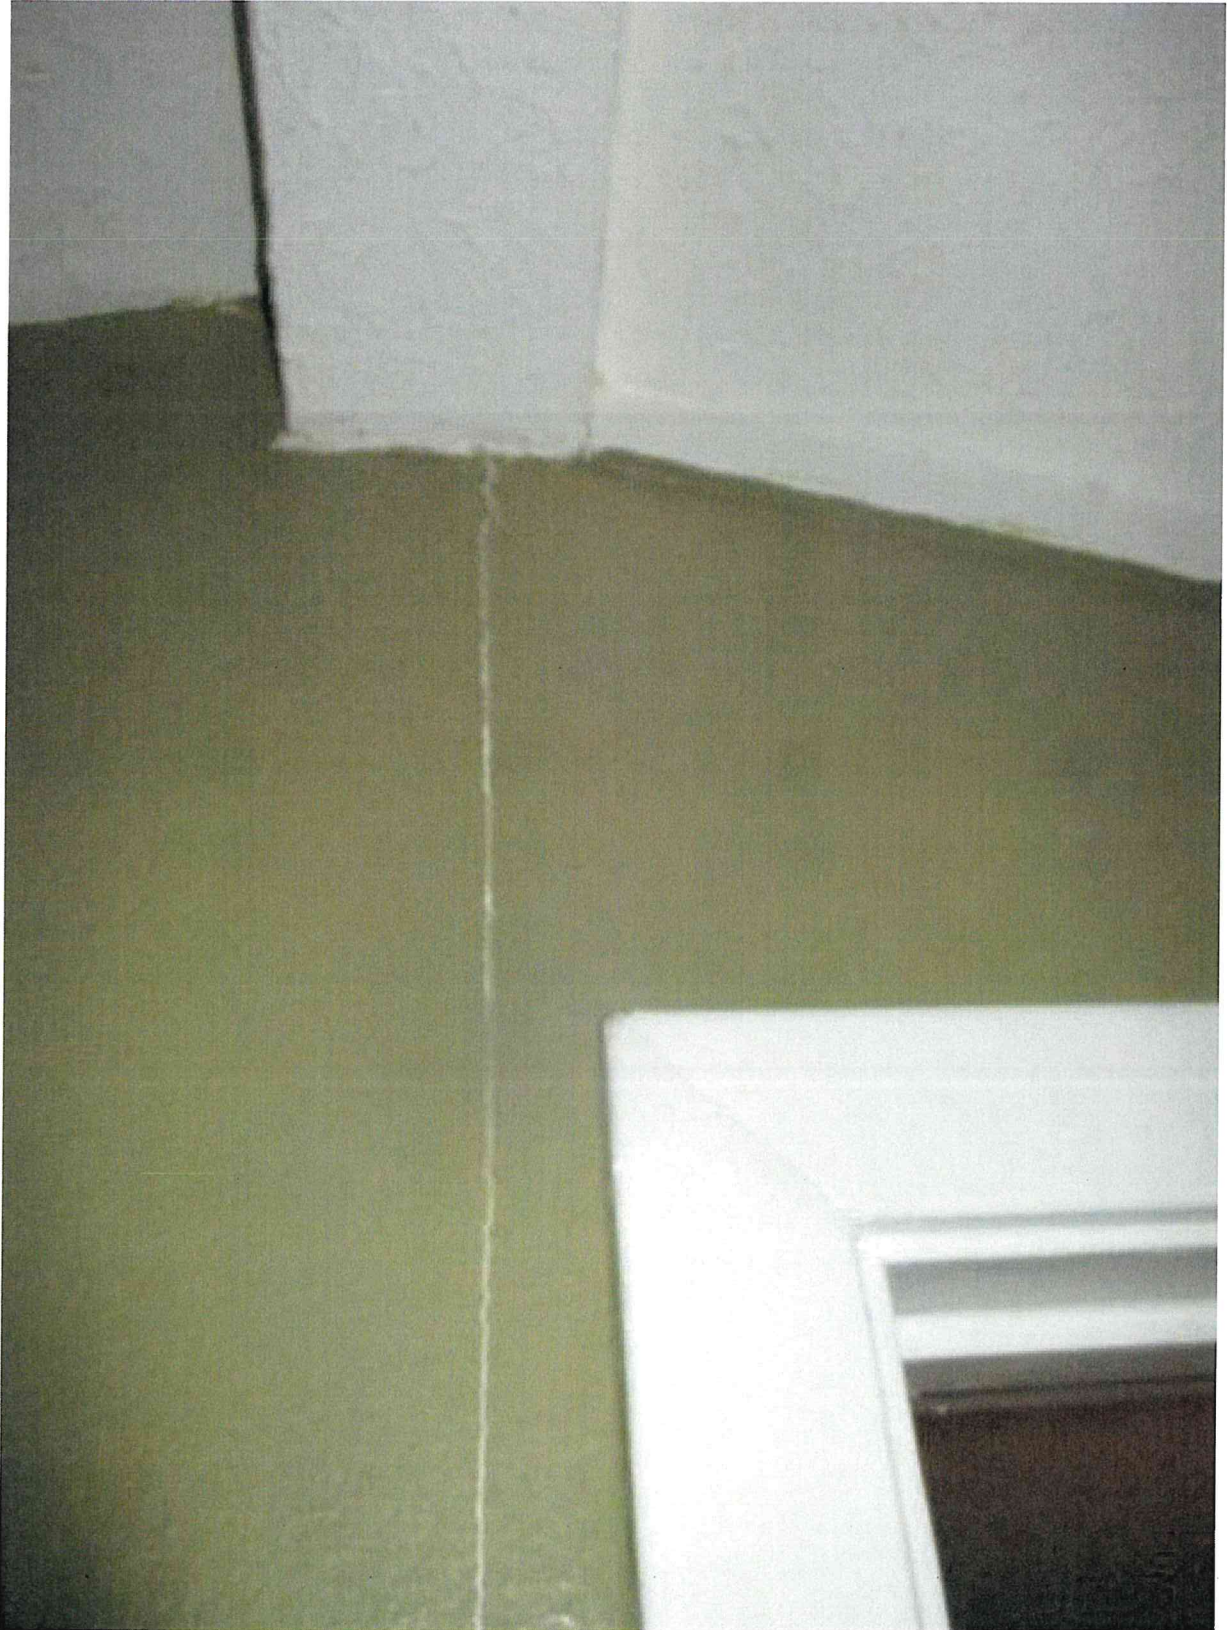
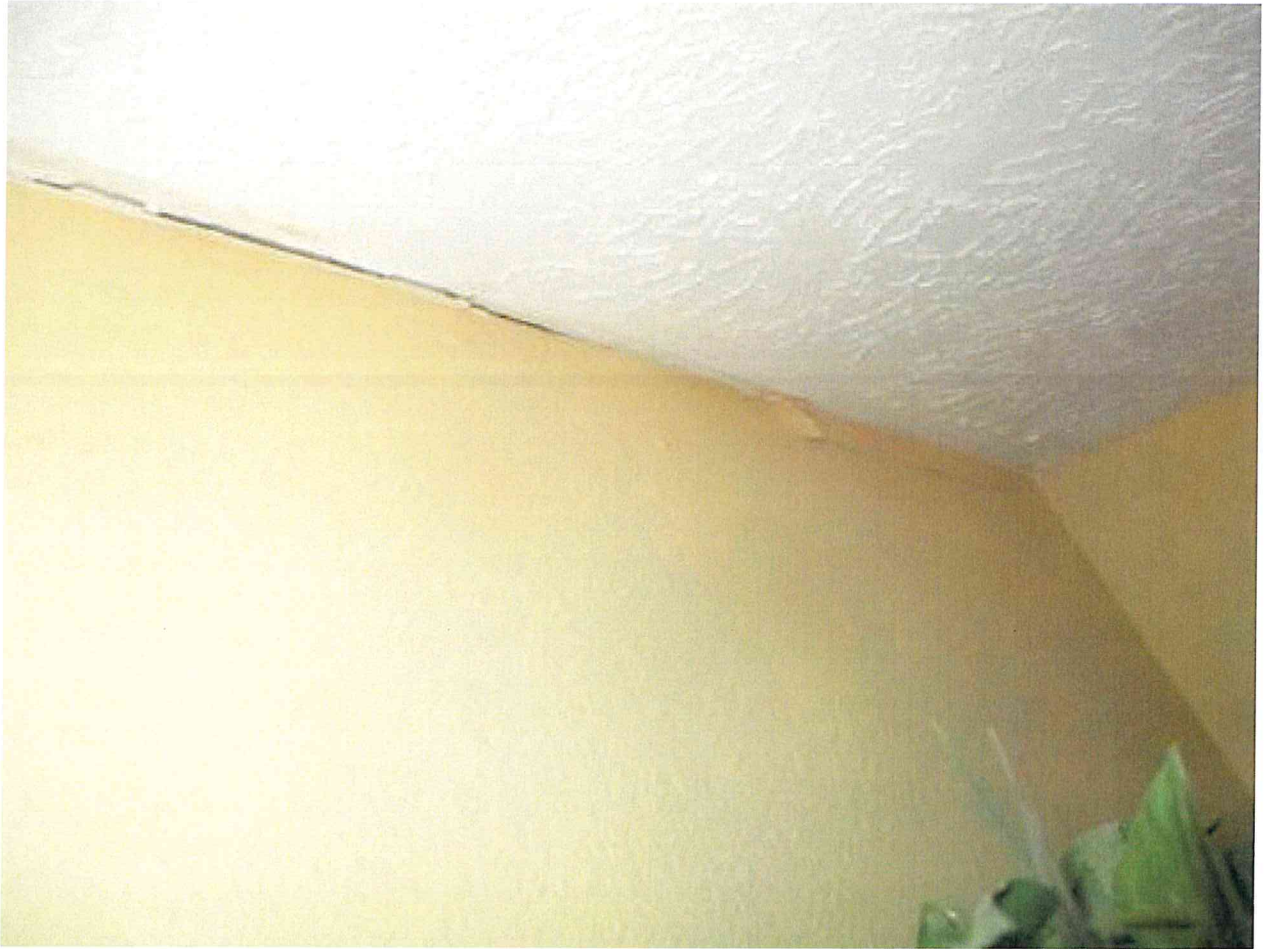
Note: Settling of the upstairs structure was evident with sheetrock separations and tape joint pulls (Picture 1&2). No evidence was detected of movement of the downstairs structure or evidence of differential movement of the foundation.

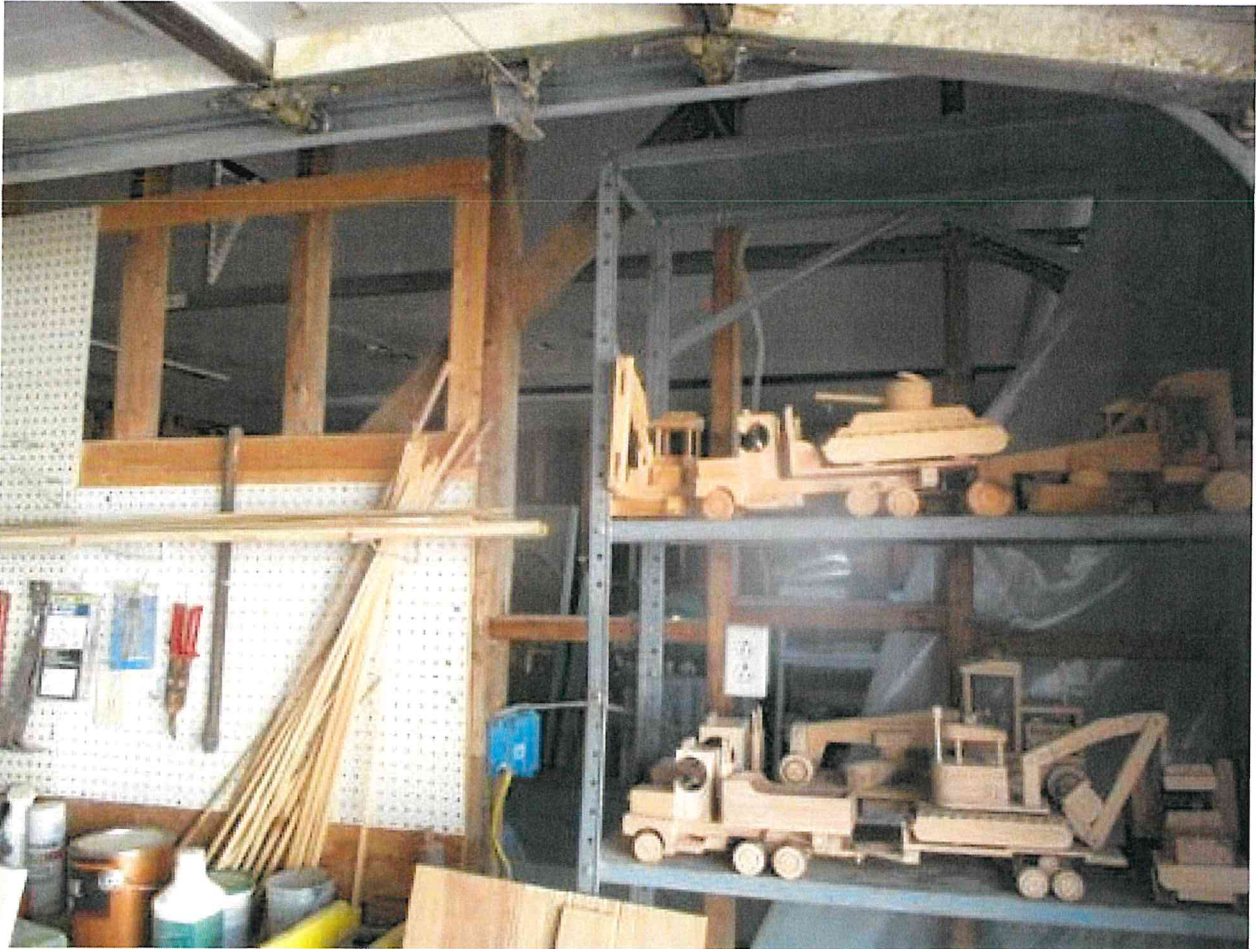
Picture 3

- 1 Walls: Separation wall between the garage and left townhouse garage was missing fire-stop material (Picture 3).
- 2 Other: Smoke detector will need to be installed and working in the sleeping room and hallways outside the sleeping rooms.

1. Walls: Separation wall between the garage and left townhouse garage was missing fire-stop material (Picture 3).

The separation wall is as-built upon initial construction of the structure. Seller was very recently told by a condo association board member that the association 'owns' all walls of the building, so the Seller should bring it to the attention of the association to be addressed, if needed. There is an upcoming board meeting this week of Oct 21st, where the Seller will raise the issue.

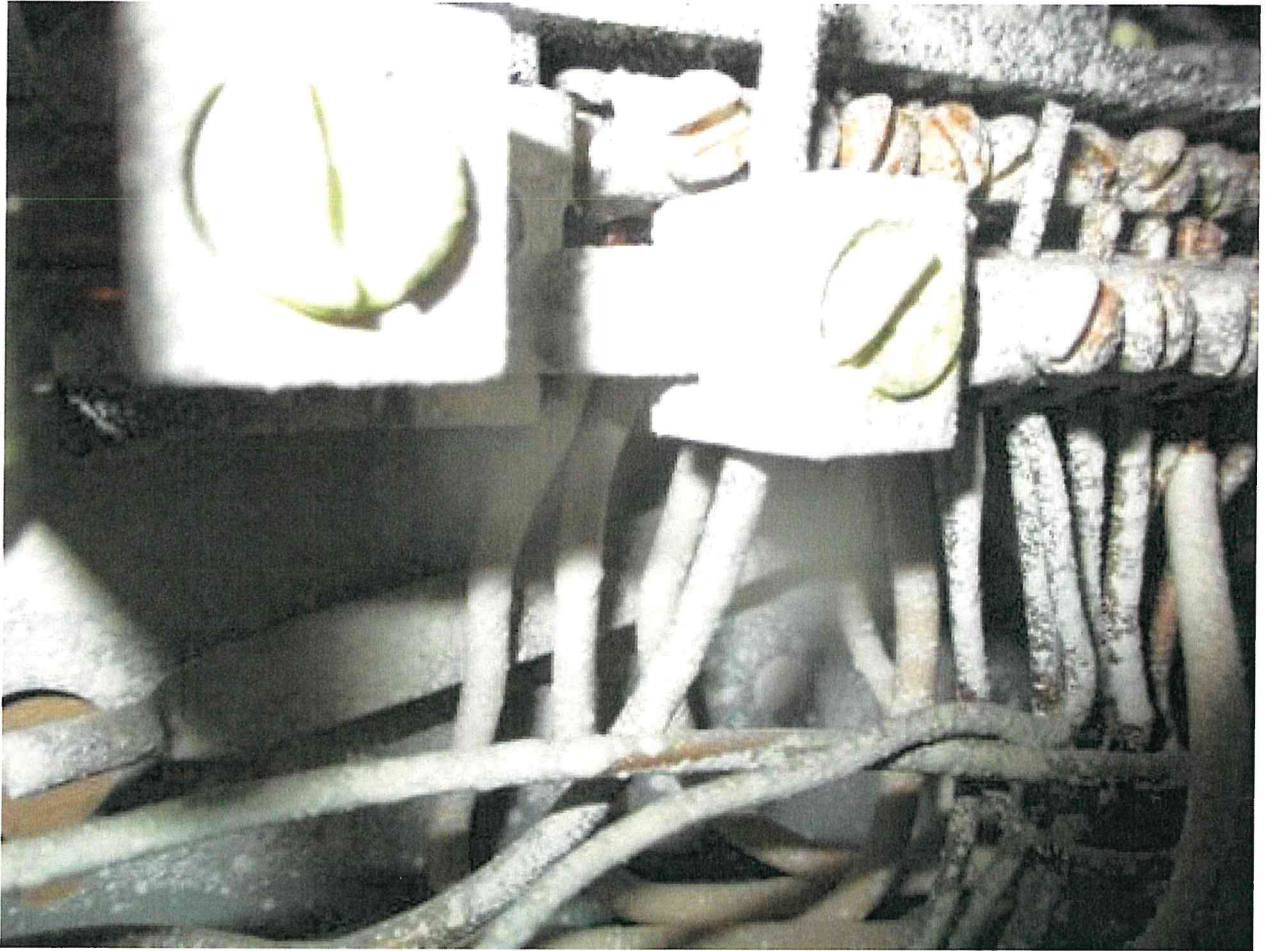
Picture 4

- 3 Service Entrance & Panel: White conductor wires on the 220 volt circuits will need to be flagged as a hot wire - red or black tape. Double tap wiring was detected on the neutral bus bar (Picture 4). Main disconnect on the right exterior of the complex will need to be identified for the unit.

(b) Double tap wiring was detected on the neutral bus bar (Picture 4).

It is not clear if this is legitimately a defect.

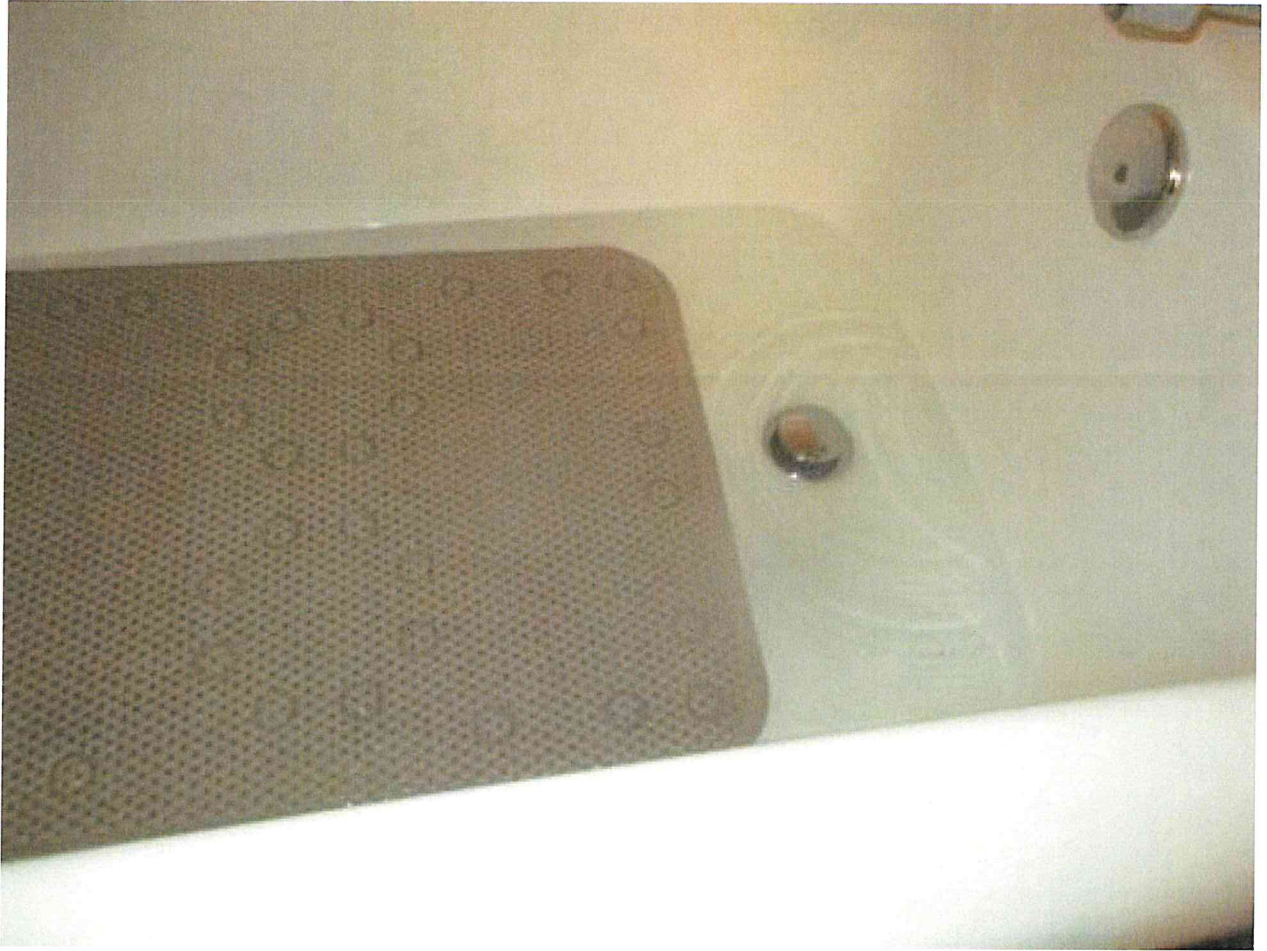
Picture 5

6. Drains, Wastes, Vents: Upstairs bath had tub slow to drain and will need debris cleared and retested (Picture 5).

Successfully cleared.

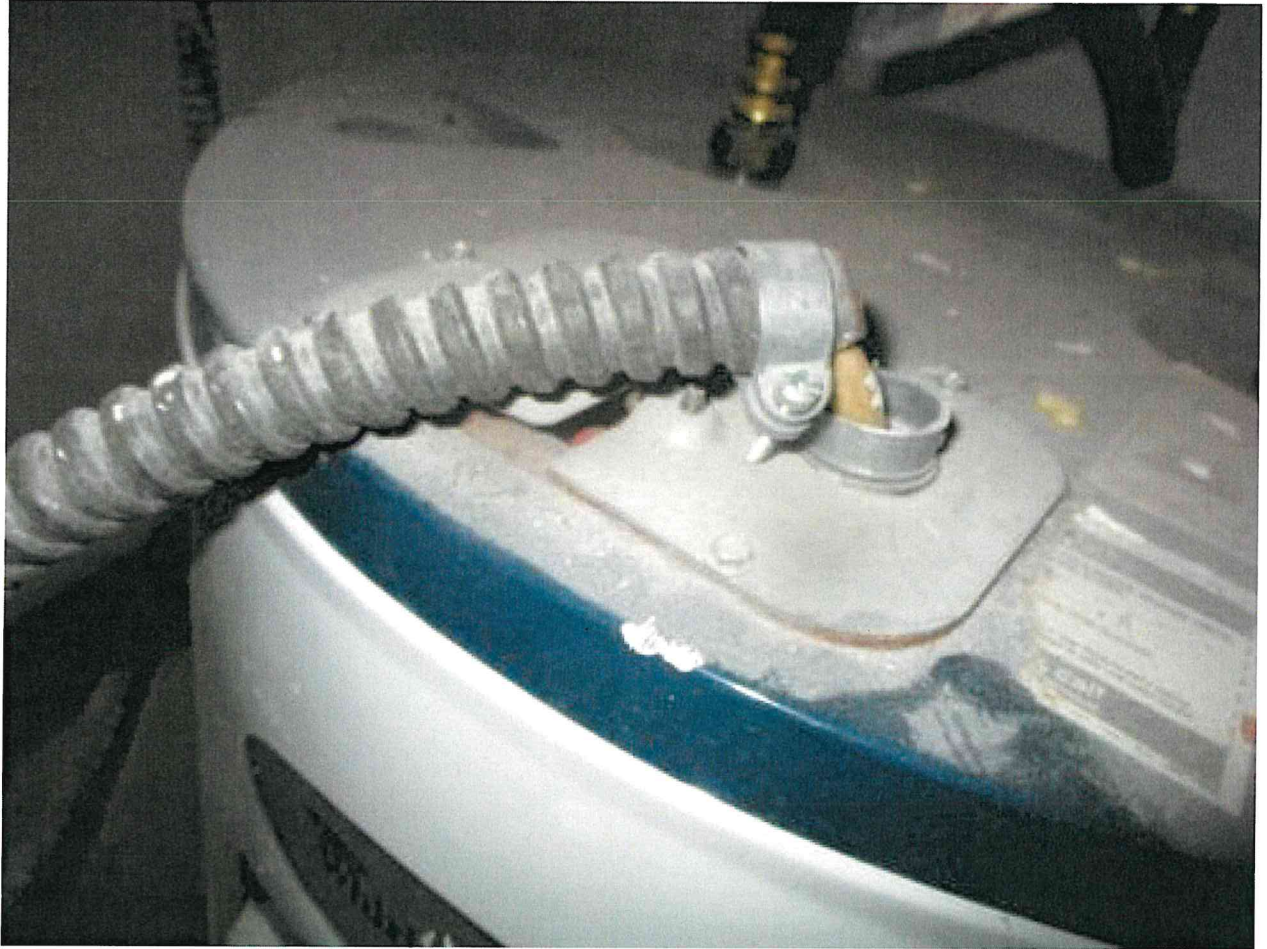
Picture 6

(a) Water heating equipment has electrical conduit not secured properly to the top section (Picture 6).

Problem corrected.

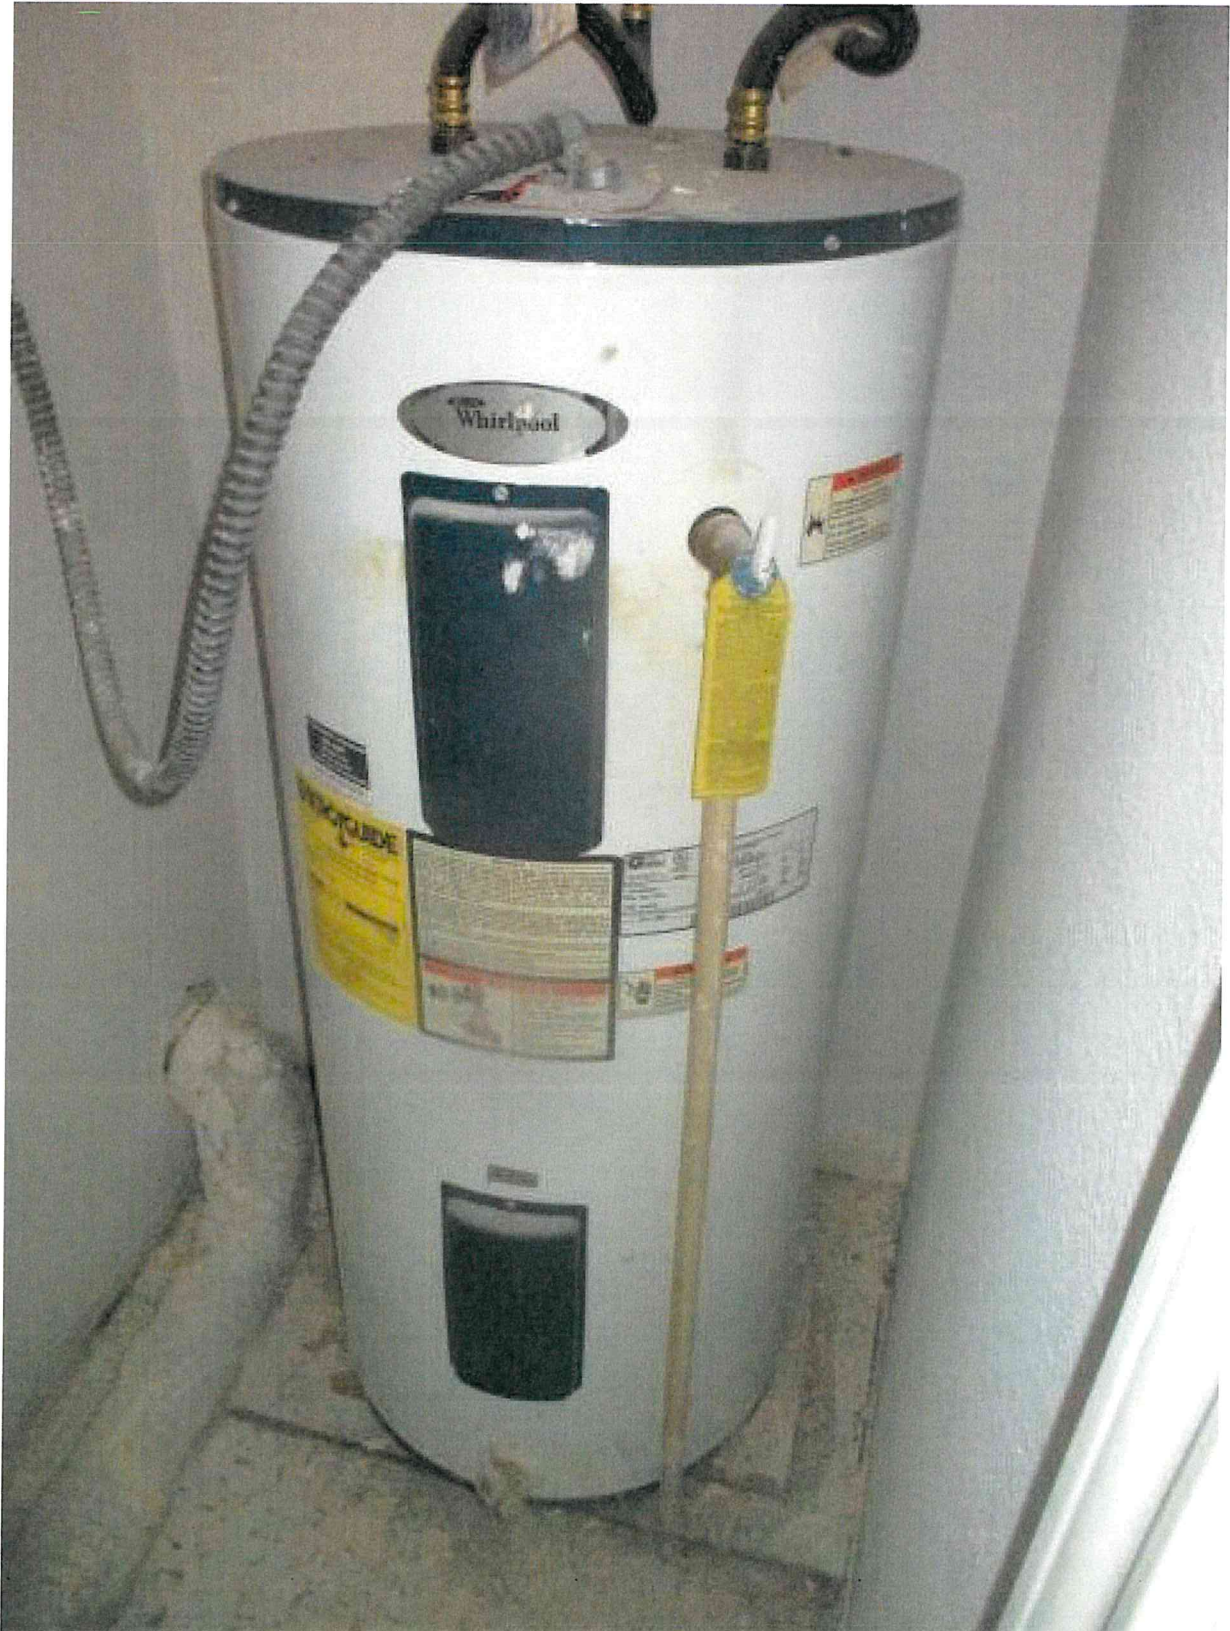
Picture 7

(b) Temperature/pressure relief valve is required to terminate to the exterior and catch pan with drain line to the exterior is required (Picture 7).

Not a defect. The inspector was not aware that the entire laundry room & water heater closet has a floor which is lower than the adjacent kitchen with a drain directly underneath the washing machine. There is no need for a water heater catch pan since any water released from the relief valve (or leaked from a broken washing machine) will safely drain away, as designed.
