# PROPERTY INSPECTION REPORT

**Concerning:** 4820 Milwee Street, Houston, TX 77092

**By:** David Gibbs, Lic #7406 TREC Professional Inspector

07/25/2019

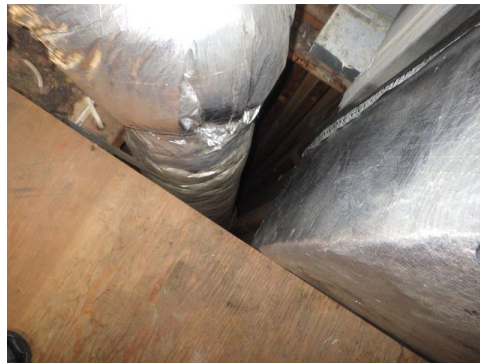
Observed an open chase in attic down to first floor for HVAC duct. These should be sealed to slow the spread of fire as required according to today's standards (Ref: IRC 302.1.1 Fireblocking). Sealing the chase with fiberglass insulation will also insulate exposed wall surfaces visible below. We recommend repair as necessary.

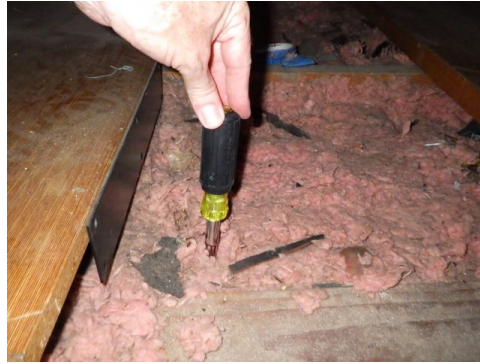
Attic insulation was missing in some areas. Overall, coverage was inadequate according to today's standards. As an energy conservation upgrade we recommend that additional insulation be installed to meet current industry standards for comfort and energy efficiency.

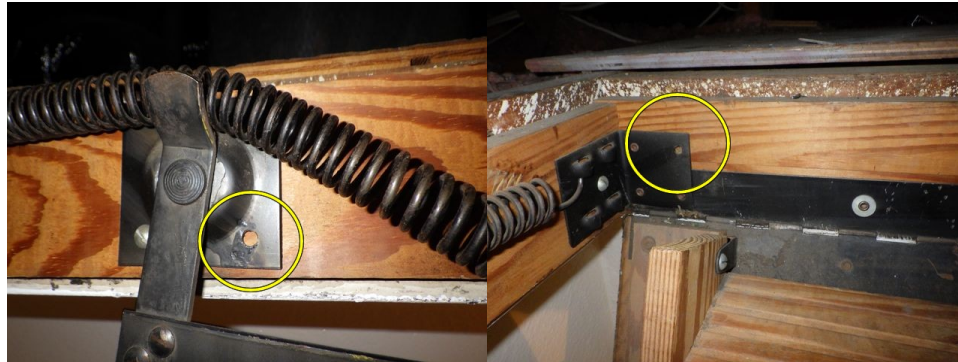
**Observed attic access stairway hinges were not properly nailed to attic framing. This may pose a hazard as stair frame may separate from ceiling framing. We recommend installing heavy nails or bolts according to manufacturer's specifications.**

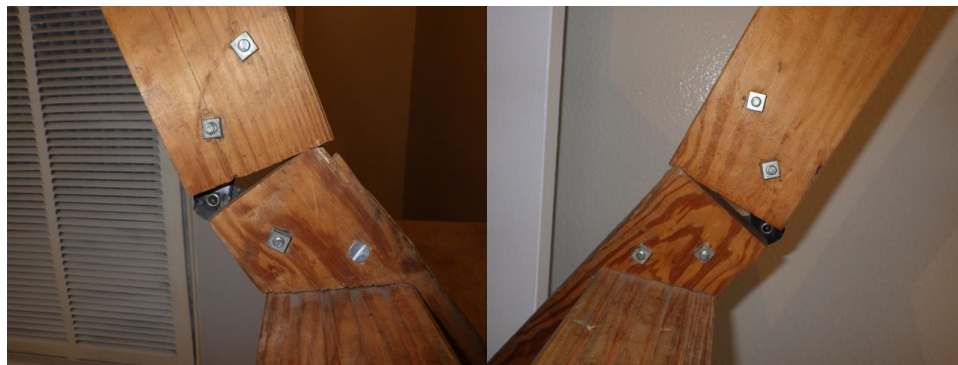
**The attic access stairway had significant gaps at joints that create additional stress and can reduce weight bearing capacity. This may be caused by wear, minor damage and loose hardware. We recommend repair or replace as necessary.**

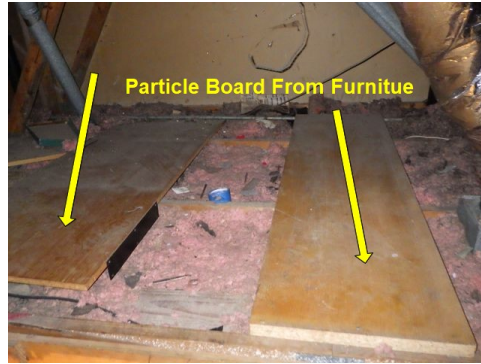
**Some attic floor decking was not adequately secured / supported or decking is not rated for use as flooring. This creates a hazard as flooring may move or collapse. We recommend secure or replace with approved floor decking as necessary.**

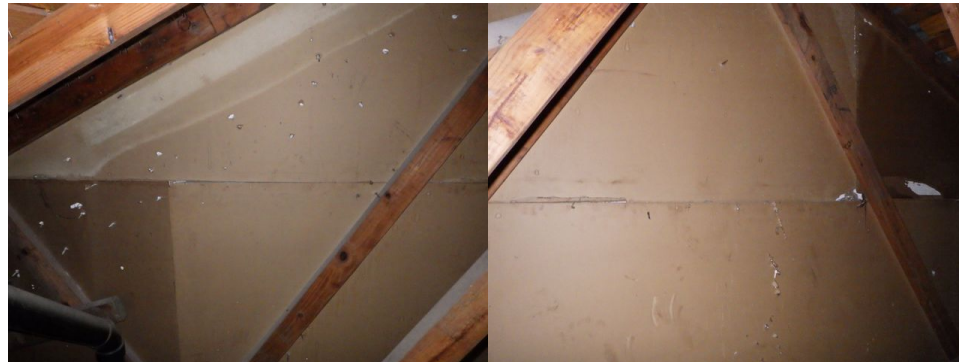
Sheetrock fire resistant wall at right side was not taped and floated in attic. This may have been allowed at the time of construction, but for enhanced safety, we recommend tape and float of seams to slow spread of fire between units as required according to today's standards.

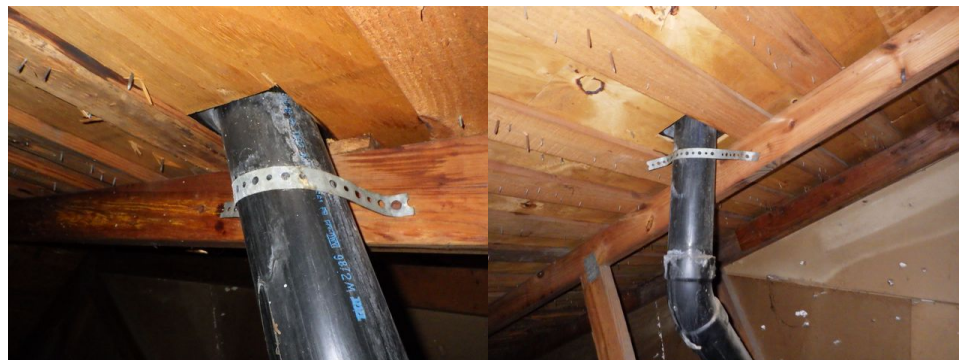
Water stains were observed in attic at plumbing vents. We recommend seal vents above roof. (See related comment - roof flashings in in Structural Systems - Other).

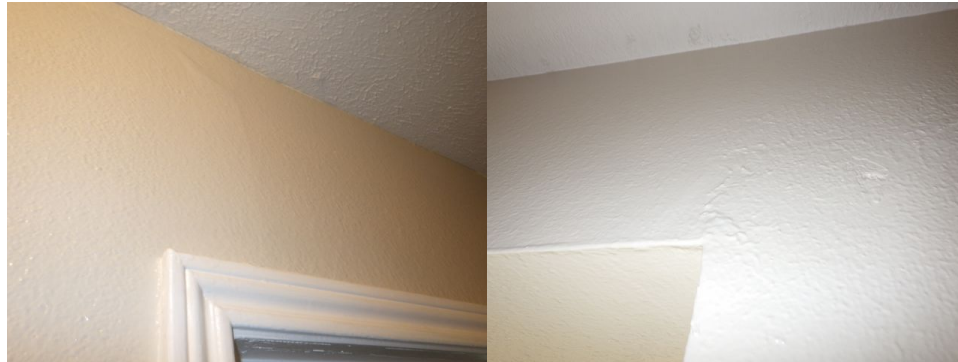
Previous repairs were observed to drywall cracks at corners of doors and windows. This is typically an indication of movement in the structure. The crack may return as movement may recur. We recommend monitor for changes and take action as necessary.

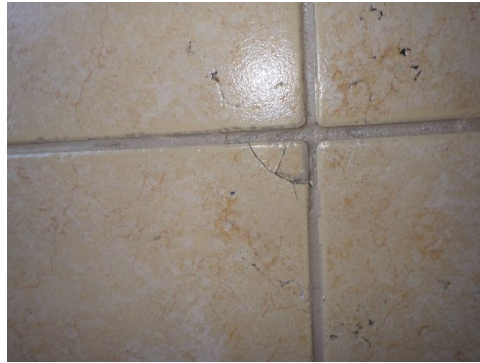
Observed floor tile cracked in breakfast area. Repair for cosmetic reasons only are recommended at this time.

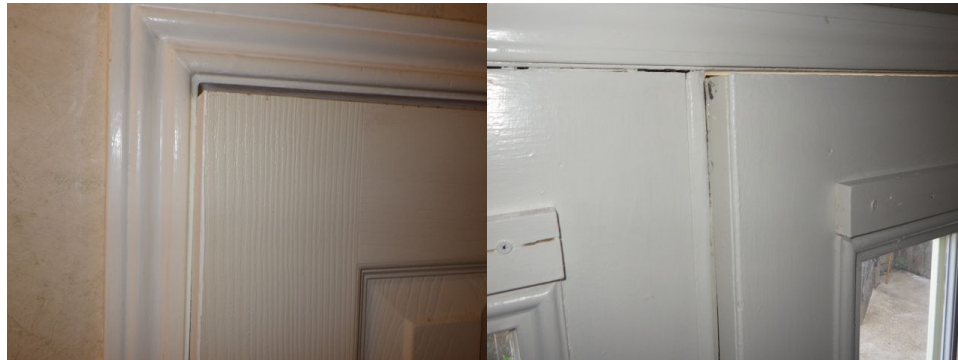
One or more interior doors was not square in jamb, but still operated properly. This may be an indication of foundation movement.

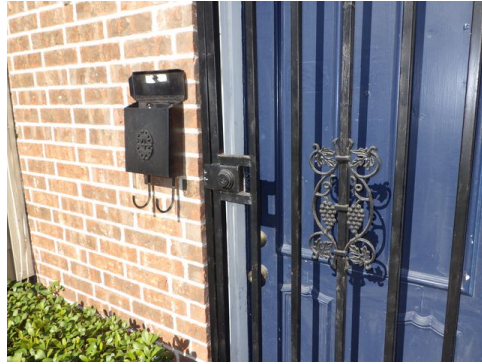
**The dead bolt on front and rear exterior doors were the type that requires a key to operate from inside. This may provide more security but can be hazardous in the event of a fire. We recommend replace dead bolt(s) with the type that can be opened from inside without a key. (Ref: IRC R311.2)**

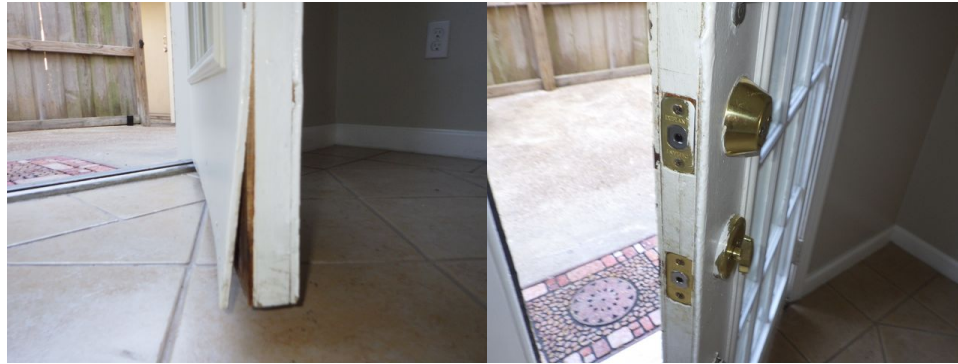
The back door was delaminated and had other minor damage. We recommend it be repaired / sealed to extend service life and prevent water penetration. The door latch was missing / removed (only had dead bolt).

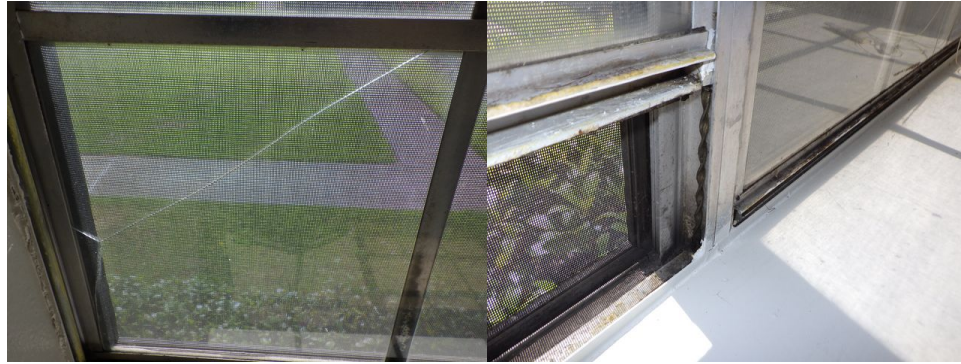
Cracked glass was observed in a living room window. We recommend all broken and/or cracked glass be replaced. The springs clips (lift mechanisms) have come loose on same window. This means it may not stay up when opened. We recommend repair as necessary.

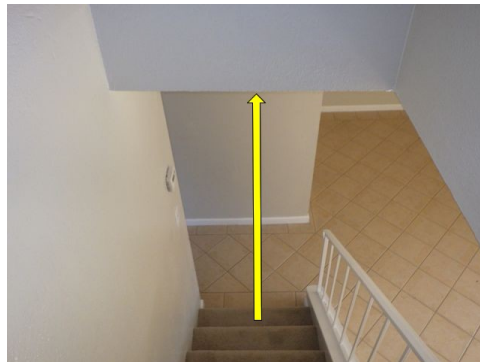
Observed inadequate headroom clearance according to today's standards. Minimum height should be 6'8". This was likely allowed at the time of construction. We recommend we recommend alteration if possible, but if not practical, use caution when going down stairs.

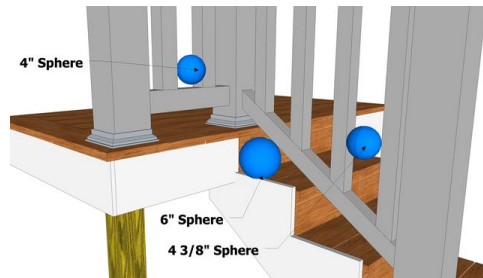
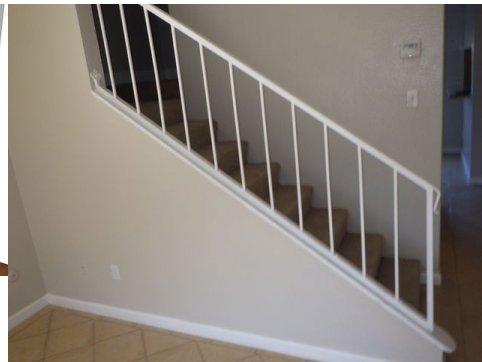
**The spaces between stairway guardrail balusters were too large. Spacing between balusters must not allow passage of an object 4" in diameter for child safety. This may have been allowed at the time of construction, but for enhanced safety, we recommend alteration if possible. (Ref: IRC 312.2)**

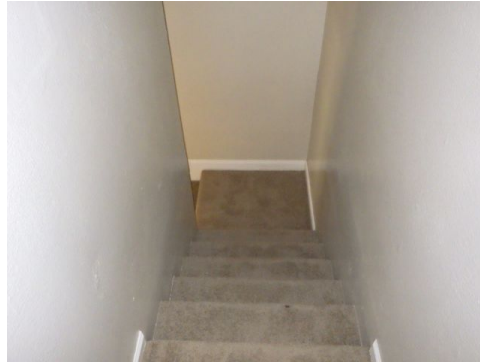
**Observed upper stairway was missing handrail. Stairs having 4 or more risers should have a handrail for safety according to today's standards. We recommend install as required according to today's standards.**

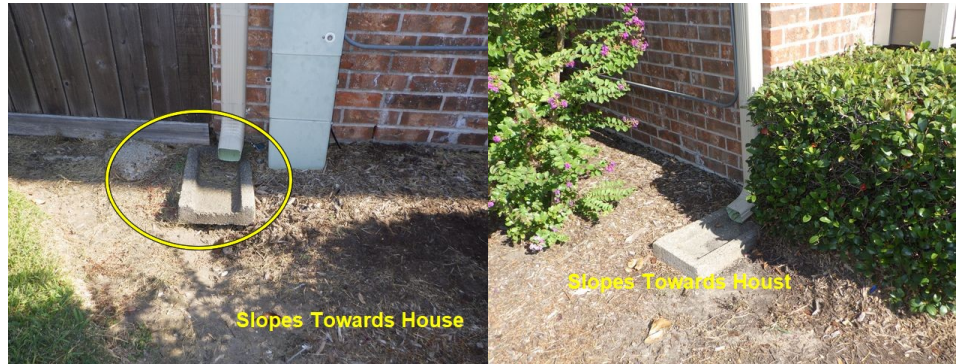
Soil grading had inadequate or negative slope in one or more areas and did not appear to properly direct runoff water away from foundation as required according to today's standards (6" drop in 10' Ref: IRC 401.3). This may promote water penetration, adversely affect the foundation and cause differential settlement. We recommend repair as necessary.

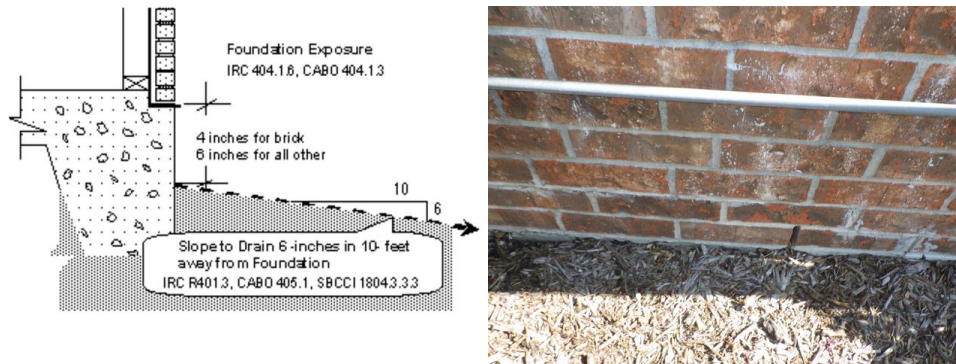
The soil level was too high in some areas. Common industry practice requires a clearance of at least 4 inches between grade level and siding or masonry veneer. High soil level promotes water penetration / wood rot and is considered a conducive condition to termite activity.

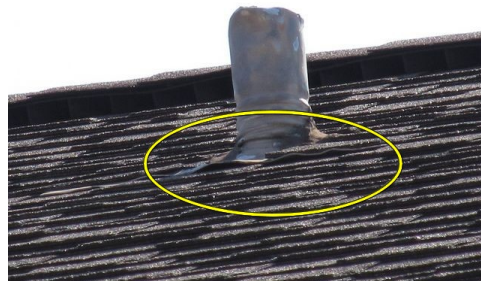
Observed lower edge of some plumbing vent flashings were lifted or not sealed down. Wind driven rains can cause water penetration. We recommend repair or replace as necessary.

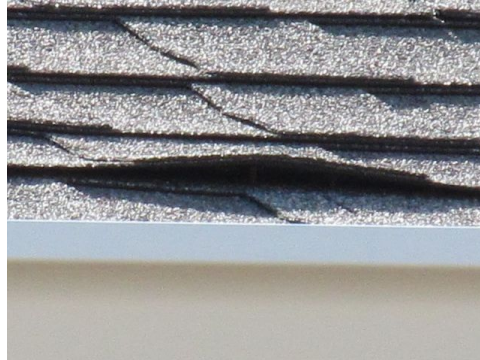
Observed shingle loose at lower edge in rear due to improper fastener installation, nails not driven to right depth. Loose shingles are more likely to be damaged in a windstorm

and in time, nail heads will puncture shingles leaving holes. We recommend repair/secure as necessary to prevent damage and water penetration.

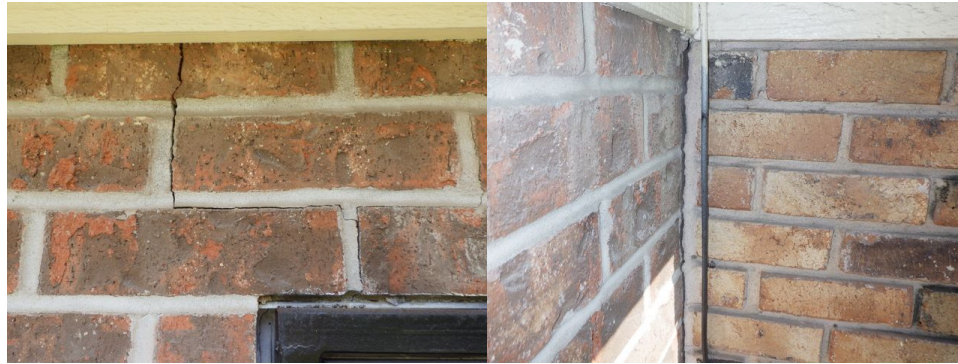
Observed brick / mortar cracks or previous repairs in masonry veneer at one or more areas. Typically these types of cracks are a result of movement in the structure. Repair of the cracks for a better appearance would be considered optional. We recommend sealing cracks to prevent water penetration and monitor for changes that may indicate movement.

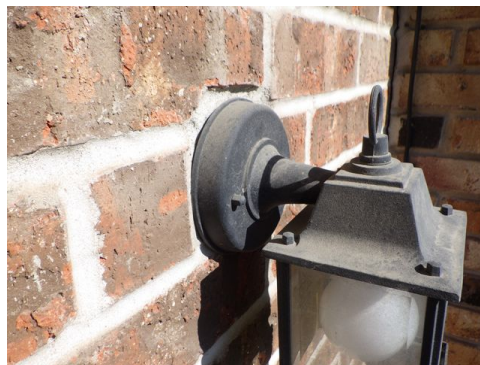
Observed caulking missing or deficient around wall penetrations in one or more areas. We recommend all wall gaps for trim / vents / plumbing / electrical etc, be caulked to prevent water penetration.

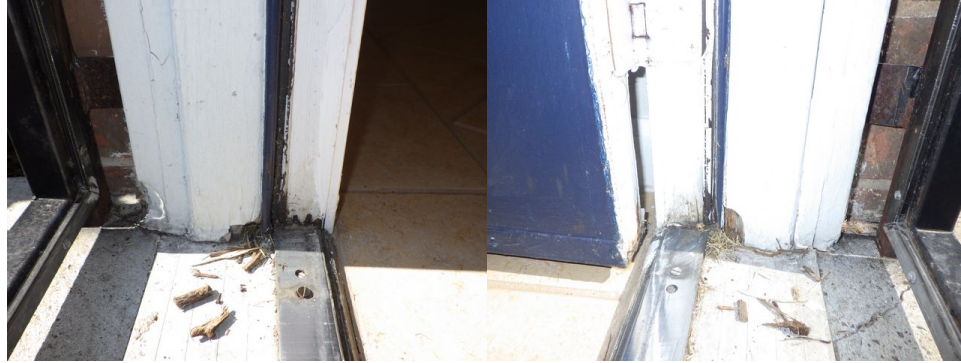
One or more sections of the wood trim was deteriorated. We recommend repair as necessary.

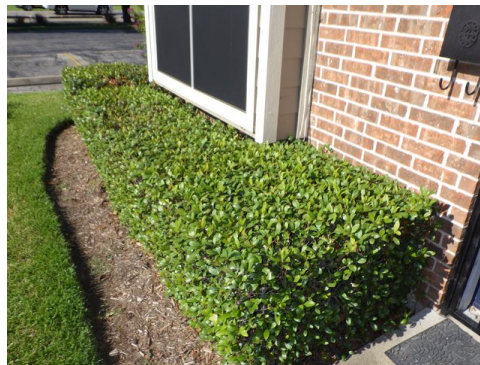
Vegetation was observed in contact with exterior walls in one or more areas. Vegetation contacting walls attracts insects and increases moisture levels. We recommend trim away from walls. Walls concealed by dense vegetation are considered inaccessible and conditions in need of repair may be discovered once the vegetation is trimmed or removed.

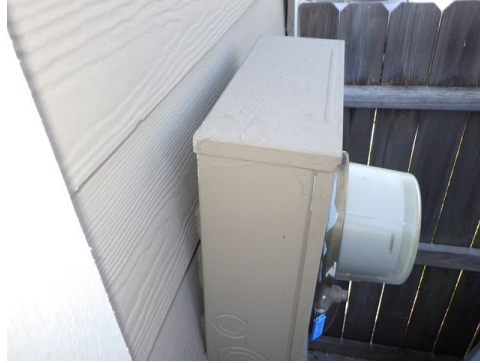
**Observed electric service meter loose, not secured to wall. This is a potential shock**

or fire hazard and can result in feeder wires becoming disconnected. We recommend repair as necessary.

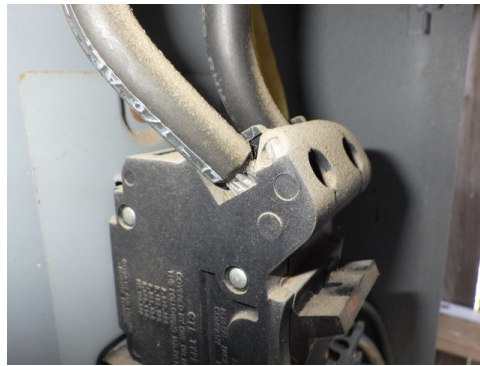
There was no anti-oxidant compound (grease) on the exposed aluminum feeder wire connections as required by TREC and many manufacturers. Antioxidant is applied to aluminum connections according to manufacturer's recommendations to prevent oxidation, electrical resistance and heat. We recommend apply antioxidant as necessary.

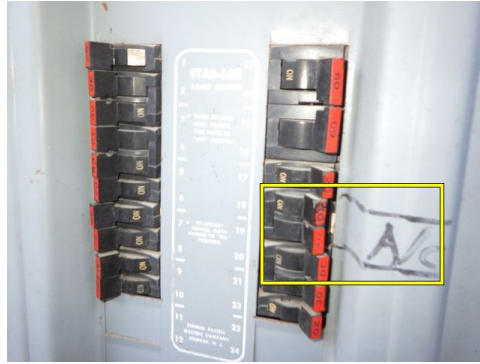
**The electric service (breaker) panel was manufactured by Federal Pacific. The equipment produced by this company has been associated with product defects and failure of their 120-volt and 240-volt overcurrent protection devices. Federal Pacific equipment is considered as unreliable and potentially dangerous, also the panel appears to be original equipment and is past it's expected service life of about 30 years. Although we observed no evidence of a failure of the breakers, we cannot guarantee their future performance. We recommend replace panel.**

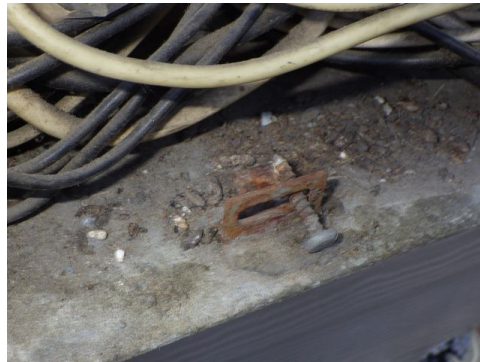
One or more electrical panel cover screws were observed to be the wrong type with sharp points. We recommend replace with the correct blunt ended screws. (Sharp / pointed ends can penetrate live electrical wiring behind dead front and cause shock.)

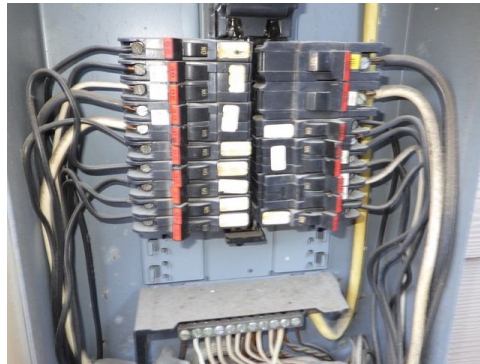
Observed improper wire colors in electric service panel. This can be hazardous for service personnel. Breakers (hot) conductors should only be black / red, Neutral are white, grounding are bare. We recommend use caution when working in panel and mark wires inside panel when possible.

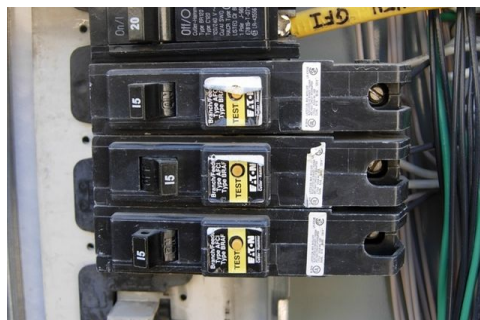
Did not observe AFCI (Arc Fault Circuit Interrupt) device protection as required by current building standards for all: family rooms, dining rooms, living rooms, parlors, libraries, dens, bedrooms, sunrooms, recreations rooms, closets, hallways, or similar rooms or areas (Ref: IRC E3902.11). AFCI devices are intended to protect against fires caused by electrical arcing faults in the home's wiring. Arc faults are a common cause of residential electrical fires. Arc faults can be created by damaged, deteriorated, or worn electrical plugs, cords, and/or branch circuit conductors. This was not required at the time of construction, but for enhanced safety, we recommend upgrading.

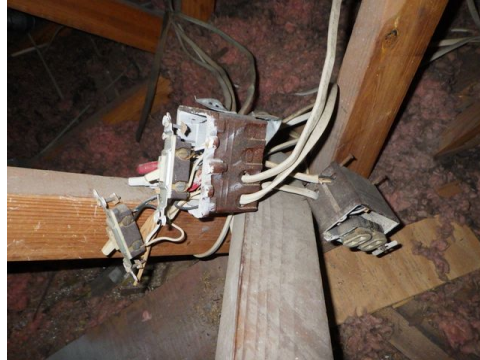
**There were switches and outlets loose / not enclosed in junction box in attic. We recommend these be installed and covered as required according to today's standards to prevent shock and/or fire hazard.**

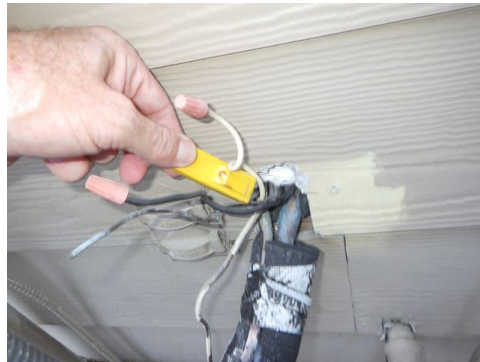
**Observed wire improperly terminated / abandoned at rear exterior. We recommend disconnect wire from source and remove if no longer in use, or cap and enclose in an approved junction box to prevent possible shock and/or fire hazard.**

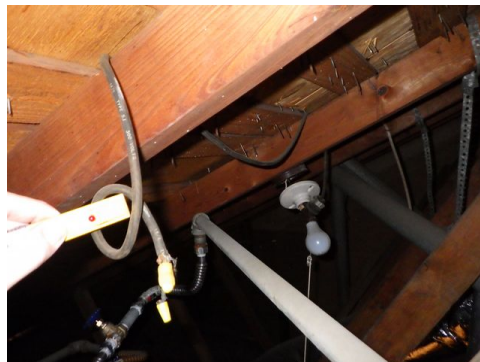
**Observed extension cord wiring was observed used improperly as permanent wiring in attic. Cord was run improperly between roof decking and rafters where it can be damaged / punctured from a roofer's nail and cause a fire or electrical short. We recommend removal.**

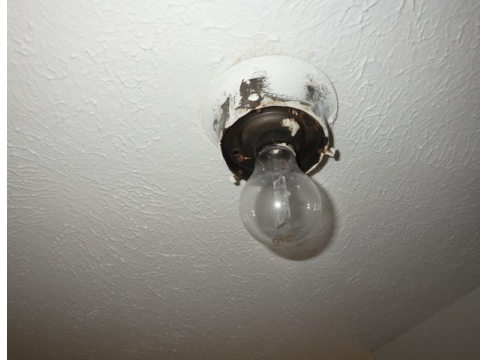
**Observed one or more lights has light diffuser / globe missing. We recommend replace.**

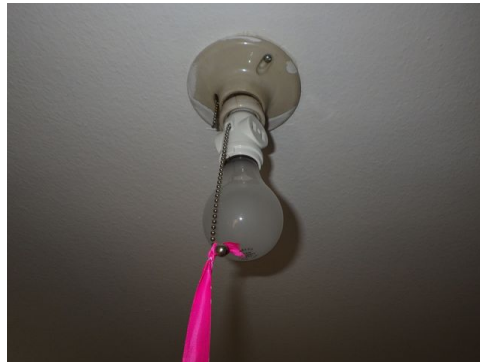
Observed one or more open incandescent type light fixtures in closet which is considered a potential fire hazard by today's standards. We recommend replace bulb (LED or CFL) or fixture with approved type.

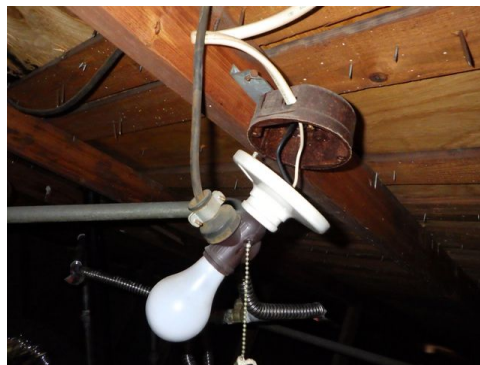
**The attic light was loose, leaving exposed wiring. We recommend repair or replace as necessary to prevent possible shock and/or fire hazard.**

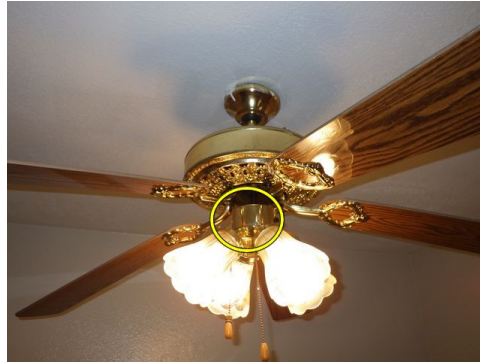
The living room ceiling fan was not working. The pull-chain speed switch was loose. We recommend repair or replace as necessary.

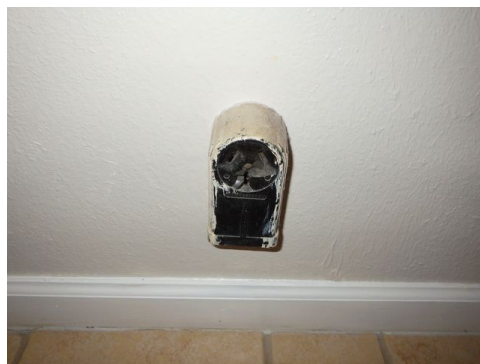
The power supply receptacle for clothes dryer is the older 3-prong type. Newer dryers with 4-prong plug will need to have cord replaced in order to operate.

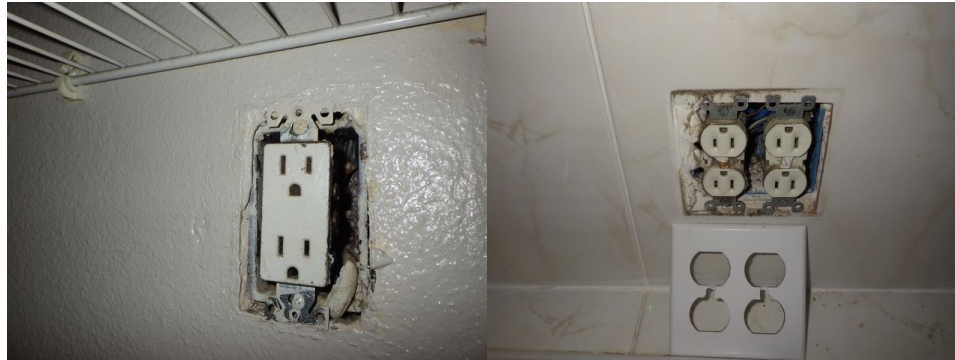
**Observed outlet cover plate in laundry room and master bathroom was missing / damaged. This is a possible shock hazard. We recommend replace any missing or damaged covers.**

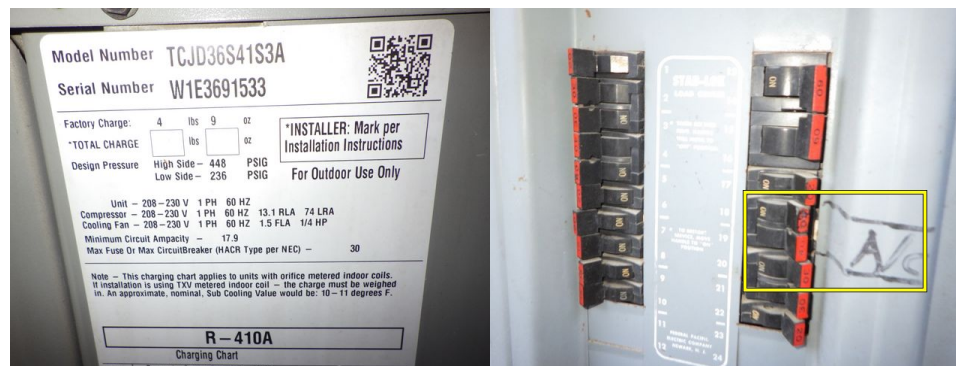
We found breaker for the air conditioning condensing unit (40 amps) is greater than maximum allowed, noted on the unit's data plate (30 amps). In overload situation, this could damage unit and/or void warranty. We recommend the circuit be equipped with an overcurrent device rated for the present unit.

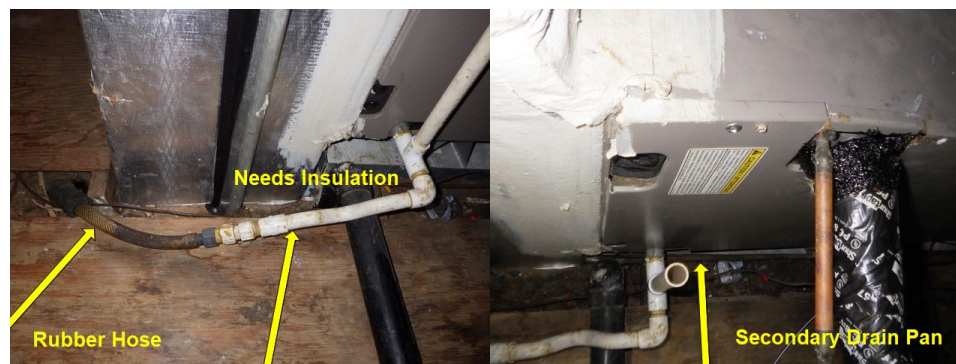
Observed evaporator coil primary drain line was improper / unapproved material (rubber hose). this may promote leakage. We recommend replace with approved material (PVC) as required according to today's standards. The primary drain line was not insulated near evaporator coil. We recommend insulating the primary condensate drain along entire length in attic to prevent condensation dripping from outside of pipe onto attic/interior surfaces. The secondary drain pan was not properly positioned below evaporator coil to catch drips. We recommend adjust pan.

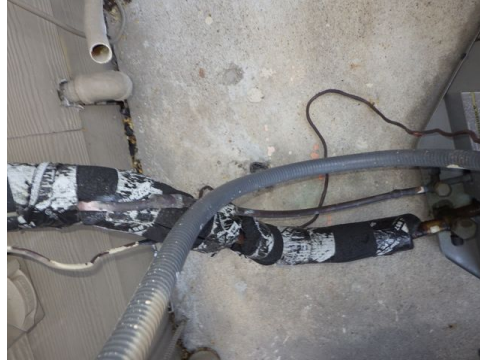
Observed gaps in insulation of air conditioning refrigerant lines at the condensing unit. We recommend that all missing insulation be replaced to increase energy efficiency and reduce condensation from dripping off of tubes.

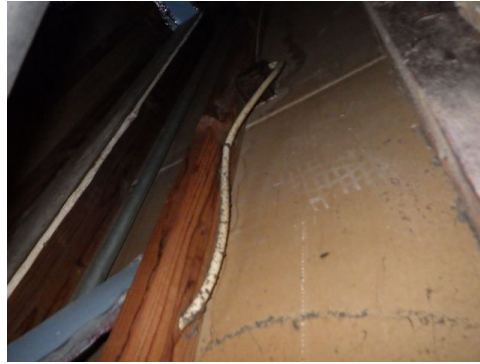
Observed 120 volt electrical wiring improperly located in return air chase. According to today's standards (code) 120 volt wiring should not be located in, or pass through chases to minimize potential fire hazard. We recommend repair as necessary.

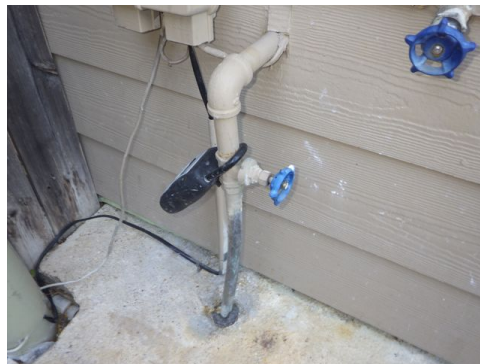
Insulation was missing from some attic and/or exterior water supply pipe. We recommend insulate where exposed to prevent freeze damage as required according to today's standards (Ref: IRC P2603.5).

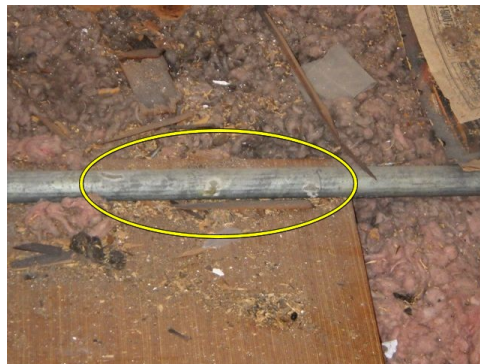
A water supply line at left side of attic over bathrooms appeared corroded indicating possible future leakage. We recommend monitor for leakage and repair as necessary.

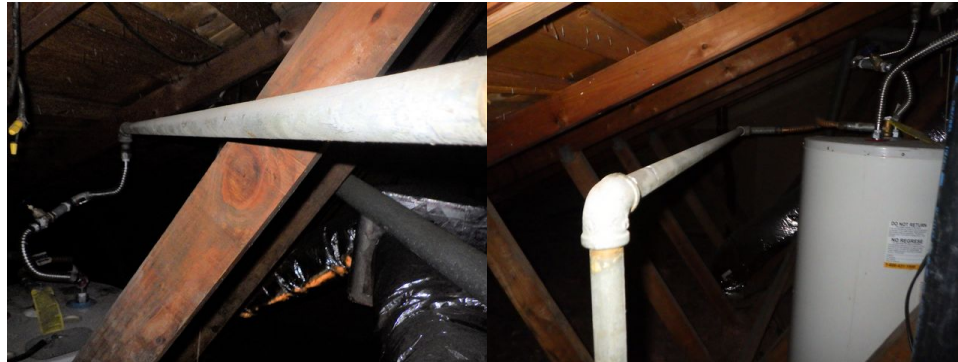
Observed horizontal water supply lines to water heater were not sufficiently supported. This can cause the lines to make noise, or possibly sag and cause joints to leak. We recommend the supply lines be supported as required according to today's standards(Ref: IRC P2605.1).

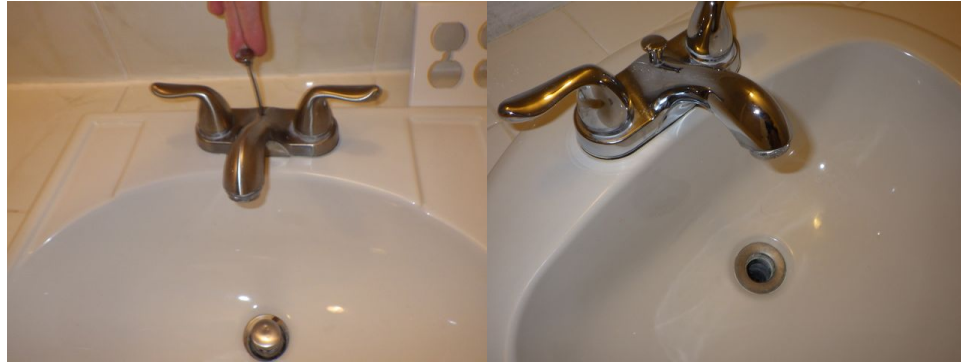
Both upstairs bathroom sink drain stops were missing or inoperative. We recommend repair or replace.

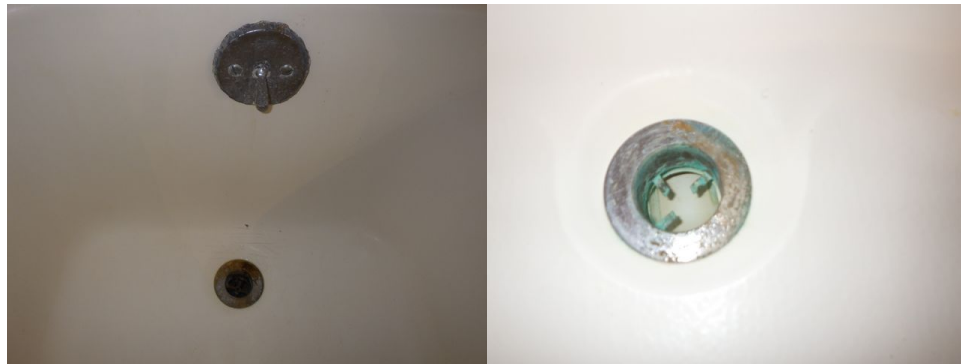
Both bathtub drain stops were missing or inoperative. We recommend repair or replace as necessary.

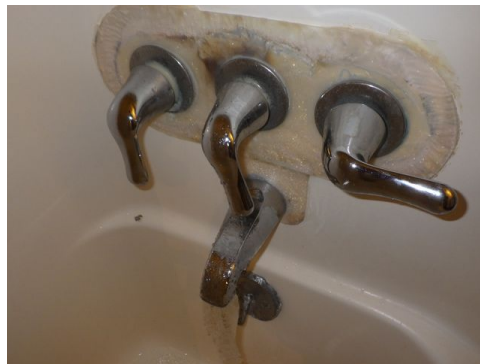
The shower diverter faucet handle in back bathroom did not hit an off stop but instead spins making it difficult to completely turn off the water. We recommend repair or replace as necessary.

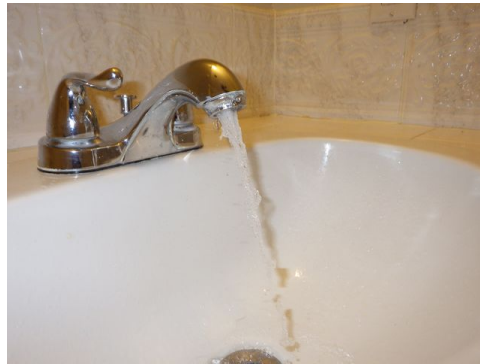
Observed low water pressure at back bathroom sink faucet. We recommend repair or replace as necessary.

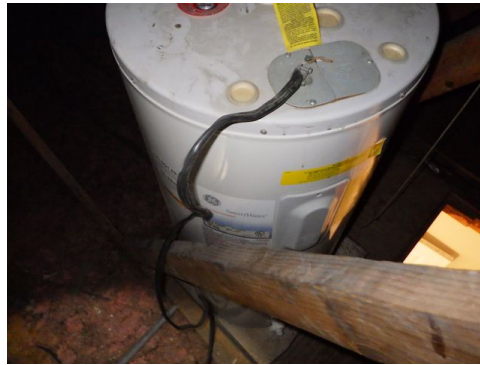
There was no electrical disconnect with in sight of water heater for protection of personnel servicing unit as required according to today's standards. We recommend install disconnect to minimize shock hazard.
