August 2, 2019

# PROPERTY INSPECTION REPORT

Concerning: 35 Penway St., Houston, TX 77022  
(Address or Other Identification of Inspected Property)

By: Edgar Gonzalez, Lic #TREC #5782 08/02/2019  
(Name and License Number of Inspector) (Date)

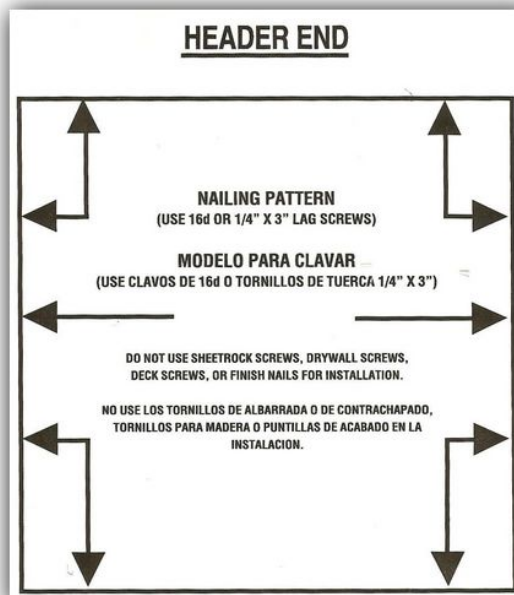
- **Note:** The hatch door is not insulated at this time. This is an "As Built" condition that does not meet current energy standards. It is recommended to insulate the hatch door / opening after taking position / ownership of the property.
- The attic ladder was observed to be installed with improper fasteners. The attic ladder should be secured in place with 16d nails or 3-inch lag bolts. This condition should be further evaluated and corrected as necessary.

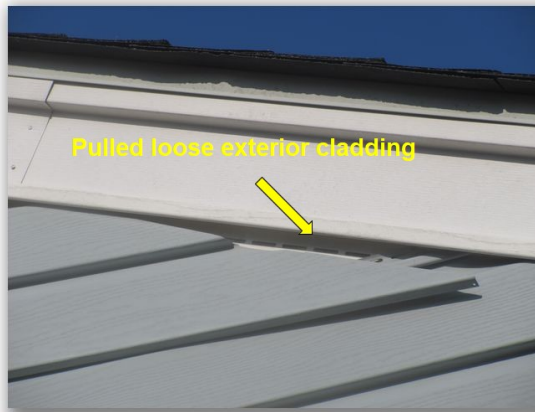
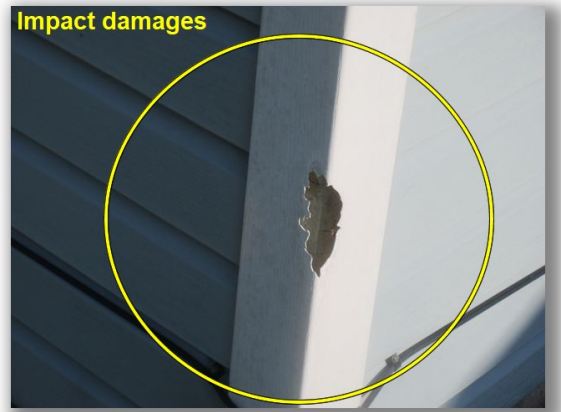
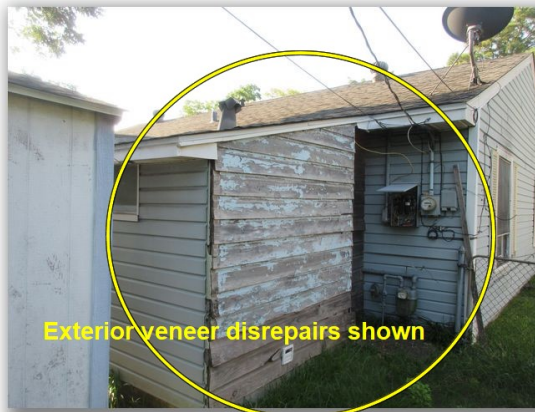
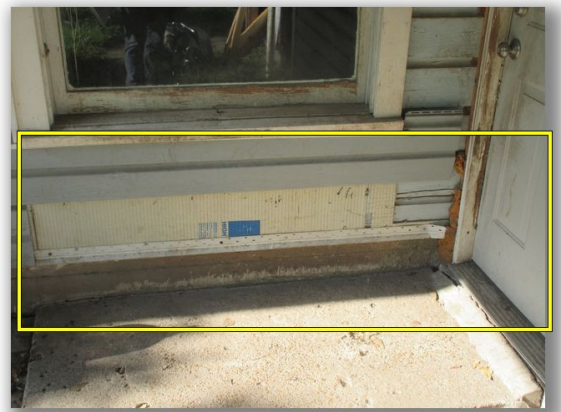
Inspector observed some considerable exterior cladding disrepair's with the most significant degree of damages noted at the rear substandard building addition construction. Further evaluations and repairs will be needed.

- The exterior veneer / cladding was observed to be pulling loose and needs to be better secured on the east side of the structure.
- The exterior wood window casing and/or sill has some deterioration and/or damage at various locations of the structure. Further evaluations and repairs needed to prevent further water intrusions and/or related structural damages.
- The area between the exterior cladding / veneer and all of the wall penetrations / openings need to be properly sealed. Areas such as utility connections, downspout's, hose bibs, lighting fixtures, receptacles etc. It is recommended to use an elastomeric caulking / sealant.

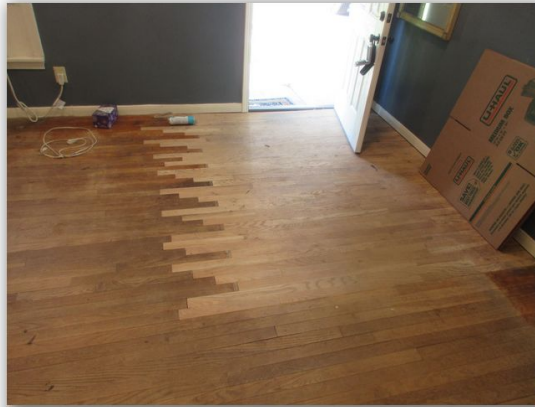
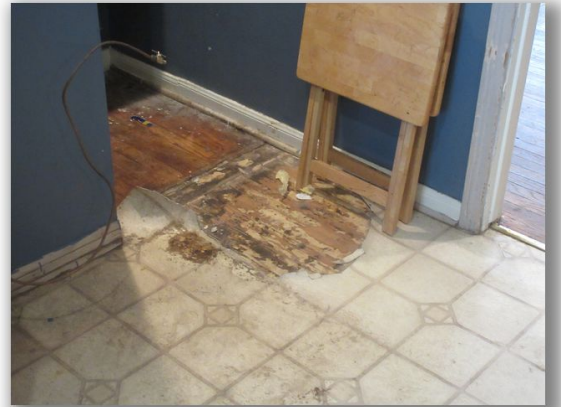
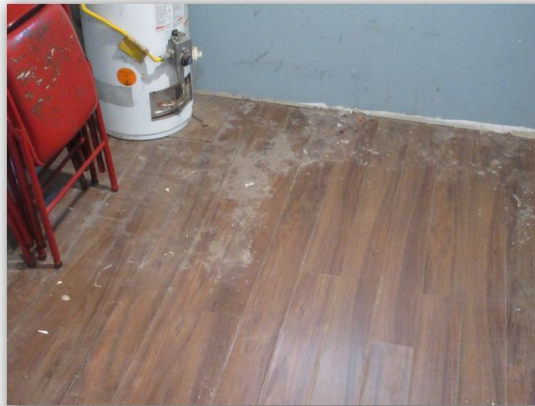
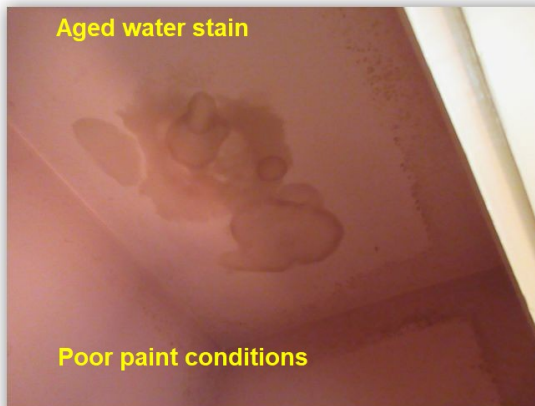
**Poor flooring conditions shown above.**

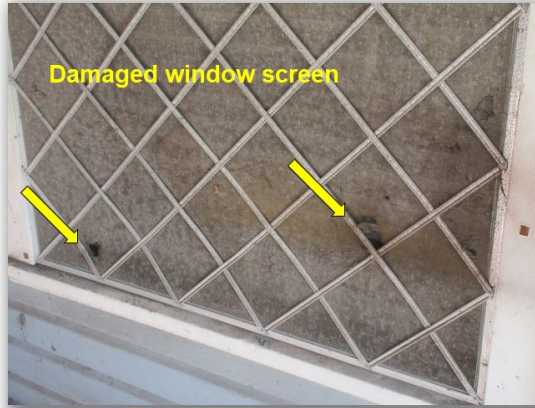
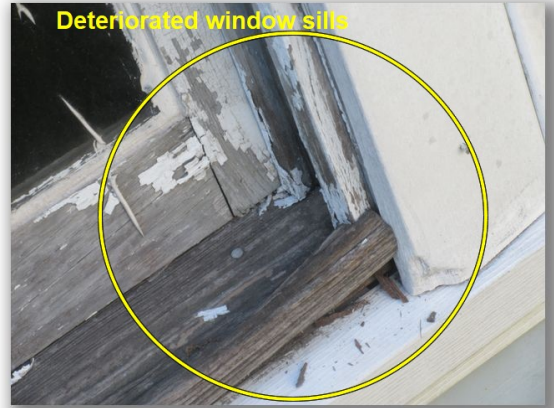
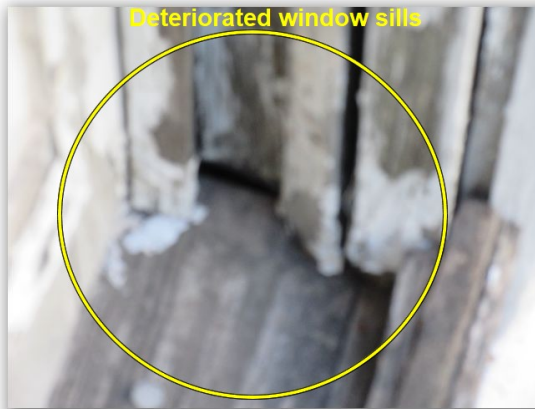
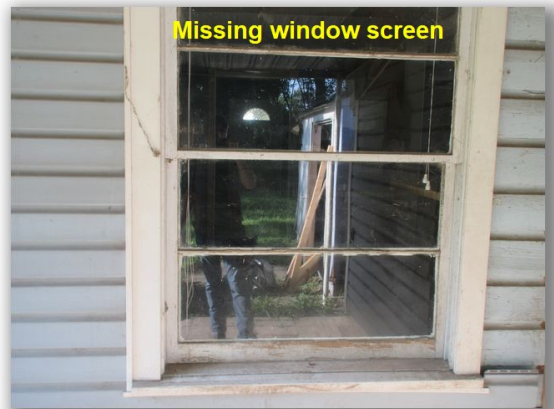
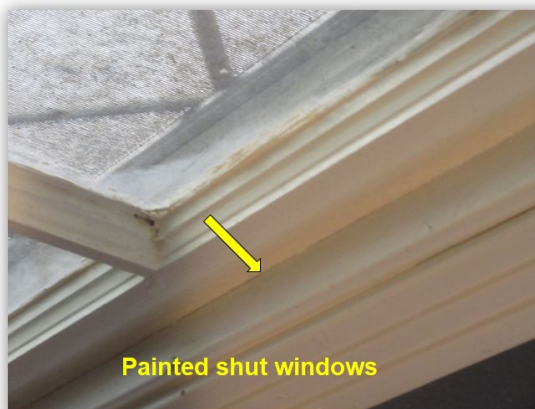
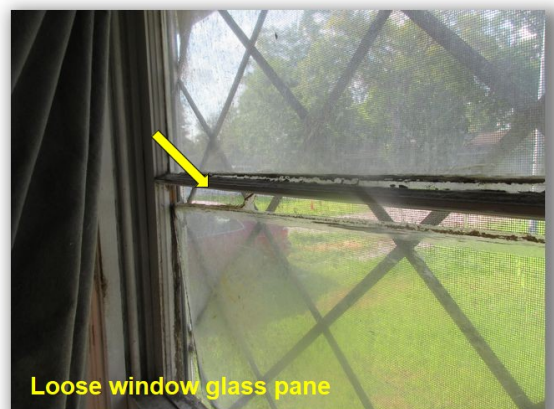
- One or more of the window screens were observed to be damaged.
- One or more of the window screens were observed to be missing.

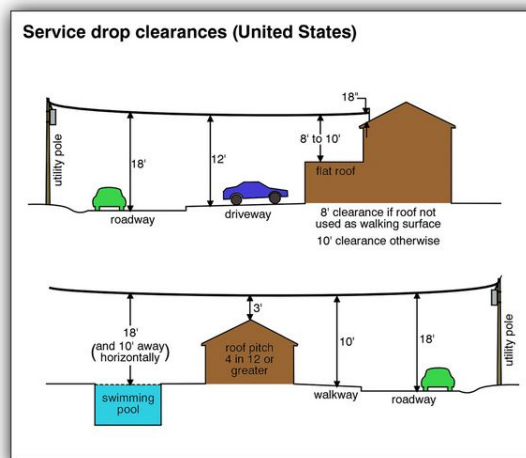
- The electrical service wires hang to low across the back yard area. The electrical service wires from the service pole to the structure should clear the ground, decks or platforms by a minimum of 10-feet.

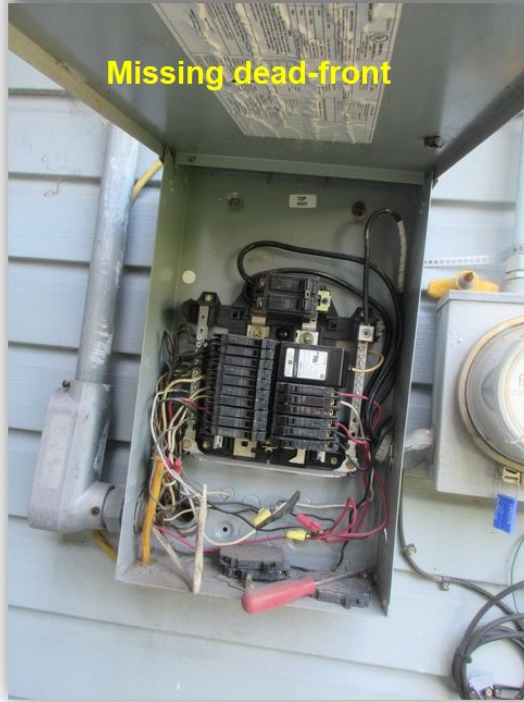
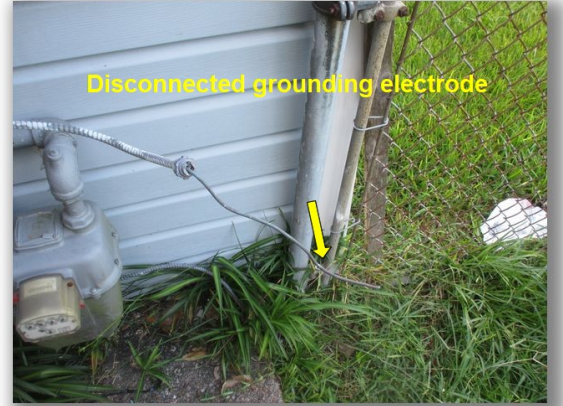
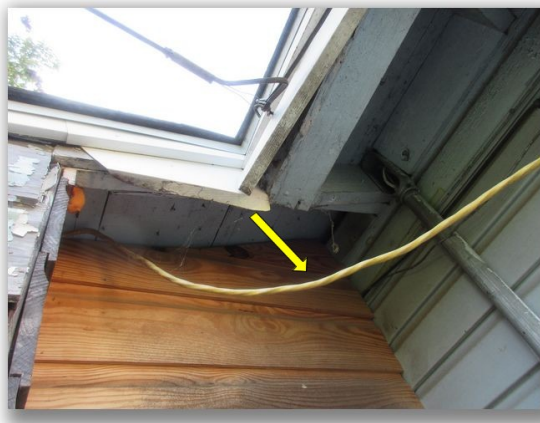
- The bonding wire connection to the ground electrode rod has pulled loose and needs to be repaired as necessary.

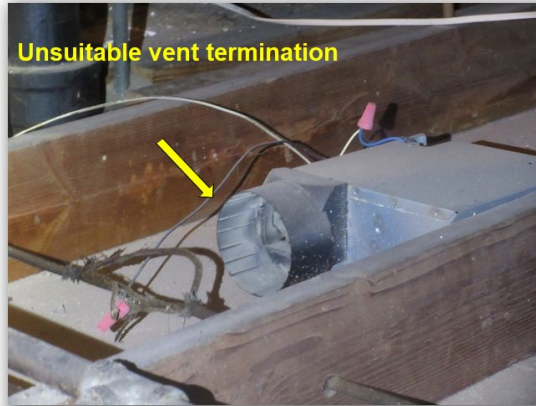
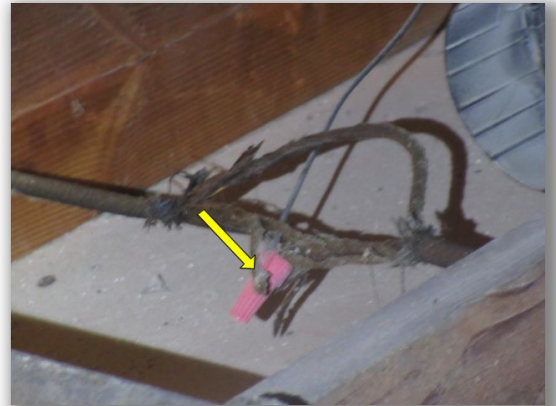
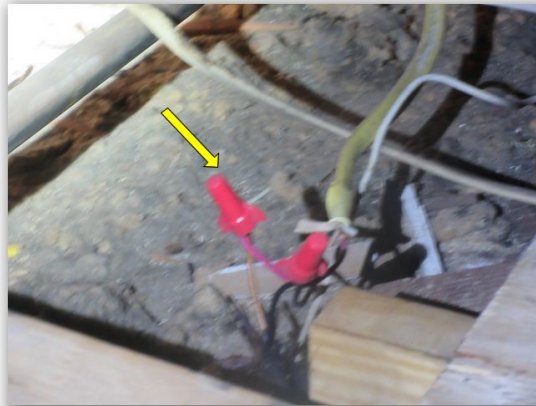
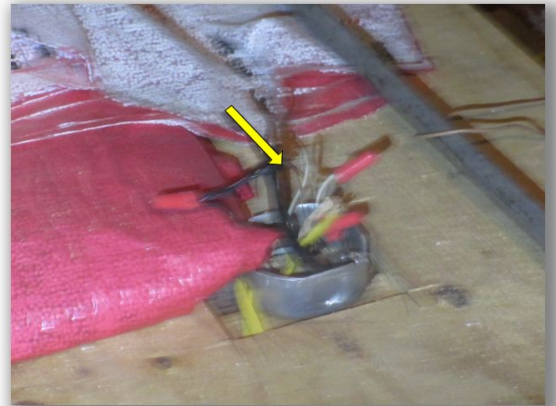
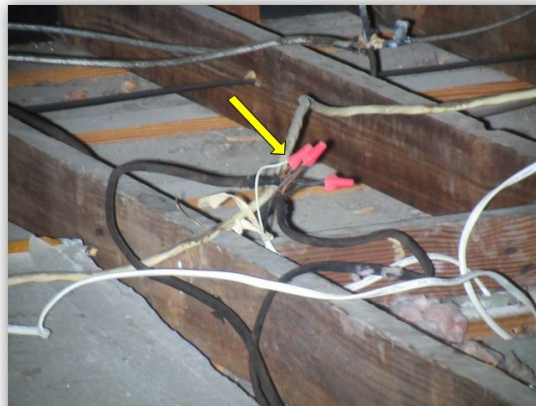
**Unsuitable electrical rout configurations and/or terminations shown above.**

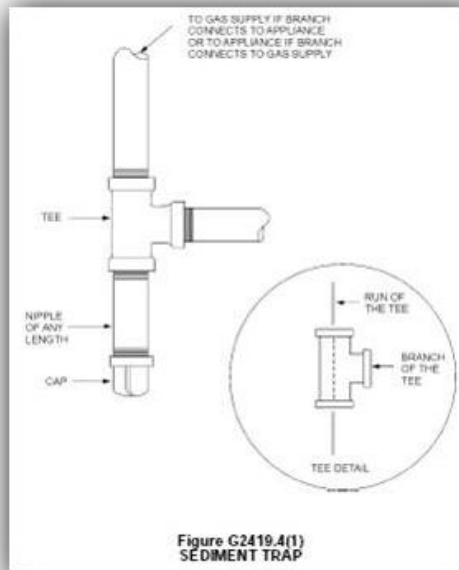
- The water heater gas supply line is not equipped with a sediment trap just before the gas appliance connector. This condition does not meet current installation requirements and should be corrected.

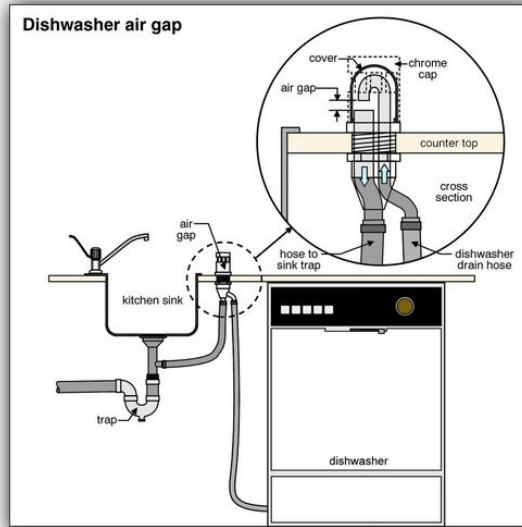
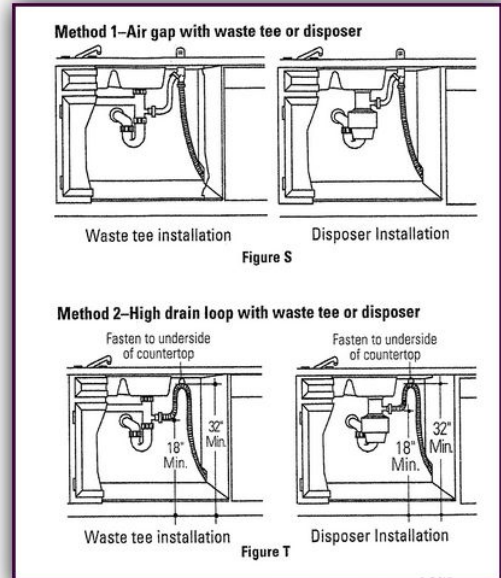
The dishwasher is inoperative, would not collect water and should be repaired or replaced.

- The dishwasher drain hose is not properly installed to prevent back flow or anti-siphoning. It is recommended that an air gap device or high drain loop be installed in the drain line.

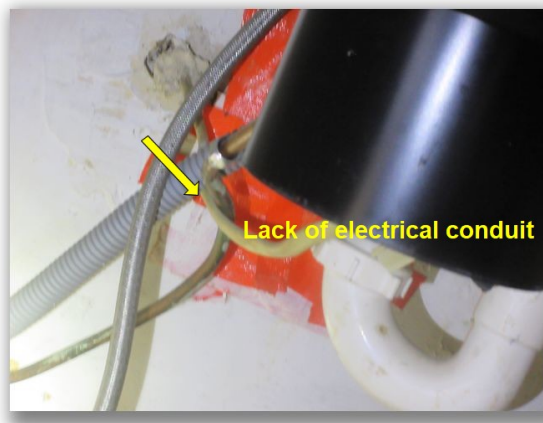
- The electrical wiring to the disposal is exposed and should be enclosed in conduit.

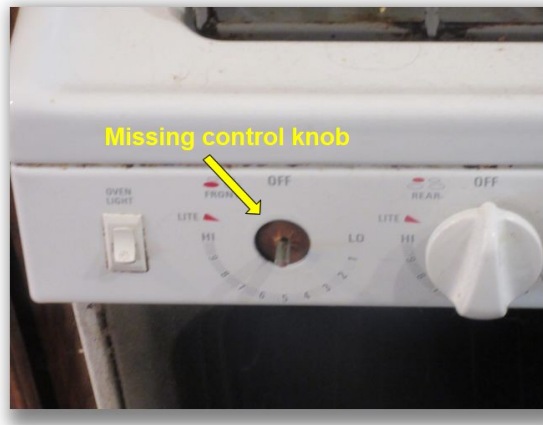
- One or more of the control knobs are missing.

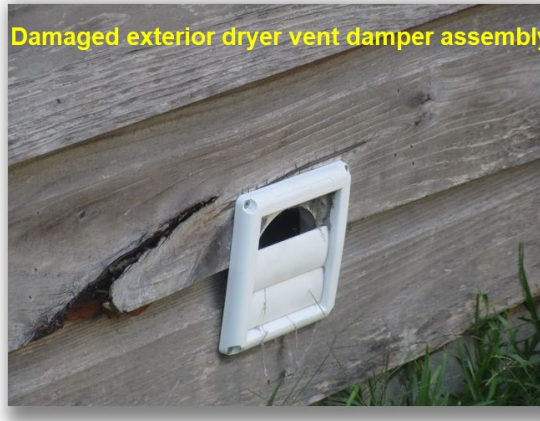
- The exterior dryer duct termination cover is damaged.

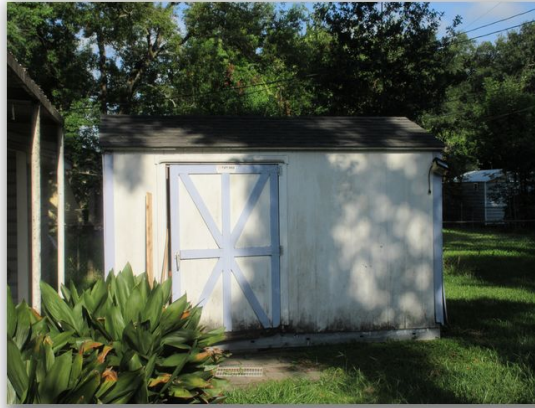
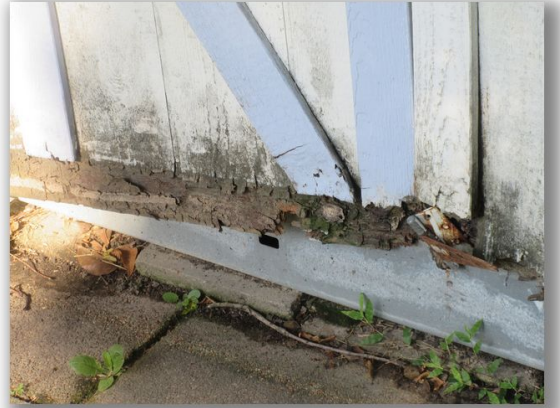
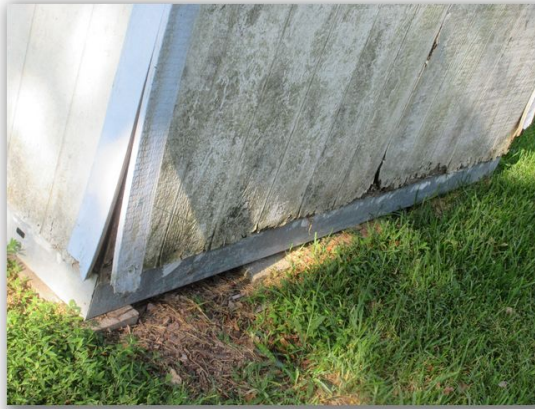
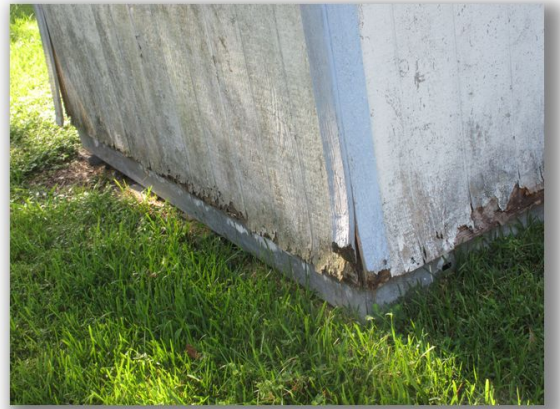
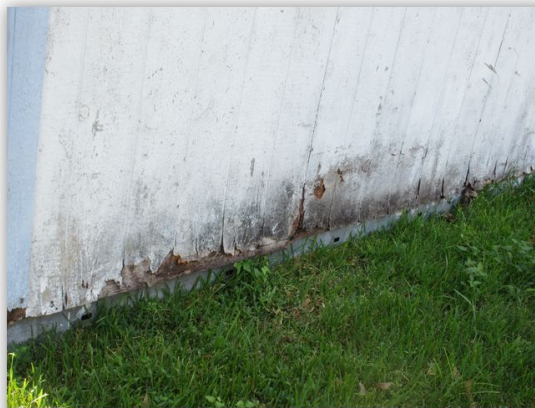
The outbuilding was found to have some considerable deterioration and/or termite damages to various areas of wall sill plates and/or exterior wall composite veneer. Further evaluations and repairs are needed.
