Total Home Inspection

Property Inspection Report

615 E Cypresswood Dr, Spring, TX 77373
Inspection prepared for: Wemberth Ferraz
Real Estate Agent: Sophia Yapo -

Date of Inspection: 10/7/2019 Time: 9:00 AM
Age of Home: 1971 Size: 2658
Weather: Cloudy - 80s/90s

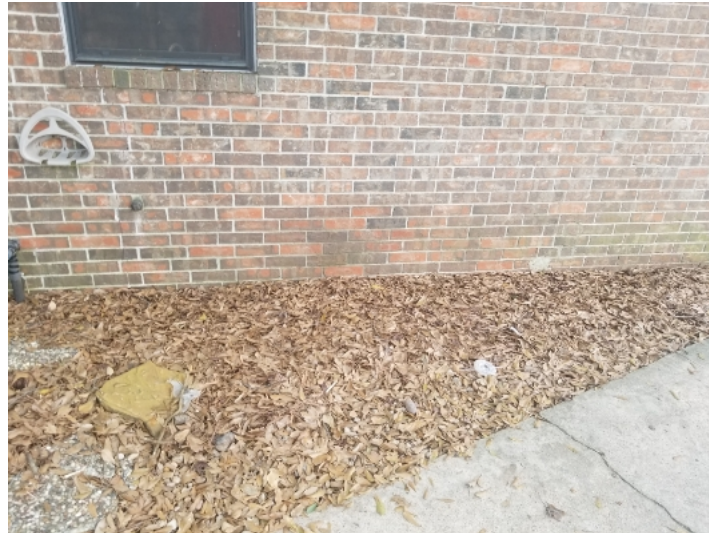
Slab exposure at some areas should be increased. Common building code calls for 4" exposure to brick and 6" exposure to siding.

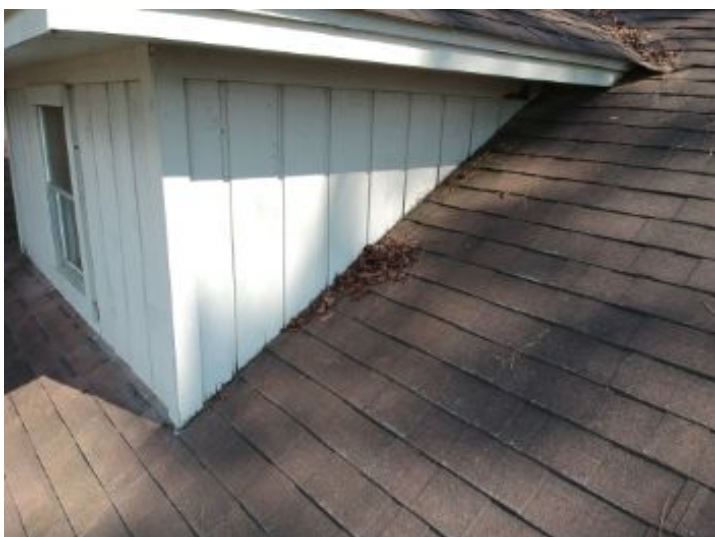
Siding was touching the roof surface at multiple areas. In our opinion, siding should be at least 1" from the roof surface.

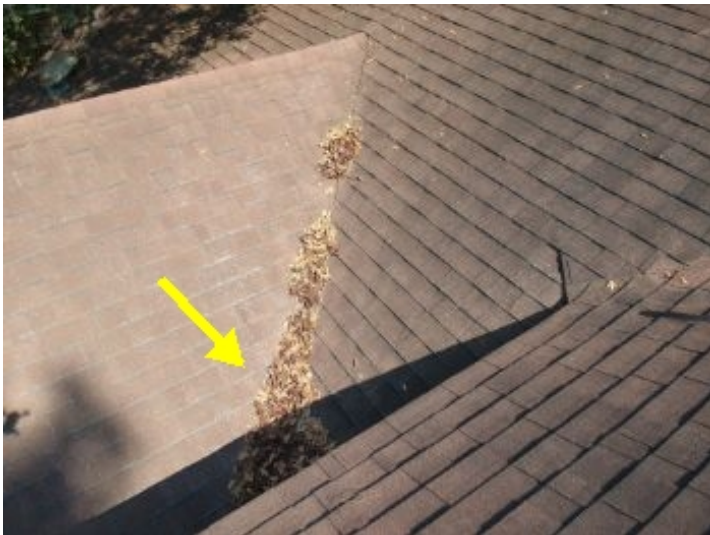
Tree debris should be cleared from valleys to allow unimpeded flow of rain water.

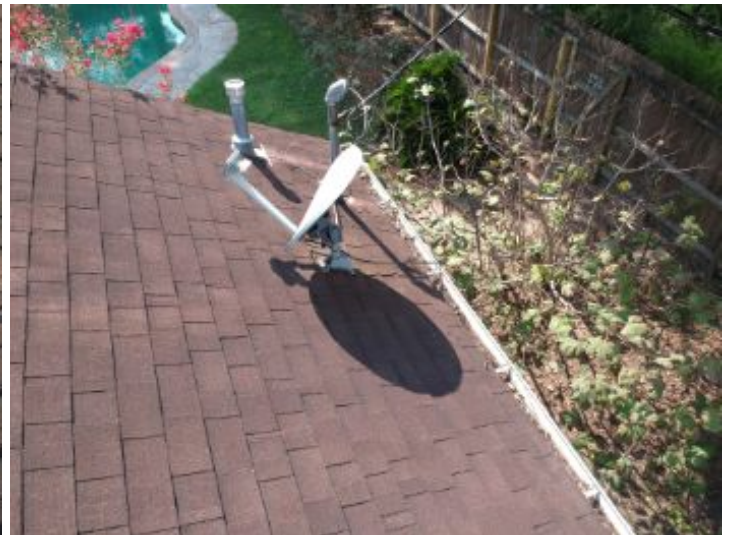
Exposed screws in satellite dish bracket should be sealed.

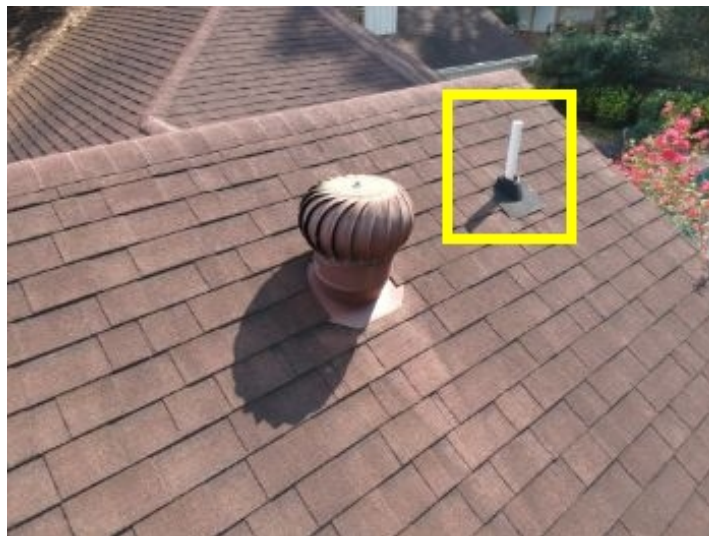
PVC is not intended for exterior exposure to UV light. PVC vent pipes were not painted above the roof surface and may deteriorate.

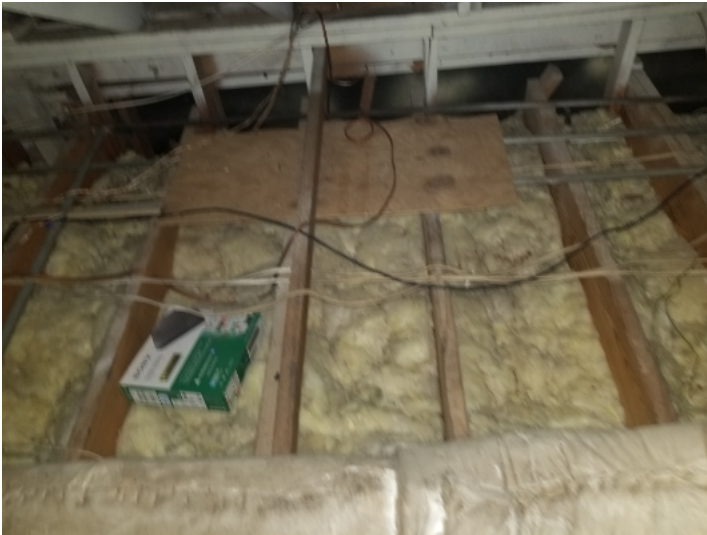
Low level of insulation and in need of improvement for better efficiency. 12+ inches of insulation or an R38 or higher is recommended.

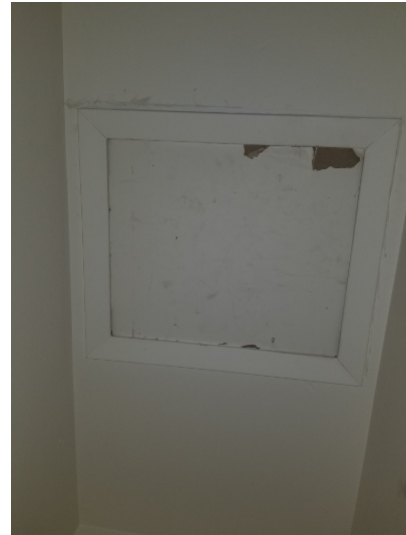
Attic entry opening was too small and was not properly accessible. Common building code requires attic access opening be large enough to allow the largest piece of attic equipment to be removed or replaced; but not smaller than (or a minimum of) 22"x 30". Attic access was measured to be 20.5" x 17.5"

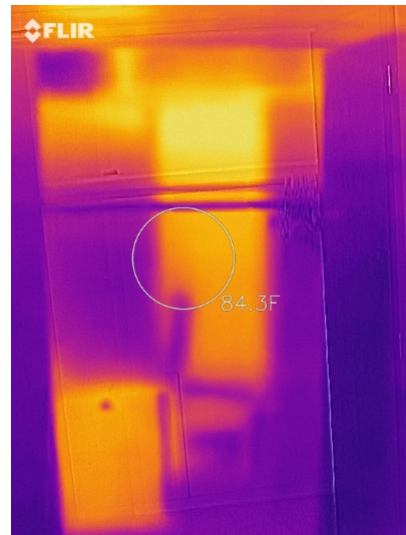
There was missing/displaced insulation in multiple walls.

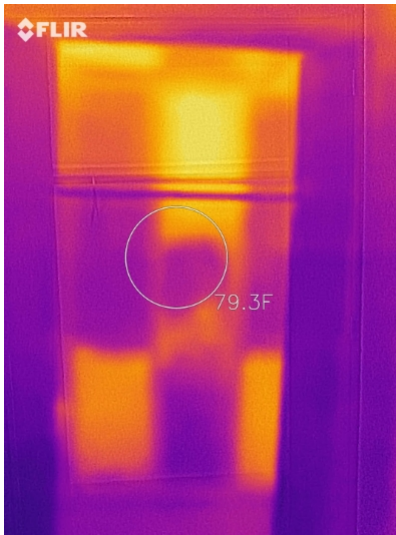
There was missing/displaced insulation in multiple walls.

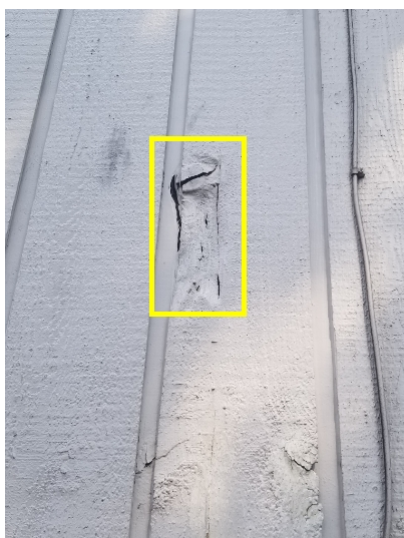
Deterioration of trim/siding was observed at the left,

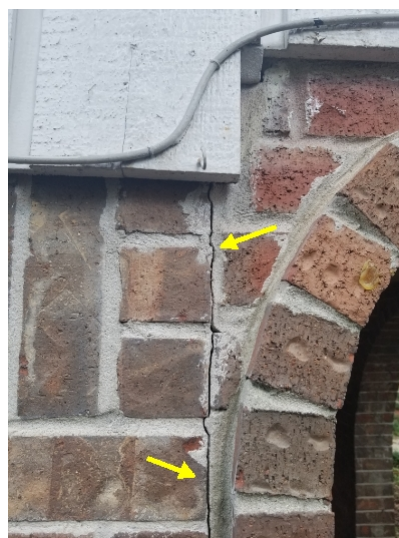
Brick/ mortar cracks were observed on the left and right sides. In our opinion, there did not appear to be excessive amounts deflection or settlement in these areas. These should be properly sealed.

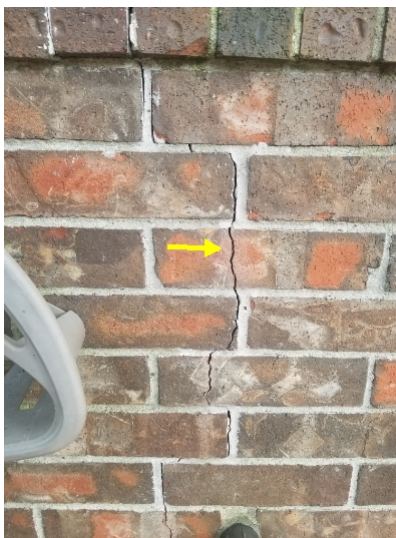
Brick/ mortar cracks were observed on the left and right sides. In our opinion, there did not appear to be excessive amounts deflection or settlement in these areas. These should be properly sealed.

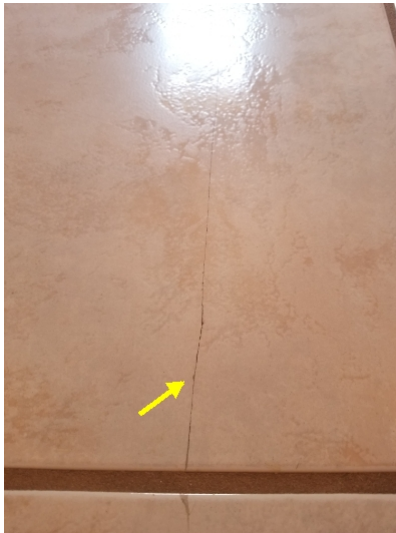
Cracked tiles observed in the 2nd level guest bathroom.

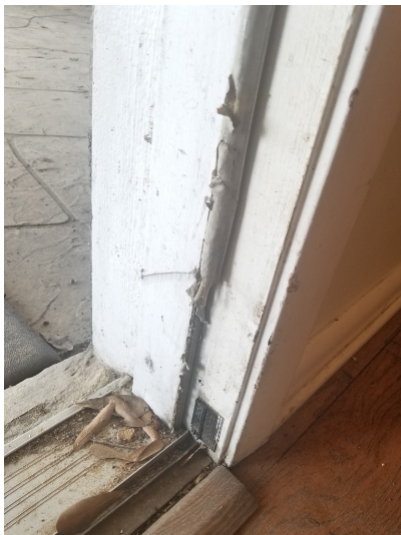
Weatherstrip was missing or damaged at the entry doors.

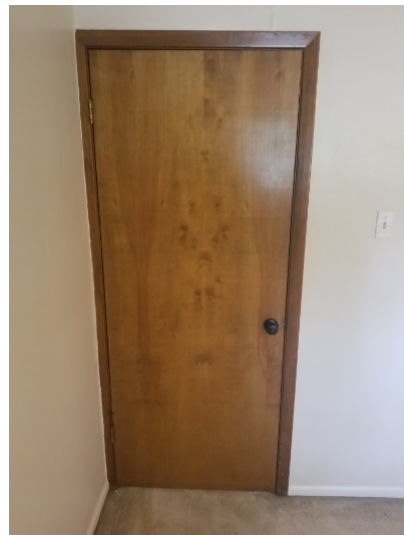
Some 2nd level doors were not square and contacting the frame and may require adjustment.

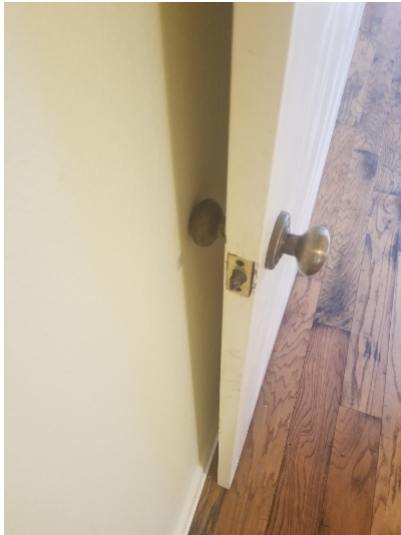
Some doors were missing stoppers; door or wall damage can occur as a result.

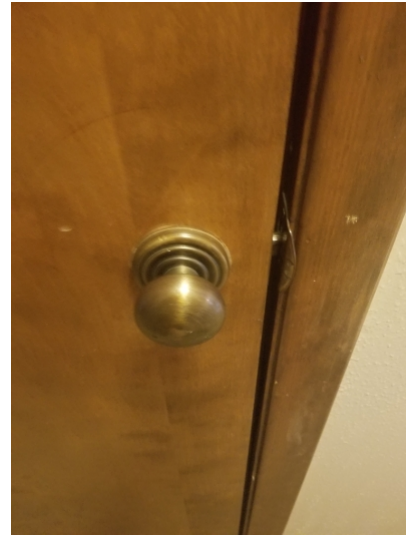
Door hardware was loose at some doors around home.

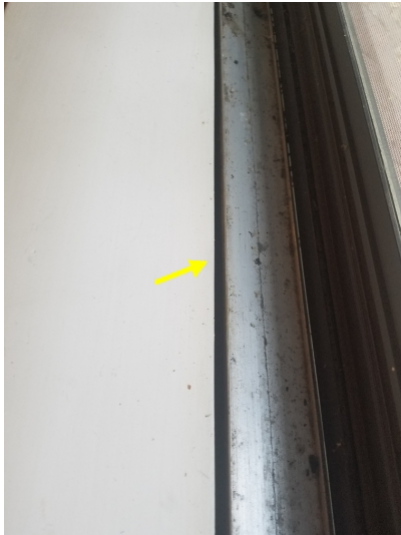
Some windows had gaps in the caulk seal around the framing/drywall junction and require a caulking upgrade.

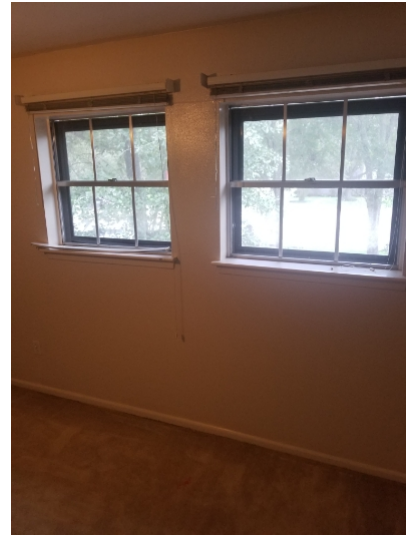
The bedroom windows were too high. This could prevent emergency egress from the room. Common building code specifies windows be no more than 44"H.

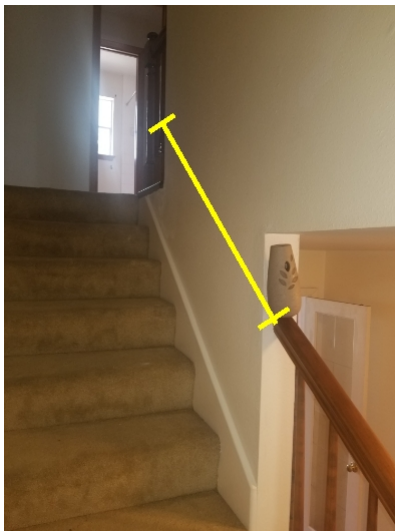
Handrails should span from top to bottom of the stairs.

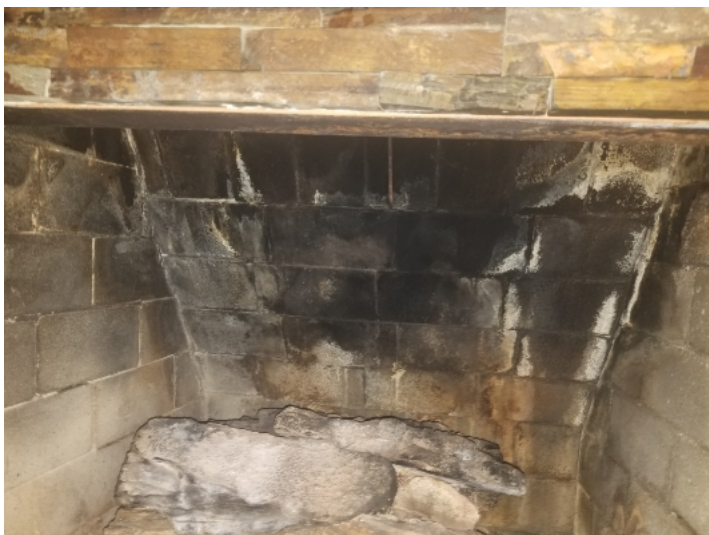
Brick in the fire box was missing mortar. Gaps and crevices should be re grouted to prevent embers from escaping.

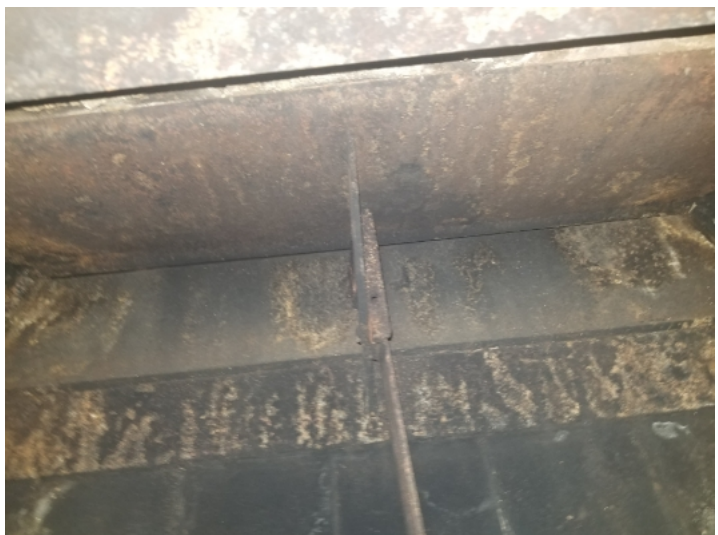
Gas starter was present and damper should be blocked open with the presence of gas accessories.

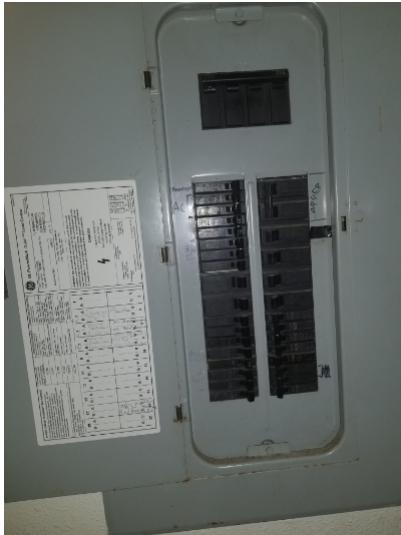
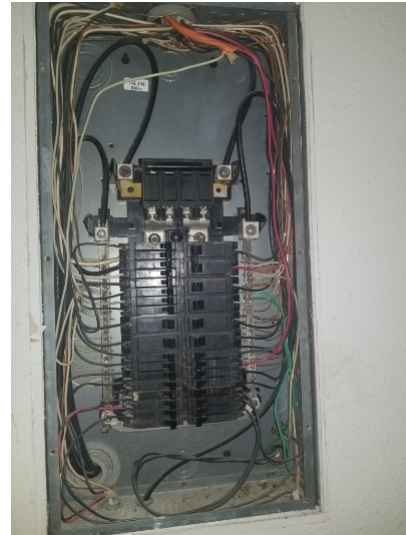
All breakers for the panel boxes and/or sub panels must be clearly and permanently labeled for identification of particular circuit.

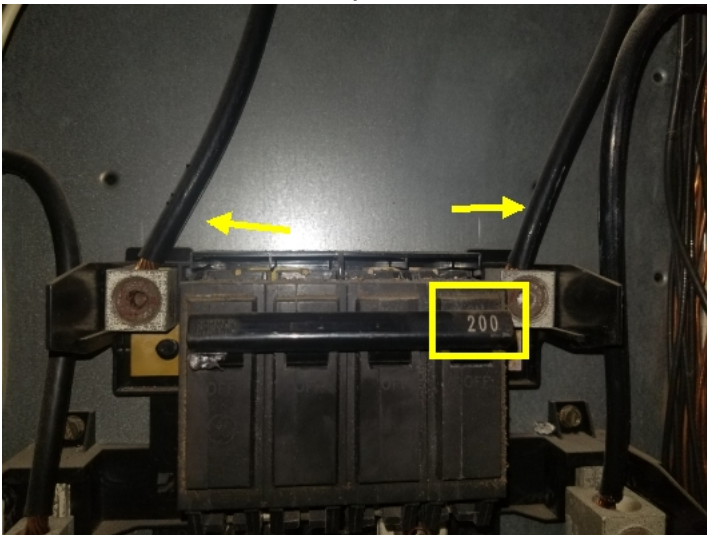
Main Breaker in electric panel is labeled as 200 amps. Wire size appears to be #2 Copper and is rated for 150 amps. Breaker is possibly oversized. Recommend further evaluation by a licensed electrician.

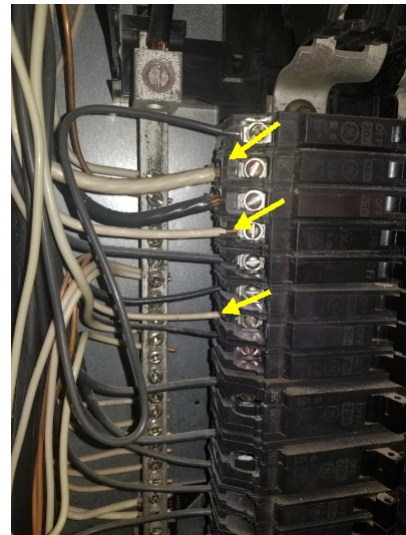
White wires were connected directly to breakers in the panel. Typically white wires should be designated as neutral only. These should be marked appropriately.

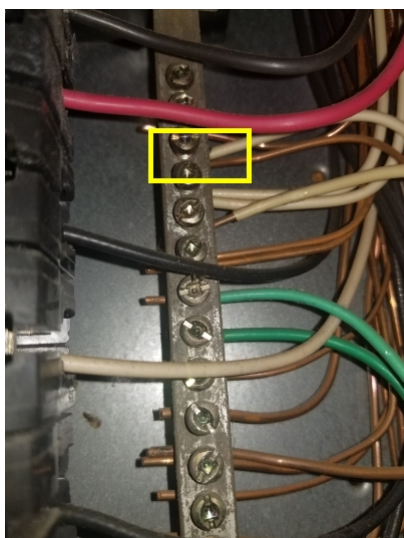
There were neutral/ground wires in the panel that were sharing spots on the bus bar.

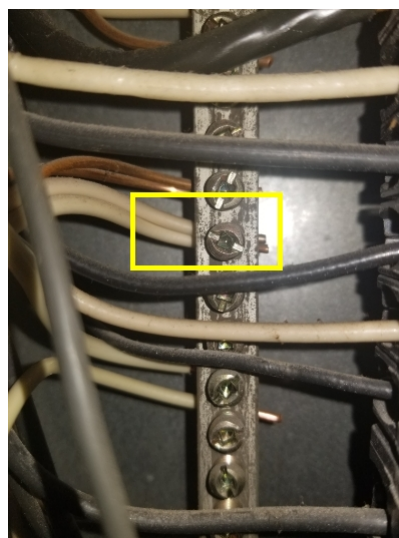
There were neutral wires in the panel that were sharing terminals on the bus bar. One neutral wire per terminal screw is permitted.

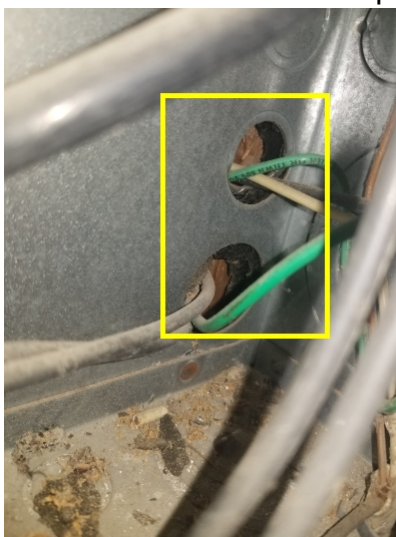
There is wiring entering the panel without the proper protective bushings. Wiring that enters the panel should be protected where it enters the panel by a bushing to prevent the sharp edges of the panel box from damaging the wiring.

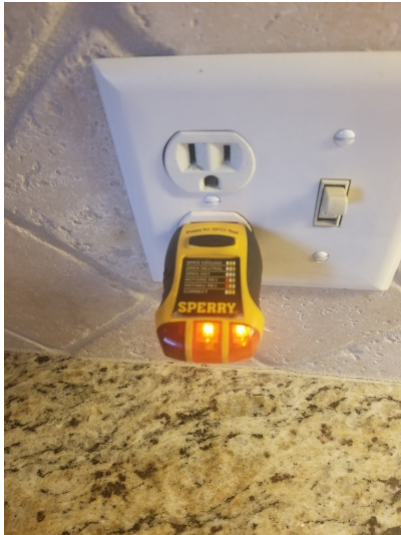
GFCI outlets were not present and functioning in the kitchen, bathrooms, garage and exterior.

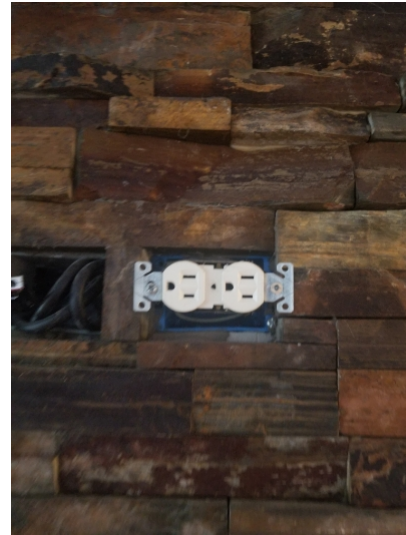
Outlet cover was missing in the living room at the fireplace.

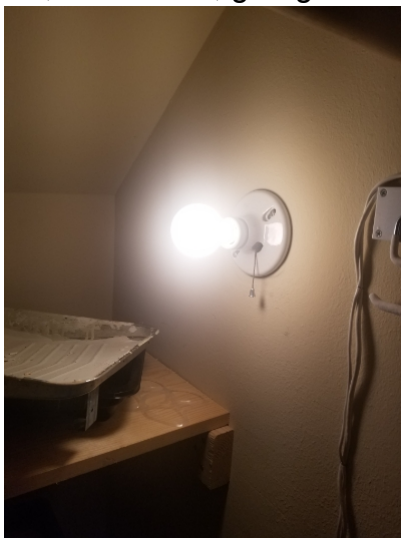
Open incandescent lighting was located in some closets and may be a fire hazard.

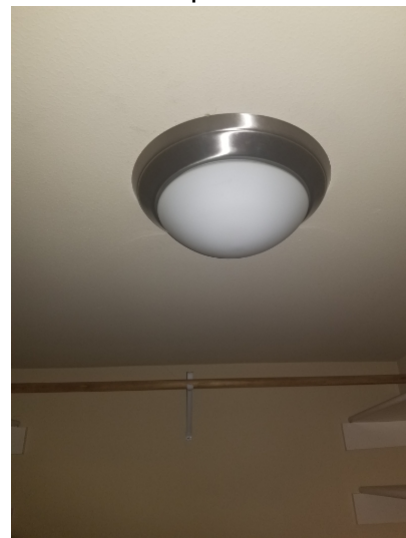
Fixture was not functioning in the master closet. Light bulbs were not tested.

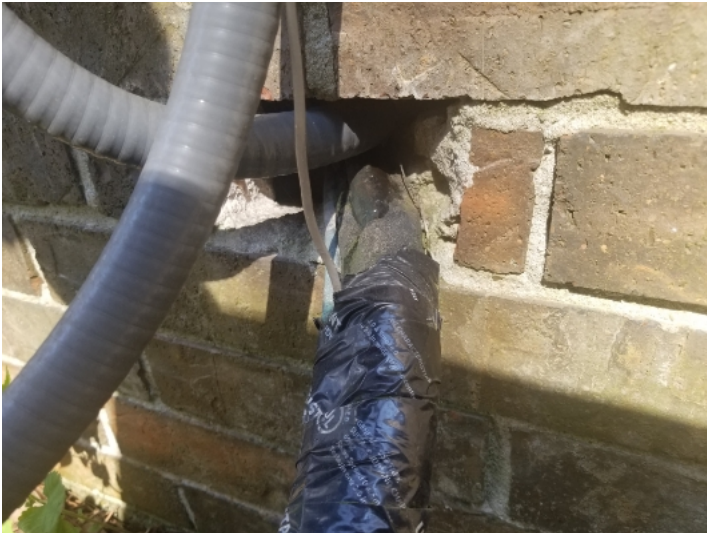
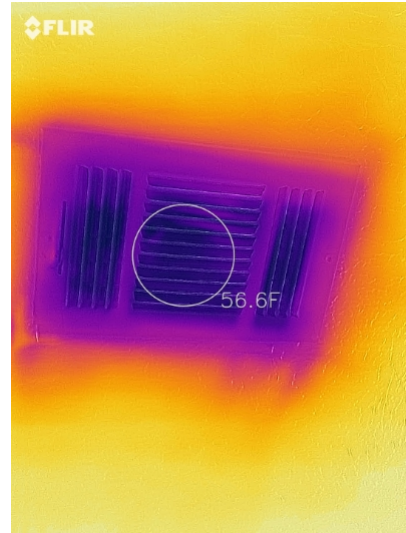
Wall should be sealed at the AC line entry point. AC appeared to be cooling properly. Temperature differential measured (74-56=18) between air supply and registers. Typical range should be 15 to 20 degrees.

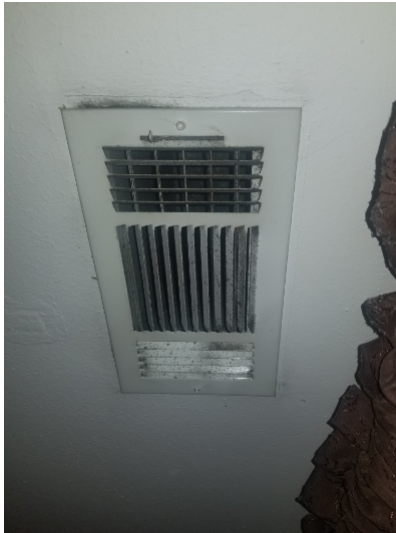
Some registers appeared to be dirty around the home.

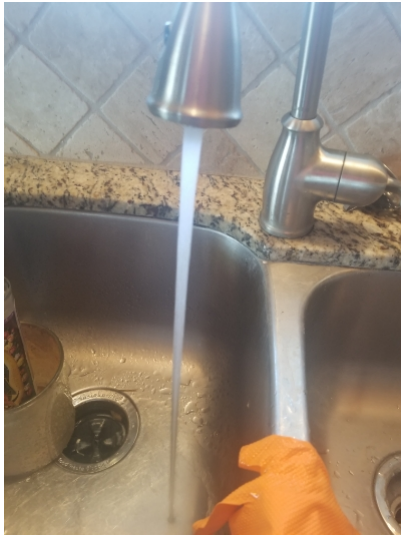
Low water flow was observed at the kitchen sink.

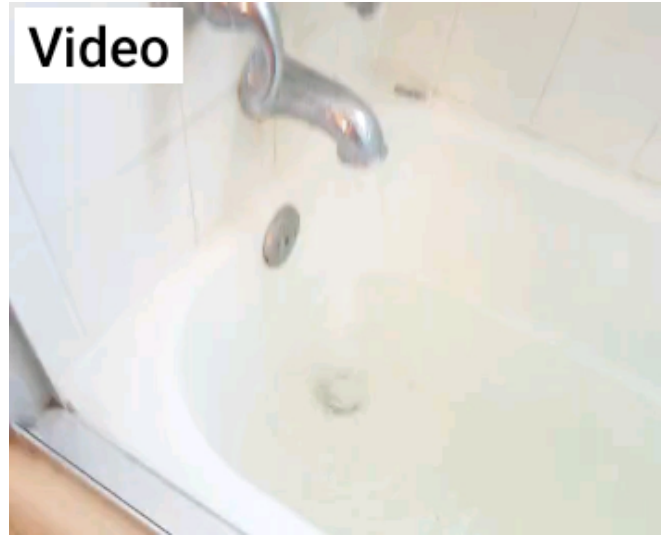
Shower diverter was not working properly in master bathroom.

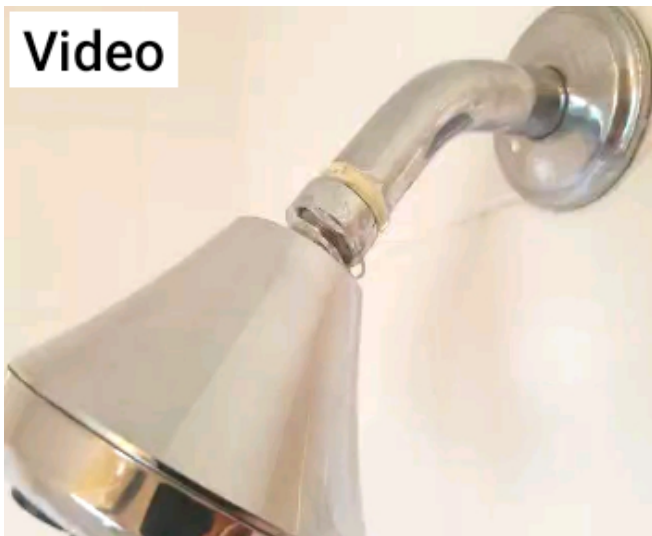
Shower head was leaking in 2nd level guest bathroom.

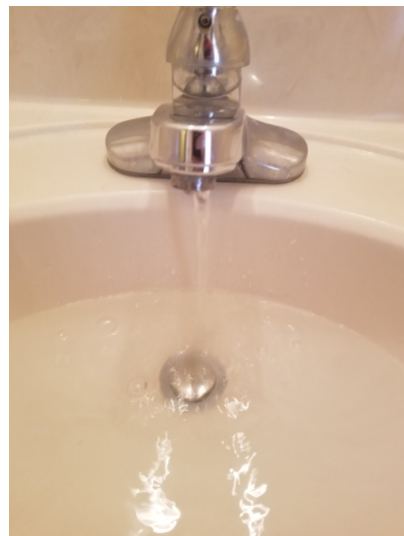
Low water flow was observed at the kitchen sink and 2nd level guest bathroom sink.

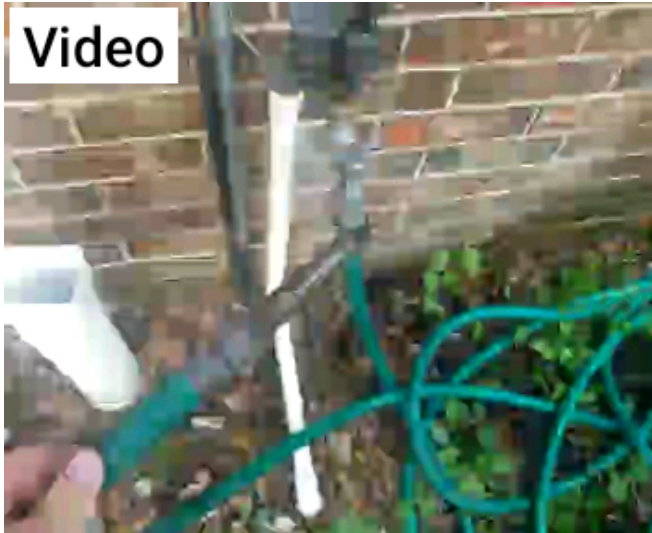
Water was running continuously at back yard exterior spigot. Shut off valve may be in need of repair.

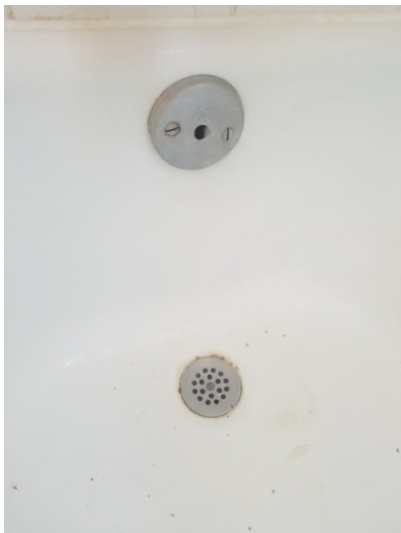
Tub stopper lever was missing/damaged in the master bathroom.

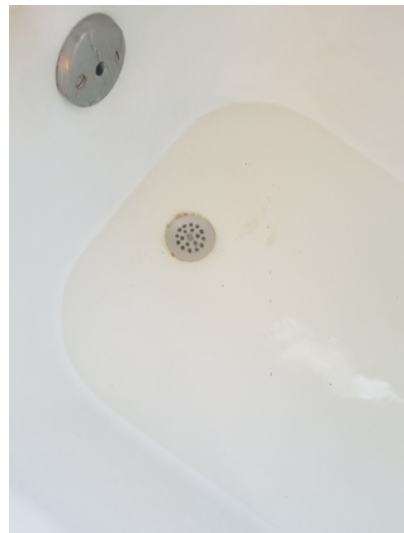
Master tub drain appeared to be draining slowly.

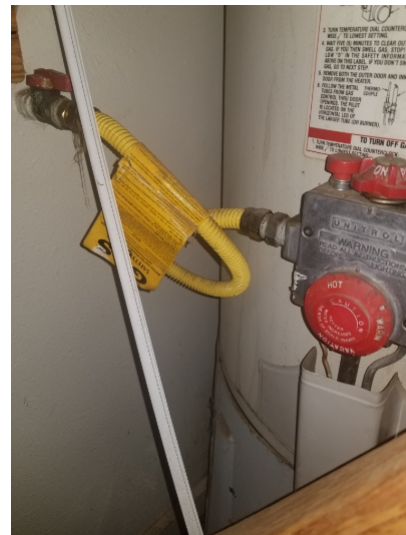
In our opinion, there should be a drip leg on the gas line. Most manufacturers recommend drip legs be installed.

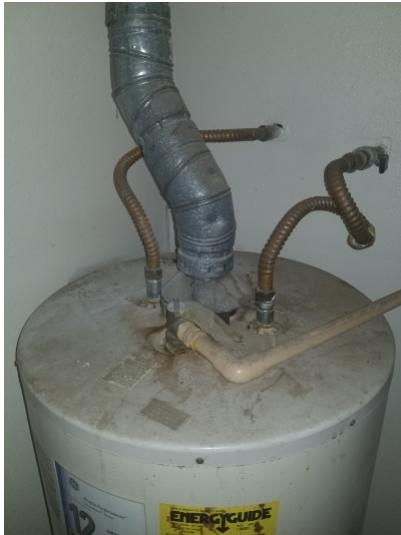
Water stains were observed on the top surface of the water heater.

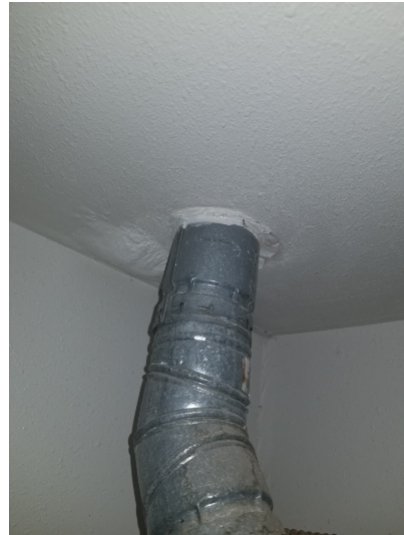
Water heater flue was not proper distance from combustibles in attic and should be at least 1 inch from wood or other combustible material.

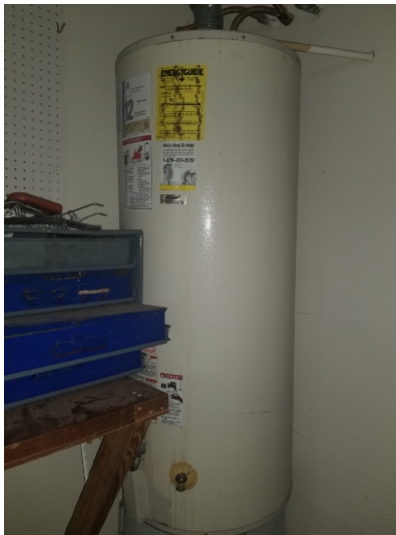
Unit was percolating and noisy. Unit may need to be flushed, consult with a qualified licensed plumber for further evaluation.

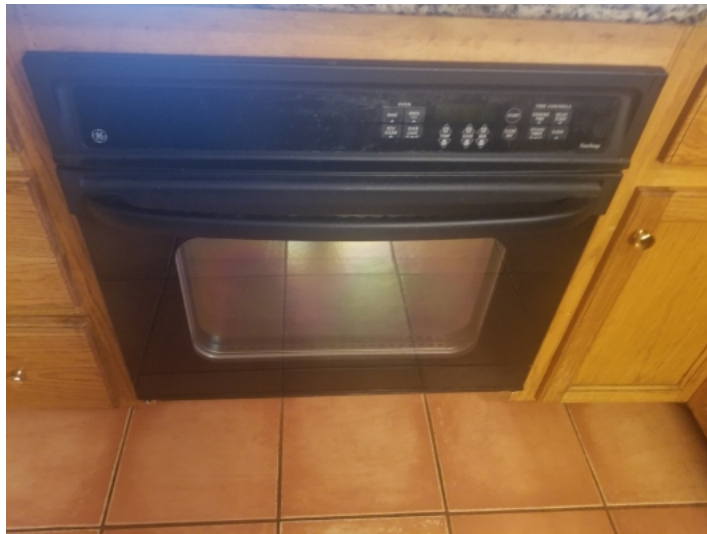
GE electric oven did not operate.

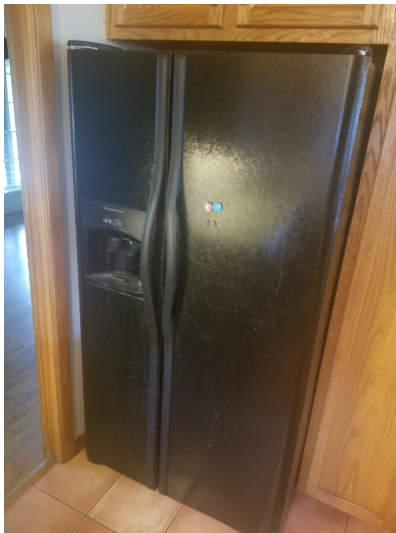
Refrigerator did not appear to be operating.

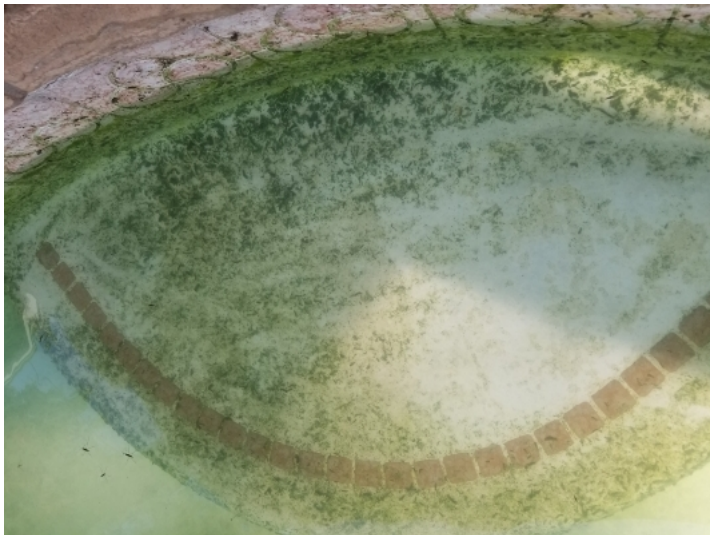
Pool surface appeared to be in need cleaning and repair and may possible need resurfacing. We recommend consulting with a pool resurfacing contractor for further evaluation.

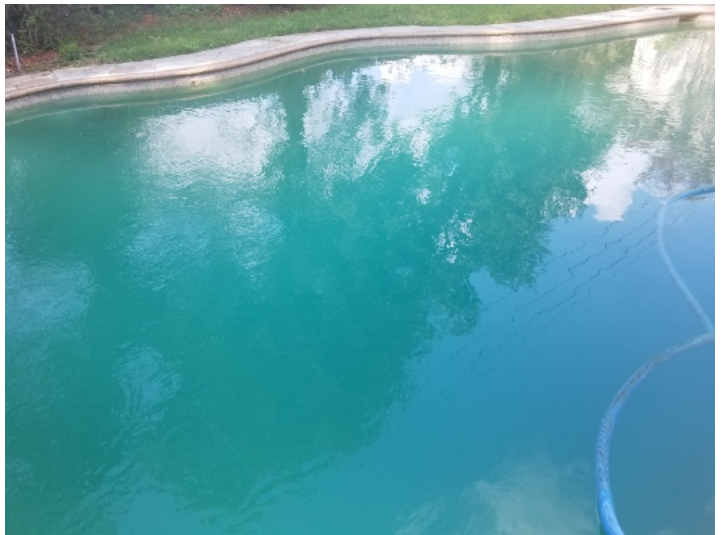
Water clarity was poor and we recommend a proper evaluation by a pool servicing contractor.

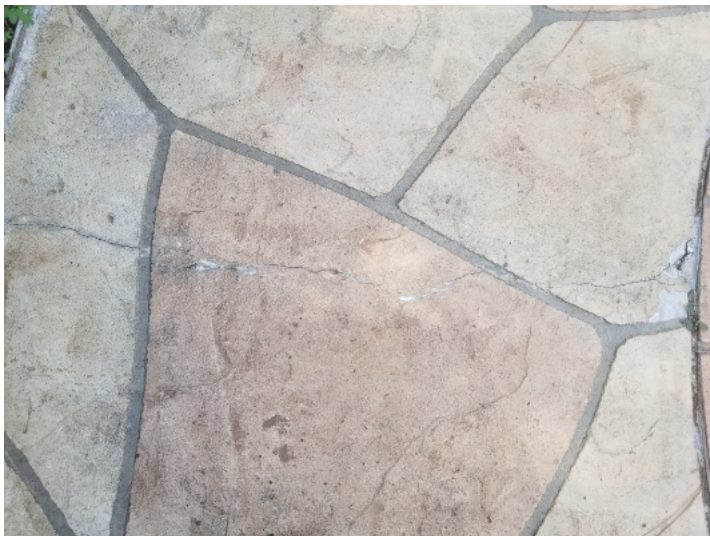
Decking appeared to be in okay condition. Some cracks were observed.

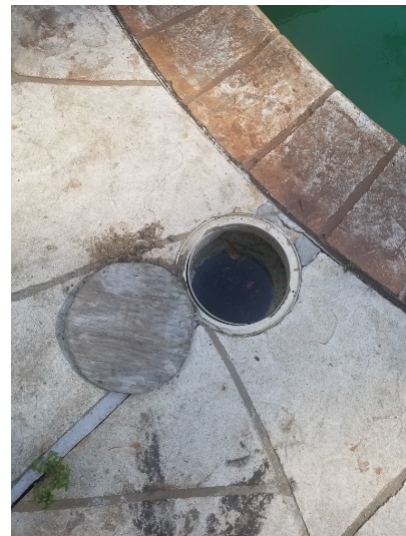
Skimmers were observed and appeared to be functioning as intended. 1 skimmer was missing the cover.

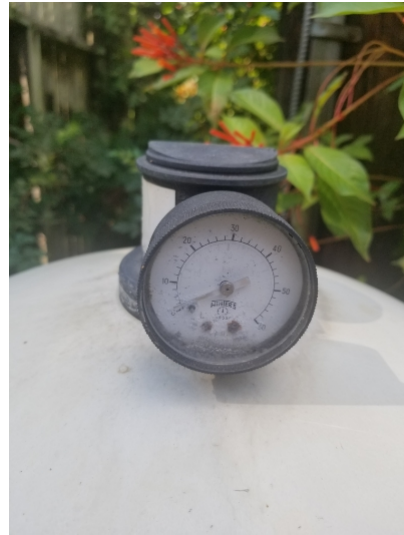
Purex Triton Nautilus DE filter was present, however there appeared to be no pressure; or pressure gauge was not functioning properly. Recommend further evaluation by pool servicing contractor for evaluation of this filter and pressure gauge.

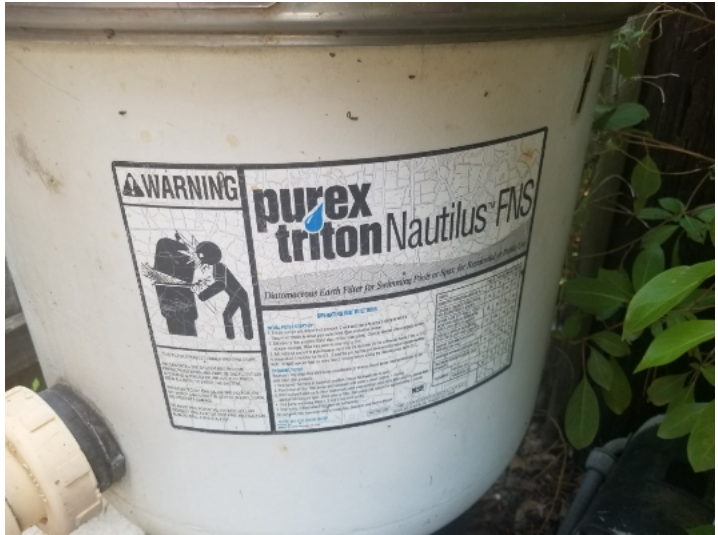
Purex Triton Nautilus DE filter was present, however there appeared to be no pressure; or pressure gauge was not functioning properly. Recommend further evaluation by pool servicing contractor for evaluation of this filter and pressure gauge.

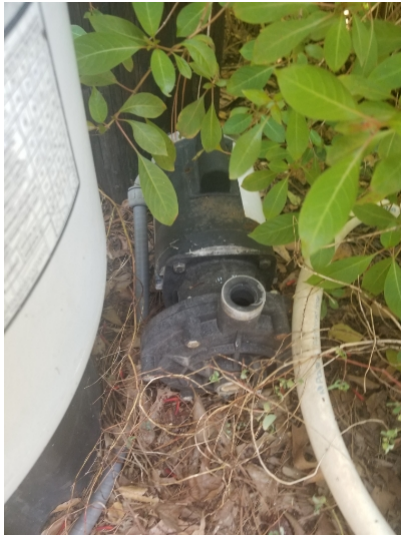
Pool pump was observed for cleaner equipment however the pump did not appear to be connected and did not appear to be operating.

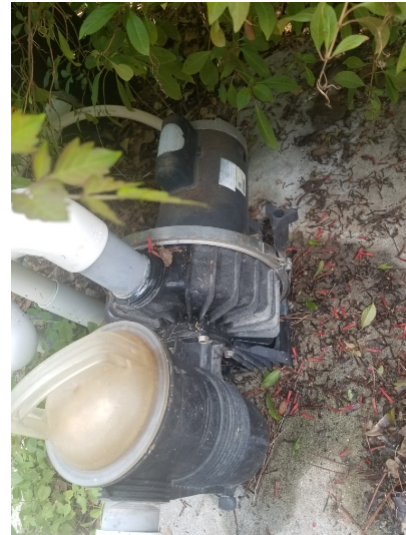
Pool pump was observed for the main pool and appeared to be operating as intended. However, pool pump was leaking may be in need of repair/replacement. We recommend consulting with a pool servicing company for further evaluation of this pump.

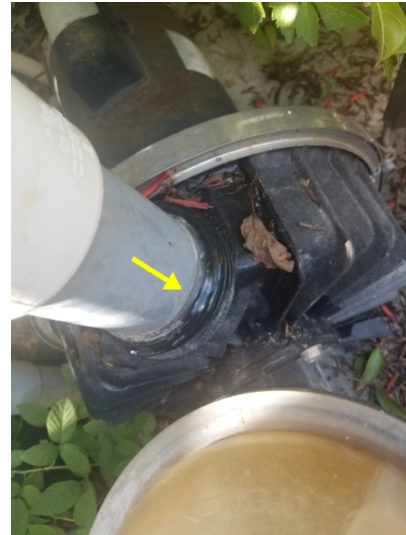
Pool pump was observed for the main pool and appeared to be operating as intended. However, pool pump was leaking may be in need of repair/replacement. We recommend consulting with a pool servicing company for further evaluation of this pump.
