Inspection Report

Property Address:
615 E. Cypresswood
Spring Tx 77373

PROPERTY INSPECTION REPORT

11/9/2019

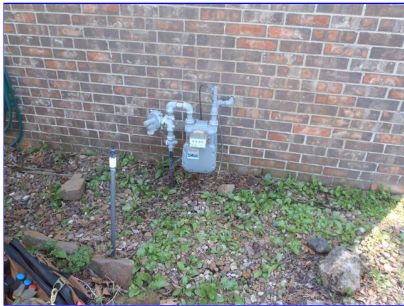
The majority of the foundation was below grade around perimeter of home at time of inspection and could not be inspected from exterior of home due to this. There were slightly sloping floors on the bottom story of home, in the dining room at front of home, that could possibly be due to foundation issues. Recommend further evaluation by a professional foundation contractor.

A. Item 1(Picture) Foundation below grade at back of home.

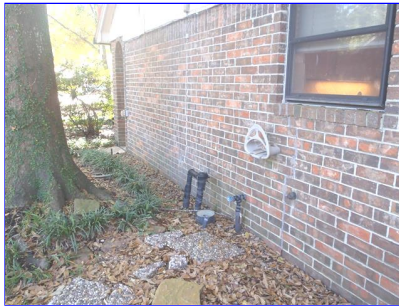
A. Item 2(Picture) Foundation below grade at right side of home.

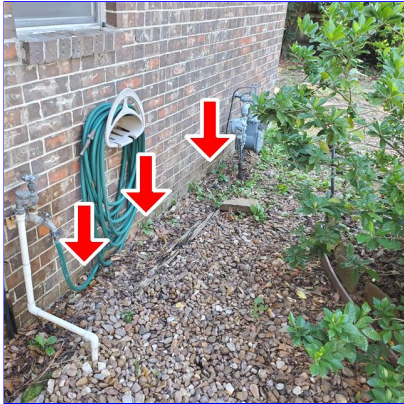
Soil is in contact with brick wall coverings around perimeter of home. This could cause damage to foundations and walls and needs to be lowered. There should be at least 4 inches between soil and brick wall coverings.

B. Item 1(Picture) Soil in contact with wall coverings at left side of home

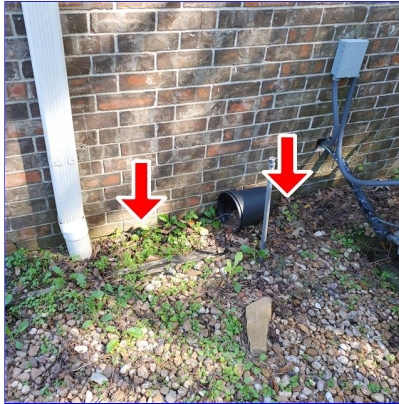
B. Item 2(Picture) Soil in contact with wall at left side of home.

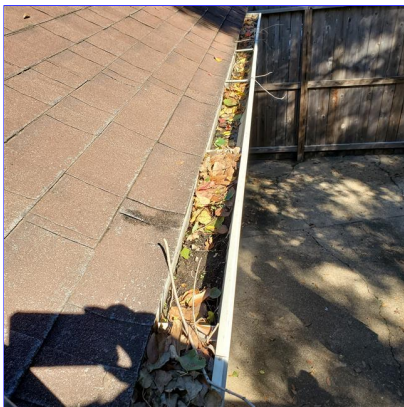
The gutters are full of debris in areas and needs to be cleaned. The debris in gutters can also conceal rust, deterioration or leaks that are not visible until cleaned, and I am unable to determine if such conditions exist.

B. Item 3(Picture) Gutters full of debris around majority of home.

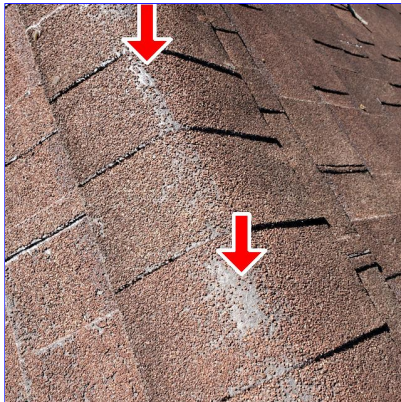
The roof coverings appeared to be aged and brittle and replacement may be needed soon. There are some exposed nails that need to be repaired to help prevent moisture intrusion.

C. Item 2(Picture) Majority of ridge shingles are losing their asphalt granules.

Recommend contacting a professional roofer for quotes on cost of repairs and to give estimates life expectancy on roof coverings.

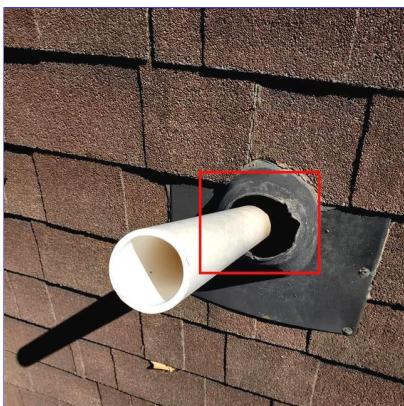
Damaged pipe flashing on garage roof needs repair to help prevent moisture intrusion.

C. Item 3(Picture) Damaged pipe flashing on garage.

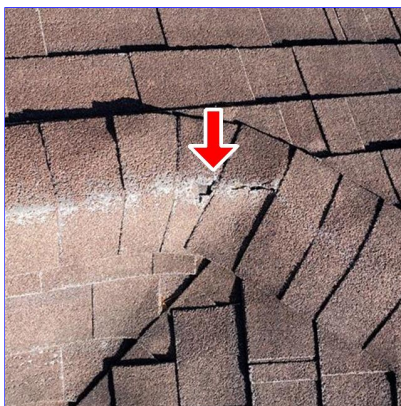
C. Item 4(Picture) Damaged hip shingles over breezeway.

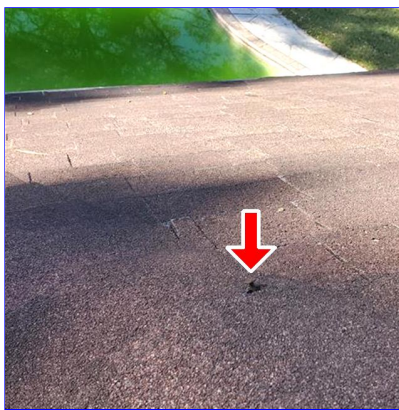
C. Item 8(Picture) Nail sticking out of roof on back facet of roof on porch cover.

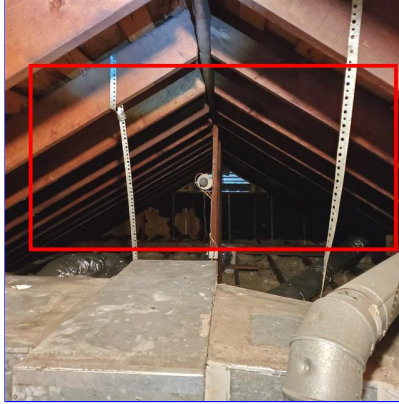
D. Item 2(Picture) Could not access part of the attic due to hvac equipment blocking path.

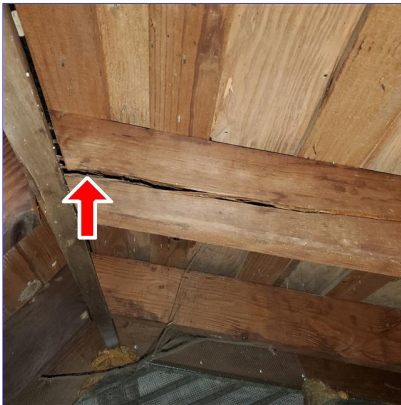
There were a couple of split rafters in the attic, approximately over the kitchen area, that need further evaluation and repair as needed.

D. Item 3(Picture) Split rafter in the attic above the kitchen

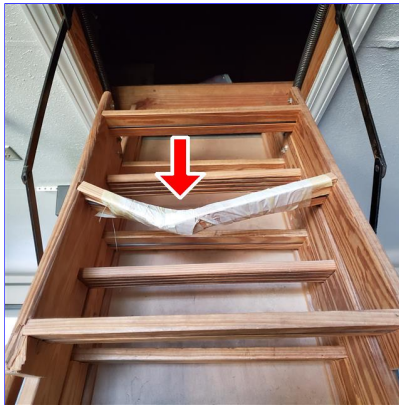
Damaged attic ladder in garage needs to be repaired to safely climb into attic.

D. Item 4(Picture) Damaged attic ladder in garage needs repaired to allow for safe entrance into attic.

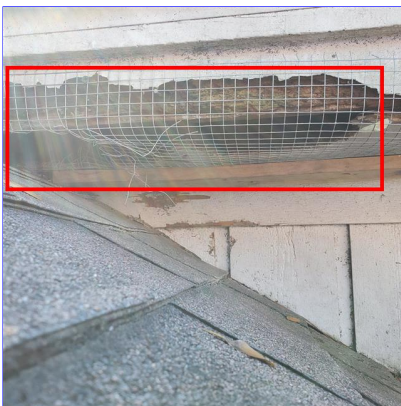
Hole in soffit/fascia on second story soffit area at back of home by the chimney needs to be repaired to help prevent critter entry and damage to property.

D. Item 5(Picture) Large hole in fascia/soffit at back of home by the chimney.

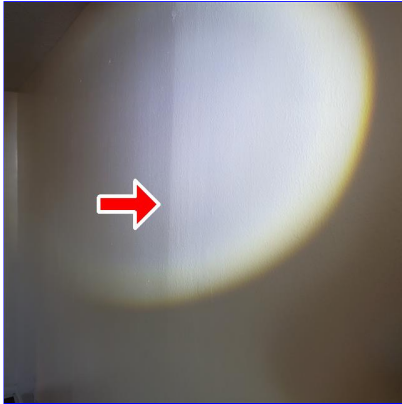
There are some small cracks and humps in interior walls. This is possibly due to settlement or slight structural movement and should be evaluated further by a professional contractor to determine cause and give recommendations on repair if needed.

E. Item 1(Picture) Hump in the interior wall in the living room.

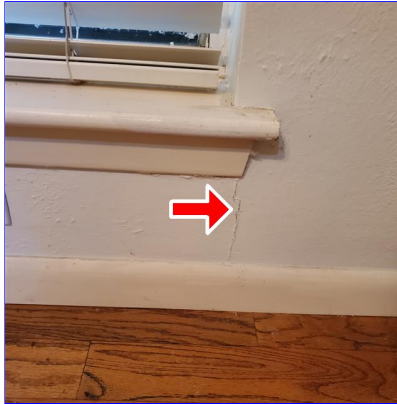
E. Item 2(Picture) Small crack in the wall under window in the dining room at front of home.

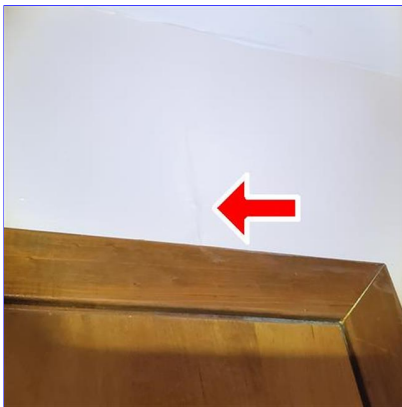
E. Item 3(Picture) Wrinkle in interior wall above door in upstairs bedroom to the right of the stairway.

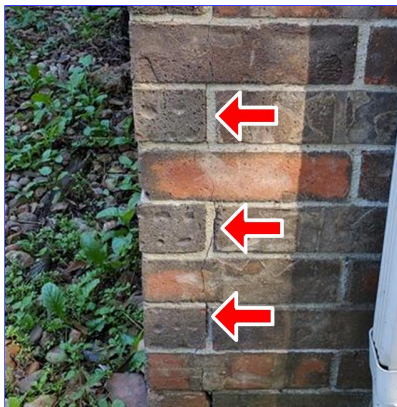
There were some small cracks in the brick veneer at both sides of home that appear to be cosmetic but should be sealed and monitored for growth. Recommend contacting a structural engineer if cracks open back and start to grow.

E. Item 4(Picture) Crack in brick wall at back left corner of home.

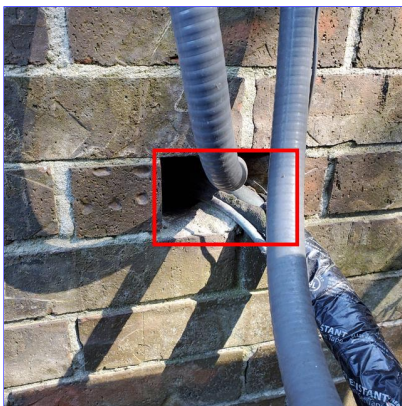
E. Item 5(Picture) Large gap in exterior walk at left side of home by ac condenser. This needs to be repaired to help prevent moisture/critter intrusion.

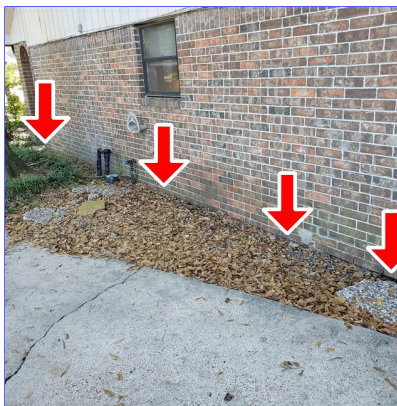
E. Item 6(Picture) Soil in contact with wall coverings at right side of home.

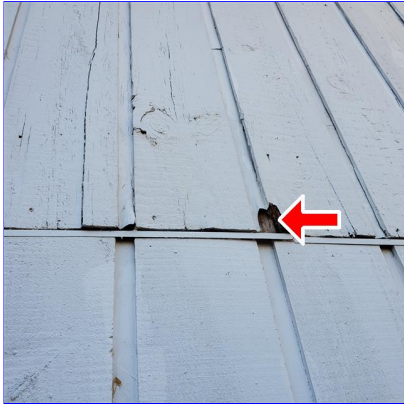
There was rotting siding in several areas on the garage and home. The siding on the home is starting to separate/lift, which could allow for moisture intrusion into the home. Recommend contacting a professional siding contractor to evaluate further and give recommendations on costs of repairs at minimum.

E. Item 7(Picture) Rotting siding on right side of garage. This was noted in a few areas on the garage and home and needs repair to help prevent moisture intrusion.

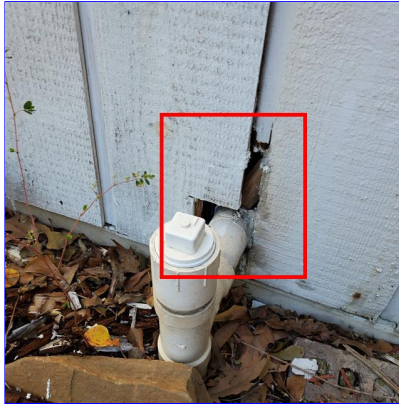
Gaps around exterior penetrations need to be sealed to help prevent moisture intrusion.

E. Item 8(Picture) Gap around penetration in exterior wall at left side of garage. This was noted in several around the home and need to be repaired to help prevent moisture intrusion.

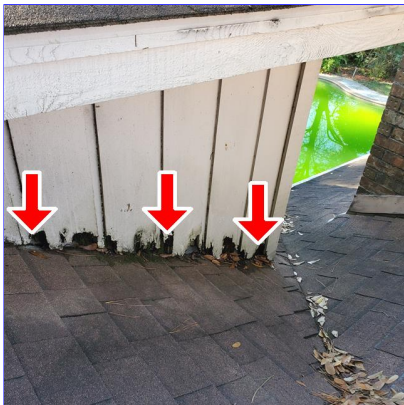
E. Item 9(Picture) Large amount of siding rot on wall at roof level by the chimney.

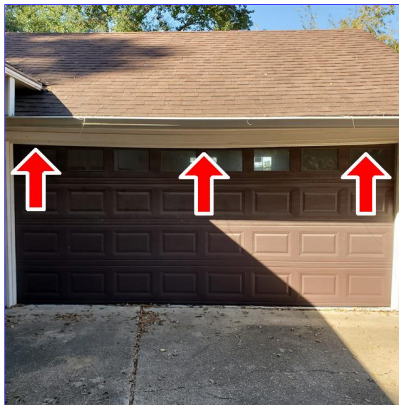
There is a sag in the wall above the garage door. Unsure of cause but recommend further evaluation by a professional contractor to determine cause and to give recommendations on repair.

E. Item 10(Picture) Sag in wall framing at top of garage.

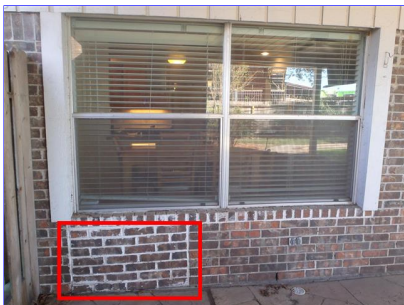
E. Item 11(Picture) Unsure of cause of previous repair to exterior wall at back of home but recommend monitoring this area.

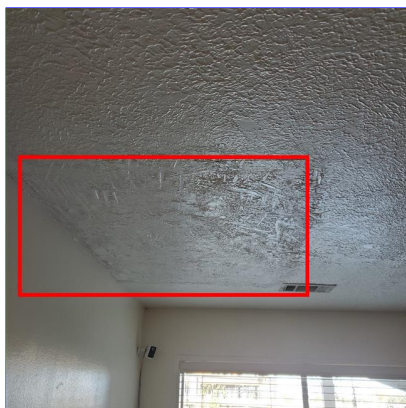
F. Item 1(Picture) Previous repair to ceiling in living room. Unsure of cause but recommend monitoring.

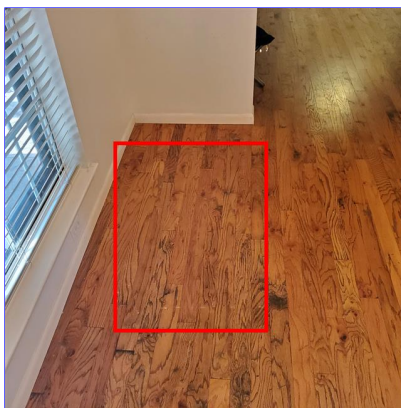
There were several dips/humps in the floors throughout home at time of inspection. Unsure of cause but

F. Item 2(Picture) Slightly sloping floor in the dining room at front of home.

recommend further evaluation by a professional contractor or structural engineer to determine cause and give recommendations on repair.

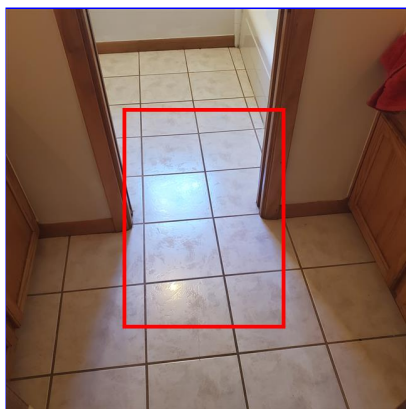
F. Item 3(Picture) Sloping floor in the bathroom. There was also a small crack in the floor tile in this area.

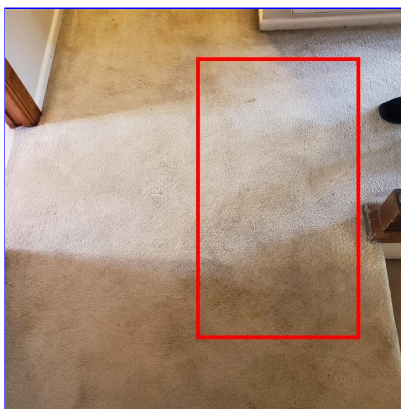
F. Item 4(Picture) Hump in the floor at the top of the stairs.

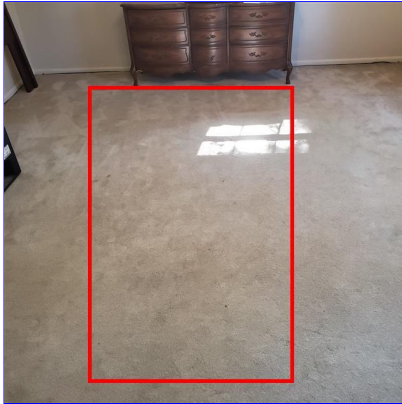
F. Item 5(Picture) Unlevel floor in the bedroom at the top of the stairs.

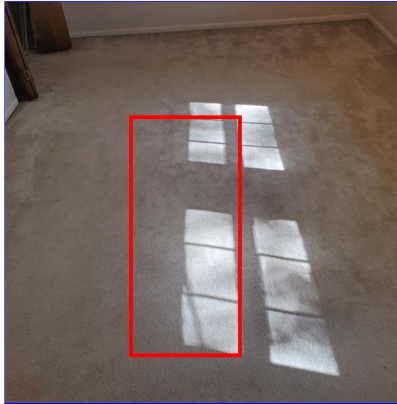
F. Item 6(Picture) Hump in the floor in the upstairs bedroom to the right at the top of the stairs.

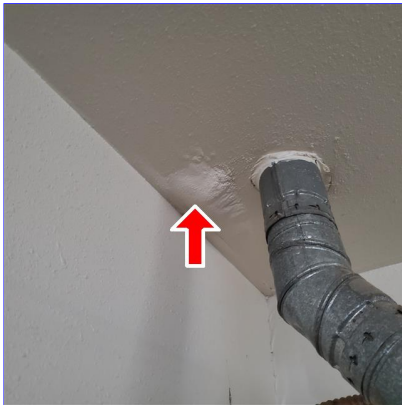
Bubble in ceiling in the garage above the water heater could be due to possible roof leak and needs further evaluation and repair.

F. Item 7(Picture) Bubble in ceiling in the garage above the water heater.

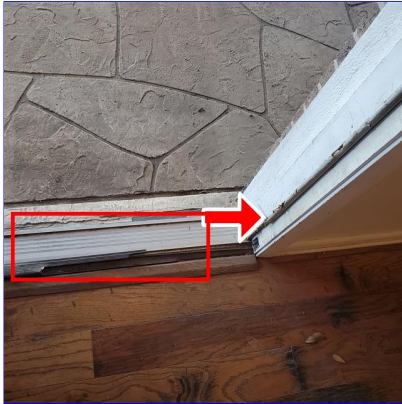
Missing weather stripping and damaged threshold at back door needs repair to help prevent moisture entry and possible trip hazard.

G. Item 1(Picture) Missing weather stripping and damaged threshold at back door.

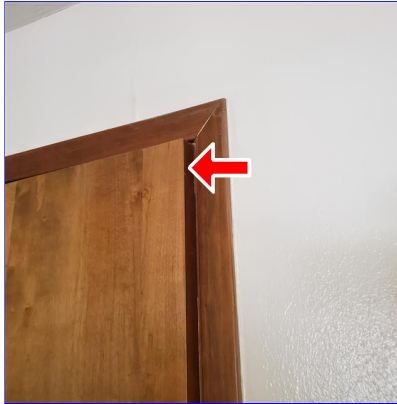
The entry door to the upstairs bedroom to the right of stairs hits the doorframe at the top when closed. Also, door does not latch and needs further evaluation and repair.

G. Item 2(Picture) Entry door, to the upstairs bedroom to the right at the top of the stairs, hits at the top of the door jamb and does not latch properly.

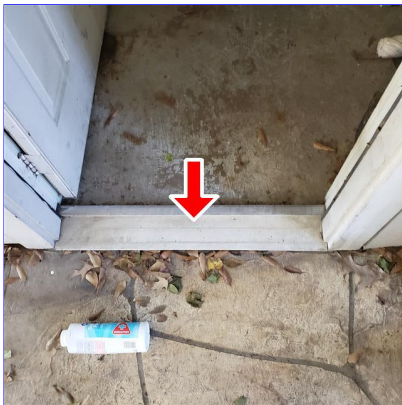
Loose threshold at the garage walk-through door needs to be repaired to prevent moisture entry and possible trip hazard.

G. Item 3(Picture) Loose threshold at garage entry door.

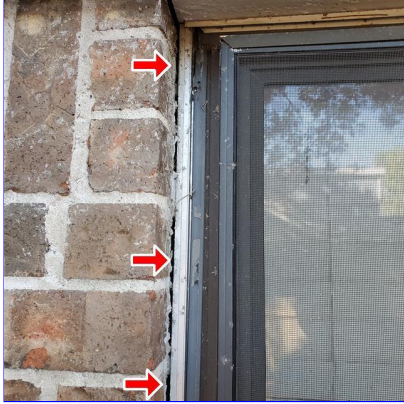
Gap around exterior window, at right side of home, needs to be sealed to help prevent moisture intrusion.

H. Item 1(Picture) Gap around window at right side of home.

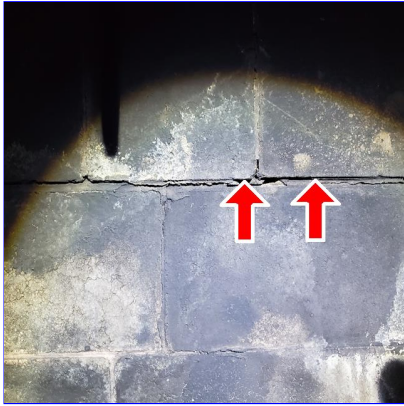
Gaps in fire brick should be sealed to help prevent fire hazard.

J. Item 1(Picture) Gaps in fire brick in firebox.

Recommend contacting professional chimney sweep for further evaluation and to give estimates on cost of repairs needed.

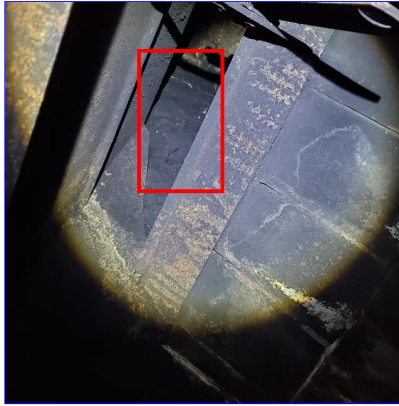
Soot in chimney should be cleaned to prevent possible fire hazard.

J. Item 2(Picture) Soot in chimney.

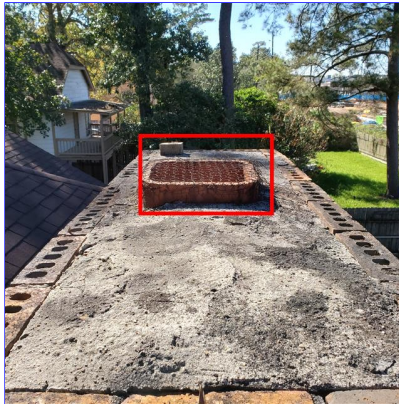
Rain cap on chimney needs to be installed to help prevent moisture intrusion.

J. Item 4(Picture) Missing rain cap on chimney.

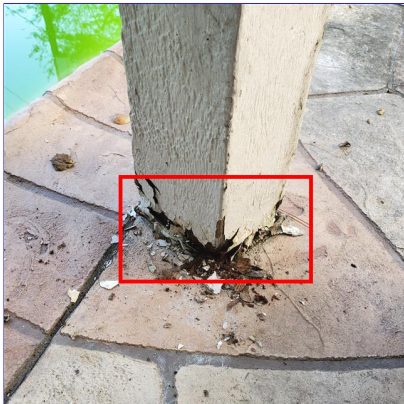
Rotting column/pillar on back porch needs repair to help prevent damage to property.

K. Item 1(Picture) Rotting porch column at back porch.

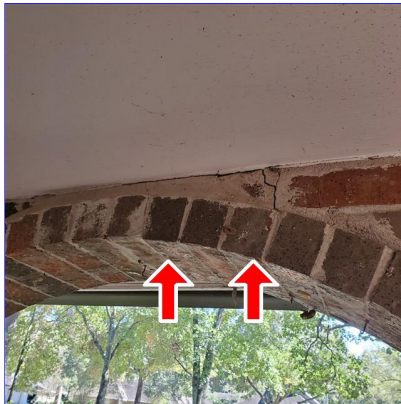
Loose bricks in archway at front of home need to be repaired for safety. Recommend further evaluation and repair by a professional contractor.

K. Item 2(Picture) Loose bricks in archway on front porch at left side of porch.

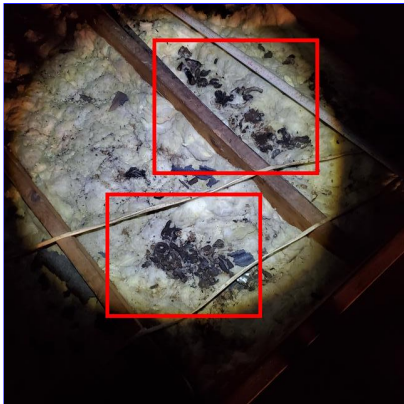
Excrement from possible pests was noted inside the attic and should be evaluated further by a professional pest service for recommendations.

L. Item 1(Picture) Large piles of what appears to be animal excrement.

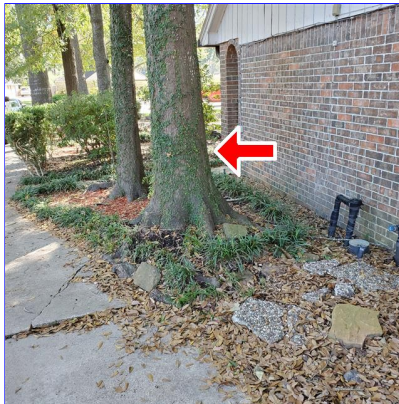
Large trees should be at least 20 feet away from the home to help prevent damage to home. This does not appear to be an immediate concern but should be monitored and removed/repared as needed.

L. Item 2(Picture) Trees within 20 feet of home at right side of home. This was also noted at the front left corner of home.

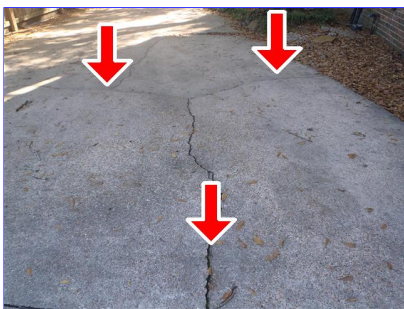
Large cracks in the driveway need to be repaired to help prevent further damage.

L. Item 3(Picture) Large cracks in the driveway at time of inspection.

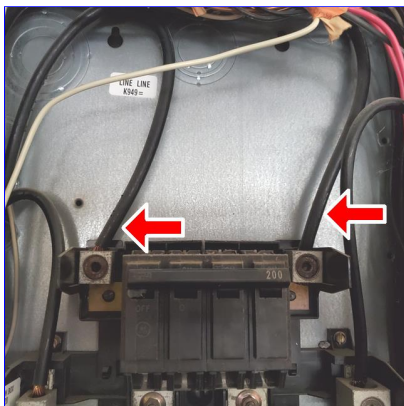
The service entrance wires to the panel appear to be undersized for the panel at time of inspection. This is a possible fire hazard and needs to be evaluated by a licensed electrician.

A. Item 1(Picture) Undersized service entrance wires in panel.

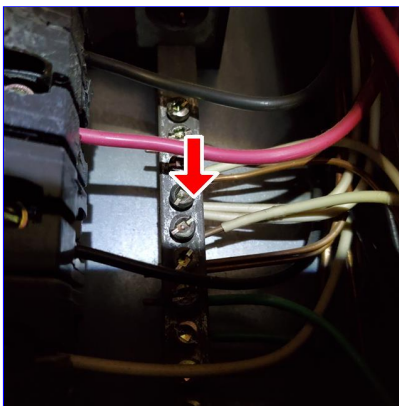
Multiple white wires under set screws on neutral bus in electrical panel. This is typical in homes of this age but can make it difficult to isolate a circuit. Recommend further evaluation and repair, as needed, by a licensed electrician.

A. Item 2(Picture) Multiple wires under set screws on neutral bus.

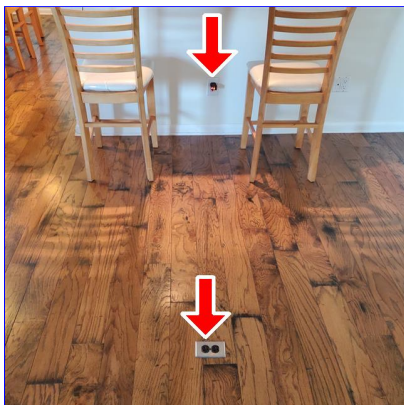
There were several hot/neutral reverses found throughout home at time of inspection. This can cause damage to electrical equipment and should be evaluated further and repaired.

B. Item 1(Picture) Hot/neutral reverse on receptacles in the living room. This was also noted on an exterior receptacle on the left side of home.

Due to the several electrical deficiencies noted recommend hiring a licensed electrician to evaluate the entire electrical system and give quotes on costs of repairs needed for safety.

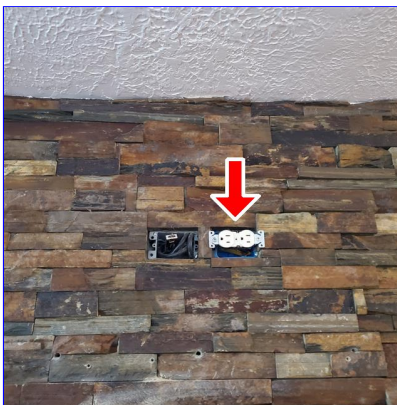
B. Item 2(Picture) Missing cover on receptacle over fireplace needs to be replaced to help prevent possible shock hazard.

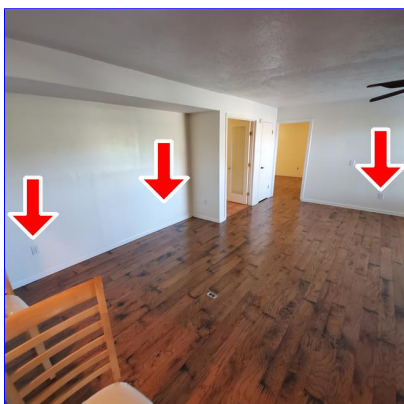
There were several open grounds found throughout home at time of inspection. This is a possible shock hazard needs to repaired for safety.

B. Item 3(Picture) Open grounds noted on receptacles in the living room. This was noted in several areas throughout the home at time of inspection.

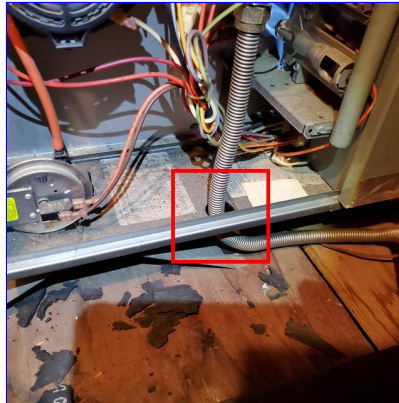
Gas flex line entering directly into furnace cabinet can possibly cause damage to gas line and should be repaired for safety.

A. Item 2(Picture) Gas flex line entering directly into furnace cabinet.

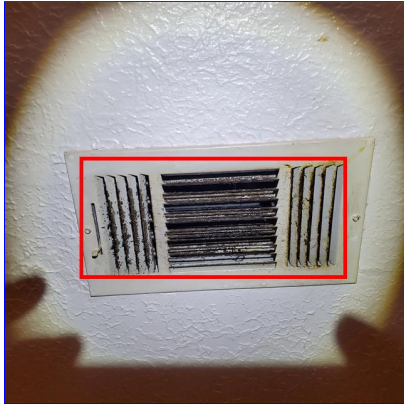
C. Item 1(Picture) Dirty vent register in the kitchen. There were several of these throughout the home at time of inspection.

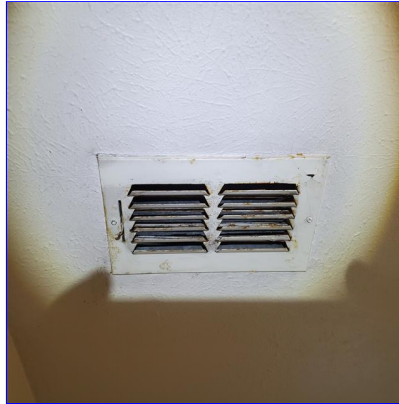
C. Item 2(Picture) Rusting vent in master bathroom appears to be due to no exhaust vent in bathroom but should monitored. This was also noted in the upstairs bathroom at time of inspection.

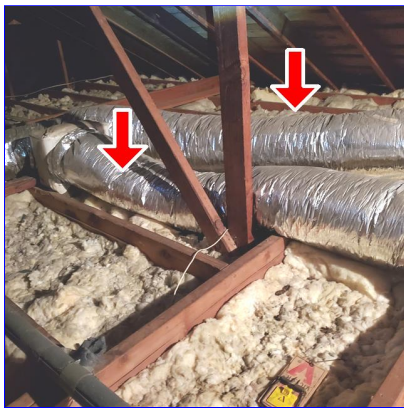
Majority of ducts were laying in insulation at time of inspection. This can cause condensation in ducts and on vent registers, which can cause fungi growth, and should be evaluated further and repaired by a licensed HVAC contractor.

C. Item 3(Picture) Ducts laying in insulation in the attic.

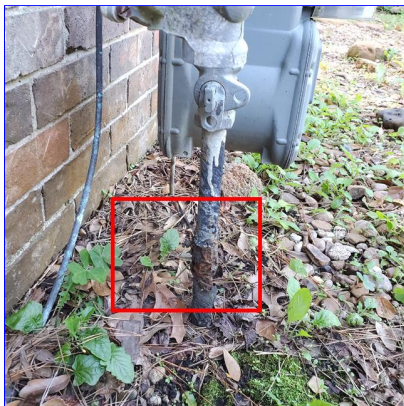
Gas piping at the meter is severely rusted and there appeared to be a gas leak in this area at time of inspection. This needs further evaluation and repair for safety. The gas was shut off at the meter once this was noticed and the property owner was contacted.

A. Item 1(Picture) Damaged corroded gas piping at meter and there was a smell of gas in this area that should be evaluated immediately.

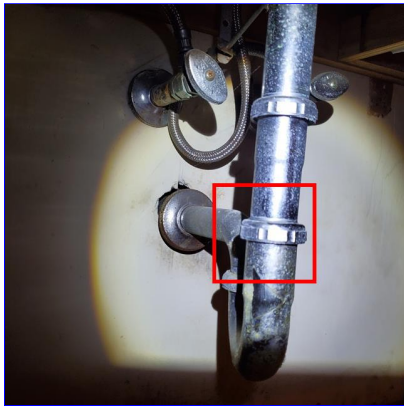
Leaky drain piping under lavatory, on the right, in the upstairs hallway bathroom needs to be repaired to help prevent damage to property and fungi growth.

B. Item 1(Picture) Leaky drain piping under lavatory, on the right, in the upstairs hallway bathroom.

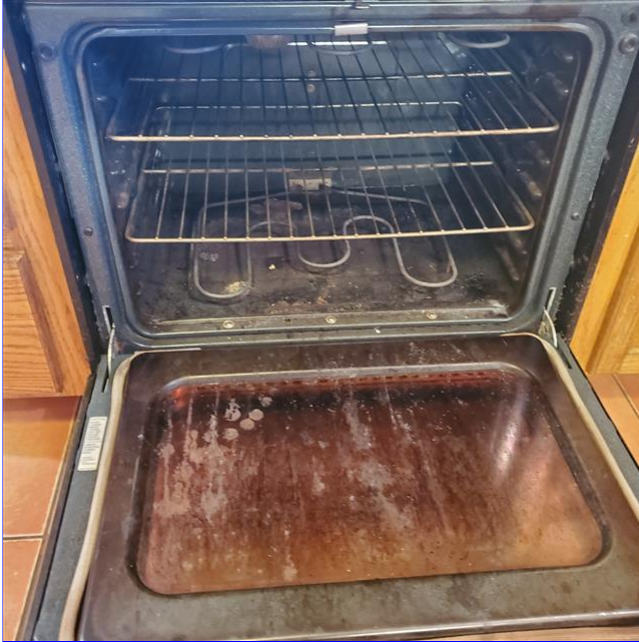
D. Item 1(Picture) Dirty oven.

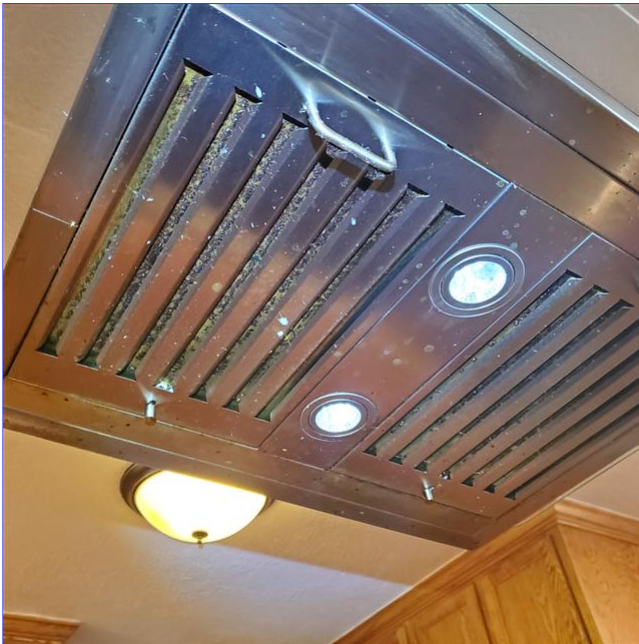
D. Item 2(Picture) Range exhaust filter is dirty and needs cleaning.
