Brad Leland
Inspections you can Trust

Inspection Report

PROPERTY INSPECTION REPORT

Concerning: 4521 Coronado St., Seabrook, TX
(Address or Other Identification of Inspected Property)

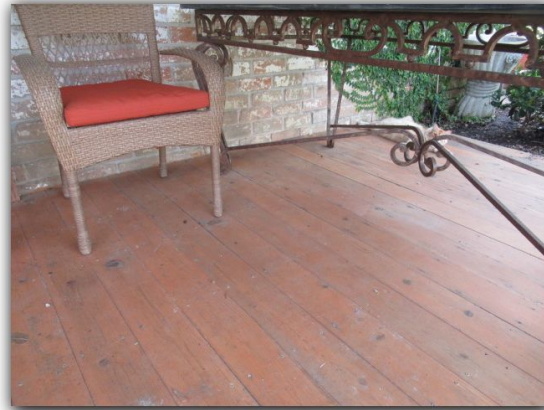
The foundation face is not visible for inspection at the back of the home where the back deck is installed.

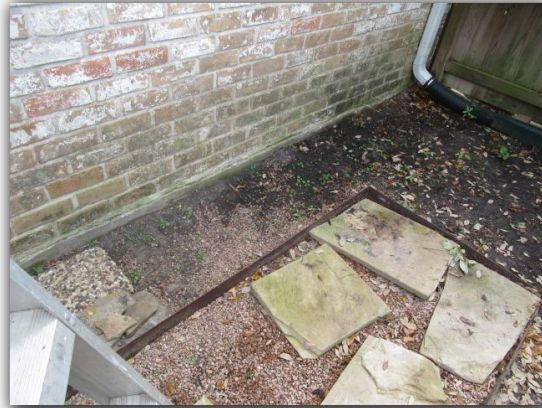
Dirt has been lowered around entire perimeter of home exposing the recommended 4-6 inches of foundation to help prevent any insect infestations from occurring in the future.

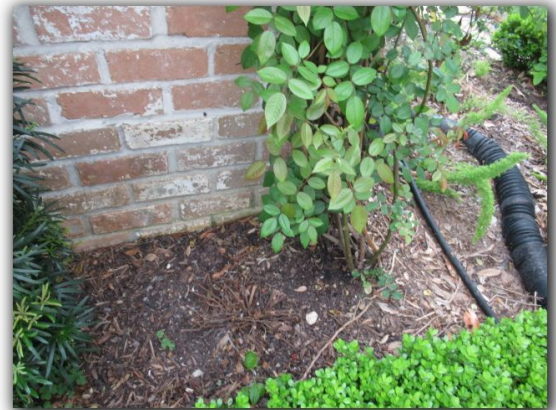
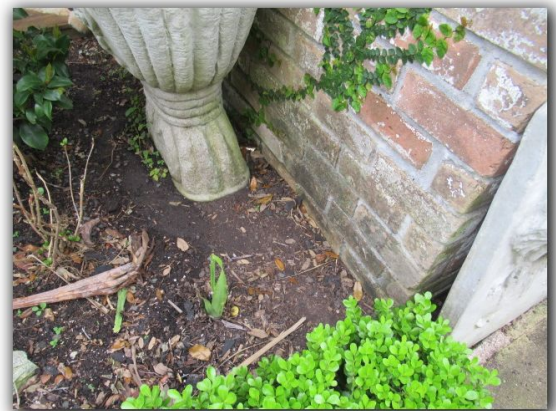
The soil levels are high in relationship with the interior in several areas. When soil levels are high against the face of the foundation it promotes water penetration of the structure and insect infestation. This item should be corrected so there is some exposure of the foundation face without creating reverse drainage. It is generally accepted that in an ideal situation, a brick veneer house should have about 4-6 inches of clearance.

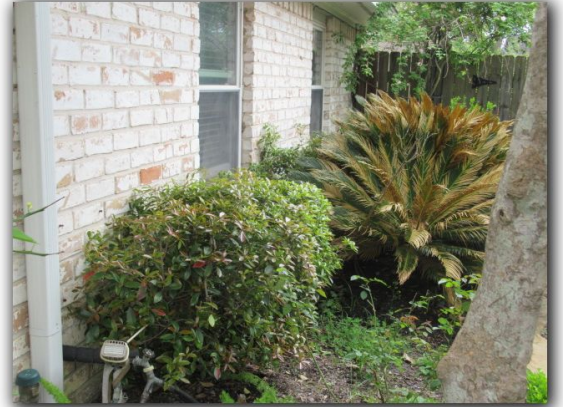
There was heavy foliage in several areas , therefore the face of the foundation and the brick walls in these areas were not visible. This condition will also hold moisture in these areas and may be

conducive for insect activity. Cutting back the foliage in these areas is recommended.

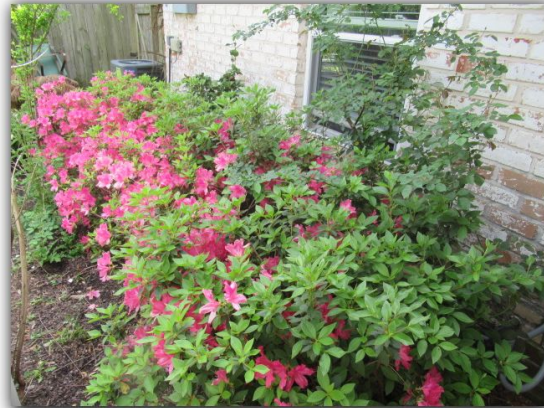
Foliage has been removed along the outside of the home, inspector recommended that it not be in direct contact with the home/foundation. All foliage contacting home was removed to prevent potential issues in the future.

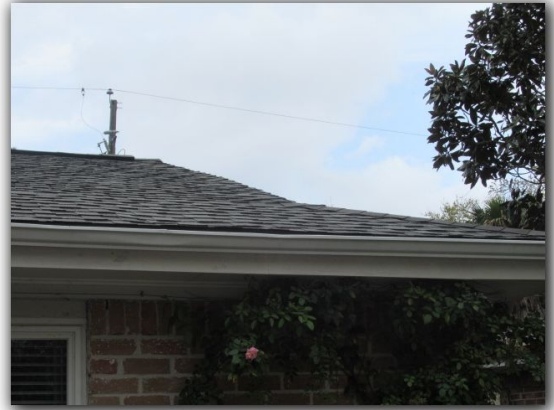
Comments: The gutter system was not sloped adequately to allow for proper drainage at the front of the home. Water loading can cause a gutter system to pull away from the roof structure. This condition makes it easier for water to pass in between the gutter and the fascia board and is considered a conducive condition for wood decay and water penetration.

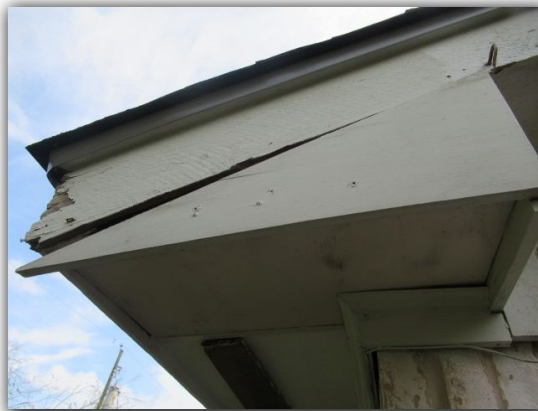
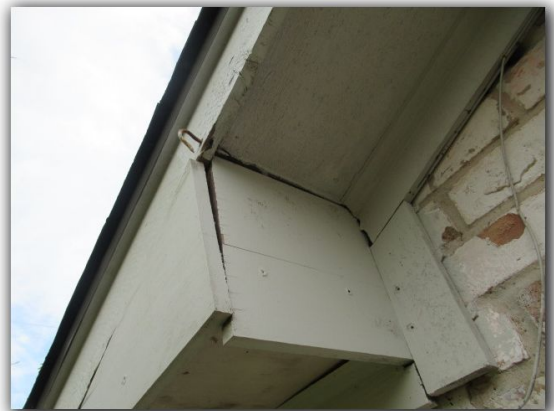
Comments: There were openings or gaps in the roof structure fascia/roof overhang at the rear northeast corner of the home. These gaps should be sealed to keep rain water from entering the interior structure.

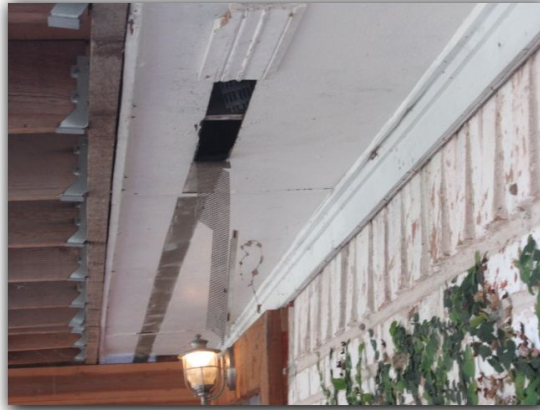
Exterior of home was cleaned and repainted to help preserve quality of the materials as well as prevent wood decay and or water penetration.

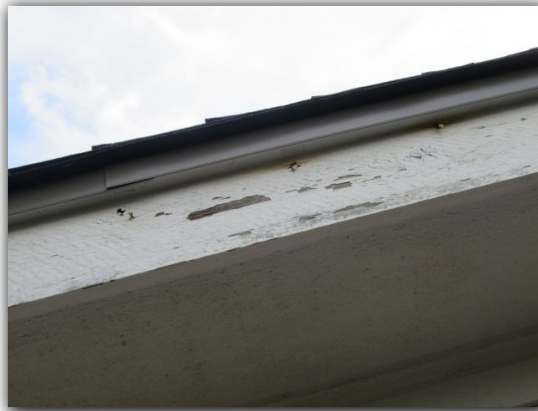
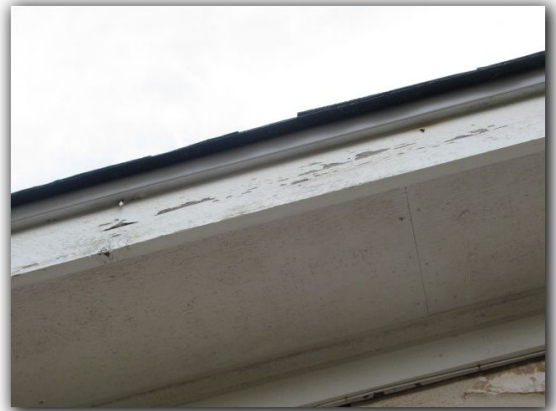
The exterior paint was peeling on the roof overhang in some areas. Exposed or weathered wood is considered a conducive condition for wood decay and water penetration.

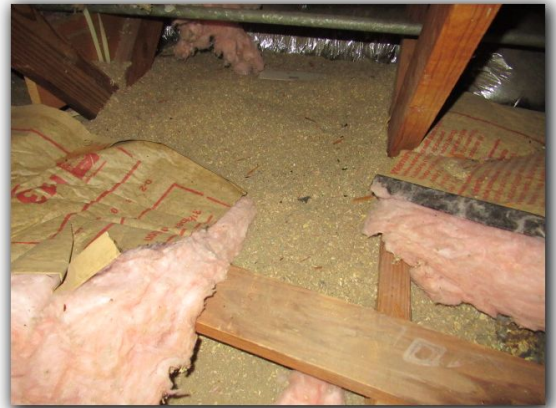
The insulation on the attic floor was thin to meet minimum current standards (r-30, 113/4"). It is recommended that additional insulation be added for energy efficiency.

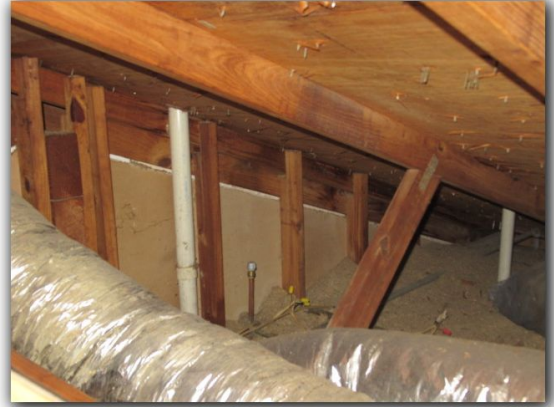
The insulation on the interior attic wall/walls was not complete where visible. It is recommended

that additional insulation be added for energy efficiency.

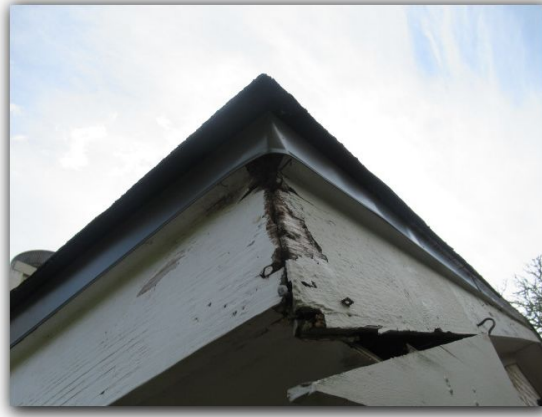
There was water damage to the roof overhang a the rear northeast corner of the home. All damaged elements should be repaired/replaced.

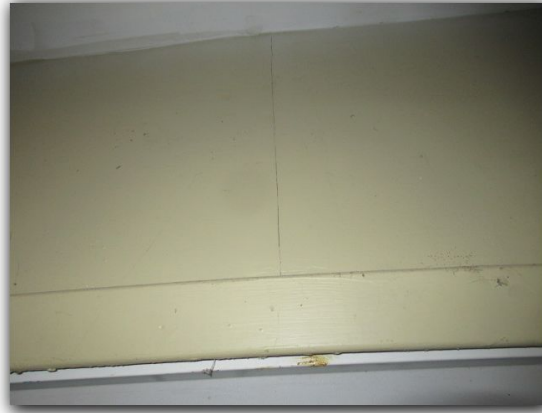
Comments: There was a small crack in the interior sheetrock above the door on the back wall of the garage. This crack should be repaired and monitored for further activity.

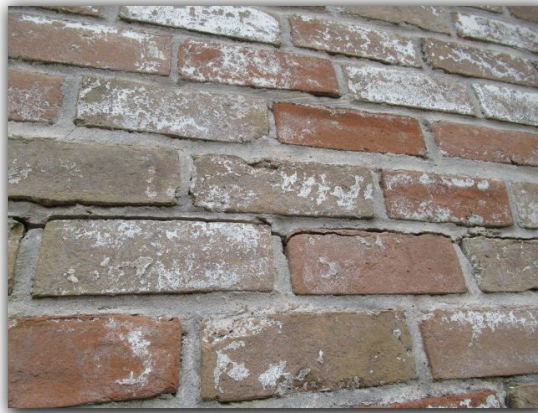
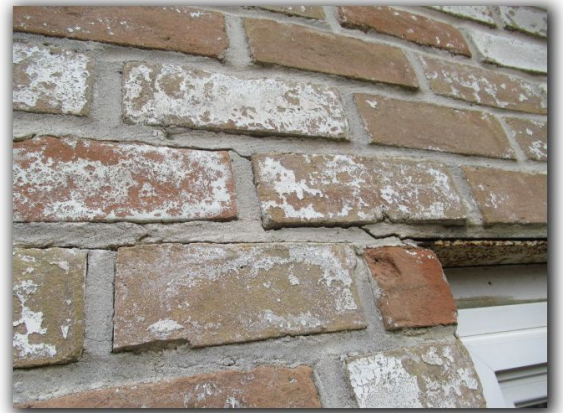
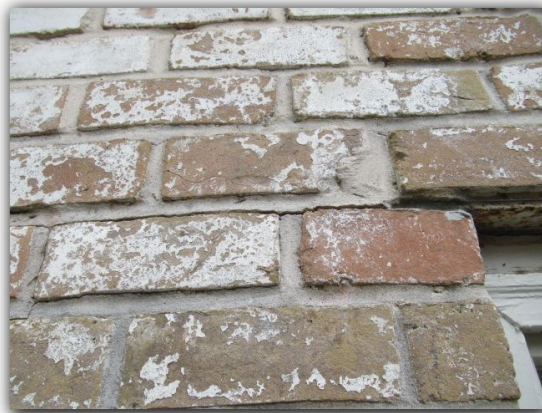
There were small cracks in the exterior brick on the north side of the home. Cracks in the exterior bricks are usually indications that there is some degree of movement occurring in the structure. The severity of the cracks can be an indication of the amount of movement in a structure. These cracks should be filled and monitored for future movement, while also maintaining an even moisture content in the soils surrounding the foundation.

Soil has been moved to help keep an even moisture content around foundation.

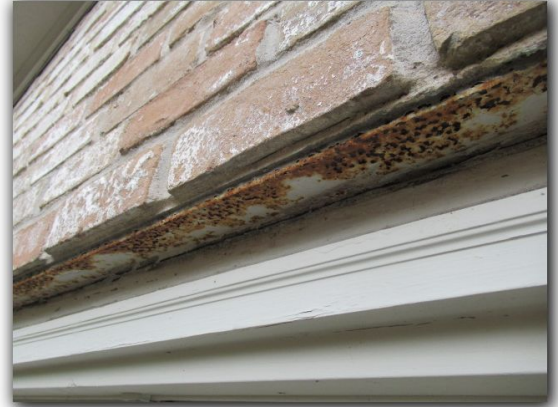
The was heavy corrosion on the metal lintels. A rust inhibitive primer/paint (e.g. Rust-O-Leum)

should be used to prevent further oxidation. These lintels are commonly found over window and door openings that have brick/stonework above the opening.

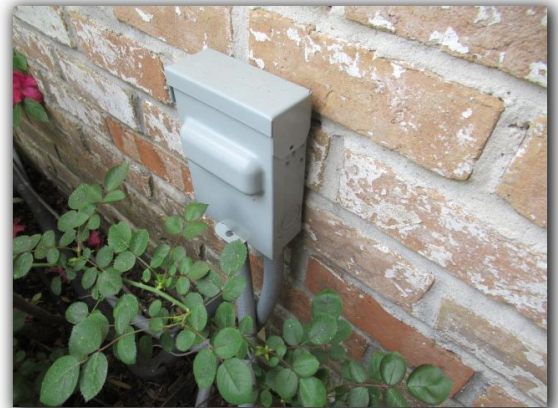
It is necessary to seal around the electric breaker box, electric meter box and the air conditioning compressor quick disconnect box to prevent moisture intrusion and corrosion to the metal boxes.

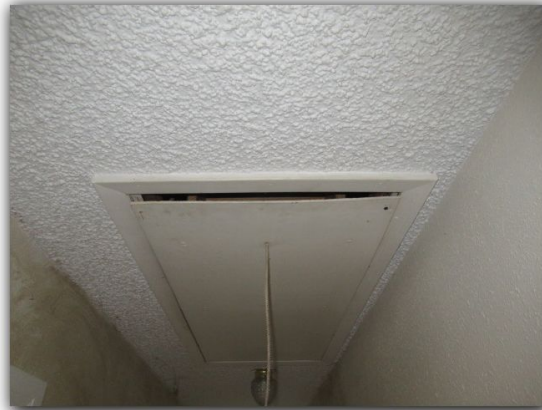
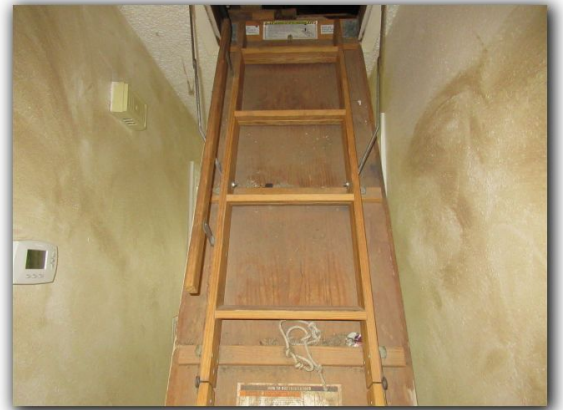
The attic access ladder panel does not seal tight when closed and is not insulated The attic ladder panel should seal tightly against the frame when closed and be insulated to prevent radiant heat from transferring from the attic to the living quarters. It is recommended that the assembly be replaced do to some of the hardware not being secured.

Attic ladder has been replaced and professionally installed and no longer has a gap when it is closed.

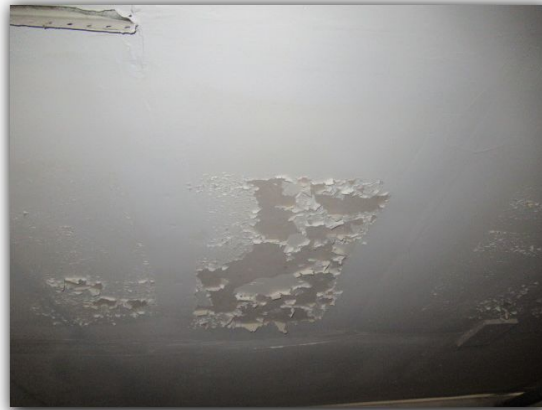
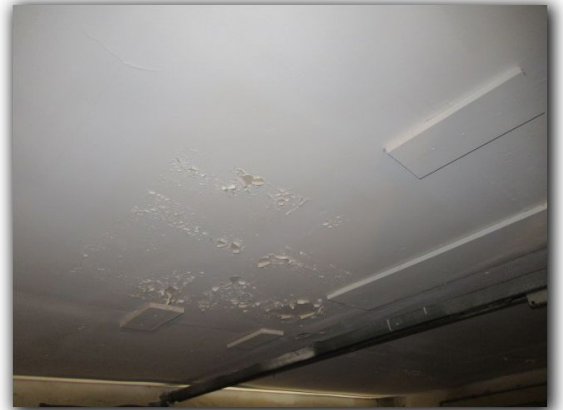
The interior paint was peeling on the ceiling of the garage. It is recommended that a qualified paint contractor be consulted regarding the repair of this condition.

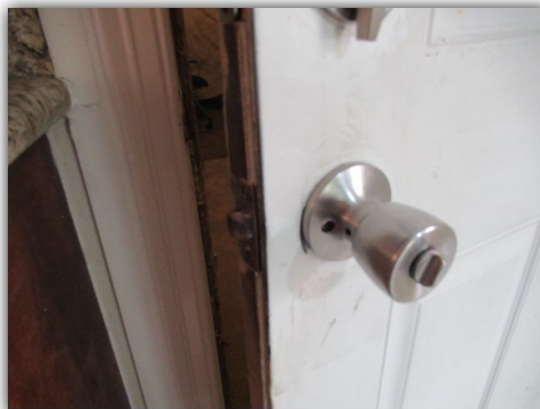
The plunger in the door knob assembly of the door from the house to the garage has been installed backwards.

Home to garage door and hardware have both been replaced and professionally installed. Issue is now resolved.

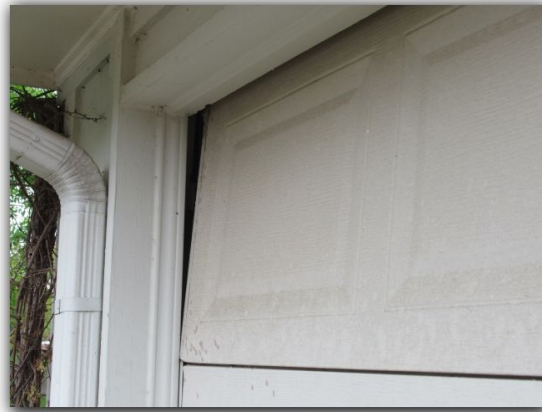
The overhead garage door does not close completely as intended and does not seal well when shut.

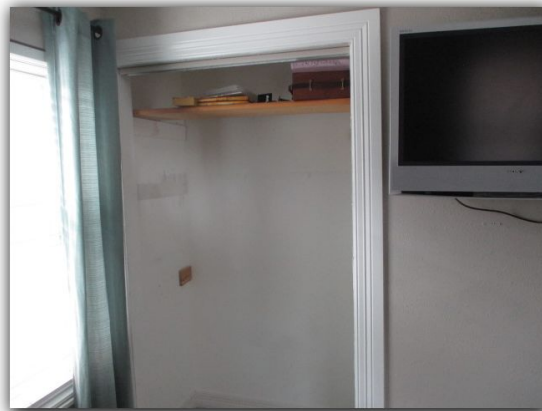
The guest bedroom closet doors have been removed.

New closet doors were purchased and professionally installed.

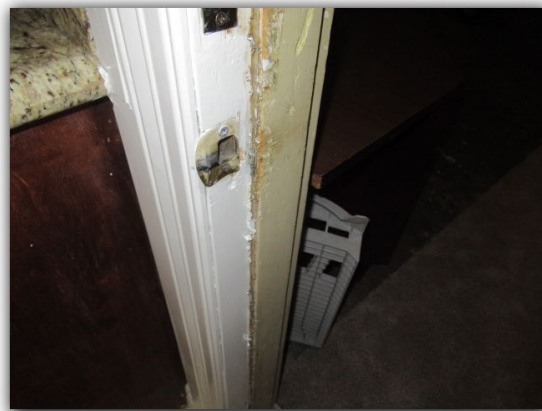
The weather stripping is torn at the door from the house to the garage.

Weather stripping was replaced along with the door. Issue is resolved.

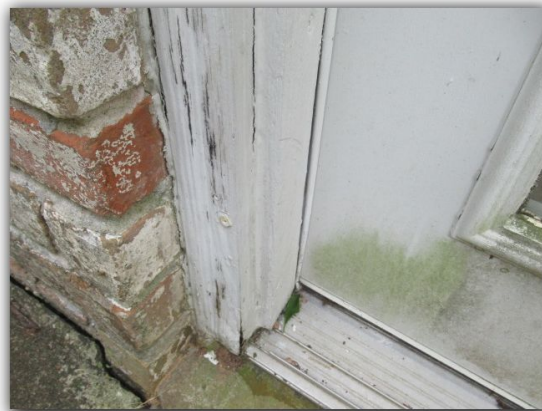
The sliding screen door was missing. Screens are mentioned in this part of the report as they are a specific item in the T.R.E.C. Guidelines. All sliding glass doors that have channels for screens should have them installed.

There is water damage to the exterior trim outside the dining area French doors. All damaged material should be replaced.

Sliding glass door was replaced with french door, screen no longer needed/intended.

New door frames were professionally installed so there should no longer be water damage to the materials.

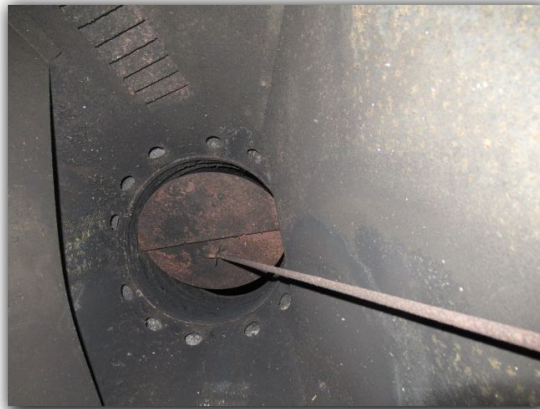
There was corrosion on the damper assembly. This condition is an indication of moisture intrusion.

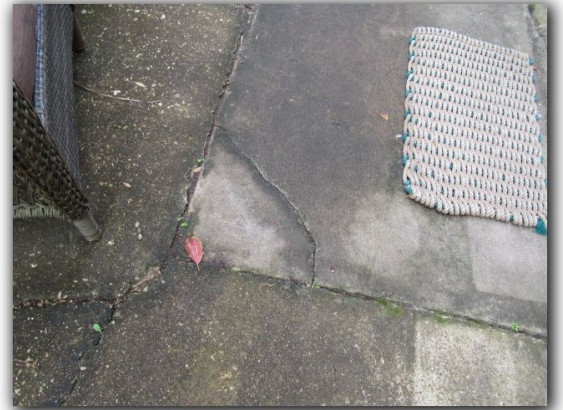
Comments: There were cracks in the north side back patio and it has settled unevenly.

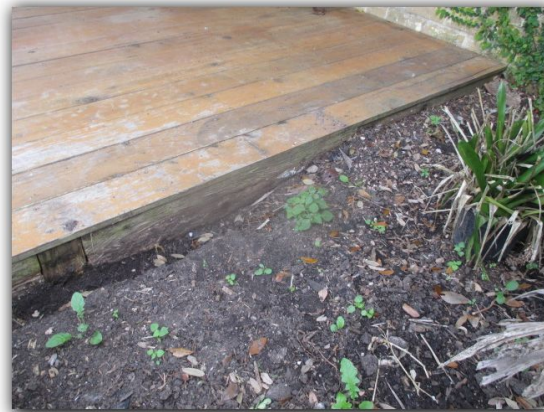
There is earth to wood contact at the back deck. This condition promotes water damage and insect infestation.

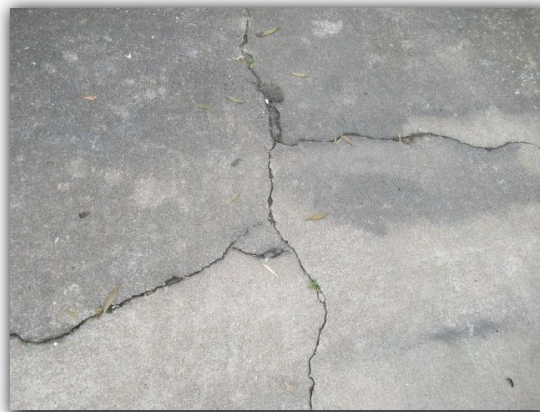
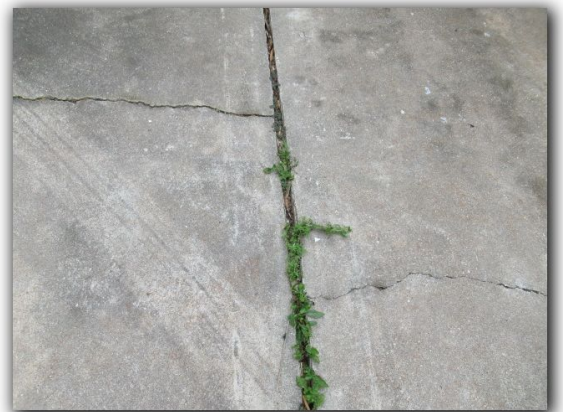
Comments: Driveway sections were cracked/settled unevenly.

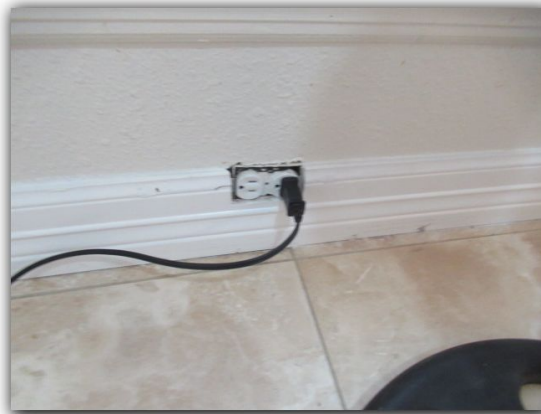
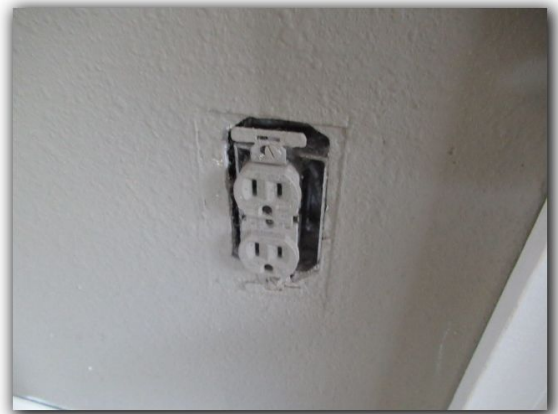
Several of the electrical fixture face plates are missing. Face plates that are missing for either light switches or electrical outlets are considered a safety. Small children can fit their fingers inside. This is an item that is specifically checked in a real estate inspection.

Professional electrician was hired and replaced all outlets, brought them up to standards, and installed face plates. These issues have been resolved.

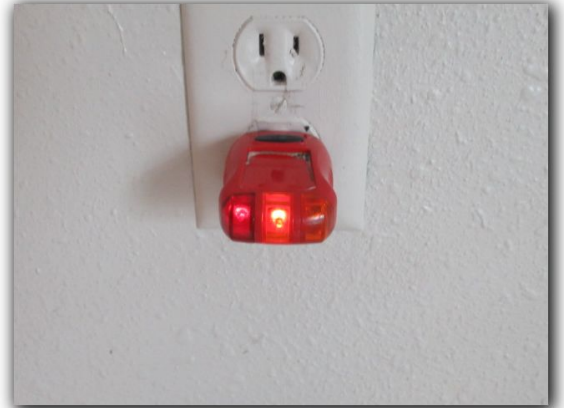
A polarity problem was detected as the hot and neutral wires appear to be reversed at the outlet at the refrigerator location and at the GFCI outlet in the kitchen. Outlets are checked using a circuit tester. As fixing one outlet may cause other outlets down the line to have problems, I recommend that the system in these areas be serviced by a licensed electrician.

Professional electrician was hired and rewired the outlets to resolve the polarity problem. Issue has been resolved.

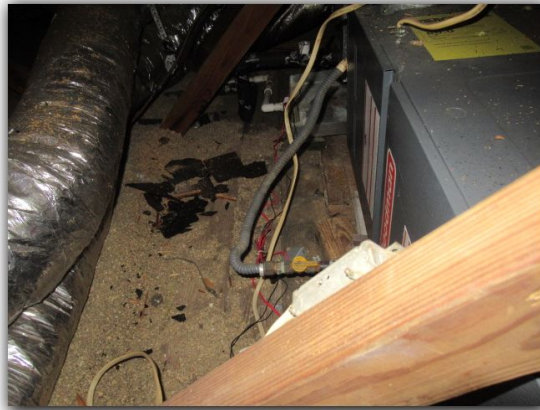
Comments: There is no condensate drip leg/sediment trap installed on the furnace gas supply line as is now required.

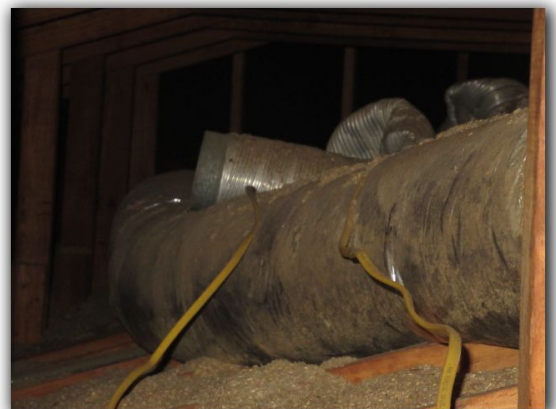
The duct work was not strapped up off of the attic floor as it should be in order to provide maximum air flow and also to prevent damage to the ducts.

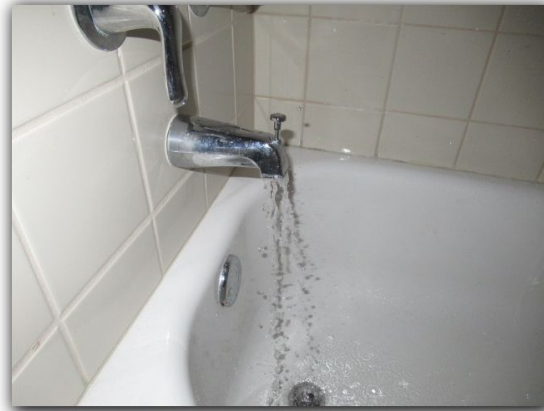
The hall bathroom tub/shower diverting valve did not operate properly. This valve should completely restrict the flow of water from the bathtub faucet and direct the pressure to the shower head. Weak or defective diverting valves should be repaired or replaced when they no longer function properly.

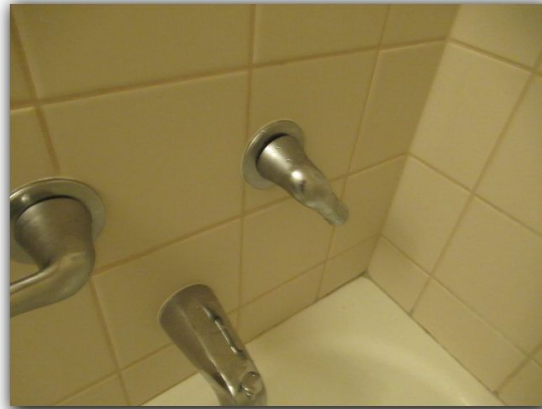
The cold water supply valve for the hall bathtub/shower does not have a positive stop.

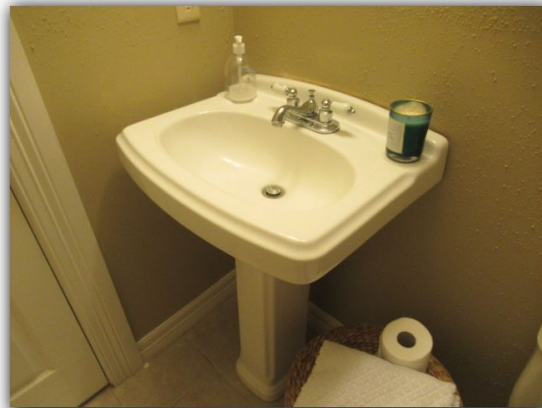
The pedestal sink in the hall bathroom is not secured to the wall.

Pedestal sink has been removed and replaced with a new bathroom vanity that was professionally installed.

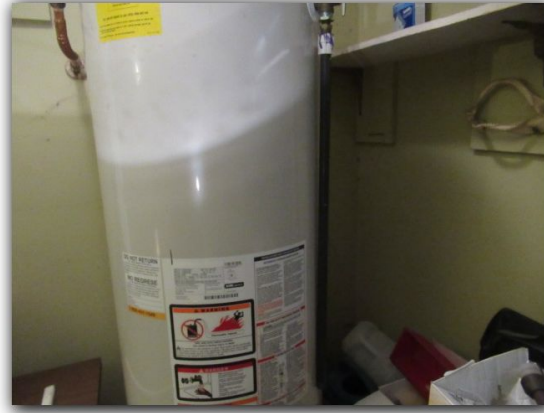
The water heater flue pipe did not appear to be completely of the double walled type as is required for gas appliances.

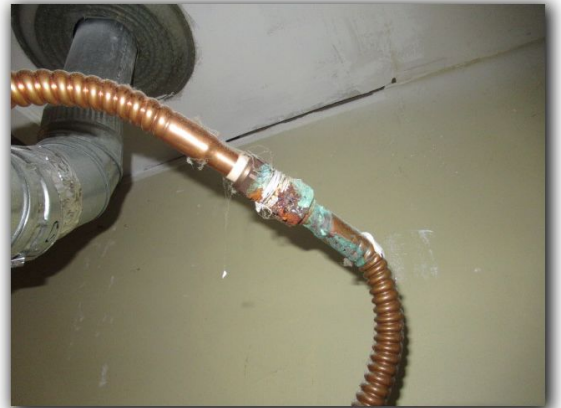
The CSST gas supply has not been bonded as is now required.

There was corrosion at the water supply lines and a slow drip leak. It is recommended that these fittings be replaced.

A qualified plumber should be consulted regarding the repair of the above items as well as check the entire water heating system for any other possible defects.

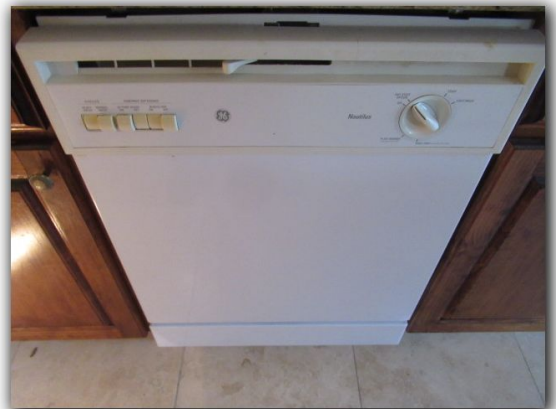
The upper basket is not secured to the left side slide rail.

Brand new stainless steel dishwasher has been installed and is now in normal working order. Issue resolved.

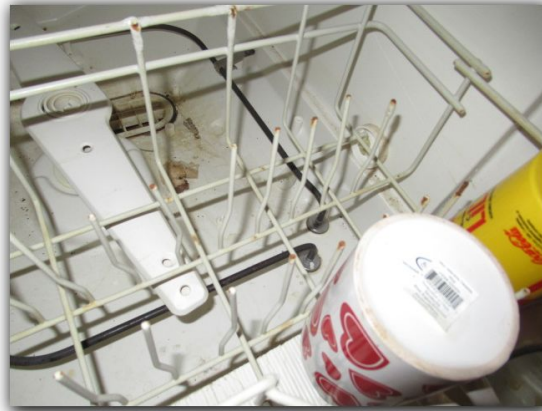
The dishwasher had rust on the baskets.

New dishwasher installed (See above comment)
