PROPERTY INSPECTION REPORT

Concerning: 106 Laurel St, Lake Jackson, TX 77566

By: Brad Summers TREC#22343 TREC#22343 / SumTex Inspections

6/29/2019

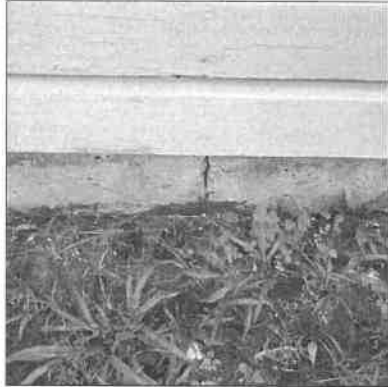
A. Item 1(Picture) right side of home

Foundation Performance: Signs of structural movement noted; suggest that an expert in this field be consulted.

(1) Crack in the slab located on the right side of the home. Crack is a sign of foundation movement.

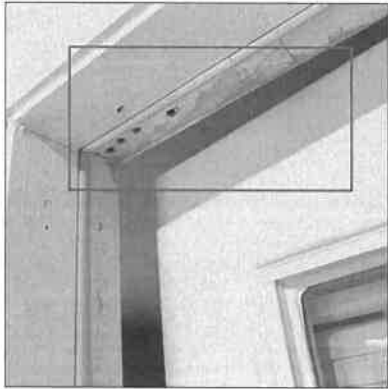
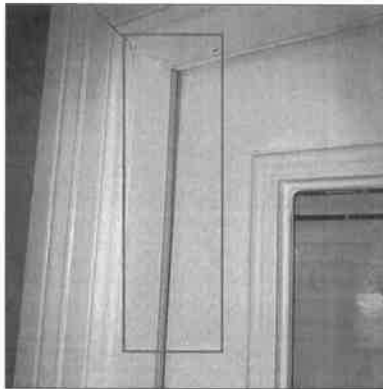
(2) Previous signs of repair at the door to the garage from the interior. The door is out of square and no longer has proper seal with weather stripping top left corner.

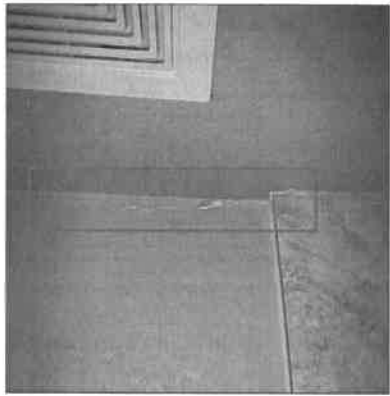
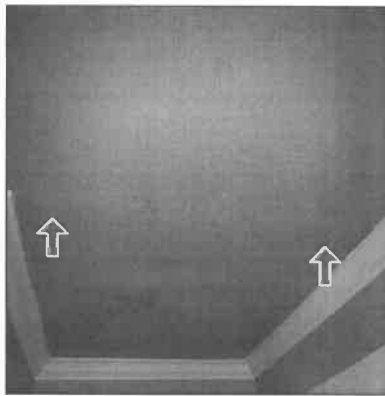
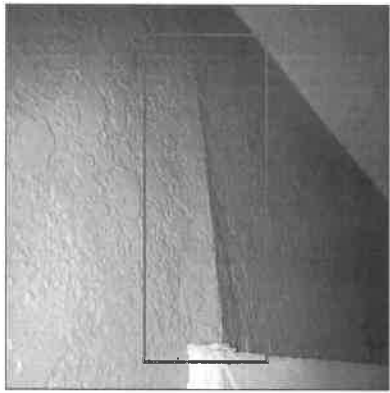
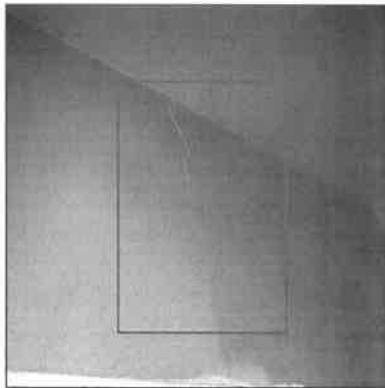
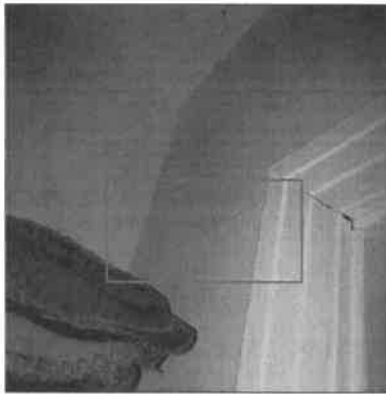
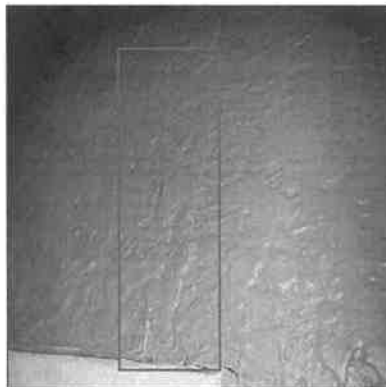
(4) Settling cracks in drywall throughout home. Cracks in drywall is a sign of foundation movement.

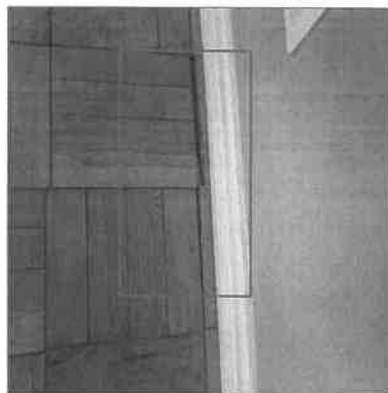
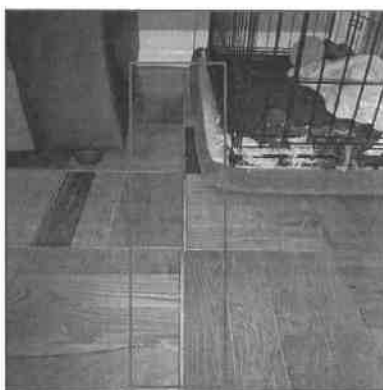
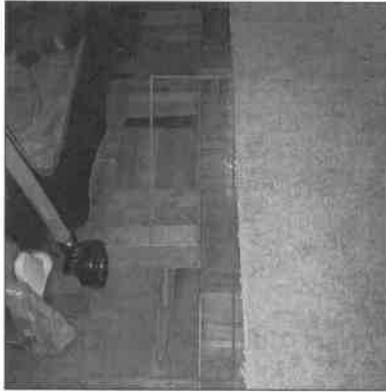
(5) The wood flooring in multiple locations has separated and appears to be caused by foundation movement.

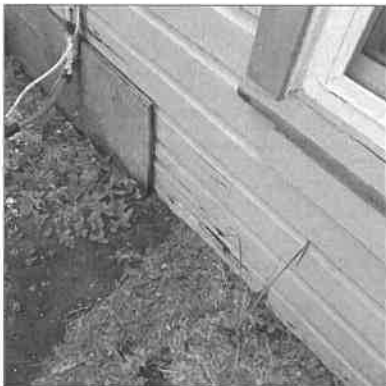
B. Item 1(Picture) rear of home

All Exterior Siding siding should be at least 2 inches above the grade. Inadequate clearance may result in moisture intrusion of the structure. Excessively high moisture levels can result in damage to the home structure or materials from decay or deterioration.

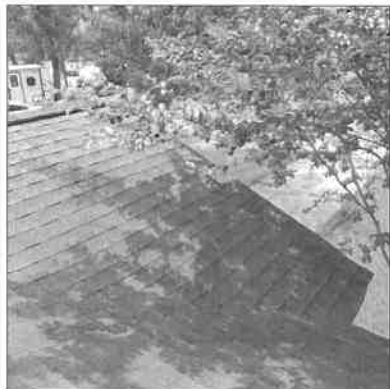
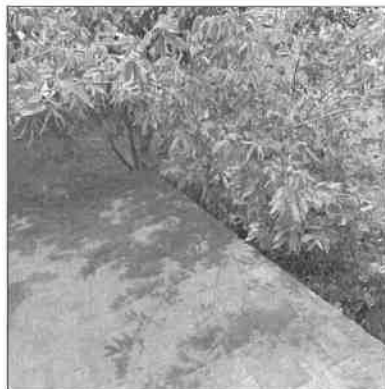
(1) Trees limbs are in contact with roof. This can cause damage to the asphalt shingle. Inspector recommends that all tree branches be cut back so that they do not overhang the roof.

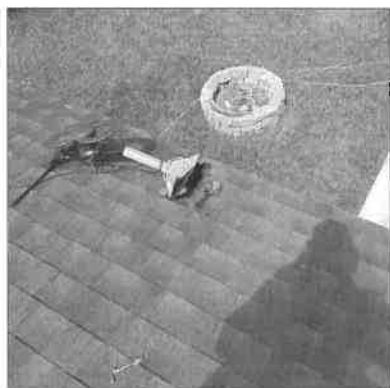
C. Item 3(Picture)

(2) Antenna that was secured to the roof is no longer secured. Holes should be repair to prevent leaking.

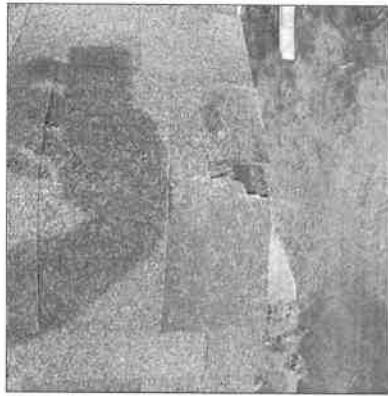
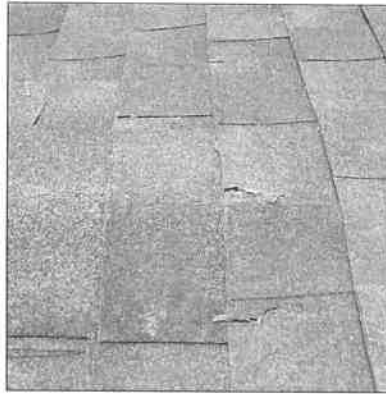
(3) Damage at the ridge on the right side of the home.

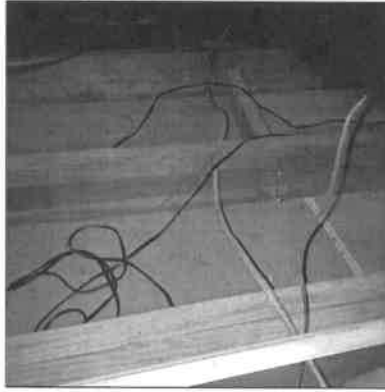
D. Item 1(Picture)

Thermal insulation installed to limit heat gain and loss in the living space was not present at the time of the inspection. To reduce energy consumption and heating/cooling costs, the inspector recommends that thermal insulation be added to meet modern standards.

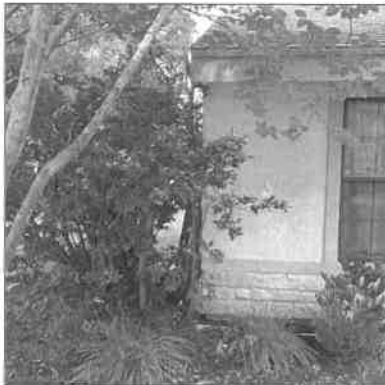
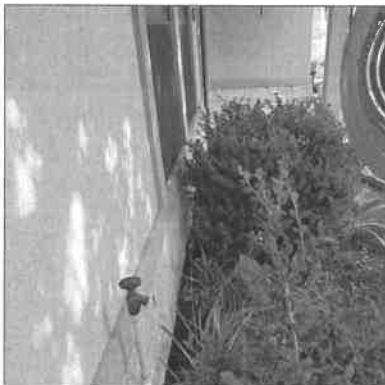
(1) Bushes in contact with home may introduce insects, pests and/or accelerate deterioration of the exterior wall covering by retaining moisture.

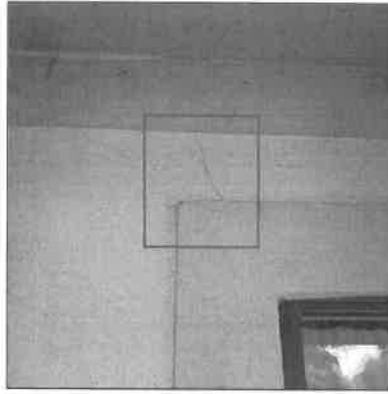
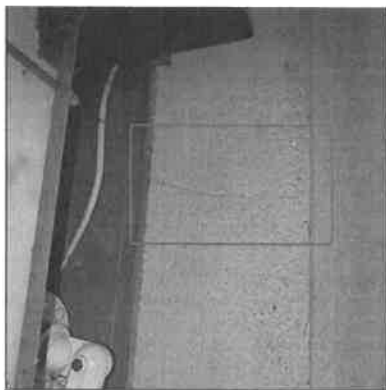
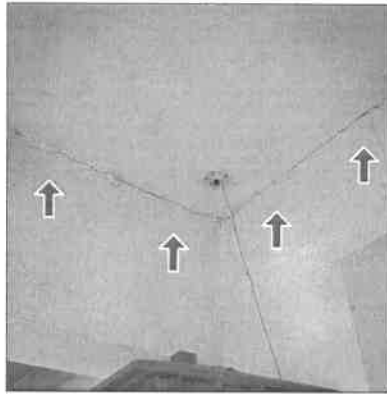
(2) Multiple cracks in stucco at the time of the inspection. Cracks in stucco can have multiple causes and the cause of cracks are undetermined. All cracks should be repaired to prevent moisture intrusion.

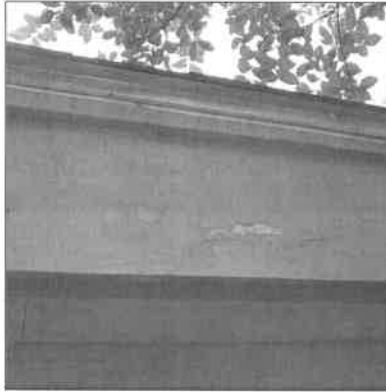
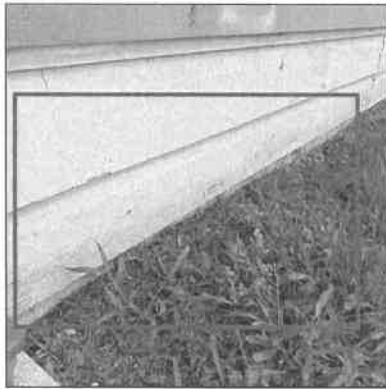
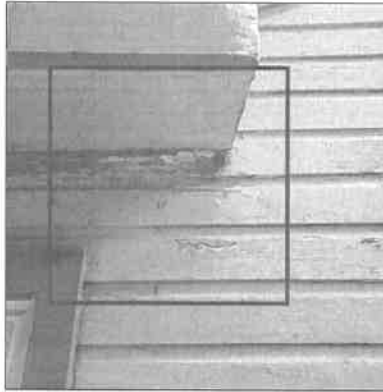
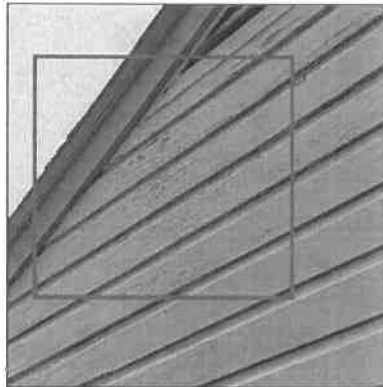
(3) All exterior wood needs to be caulked and painted to prevent decay from moisture intrusion.

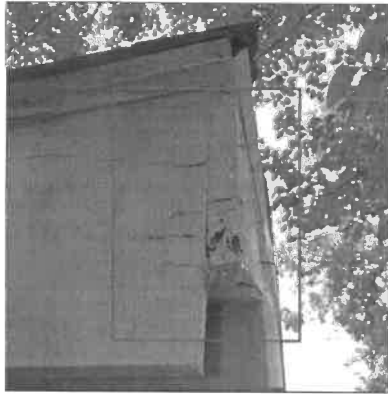
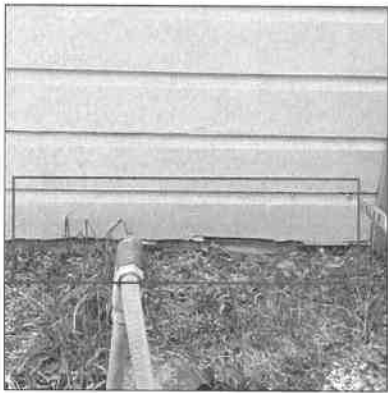
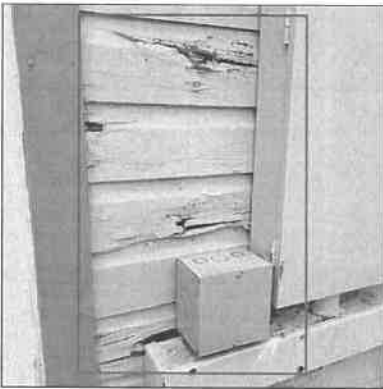
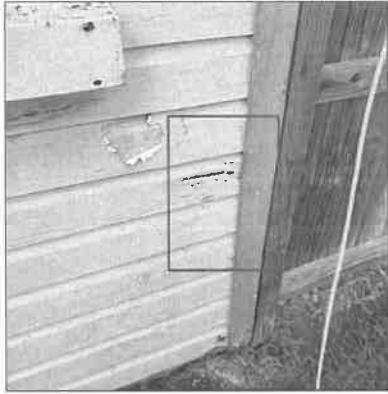
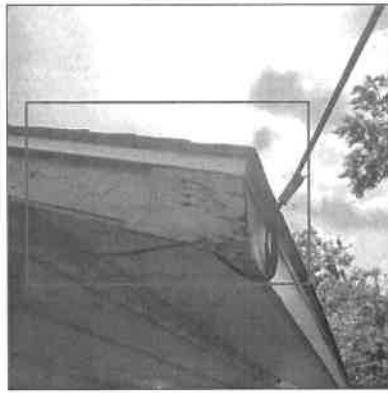
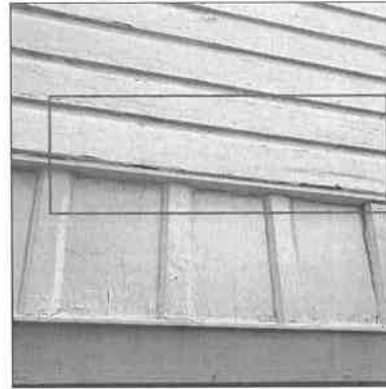
(4) Wood siding had areas of advanced deterioration that will allow moisture intrusion of the wall assembly. The Inspector recommends replacement of siding in any such areas to help prevent damage from moisture intrusion to the home materials and the exterior wall structure.

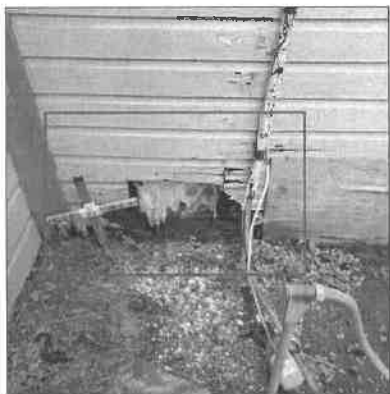
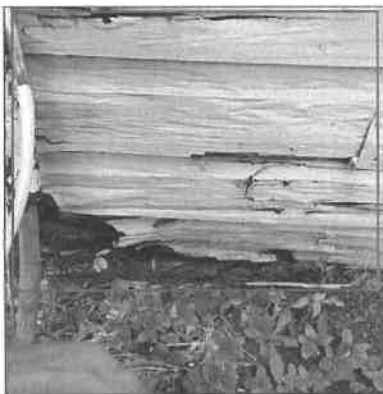
(5) Large hole in siding at the rear of the home near the AC unit. Hole should be repaired to prevent moisture damage.

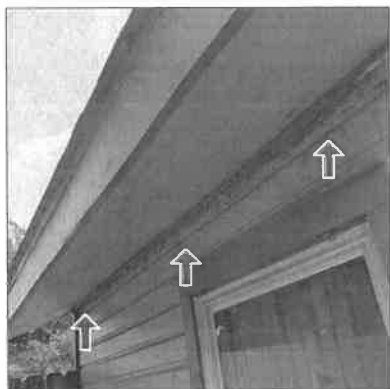
E. Item 40(Picture)

(6) Previous signs of repair left side of home. Buyer should inquire about repair from seller.

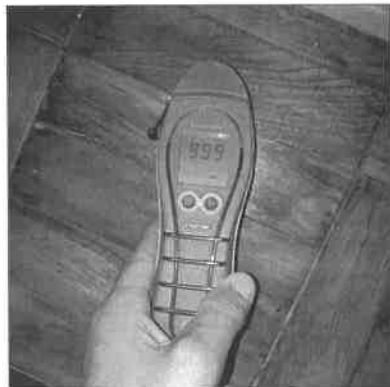
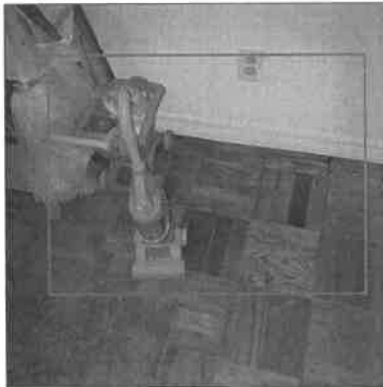
(1) Moisture damage and current signs of moisture in the back left bedroom near the exterior wall. The moisture is coming from the hole in the siding noted in the walls section of this report.

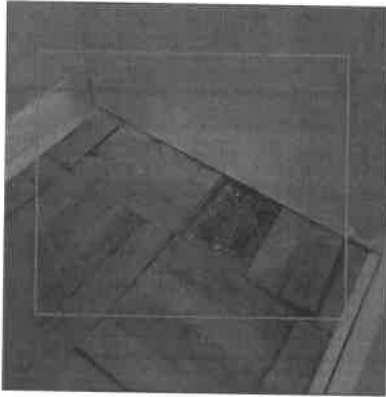
F. Item 3(Picture)

(2) Damage and missing wood tiles in the front left secondary bedroom closet.

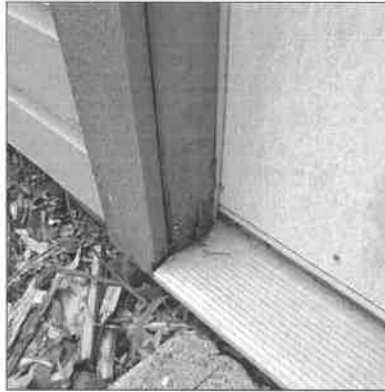
G. Item 1(Picture) right side of home

(1) A door frame to the exterior at the right side (facing front) of home exhibited Moderate damage or deterioration.

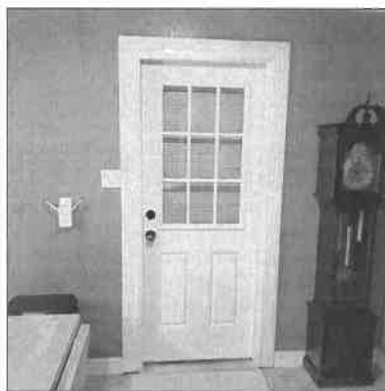
G. Item 5(Picture)

- (2) The door in the wall between the garage and the home living space did not have operable self-closing hinges as is required by generally-accepted current safety standards.
- (3) The door in the wall between the garage and the home living space did not meet generally-accepted current safety standards. Doors in firewalls must be a minimum of 1 3/8 inches thick, metal or a 20 minute fire-rated panel door.

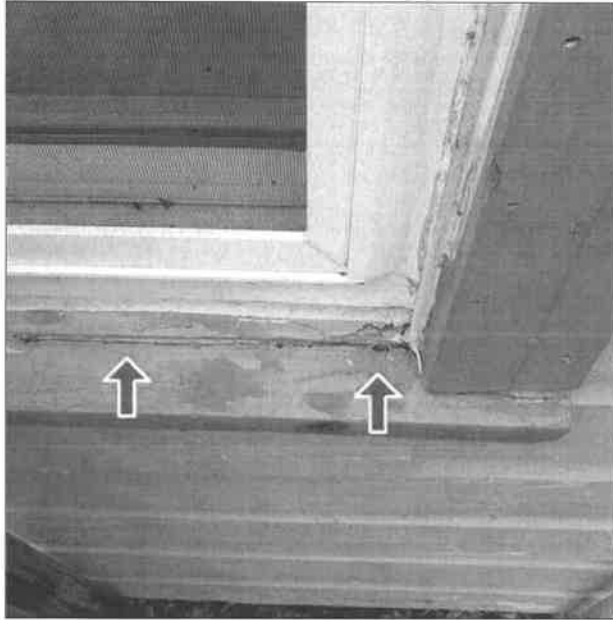
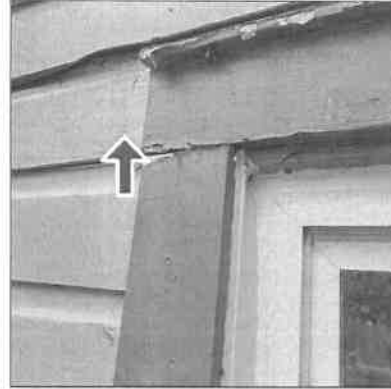
Window trim at the rear of the home needs to be caulked and painted.

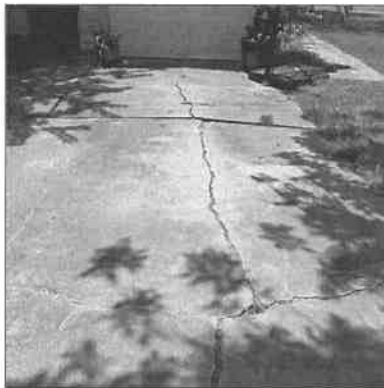
L. Item 1(Picture)

Driveway has settling damage and should be repaired.

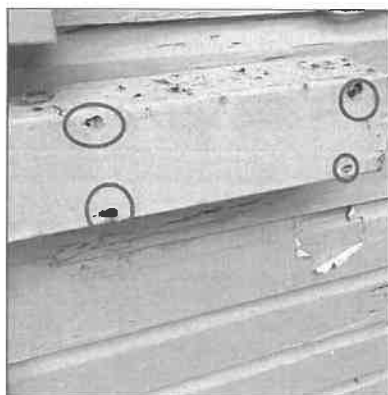
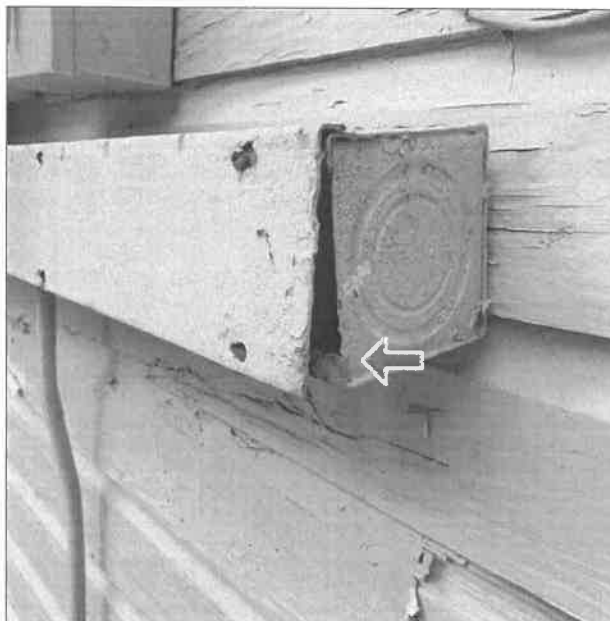
- (4) Cable trough below main electrical panel is not properly secured.

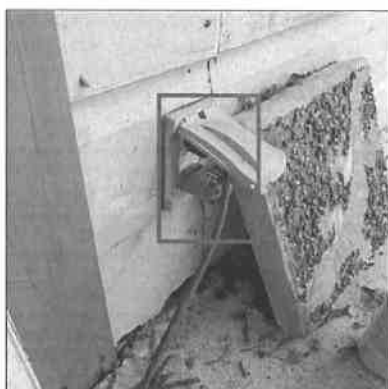
B. Item 1(Picture) rear of home

(1) A ground fault circuit interrupter (GFCI) electrical receptacle did not respond to testing, did not re-set, was slow to re-set or made a buzzing sound when re-set. The Inspector recommends replacement of the receptacle to ensure that it works correctly when required.

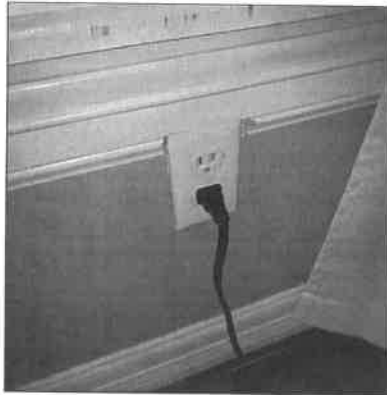
B. Item 2(Picture) main living area

(4) Outlet is loose at the wall and needs to be secured.

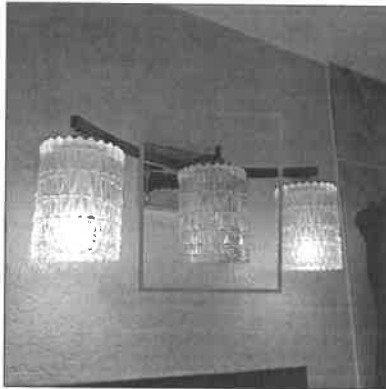
B. Item 3(Picture) guest bath

(5) Light fixtures did not respond to the switch. The bulb may need to be replaced or there may be a problem with the switch, wiring or light fixture.

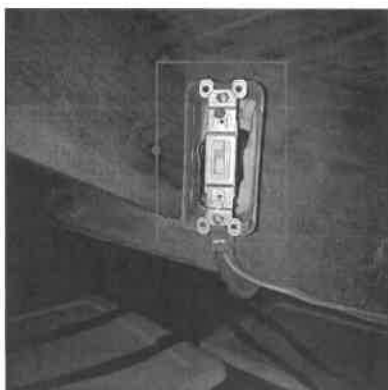
B. Item 5(Picture)

(8) Missing electrical switch cover in the attic. Switch cover should be installed to prevent possible shock.

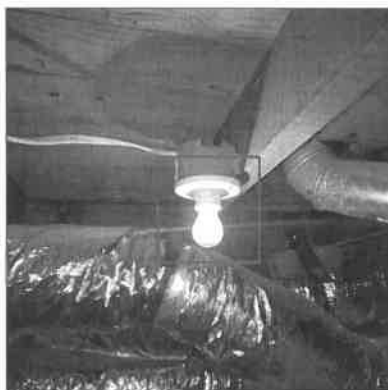
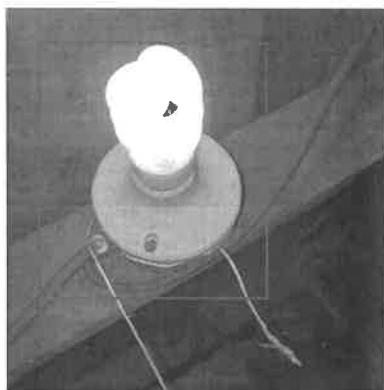
(9) The lighting in the attic were not properly protected. Suggest replace the fixture with proper guard.

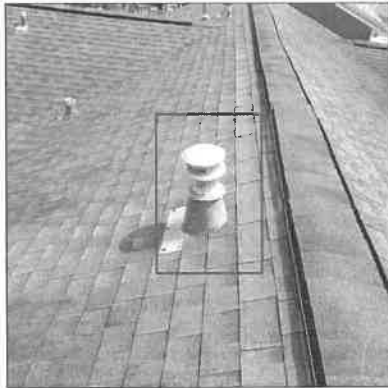
A. Item 1(Picture)

Improper flue height. Exhaust flues require a minimum of 3 ft of vertical height above the roof line and 2 ft above any part of the building.

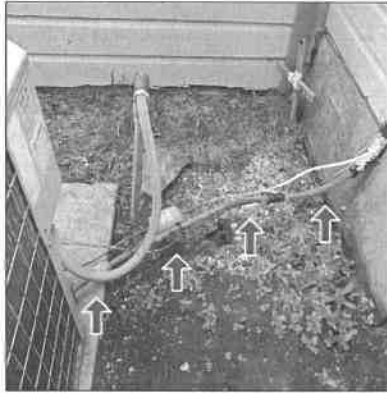
B. Item 1(Picture)

(2) The foam sleeve on suction line is missing foam sleeve in area(s) at outside unit. Missing foam on suction line can cause energy loss and condensation. I recommend service or repair as needed.

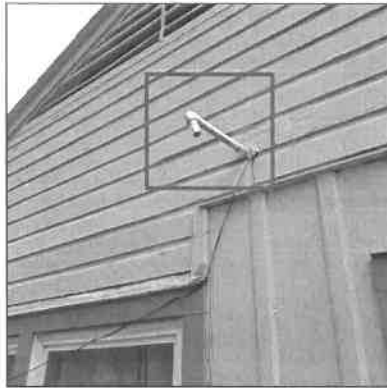
B. Item 2(Picture)

(4) The condensate tube, the purpose of which is to safely discharge condensate produced by the operation of the air-conditioning evaporator coils, discharged condensate to an improper location. The lines should discharge away from the foundation of the home.

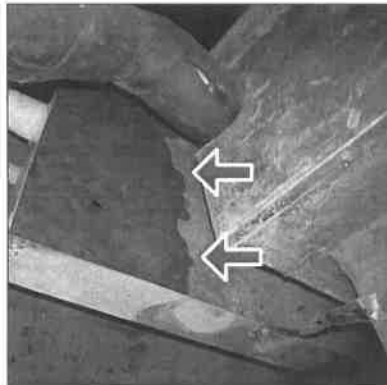
B. Item 3(Picture)

(5) Rust and water in the bottom of the drip pan. This is an indication that the primary drain line is clogged and should be repaired.

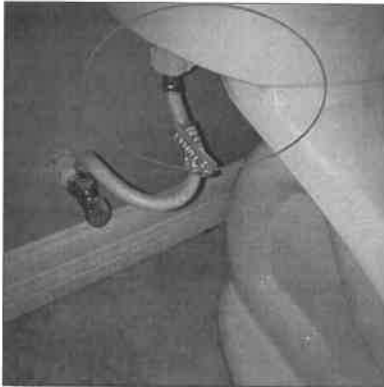
A. Item 7(Picture)

(3) The toilet leaks from the tank in the half bath.

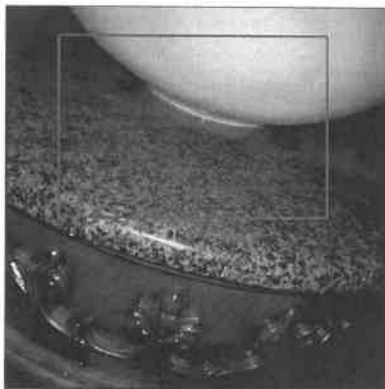
A. Item 8(Picture)

(4) The sink leaks at the base of the bowl in the half bath.

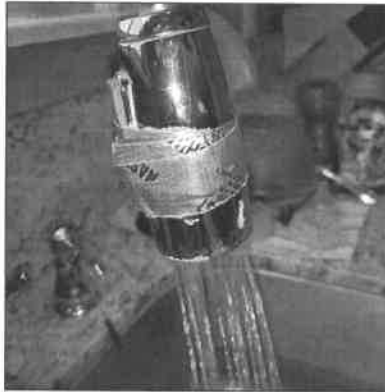
A. Item 9(Picture)

(5) Vegetable sprayer button is inoperable at the time of the inspection.

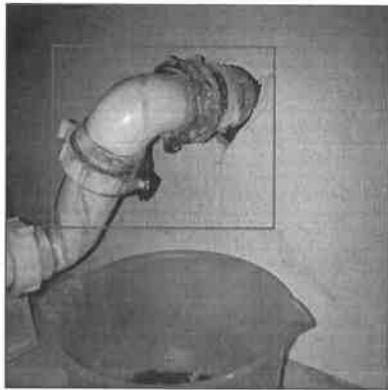
B. Item 1(Picture)

(1) Multiple plumbing leaks under kitchen sink at the time of the inspection.

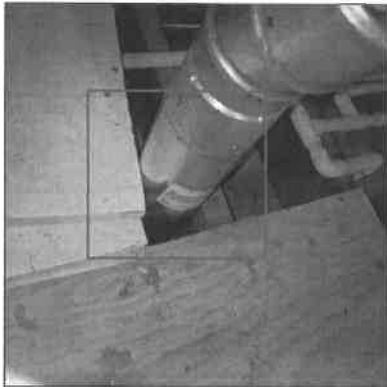
C. Item 1(Picture)

(2) The exhaust flue for this gas-fired water heater had inadequate clearance from combustibles. This type of exhaust flue requires 1-inch clearance from combustible materials.

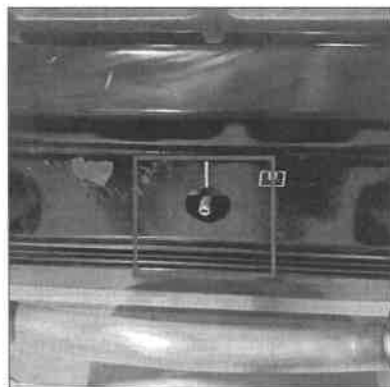
D. Item 1(Picture)

(1) Missing missing knob middle burner at the time of the inspection. Inspector was unable to test middle burner.
