# A-Action Home Inspection Group

## PROPERTY INSPECTION REPORT

Concerning: 4810 Wedgewood Dr., Bellaire, TX 77401  
(Address or Other Identification of Inspected Property)

By: David Schmeck, Lic #22972 04/11/2019  
(Name and License Number of Inspector) (Date)

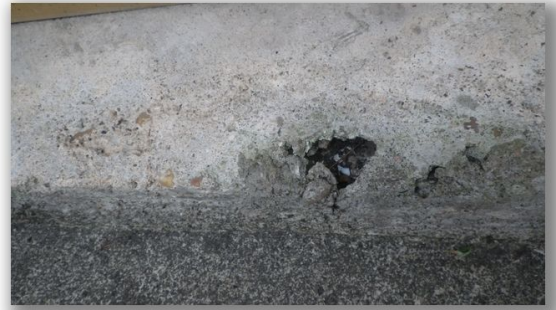
The foundation appears to have had movement that may be beyond normal. A Professional Engineer licensed by the State of Texas should be consulted on the current integrity of the foundation and any repairs that may be necessary (If Any). The observations made to support the rendering of this opinion are listed but not limited to the following:

- In my opinion, this foundation is showing signs of movement that exceeds normal tolerances. The changes in the floor elevation of the house were greater than would normally be expected.
- Deflection cracks were observed in the exterior veneer.
- Misalignment of interior doors due to foundation movement.
- Interior door(s) stick and/or not closing due to foundation movement.
- Separations of the exterior veneer and window frames were observed.
- Frieze board separations were observed.
- Cracks were observed in the floor of the foundation.
- Floor slopes and/or unlevelness were observed.
- Interior drywall cracks and/or stress indicators.

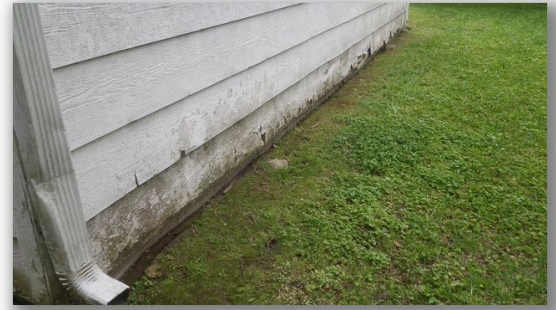
- **Poor to negative site drainage** was observed on the east side of the structure. Proper drainage is needed to help prevent water from standing and/or pooling next to the foundation beam. Corrective measures may be needed if the water stands within 10-feet of the foundation perimeter beam for more than 24-hours.

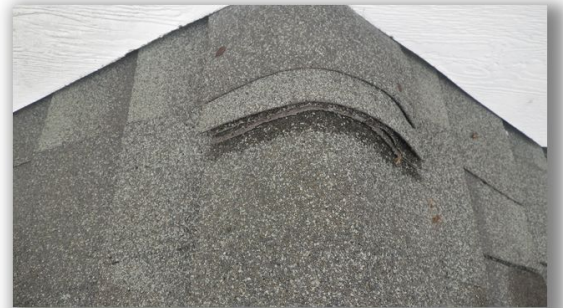
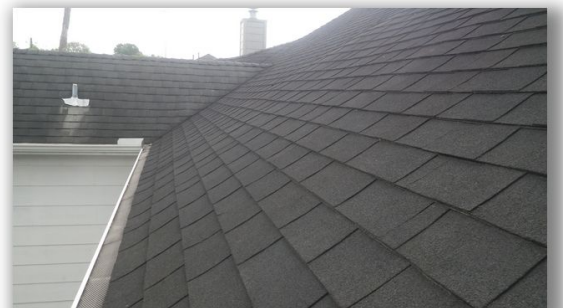
- One or more of the shingles were observed to be lifting on the east side, west side of the roof structure.
- The composition roofing material has experienced considerable granular loss in various locations throughout the roof.
- Some blistering of the roofing material was observed at the time of this inspection.
- Tree and shrub branches need to be trimmed away from the roofing material at all times to help prevent damage to the roofing material. It is the opinion of this Inspector that there are some branches too close to the roofing material at this time and corrective measures are needed.
- Shingle fasteners (staples and/or nails) were observed to be pushing through the roofing material in various locations.
- **Note:** Roof fasteners (nails and/or staples) were observed to be exposed and should be properly sealed at the ridge caps and flashing areas.

You are strongly encouraged to have a properly certified roofing contractor to physically inspect the roof, prior to the expiration of any time limitations such as option or warranty periods, to fully evaluate the condition of the roofing material. The observation made to support the rendering of this opinion are listed but not limited to the following:

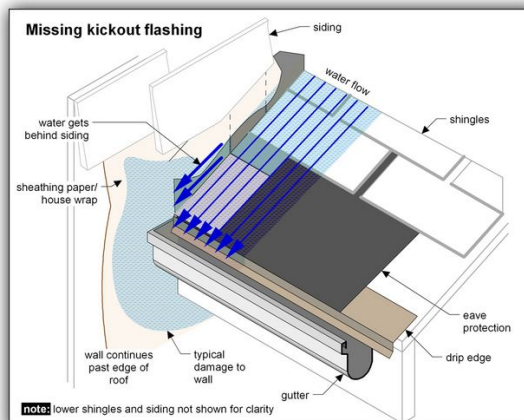
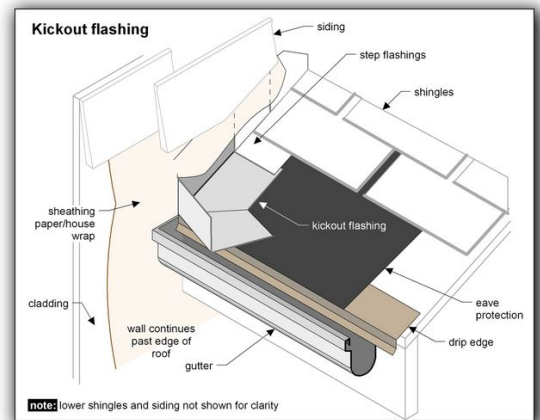
- There was no kickout flashing details observed at the lower bottom edge of the roof line interface and the sidewall that continues past the edge of the roof. The lack of this kickout flashing will allow water to penetrate at these points.

- One or more of the flashing detail flanges are not properly set into the roofing material. This condition needs to be corrected to help prevent water intrusion at this points.

- The lead jack flashing at the plumbing vent stack needs to be replaced at the time of the inspection.
- The metal valley flashing details were observed to be rusted and should be corrected as necessary.

- The plumbing vent pipe(s) need to be properly sealed to help prevent water intrusion into the structure.
- The heater flue was observed to be terminated at the roof level into a bonnet type vent. This configuration is susceptible to back drafting which could emit Carbon Monoxide into the attic area, which is a know safety hazard.

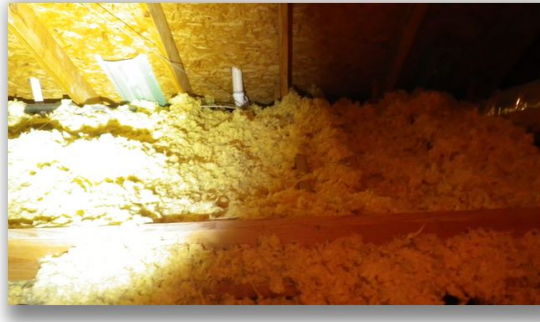
- One or more of the roof vent covers were observed to be damaged on the east side of the roof structure.

- The attic insulation is lower than typical and it is recommended to add additional insulation to achieve at least a R-30 rating.

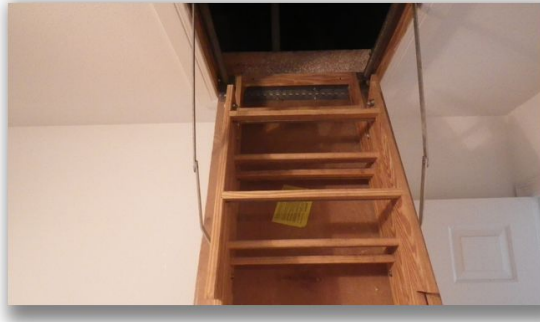
- **Note:** There was not weather-stripping observed around the attic ladder opening. This is an "As Built" condition that does not meet current energy standards. It is recommended to weather-strip the hatch opening after taking position / ownership of the property.

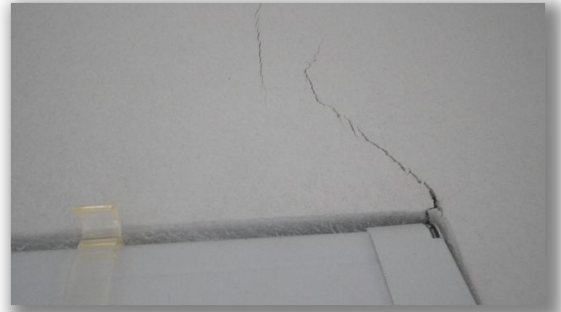
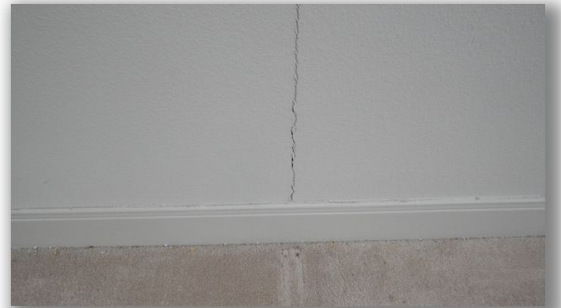
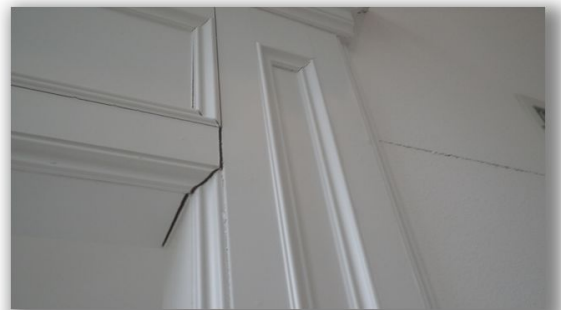
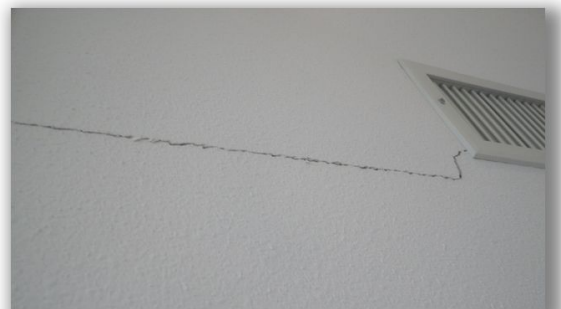
- Interior wall stress cracks were observed in the living room, dining room, master bedroom.
- Interior wall joint cracks were observed in the various locations throughout the house.

**Note:** There is evidence of painting and patching to the interior finish and prior interior finish repairs. This condition could limit the Inspectors visual observations and ability to render accurate opinions as to the performance of the structure.

**Note:** Nail heads were observed to be pushing through the interior finish in one or more locations.

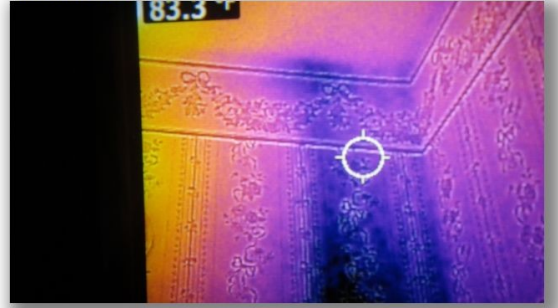
Moisture elevated on the North Wall upstairs Jack and Jill Bathroom

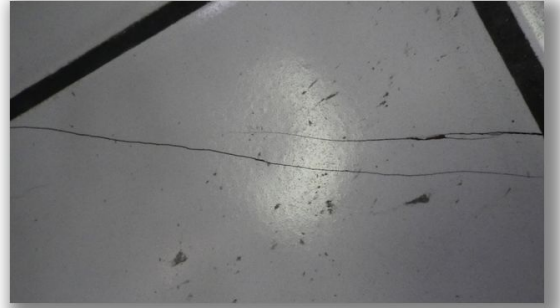
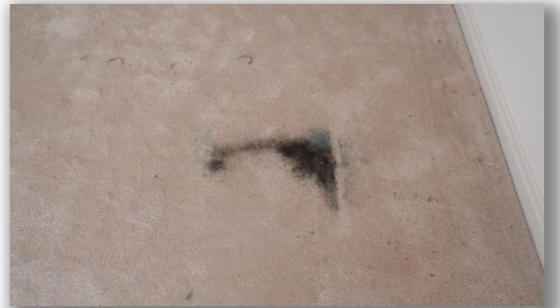
- The floor tile(s) were observed to be cracked and/or damaged in kitchen.
- The floors were observed to be out-of-level in some areas of the house.
- The floor covering is noticeably stained in one or more locations of the home.

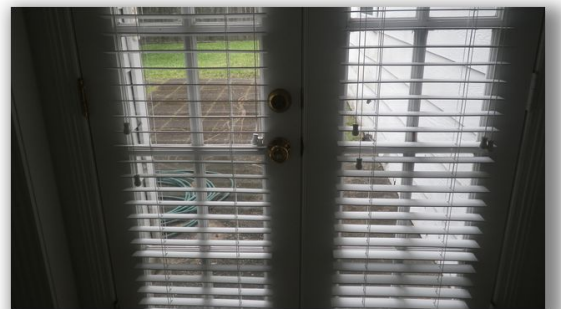
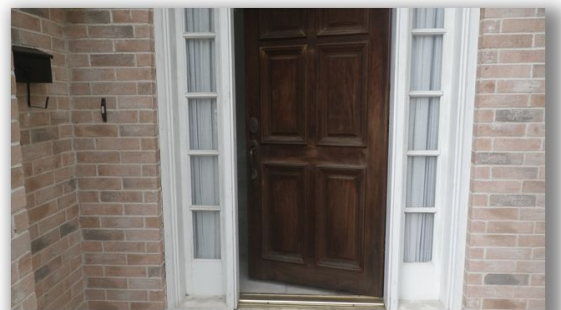
- The exterior door threshold has some deterioration and/or damage to the side driveway entry.
- Double cylinder locks were observed on one or more of the exterior exit (egress) doors. All exterior egress doors should be readily operable from the side from which egress is to be made without the use of a key or special knowledge or effort.
- The door is sticking to the backyard entry door, garage entry door.

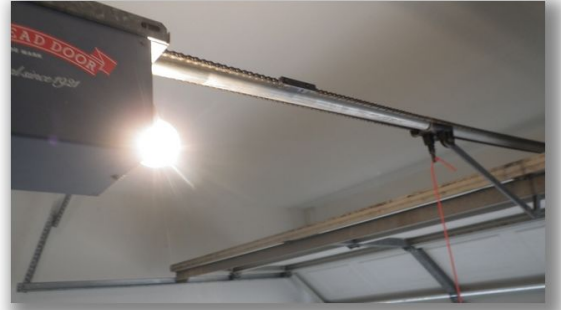
- It is recommended to lubricate the overhead garage door components, such as rollers, tracks and hinges.
- The weather-stripping at the bottom of the overhead garage door is damaged and repairs or replacement may be necessary.

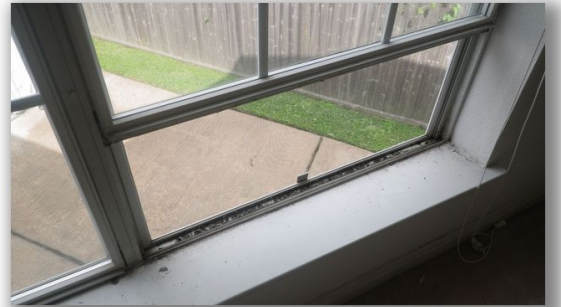
- One or more of the window screens were observed to be damaged.

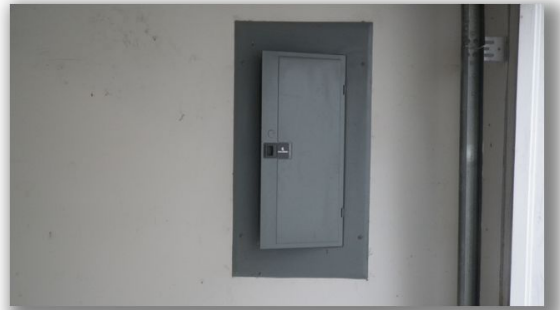
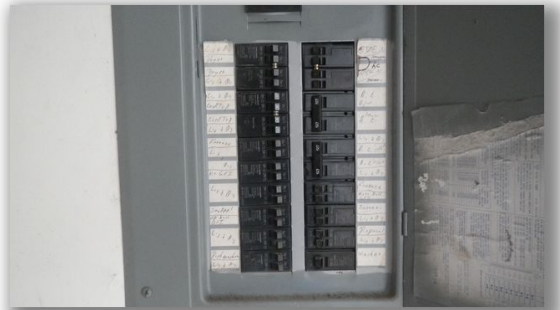
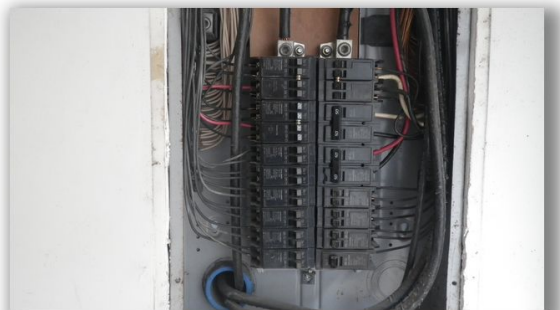
- The electrical cabinet has pulled loose at the wall mount and should be better secured.
- One or more of the neutral wires in the electrical cabinet were observed to be double lugged (i.e. two wires under one screw). The neutral wires need to be separated to prevent damage to the panel box and electrical system.

The buyer should have the electrical system checked by a Qualified Licensed Electrician. The observations made to support the rendering of this opinion are listed but not limited to the following:

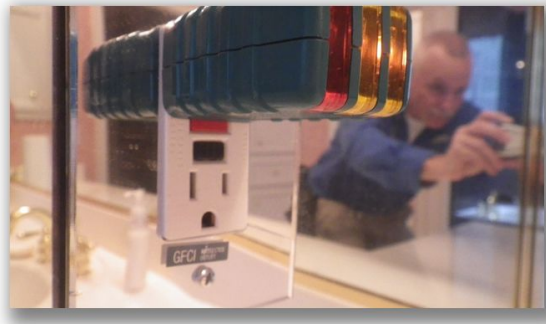
- One of the ground fault circuit interrupter (GFCI) devices does not appear to be functioning properly at the time of this inspection. The device in question is located in the master bathroom.
- One or more of the receptacles were observed to be loose at the wall mount in the various locations throughout the house.
- Not all of the garage receptacles appear to be connected to a ground fault circuit interrupter (GFCI) device. Under current electrical standards, all of the garage receptacles should have GFCI protection. There New National Electrical Code (NEC) no longer has an exception for “non-appliance dedicated”.

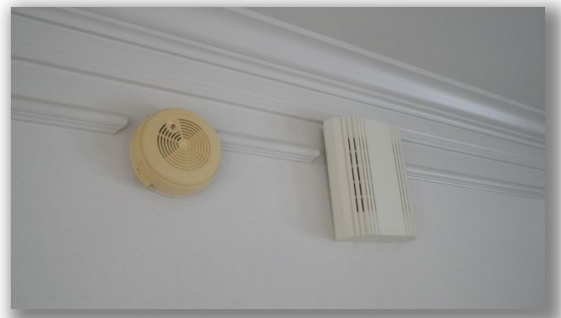
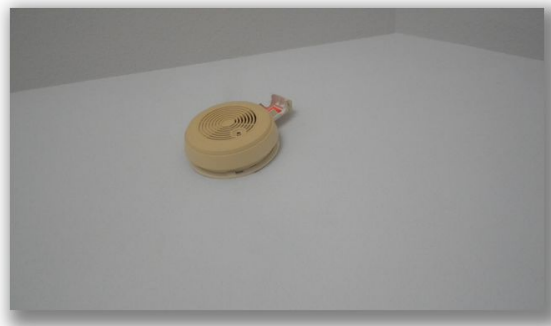
- An audible sound can be heard from one or more of the smoke detectors, indicating that the batteries need to be changed. It is recommended to replace the batteries in all of the smoke detectors once a year for reasons of safety.

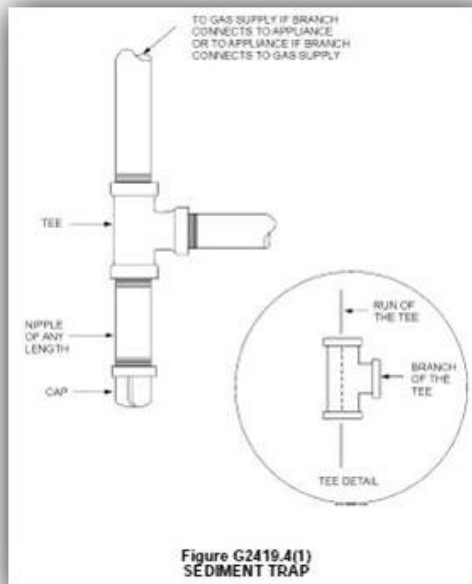
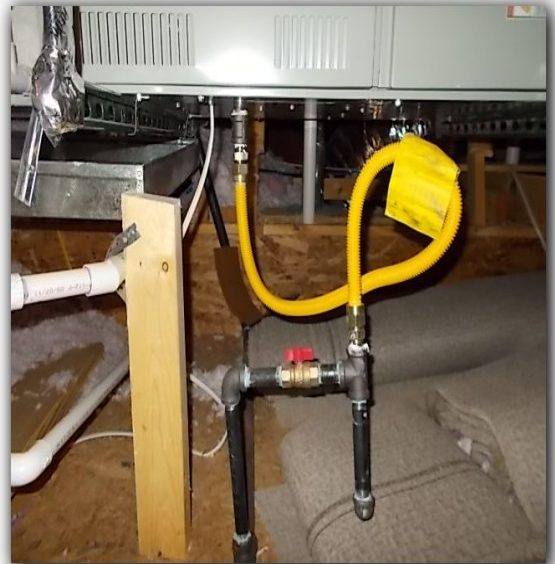
Samples of correct sediment trap installation.

- The heating equipment, both units appear to be inoperative at the time of the inspection.
- The integrity of the heat exchanger is questionable and should be further evaluated by a Qualified HVAC Technician.
- The heater gas supply line is not equipped with a sediment trap just before the gas appliance connector. This condition does not meet current installation requirements and should be corrected.

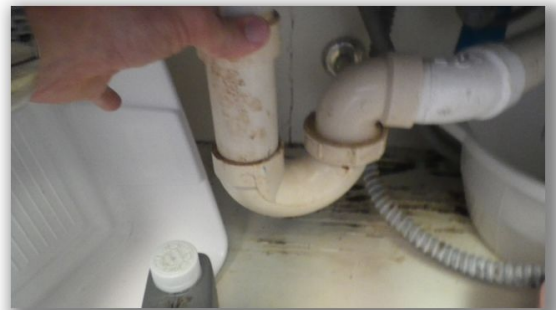
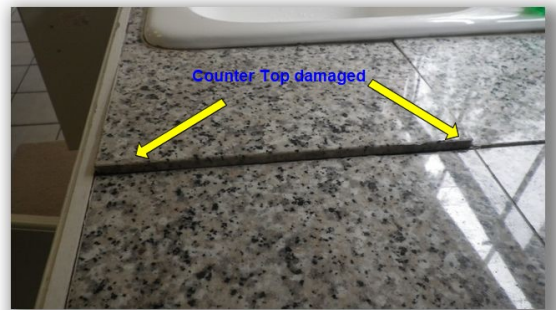
- The shelf in the cabinet under the sink has had previous water damage.

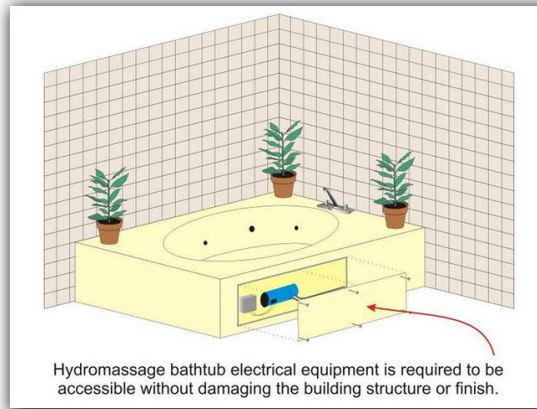
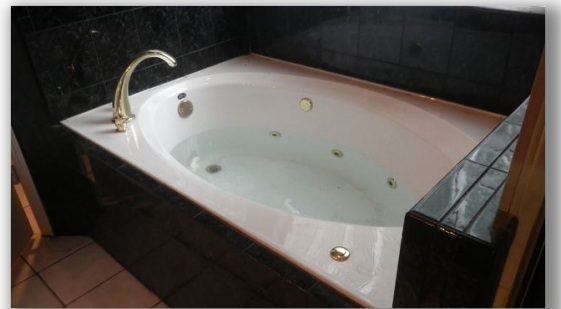
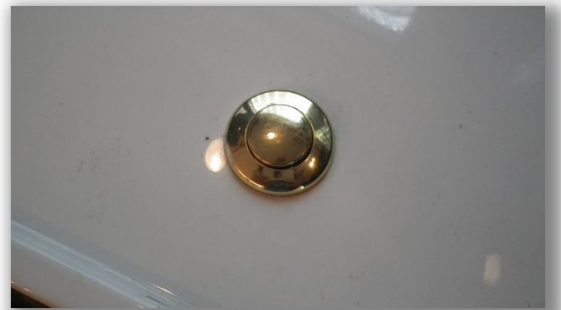
- The access to the hydro-massage therapy equipment motor is not readily accessible and inspection of the equipment lines and motor could not be performed. This does not meet current installation standards.
- The hydro-massage therapy equipment appears to be inoperative at the time of this inspection. This condition should be further evaluated and corrected as necessary.

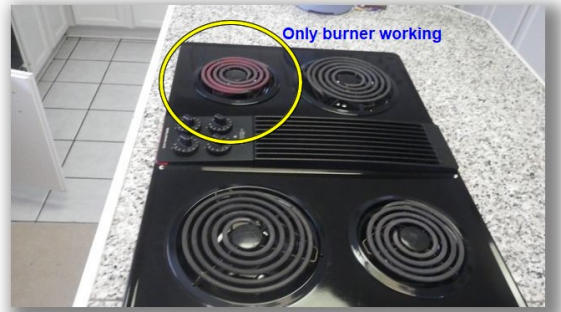
- One or more of the burners do not function properly and should be further evaluated.

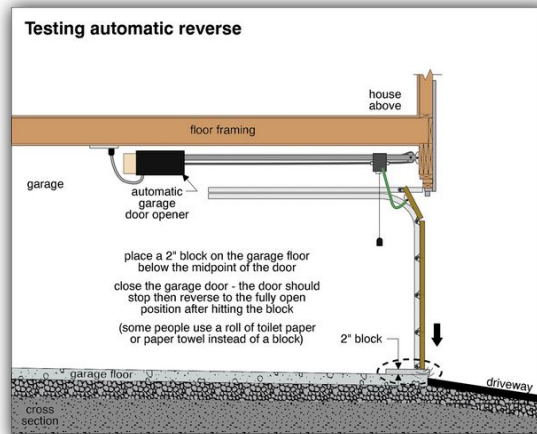
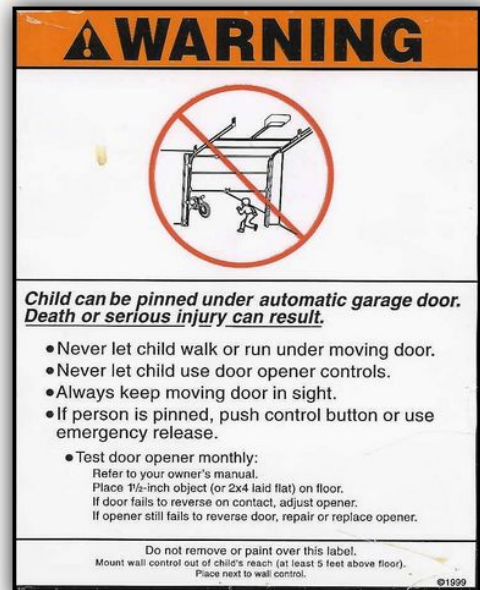
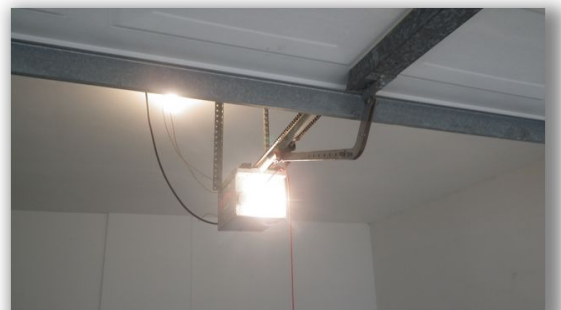
- When an automatic garage door opener is in use, the manual lock should be disabled or removed.
- The garage door opener ***DID NOT*** automatically reverse under reasonable resistance when closing. Improvement may be as simple as adjusting the sensitivity control on the opener.
- The garage door opener does not appear to be functioning properly when operated. The cause and remedy should be further evaluated and corrected as necessary.

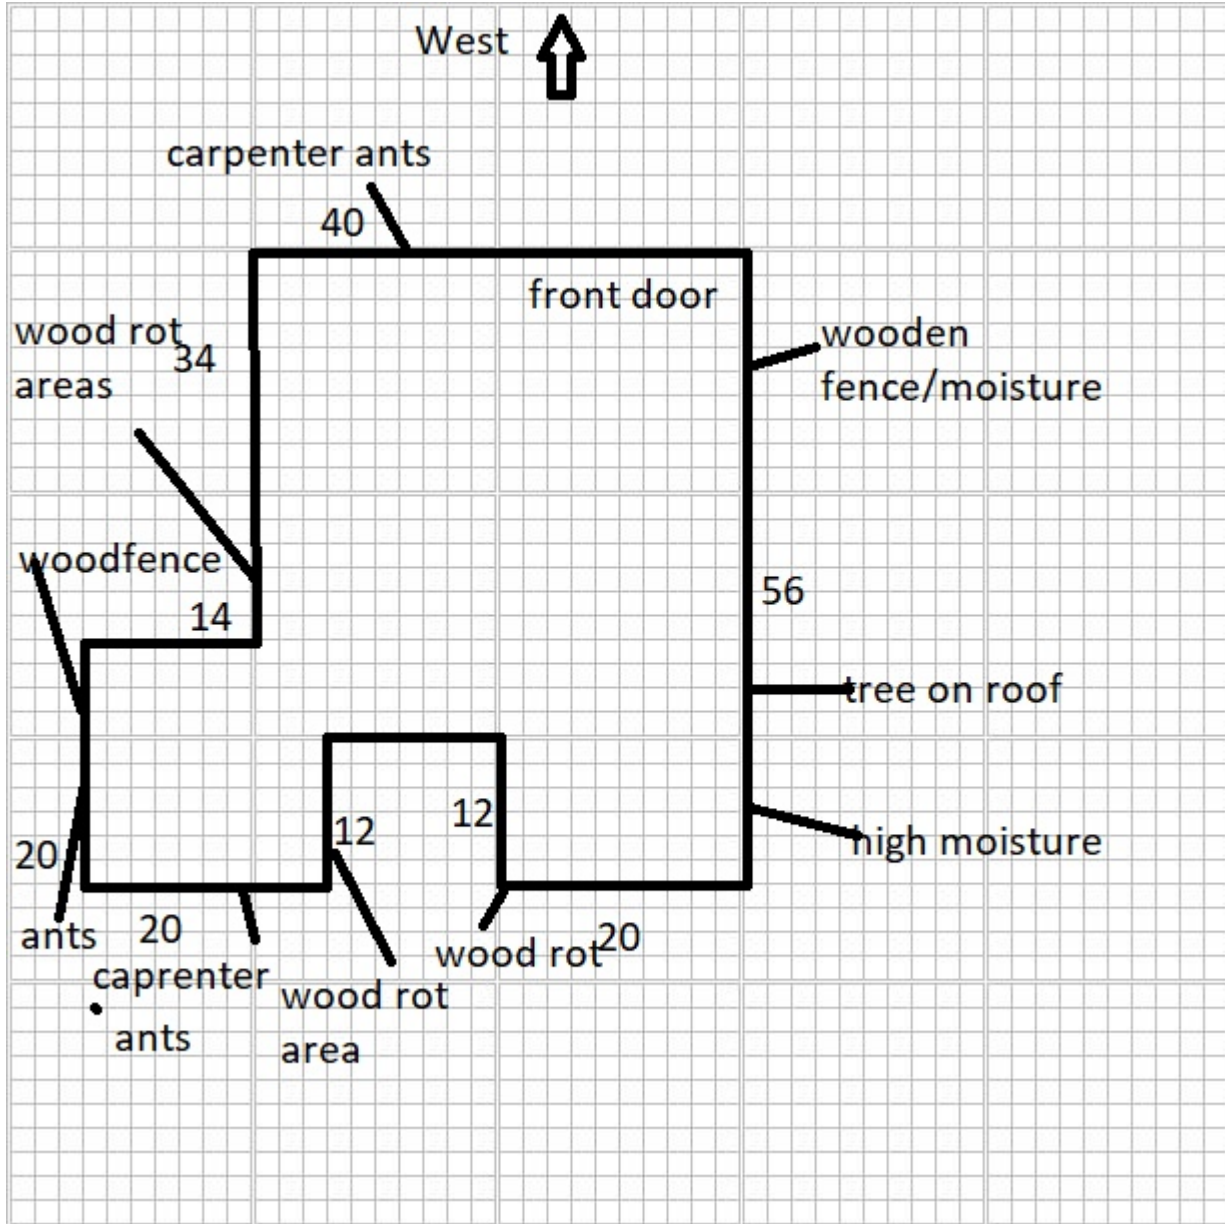
Additional Comments An ACTIVE Infestation of carpenter ants was discovered at the time of this inspection. See diagram for location(s). Treatment Recommended.
