Mold Inspection & Testing | MI&T Nationwide Unbiased Mold Testing

Location Address: 6739 Miller Shadow Ln, Sugar Land, Texas, 77479

Inspection Date: 07/12/2018 Time of Inspection: 11:30 AM

Basic Mold Inspection Report

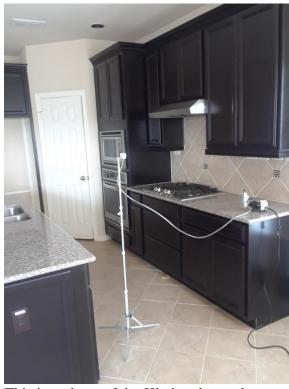
This is a photo of the Kitchen located next to the living room / main common area; the homeowner requested that this area be tested primarily.
