Mold Assessment Inspection Report

Concerning: 2206 Pine Bend Dr, Humble, TX 77339

By: David Jones on Wednesday, August 14, 2019

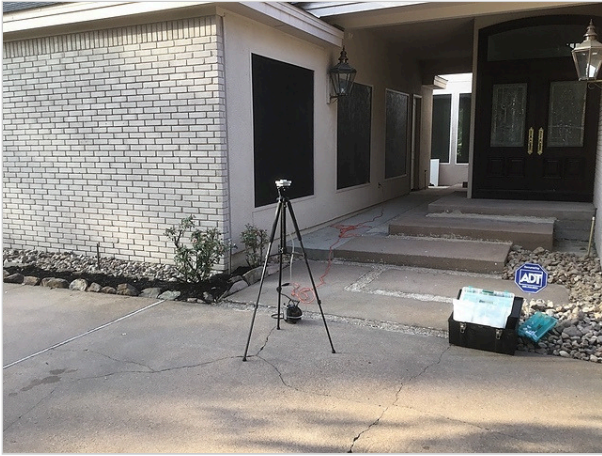
Photo 1

Exterior sample area (control)

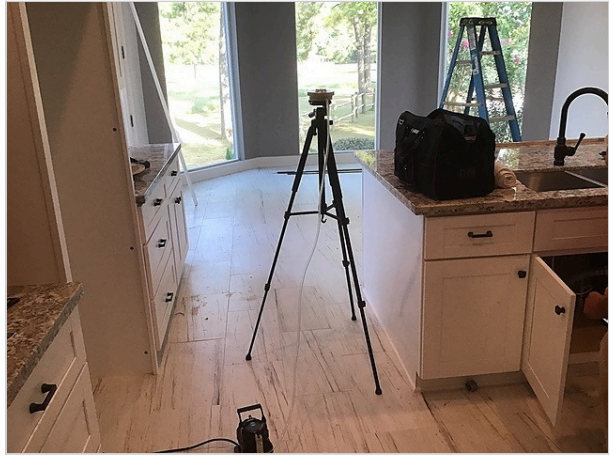
Photo 2

Interior sample area (kitchen)

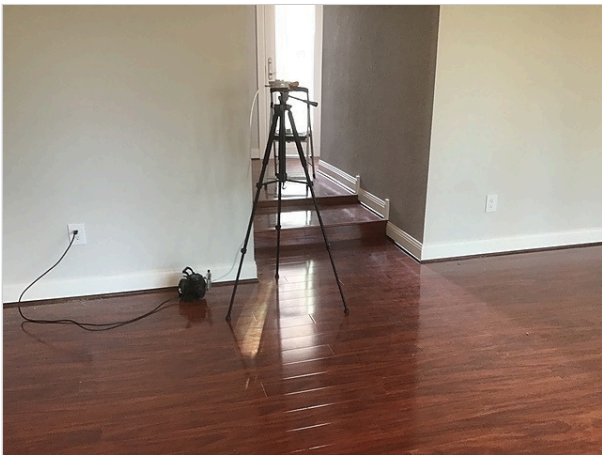
Photo 3

Interior sample area (living room)

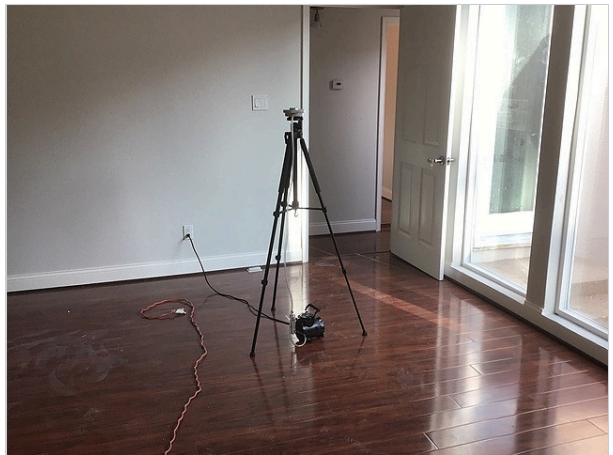
Photo 4

Interior sample area (master bedroom)

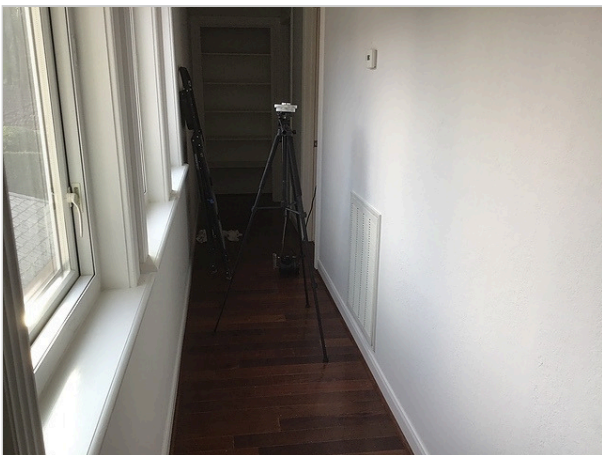
Photo 5

Interior sample area (left upstairs)

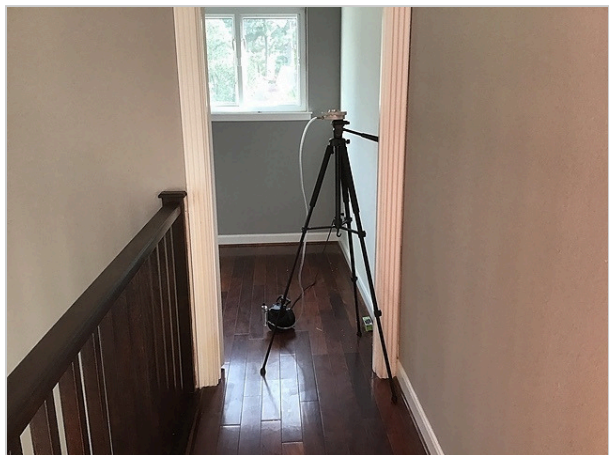
Photo 6

Other results of the following air sample showed the overall total spore count was higher in the interior area of the middle upstairs (640) than on the exterior (480), in the opinion of this assessor the individual spore counts did not meet the bottom threshold to be considered a “**red flag**”.

Interior sample area (middle upstairs area)

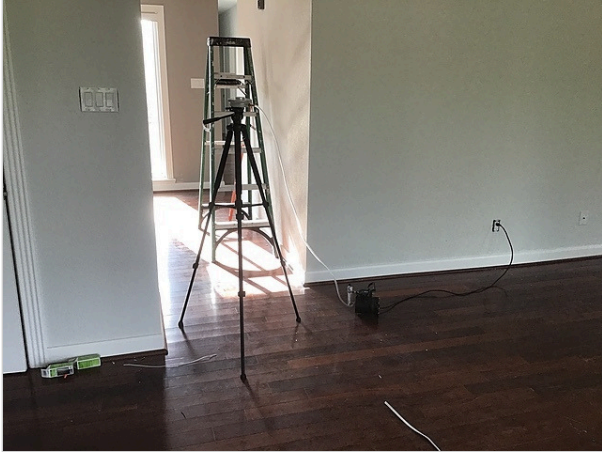
Photo 7

Interior sample area (upstairs living room)
