HEDDERMAN ENGINEERING, INC.

REF: CONDITION OF PROPERTY SURVEY

At your request, a visual survey of the house located at 36951 Anglers Way, Pinehurst, Texas, was made by Mr. Ruben Martinez.

36951 Anglers Way

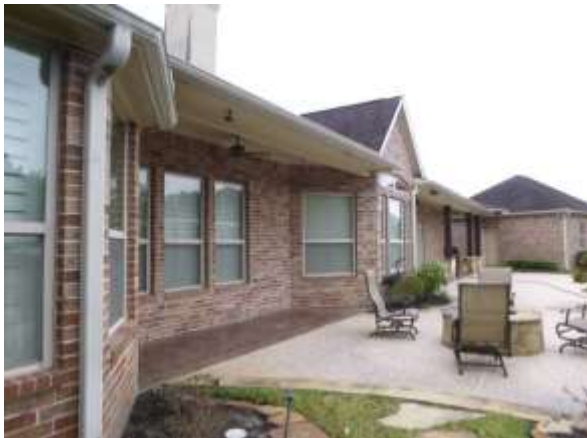
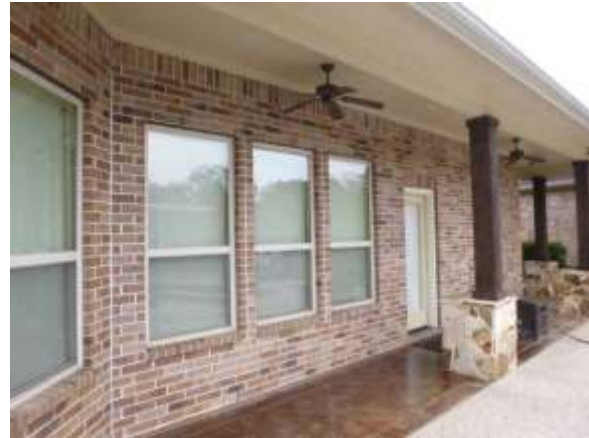
It is pointed out that a portion of the foundation concrete could not be viewed at the rear of the house due to the patio that adjoined the foundation.

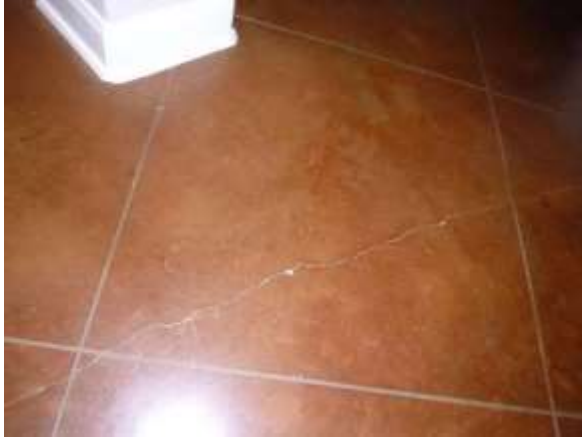
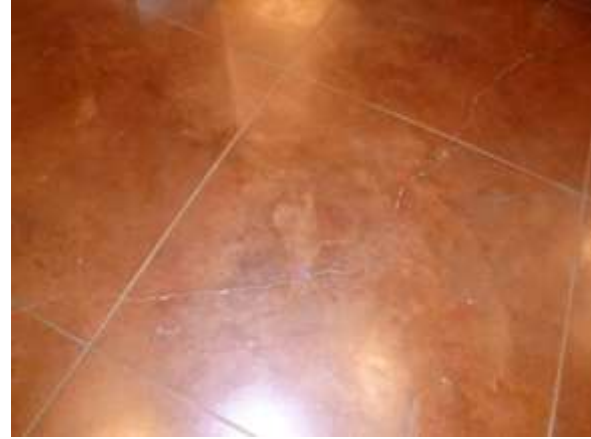
* Some separations and differential movement of materials due to differential foundation movement were observed, including the following:

- The floor tile was cracked along the foyer and the family room

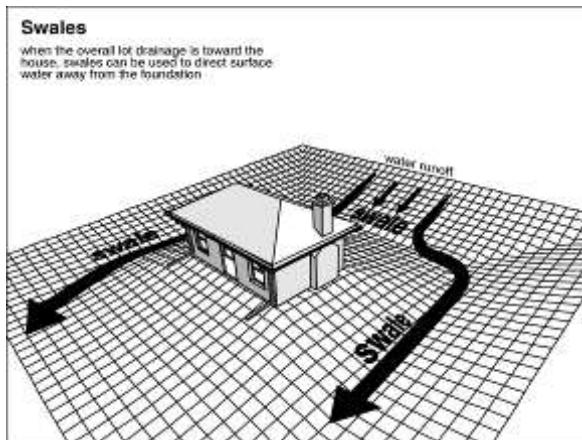
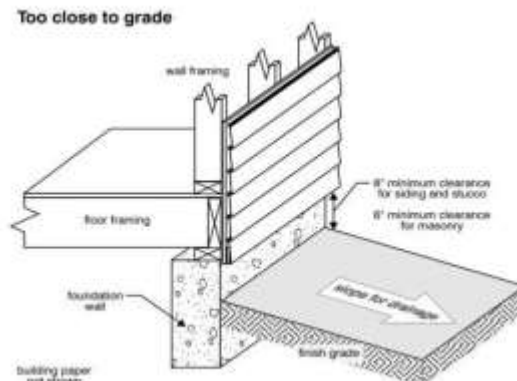
The perimeter drainage around the property appeared to generally be adequate. It was not raining at the time of the inspection and, therefore, it could not be determined with certainty if water would pool at any localized low areas around the property. Further investigation with the homeowner is recommended to determine if there are any drainage problems or standing water after a rain.

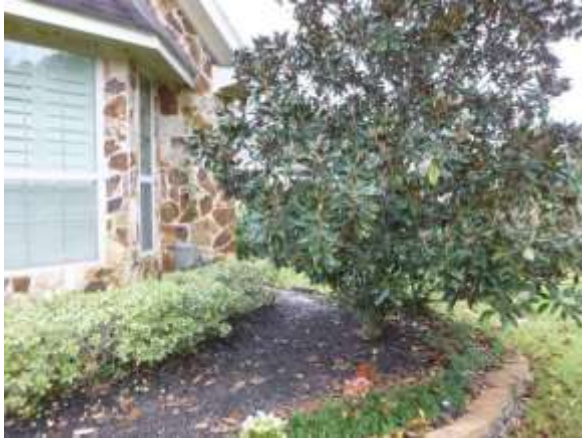
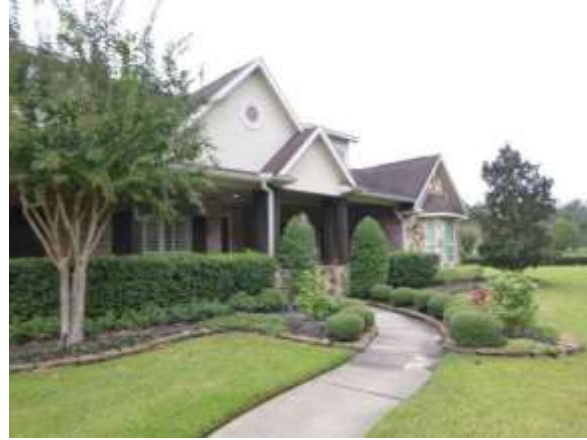
Trees and/or foliage were observed in the vicinity of the house, which can contribute significantly to differential movement of the house foundation. Care should be taken to

prevent the trees and foliage from removing an excessive amount of water from near the foundation of the house. Consideration should also be given to cutting the tree roots that extend under the foundation, and installing a root barrier to prevent any further moisture from being removed from under the interior of the house.

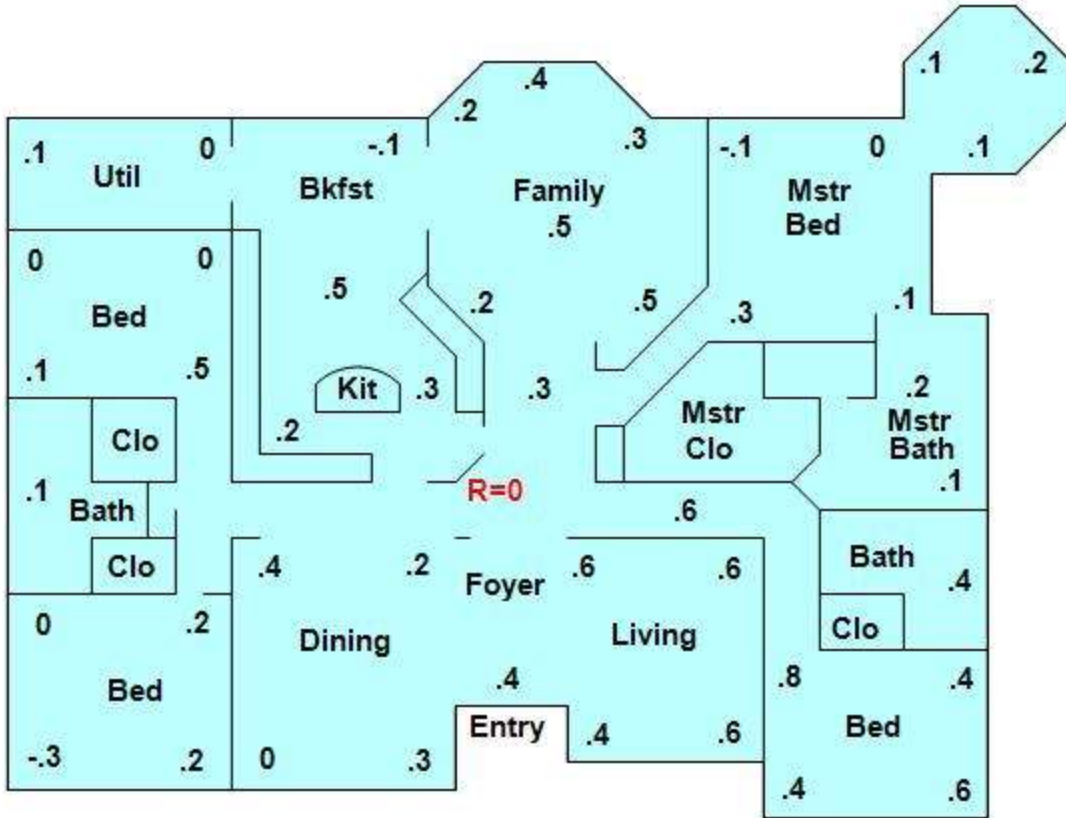
36951 Anglers Way
Elevation Readings

The floors were checked with an electronic level, and were observed to be acceptably level throughout the house. The difference in elevation between the high point and low point was 1.1 inches. The high point was located at the northeast bedroom, and the low point was located at the southeast bedroom. The unlevelness takes place over a horizontal distance of approximately 70-75 feet.
