Slab To Shingle

Property Inspection Report

5014 Quill Rush Way, Richmond , Texas 77407
Inspection prepared for: Chris Morris & LEEANNE MORRIS
Date of Inspection: 1/24/2018
Age of Home: 2012 Size: 3,188 Sqft
Weather: Clear/63°
House Direction: West

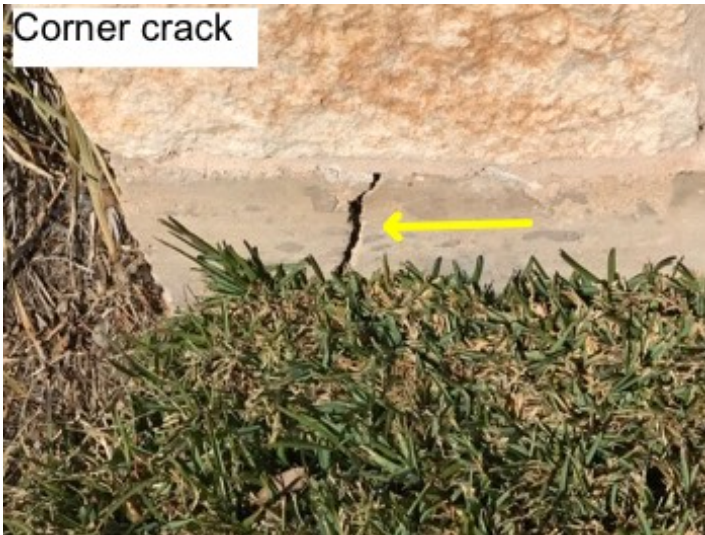
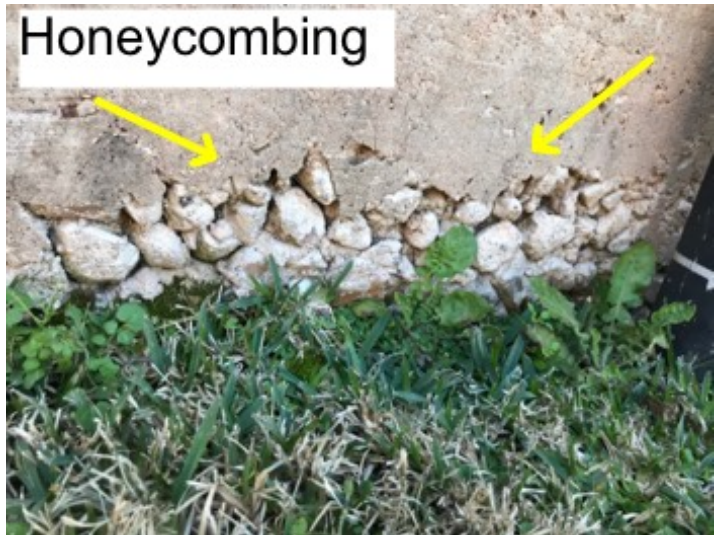
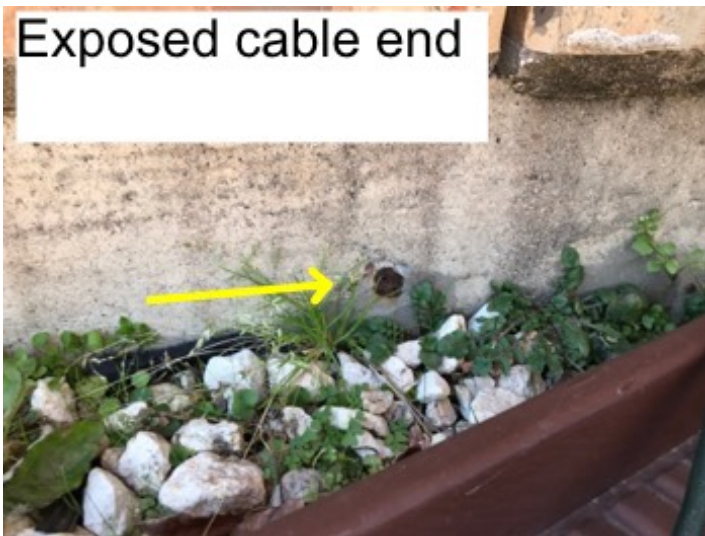
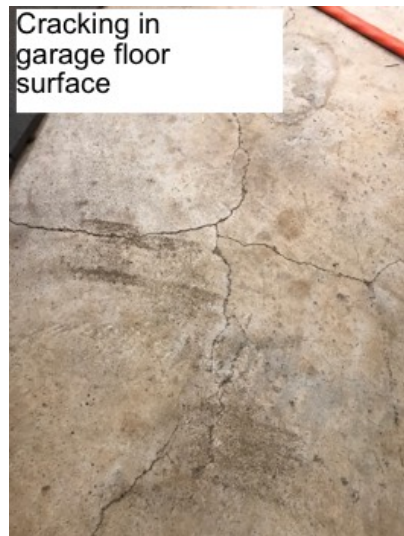
- **There are cracks in the garage floor surface and cracking in the brickwork that in the opinion of this home inspector do not appear to be causing serious structural issues at this time, recommend to seal cracks and monitor. Sometimes these types of cracks are from concrete shrinkage and others can be from foundation movement. You should consider having further evaluation by a qualified foundation contractor to see if corrective action is needed at this time. All cracks need to be filled in and monitored for any further cracking. If future cracking occurs, a foundation contractor will need to evaluate foundation further.**

- **Exposed cable ends on the east side of the house need to be evaluated, cleaned and covered over properly to reduce rust damage issues. • Foundation has a honeycombed surface on the north side that needs to be repaired (covered). • Corner cracks observed on southwest and north center corners, fill in cracks in order to reduce chance of rust damage to post tension cables, cracks appear to be cosmetic and common to many homes.**

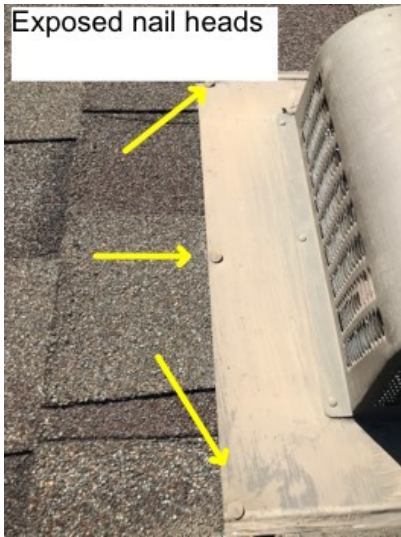
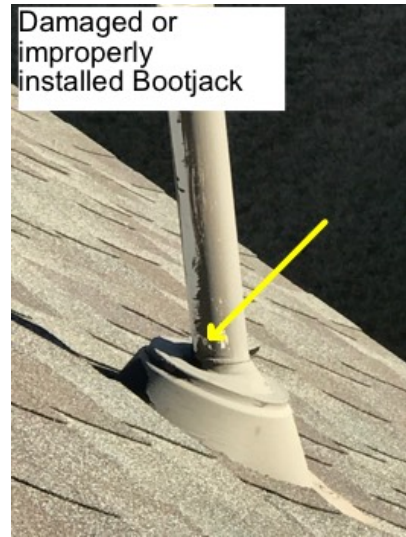
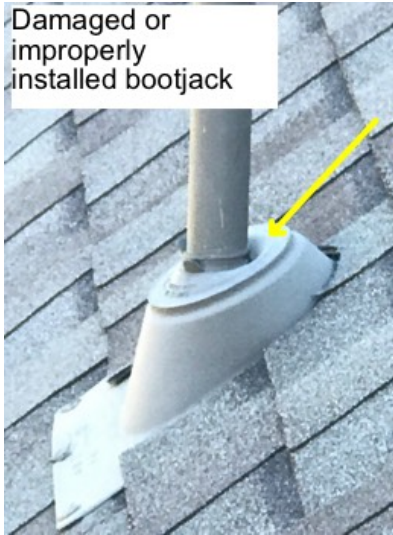
- **Exposed nail heads on the roof need to be properly sealed over with roof cement to reduce chance of roof leak issues.**
- **One of the bootjacks on the north and one on the south side of the roof appears to be improperly installed or possible damaged, needs further evaluation by a qualified roofing contractor and repair as needed.**
- **Need to install splash blocks at the ends of the gutters to reduce potential erosion issues.**

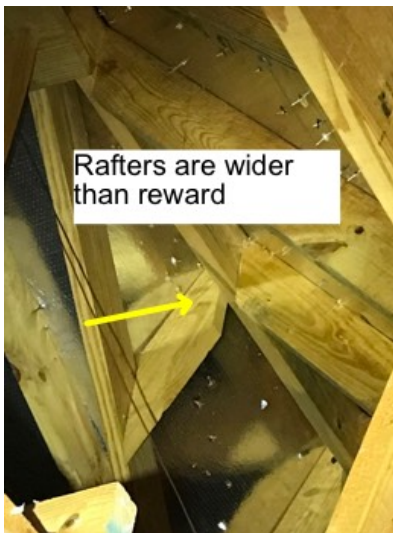
- **The rafter boards on the west side of the attic are wider than the ridge board which could possibly cause the rafters to separate from the ridge board from hinge action, should be evaluated and repaired as needed by a qualified contractor.**

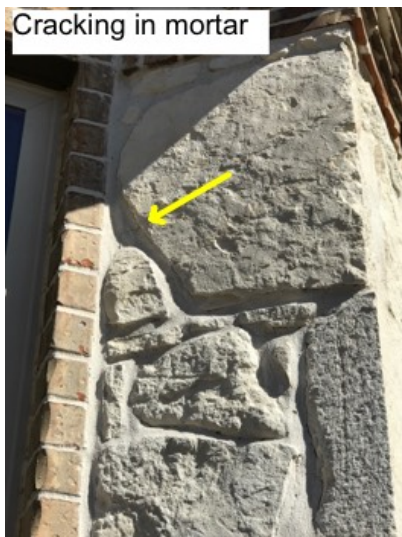
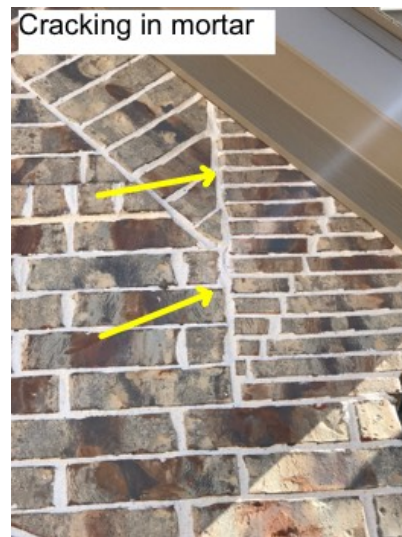
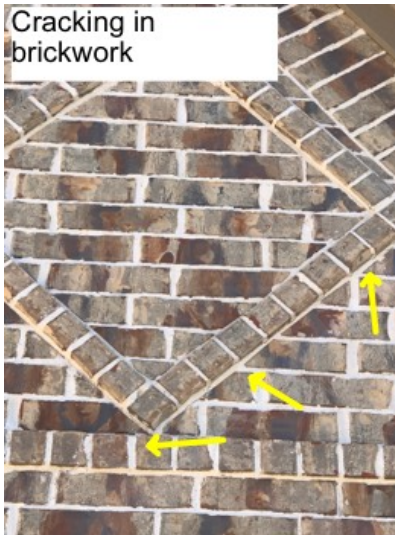
- **There are step cracks in the brick, stone and mortar joint on the west side of the home, cracks appear to have been caused by settlement and movement of the foundation, needs further evaluation and repair as needed by a qualified contractor.**
- **Bushes in close proximity to the home. Branches/ leaves can cause serious damage in the long term branches need to be trimmed back.**
- **Peeling paint noted on the base boards in the second floor west game room wall, could not determine cause, needs further evaluation to determine cause and repair as needed, no moisture noted at time of inspection.**

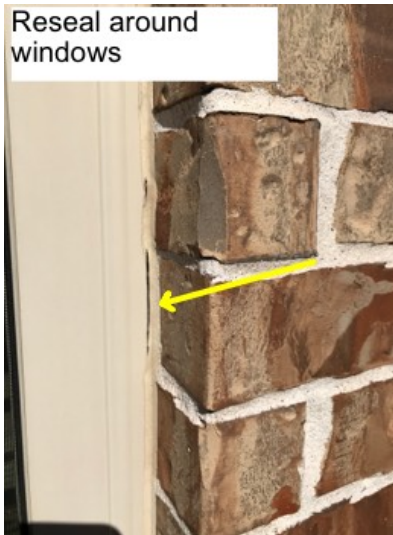
- **Need to caulk and seal around the exterior windows to reduce possibility of water leaking in.**
- **The right window in the master bedroom and right window in the formal dining room has a loose spiral spring on the side of the window frame which holds window open, needs to be properly re-installed up into the frame.**
- **Two pane, insulated window on the left side of the master bathroom and right game room window, appears to have a damaged seal on the window, window appears to be fogged up, window needs evaluation and repair as needed by a qualified contractor and recommend further evaluation of the rest of the windows also.**

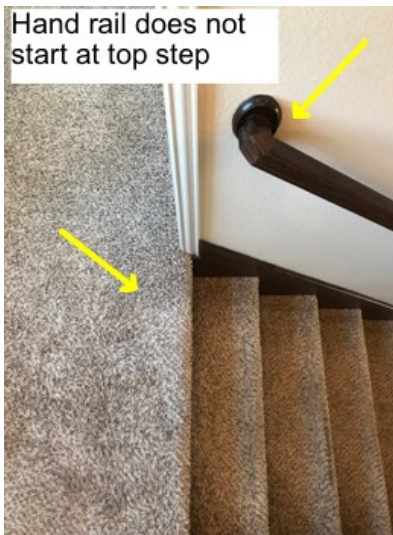
The hand rail does not start at the top step, it should this is a safety issue and a current requirement.

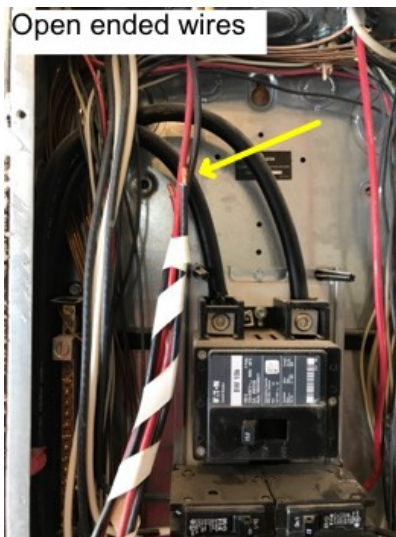
- **Open ended wiring in electrical panel needs to be capped.**

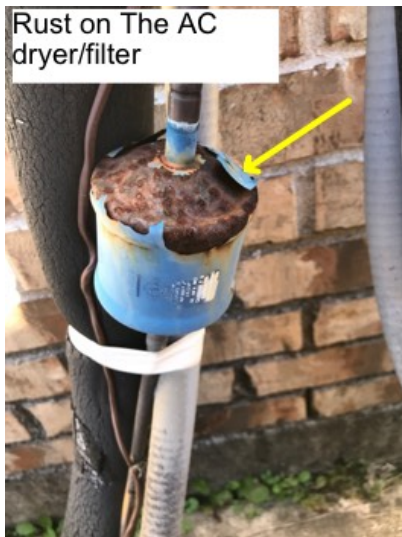
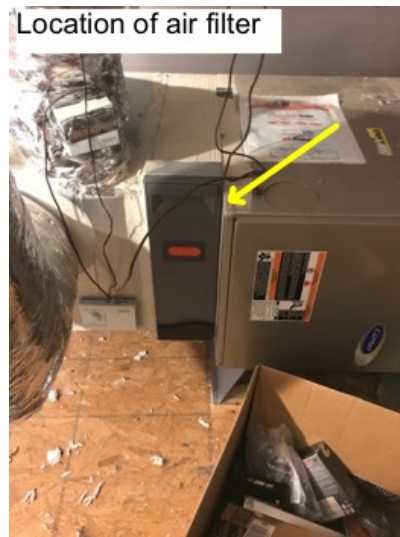
- **Differentials are high, systems need to be evaluated by a qualified HVAC contractor.**
- **The return filters were dirty, the A/C system/coils need to be evaluated further and cleaned by a qualified HVAC contractor to check for possible damage/rust issues, units need to be cleaned and filters need to be replaced and ducts should be evaluated for cleaning also.**
- **Dryer/filters on the exterior units have rust damage to them, recommend further evaluation by a qualified HVAC contractor for possible leaks.**

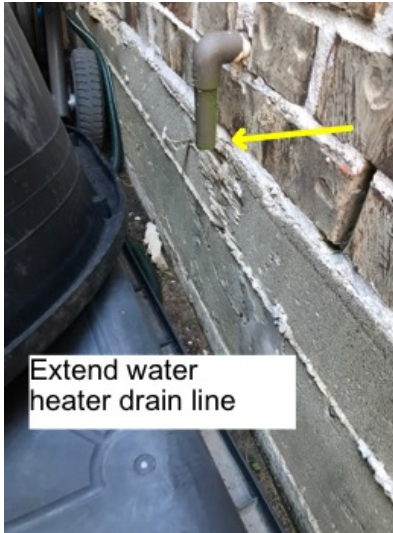
• External water heater drain line needs to be extended, they should drain no higher than 6 inches from the ground for safety reasons, needs repair.
