RESIDENTIAL INSPECTION REPORT

12813 Kylewick Dr Houston TX 77085

PROPERTY INSPECTION REPORT

Concerning: 12813 Kylewick Dr, Houston TX 77085

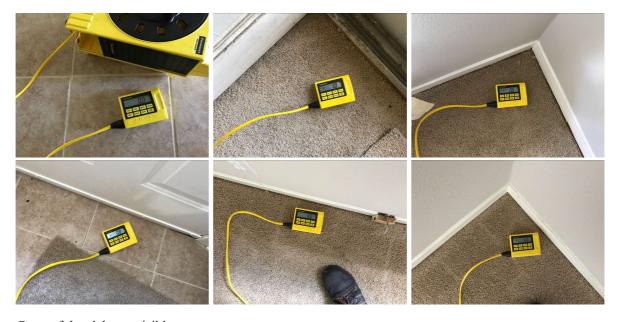
Foundation Inspected with Digital Level:

This foundation was measured with the use of an electronic digital measurement tool. Multiple elevation points were registered on the foundation throughout the property to determine if there were elevation variations that indicated excessive movement of the foundation.

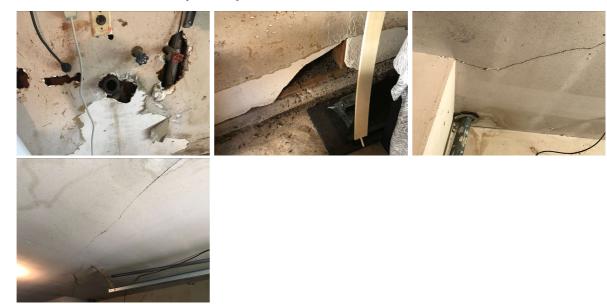
Garage

8: Interior: Damaged Drywall (or other wall covering)

Damaged Drywall (or other wall covering) was observed. Remedy as needed to prevent pest intrusion and energy loss.

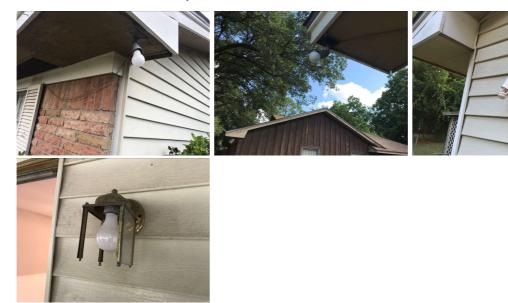
One or more lights were not operating. New light bulb possibly needed. Remedy as needed.

Recommendation: Contact a qualified electrical contractor.

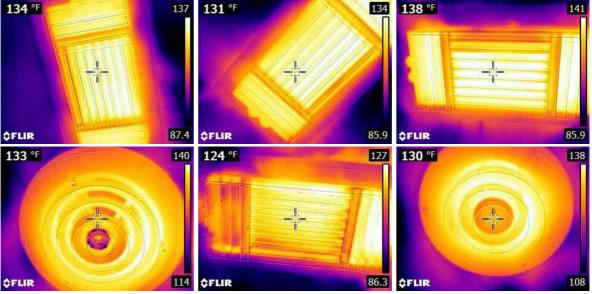
134 °F

The Heating System was functioning at the time of inspection. Refer to the Inspection Report for any further recommendations.

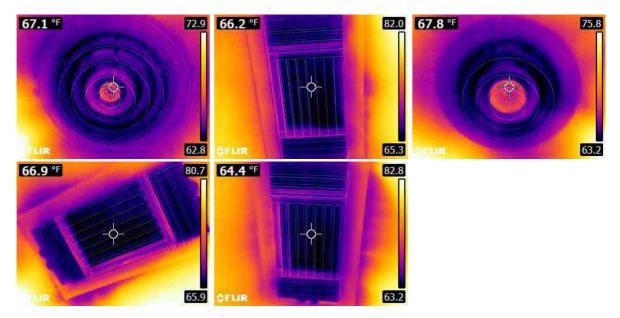
Temperature difference (delta) - First Floor: 16°

The Cooling System was functioning at the time of inspection. Refer to the Inspection Report for any further recommendations.
