Gerard J. Duhon, P.E., #59832
Engineered Foundation Solutions, #F-12259
281-788-7393 gerard@texashomeengineer.com

ENGINEERING OPINION
INVESTIGATION OF FOUNDATION PERFORMANCE
RESIDENCE AT 2738 28th AVENUE N, TEXAS CITY, TEXAS, 77590
Date of Inspection: March 29, 2019
Date of Report: April 7, 2019

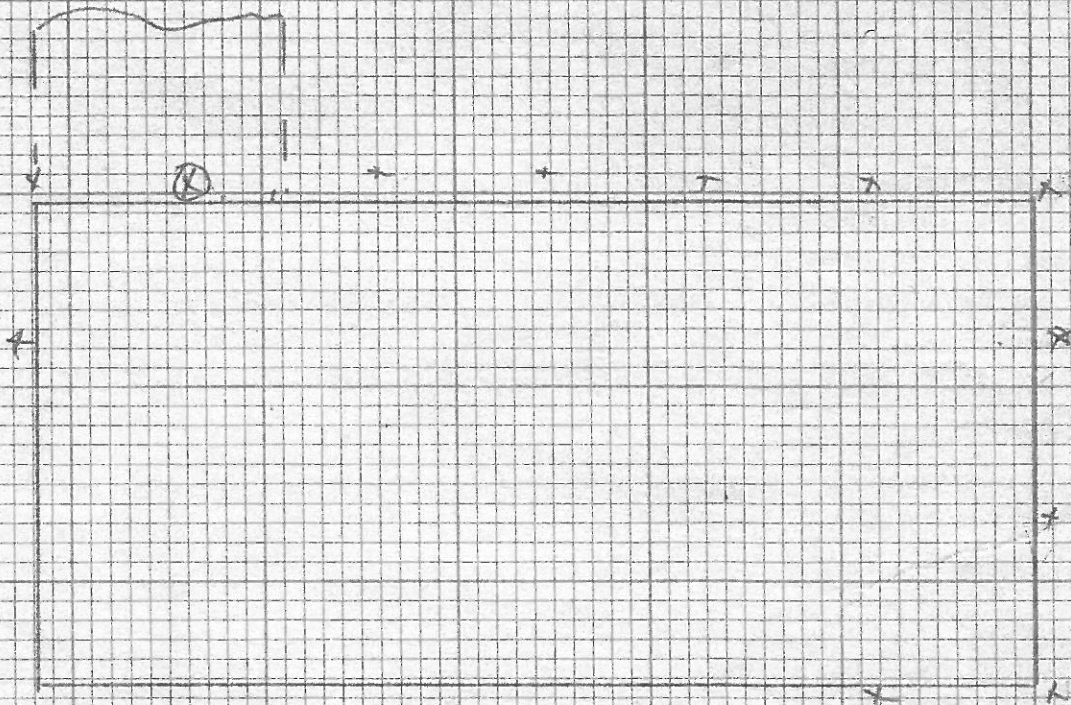
NAME BROWER
ADD. 2738 28th Ave N
TR CITY
TEL 409 945 7527
DATE 4/17 MAPSCO 70200

The following information was provided: The foundation was repaired in 2002 with 12 exterior piles.
