Report Identification: 5809 Darling Unit B Houston, TX. 77007

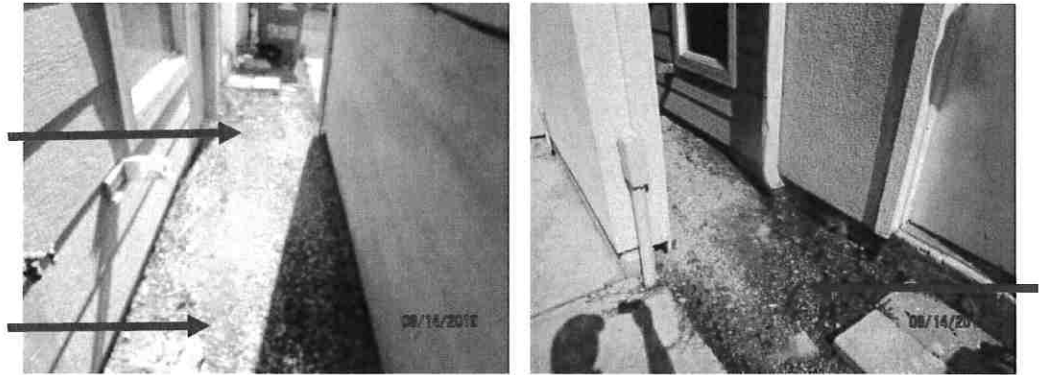
There were areas around the structure where the grading does not having the minimum clearances of 6" for siding as required. Recommending pulling back/reworking the clearances in these areas to a minimum of 6" as required.

Some of the gutter down spouts do not divert water away from the foundation properly, down spouts should divert water away approximately 5' from foundation. Recommend adding splash blocks or diverters.

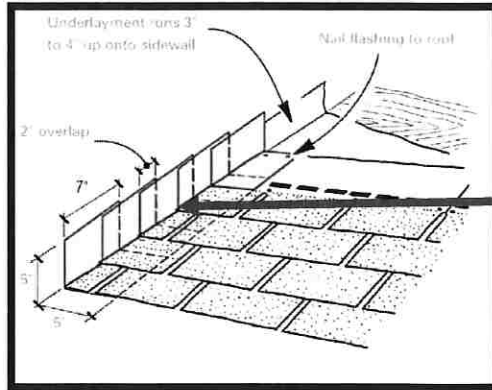
Counter flashing at the roof line off the terrace area has not been painted & the nails have not been properly sealed. Recommend painting the flashing & sealing the nails as required.

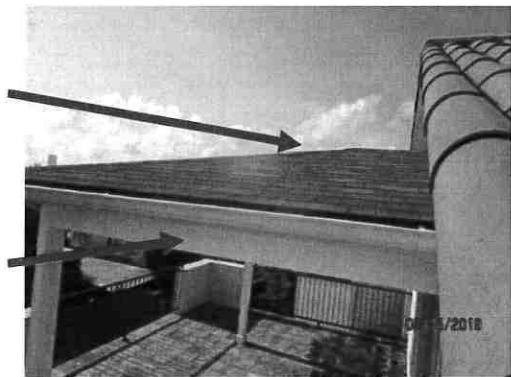
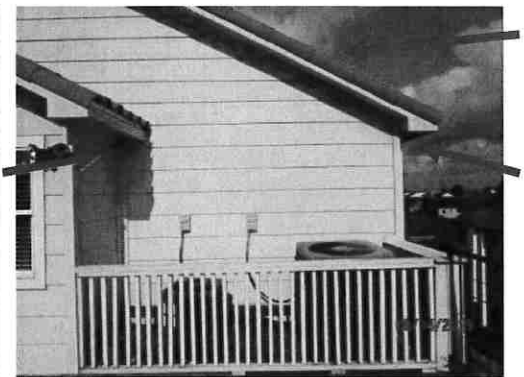
Existing/previous moisture penetration/staining were observed in multiple areas on the exterior substrate from within the attic space however the inspector was unable to get to the areas where the moisture penetration/staining was observed & could not determine if an active leak was present. Recommend further evaluation/repair.

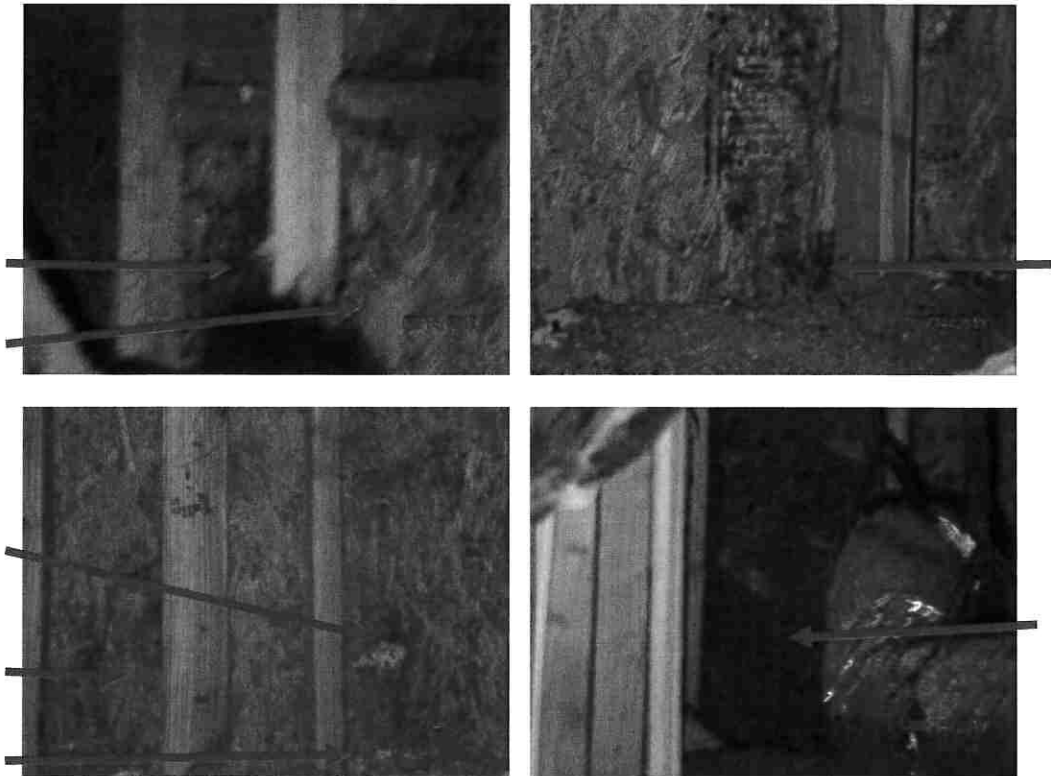
Exterior walls showed signs of possible moisture penetration as noted by the discoloring of the hard coat in some areas. Recommend further evaluation to determine the source of the moisture & to determine if any hidden structure damage has occurred.

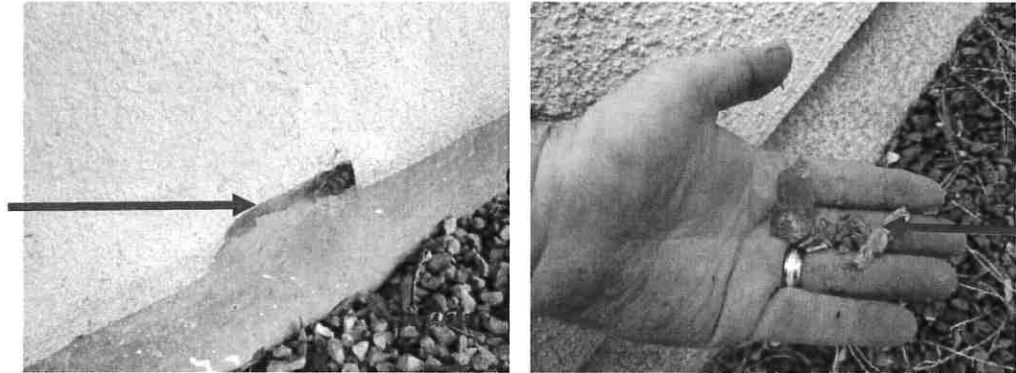
Damage/decay to the siding/trim was observed in some areas around structure & at the terrace level. Recommend repairing as required.

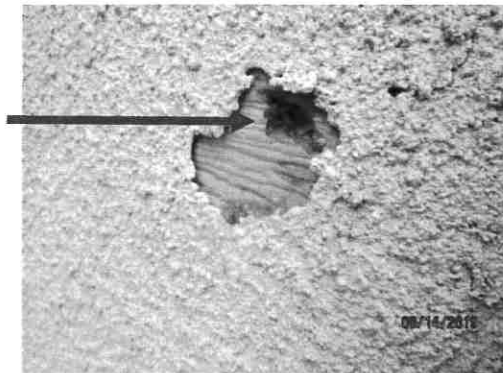
Damage/decay to the substructure at the terrace level by the condensing units was observed. Recommend further evaluation to determine the source of the damage & to determine if any hidden structure damage has occurred.

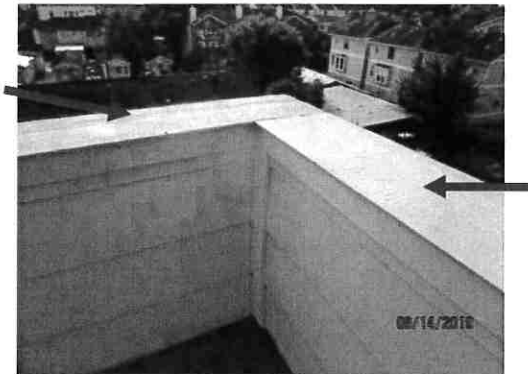
Exterior walls should be cut back a minimum of 2" where the wall/trim meets the roof line.

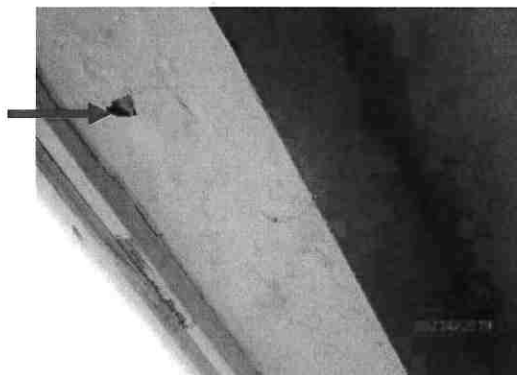
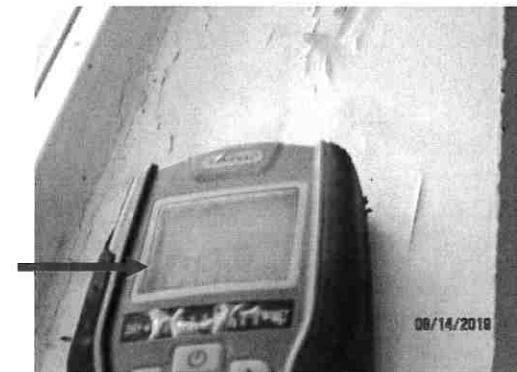
Cosmetic cracks were observed in some areas. This is normal wear & tear that is caused by movement that occurs in any structure of its life. These are considered normal wear & tear items & are not considered to be excessive or unreasonable structural deficiencies. This condition can be easily repaired with the applications of sheetrock mud or caulking.

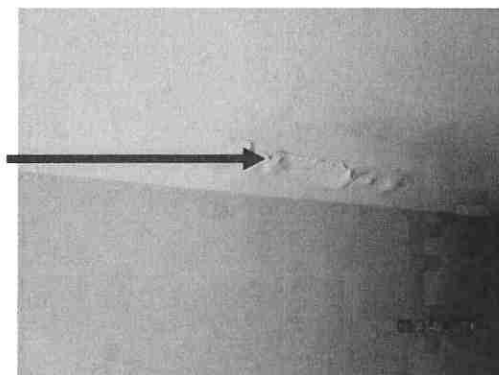
Existing/previous moisture penetration/staining was observed but may not be limited to under the water heater closet area on the floor. The inspector was unable to access the area to take a moisture reading due to limited access. Recommend further evaluation to determine the source of the moisture & to determine if any hidden structure damage has occurred.

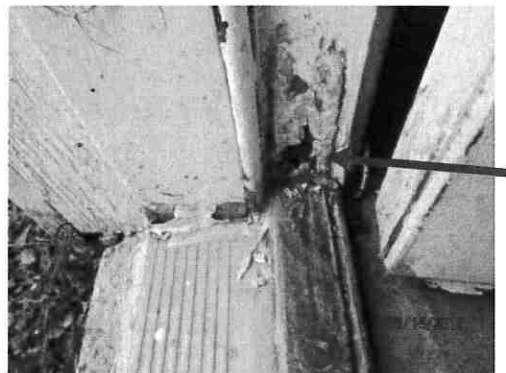
Damage to the trim at the base of the terrace & back doors was observed. Recommend repairing.

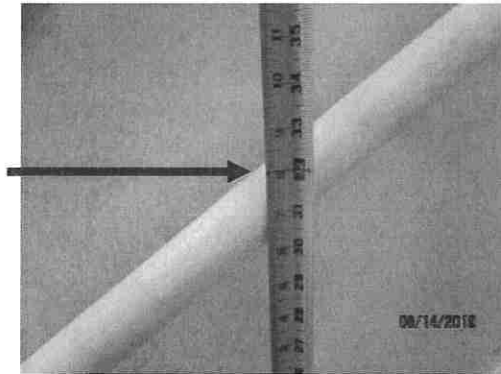
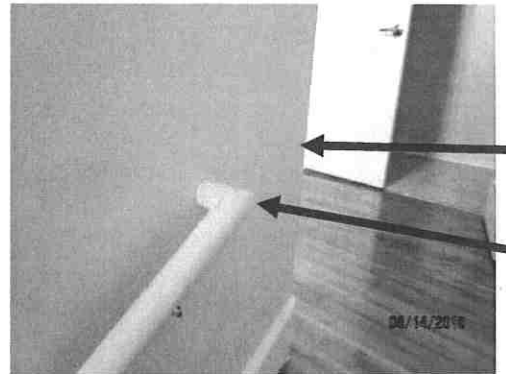
The main stair riser heights do not meet current building standards of a maximum of 7 3/4" with a variance of 3/8". The riser heights varied from approx. 4 1/4" - 8".

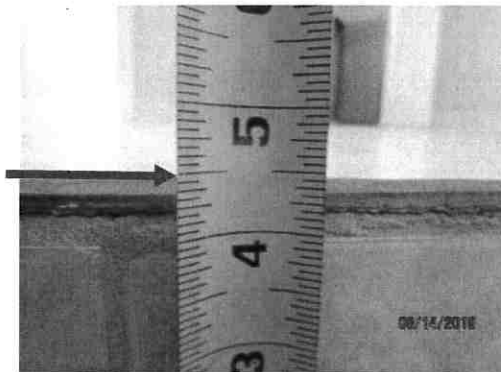
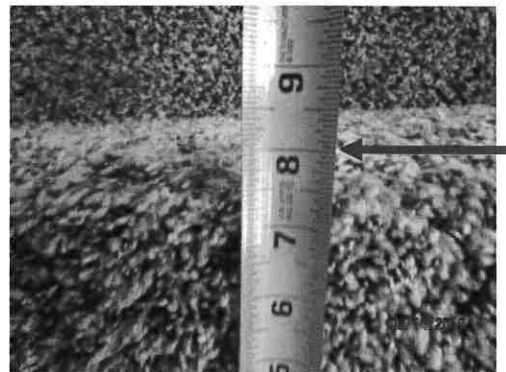
The front exterior stair riser heights do not meet current building standards of a maximum of 7 3/4" with a variance of 3/8". The riser heights varied from approx. 7" - 8 1/4".

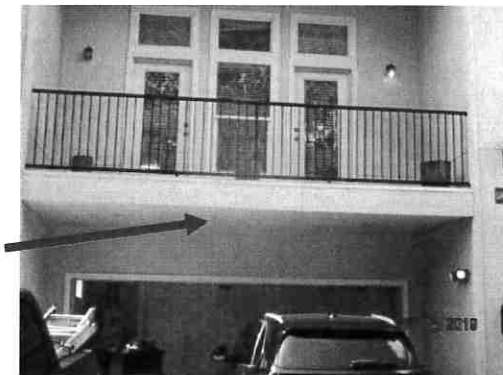
The balcony is sagging. Recommend further evaluation to determine the source of the sagging & to determine if any corrective measures may be required.

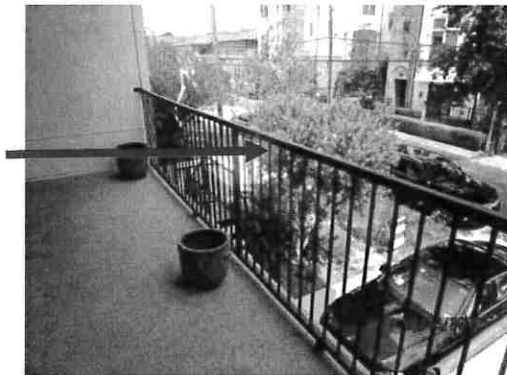
Guard rail at the balcony wobbles, loose/not properly secured. Recommend securing.

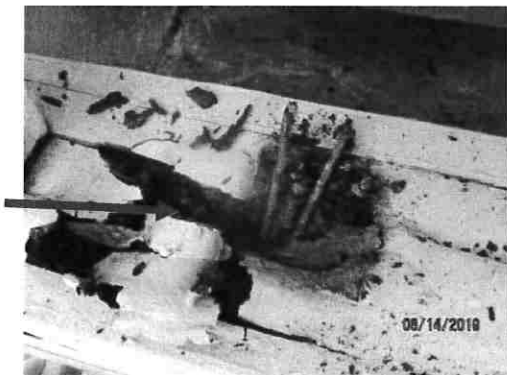
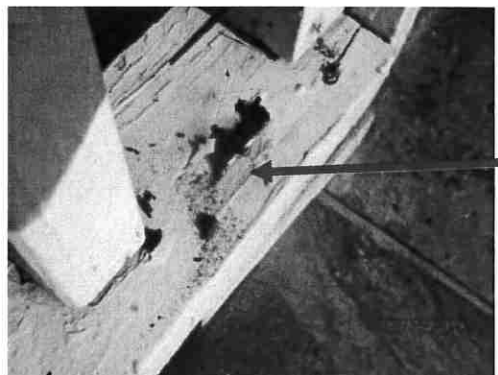
Some of the balusters & base board at the terrace are not properly secured at the base, showed signs of damage & the fasteners showed signs of rusting which is an indication that galvanized fasteners were not used.

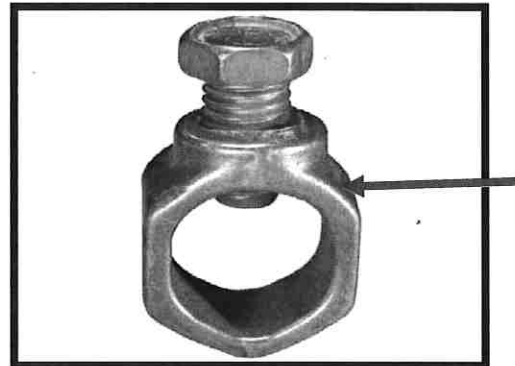
Grounding electrode clamps are pipe clamps & not an acorn clamps as required.

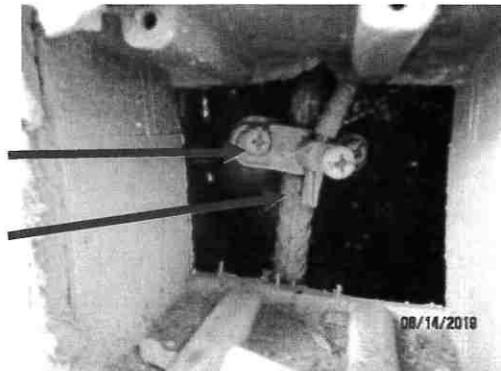
Grounding electrode clamp at the UFER in the garage is a pipe clamp, not an acorn clamp as required & the clamp, conductor & rebar have been painted. Painting may inhibit the potential bonding at the clamp/pipe & is potentially as an unsafe condition. Recommend the removal of the paint from the rebar & conductor as required & install an acorn clamp as required.

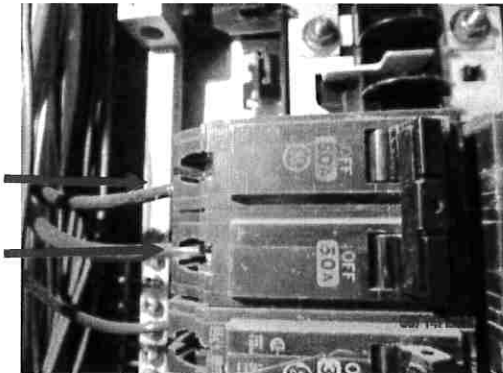
A # 8 conductor is connected to a 50 AMP breaker. 50 AMP breakers should be supported with a # 6 conductor by today's standards. Recommend further evaluation/repair.

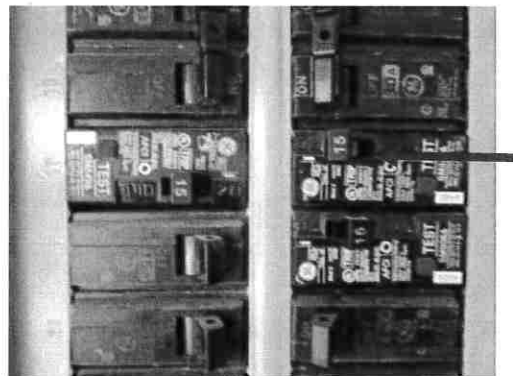
The top right 15 Amp AFCi breaker did not trip when tested. This is a potential safety issue. Recommend further evaluation/repair.

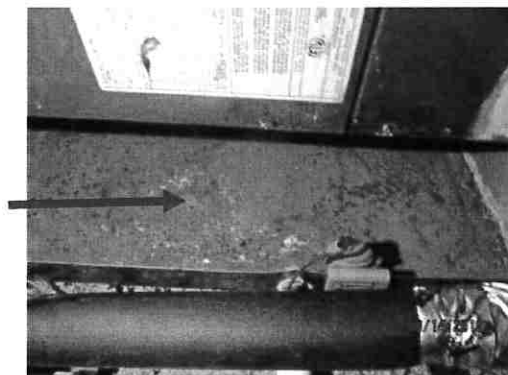
Rust was observed in the attic secondary drain pan. This is an indication of previous/existing condensation leaking form the primary drain pan. Due to not knowing the extent of the rust damage it is recommended that the pan be replaced.

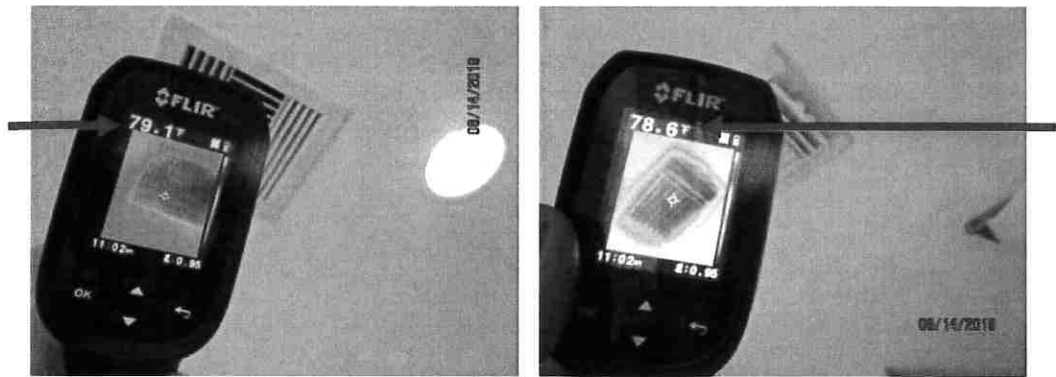
Little to no supply air was observed at the supply air registers at the 4th floor level & the 4th floor qarea was hot due to improperly air flow. Recommend further evalaution/repair.

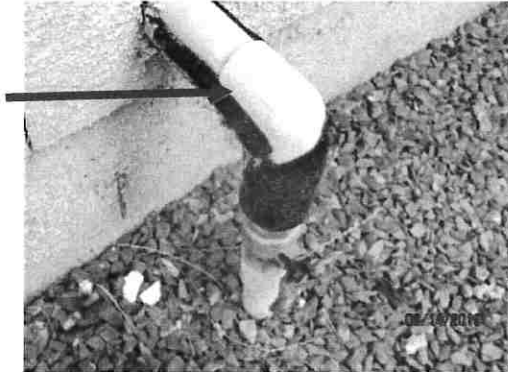
The main water supply line on the side of the structure is missing insulation. Recommend insulating as required.

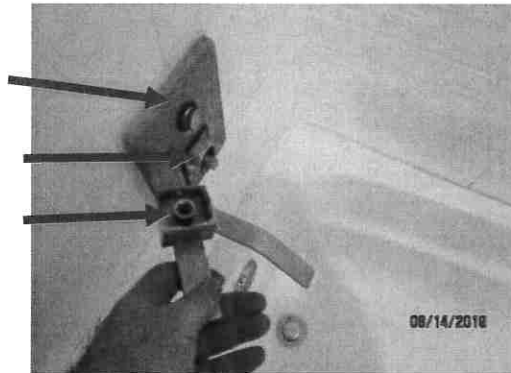
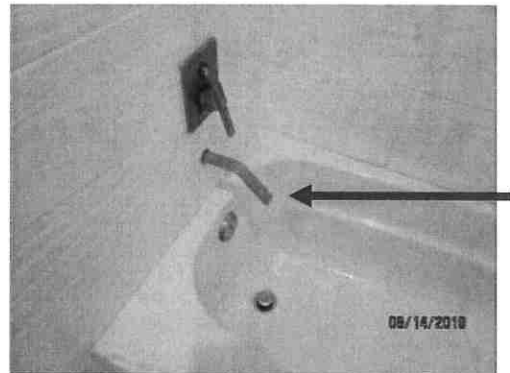
The faucet handle at the 3rd floor guest bath is not properly secured & the shower diverter valve could not be disengaged to allow water to flow out of the faucet. Recommend repair/replacing.

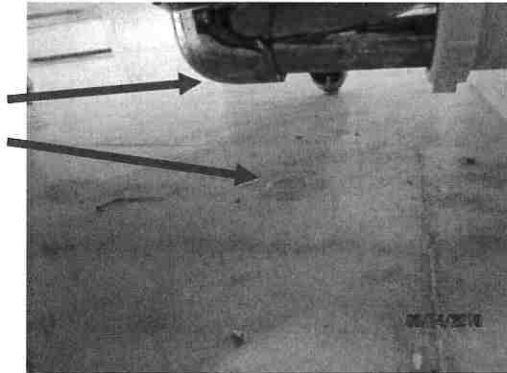
Active leak under the master bathtub was observed. Recommend repairing.

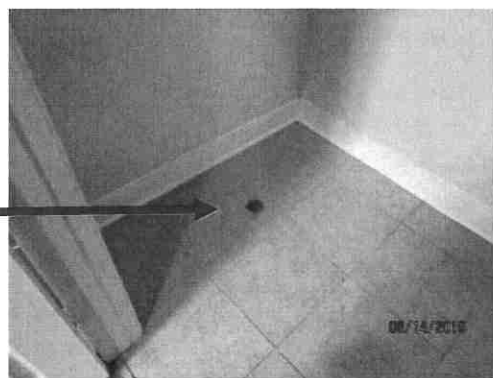
The washing machine on the 3rd floor does not have an over flow drain pan installed. This is typically recommended (not required) when the washing machine is located above the 1st floor.

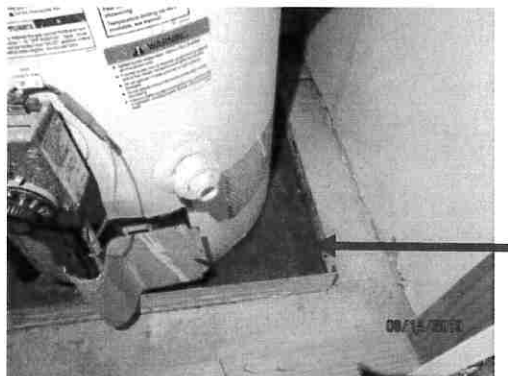
Rust was observed in the drain pan. This is an indication of previous/existing leaking from the water heater tank. Due to not knowing the extent of the rust damage it is recommended that the pan be replaced.

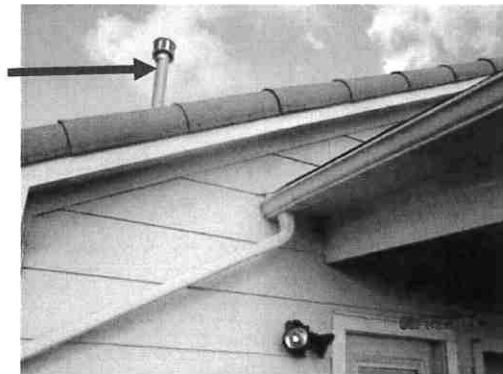
The flue vent pipe at the roof line has not been painted. Recommend priming & painting to prevent rusting.
