RESIDENTIAL INSPECTION REPORT

4518 Sunlit Pass Loop
Humble TX 77396

Lenda Narcisse
AUGUST 6, 2019

PROPERTY INSPECTION REPORT

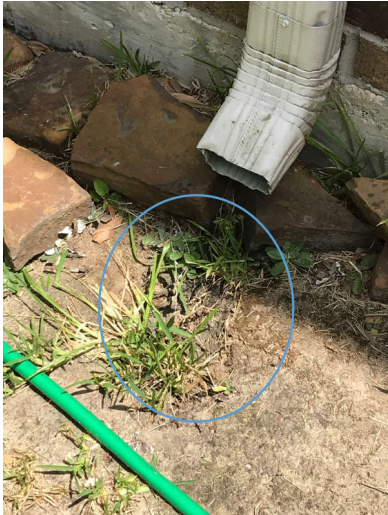
1: Gutters & Downspouts: Missing Splash Blocks

A splash block placed beneath the downspout elbow helps to disperse water away from the foundation and to prevent soil erosion. Remedy as needed.

Recommendation: Recommended DIY Project

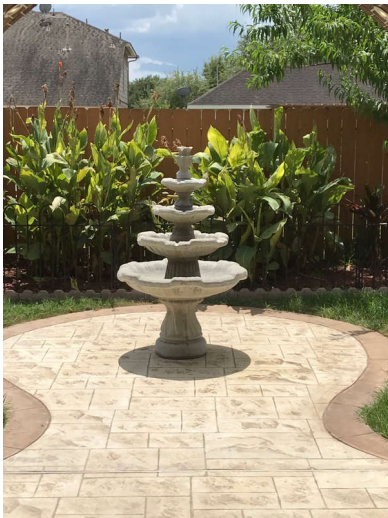
2: Rear exterior fountain was not functioning properly at the time of the inspection.

Recommendation: Contact a qualified professional.

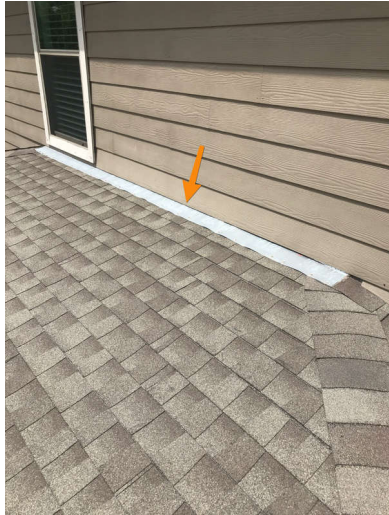
1: Flashing: Unpainted Materials

Rear exterior

Roof materials were not painted (flashings, roof jacks). This can help extend the life of the flashing material, but also helps maintain a consistent look with other roofing materials. Remedy as needed.

Recommendation: Contact a qualified roofing professional.

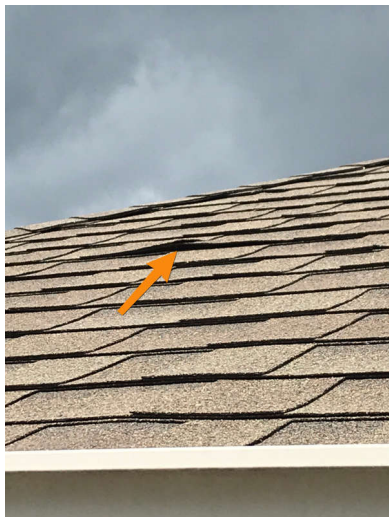
2: Nail pop was observed.

Rear slope

Recommendation: Contact a qualified professional.

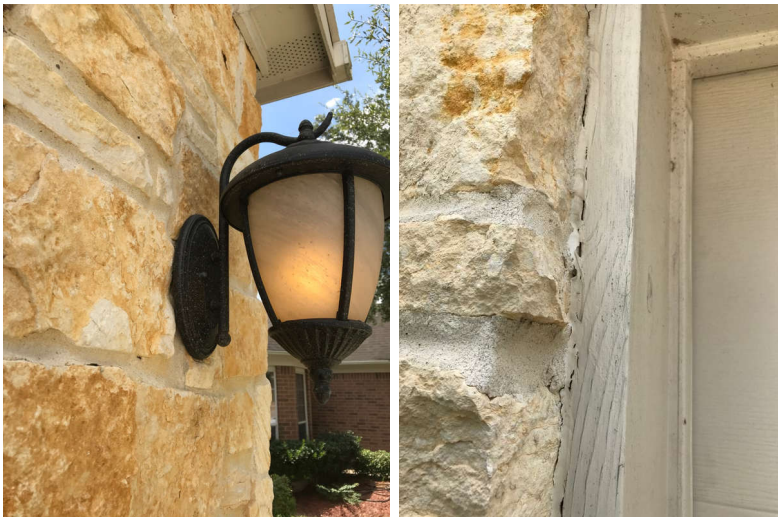
1: Exterior: Seal Wall Fixtures

All Exterior Wall Penetrations, Light Fixture(s), Trim boards - Fixtures/Electrical boxes were not properly sealed. Remedy as needed.

Note: Modern building practices recommend sealing around components that are mounted on or pass through the exterior wall to limit moisture intrusion.

Recommendation: Recommended DIY Project

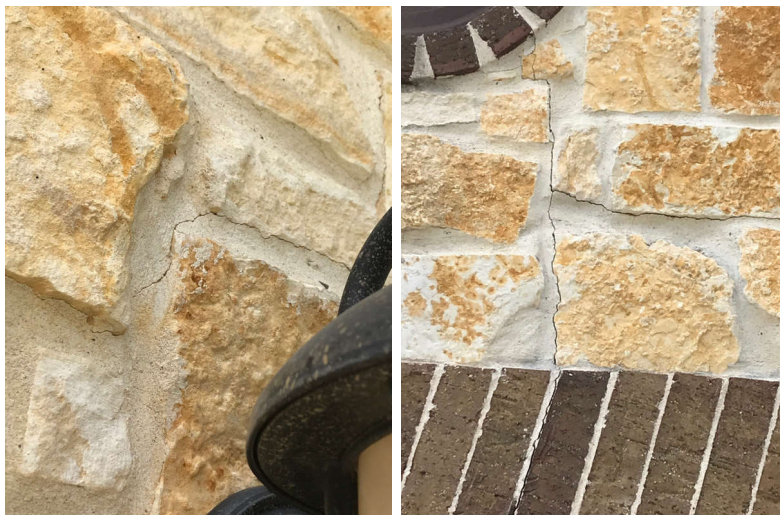
2: Exterior Masonry: Minor Brick Cracks

Multiple Locations

Cosmetic hairline cracks were observed in the masonry siding. Hairline cracks may be a result of thermal expansion of the veneer and/or normal structural movement. Monitoring is recommended.

Recommendation: Recommended DIY Project

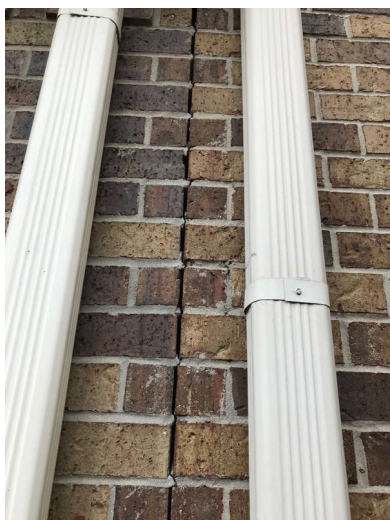
3: Exterior Masonry: Seal Expansion Joints

Left exterior

Sealant in the expansion joints is missing or has deteriorated. Remedy as needed.

Recommendation: Contact a qualified masonry professional.

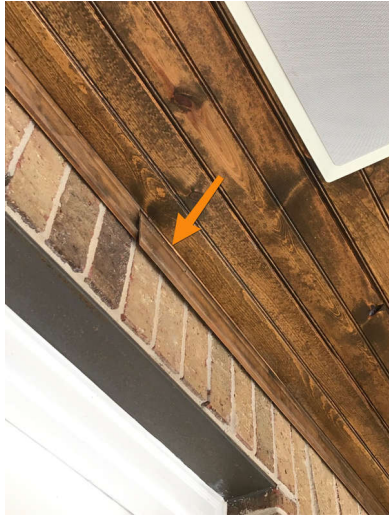
4: Exterior: Trim missing, loose, or damaged

Rear exterior

Sections of exterior trim were either missing, loose, or damaged. Remedy as needed.

Recommendation: Contact a qualified professional.

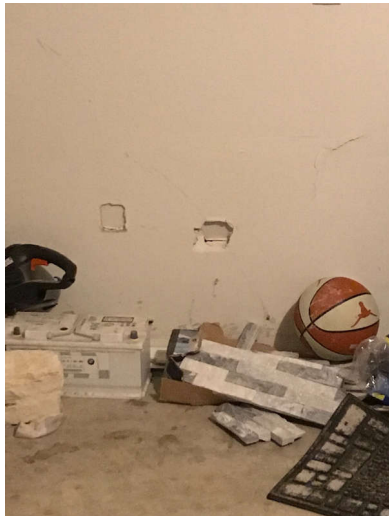
5: Interior: Damaged Drywall (or other wall covering)

Garage

Damaged Drywall (or other wall covering) was observed. Remedy as needed to prevent pest intrusion and energy loss.

Recommendation: Contact a qualified professional.

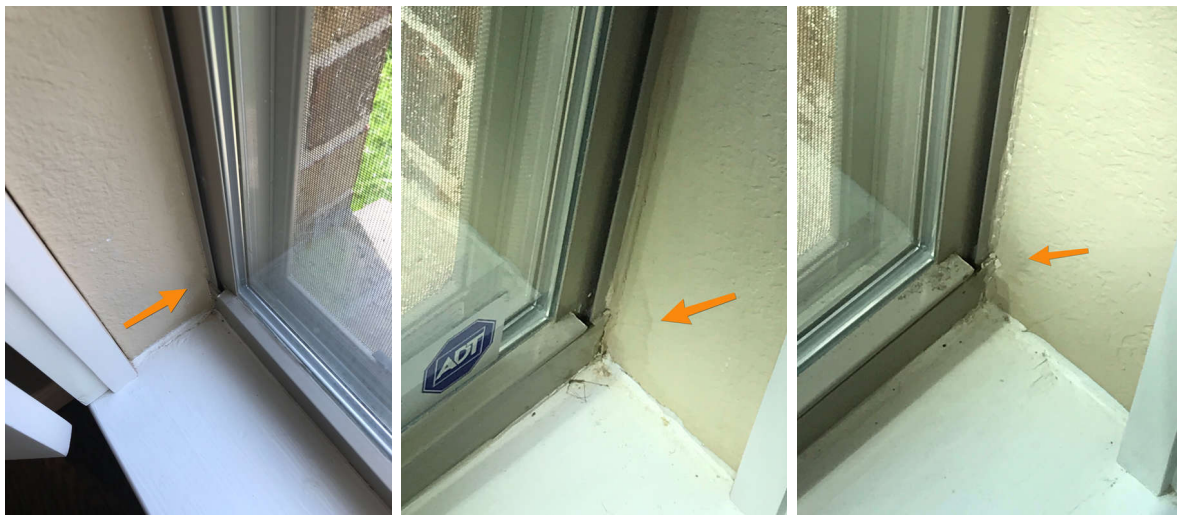
6: Interior: Evidence of Previous Moisture Contact

Near the bottom corner of multiple windows

Wall structure showed signs of previous water intrusion. Tested negative for moisture at the time of the injection. Evaluate and remedy as needed.

Recommendation: Contact a qualified professional.

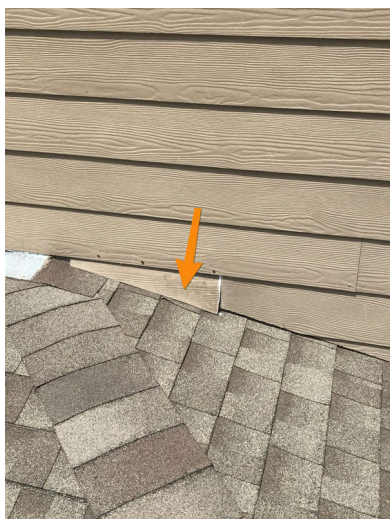
7: Loose siding was observed at rear exterior

Recommendation: Contact a qualified professional.

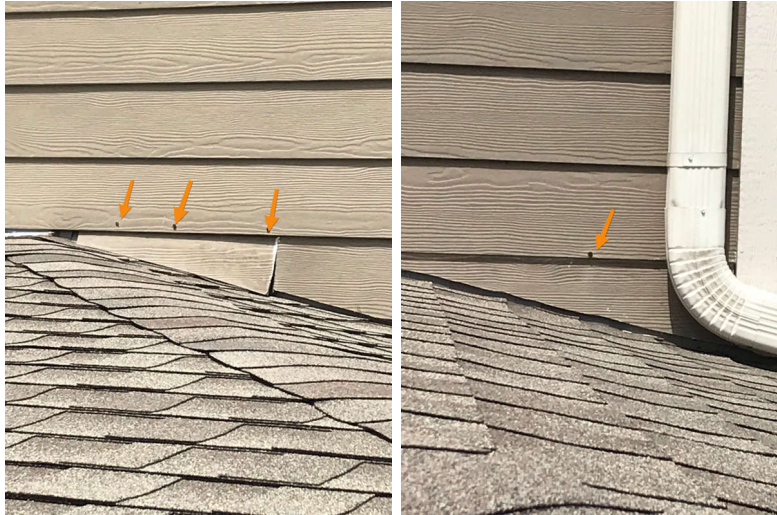
8: Exposed and rusted fasteners were observed at rear wall

Recommendation: Contact a qualified professional.

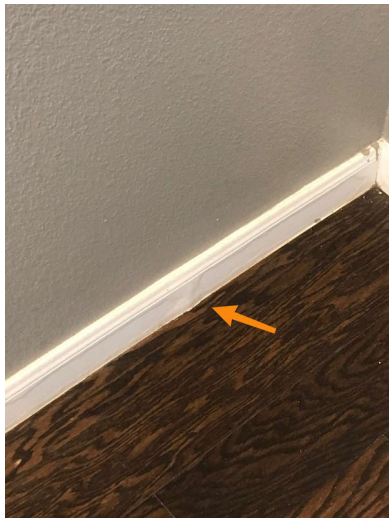
9: Swollen trim board near the front door can be a sign of previous moisture contact.

Recommendation: Contact a qualified professional.

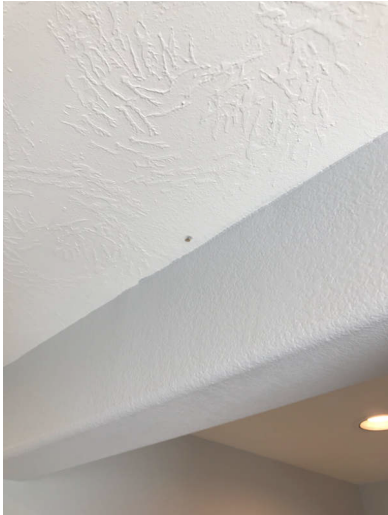
1: Ceiling: "Popped" Nails

Master bedroom

"Popped" (loose) drywall nails are observed on the ceiling. This condition is typically considered cosmetic. Re-seat and seal as needed.

Recommendation: Contact a handyman or DIY project

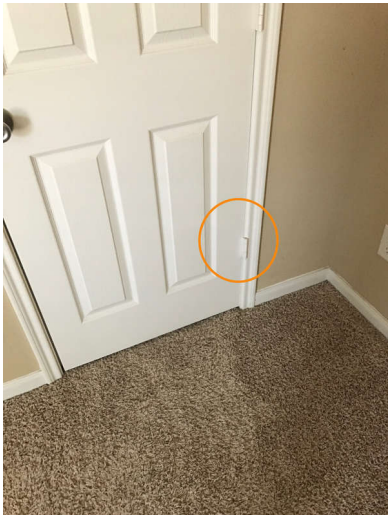
2: Door Hardware: Hinges Loose

Rear left guest bedroom closet

Loose hinges were observed. Loose hinges can cause door to stick or eventually fall out of place. Remedy as needed.

Recommendation: Recommended DIY Project

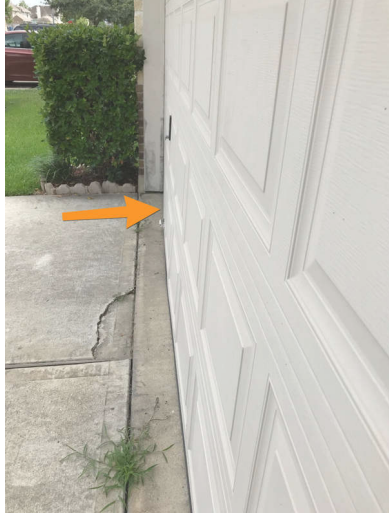
4: Garage Vehicle Door: Damaged

Evaluate and remedy as needed

Recommendation: Contact a qualified garage door contractor.

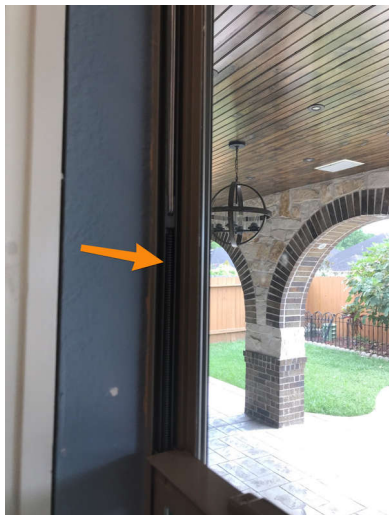
2: Window ballasts/springs are broken

Middle window family room

Window ballasts (or guidesprings depending on the window style) were detached or damaged. These mechanisms serve to hold the window sash up, and if they are damaged the window may not stay open. Remedy as needed.

Recommendation: Contact a qualified window repair/installation contractor.

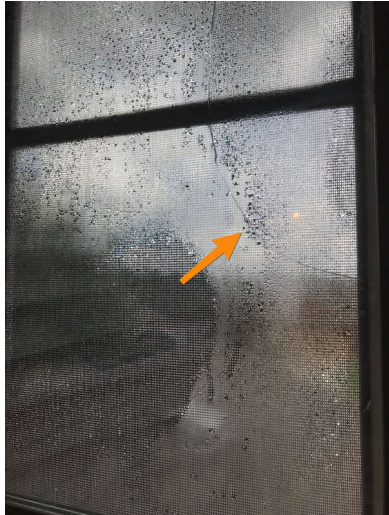
3: Cracked/Broken Glass Panes

Front left guest bedroom

Cracked or broken glass panes were present. Remedy as needed.

Recommendation: Contact a qualified window repair/installation contractor.

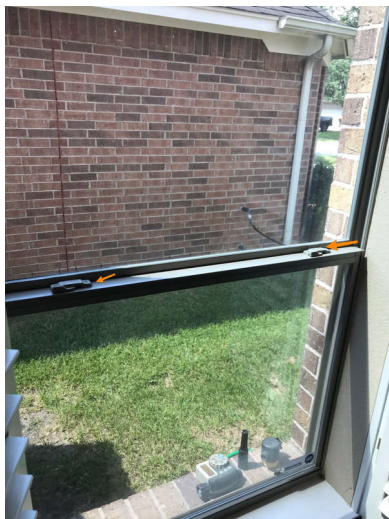
4: Does not close completely to lock

Main entry

One or more windows do not close completely enough to lock/latch. Evaluation and remediation by a window professional as necessary.

Recommendation: Contact a qualified window repair/installation contractor.

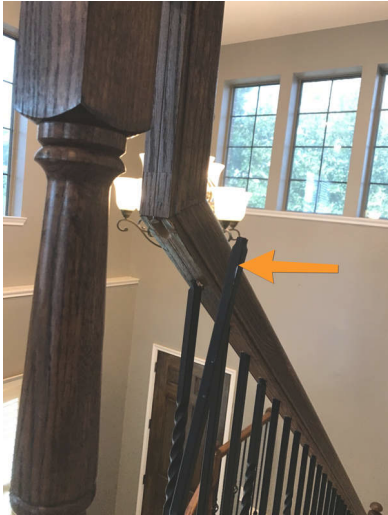
1: Loose balusters were observed.

Recommendation: Contact a qualified professional.

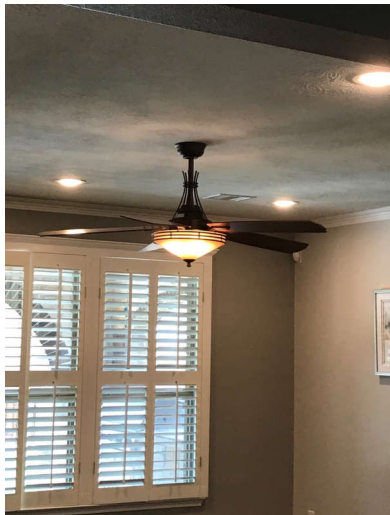
1: Ceiling Fan Defects

Inoperative -
Further evaluation is recommended.

Recommendation: Contact a qualified professional.

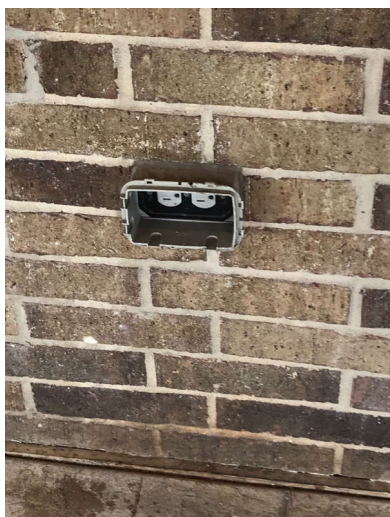
2: Receptacles: Weatherproof Cover Missing/Damaged

Rear exterior

A weatherproof cover was not installed or damaged on an exterior receptacle. Remedy as needed

Recommendation: Contact a qualified professional.

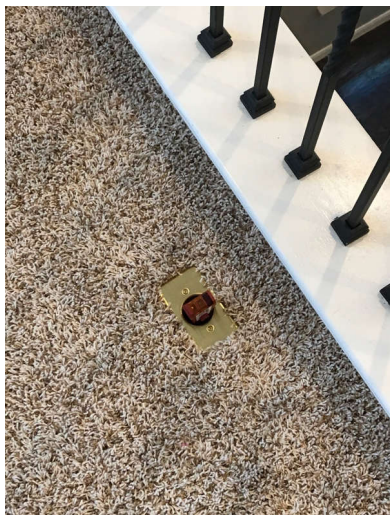
3: Receptacles: No Power

Second floor floor outlet

Receptacle had no power. Evaluate and remedy as needed.

Recommendation: Contact a qualified electrical contractor.

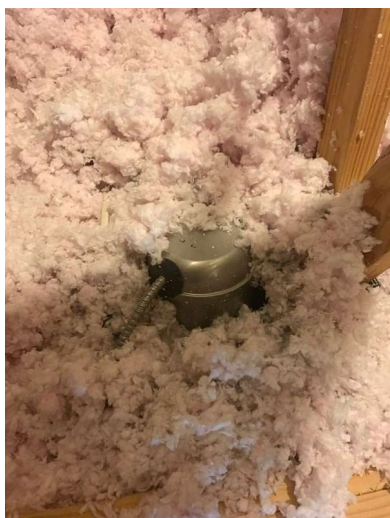
5: Light: Insulation on can lights

Insulation was too close or touching can lights. Insulation should be removed from can lights in attic. A 3-inch clearance is generally required for safety. Remedy as needed.

Recommendation: Contact a qualified electrical contractor.

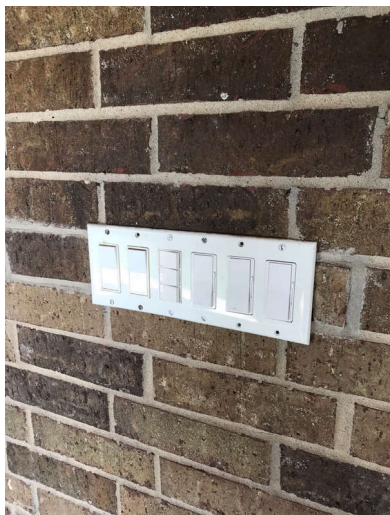
6: Light: Switch Has No Apparent Function

Multiple at rear

A switch had no apparent function. Evaluate and remedy as needed, or ask seller for further clarification.

Recommendation: Contact a qualified electrical contractor.

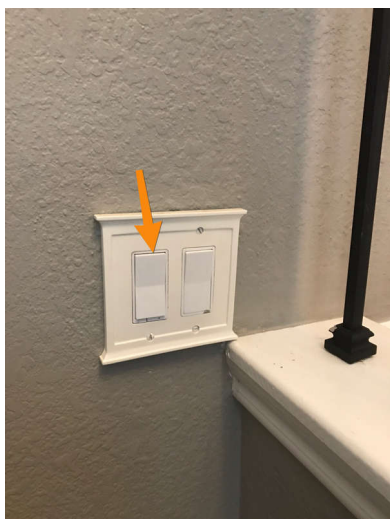
7: Light switch does not function properly at front door

Recommendation: Contact a qualified professional.

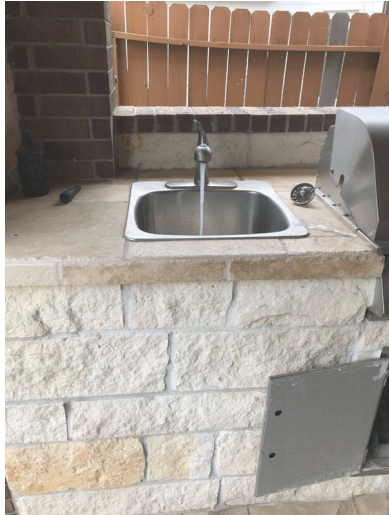
8: Current building standards require a GFCI protected outlet be located within 36 inches of all sinks.

Rear exterior

Recommendation: Contact a qualified professional.

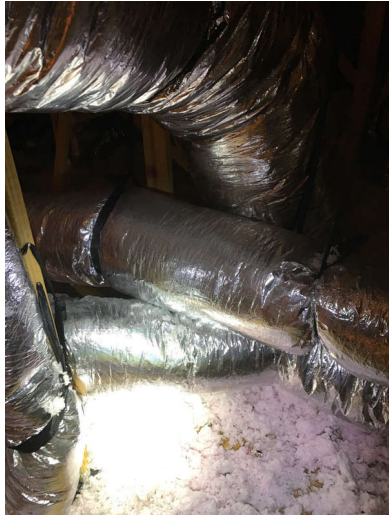
2: Ducts: Ducts resting on each other.

Ducts were resting on each other. This can result in condensation forming between the two sections of ductwork. Remedy as needed.

Recommendation: Contact a qualified professional.

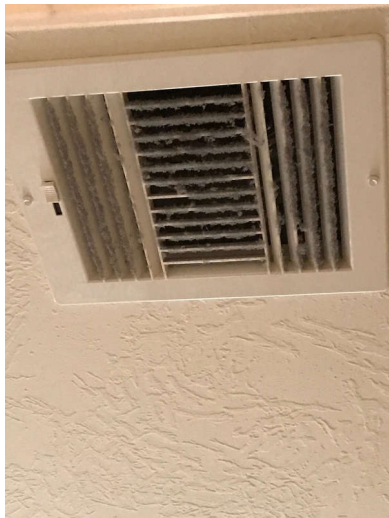
3: Multiple dirty registers were observed

Recommendation: Contact a qualified professional.

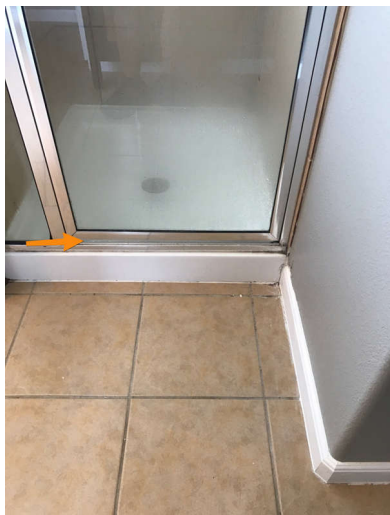
2: Shower: Door Missing/Damaged Seal

The seal (also known as a gasket or floor sweep) at the shower door was missing or damaged. Remedy as needed.

Recommendation: Contact a qualified professional.

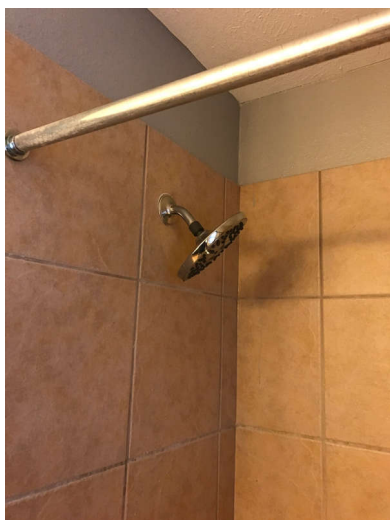
3: Shower: Loose pipe at showerhead

The pipe supplying water to the showerhead was loose at the wall . Remedy as needed.

Recommendation: Contact a qualified plumbing contractor.

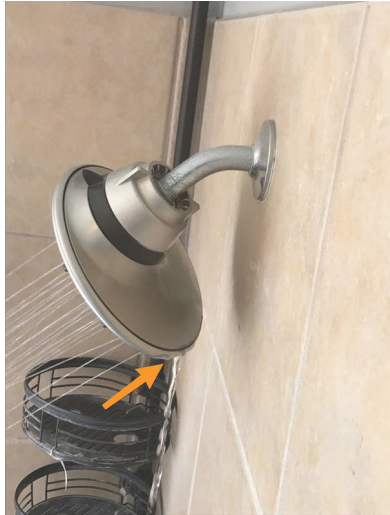
4: Shower: Showerhead leaks/sprays

Water leaked/sprayed around the showerhead during operation. Remedy as needed.

Recommendation: Contact a qualified plumbing contractor.

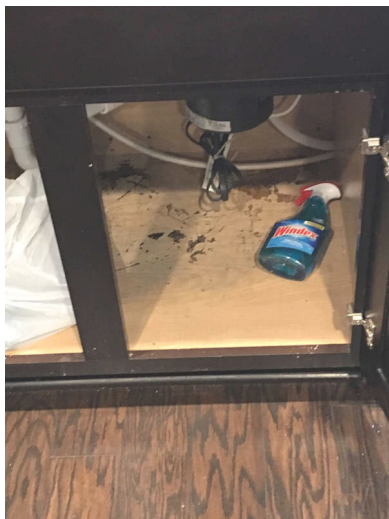
1: Note: Evidence of Previous Leak

Note: Evidence of a previous leak was noted under the sink. No leaking occurred at time of inspection and the area remained dry.

Recommendation: Recommend monitoring.

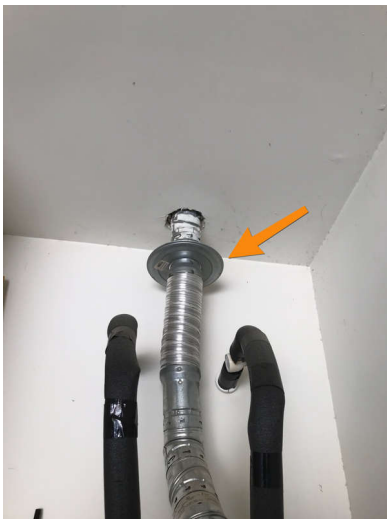
4: Venting system: Missing/loose ceiling collar

The collar was missing/loose where the flue passes through the ceiling. Remedy as needed.

Recommendation: Contact a qualified professional.

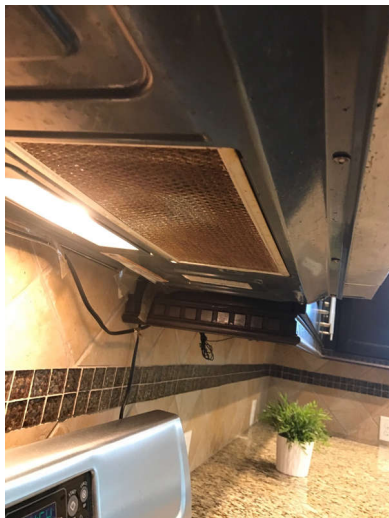
1: Flex Vent Pipe Improper

Section(s) of the kitchen exhaust vent pipe were corrugated. Smooth-walled material is recommended to prevent grease build-up inside the vent pipe.

Recommendation: Contact a qualified professional.

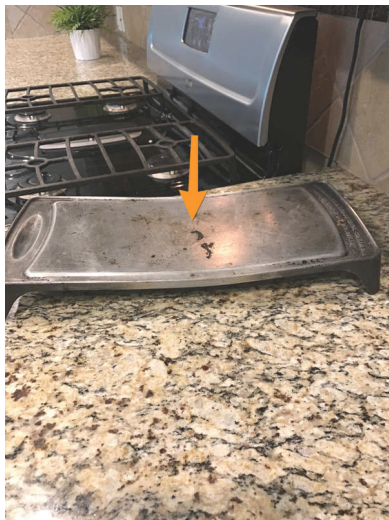
1: Bent griddle was observed.

Recommendation: Contact a qualified professional.

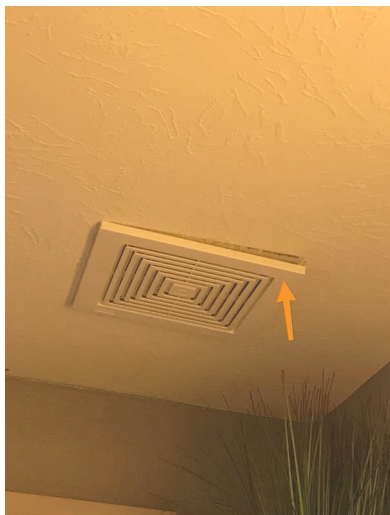
3: Loose Vent Cover

The exhaust vent cover was loose at the ceiling. Remedy as needed.

Recommendation: Contact a qualified professional.
