# PROPERTY INSPECTION REPORT

Concerning: 3373 Zubin Lane, Katy, TX 77493-6015  
(Address or Other Identification of Inspected Property)

By: Randall E. Keith License # 6339 April 9, 2019  
(Name and License Number of Inspector) (Date)

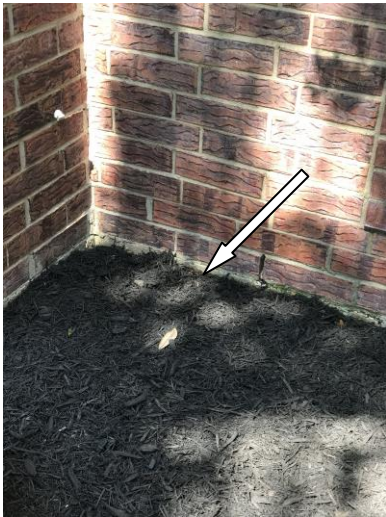
The mulch was too high at the front flowerbed with less than four inches in separation from the top of the foundation at the brick veneer to the grade. I recommend pulling the mulch back from the edge of the foundation to provide for sufficient separation without creating a trench for water to pond.

*FYI: TREC requirement state four inches of the foundation should be visible between the ground and brick veneer siding.*

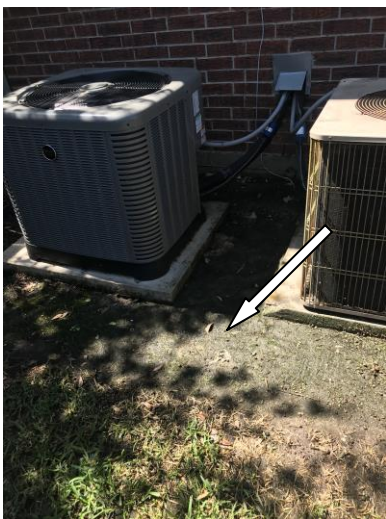
As common with homes built in this time period, the grade of the rear lot was very flat and did not appear to drain storm water properly around the house and into the street by current standards.

*FYI: TREC requirements state the grade should be sloped away from the house 6" every 10' and channeled (sloped) around the house and into the street.*

*FYI: The surface ground at the right rear of the home (by the A/C condensers) was very moist likely caused by the grade and shaded foliage cover limiting the soils ability to dry.*

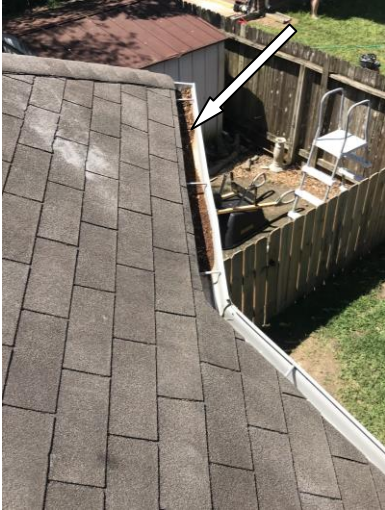
The gutters at the rear left of the home noted full of debris and should be cleaned to operate properly and not hold water providing a breeding ground for mosquitoes and insects and early deterioration of the gutter system.

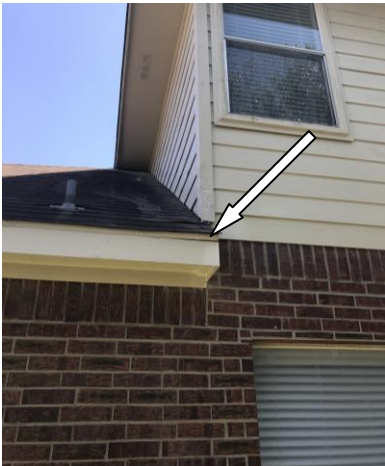
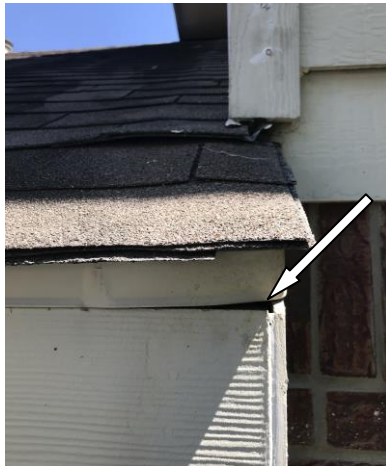
The drip edge at the left rear boxed eave end did not properly cover and seal the fascia board.

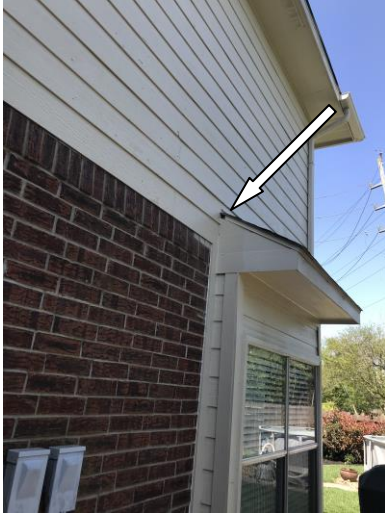
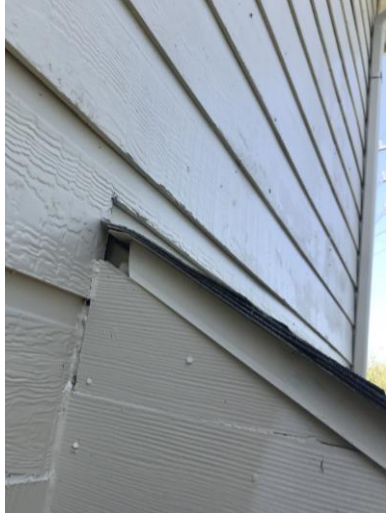
The drip edge flashing was not properly cut and exposed a gap at the rear right boxed window covering.

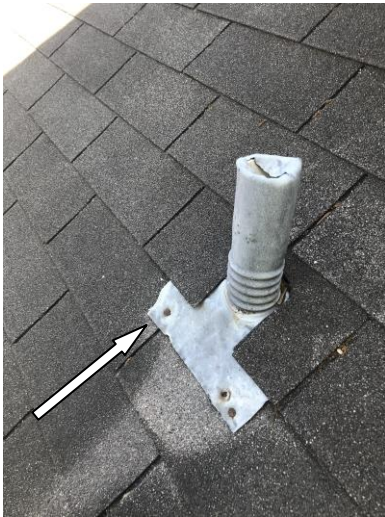
Roof appeared to be a 20-year Class A asphalt composition shingle. The asphalt tile was in good condition and showed no signs of leakage from the exterior or the interior.

Uncaulked nail heads were visible on lower portions of plumbing stacks and at the ends of the ridges.

*FYI: All exposed nail heads on the roof should be caulked to prevent possible moisture penetration as per shingle manufacturer's installation recommendations.*

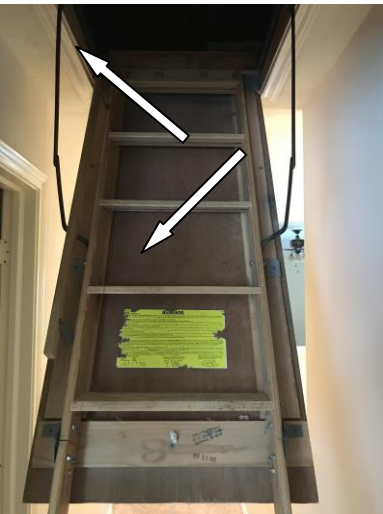
The pull down attic access door was not insulated on the backside of the door and not weather-stripped around the edge to help prevent transfer air into the home.

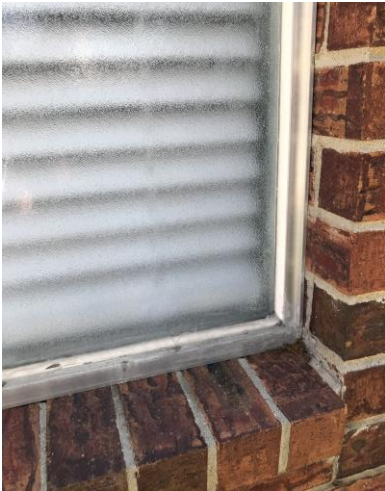
Common caulking was needed at the joints around the exterior master bathroom window where the window frame and brick meet to prevent possible moisture penetration.

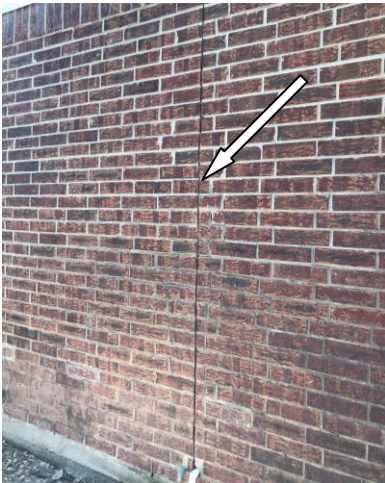
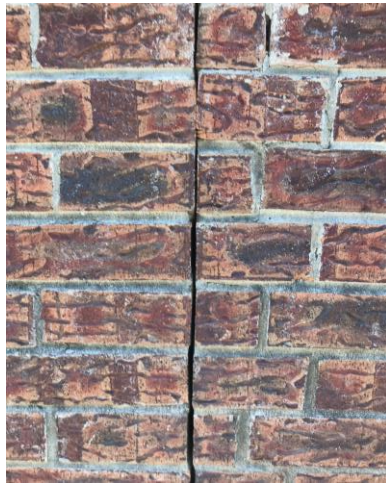
The expansion joint at the left rear of the house need to be caulked to prevent possible moisture penetration.

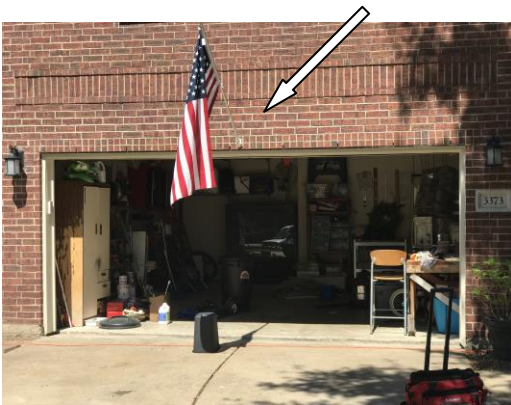
*FYI: A minor vertical brick and mortar crack (about 3 feet long) was observed over the center of the garage door header from the header upwards with about a 1/8" separation at the bottom. This type of separation is common and usually caused by the header board slightly sagging from the weight of the brick and mortar wall. No repair is recommended.*

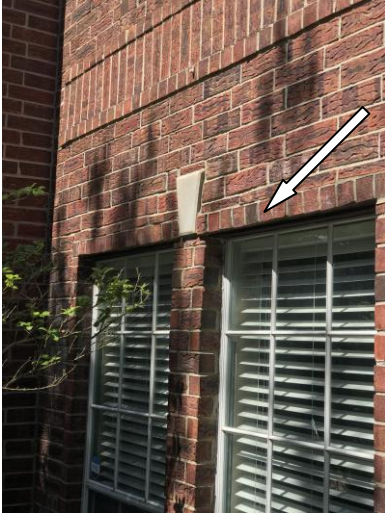
*FYI: No weep holes were installed over the windows above the brick lintels.*

*FYI: At the time of construction window lintel weep holes were not required.*

*FYI: A weep hole is a gap in the bottom layer of exterior brick and mortar (walls, door and window lintels) that allows for drainage of water or moisture that penetrates into the wall. Weep holes are required to be placed every 33" by today's standards of construction.*

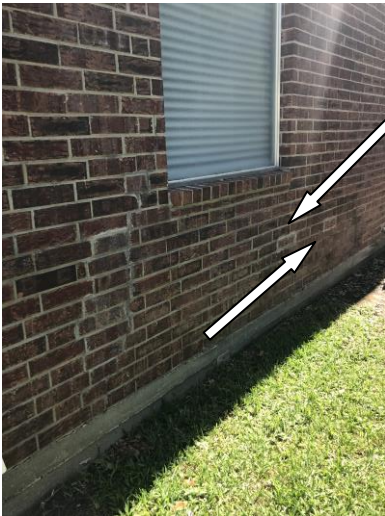
*FYI: A previously repaired crack in the brick veneer was observed at the rear left. The sealant was older and there was no separation from the sealant joint since the repair indicating no obvious movement.*

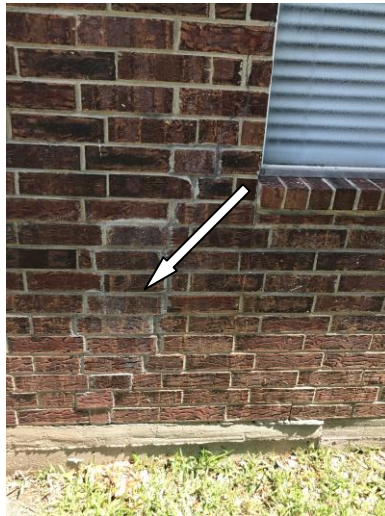
*FYI: Several individual bricks on a similar row appeared to have been replaced or repaired at the rear left with no understanding or explanation.*

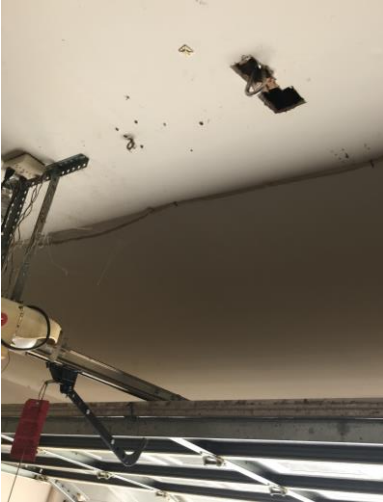
A small cutout was noted in the garage ceiling and should be sealed.

*FYI: Walls and ceilings in attached garages are required to be covered with gypsum board and taped and floated or covered with some fire retardant material since the majority of home fires originate in garages.*

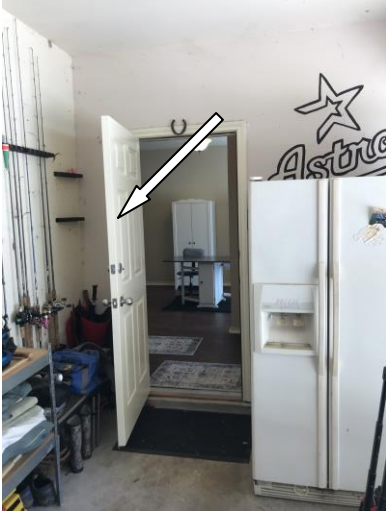
The garage entry did not have a self-closing device as recently required (Jan 2015) on new construction of all doors leading from the house to an attached garage.

*FYI: Recently, building standards in Texas have changed to include a self-closing device (usually a door hinge) on attached garage entry doors because a large majority of home fires originate in the garage and the door is a fire barrier only when closed.*

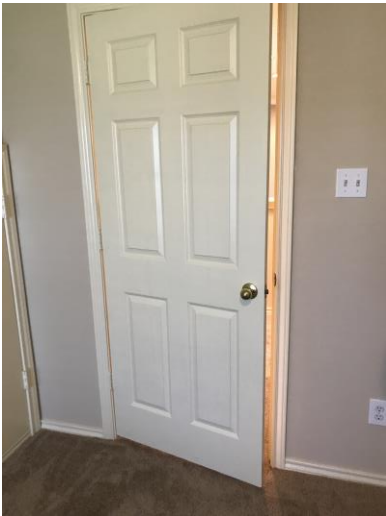
*FYI: The two upstairs secondary bedroom entry doors on the left side of the home gradually closed when left open and could be a result from the doors not being installed square with the doorframes.*

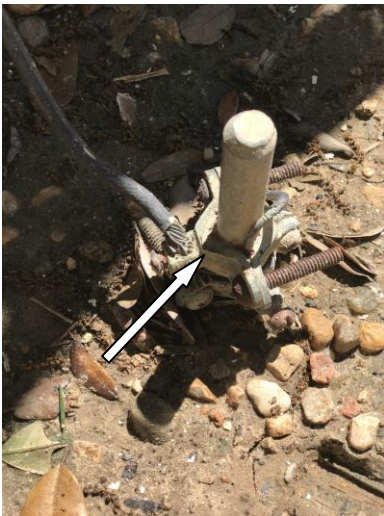
The ground wire connection to the grounding rod used a pipe grounding connection and not an acorn style as required for ground rods currently.

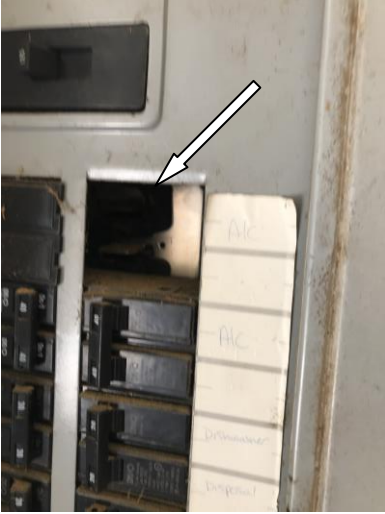
A plug was missing on the dead front cover in the panel box where there was no breaker.

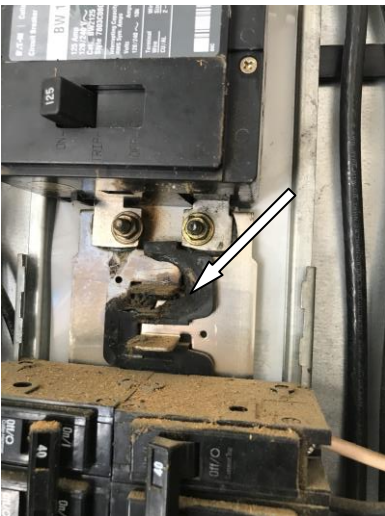
Evidence of overheating was observed in the electrical panel. It appears the issue was addressed and the location of breakers in the panel modified. I recommend a licensed electrician review and perform any corrections (if determined to be necessary by the electrician) to assure proper serviceability.

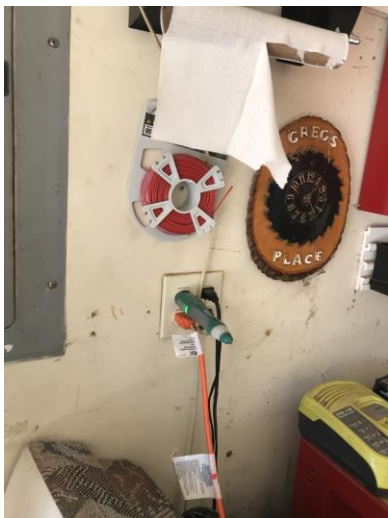
GFCI protection was not provided at all the electrical receptacles in the garage as recommended for safety. Today's standards require GFCI protection at all garage electrical receptacles be GFCI protected.

The garage electrical receptacle to the right of the electrical panel and the ceiling receptacles to power the garage door opener were not GFCI protected.

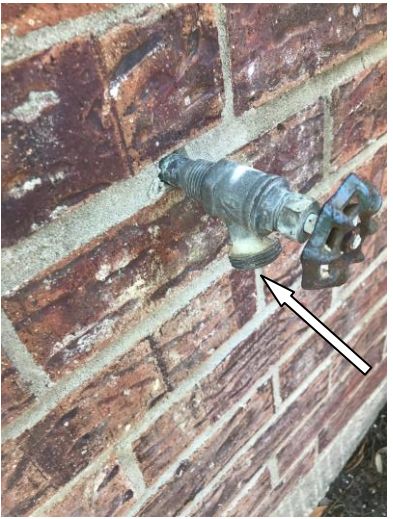
Anti-siphon devices were not installed on exterior hose bibs.

*FYI: All exterior hose bibs should be equipped with anti-siphon appendages that act to prevent gray water from being drawn back into the fresh water supply of the home in the event of pressure loss by the city supplier.*

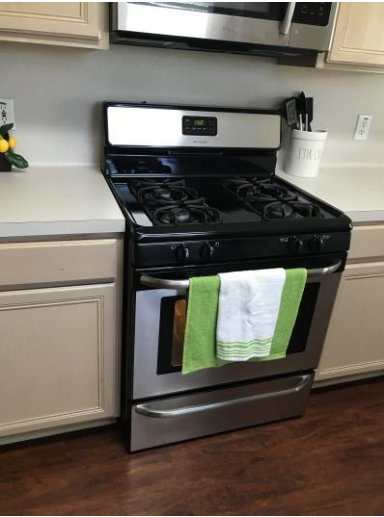
The unit did not have an anti-tip device installed as required on free standing units.

*FYI: An anti-tip device is usually a bar with a lip attached to the wall at the back base of the unit to prevent the unit tipping in the event the door is open and someone uses it as a step to reach items in above shelves causing the oven to tilt forward.*

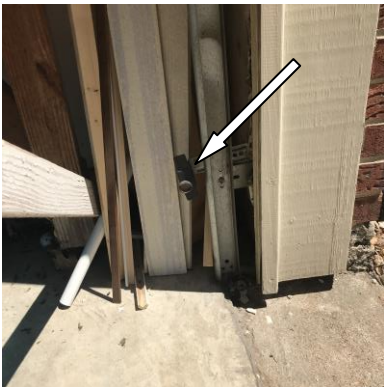
The electric infrared eyes on the garage door were 11" above the ground and recommended by the manufacturer to be installed within 6" of the ground for the safety of children and pets.

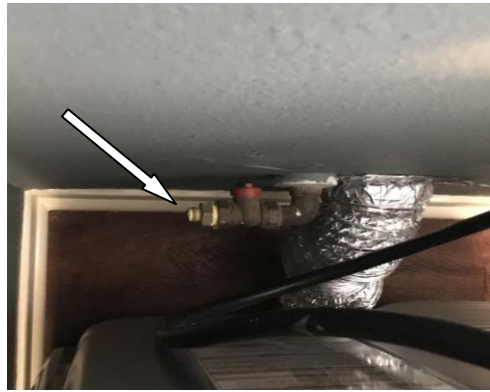
The gas line in the utility room was not properly capped and not connected to a device. The gas valve could leak if the valve if accidentally bumped.

*FYI: Anytime a gas line is not attached to an appliance, the line should be capped with a pipe cap.*
