Inspection Report

Property Address:
26 South Bethany Bend
Woodlands Texas 77382

PROPERTY INSPECTION REPORT

Concerning: 26 South Bethany Bend, Woodlands, Texas 77382

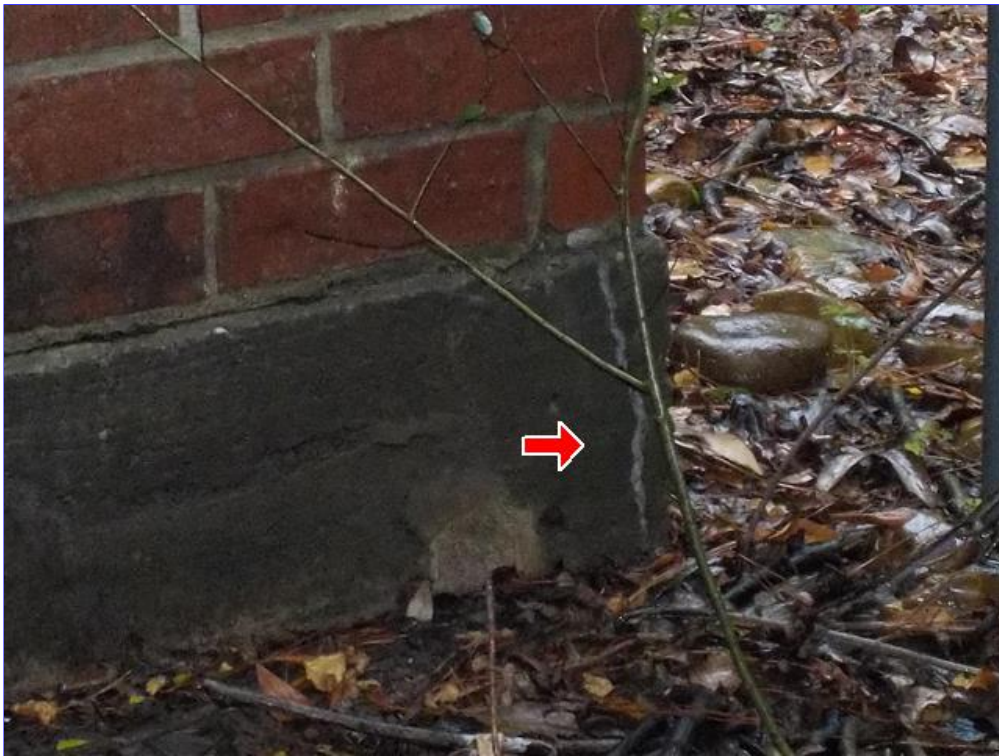
A. Item 1(Picture) Corner of Foundation is popped-out

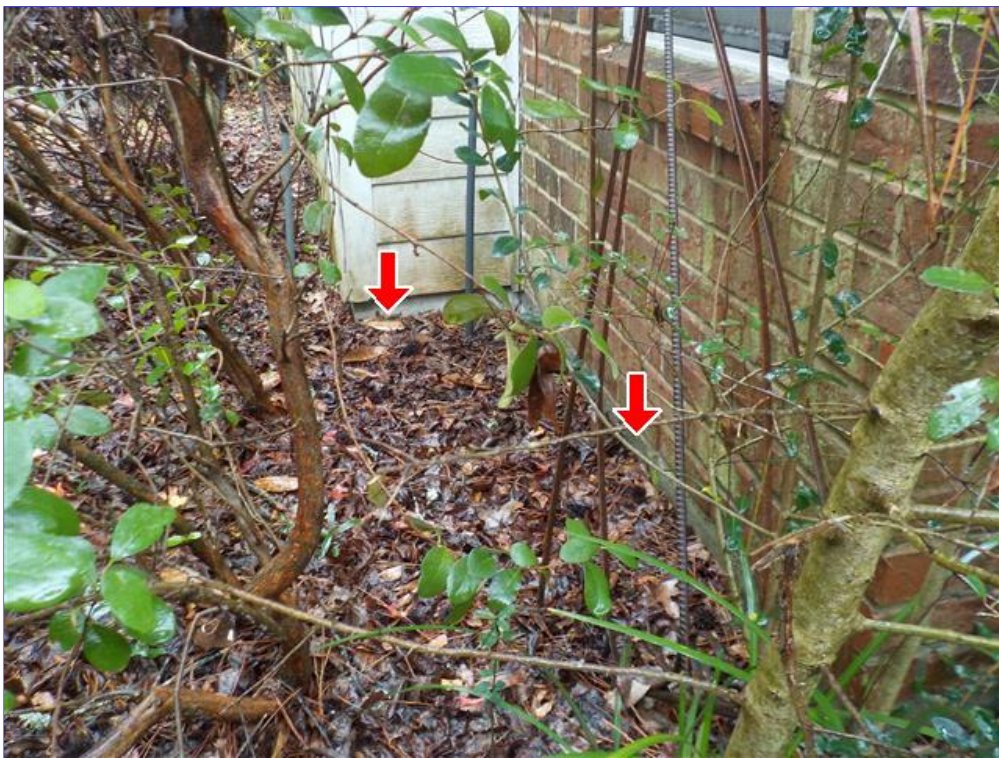
A. Item 3(Picture) Sprinkler heads should be 12in from the foundation

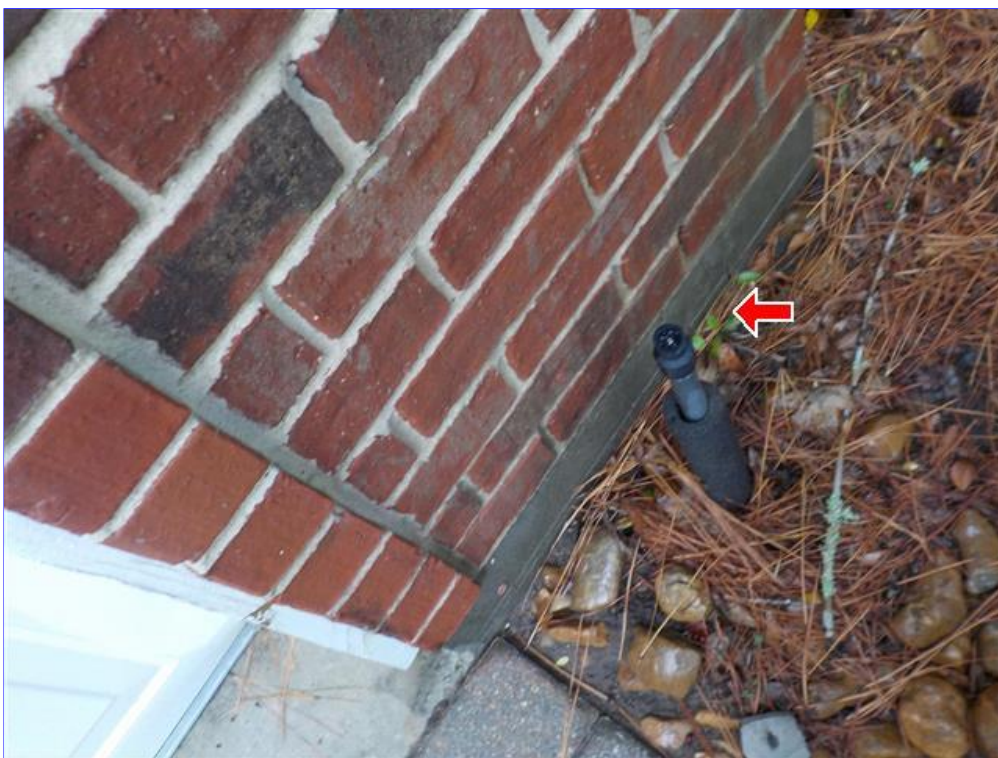
B. Item 1(Picture) Sprinkler head should be 12in from the structure

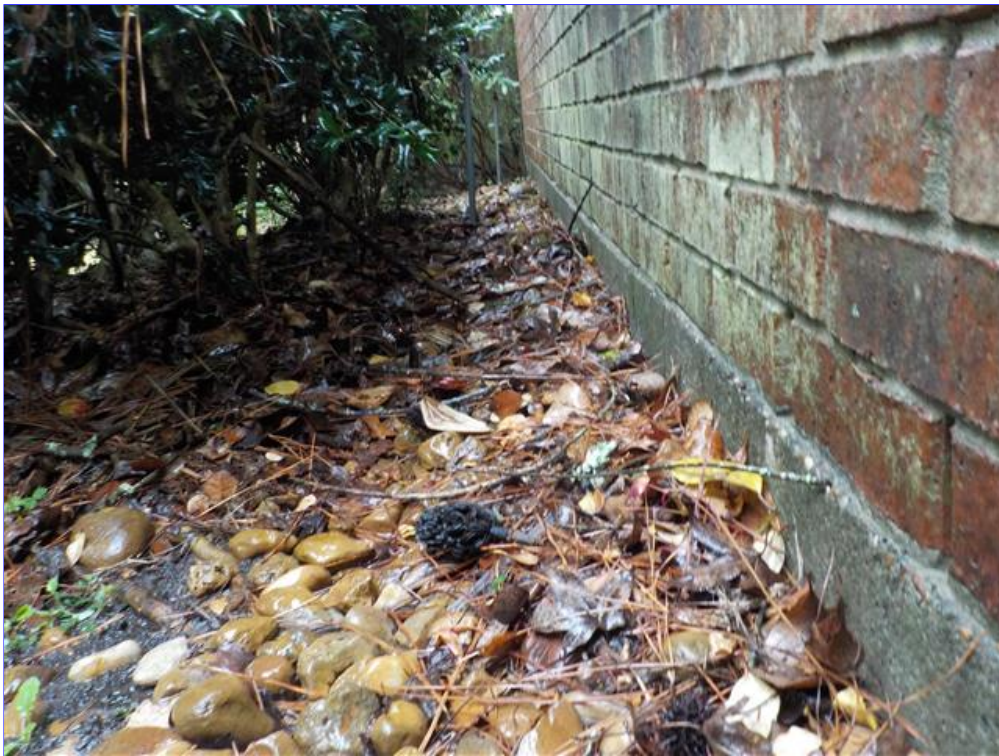
B. Item 3(Picture) Ponding water around the foundation

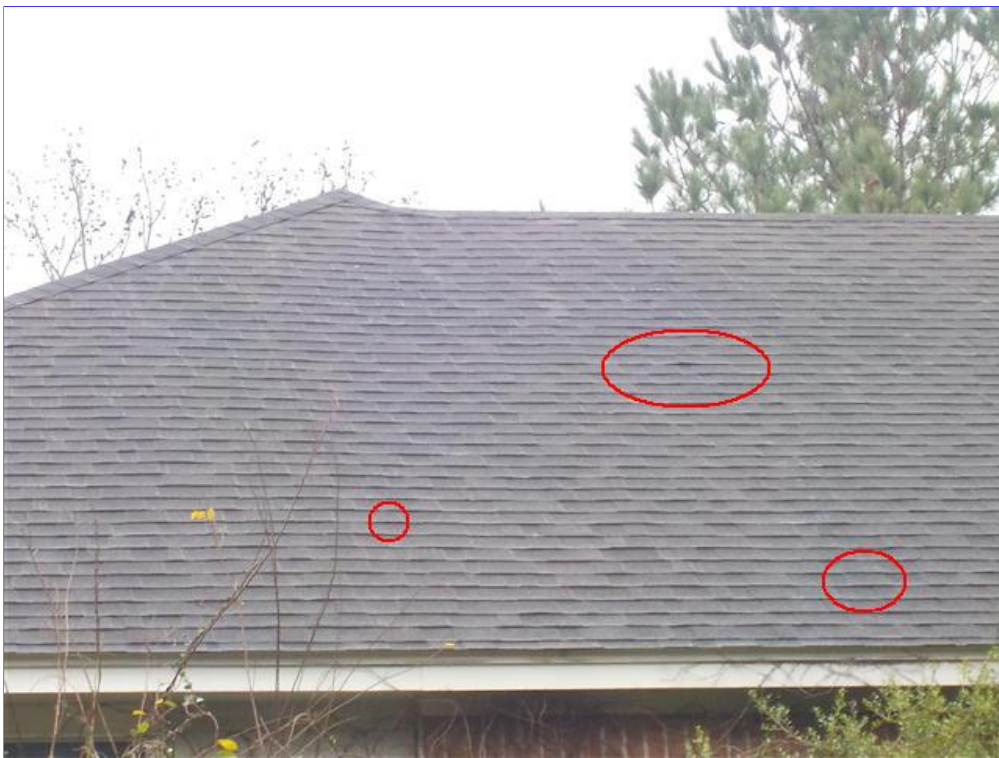
C. Item 6(Picture) Shingles are popping out of place

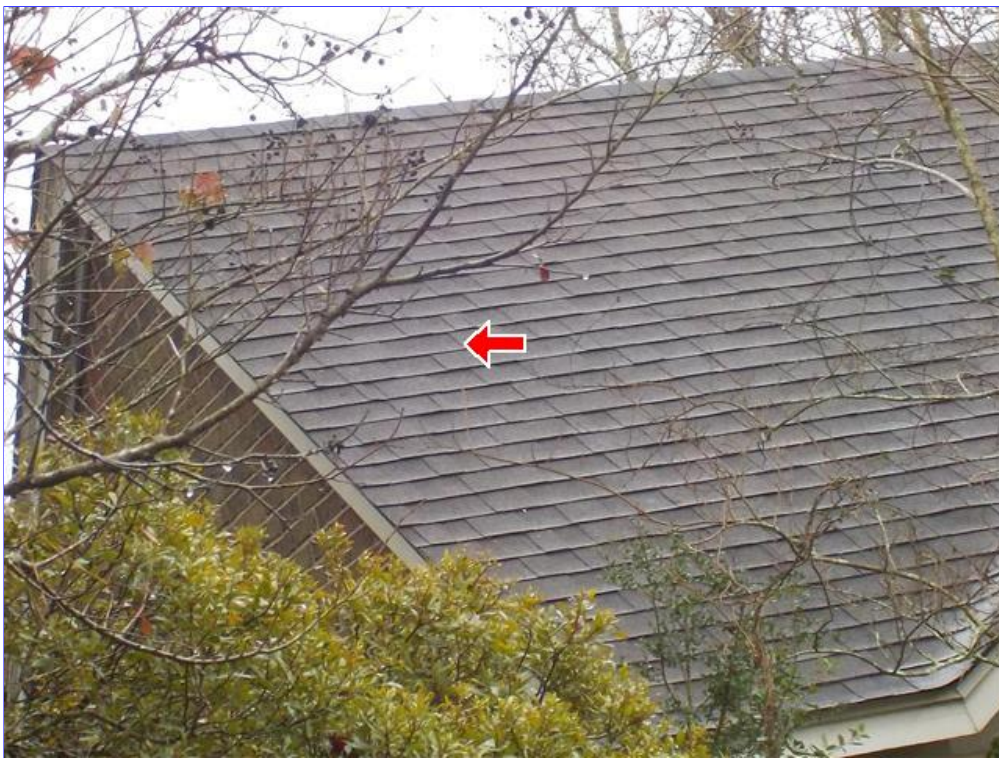
C. Item 8(Picture) Foilage overhanging the House

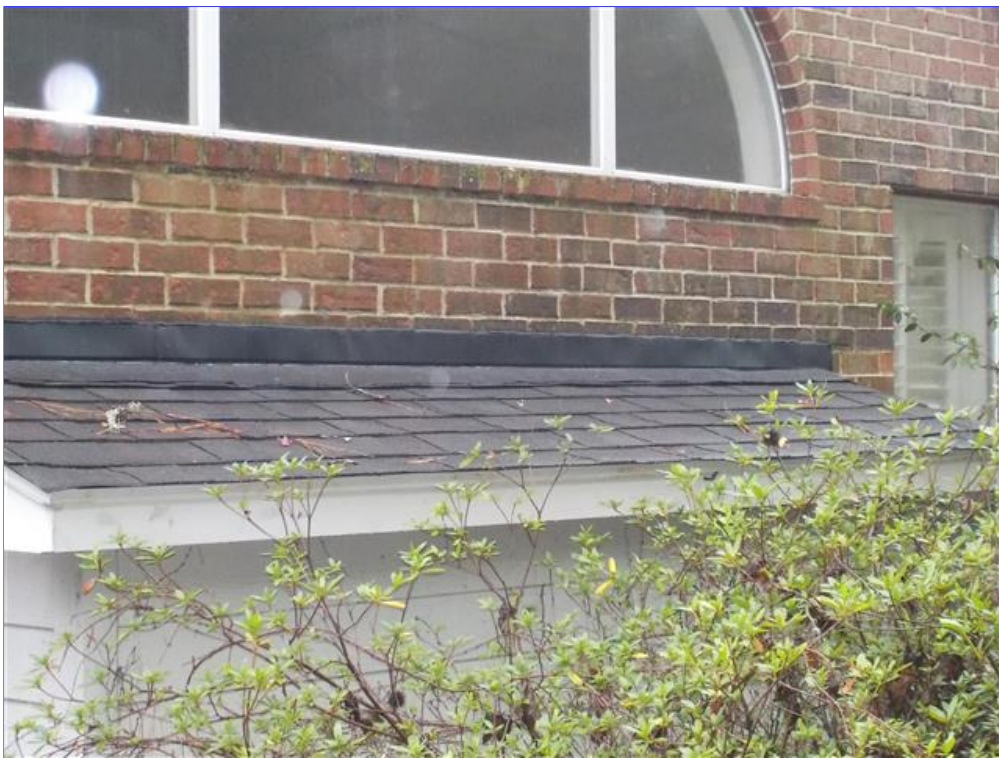
C. Item 10(Picture) Areas of inaccessibility due to vegetation or debris

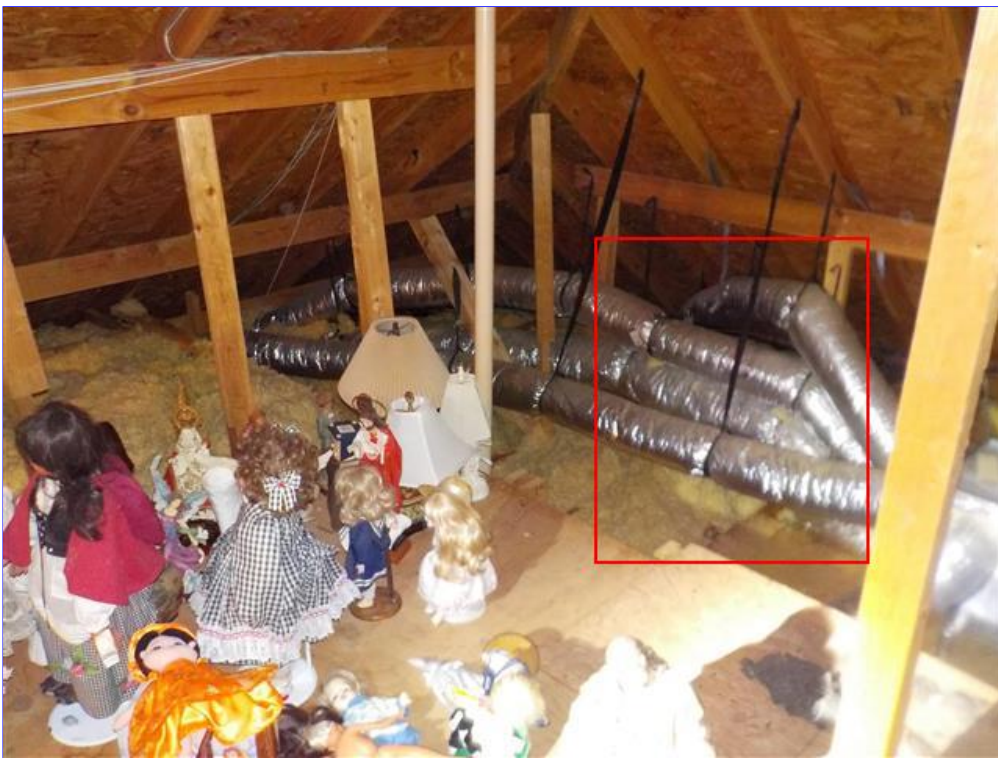
C. Item 16(Picture) Ducts are touching which makes them sweat condensation

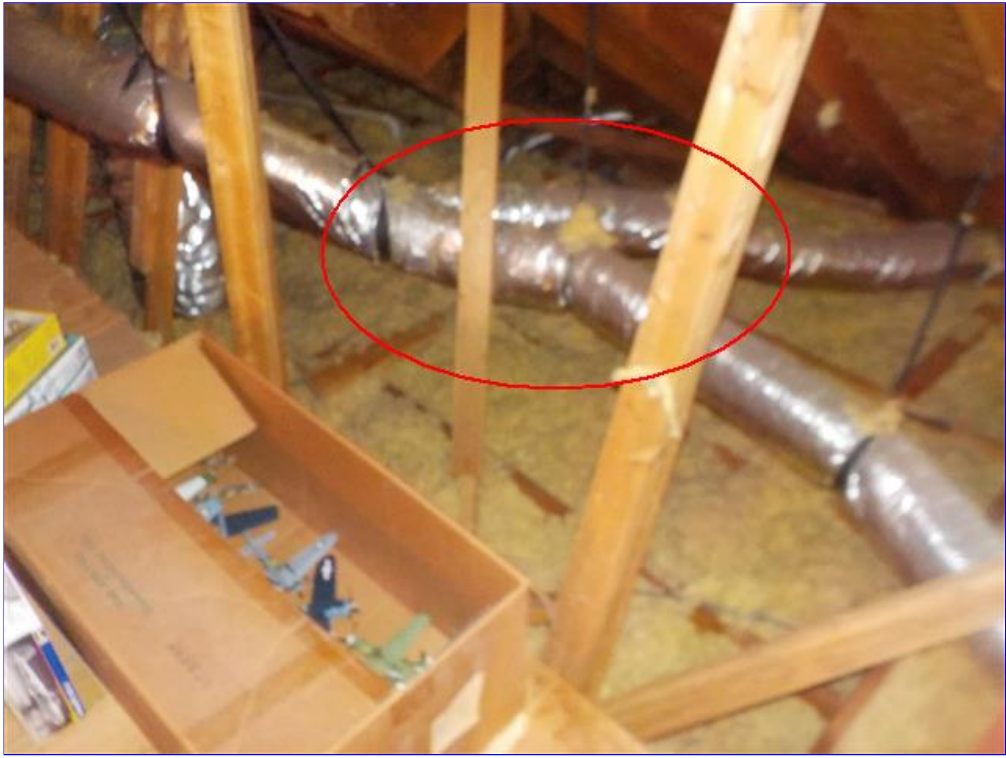
C. Item 18(Picture) Ducts in contact, recommend adding baffles to the attic ventilation

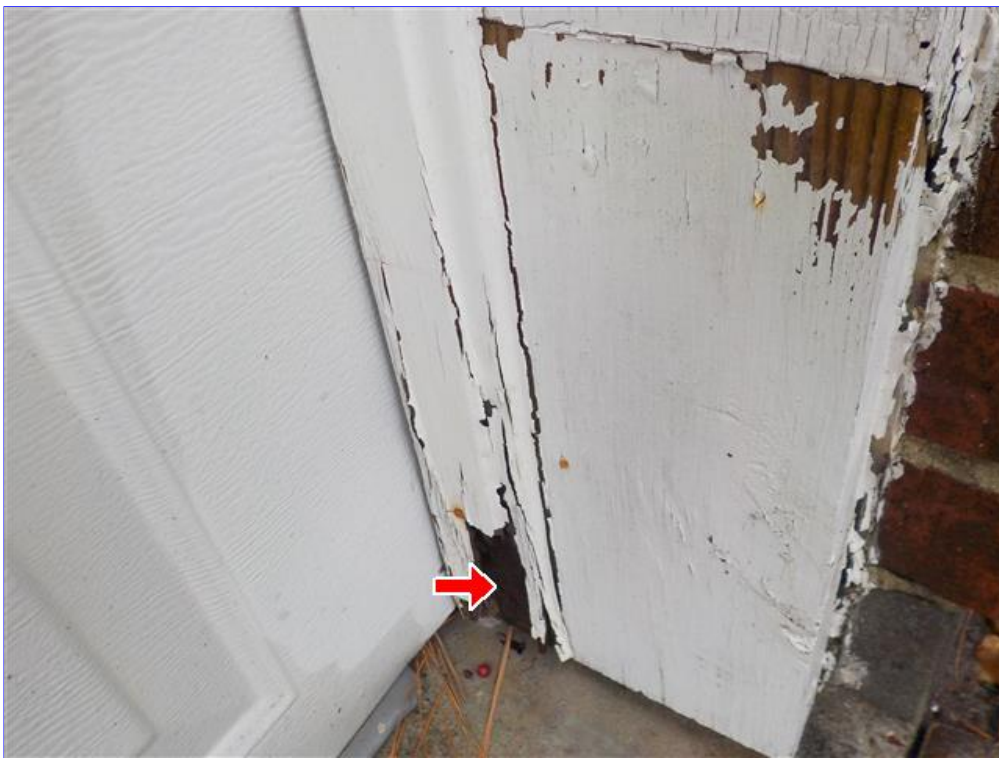
D. Item 2(Picture) Wood rot visible

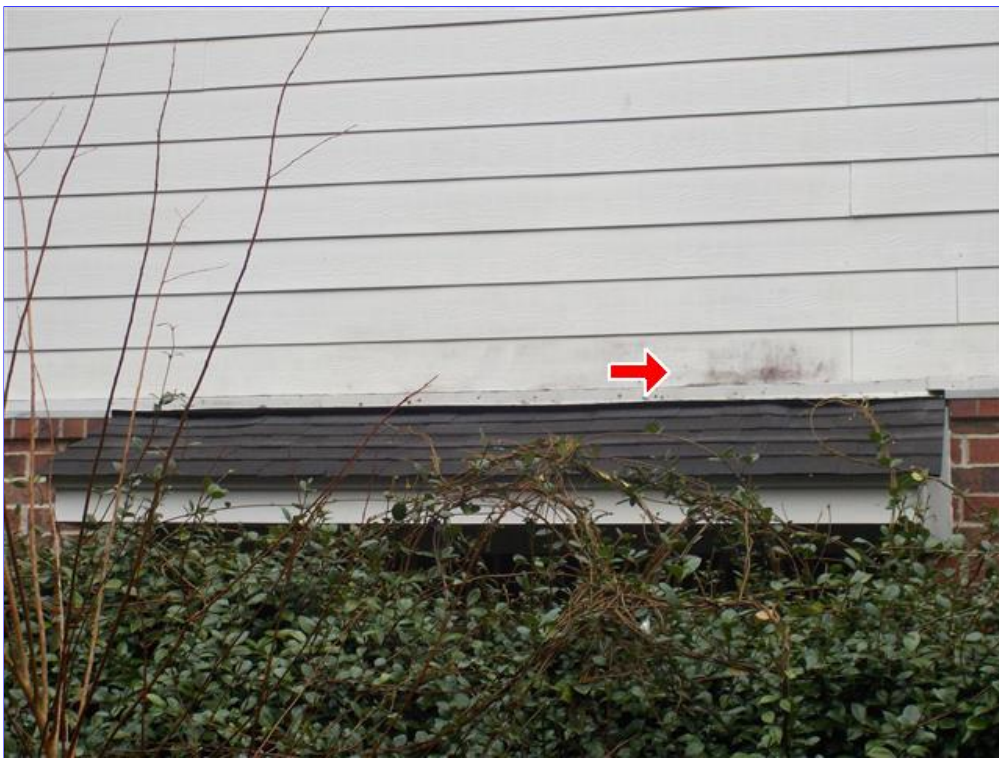
D. Item 6(Picture) WDO issues

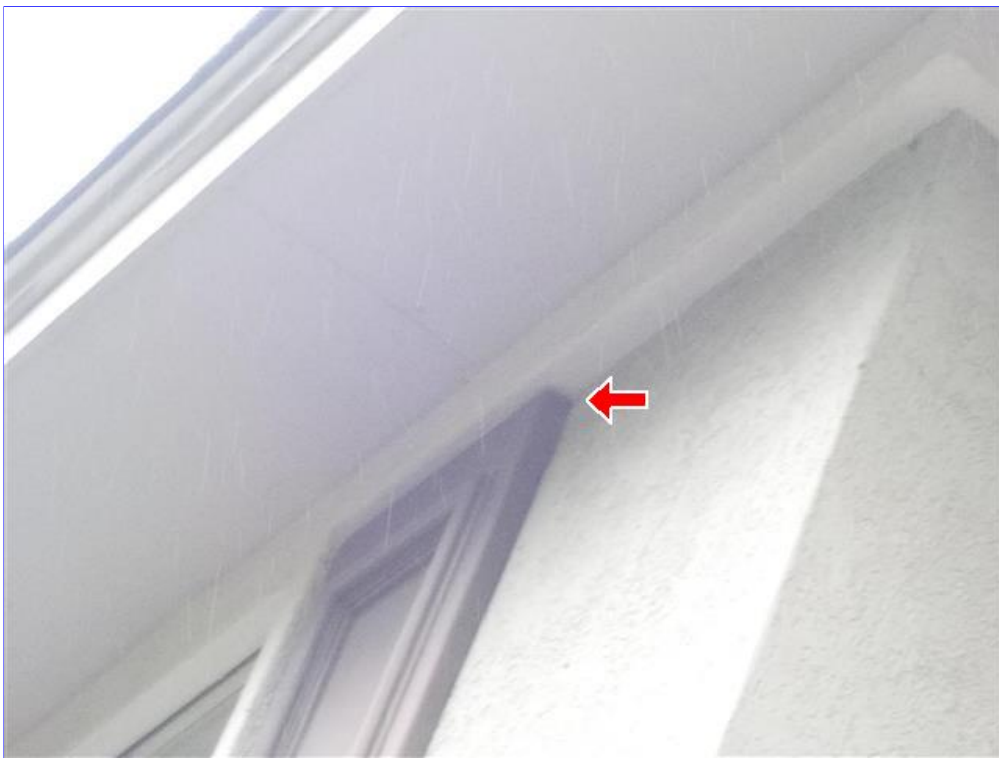
D. Item 8(Picture) Wood touching the fascia

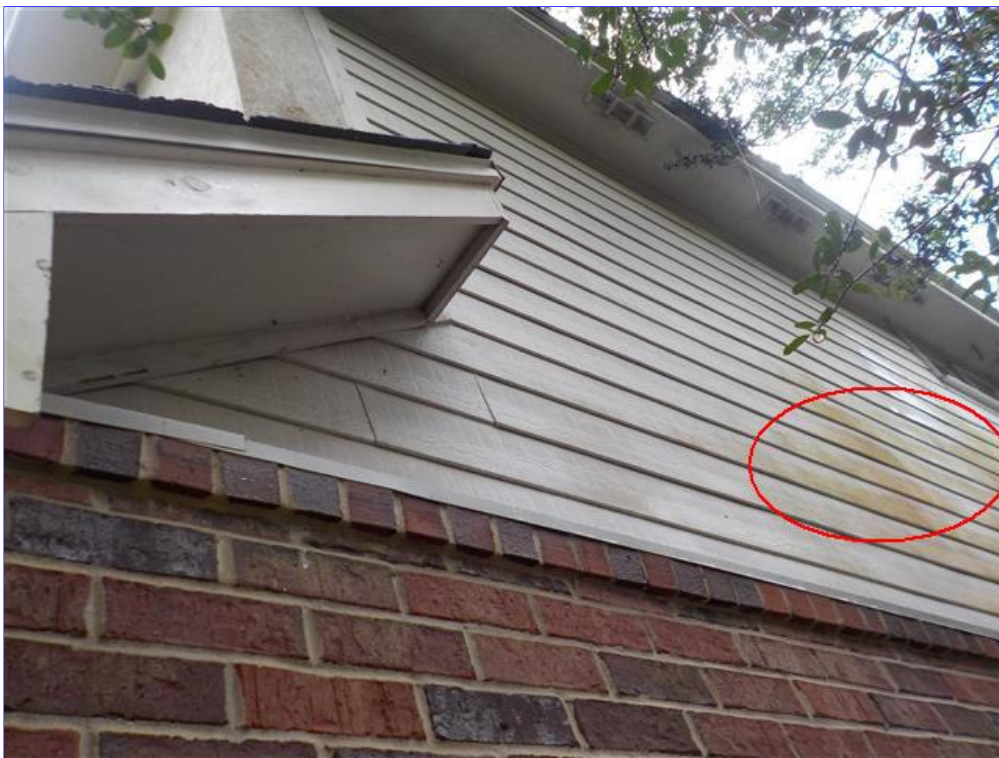
D. Item 10(Picture) Moisture issues causing discoloration

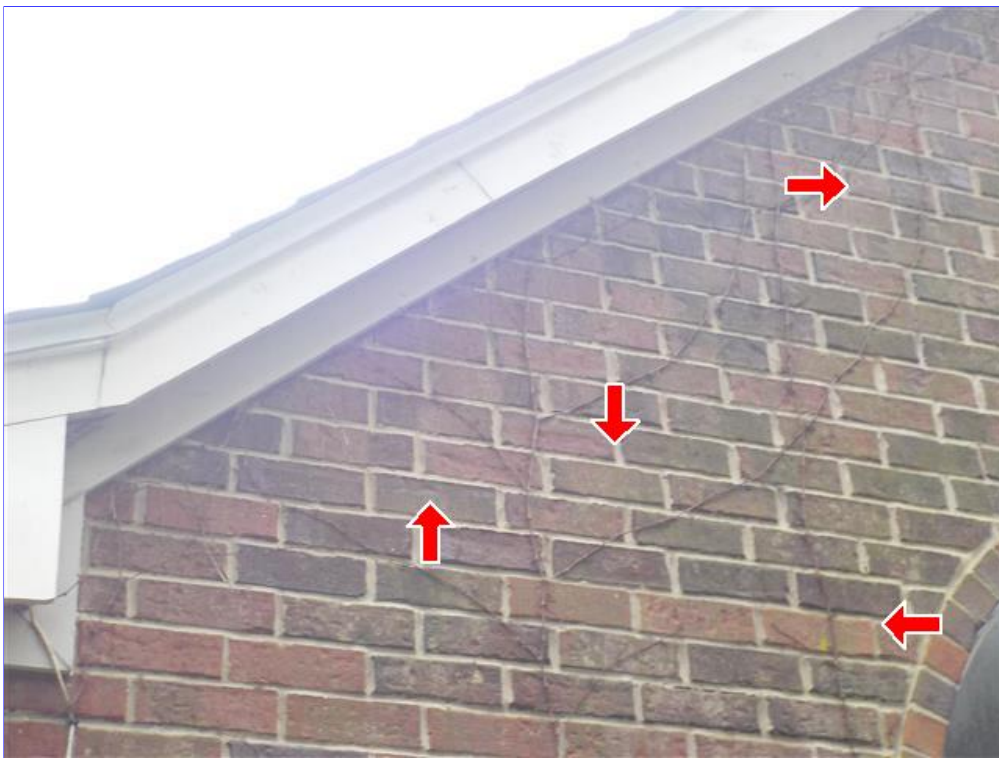
D. Item 14(Picture) Vines eat into the home

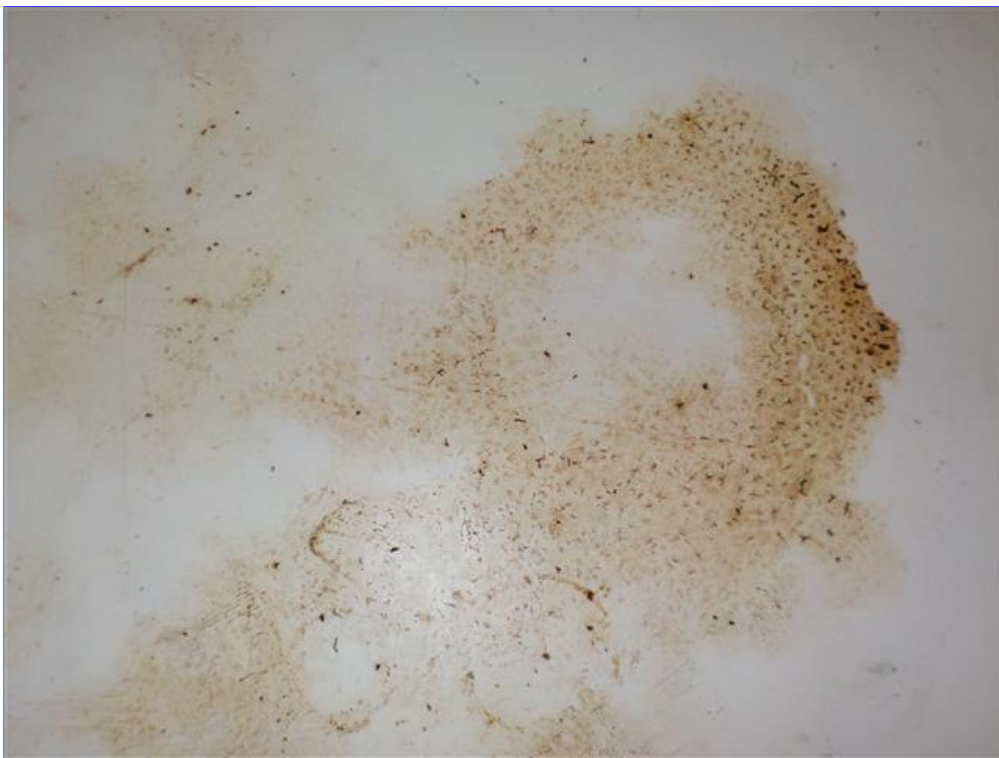
E. Item 2(Picture) Counter tops have stains

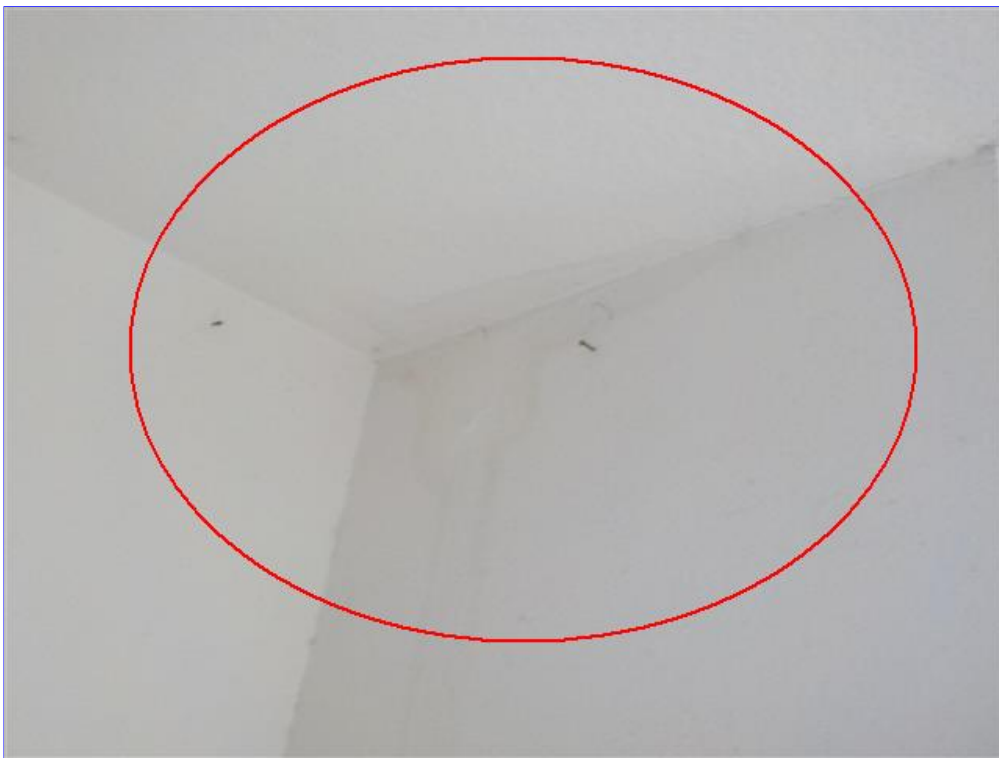
E. Item 4(Picture) Evident moisture problems

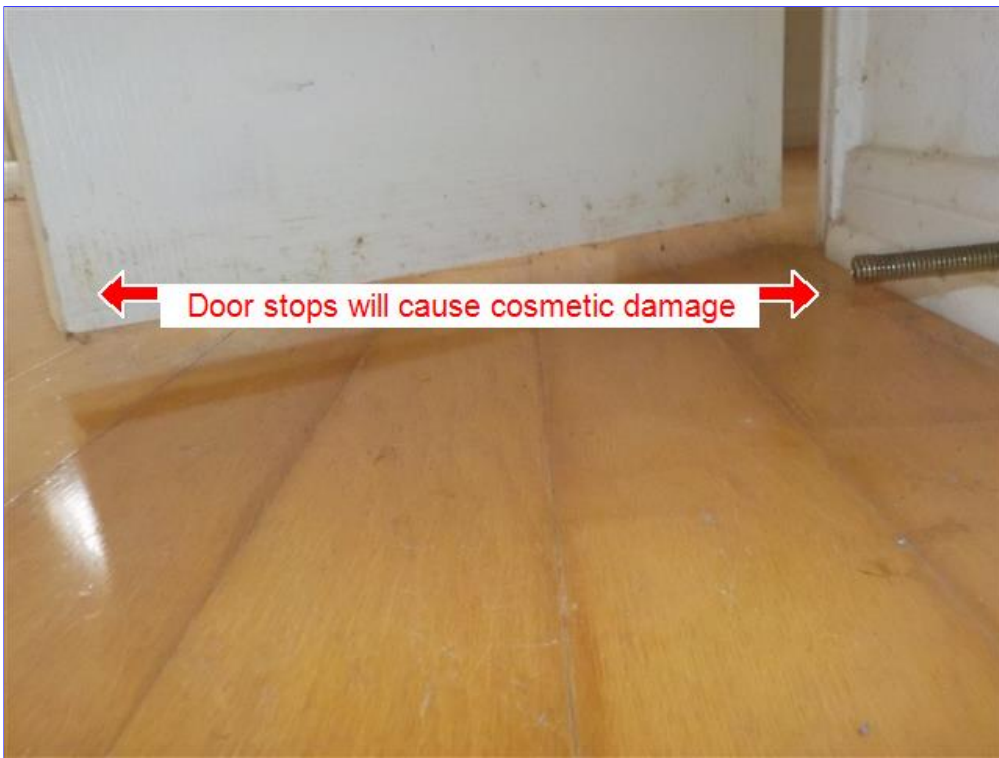
E. Item 8(Picture) Door stops not all installed

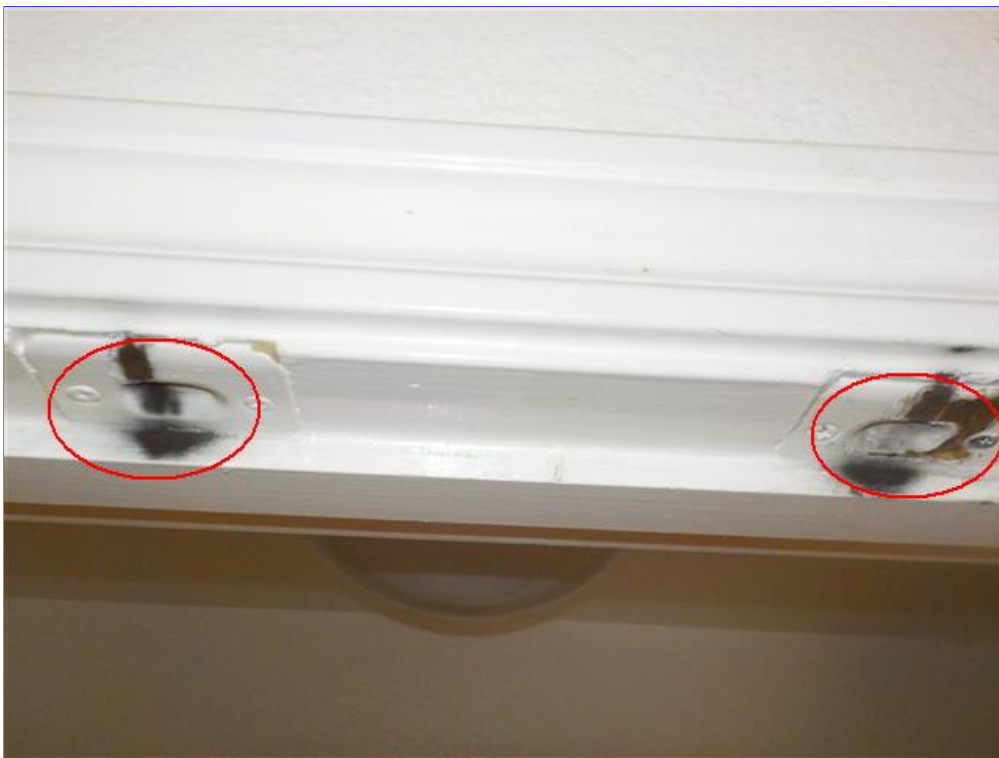
F. Item 6(Picture) WDO

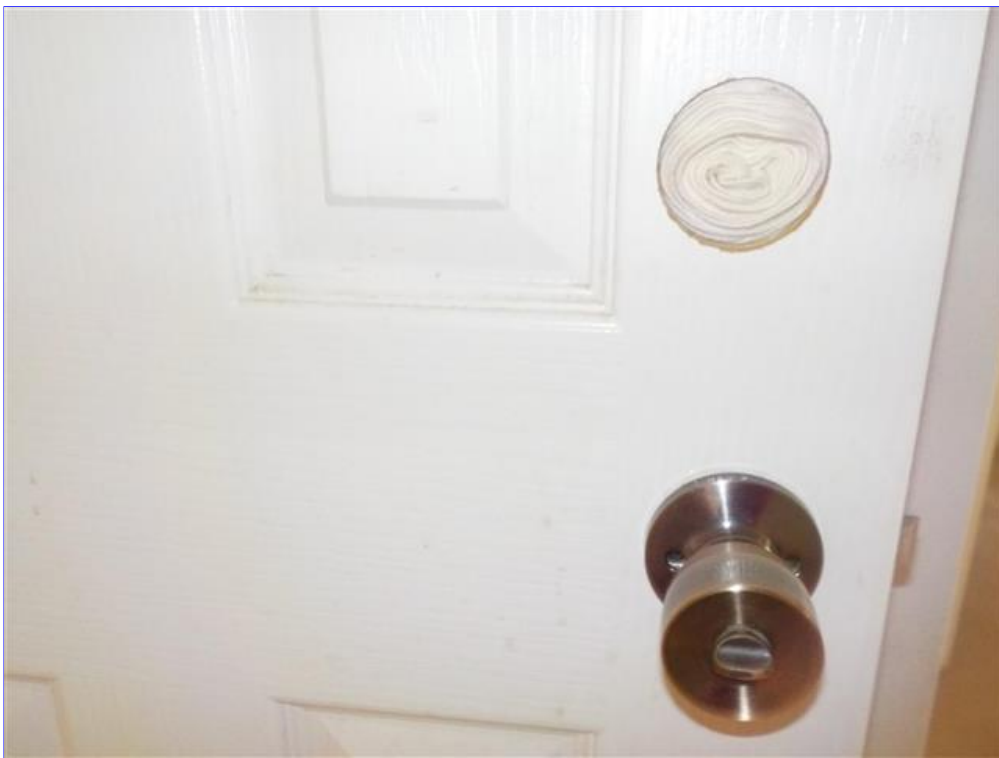
F. Item 8(Picture) Not a proper cover

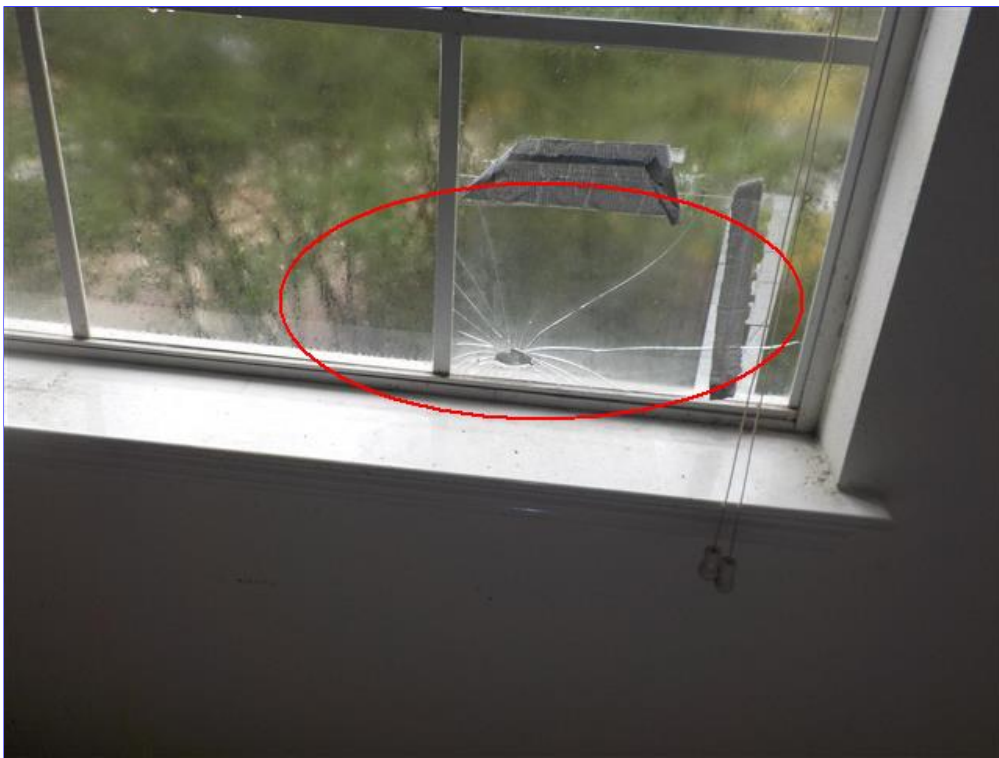
G. Item 6(Picture) Broken window is evident

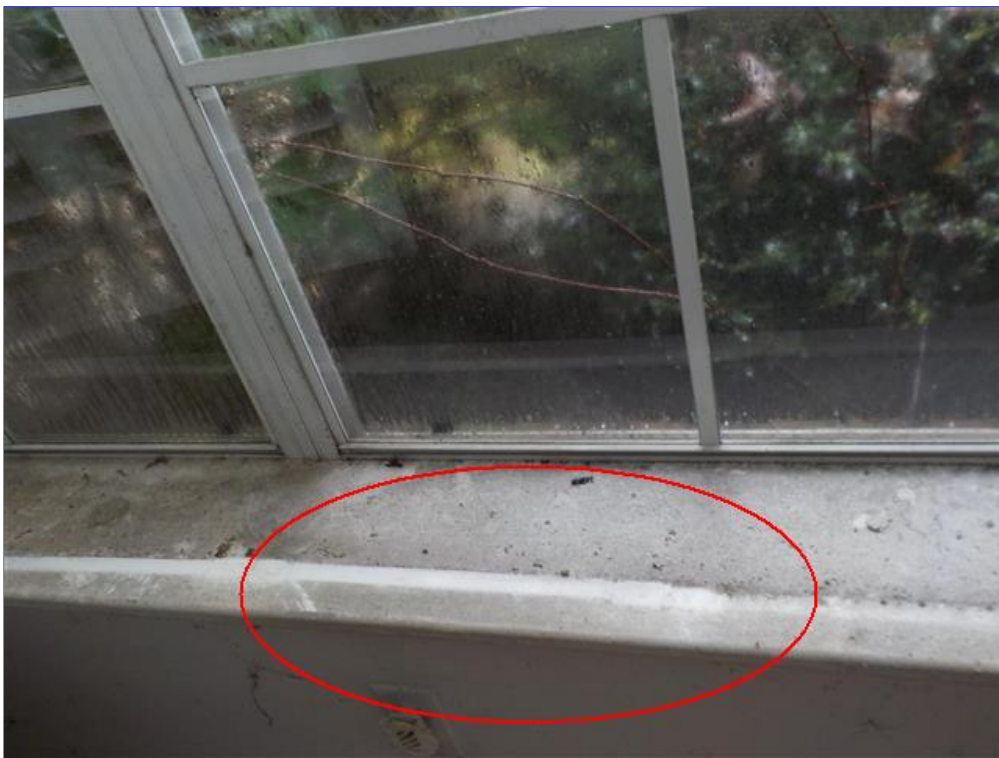
G. Item 12(Picture) WDO and warping due to the moisture issues

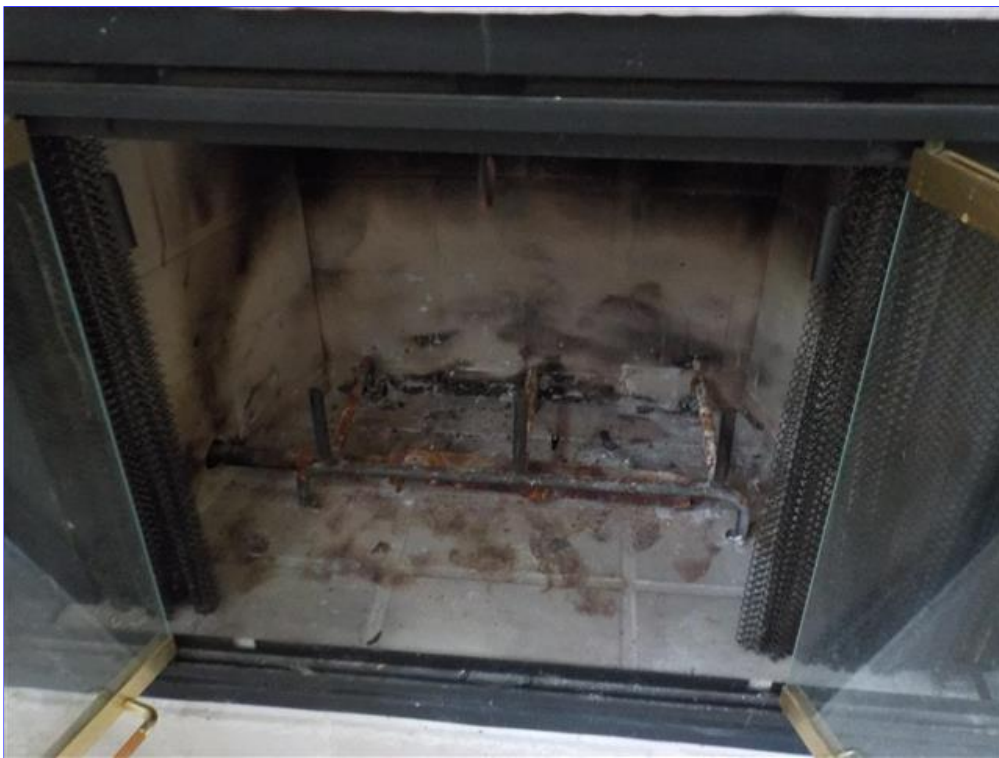
I. Item 6(Picture) Cracks in chimney can cause a fire

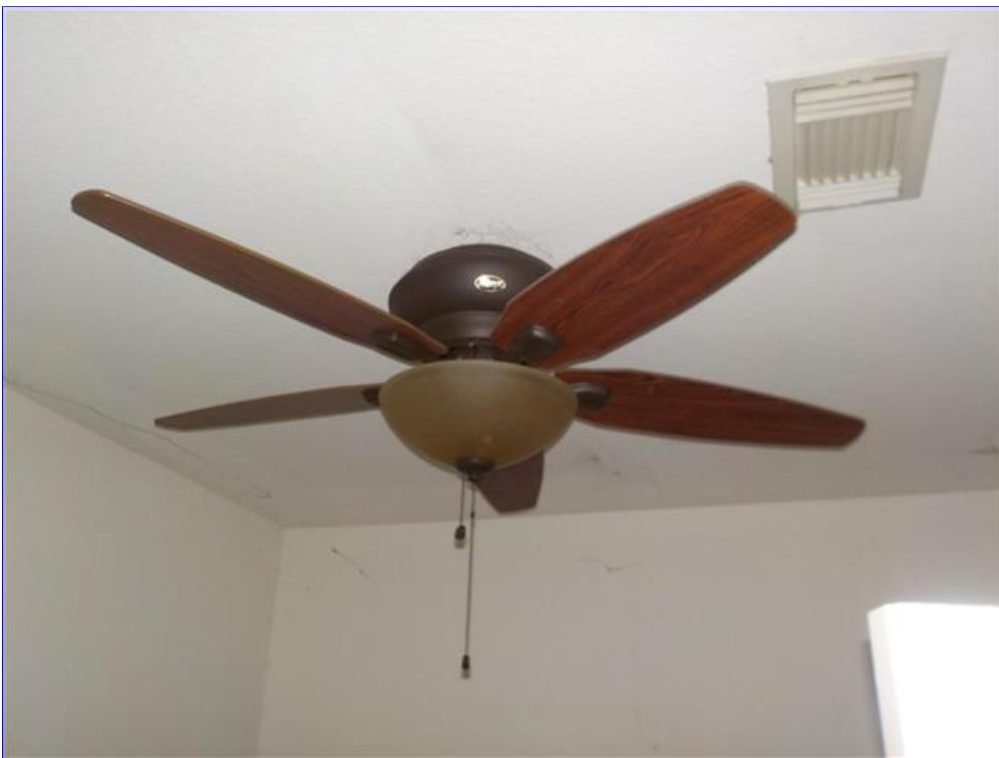
B. Item 10(Picture) Ceiling fan is in the garage

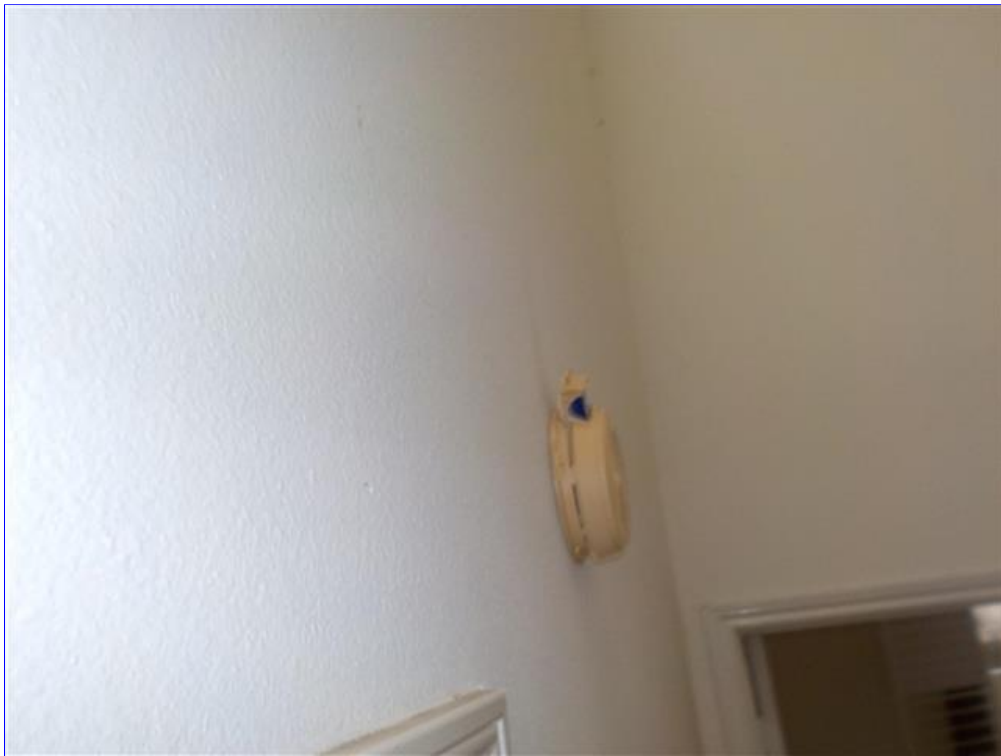
B. Item 12(Picture) Smoke alarms should be updated

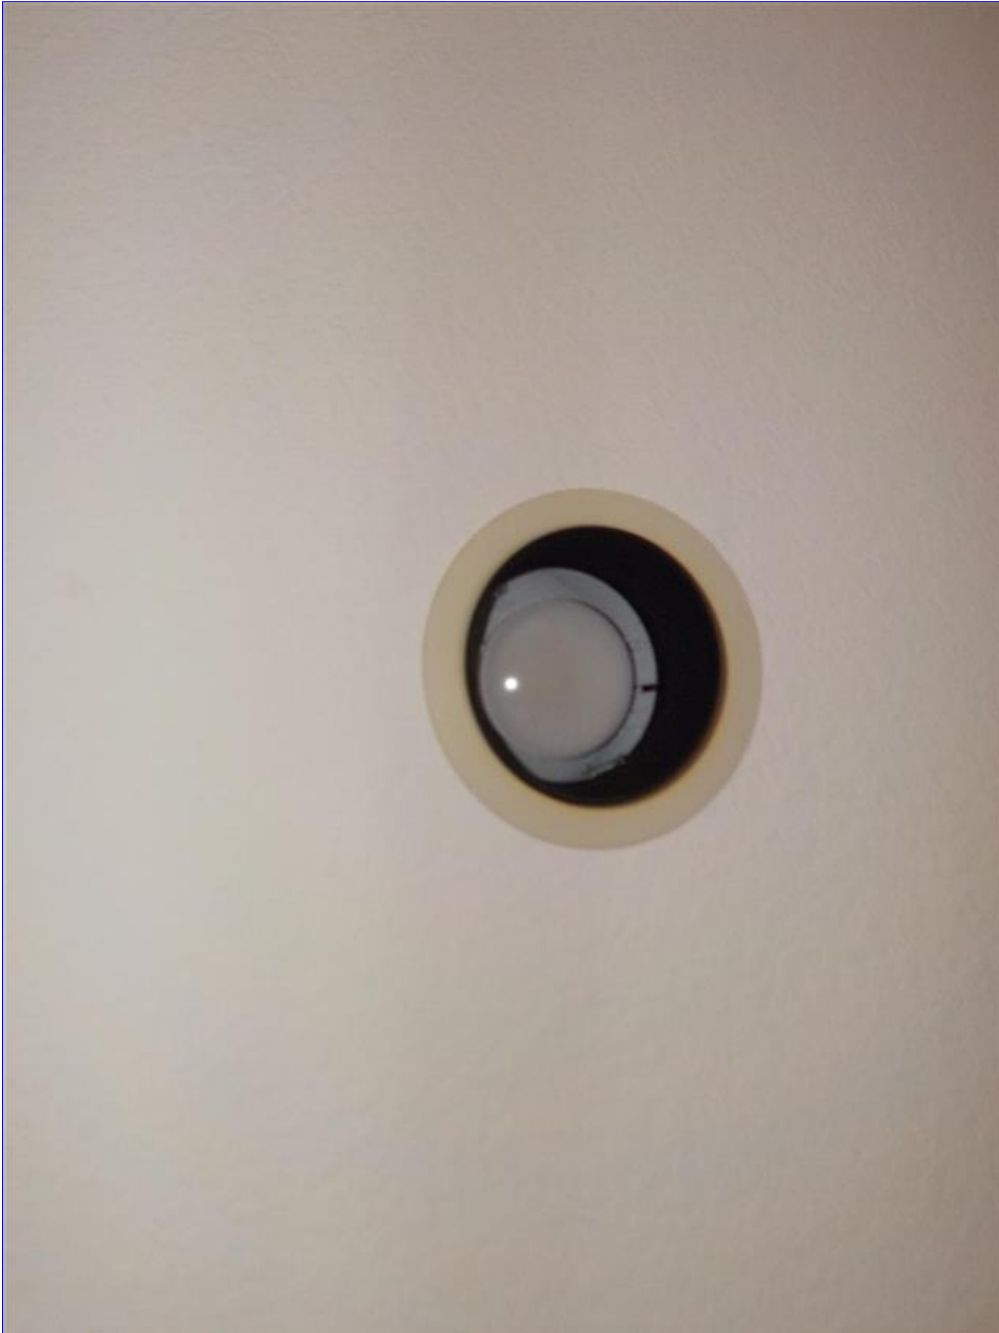
B. Item 13(Picture) non IC can

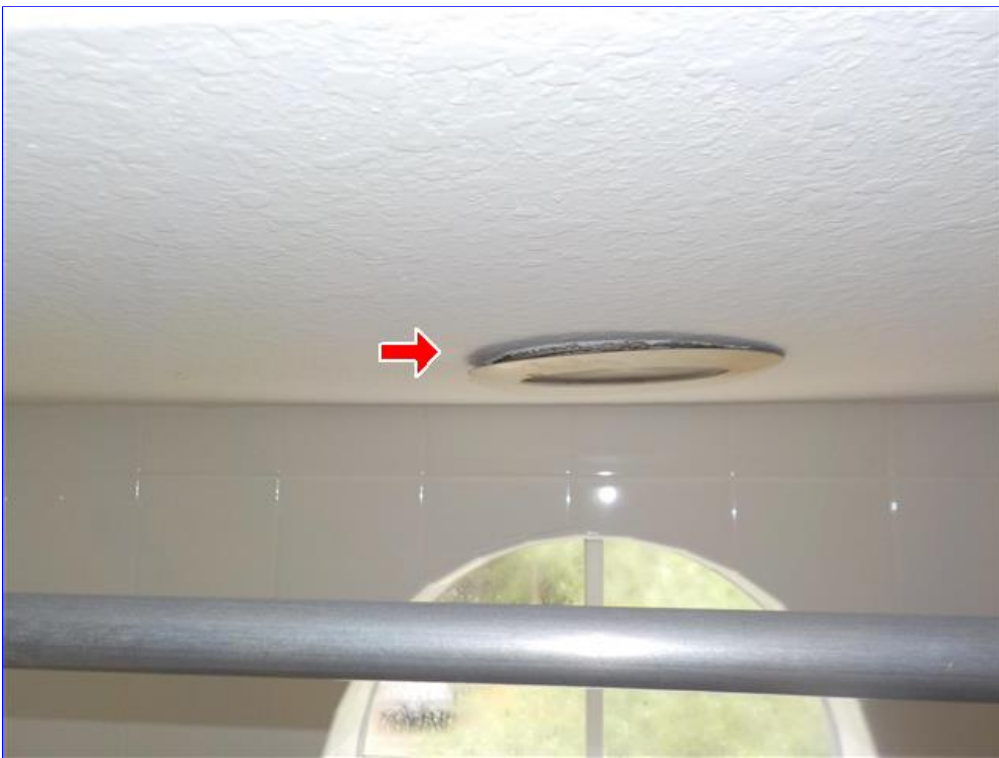
B. Item 15(Picture) Recessed lighting not flush or secure and its non ic can non insulated

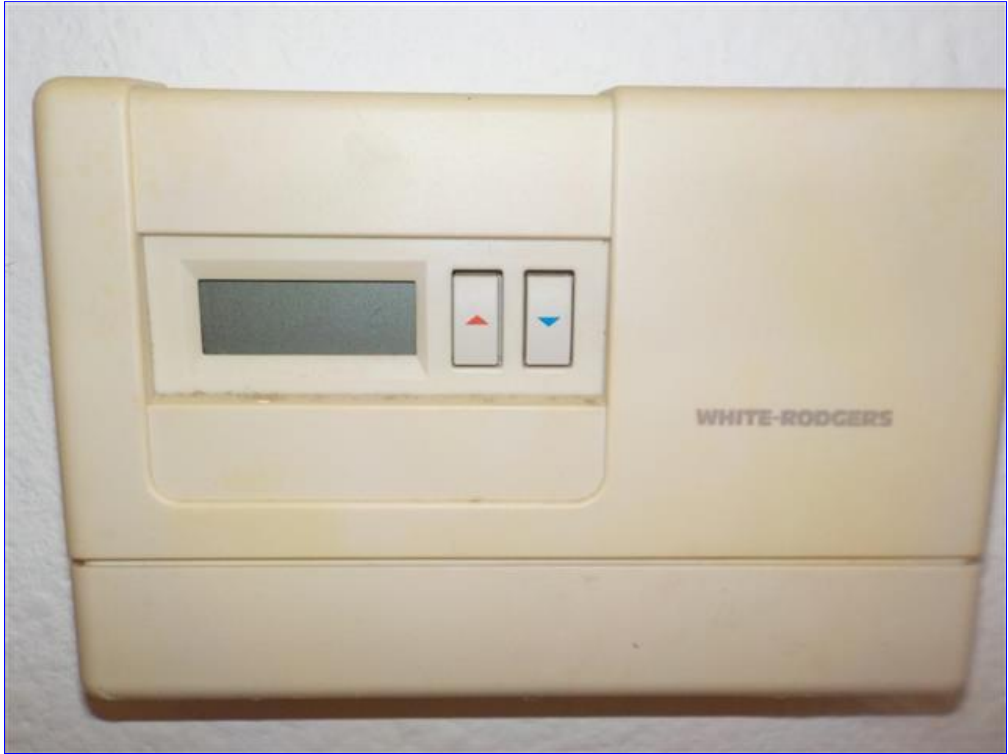
A. Item 4(Picture) not working and aged

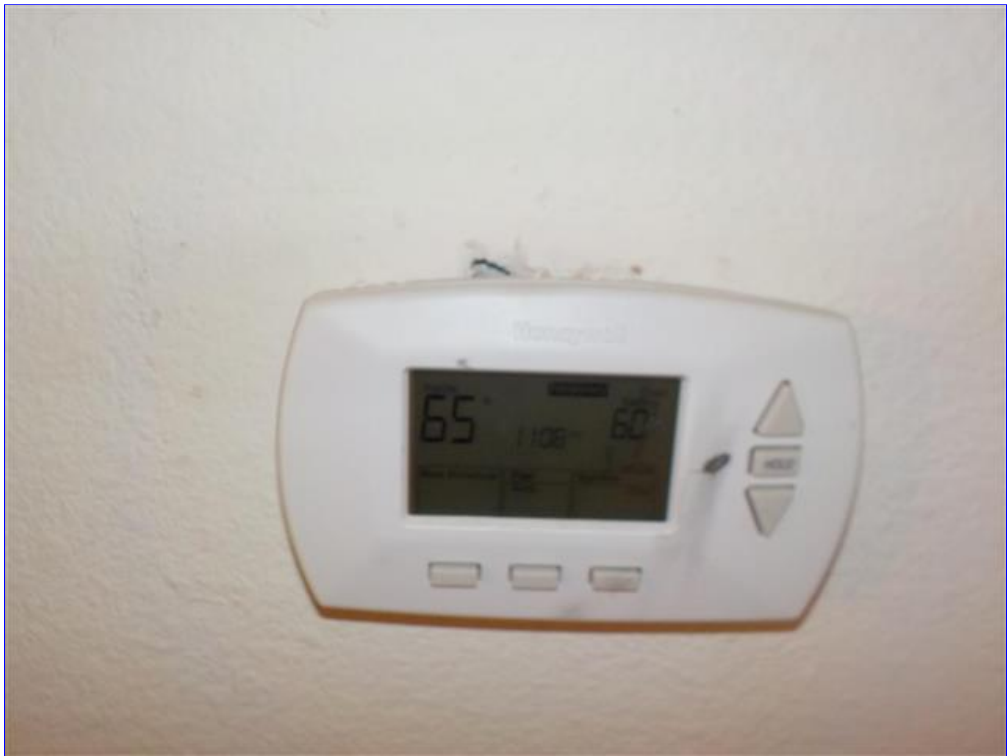
A. Item 5(Picture) this one worked aged ac units one would not come on most likely thremostat

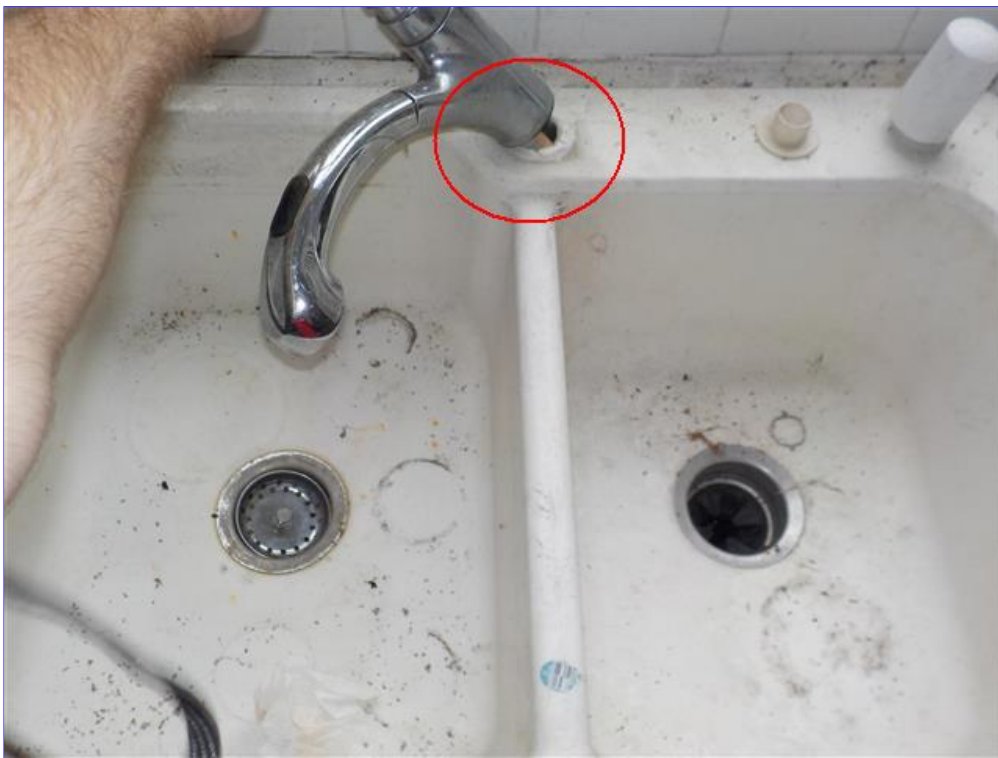
A. Item 6(Picture) Improper installation or deterioration of the installation resulted in a unsecured sink
