Inspection Report

Property Address:
26 South Bethany Bend
Woodlands Texas 77382

PROPERTY INSPECTION REPORT

Concerning: 26 South Bethany Bend, Woodlands, Texas 77382

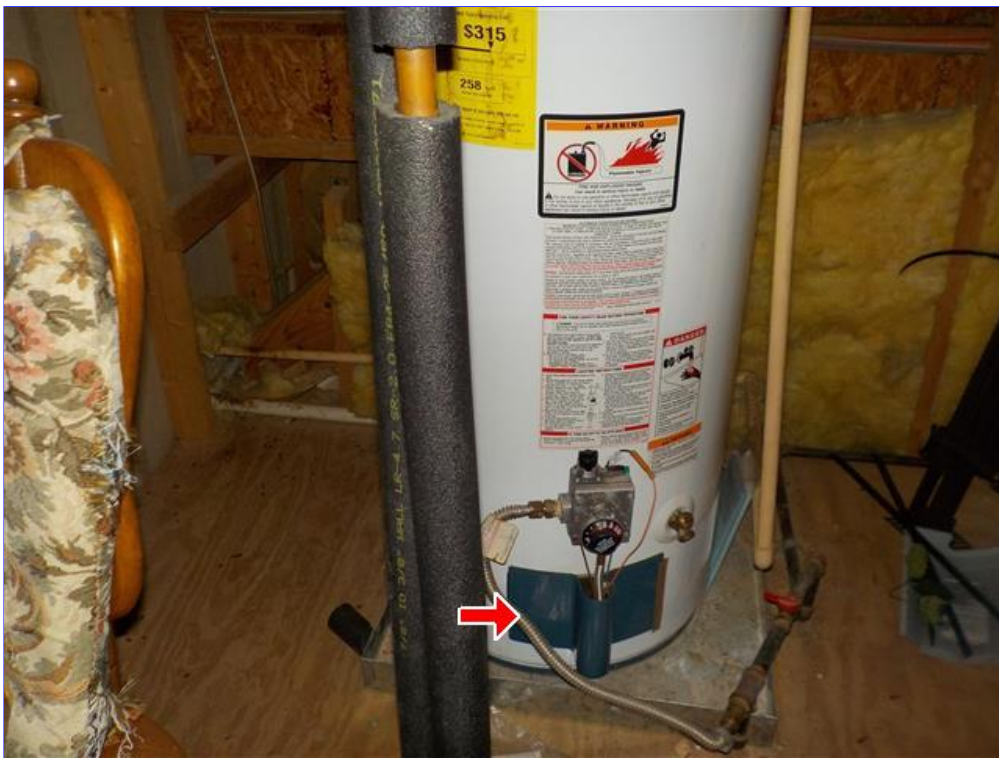
C. Item 2(Picture) make sure gal line is bonded and gas meter bonded

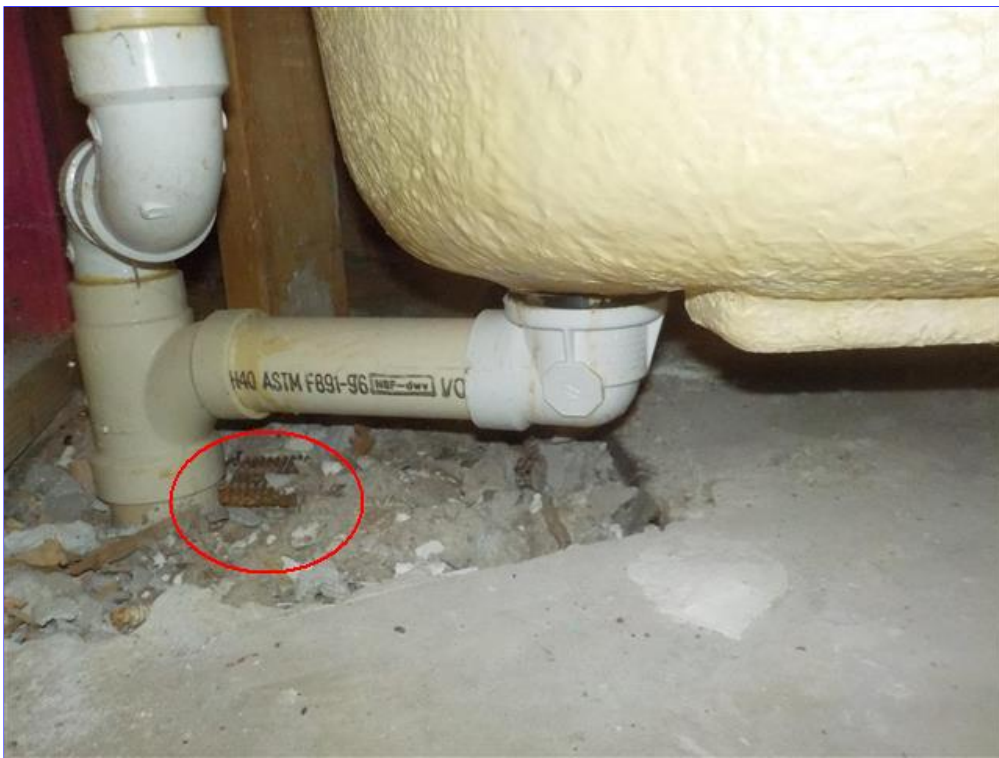
D. Item 4(Picture) Exposed rebar can rust more as time goes

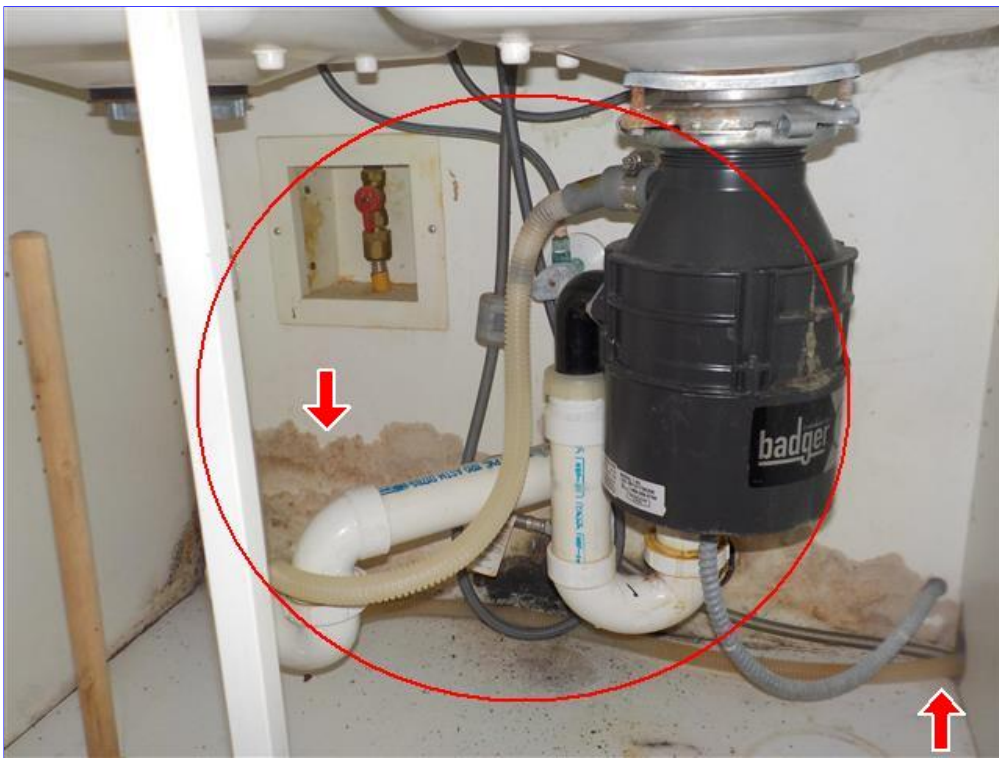
B. Item 2(Picture) Moisture stains are indicative of further moisture related issues

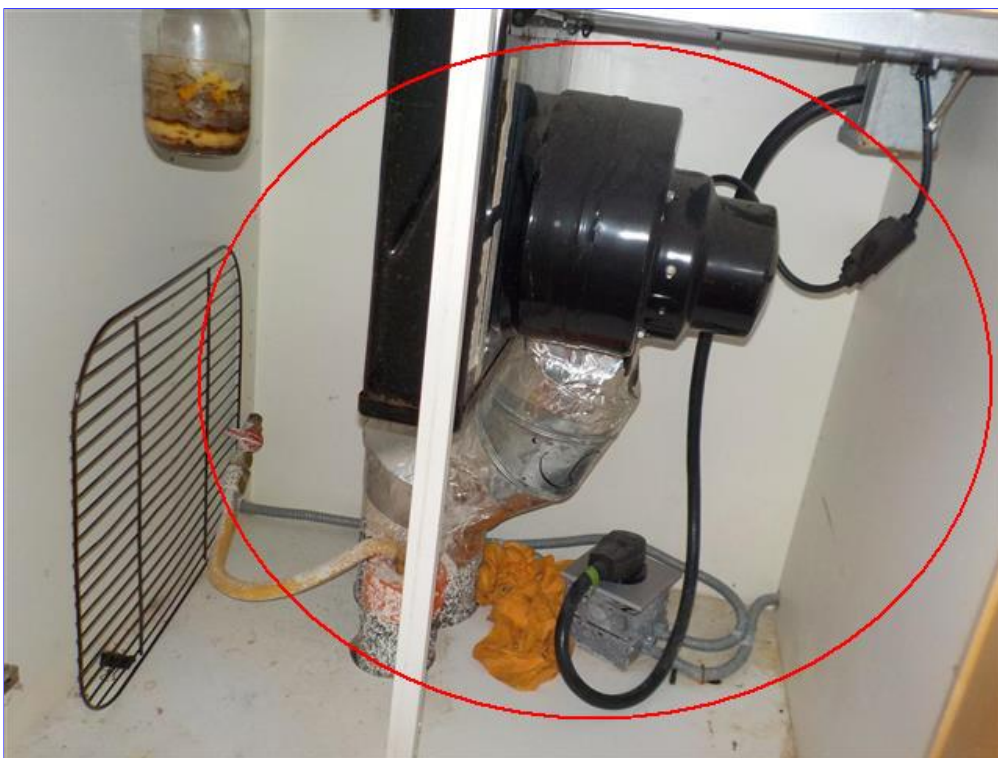
D. Item 2(Picture) Recommend further evaluating this appliance and consider replacement

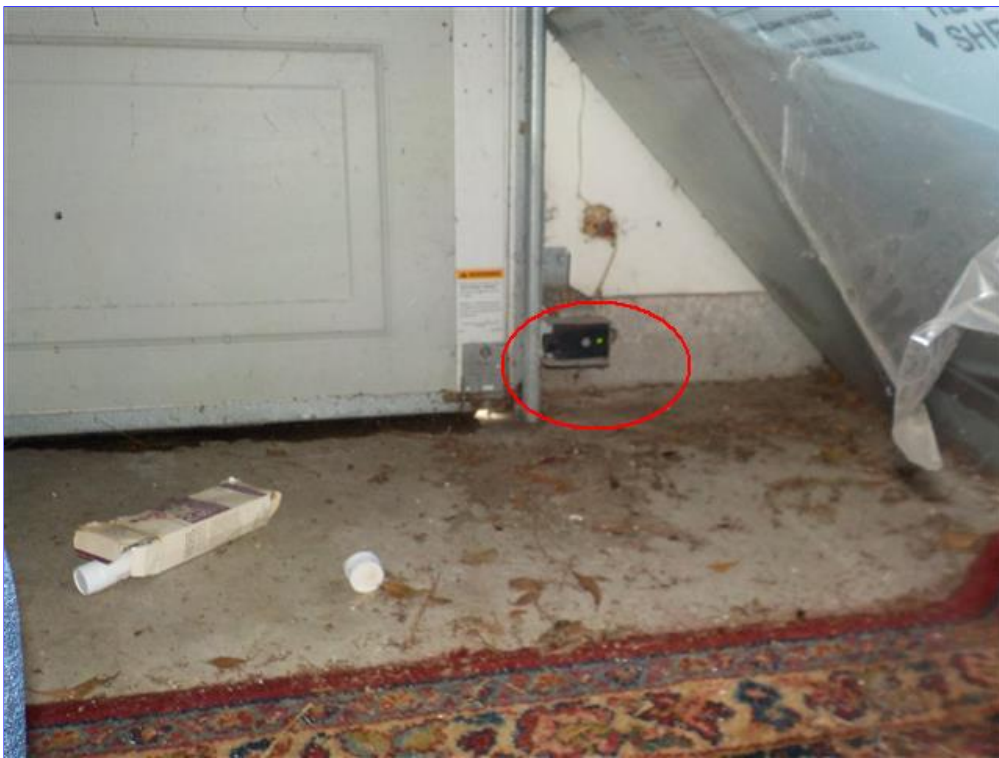
H. Item 2(Picture) Should be 6in from the center of the eye, its within tolerance

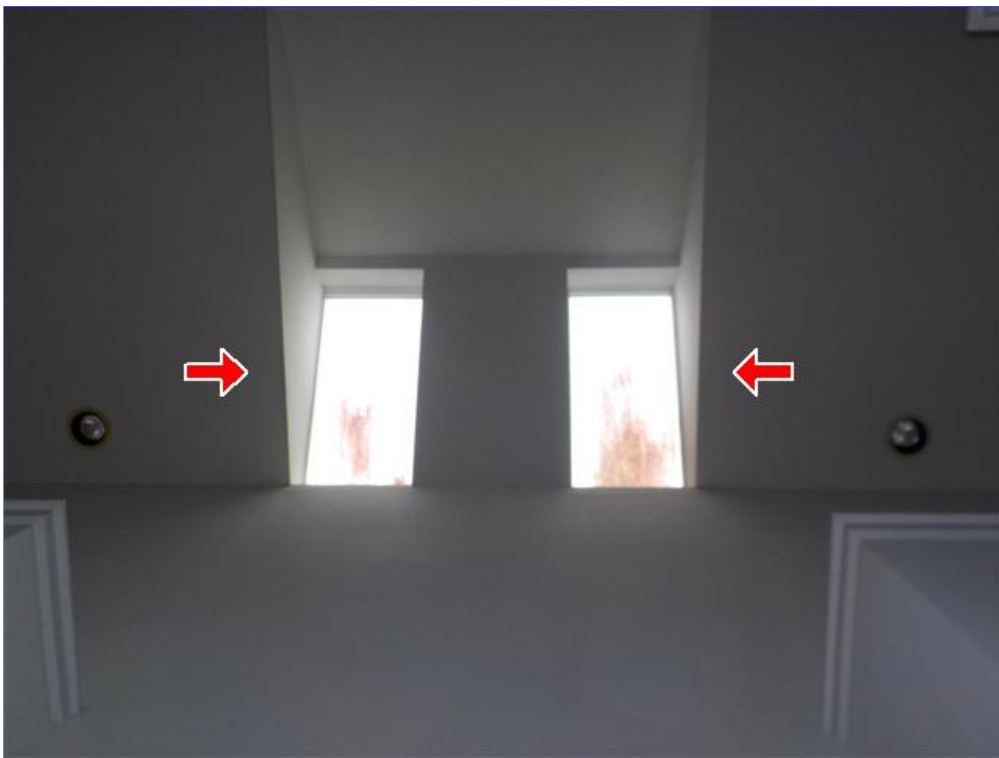
J. Item 2(Picture) Unsure what the stain is composed of
