PROPERTY INSPECTION REPORT

Concerning: 4910 Amorgas Isle Dr.

Spring, TX 77388

09/14/2019

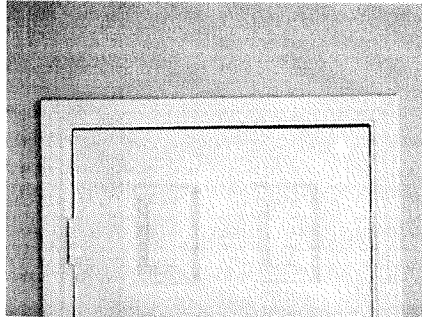
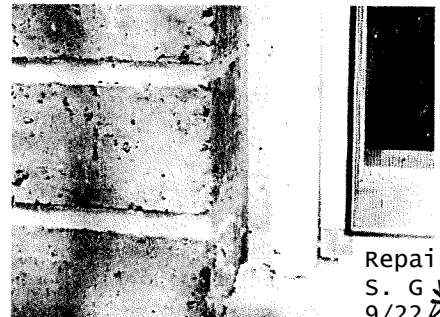
Deficiency: There are signs of excessive differential foundation settlement in the structure such as cracks in the exterior brick veneer, the exterior brick veneer's mortar appears patched on front of the breakfast room, un-level door headers, separation between the middle window on front of the breakfast room and the exterior brick veneer (filled with mortar), freeze boards that are out of place and/or modified on front of the breakfast room and cracks in the foundation's exterior grade beam. These conditions indicate that the foundation may require a permanent remedy to stabilize the structure in some areas. The best course to follow for foundation settlement is to consult a professional (structural) engineer and/or a qualified foundation repair specialist so that a course of corrective procedures can be evaluated.

Repaired by
 S. G Willett
 9/22/2019

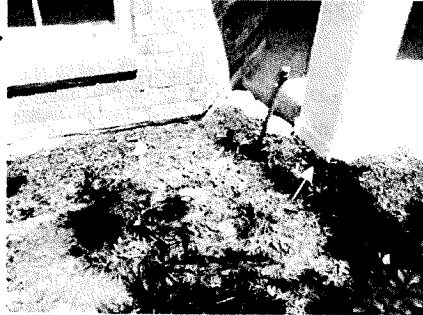
Deficiency: The soil levels are high against the foundation at the flowerbed on the front of the home. It is generally accepted that there should be at least 4 to 6 inches of exposed concrete between the bottom of the veneer or siding and the soil. The soil adjacent to the foundation should slope away from the foundation at least 6 inches in the first 10 feet where possible.

Repaired by
S. G Willett
9/22/2019

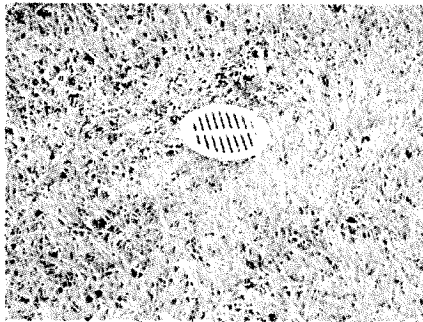
Deficiency: Water appears to collect at multiple low areas in the backyard. The yard's general grading should be improved at these locations to allow for adequate drainage of water towards the street.

Deficiency: The yard should be graded to drain towards the surface drains on the west side of the home.

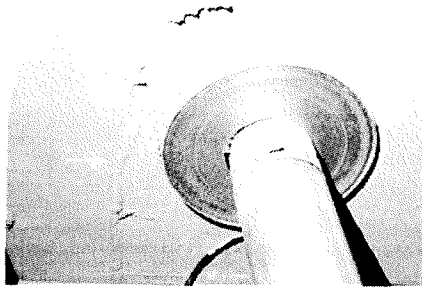
***Deficiency:** There is water damaged paint on the ceiling in the garage above the water heater. This indicates that the roof above this area may allow water to penetrate into the home. A roofing contractor should evaluate the roof above this area and make any necessary repairs.

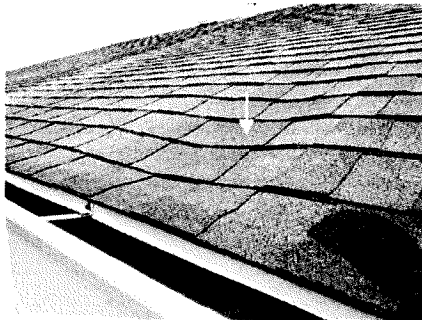
Deficiency: The roof decking is abnormally depressed along the west edge of the home approximately above windows above the dining/living room. This indicates that the roof above this area may allow water to penetrate into the home. A roofing contractor should evaluate the roof above this area and make any necessary repairs.

Repaired by
S. G Willett
9/22/2019

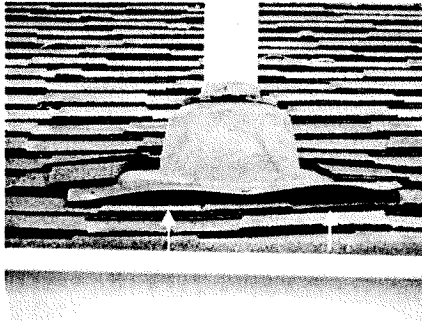
Deficiency: The open space(s) should be sealed underneath at least 4 roof jacks.

Repaired by
S. G Willett
9/22/2019

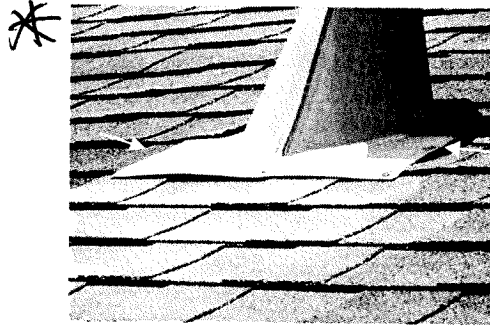
Deficiency: At least 1 vent roof jack is not installed properly on the east side of the home. Shingles should overlap the sides of the roof jack.

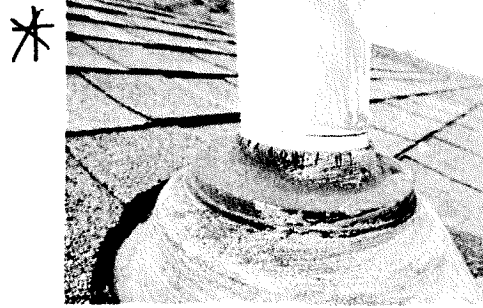
Deficiency: The seals are damaged around the pipes at a majority of the plumbing vent roof jacks.

Repaired by
S. G Willett
9/22/2019

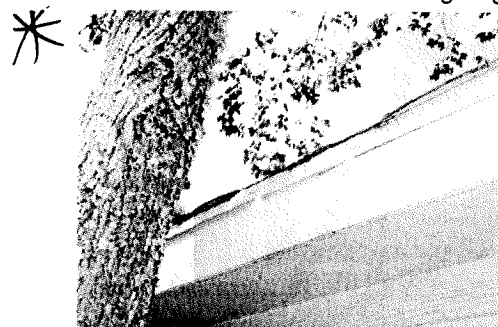
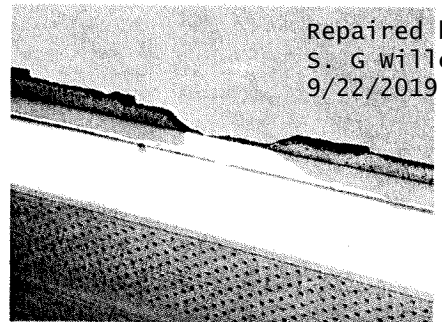
Deficiency: Multiple shingles are damaged above the front of the breakfast room and above the front of the garage.

Repaired by
S. G Willett
9/22/2019

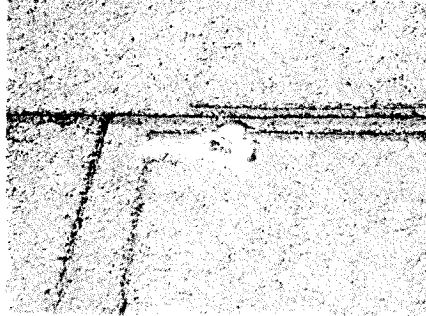
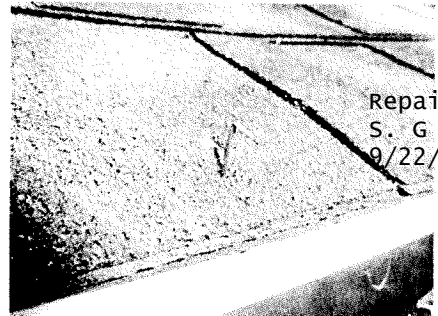
Deficiency: Multiple nails and staples protrude from exposed portions of shingles on all sides of the roof.

Repaired by
S. G Willett
9/22/2019 *

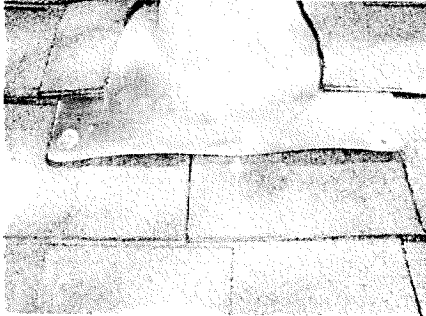
Deficiency: Several exposed nail heads were observed on the roof at multiple locations around the home. All exposed nail heads should be properly covered with roofing compound.

Repaired by
S. G Willett
9/22/2019 *

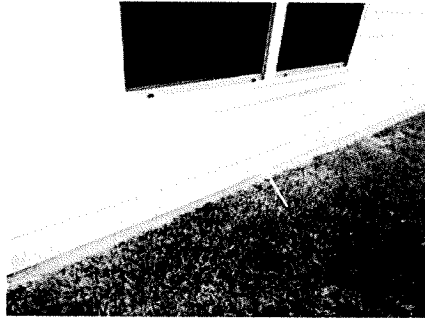
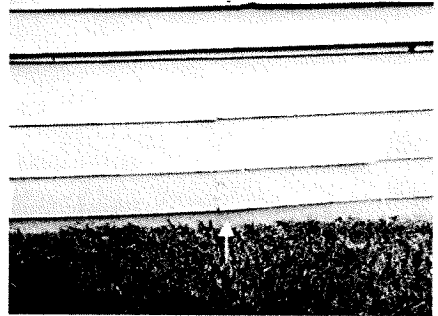
Deficiency: The exterior siding/trim is loose and out of place underneath the windows on the west side of the dining/living room. This siding bulges outwards. The exact cause of this condition was not determined. The condition of the wall behind the siding was not visible and was not determined. **Note:** The roof appears to leak approximately above this location and may be associated with this condition.

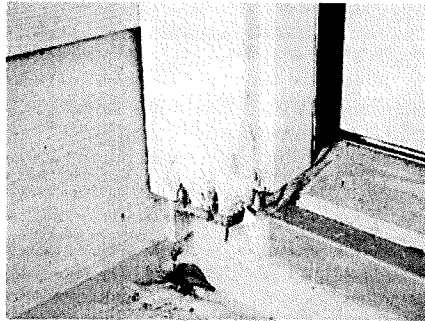
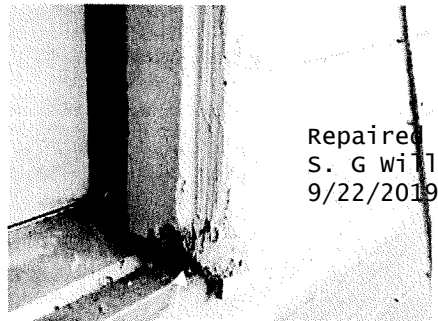
Deficiency: There is damaged exterior wood trim near the ground on both sides of the rear exterior door.

Repaired by
S. G Willett
9/22/2019

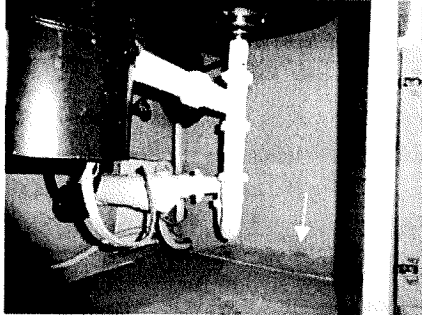
Deficiency: Water damaged cabinetry is present underneath the kitchen sink. Any sources of water should be located and repaired. All damaged materials should be appropriately repaired/replaced as needed.

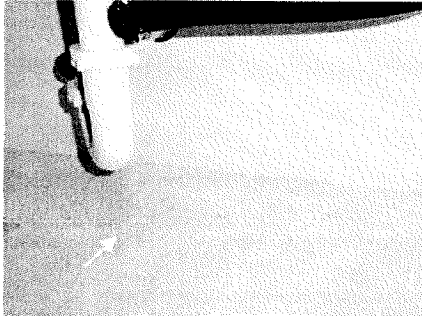
Deficiency: Water damaged cabinetry is present underneath the sink in the hall bathroom. Any sources of water should be located and repaired. All damaged materials should be appropriately repaired/replaced as needed.

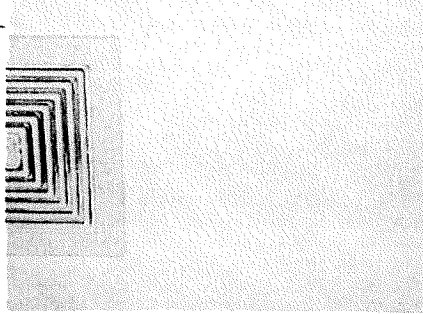
Deficiency: The ceiling's sheetrock is water stained/damaged near the exhaust fan on the ceiling above the hall bathroom. Any sources of water should be located and repaired. All damaged materials should be appropriately repaired/replaced as needed.

Repaired by
S. G Willett
9/22/2019

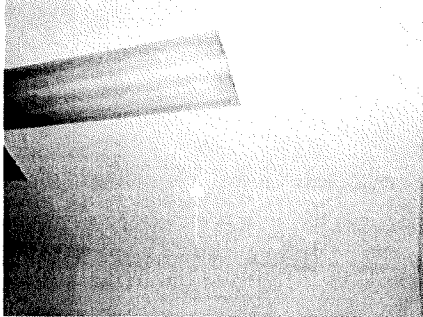
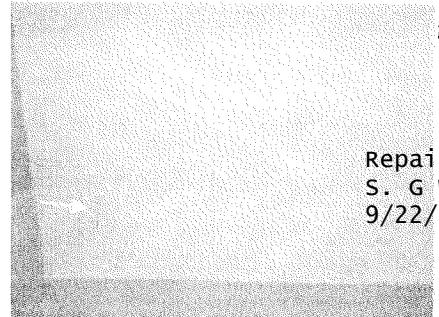
Deficiency: The ceiling's sheetrock is discolored and sags above the south side of the utility room. This may be a result of exposure to water. Any sources of water should be located and repaired. All damaged materials should be appropriately repaired/replaced as needed.

Repaired by
S. G Willett
9/22/2019

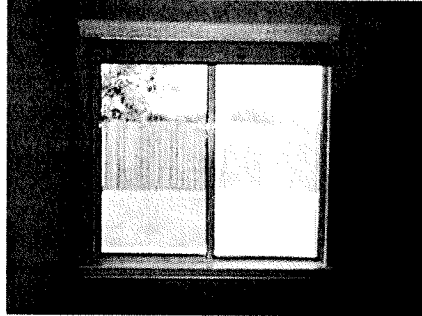
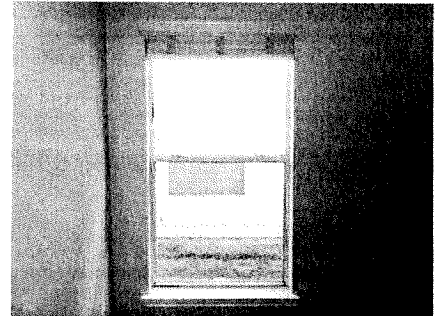
Deficiency: Multiple double paned windows are discolored and/or had moisture between the panes of glass during the inspection. This includes, but is not limited to:

This indicates that the seals between the panes of glass have broken. This can cause the windows to lose some of their insulating properties and become unsightly. A contractor that specializes in windows should evaluate all of the home's windows and make the necessary repairs. Note: Certain atmospheric and weather conditions can make this condition more or less noticeable.

Repaired by
S. G Willett
9/22/2019

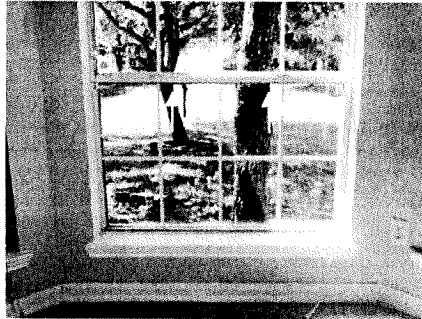
Deficiency: The lower panes of glass are loose near the window's lock at the middle window in the breakfast room.

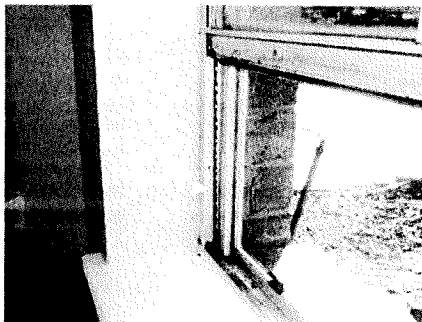
Deficiency: At least 1 metal tension rod is out of place along the sides of multiple windows. This includes:

- The left (east) window in the breakfast room
- The middle window in the breakfast room
- The left (north) window in the master bedroom

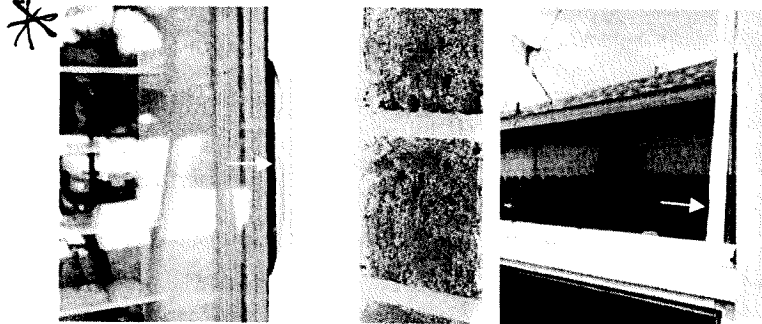
Deficiency: Plastic window beads are damaged around panes of glass at multiple windows.

Repaired by
S. G Willett
9/22/2019

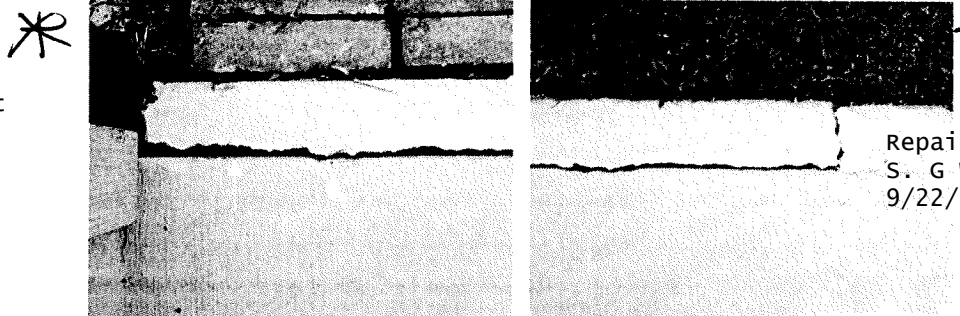
Deficiency: Broken concrete is present along the edge of the foundation along both open sides of the patio on the back of the home.

Repaired by
S. G Willett
9/22/2019

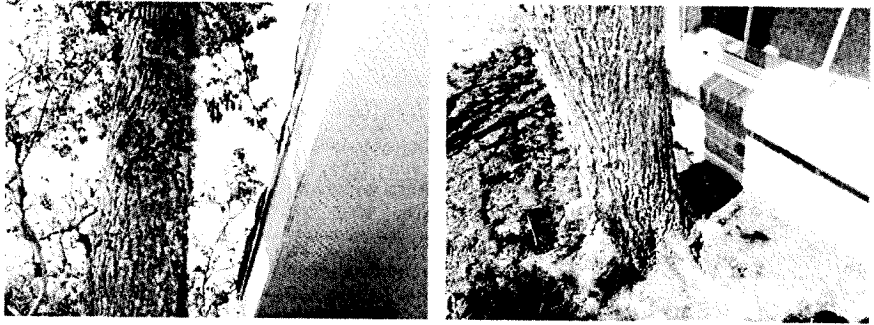
Deficiency: A tree is very close to the structure on the front of the breakfast room. Trees can have a negative impact on the structure. This includes, but is not limited to, the foundation, the roof and the sewer plumbing. This tree appears to have previously directly damaged the roof. Removal of the tree is recommended.

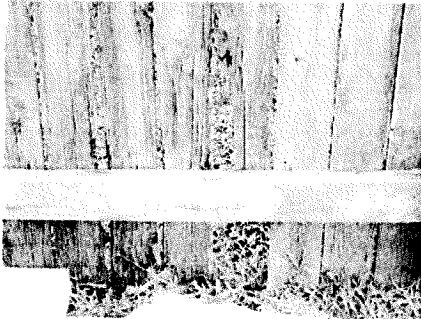
Deficiency: Numerous fence pickets are damaged and/or loose.

Neighbors Fence

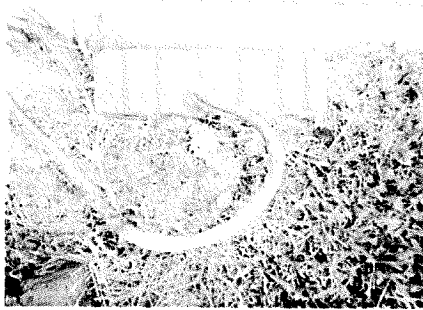
Deficiency: The main grounding electrode is not connected to the ground rod. The clamp is damaged.

Repaired by
S. G Willett
9/22/2019

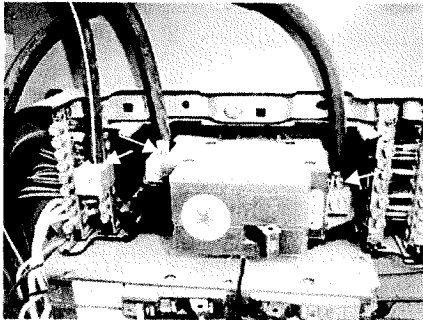
Deficiency: Anti-oxidant compound is not present on the aluminum service connections.

Repaired by
S. G Willett
9/22/2019

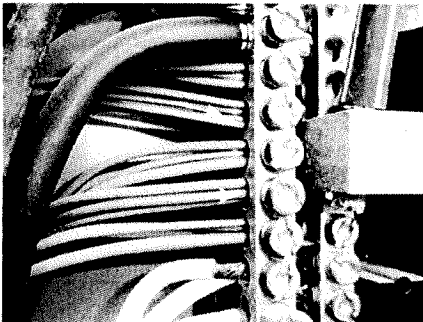
Deficiency: At least 3 ground wires have been installed under single terminal lugs on the ground busbar in the main electric panel. The manufacturer's installation instructions should be consulted to determine the maximum number of wires allowed under 1 screw. This is typically 1 or 2 ground wires.

Repaired by
S. G Willett
9/22/2019

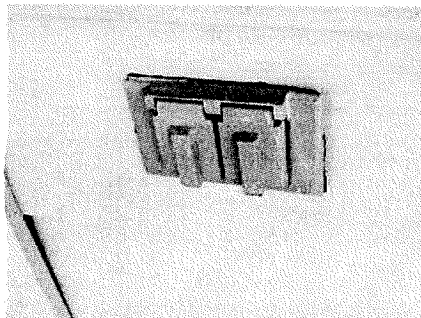
Deficiency: The exterior receptacle on the back patio is loose.

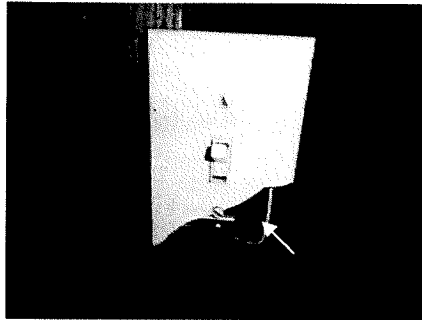
Deficiency: The cover plate is damaged on the light switch in the attic.

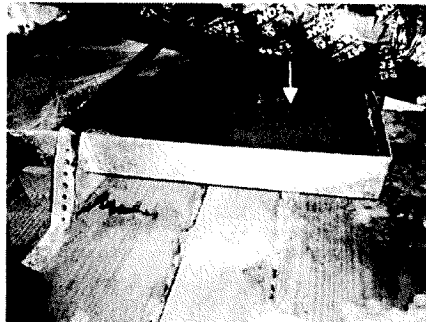
Deficiency: The A/C did not cool properly. The temperature differential across the evaporator coil was 11 degrees. Normal is approximately 15-20 degrees.

Deficiency: Standing water was present in the A/C's drain pan and water was dripping outside through the secondary drain line. This typically indicates that the evaporator coil's primary condensate drain line is blocked/clogged.

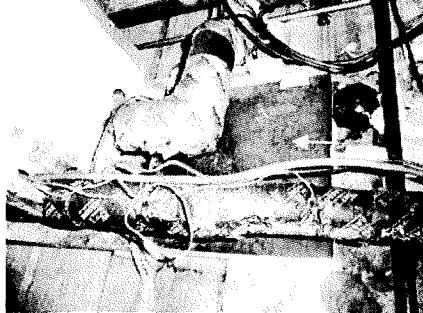
Deficiency: The drain pan underneath the A/C's evaporator coil is excessively rusted and should be replaced.

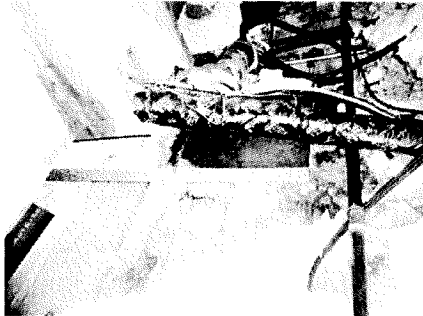
Deficiency: Discoloration on the attic's floor around the A/C's drain pan indicates the pan may have previously overflowed. This indicates that the pan's float type kill switch may not function properly.

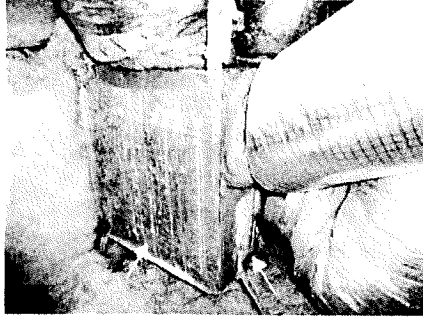
Deficiency: Water streaks and abnormal discoloration are present on the supply plenum located inside the attic. This indicates that abnormal condensation forms on the plenum and may drip onto the ceiling. A licensed HVAC technician should evaluate this condition and make any necessary repairs.

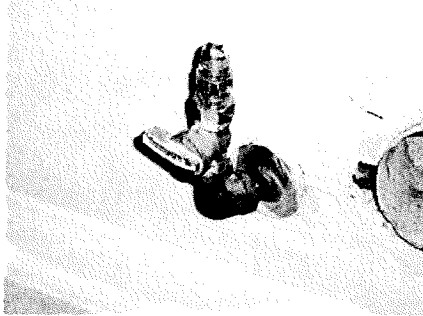
Deficiency: A gas leak was detected near the gas supply line and shut off valve in the utility room. A licensed plumber should evaluate this condition.

Repaired by
S. G Willett
9/22/2019

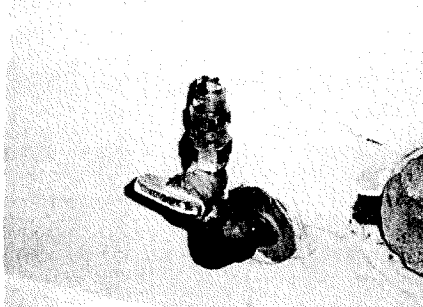
Deficiency: The gas supply line in the utility room for a clothes dryer should be capped/plugged if not in use.

Repaired by
S. G Willett
9/22/2019

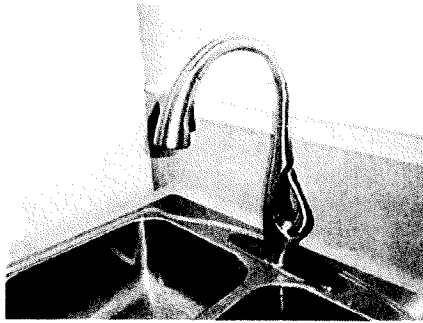
Deficiency: Hot water was not supplied at the kitchen sink's faucet.

Repaired by
S. G Willett
9/22/2019

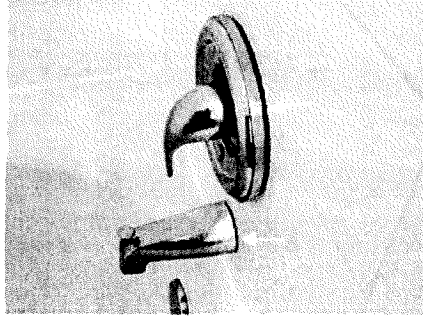
Deficiency: The open spaces should be properly caulked/sealed between the bathtub's faucet/spout and the tile wall in the master bathroom.

Repaired by
S. G Willett
9/22/2019

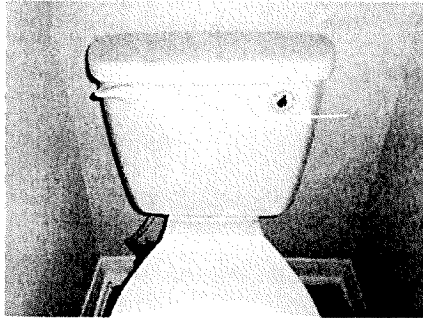
Deficiency: The toilet's tank is loose in the master bathroom.

Repaired by
S. G Willett
9/22/2019

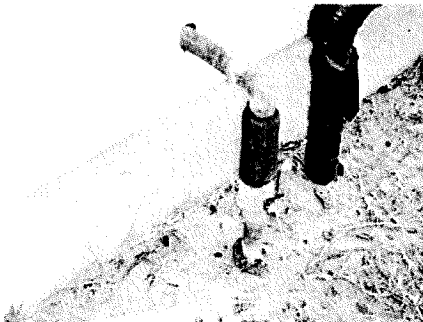
Deficiency: The main water supply plumbing outside on the west side of the home should be insulated.

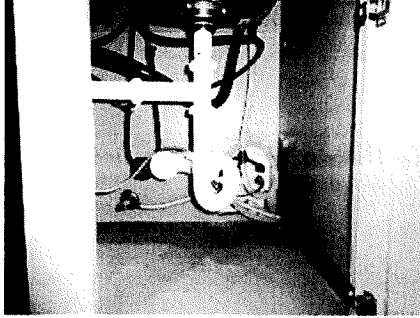
Deficiency: The drain line leaks water underneath the kitchen sink.

Repaired by
S. G Willett
9/22/2019

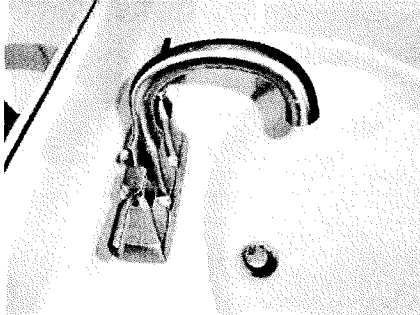
Deficiency: The sink's stopper does not function in the hall bathroom.

Repaired by
S. G Willett
9/22/2019

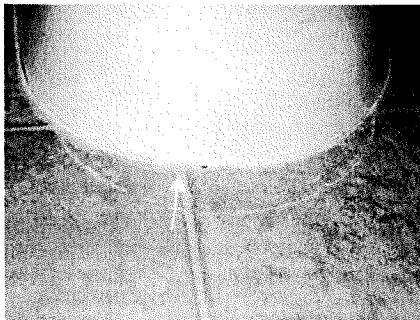
Deficiency: Water leaks from between the toilet and floor in the master bathroom.

Repaired by
S. G Willett
9/22/2019

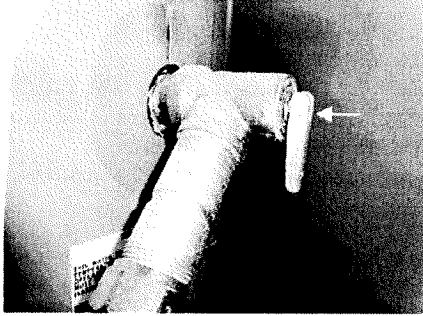
Deficiency: The Temperature and Pressure Relief (TPR) Valve serving the water heater is inoperative and should be replaced.

Repaired by
 S. G Willett
 9/22/2019

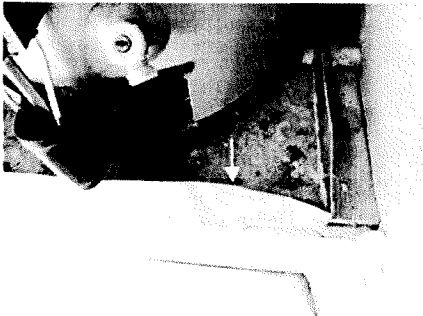
Deficiency: The metal drain pan under the water heater is bent/damaged.

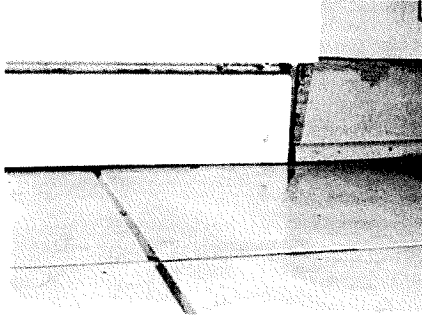
Deficiency: Water leaked from the dishwasher onto the kitchen floor while the dishwasher was in operation.

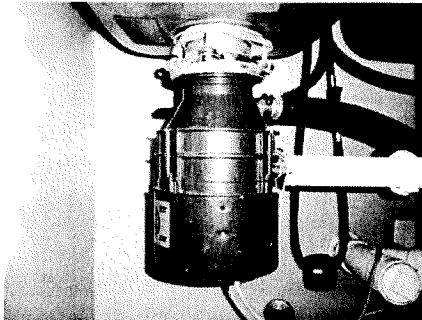
Deficiency: The disposer did not function.

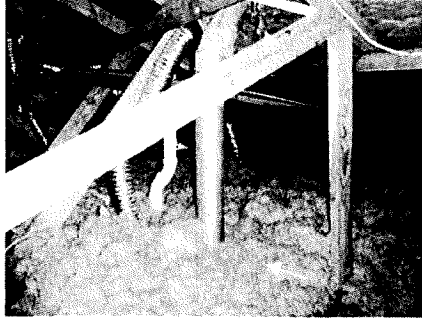
Deficiency: Dryer lint was observed at several locations inside the attic. This indicates that the dryer vent does not properly expel exhaust outside. The dryer vent may be clogged and/or it may leak.

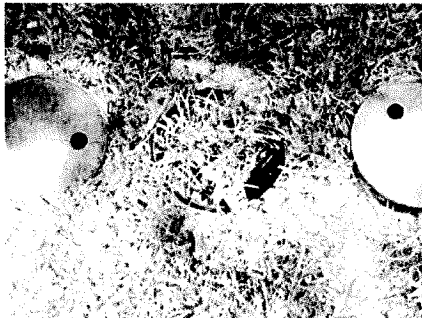
Deficiency: The cover is missing on 1 solenoid valve for the sprinkler system in the ground on the west side of the home.
